RTO AGARDograph **AG-AVT-140**

Corrosion Fatigue and Environmentally Assisted Cracking in Aging Military Vehicles

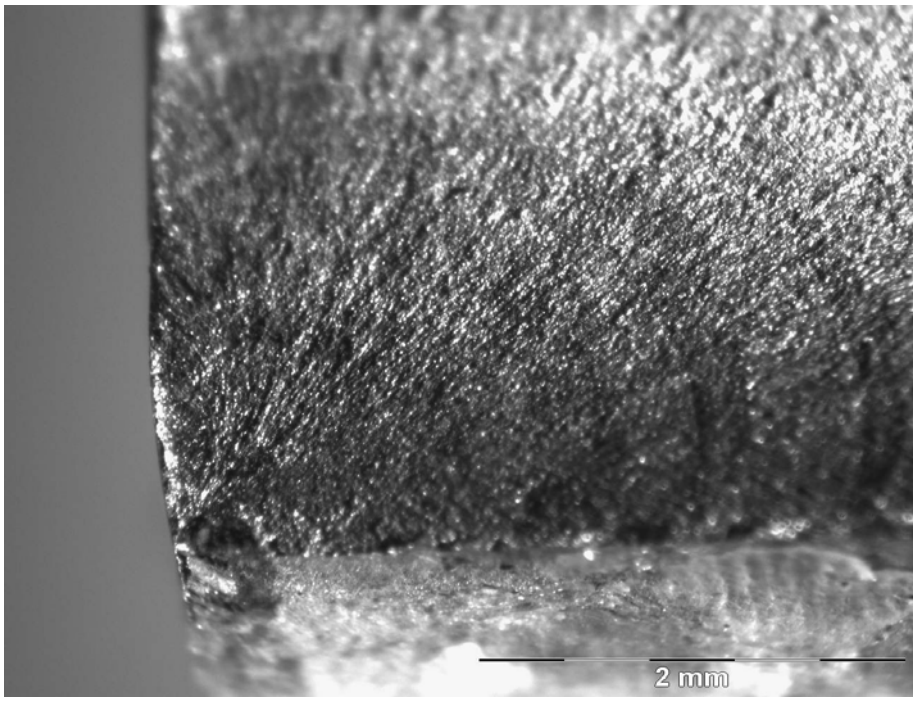
River marks on the fracture pointed back to a single origin at a corrosion pit (Figure 19-2) that was approximately 175 microns deep and hemispherical in nature. Other surface pitting was evident in areas adjacent to the failure location (Figure 19-3).

Figure 19-2: Optical Micrograph Showing Pitting at Origin and River Marks Emanating from Region.

Although the components contained a corrosion protection coating in service, the contact of a stainless steel retaining ring against the aluminum, in combination with the dynamic operating environment, is believed to have damaged the coating. Unrelated maintenance activities on these components may also have adversely affected coating integrity. Once the coating was compromised, the presence of a crevice and galvanic couple (between the retaining ring and the component) and a harsh operating environment made the component very susceptible to pitting. The violation of surface integrity caused by the pitting then made the part susceptible to corrosion fatigue.

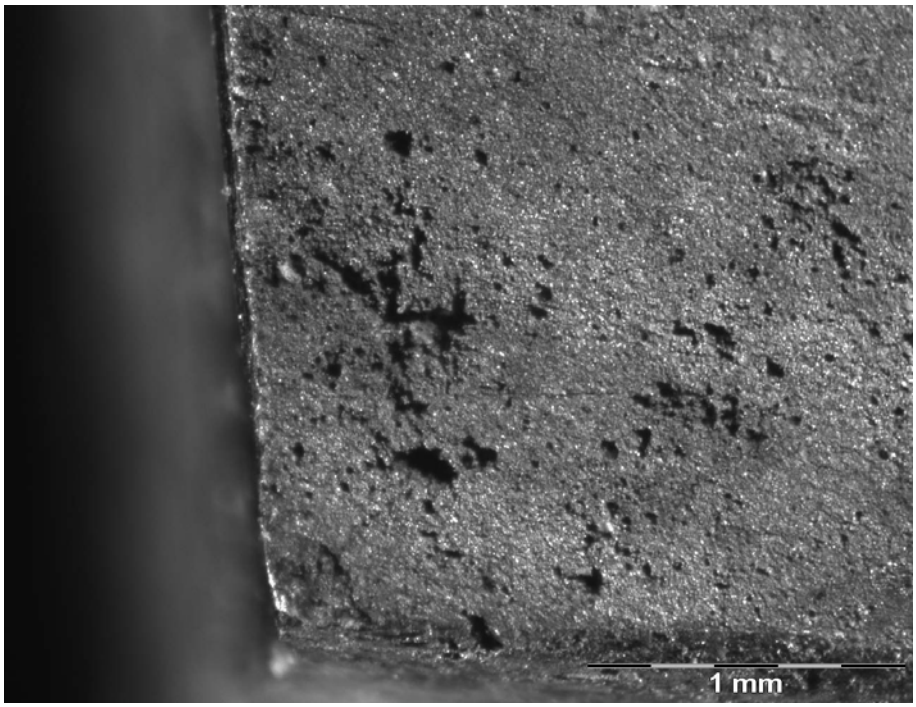
Figure 19-3: Optical Micrograph of Surface Perpendicular to Fracture Plane Showing Clusters of Corrosion Pits.

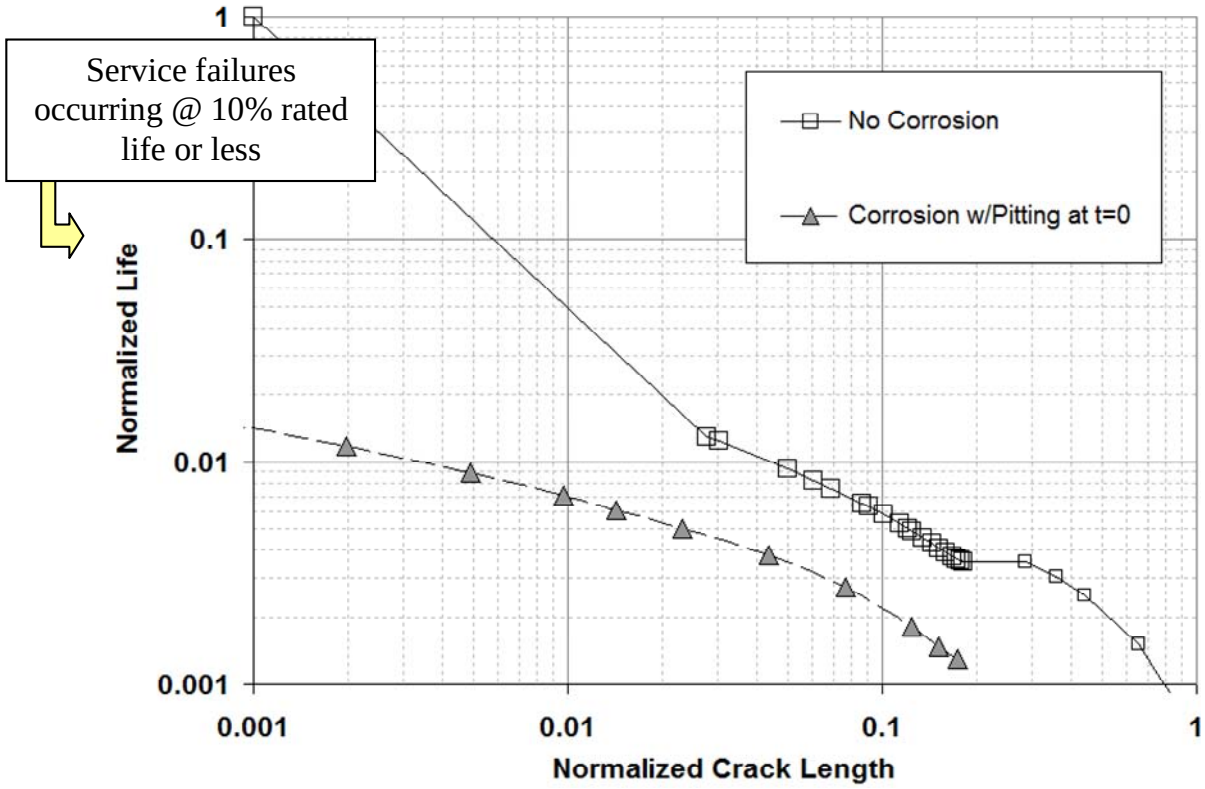
This exercise was repeated assuming the presence of a 175-micron deep, hemispherical corrosion pit at the critical location on the component. In the models used, the presence of the pit amplifies the beta solution associated with the crack, which causes a shift in stress intensity, an increase in crack growth rate, and a decrease in fatigue life [3]. The results shown in Figure 19-4 illustrate the very severe influences of a corrosion pit in this scenario. If the pit had existed from time zero, the analysis shows that the part would only have about 1.5% of its original rated life capability. In reality, the components are failing at closer to 10% rated capability, but this is simply an indicator that the pits are not in the components at manufacture; rather, they form during operational usage. However, it is safe to say that once the coating is compromised, pitting is likely to follow, and once the pits form, failure of the component will follow shortly thereafter.

Figure 19-4: Plot of Normalized Life versus Normalized Crack Length for a Helicopter Main Rotor Component With and Without Corrosion Pitting.

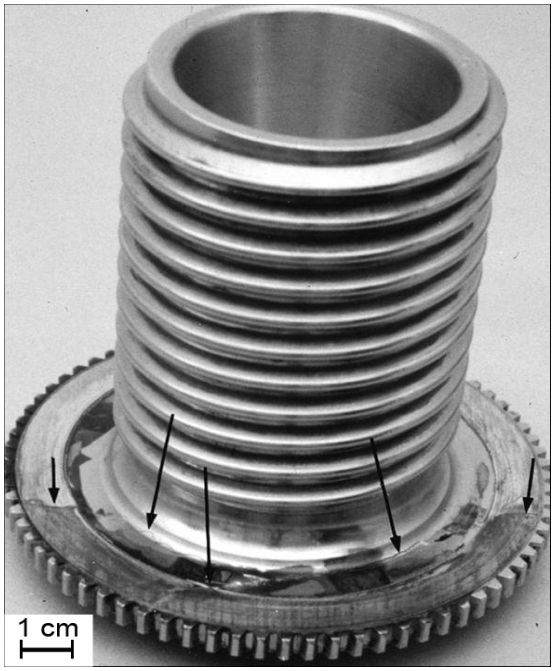
Figure 20-7 shows the extent of cracking of the bolt. The crack was broken open and the fracture surfaces were examined.

Figure 20-7: Case History 20.5.1 – The Cracked Blade-Retaining Bolt (the arrows point to the crack).

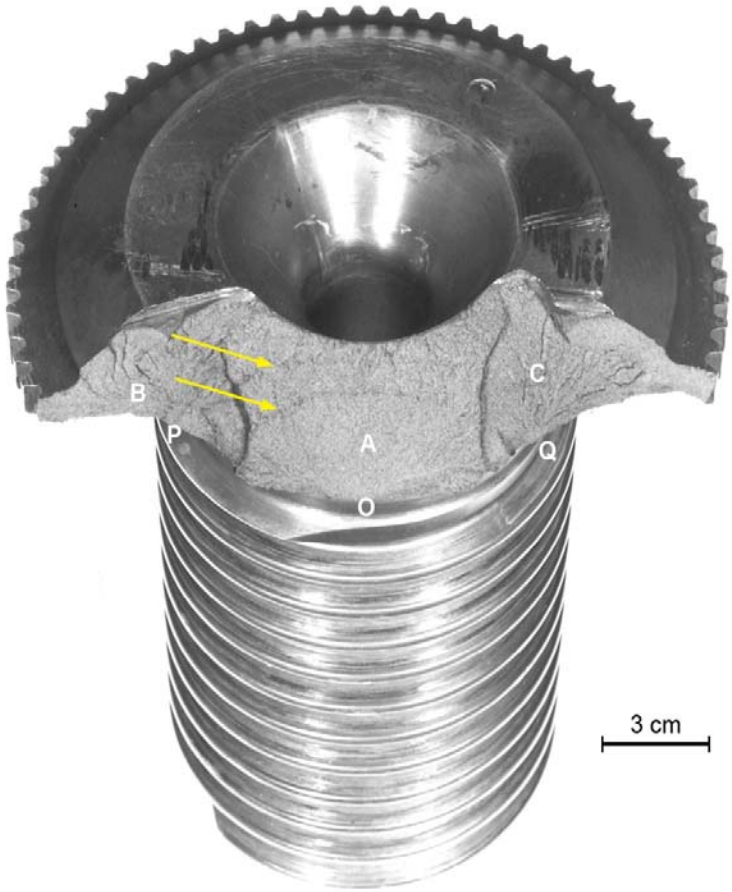
Figure 20-8 shows the main part of the broken-open bolt. The main crack (A) initiated at O, and the two adjacent cracks (B and C) initiated at points P and Q, respectively. Note the two progression marks (arrowed) on the fracture surface of crack A. These marks are due to locally higher roughness, and may signify peak loads that occurred during service.

Figure 20-8: Case History 20.5.1 – Fracture Surface of the Blade-Retaining Bolt (the main crack (A) initiated at O, and the two adjacent cracks (B and C) initiated at points P and Q, respectively – note the two progression marks (arrowed)).

Optical examination showed that the three crack initiation sites O, P and Q had their origins at small pits near the radius run-out under the bolt head. The pits were surrounded by semi-circular regions having a black-brown colour. Apart from these regions, whose greatest depth was about 250 μm, most of the fracture surface was clean.

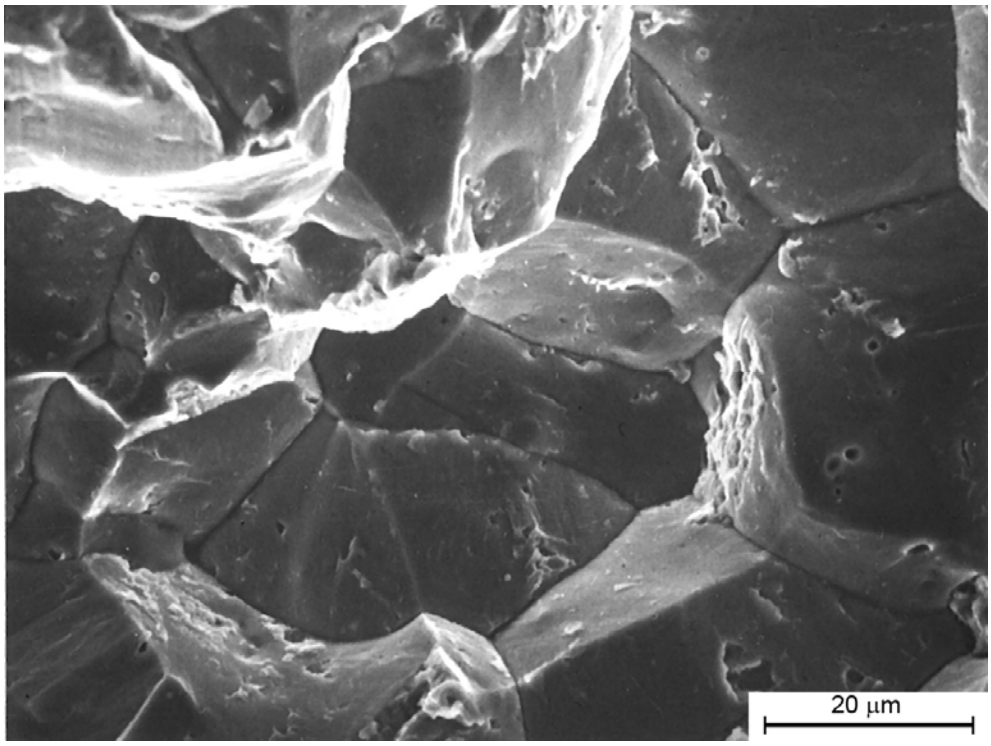
SEM fractography showed mainly clean intergranular fracture typical of IHE, e.g., Figure 20-9. However, examination of crack initiation site O showed not just the pit at the origin, Figure 20-10, but also deposits on intergranular fracture in the semi-circular region surrounding the pit, see Figure 20-11. Energy Dispersive Analysis of X-rays (EDAX) indicated that these deposits were rich in cadmium. Intergranular fractures similarly contaminated with cadmium were present in the semi-circular regions surrounding the pits at the crack initiation sites P and Q. This cadmium contamination suggests that all three semi-circular regions had been present before the last plating operation, most probably owing to IHE from the previous plating operation.

Figure 20-9: Case History 20.5.1 – Example of Clean Intergranular Fracture.

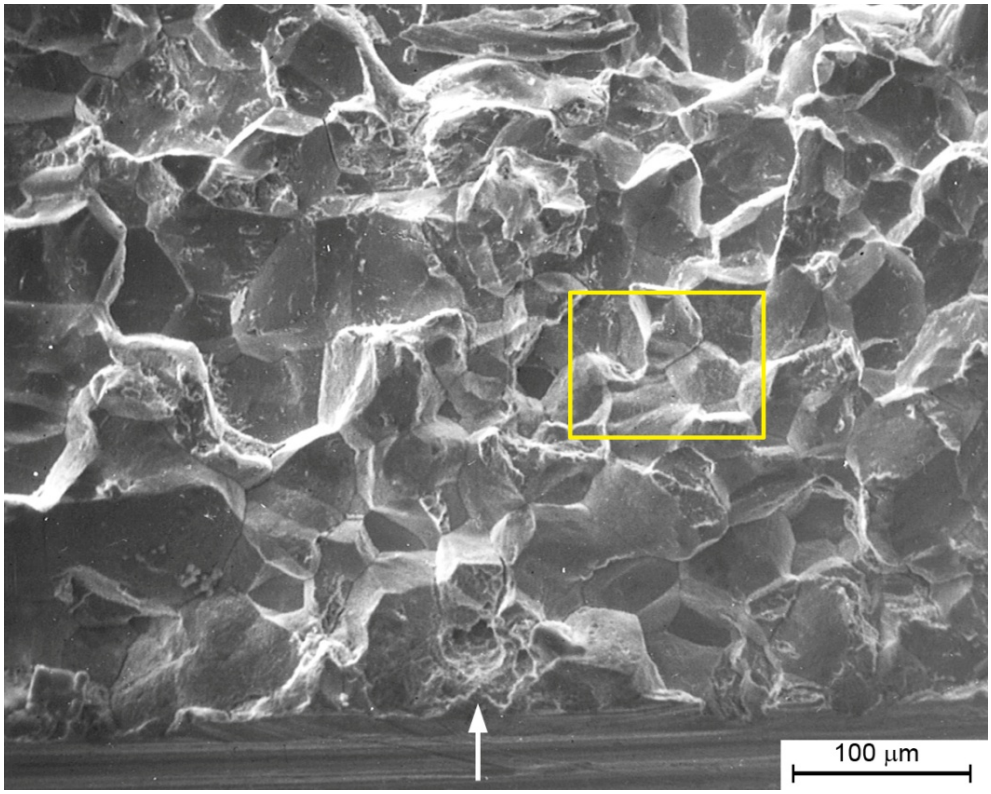
Figure 20-10: Case History 20.5.1 – Overview of Initiation Site O (the arrow points to the pit at the origin – the framed area is shown in more detail in Figure 20-11).

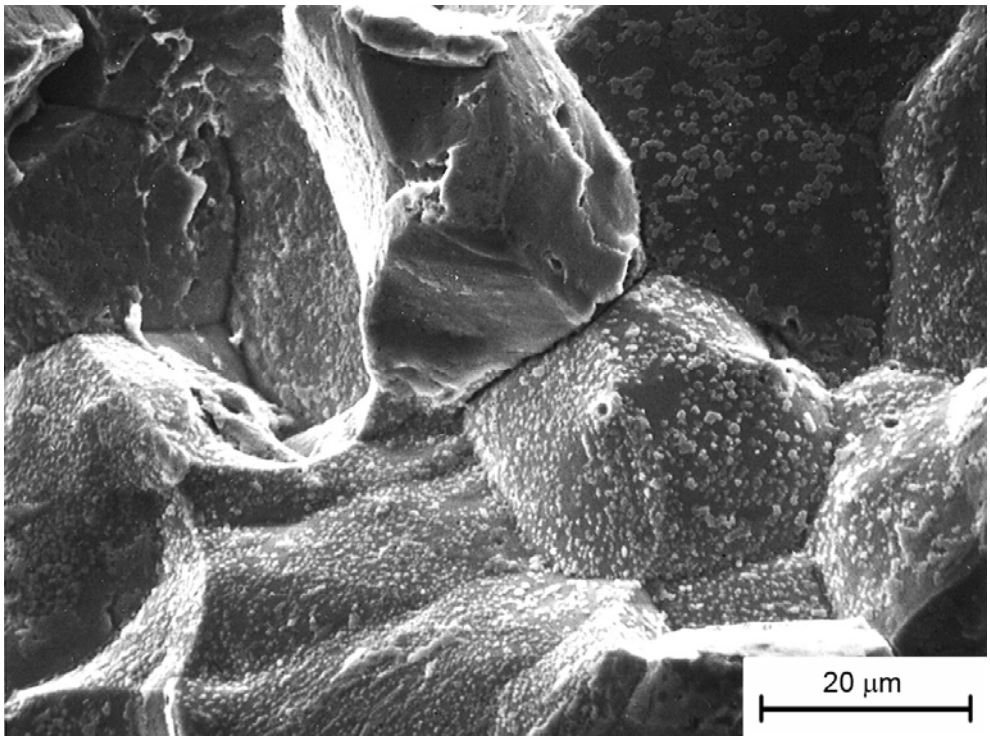
Figure 20-11: Case History 20.5.1 – Detail from Figure 20-10 Showing Deposits on the Intergranular Fracture (EDAX indicated that these deposits were cadmium-rich).

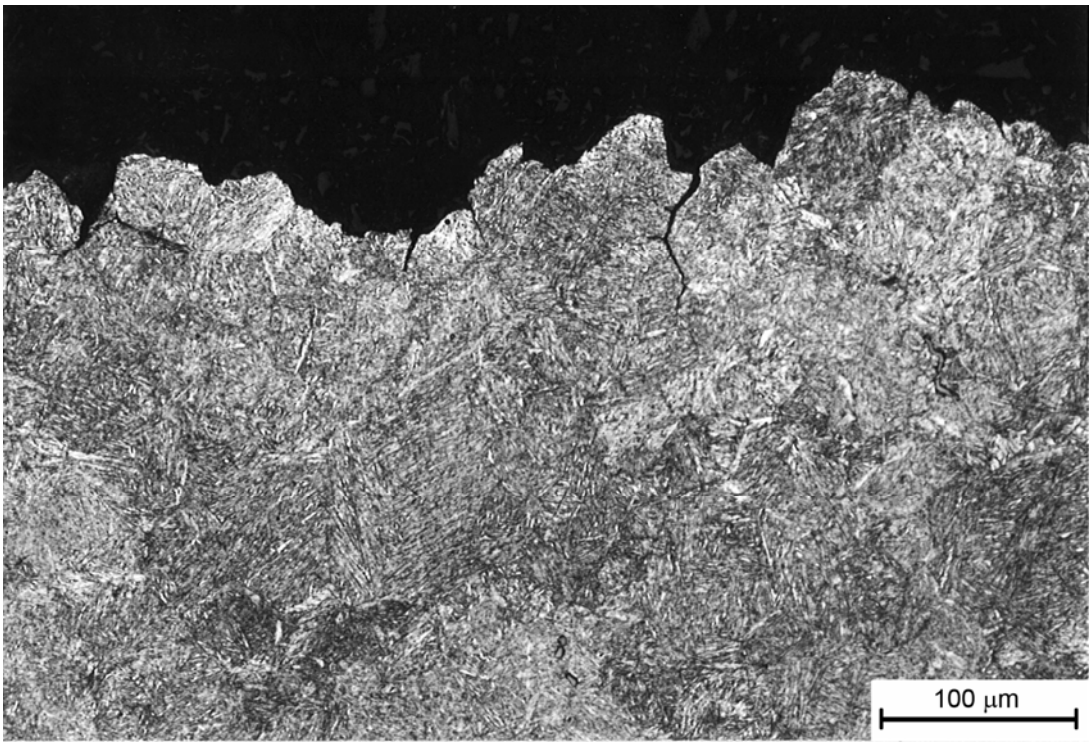
Figure 20-12: Case History 20.5.1 – Nital-Etched Metallographic Section Through Crack A (see Figure 20-8), Showing Tempered Martensite and the Intergranular Crack Path, Including Crack Branching.

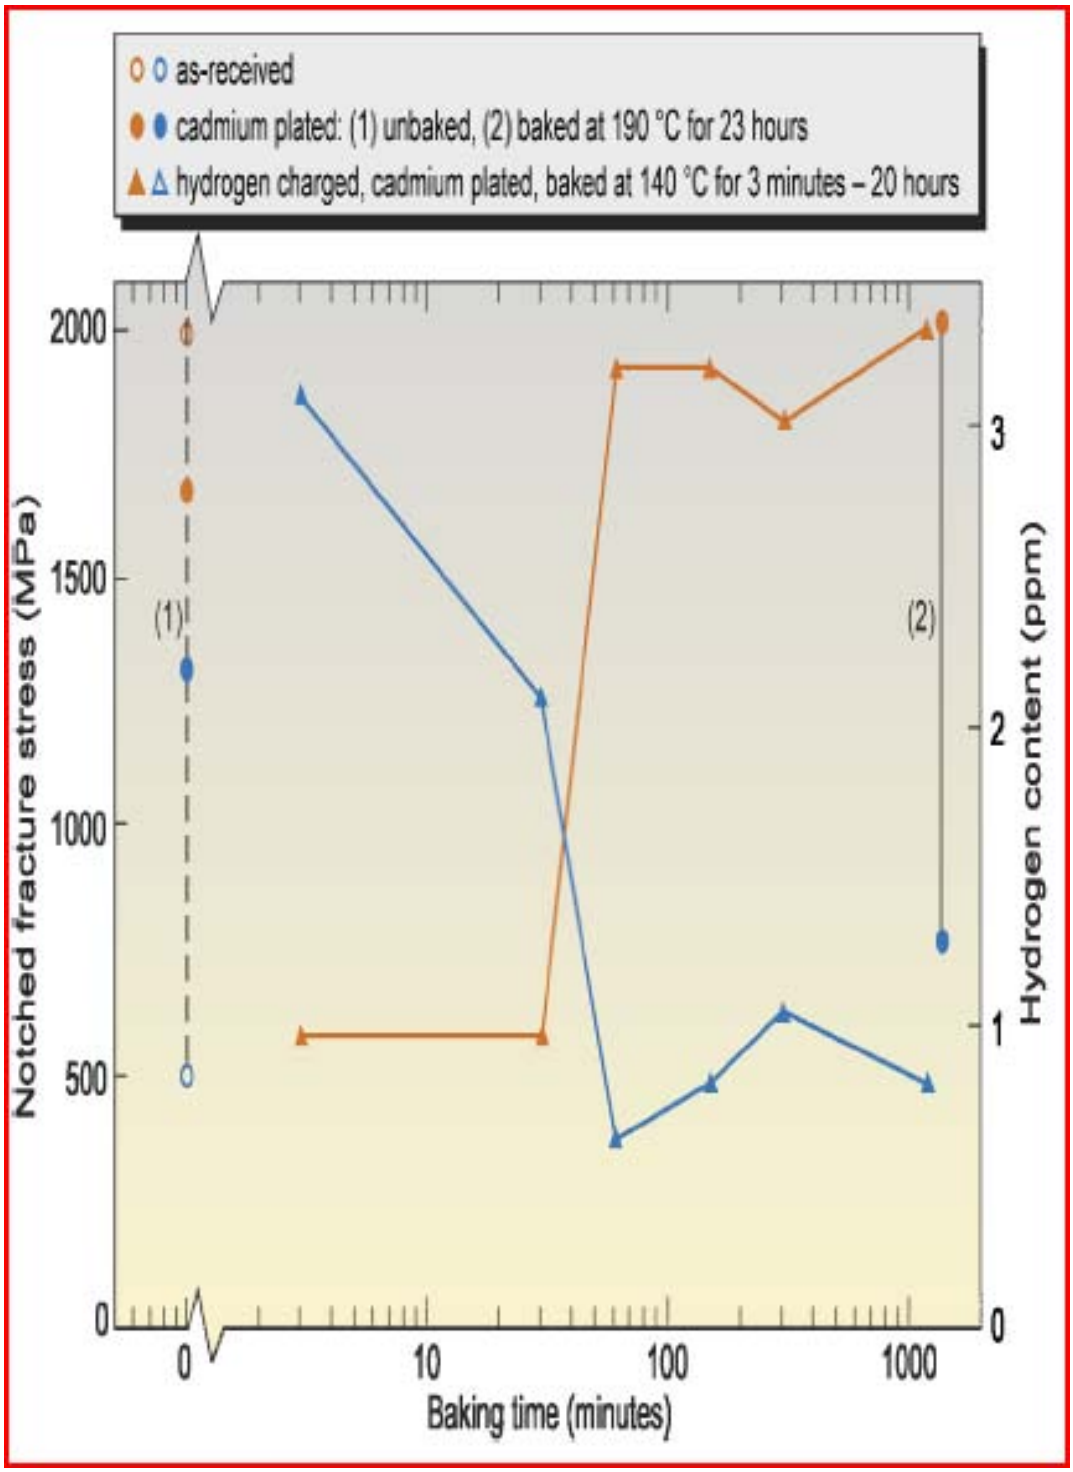
The specimens were tested to failure at a cross-head displacement rate of 2.1×10^{-4} mm/s. After fracture they were immediately stored in liquid nitrogen to await hydrogen analysis *in vacuo* at 600°C. The results of the tests and analyses are shown in Figure 20-13. There are several observations to be made:

1) After baking to remove any diffusible hydrogen, the as-received specimen contained about 0.8 ppm of trapped hydrogen (this trapped hydrogen was removed by hydrogen analysis *in vacuo* at 600°C). The fracture stress of this specimen was 1985 MPa, and is a reference for the degree of embrittlement of the other specimens.
2) Baking had a beneficial effect on the fracture stress of cadmium plated specimens, and there was a concomitant decrease in hydrogen content from 2.3 ppm to 1.3 ppm.
3) Baking times longer than 30 minutes removed substantial embrittlement due to hydrogen charging followed by cadmium plating.

Figure 20-13: Case History 20.5.1 – Results of the Notched Tensile Tests and Hydrogen Analysis.

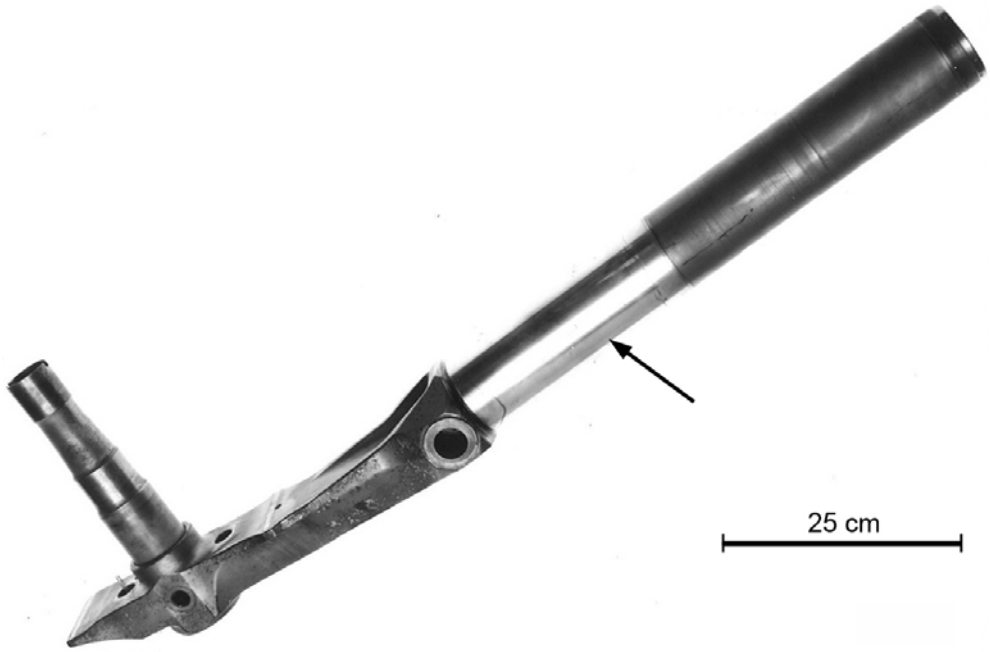
The assembly is shown in Figure 20-14. It was made from 35NCD16 low alloy steel heat-treated to a Rockwell hardness of 51 HRC, corresponding to a tensile strength of about 1793 MPa. The nominal chemical composition in wt. % is: 0.4 C, 4.0 Ni, 1.8 Cr, 0.45 Mn, 0.45 Mo, 0.03 V, 0.3 Si.

Figure 20-14: Case History 20.5.2 – Main Undercarriage Half-Fork Assembly Sent for Examination (the arrow points to the chromium plated cylindrical section).

Since the aircraft fleet to which the undercarriage half-fork assemblies belonged was very near retirement, and the lead time for replacements was likely to be longer than the remaining life required, it was decided to tolerate a particular level of cracking based on the results of the above investigation and re-inspection that was done at the DSTO and used the same dye penetrant NDI.

Half-fork assemblies that on inspection revealed extensive linked-up cracking, suggestive of fatigue, at the more highly stressed lower end of the cylindrical section were replaced with components held in stock. Assemblies with less severe cracking away from the lower end of the cylindrical section were allowed to remain in service. These mildly cracked assemblies were re-inspected at intervals conservatively based on the known time during which fatigue cracks developed in the investigated half-fork assembly.

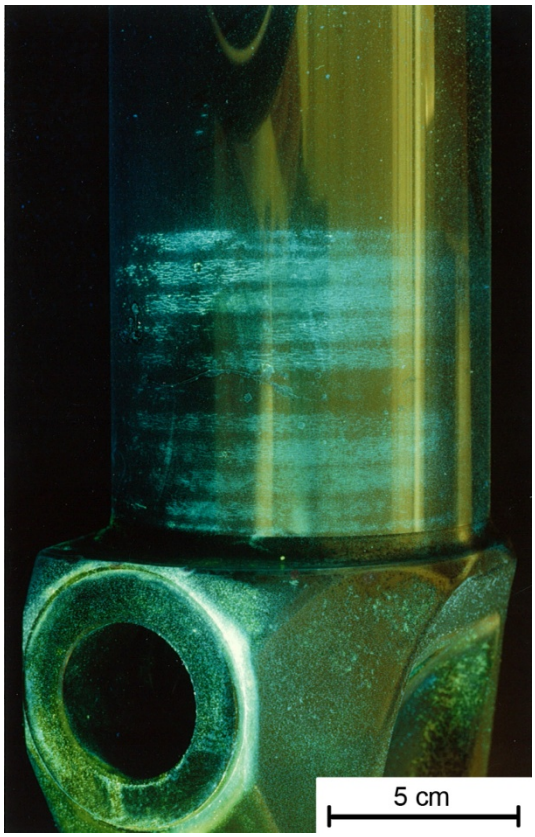
The arrowed cylindrical section in Figure 20-14 had been hard-chromium plated. Dye penetrant showed helically banded cracking at the lower and upper ends of the section, e.g., Figure 20-15.

Figure 20-15: Case History 20.5.2 – Example of Helically Banded Cracking in the Hard-Chromium Plate (see Figure 20-14 for the location).

1) The hard-chromium electroplating on the cylindrical section of the assembly showed helically banded cracking at the lower and upper ends of the section. The same crack pattern was present in the underlying steel.

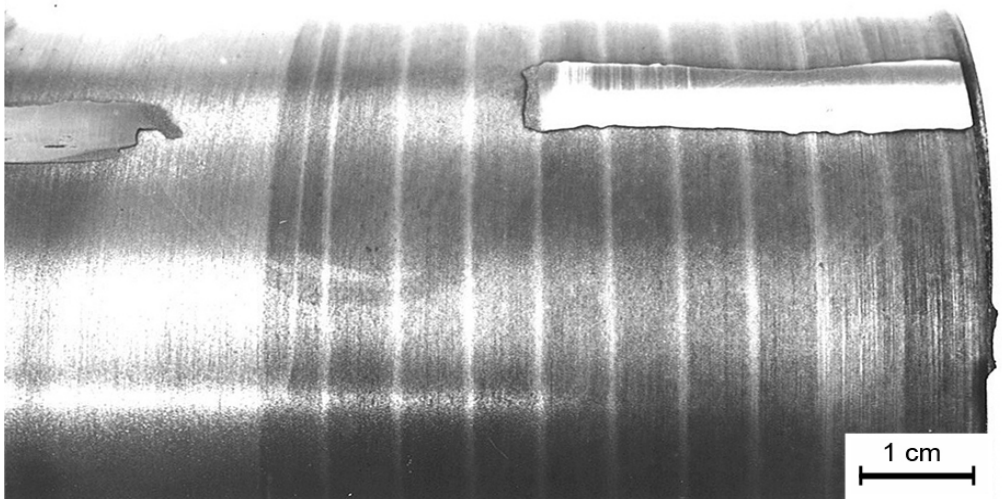
The chromium plating was removed from selected areas of the cylindrical section by chemical dissolution in sodium hydroxide solution. Dye penetrant NDI of the stripped areas revealed the same pattern of helically banded cracking in the steel. Since this form of banding is characteristic of grinding damage, the steel surface was etched with nital. Helical dark etching bands confirmed the presence of grinding damage, see Figure 20-16. Discussions with the OEM suggested that this damage had occurred during overhaul of several batches of the half fork assemblies, owing to grinding conditions beyond the specified limits, i.e., abusive grinding.

Figure 20-16: Case History 20.5.2 – Helical Dark Etching Bands Indicating Grinding Damage of the Steel Surface of the Lower Part of the Cylindrical Section (note the irregular areas with retained hard-chromium plate).

2) The crack pattern in the steel suggests grinding damage. This was confirmed by etching the steel surface.

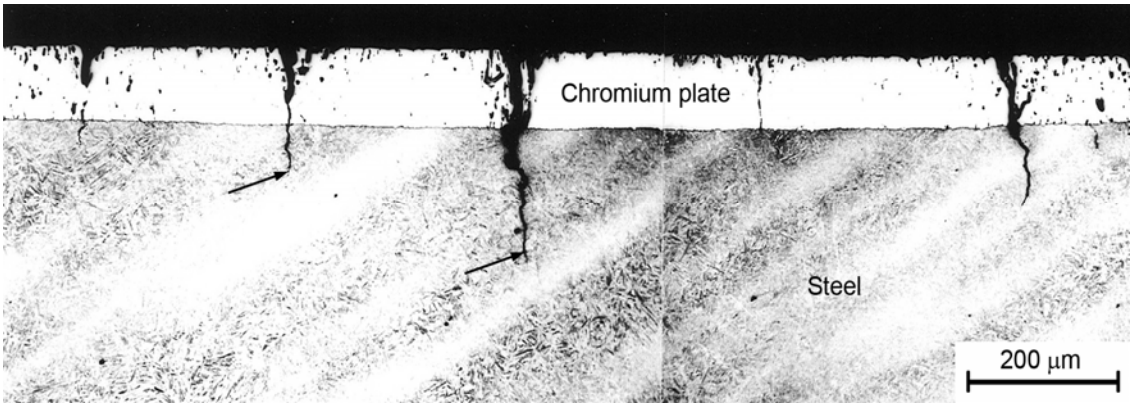
Several cross-sections were made of the grinding damage in non-stripped areas. Figure 20-17 gives an example close to the lower end of the cylindrical section. There were numerous intergranular cracks in the steel, penetrating along prior austenite grain boundaries to a depth of about 130 μm. Most of these cracks were associated with cracking in the overlying chromium plate, as in Figure 20-17, but some were not. This suggests that initiation of (some) cracks in the steel may have preceded cracking of the chromium plate. Be that as it may, the initially intergranular nature of the steel cracks indicates that they were due to IHE. In turn, high tensile stresses introduced by abusive grinding could have caused IHE, and this may well have been exacerbated by hydrogen pick-up during electroplating.

Figure 20-17: Case History 20.5.2 – Typical Cross-Section Through a Non-Stripped Area Containing Grinding Damage (the arrows point to transgranular fatigue cracks growing from intergranular crack).

The arrows in Figure 20-17 point to transgranular cracks growing into the steel from the intergranular cracks. These transgranular cracks were found only near the lower end of the cylindrical section, where the service stresses would have been highest. From their transgranular nature and location it seems most likely that these were fatigue cracks.

3) The initially intergranular nature of the steel cracks suggests that they were the result of IHE owing to high tensile stresses introduced by abusive grinding and hydrogen pick-up during electroplating.

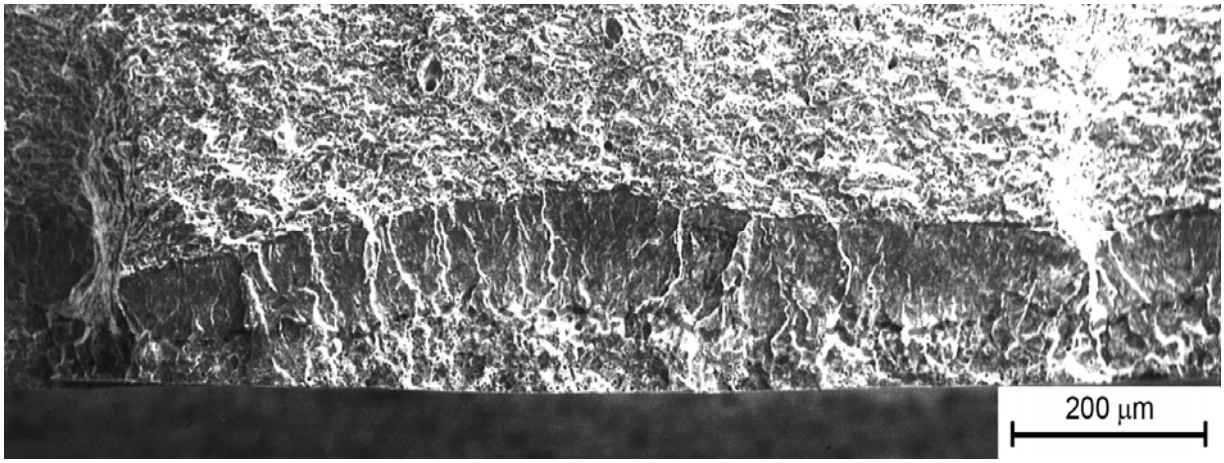
The area containing suspected fatigue cracks was broken open. SEM fractography confirmed that fatigue cracks were growing from the intergranular cracks. An example is shown in Figure 20-18, which indicates the three successive regions of intergranular cracking, transgranular fatigue cracking, and overload fracture. More detailed observations were hindered by extensive pitting corrosion on the intergranular and fatigue fracture surfaces.

Figure 20-18: Case History 20.5.2 – A Broken-Open Crack Showing Intergranular Fracture Followed by Transgranular Fatigue Fracture and Overload Fracture.

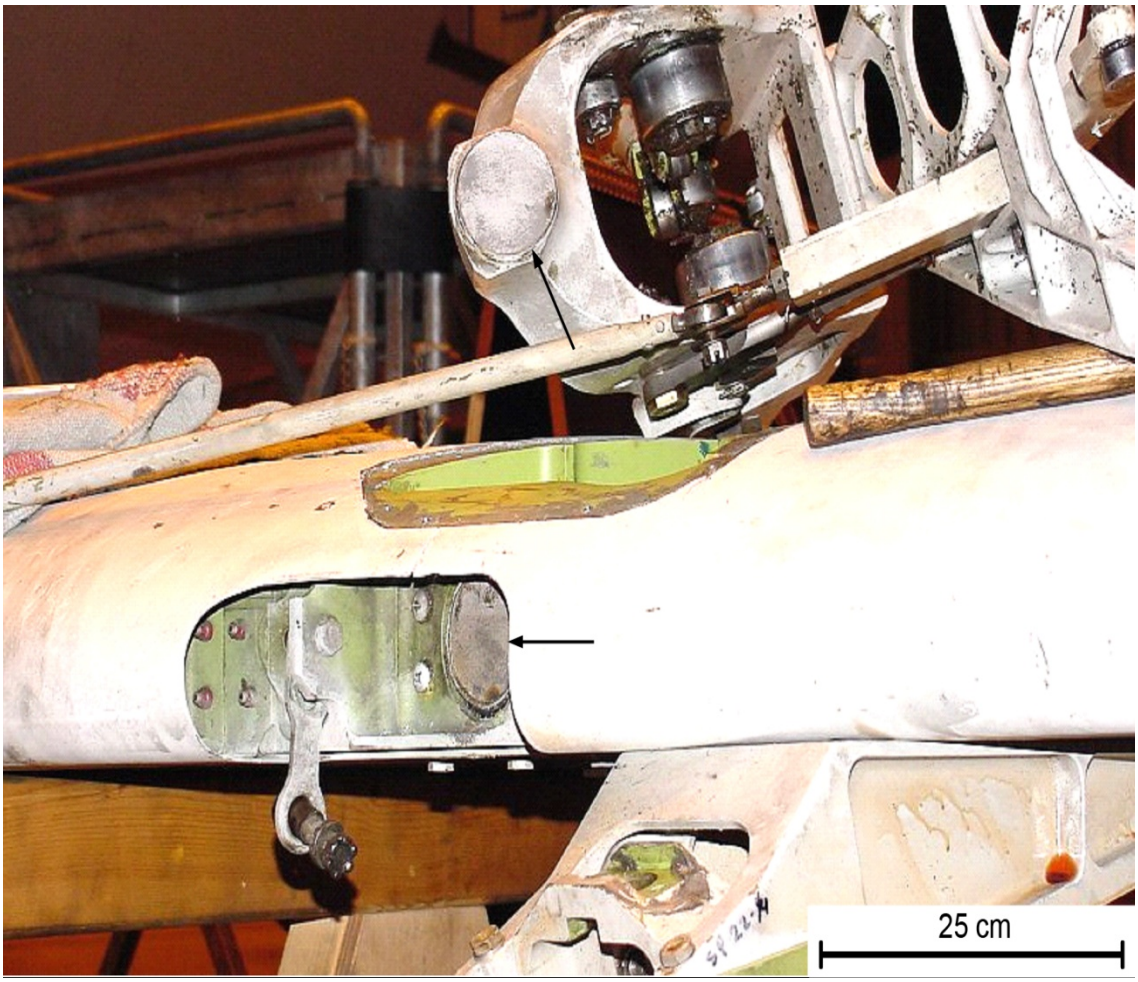
Figure 20-19: Case History 20.5.3 – Broken Inboard Carriage Assembly *In Situ* (arrows point to the fracture surfaces).

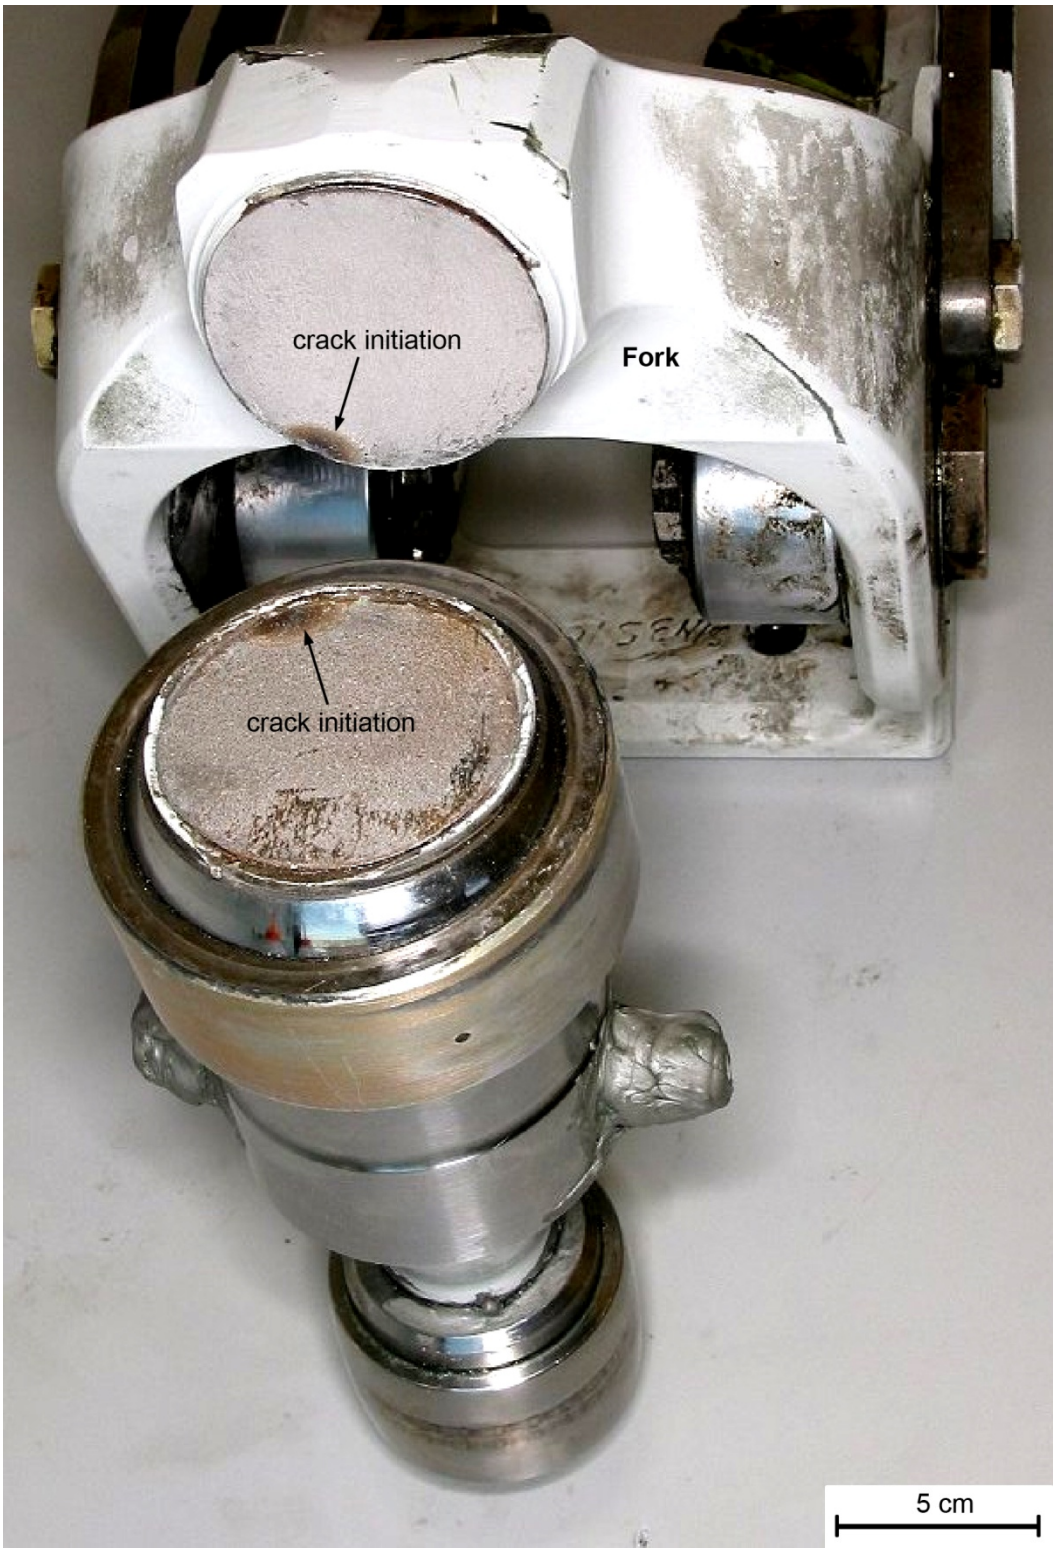
Figure 20-20: Case History 20.5.3 – Overview of the Fractured Spindle and Fork Assembly.

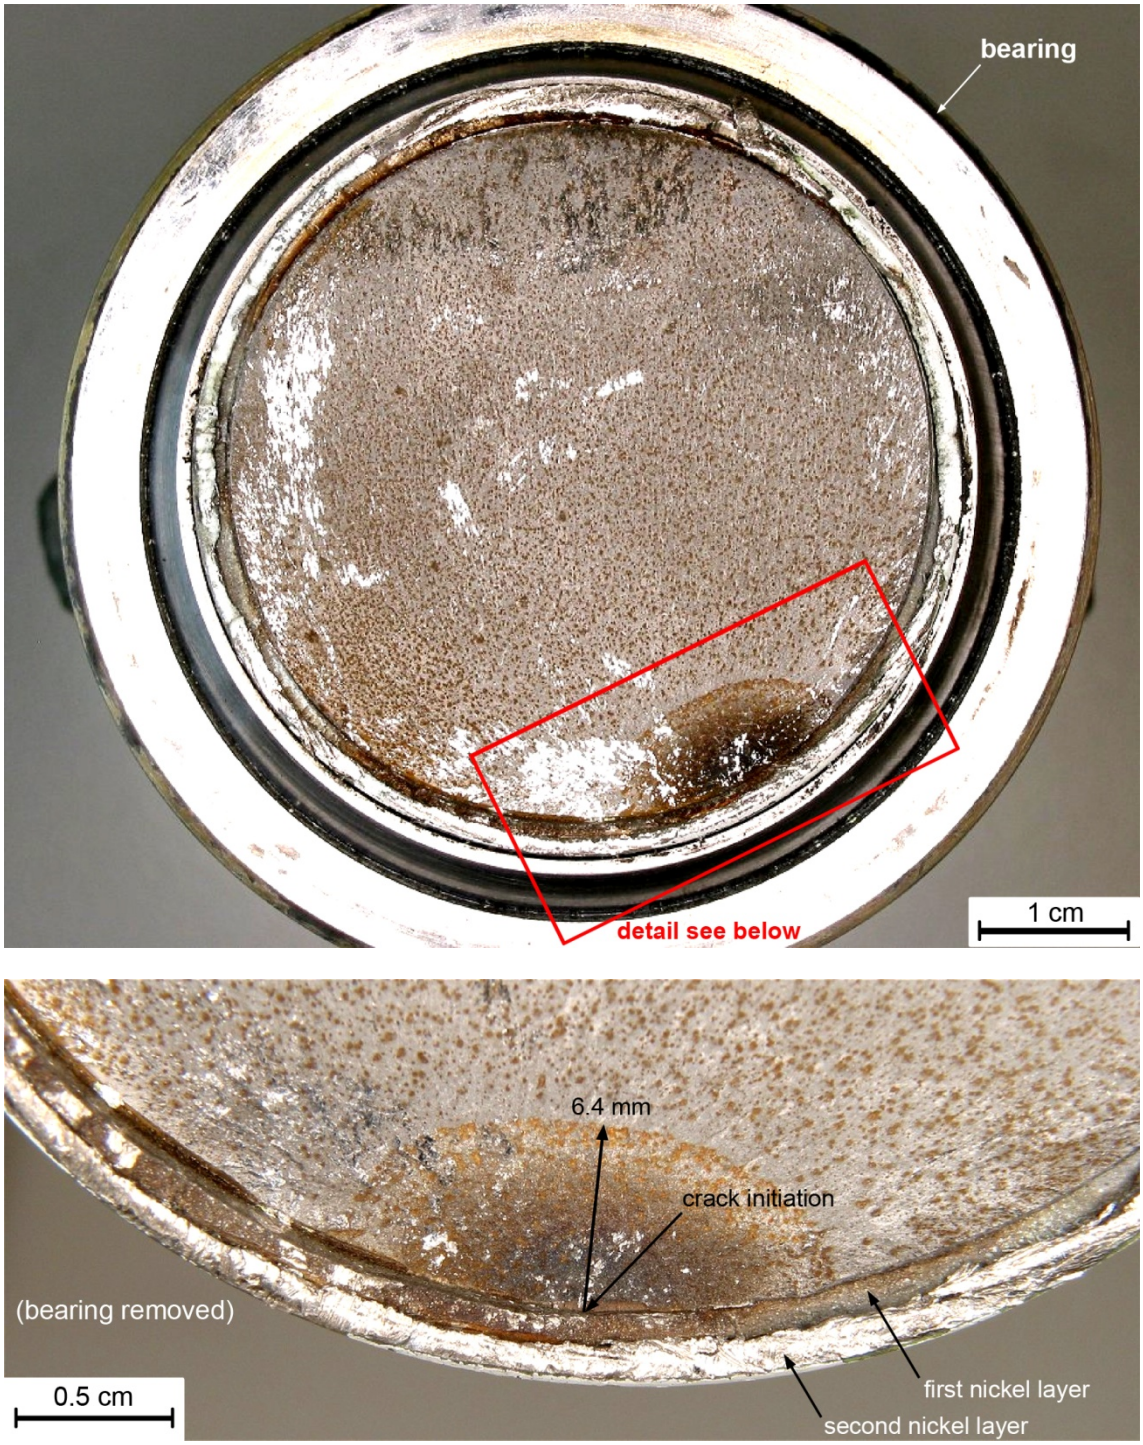
Figure 20-21: Case History 20.5.3 – Spindle-Side Fracture Surface.

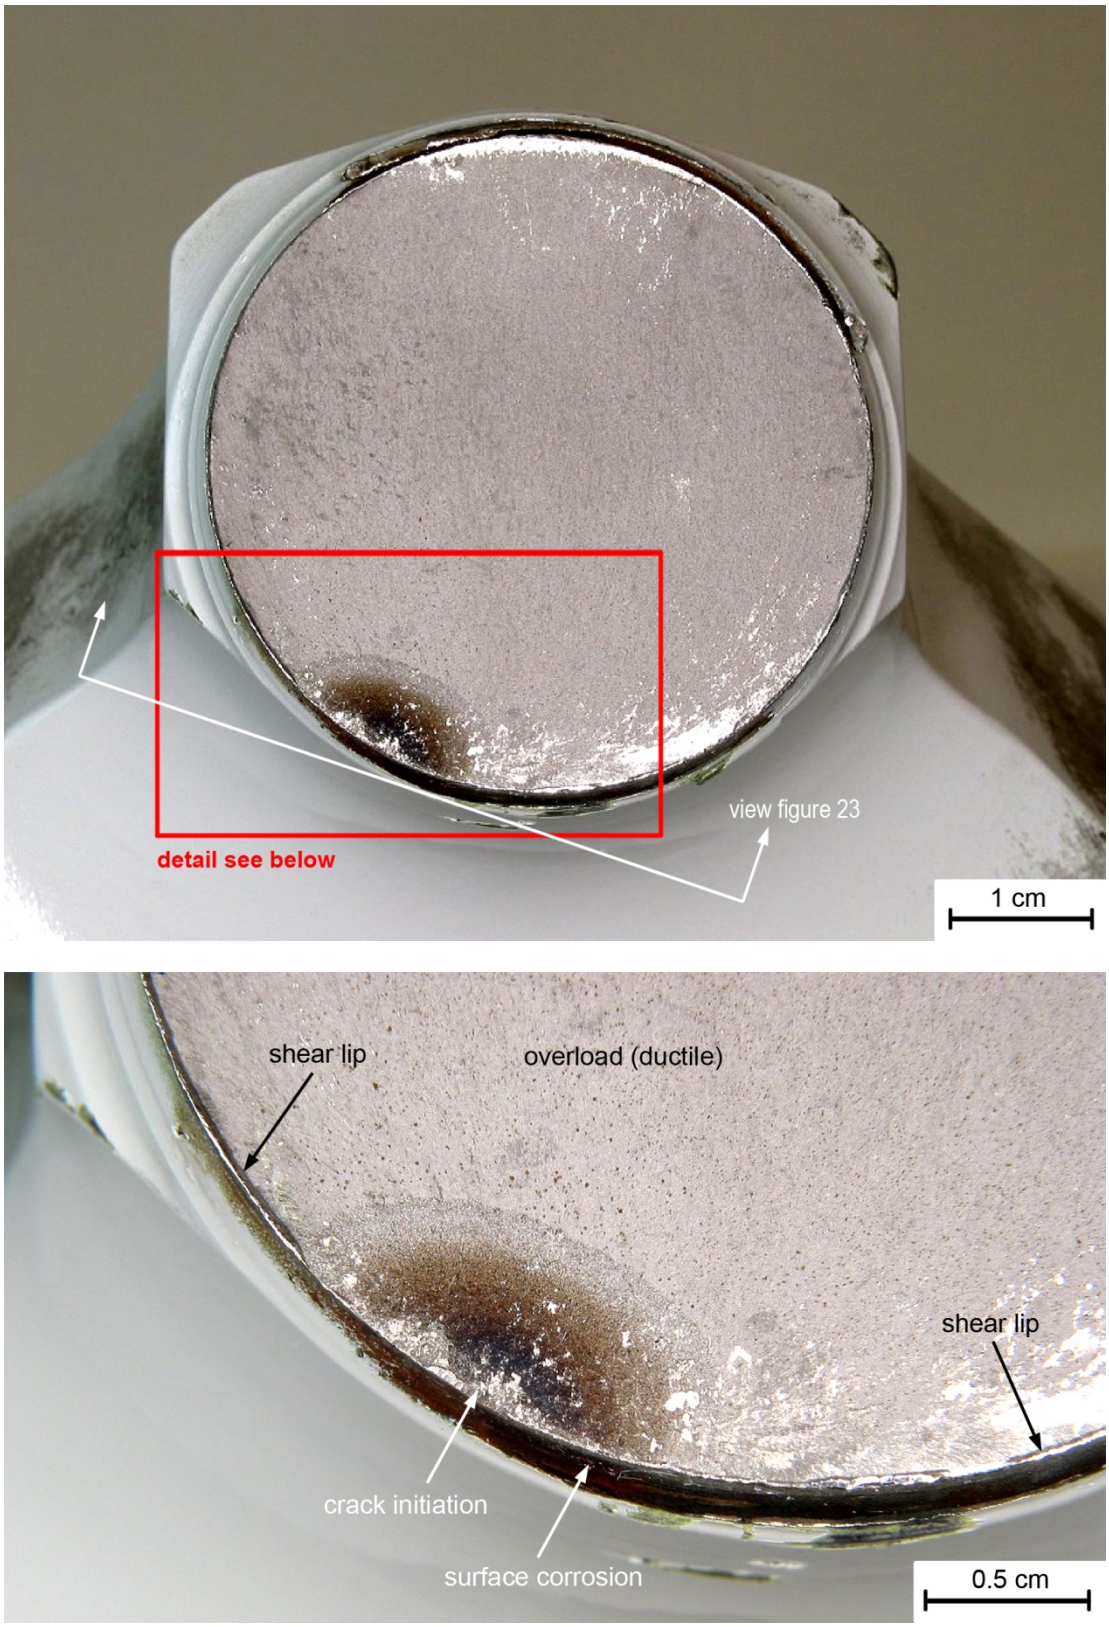
Figure 20-22: Case History 20.5.3 – Fork-Side Fracture Surface.

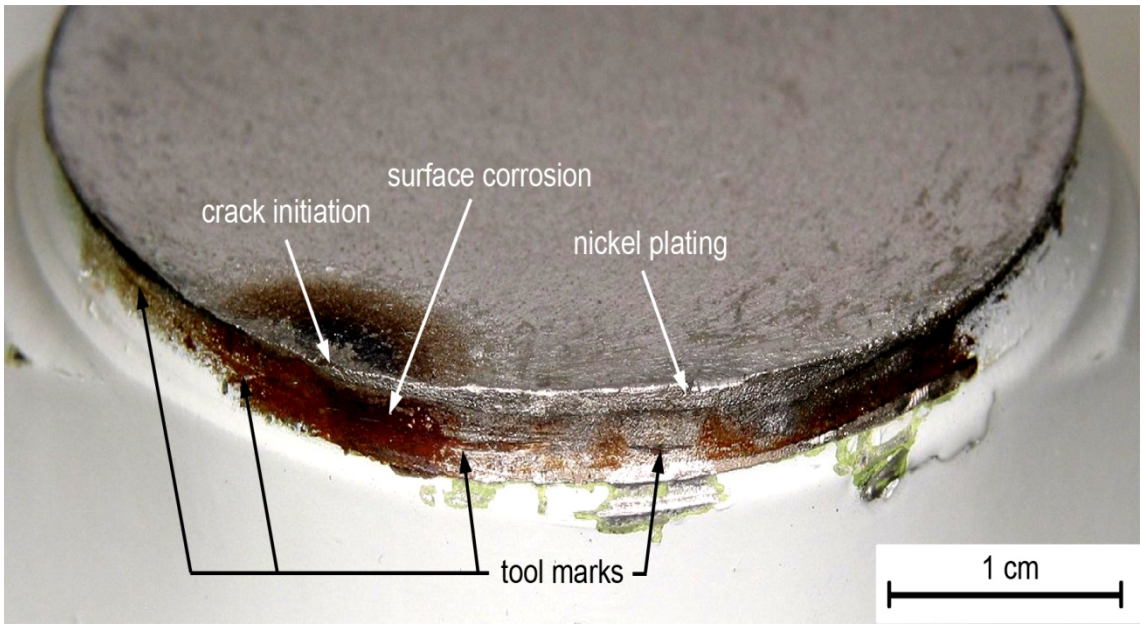
Figure 20-23: Case History 20.5.3 – Side Surface Around Fork-Side Crack Initiation Region.

2) *Fork-Side Cross-Section*, Figure 20-25. The radius area was unprotected by electroplating and paint, and had undergone corrosion (also visible in Figure 20-23). Thin white-etching layers at the steel surface indicate untempered martensite caused by grinding.

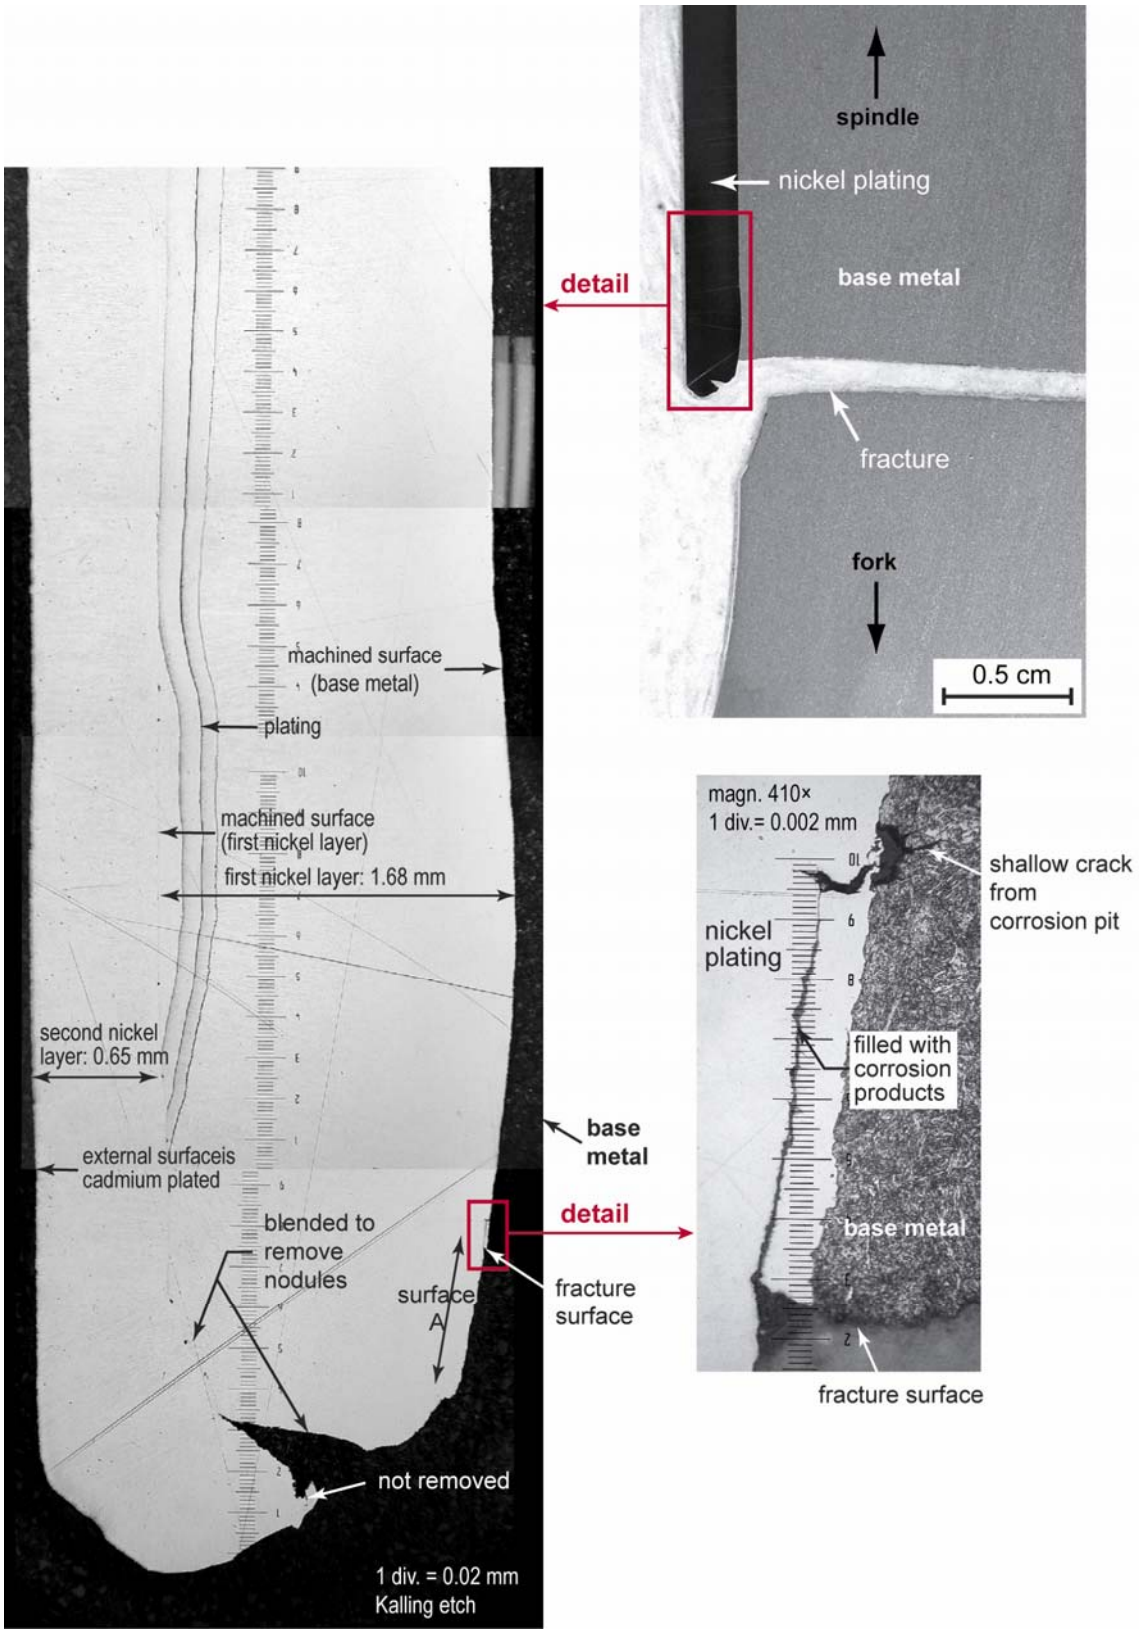
Figure 20-24: Case History 20.5.3 – Metallographic Cross-Section Through the Spindle-Side Crack Initiation Region (Note: Surface A matches surface B in Figure 20-25).
