RTO AGARDograph **AG-AVT-140**

Corrosion Fatigue and Environmentally Assisted Cracking in Aging Military Vehicles

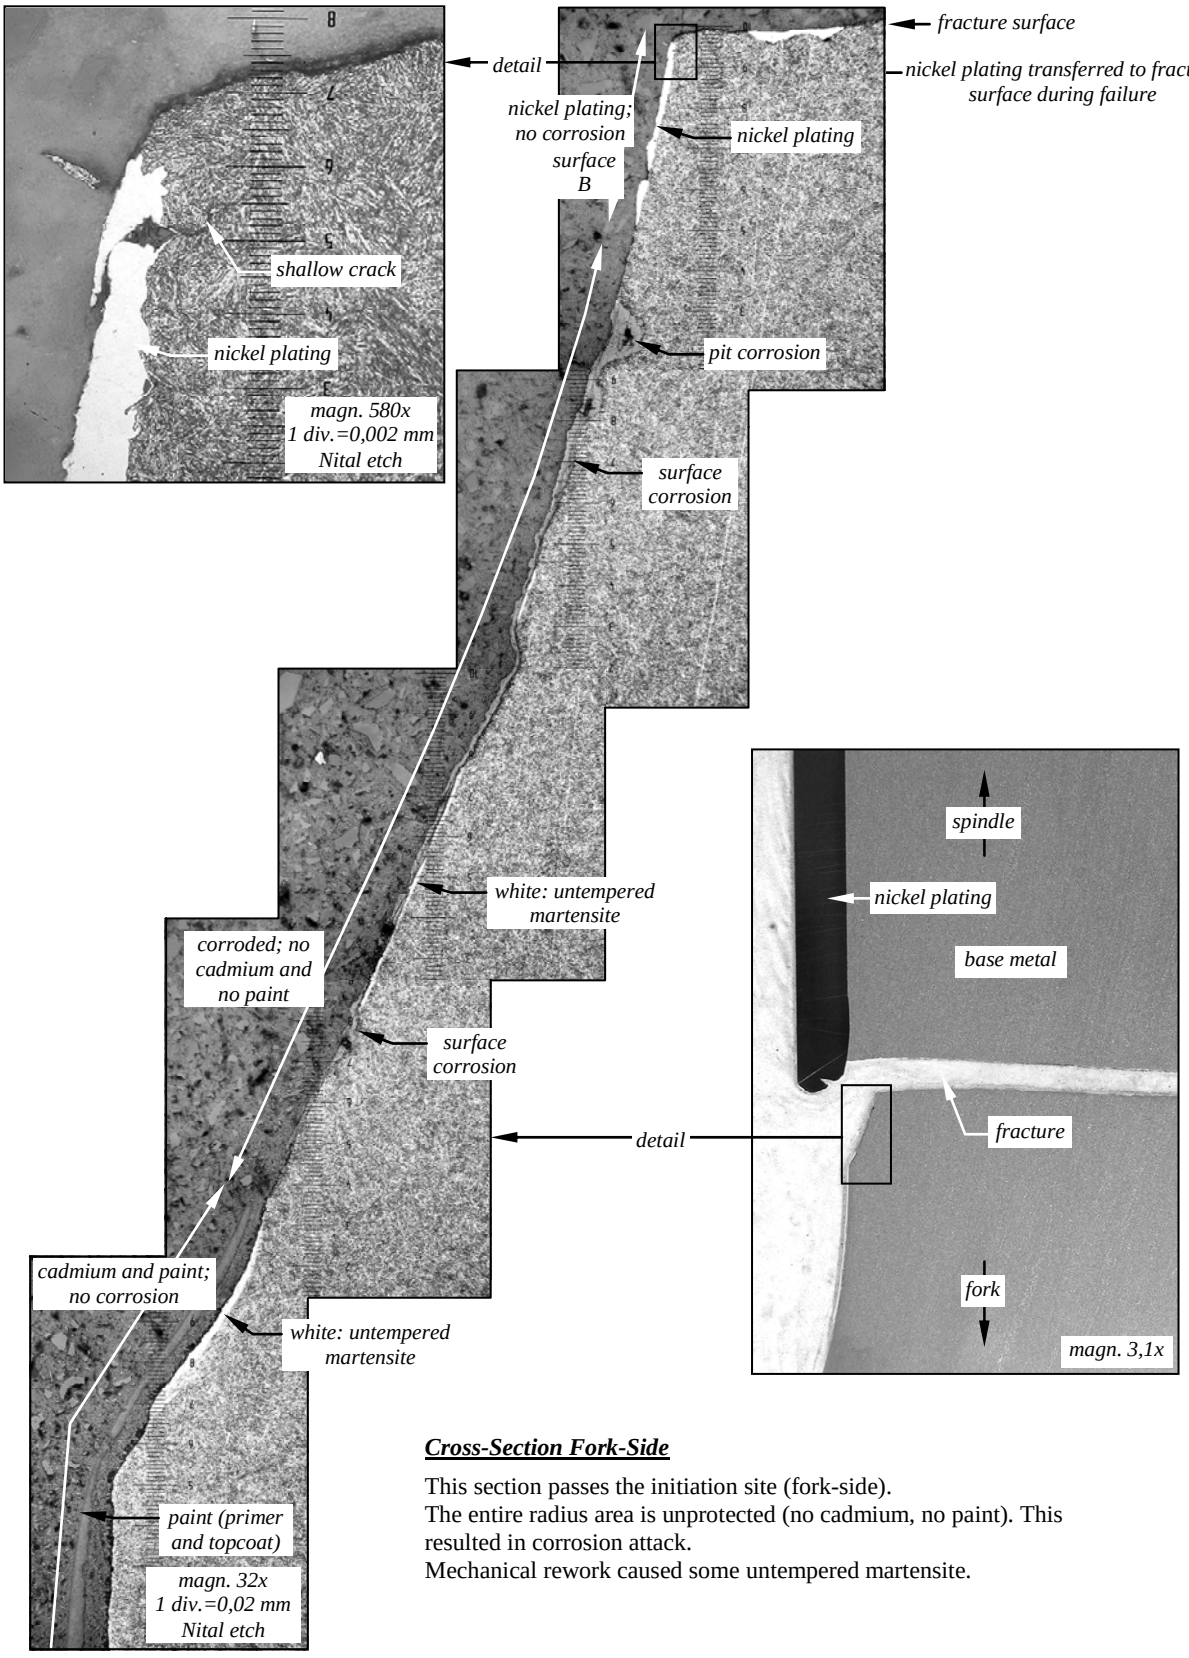
Cross-Section Fork-Side

2) *Fork-Side Cross-Section*, Figure 20-25. The radius area was unprotected by electroplating and paint, and had undergone corrosion (also visible in Figure 20-23). Thin white-etching layers at the steel surface indicate untempered martensite caused by grinding.

A detail of the cross-section, including the fracture initiation region, shows remnants of nickel plating and a small secondary crack growing from a corrosion pit.

This section passes the initiation site (fork-side).
The entire radius area is unprotected (no cadmium, no paint). This resulted in corrosion attack.
Mechanical rework caused some untempered martensite.

Figure 20-25: Case History 20.5.3 – Metallographic Cross-Section Through the Fork-Side Crack Initiation Region (Note: Surface B matches surface A in Figure 20-24).

5) Figure 20-25 shows an anomaly, namely that the operator indicated nickel plate to have been transferred to the fracture surface during failure. This is most unlikely. However, the operator's report mentioned that the two fracture halves were reassembled to visualize the nickel plating transition in the radius. It is possible that this reassembly – which should not have been done! – caused smearing of some loosened or protruding nickel plate onto the fracture surface.

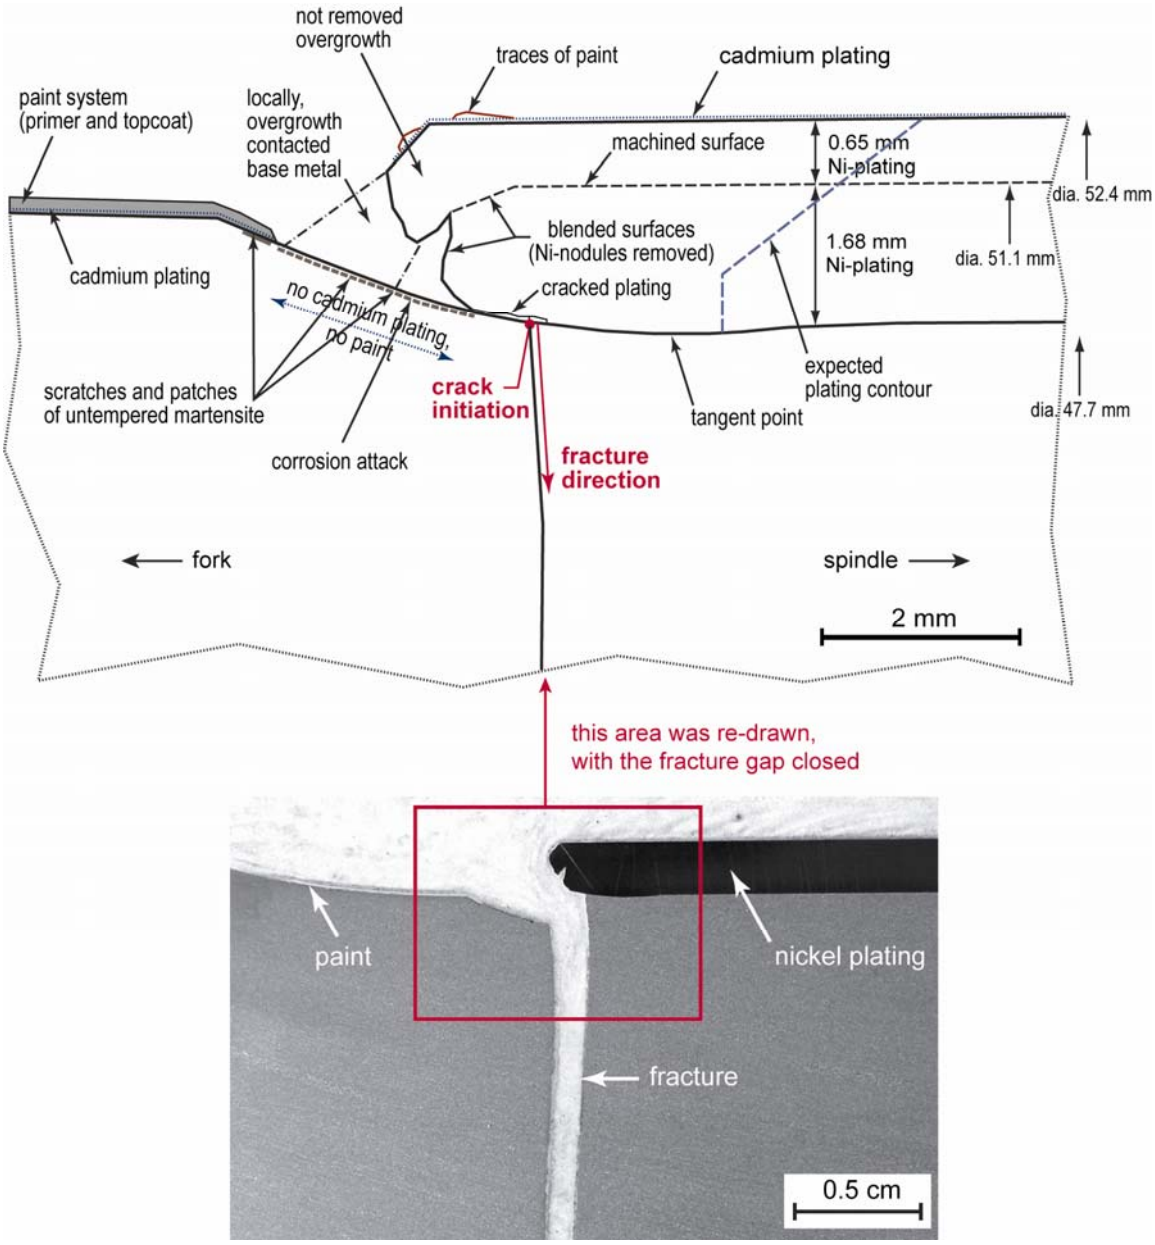
Figure 20-26 summarises the metallographic observations in a detailed sketch that schematically rejoins the fracture surfaces. This sketch clearly shows the extent of the unprotected, and hence corroded, steel surface.

Figure 20-26: Case History 20.5.3 – Summary of the Metallographic Observation.

The repair history will be reviewed with the aid of Figure 20-26. Initially, corrosion removal required machining the spindle to below the minimum repair diameter. However, the OEM issued a directive to allow repair by nickel plating and installing a sleeve. The actual repair was done solely with nickel plating. The nickel plating was applied in two layers, each followed by baking for 23 hours. The first nickel layer was machined and blended, removing nickel nodules in the radius area. This resulted in damage to the

steel surface (tool marks, see Figure 20-22, and untempered martensite, see Figure 20-25). The second nickel layer was also machined, but the overhanging nodules in the radius area were not removed.

d) No cracks in the regions of untempered martensite, see the details in Figure 20-24 – Figure 20-26.
4) Nickel electroplating was most probably carried out using a sulfamate bath, a type of bath which results in only moderate hydrogen pick-up by high strength steels. More importantly, there was an unplated "window", see Figure 20-25 and Figure 20-26, through which hydrogen could have readily diffused, both during and after the baking.

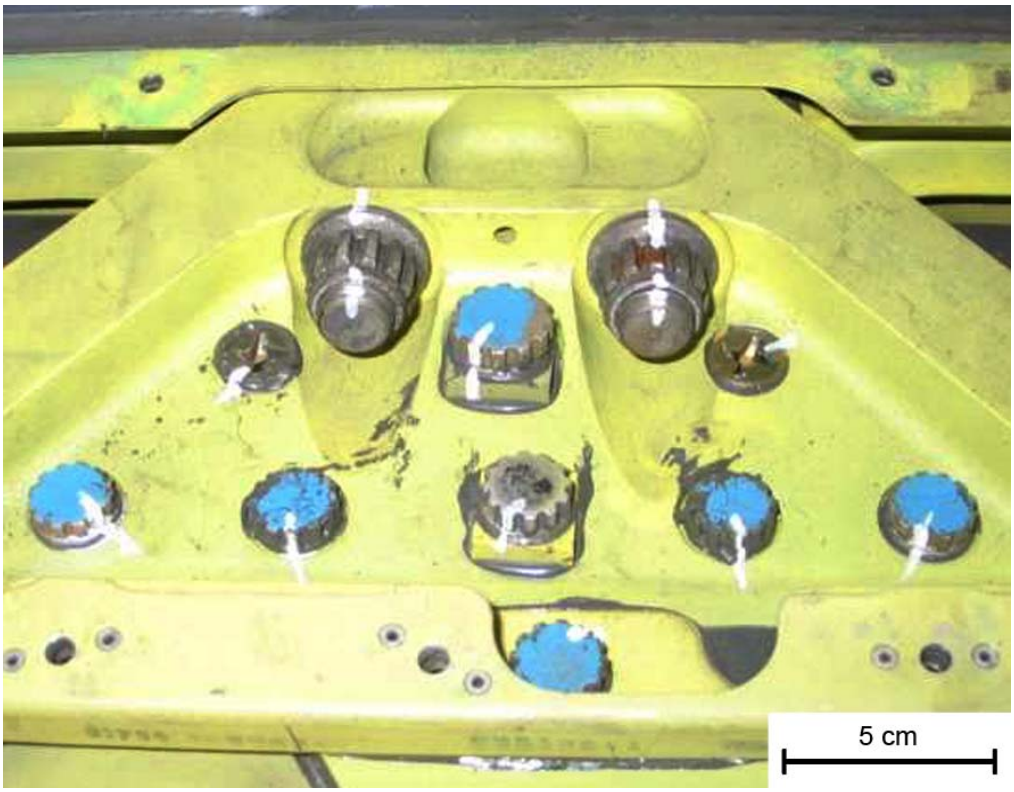
Figure 20-27: Case History 20.5.4 – Example of a Surface-Rusted WAF Bolt (R.H. bolt in photograph).

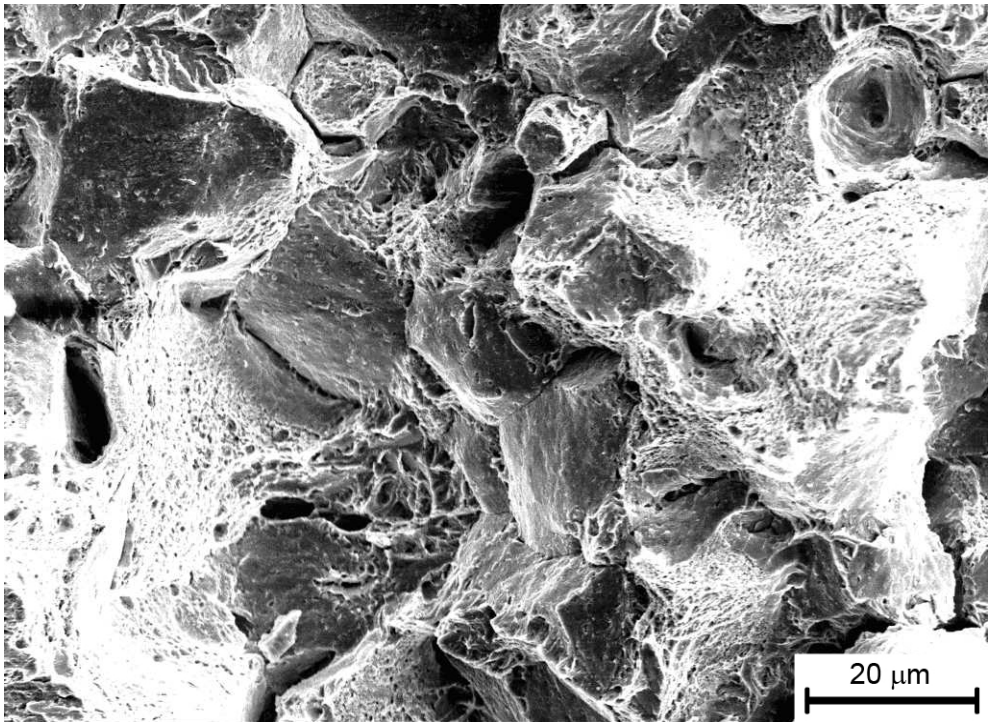
transgranular dimpled rupture, for example the SEM fractograph in Figure 20-28. This type of overload fracture has been observed for other high strength steels [6].

Figure 20-28: Case History 20.5.4 – Fracture Characteristics of the Non-Suspect Used D12 Bolt from the Pilot Tensile Tests.

All the bolt-break failures were examined fractographically. The fractures were due to overload by a mixture of intergranular and transgranular dimpled rupture, as already illustrated in Figure 20-28. There was no evidence of small semi-circular regions of IHE at the thread roots.

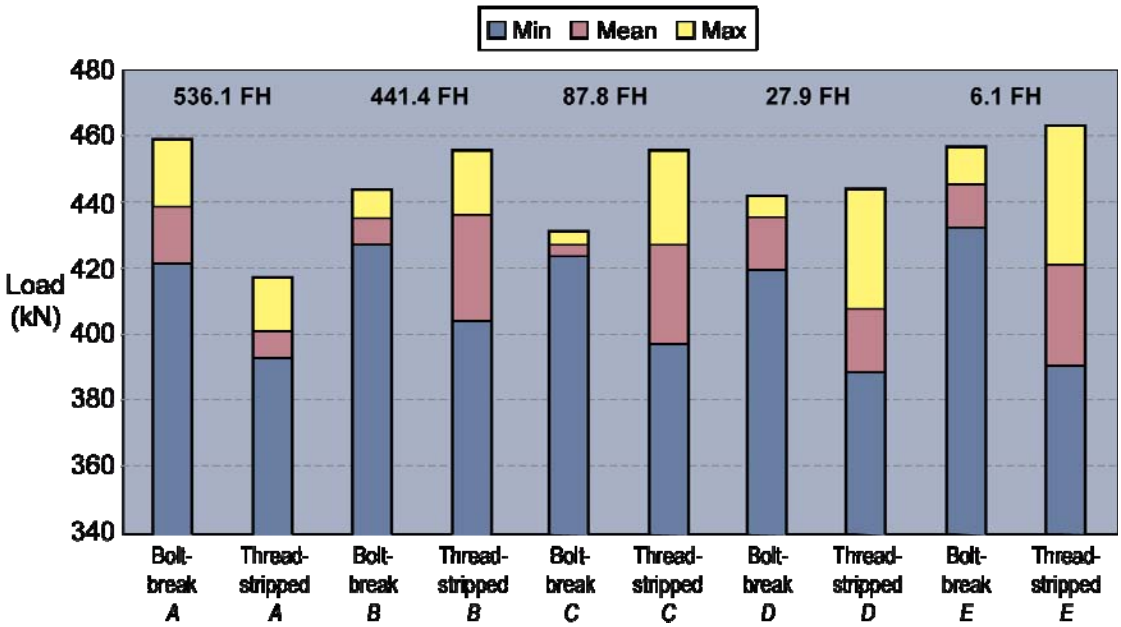
Figure 20-29 summarises the test data in a histogram. This gives the ranges in failure loads for the two failure modes, bolt-break (19 cases) and thread-stripped (31 cases). For each of the 5 aircraft the bolt-break failure mode resulted in minimum and average failure loads at least as high as those for the thread-stripped failure mode. Also, there is no apparent relation between the failure loads and flight hours since paint stripper treatment.

Figure 20-29: Case History 20.5.4 – Histogram of the Definitive Tensile Test Data (FH = Flight Hours since paint stripper treatment).

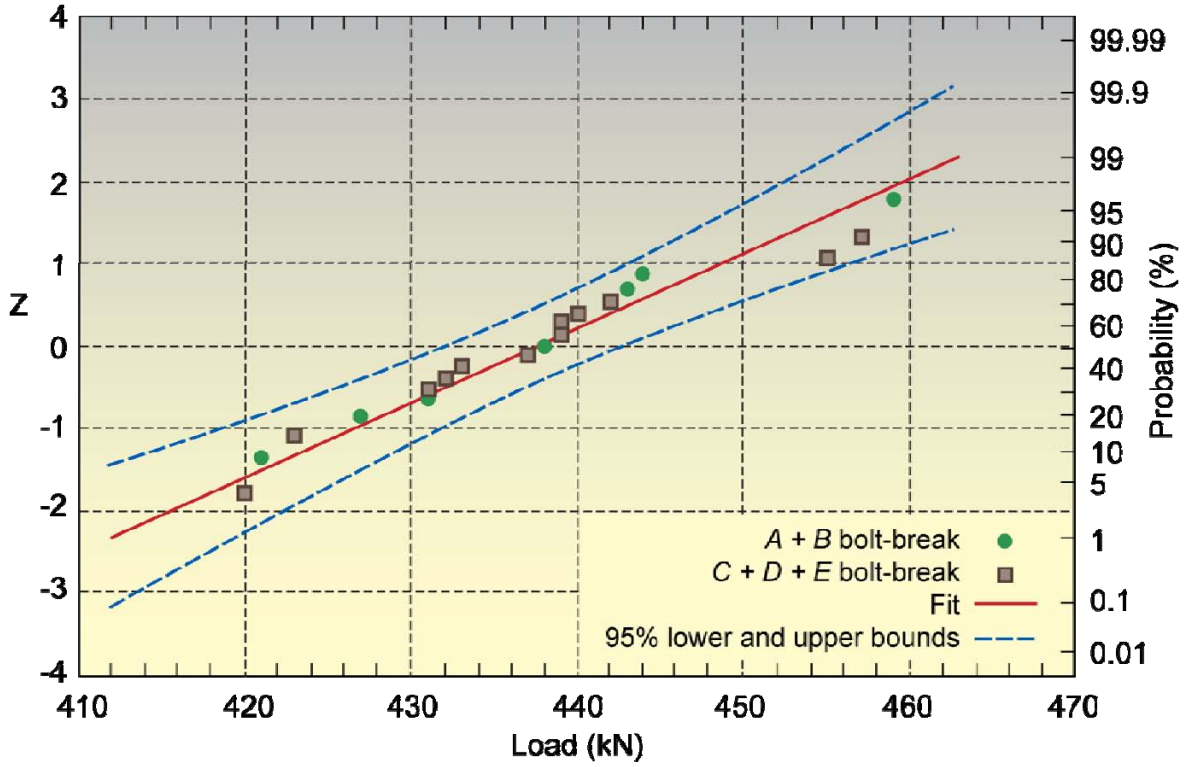
Figure 20-30: Case History 20.5.4 – Normal Fit for the Bolt-Break Failure Load Data from the Definitive Tensile Tests.

2) In combining data from all 5 aircraft, it can be seen from Figure 20-30 and Figure 20-31 that the bolt-break minimum and mean failure loads were well above those for the thread-stripped failures. The mean values were 437 kN and 422 kN, respectively.

3) *Flight Hours since Paint Stripper Treatment* – The major differences in flight hours since paint stripper treatment (***A*** and ***B*** versus ***C***, ***D*** and ***E*** bolts) are indicated by filled and open symbols in Figure 20-30 and Figure 20-31. There is no clustering of the failure loads according to flight hours, in agreement with a lack of a trend in Figure 20-29.

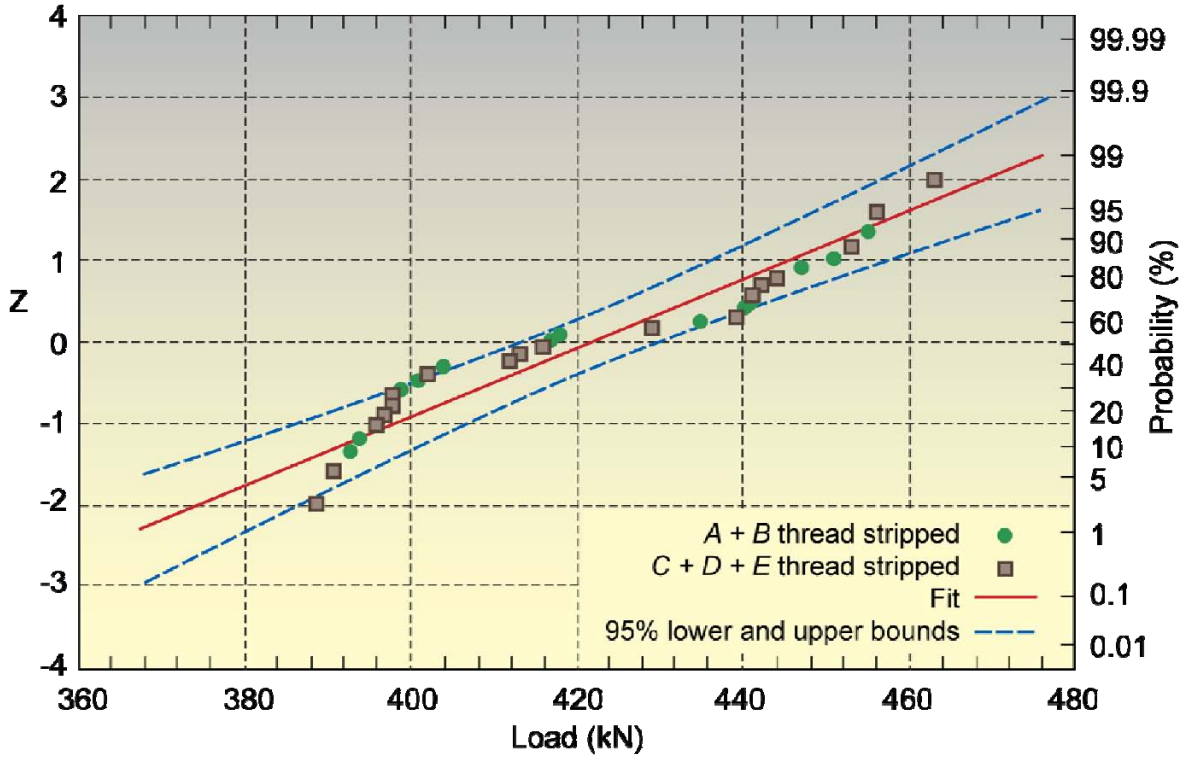
Figure 20-31: Case History 20.5.4 – Normal Fit for the Thread-Stripped Failure Load Data from the Definitive Tensile Tests.

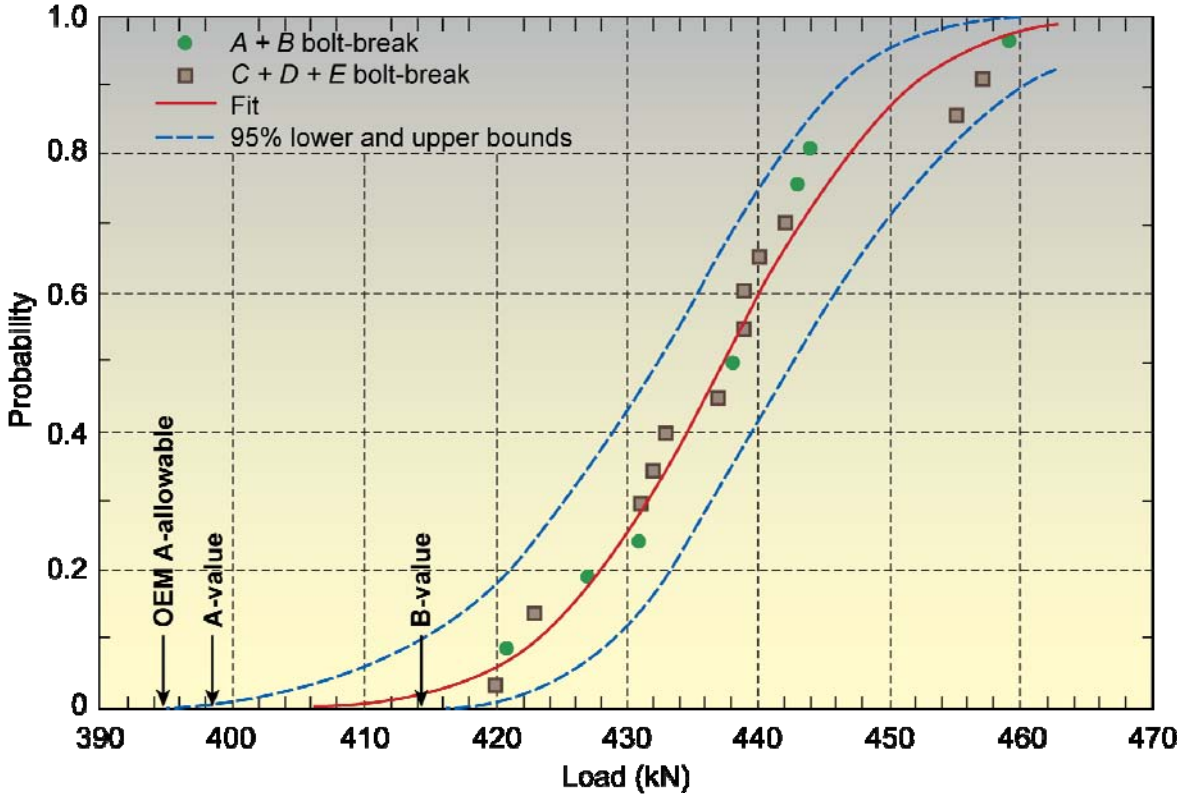
4) *Minimum Strength Level* – Figure 20-32 depicts the same information for the bolt-break failure data as Figure 20-30, but now in terms of a Cumulative Distribution Function (CDF), together with the failure strength A- and B-values[4]. These represent the 95% confidence lower limits on the first and tenth percentiles of the property distributions, 399 kN and 415 kN, respectively. The confidence limits were determined using the Fisher information matrix [17].

Figure 20-32: Case History 20.5.4 – Cumulative Distribution Function (CDF) for the Bolt-Break Failure Load Data from the Definitive Tensile Tests.

Figure 20-32 also shows the OEM failure strength A-allowable for D12 bolts, 395 kN. The estimated A-value from the bolt-break tests is higher, even though based on a limited data set of 19 cases. One may expect the A-value for a larger data set to be still higher.

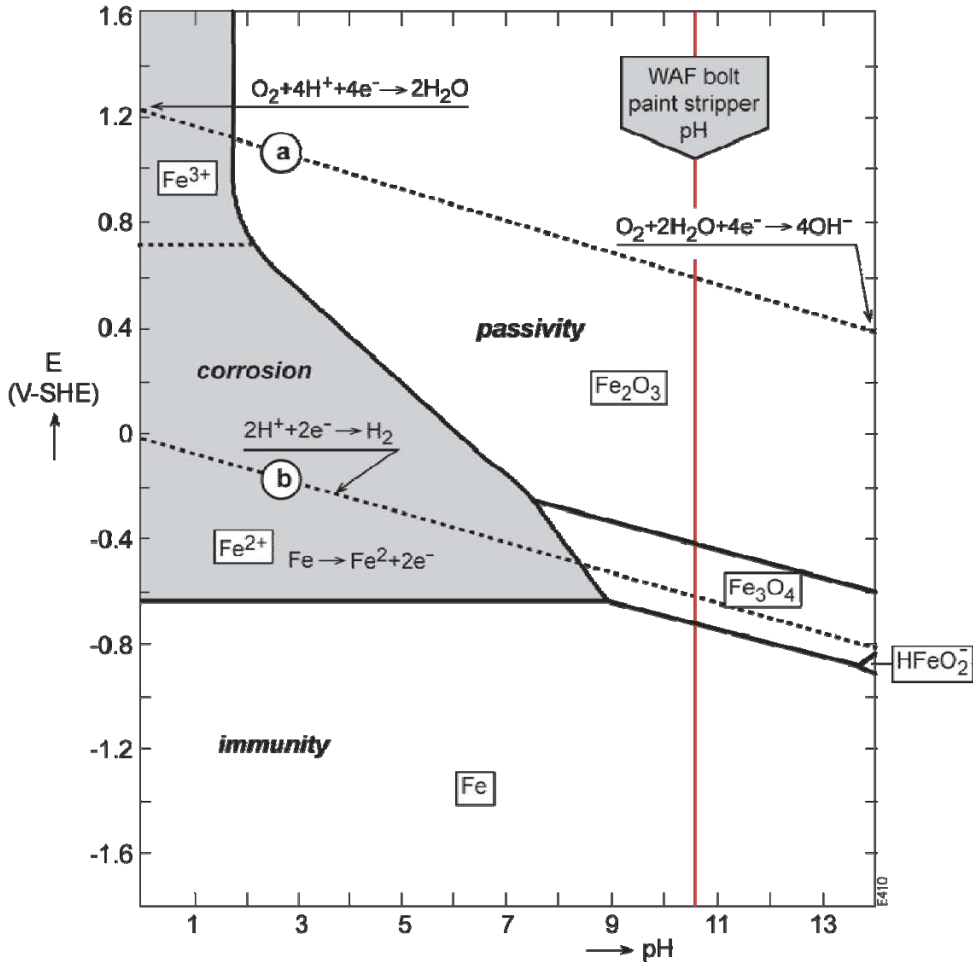
Figure 20-33: Case History 20.5.4 – Simplified E – pH Diagram for the Iron-Water System at 25°C (E is the electrode potential with respect to the Standard Hydrogen Electrode (SHE)).

The pH of the WAF bolt paint stripper is shown as a dashed vertical line in Figure 20-33. Knowing that the bolts would initially be cadmium plated, and that cadmium plating is sacrificial with respect to steel, this E – pH diagram suggests that:

2) The bolts would not corrode in the paint stripper, since its pH line is well outside the corrosion region. Note that the suggestion about no corrosion of the bolts is consistent with measurements of the open-circuit potential of another low alloy steel (4340) in paint strippers having pH values ranging from 8 – 11.5 [19]. These measurements showed that the bare steel was in the water-stable (passivity) region of the E – pH diagram. In other words, even if all the cadmium plating on the WAF bolts were to be removed by anodic attack, the bolts would remain uncorroded. (In fact, as mentioned earlier, inspection of all the suspect bolts before tensile testing showed no evidence of corrosion except service-induced light rusting on some of the bolt ends from the aircraft ***A*** and ***E***.)

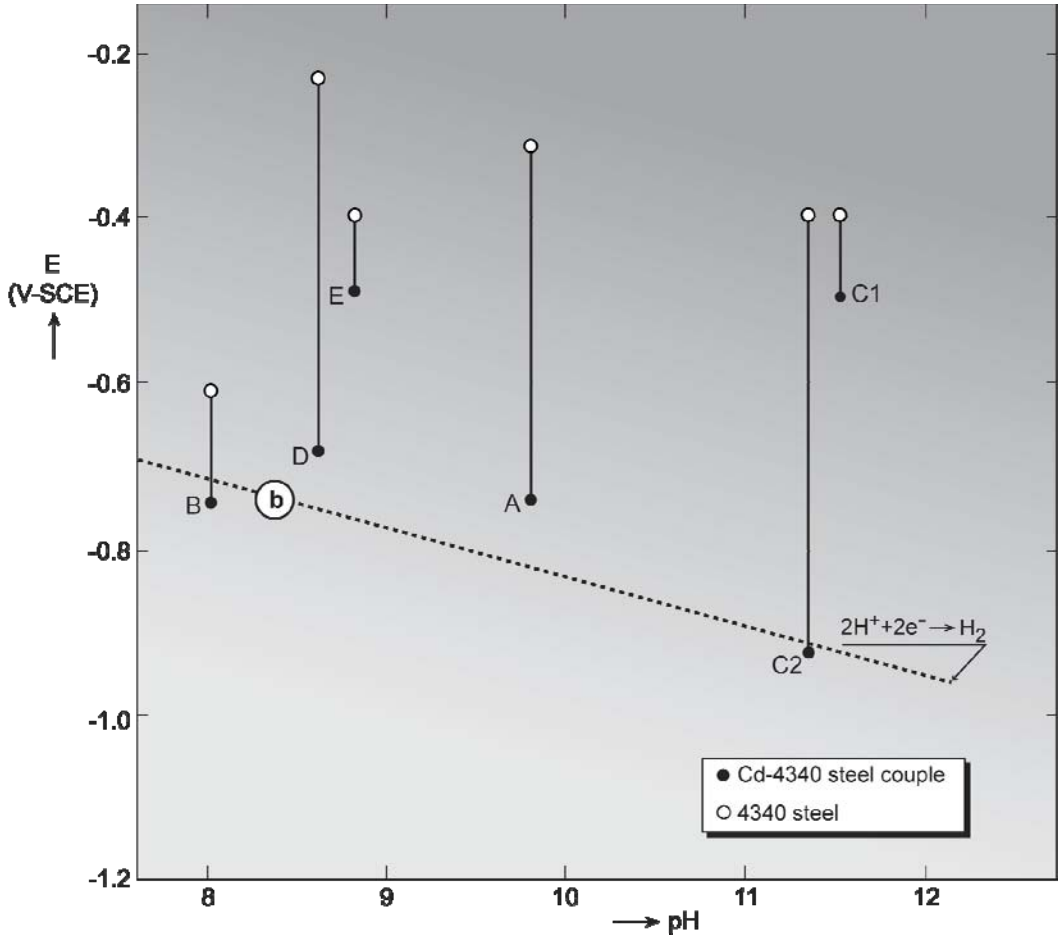
With respect to 1) above, there is the question of hydrogen absorption into the WAF bolts during the anodic attack and removal of the cadmium layer by the paint stripper. This could occur only if the galvanic coupling potential was below line (b), *as may have been the case*. For example, Figure 20-34 shows the galvanic coupling potentials for cadmium and 4340 steel in several paint strippers [19], whereby it is seen that it is possible to transgress below line (b).

Figure 20-34: Case History 20.5.4 – E – pH Diagram for (1) Open Circuit Potentials of 4340 Steel and (2) Galvanic Couple Potentials for Cadmium and 4340 Steel in Paint Strippers [19] (E is the electrode potential with respect to the Saturated Calomel Electrode (SCE): E (SCE) = 0.241 E (SHE) at 25°C).

2) The data in Figure 20-34 show that some paint strippers can cause hydrogen pick-up in cadmium plated high strength steels. Hence relaxation of the proof test duration from 200 hours to 150 hours in so-called passive service environments, as mentioned in Section 20.4.3, is not necessarily advisable.

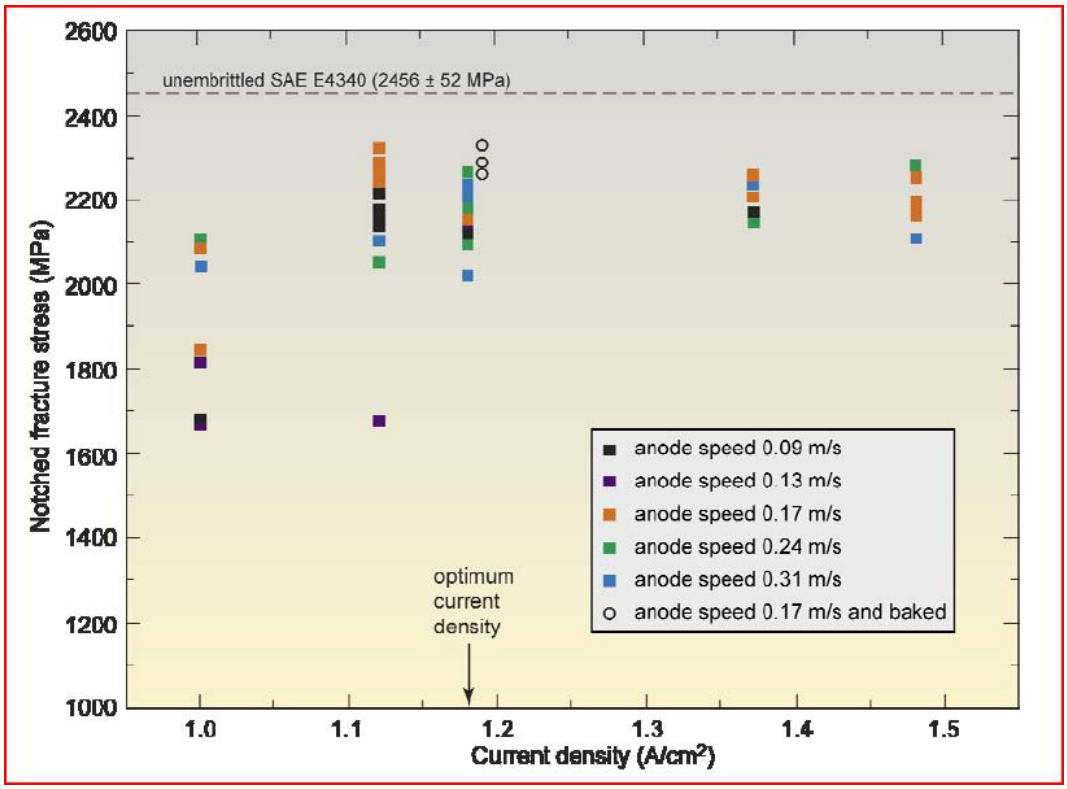
Figure 20-35: The Effect of Current Density in the Range Suggested by the Manufacturer on the Notched Fracture Stress of SAE E4340 Steel Specimens.

All of the SSRT specimens showed notched fracture stress reductions compared to the unembrittled fracture stress of 2456 ± 52 MPa. This was also observed in trials on Low Hydrogen Embrittlement (LHE) cadmium brush plated D6ac steel SSRT specimens [22]. More specifically, Figure 20-35 and Figure 20-36 indicate that the minimum reductions in fracture stress were obtained for SAE E4340 specimens plated under optimum conditions, whether subsequently baked or not. These results suggest that part of the fracture stress reductions may be due to some other phenomenon instead of IHE. One possibility is that the notch roots were slightly damaged by cleaning before plating.

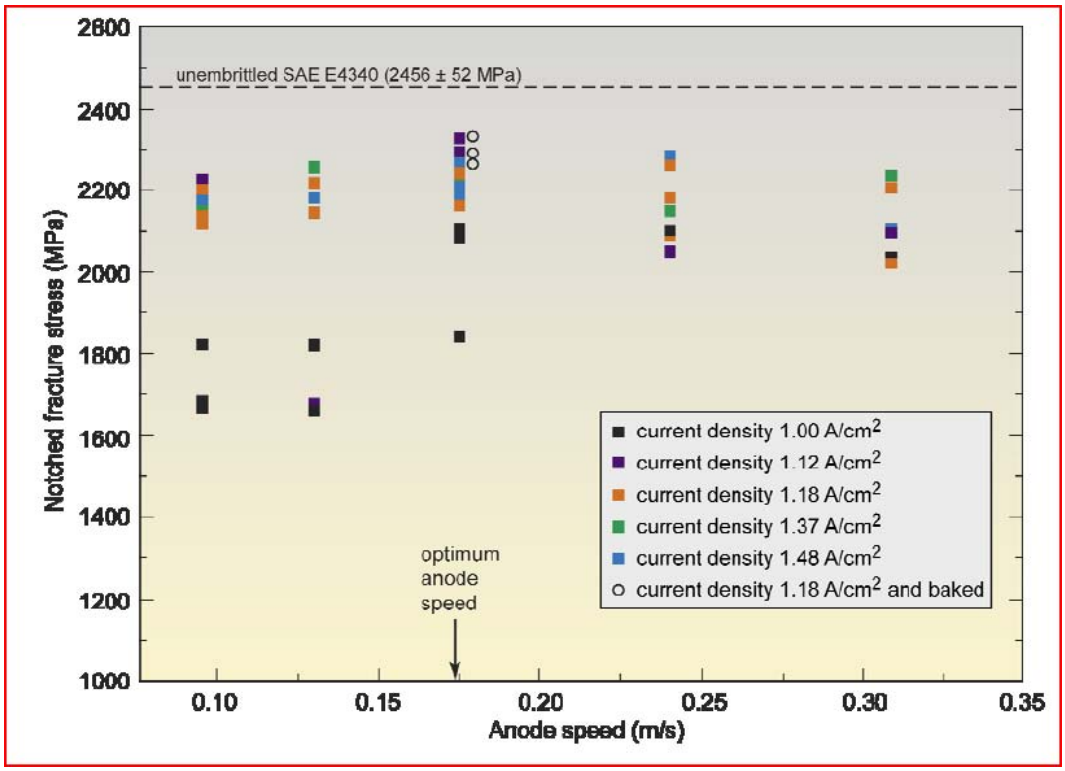
Figure 20-36: The Effect of Anode Speed on the Notched Fracture Stress of SAE E4340 Steel Specimens.

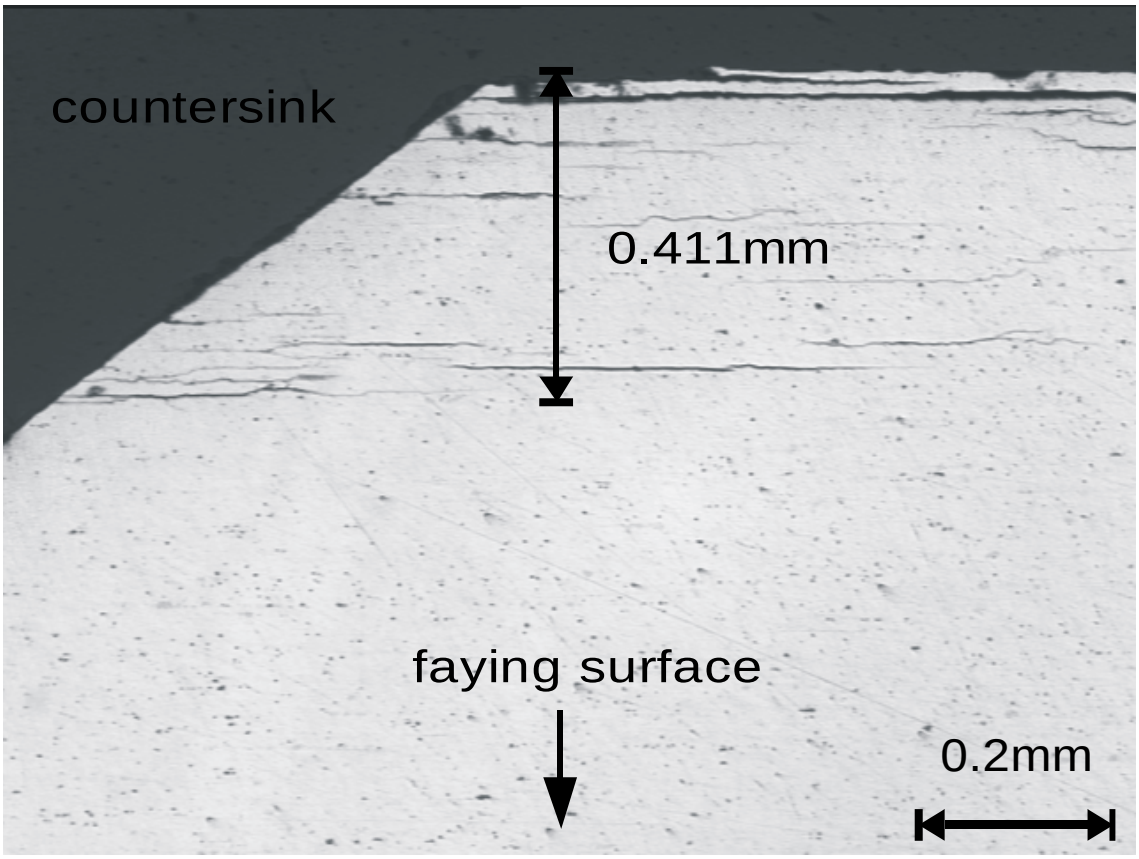
Figure 21-4: Metallographic Section Around a Fastener Hole in a Boeing 707 Wing Skin Plank, Showing Multiple Layers of Intergranular Attack from Pits in the Countersink – the material is 7178-T6 aluminum (from Forsyth et al. [24]).

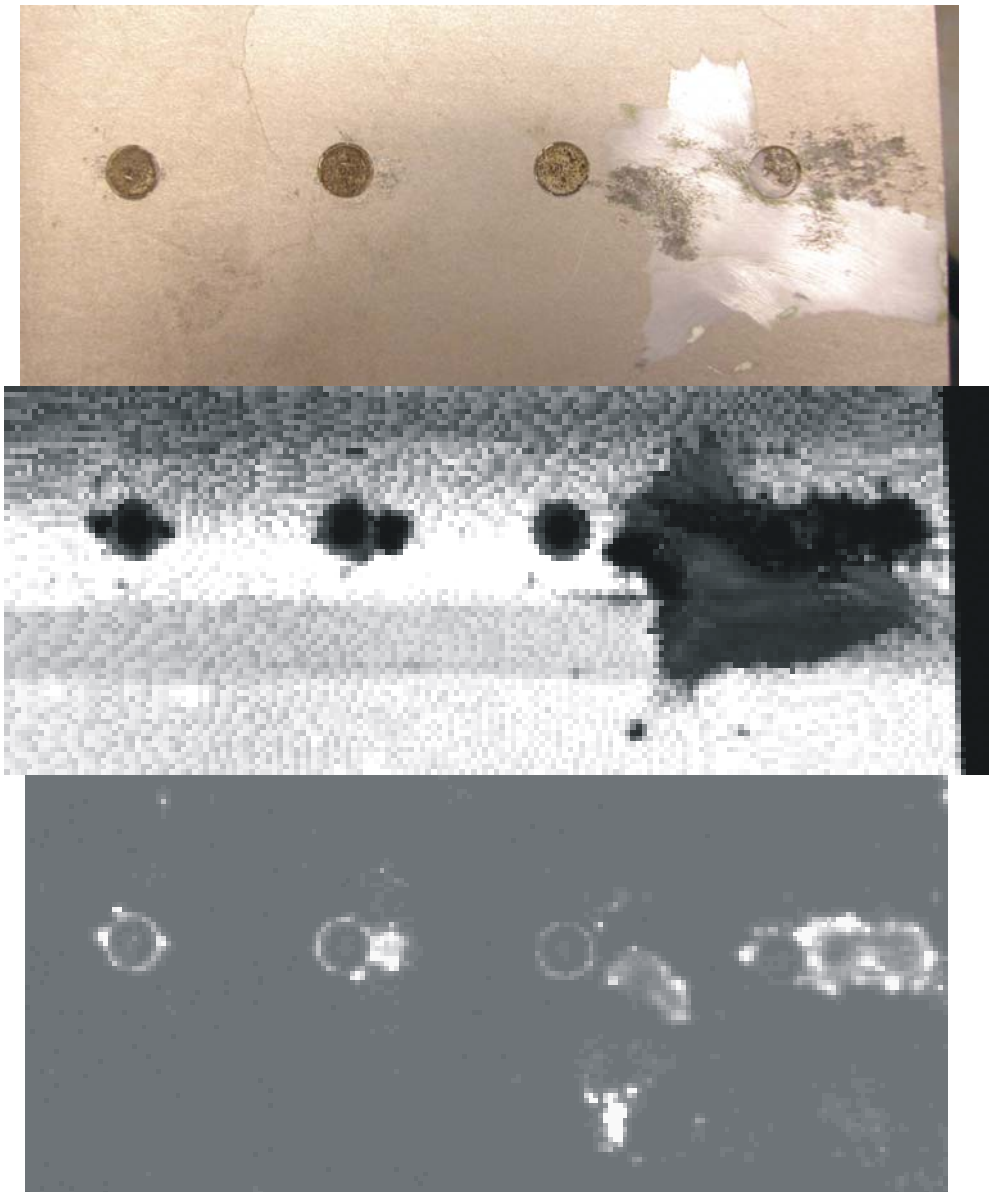
Figure 21-5: From Top to Bottom: A Photograph, a UT Image, and an IR Image of a Section of Wing Plank from a Boeing 707, Showing Exfoliation Damage and Grinding Marks from Repairs – the material is 7178-T6 aluminum (from Forsyth et al. [24]).

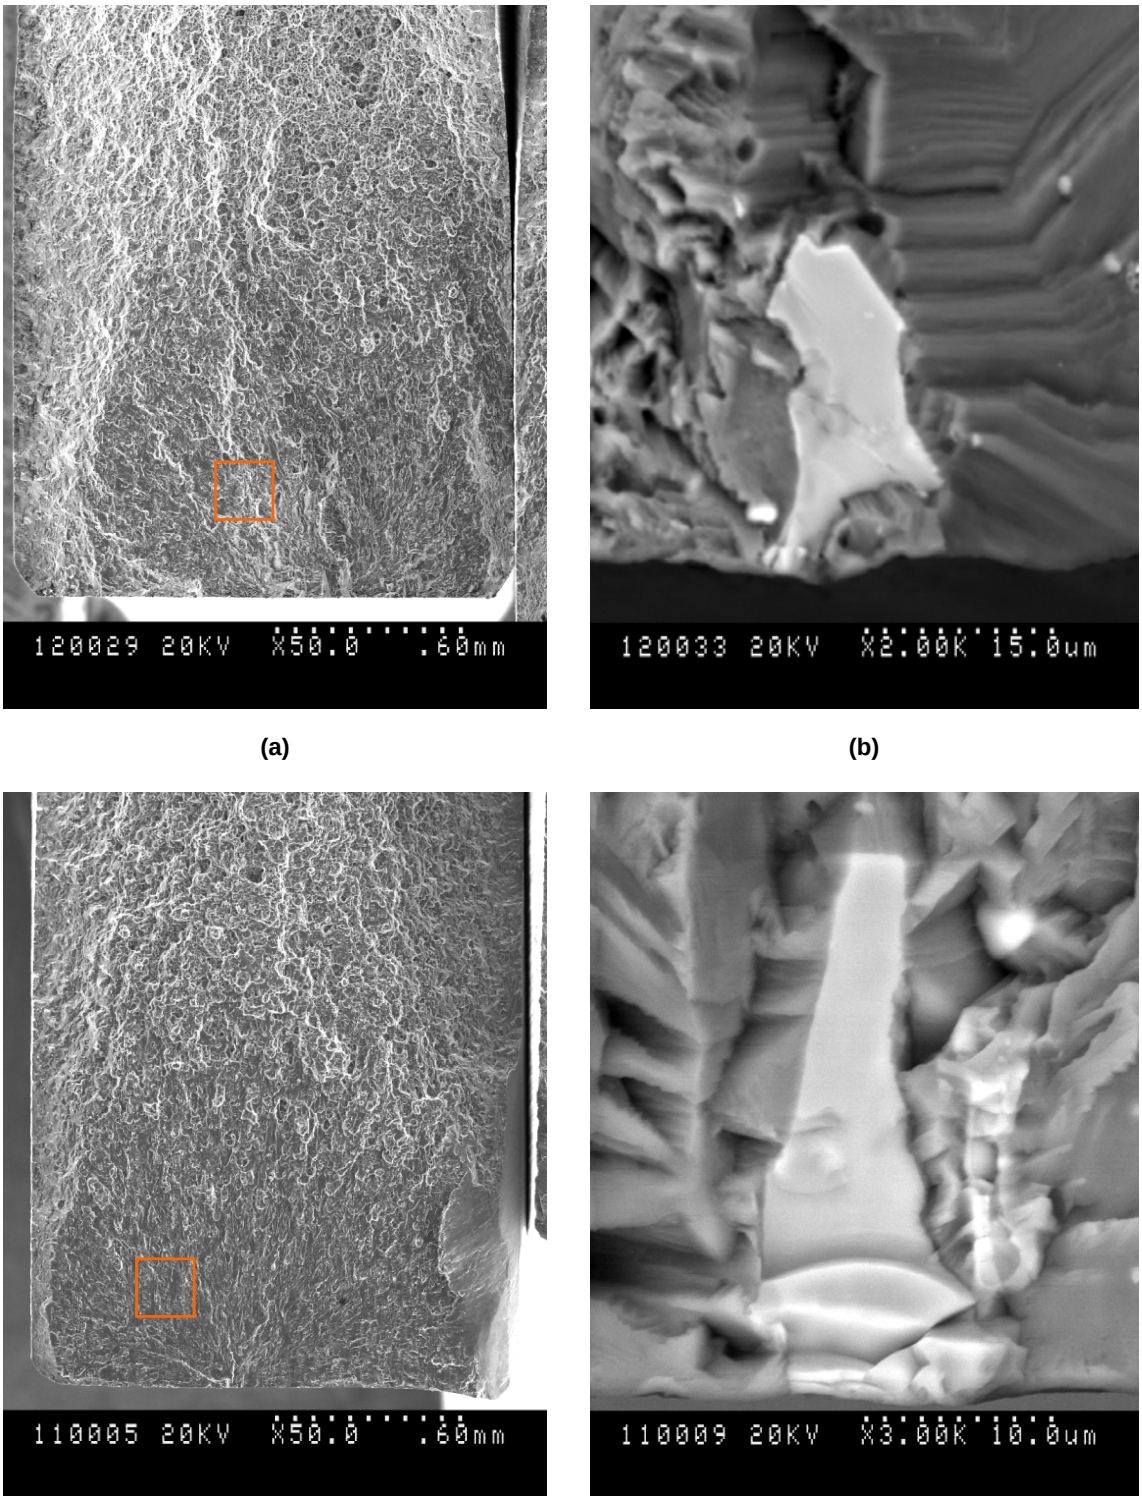
Figure 24-3: SEM Micrographs of Fracture Surfaces of Fatigue Coupons of 2024-T3 and 7075-T6 Sheets, Indicating Constituent Particles as Crack Origins – (a) Low magnification view of fracture surface for 2024 specimen; (b) High magnification, backscatter view of the (window) nucleation site; (c) Low magnification view of fracture surface for 7075 specimen; and (d) High magnification, backscatter view of the (window) nucleation site [15],[22],[23].

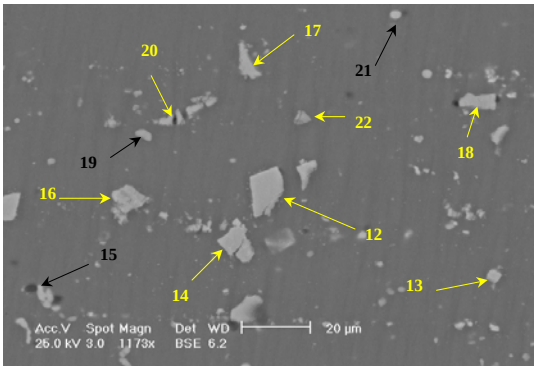
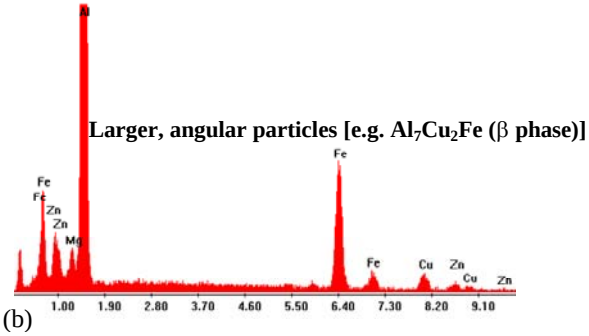
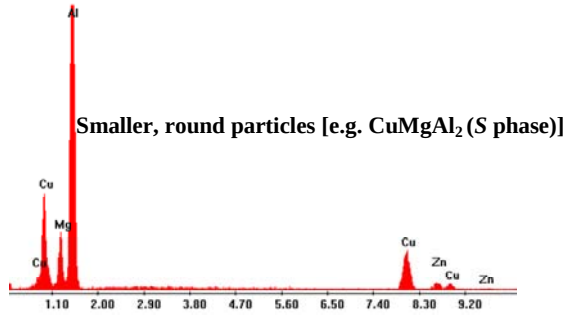
Figure 24-4: (a) SEM Micrograph of Typical Constituent Particles in a 2024-T3 Alloy. EDX results showed that (b) larger and more angular particles have considerable amounts of iron, whereas (c) the smaller, spherical particles do not. The spectra from the fatigue crack nucleating particles were identical to those from analysis of large particles found in metallographic sectioning [22].

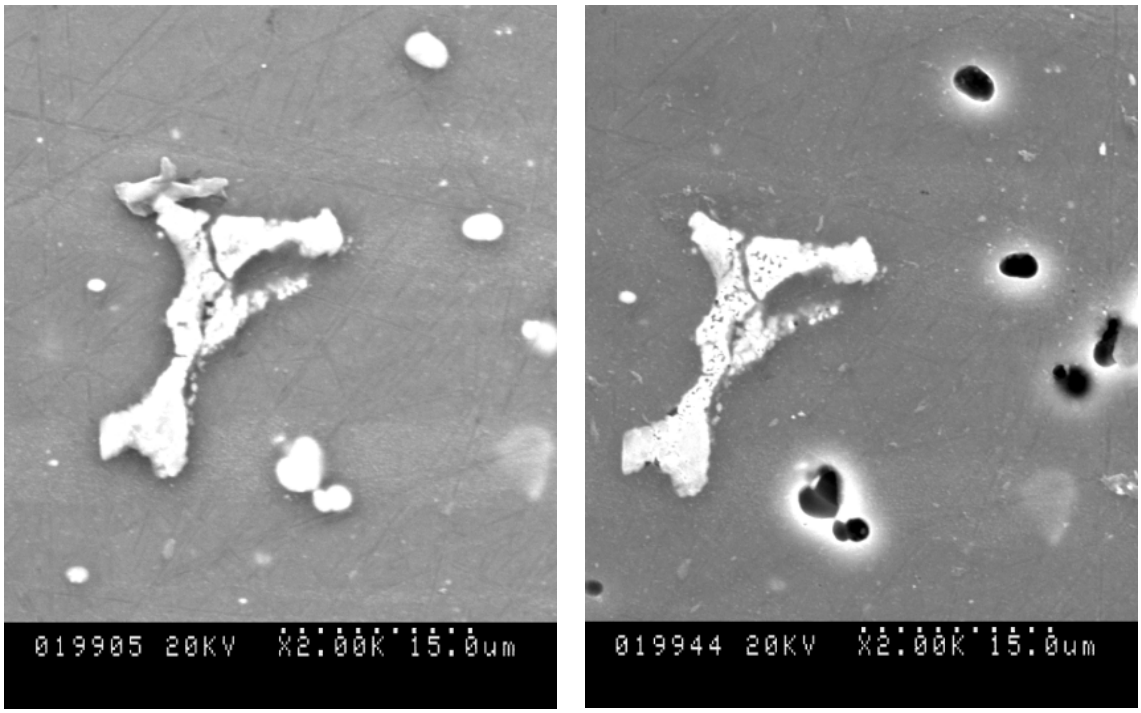
Spherical particles seem to be mainly of the $CuMgAl_2$ (S-phase) type. They do not appear to be as harmful as iron bearing β-phase particles to fatigue performance. However, when these alloys are exposed to corrosive solutions, S-phase type particles appeared to be the weak link of the microstructure in terms of initiating pitting corrosion (Figure 24-5).

Figure 24-5: Constituent Particles – (a) Prior to corrosion; and (b) After 2 hours in corroding solution. Although, spherical particles did not seem to be harmful to fatigue performance, they appeared to be the weak link of the microstructure in terms of initiating pitting corrosion [22].

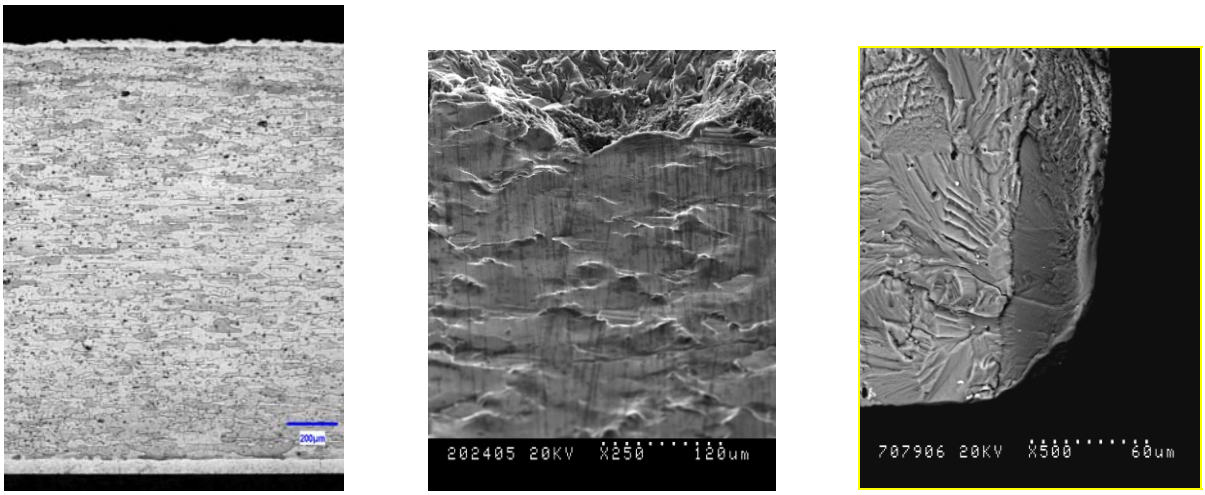
Figure 24-6: The Thin Clad Layer Corrodes Rather Mildly and Uniformly to Protect the Core Alloy – (a) General corrosion of clad layer at the exterior surface of fuselage skin (top surface) from B727; (b) Tilted image crack nucleation site as indication of severe deformation and cracking at clad layer at the surface of 2024 core alloy which failed in fatigue testing; and (c) Fracture surface showing the clad layer (~ 50 μm) at the right side [15].

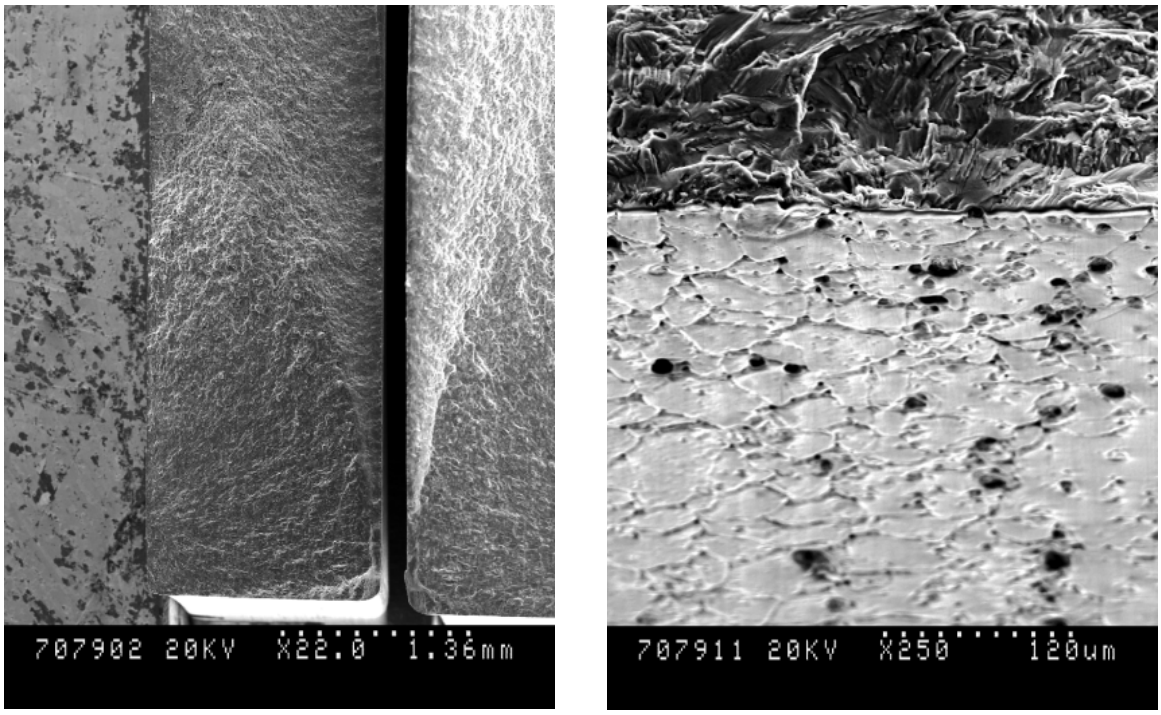
Anodizing also harms the fatigue life in various ways, with the main effect again being the encouragement of crack nucleation. The anodizing process produces a brittle and hard oxide film with inherent pores, which would readily crack when deformed. The presence of defects in the oxide film facilitates the early nucleation of fatigue cracks (Figure 24-7). The fatigue life of anodized specimens is also affected by the formation of so called “etch pits”. A long etching time (deoxidizing) prior to anodizing could result in pitting, particularly in the vicinity of chemically active regions such as grain boundaries and intermetallic particles at the surface [41],[42].

Figure 24-7: Fatigue Fracture Surface of Coupons Made of Anodized 1.6 mm Thick 7079-T6 Alloy. The sheet was removed from a retired C-5 fuselage skin – (a) Fracture surface of fatigue coupon with window showing the nucleation site; and (b) Tilted SEM image represents a close up view of nucleation site (the window) indicating a brittle and hard oxide film anodized layer with inherent pores and tiny cracks [13].
