RTO AGARDograph **AG-AVT-140**

Corrosion Fatigue and Environmentally Assisted Cracking in Aging Military Vehicles

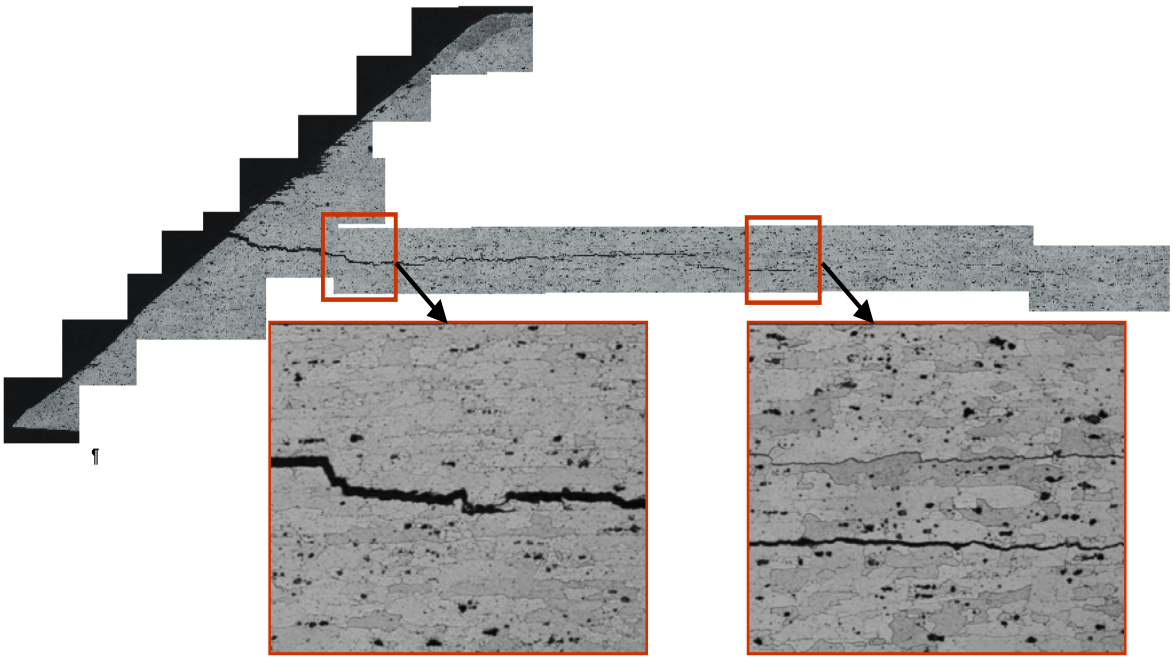
Figure 24-8: SCC Failures During Service at Mid Thickness of a Sheet Made of Alloy 7079-T6. Section of rivet hole, displaying a 4 mm (0.157") long crack. Crack at fastener hole on a fuselage panel near the troop door of C141 Starlifter [14].

It is also important that new materials achieve maturity before being used in aircraft. Experience with alloys in service, perhaps in aircraft secondary structures or non-aeronautical applications or simulated service behavior concerning corrosion, inspection, long term performance, etc. should be known prior to use in aircraft primary structure. A good lesson from the past is the launch of the high strength alloy 7079 in T6 temper for thick products. The alloy was introduced as a replacement for 7075-T6 to improve SCC performance in the short transverse direction. Laboratory tests in 3.5% NaCl solution by alternate immersion showed superior performance to the alloys in use at the time. Despite the good resistance predicted by the accelerated testing, service failures of alloy 7079-T6 showed it to be by far the most SCC susceptible alloy and temper among the commonly used high strength aluminum alloys available at that time. Although it was resistant to nucleation of SCC cracks, the rate of growth of SCC was orders of magnitude faster than that of the other alloys. The pre-cracked SCC test was not a standard test at the time in early 1950s. Figure 24-8 shows the nature of the crack paths for EAC in aluminum alloys which are almost exclusively intergranular [14]. Widespread service failures resulted in recommendations that 7079-T6 be replaced with alternative materials such as 7475-T7 [10].

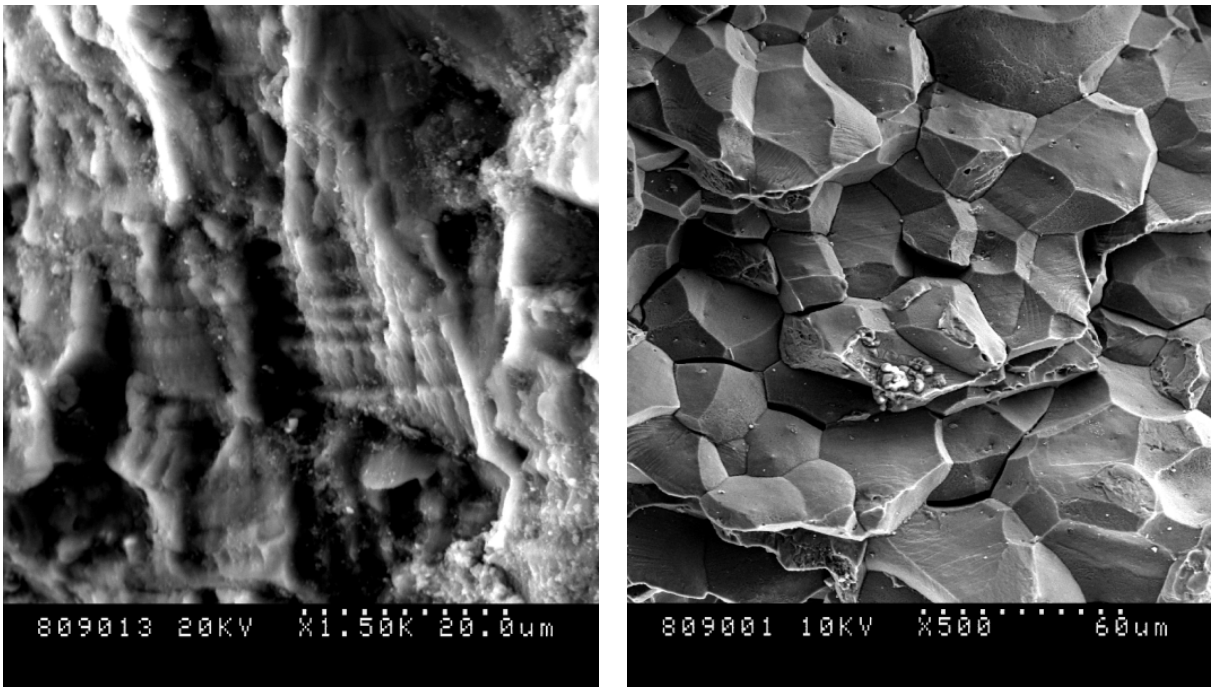
In the case of the CH149 Cormorant Search and Rescue Helicopter, 8090 Aluminium-Lithium (Al-Li) alloys in different product forms and tempers have been used to replace most of the conventional aircraft alloys such as 7075-T6 and 2024-T3 [56]. This is because of their low density and high elastic modulus. Although the Cormorant is in the early stages of its life cycle, signs of premature material failure are raising concerns about long-term durability. The fracture surfaces of a number of in-service failed Al-Li parts indicate that brittle intergranular fracture is the most common mode of failure (Figure 24-9).

Figure 24-9: Typical Fracture Feature Found During Maintenance Inspection of the CH149 Cormorant at the Secondary Structures (Under-Floor Z-Stiffeners) After Only a Few Years of Service. The most common failure mode observed was (a) small area of fatigue followed by (b) major part of fracture as brittle intergranular failure. The part is made of 8090-T8 aluminum lithium [56].

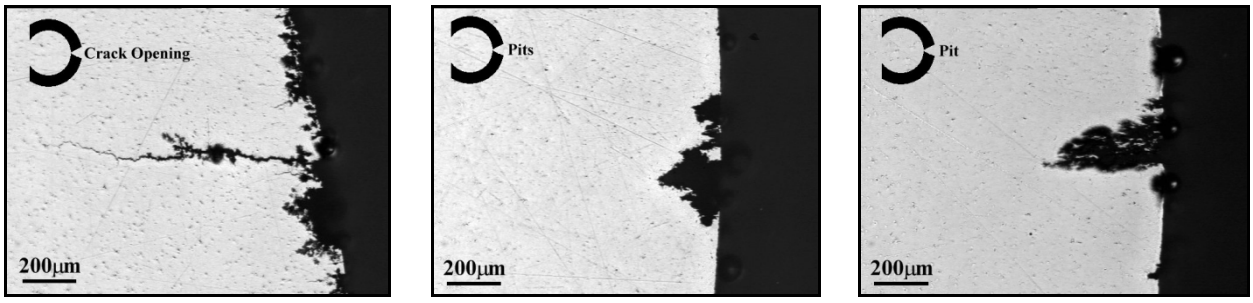
Stress corrosion cracking tests were conducted in accordance with ASTM Standards G 38 and G 44. The C-ring specimen was chosen because of the limited material thickness available in the S-T orientation. The specimens were pre-stressed to 45 and 54 ksi and placed in an alternate immersion tank where they were exposed to a 10 minute immersion in a 3.5% NaCl solution followed by 50 minutes of drying time. According to Federal Specification Sheet QQ-A-200/11E [21], the test duration is to be 20 days and specimens lasting until the end of 20 day period are considered to have SCC resistance equivalent to the T73 temper. The RRA treated specimens successfully completed the 20 day exposure period without developing evidence of intergranular cracks. Figure 25-5 shows polished x-sections of typical T6511, T73511 and T6RRA C-ring specimens.

T6 Specimen SK29
(16 days to failure)

T73 Specimen SL03
(20+ days)

Figure 25-5: C-Ring SCC Comparison with 54 ksi (372 MPa) Pre-Stress Level.

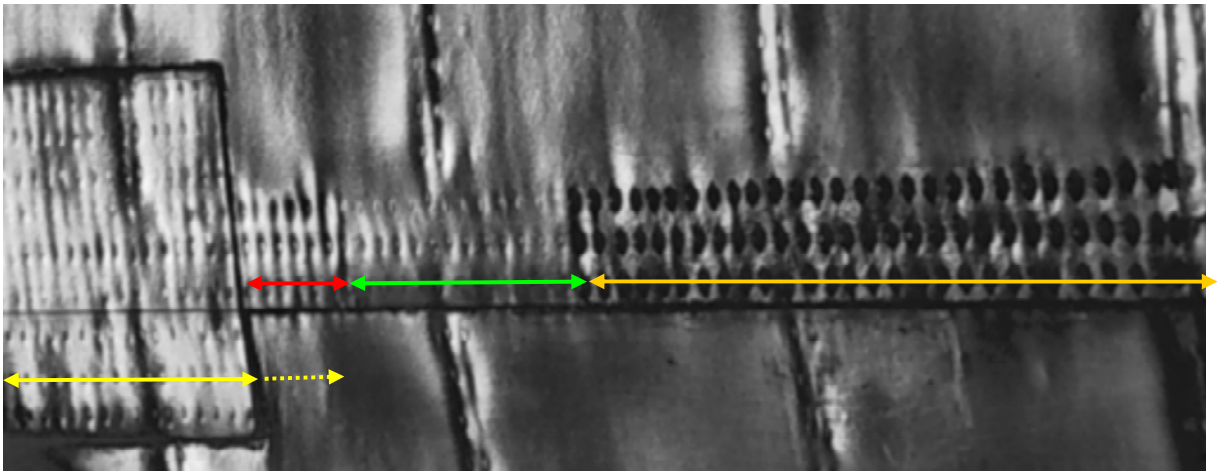
This inspection system enables enhanced visual inspections of intact joints [5]. Figure 27-1 is a DAIS image of a lap joint that illustrates the stages in corrosion growth, detection and repair:

- Red line: this area suffered un-repaired corrosion damage, visible as pillowing. Either this damage had occurred since the repairs were carried out or it was present at the time and was missed by the inspection techniques employed. At the next D-check the external doubler repair (solid yellow line) was removed and replaced with a larger doubler that covered the expanded repair area, as indicated by the dotted yellow line.

Figure 27-1: Lap Joint Corrosion and Repairs.

In the above illustration the rivet-to-rivet and row spacings in the joint were nominally equal, which caused the pillowing response when the skins were deformed by the accumulation of corrosion products between the fasteners restraining them. However, each manufacturer has invested heavily in the understanding of their proprietary joint designs and chosen specific rivet / rivet row spacings. These spacings directly affect the corrosion pillowing response and inspectability. For example, Airbus and Lockheed L1011 joints do not pillow, they make waves. Douglas DC-10 joints also make waves, but the view is complicated by the use of 'beauty strips' (external butt joint doublers). Douglas DC-9 longitudinal joints do not appear to pillow or make waves unless they are viewed perpendicular to the joint rather than along it as in Figure 27-1. The reason is that the DC-9 has closely spaced rivets in widely spaced rows, and corrosion product accumulation results in wave-like distortions parallel to the joint. These are almost impossible to detect when viewed along the joint.

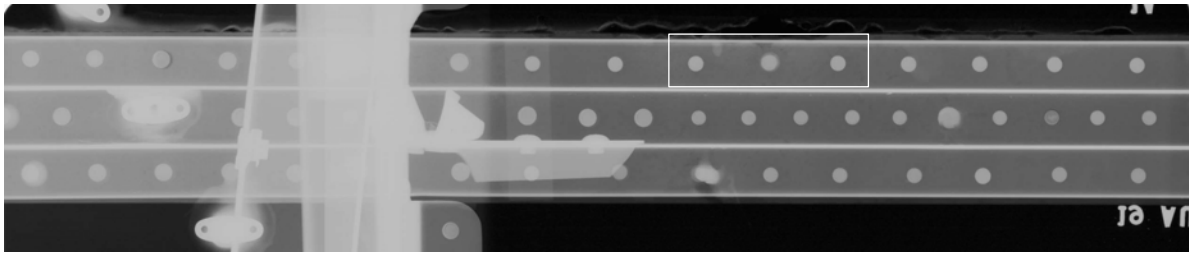
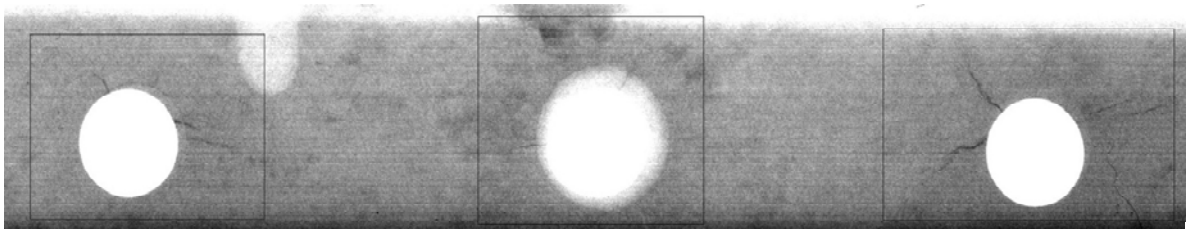
X-radiography is not typically used for corrosion detection, as is mentioned also in Part 2 of this chapter. However, the pillowing forces generated by the corrosion activity in multi-layer structures can lead to tensile forces sufficient to nucleate cracks which are detectable by X-ray, Figure 27-2.

(a) Typical x-ray film of intact joint.

(b) Non-surface breaking cracks (enlargement of area in white box).

Figure 27-2: Corrosion-Induced Pillowing Cracks.

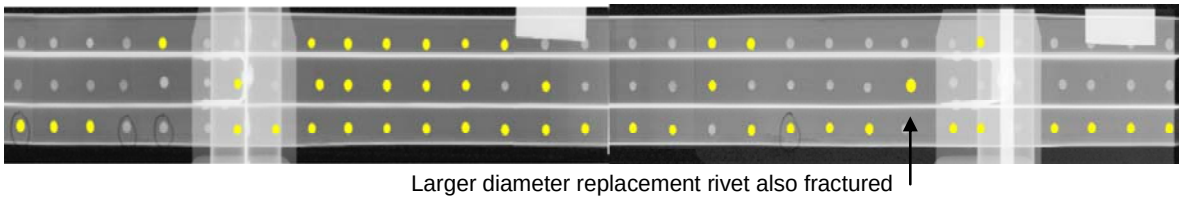
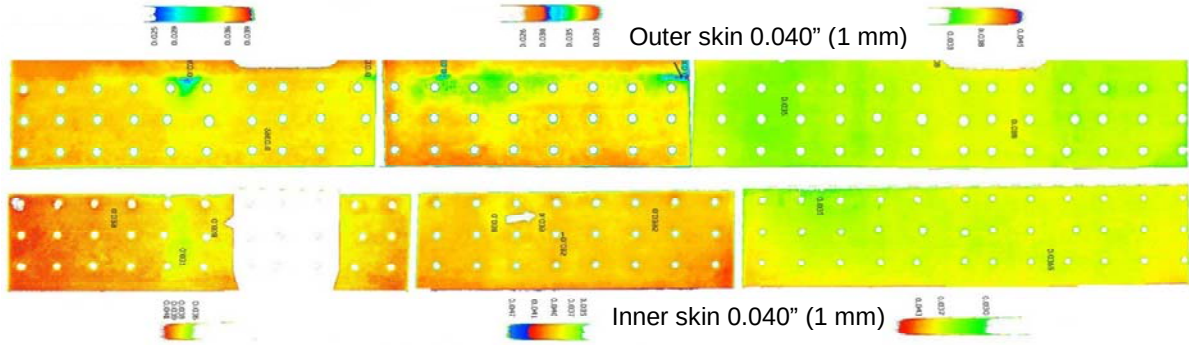
Skin thickness loss and cracked rivets – Figure 27-3 shows X-ray inspection results for an intact and disassembled lap joint. The skins of the lap joint suffered only 3 – 4% combined thickness loss yet 43 of the 93 rivets in the joint, a total of 47%, were *subsequently* (during teardown) found to be fractured, including a larger diameter replacement rivet in the middle row. Fractured rivets were those that easily broke into two during teardown of the joint (shop heads machined off and rivets pressed out).

(a) Rivet condition: Yellow – fractured.

(b) False-color digitized X-ray thickness loss (calibration ramps adjacent to sections).

Figure 27-3: X-Ray Inspection Results for (a) Intact and (b) Disassembled Joint.

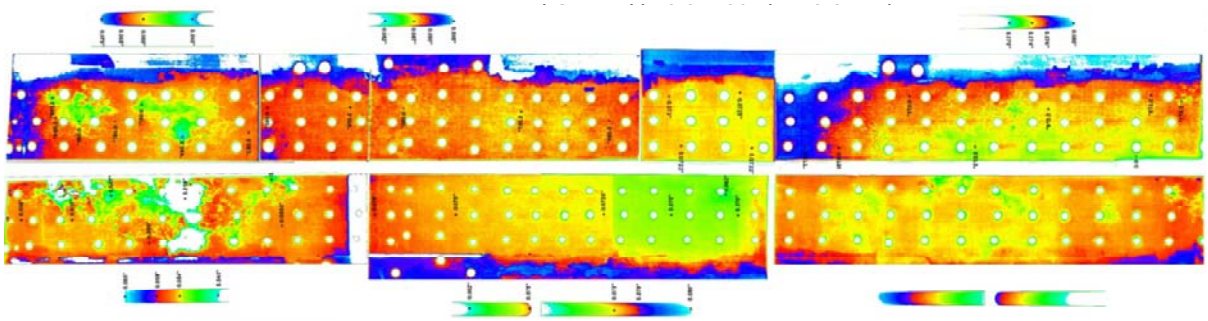
Figure 27-4 gives another example of X-ray inspection results for an intact and disassembled lap joint. The upper X-ray was taken before the joint was disassembled and cleaned of paint, primer, sealants and corrosion product to facilitate the thickness loss mapping of the separate skins. Both skins had been taper-machined: the outer skin from 0.07 to 0.09 inch (1.78 – 2.28 mm) and the inner skin from 0.06 to 0.08 inch (1.52 – 2.03 mm). Disassembly allowed detection of the thickness loss due to corrosion.

(a) Rivet condition: Red – Failed-in-place, Yellow – Fractured, Blue – Replaced.

(b) False-color digitized X-ray thickness loss (calibration ramps adjacent to sections).

Figure 27-4: X-Ray Inspection Results for (a) Intact and (b) Disassembled Joint.

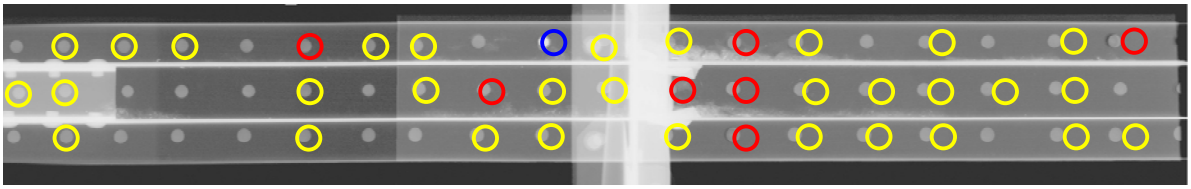
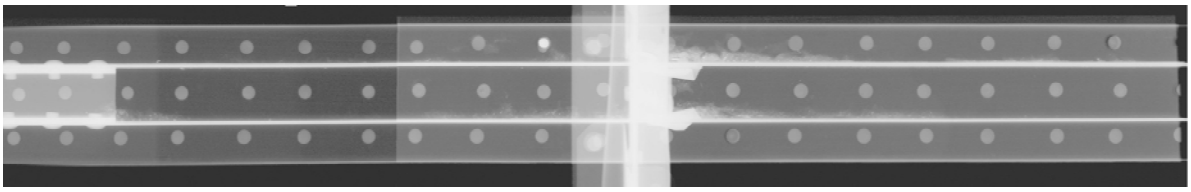
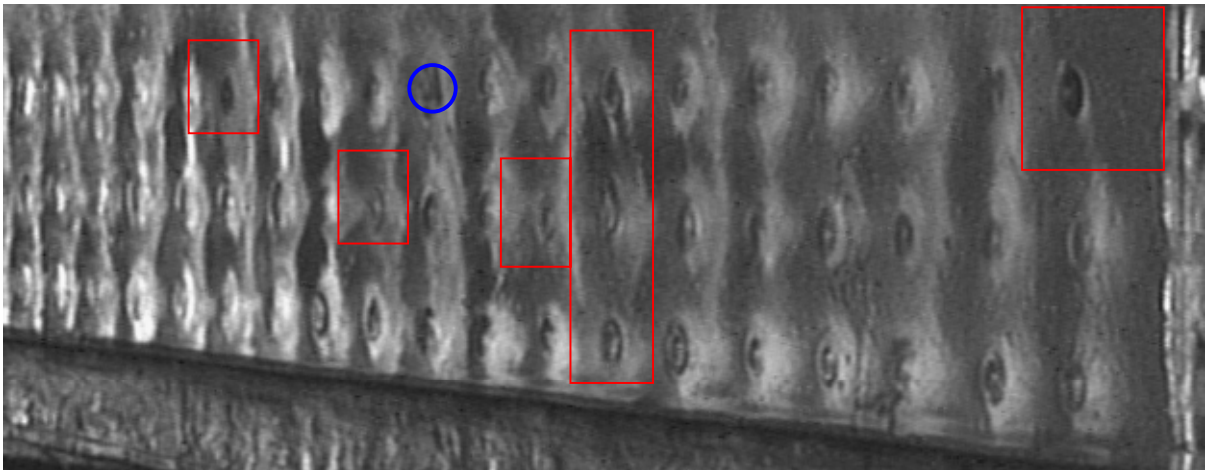
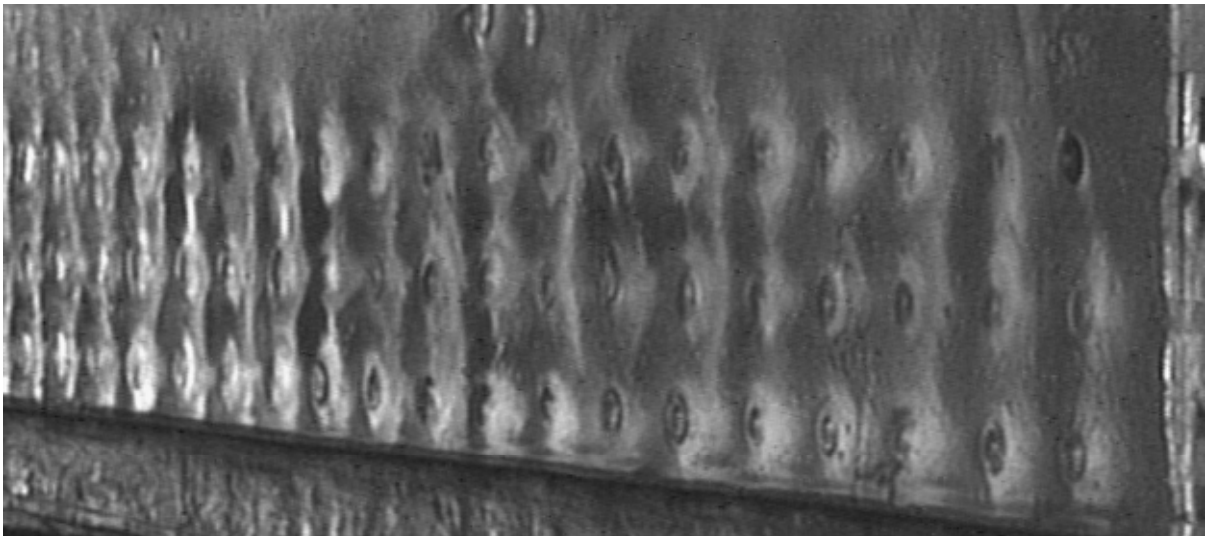
Figure 27-5 provides a closer assessment of the fasteners at the right end of the joint shown in Figure 27-4. The key for the colored circles applied to the X-ray image of the joint in Figure 27-5(a) is:

- Red – cracked around base of rivet head or head missing.
- Yellow – partially cracked.
- Blue – replacement for previously failed rivet.

(a) Rivet damage assessment on X-Ray of intact joint.

(c) Replaced rivet (blue circle), fractured rivets (red).

Figure 27-5: DAIS and X-Ray Images of Left End of Joint (Figure 27-4) Showing Failed Rivets *In Situ*.

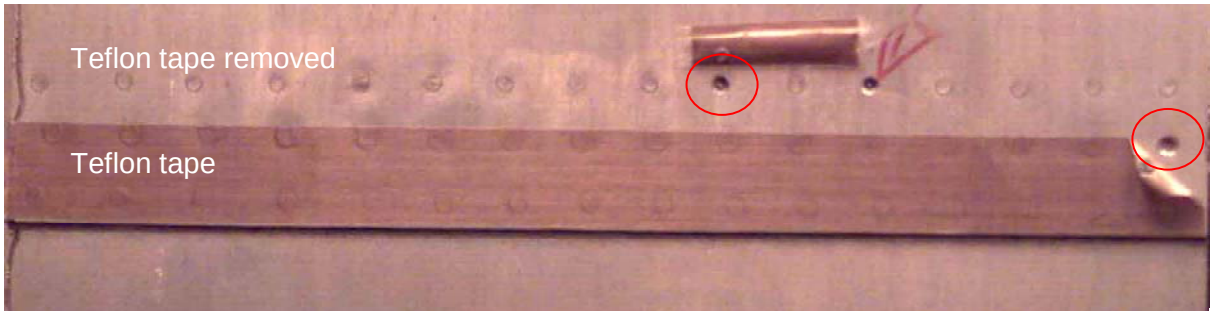
Figure 27-6 shows an unpainted longitudinal lap joint. One rivet head in the top row was missing (arrow) and this visible damage contributed to the selection of this joint for study. An automated eddy current scan of the joint was carried out before teardown. Scanning of the entire intact joint required the application of Teflon tape to prevent wear of the eddy current probe. After the scan the tape was peeled off, and this resulted in two additional rivet heads being released (circled). Observation of the parts of these two failed rivets showed that they had cracked and ultimately failed owing to the force created by corrosion pillowing. There was only minor corrosion on the rivet surfaces.

Figure 27-6: Corrosion Pillowing Induced Failure-in-Place of Rivets Discovered by Tape Peel.

During many similar eddy current scans, often on painted joints, there were numerous cases where Teflon tape removal also resulted in the discovery of rivets failed *in situ*. Neither X-ray nor eddy current inspections of the intact joints indicated any difference between undamaged, cracked or failed rivets.

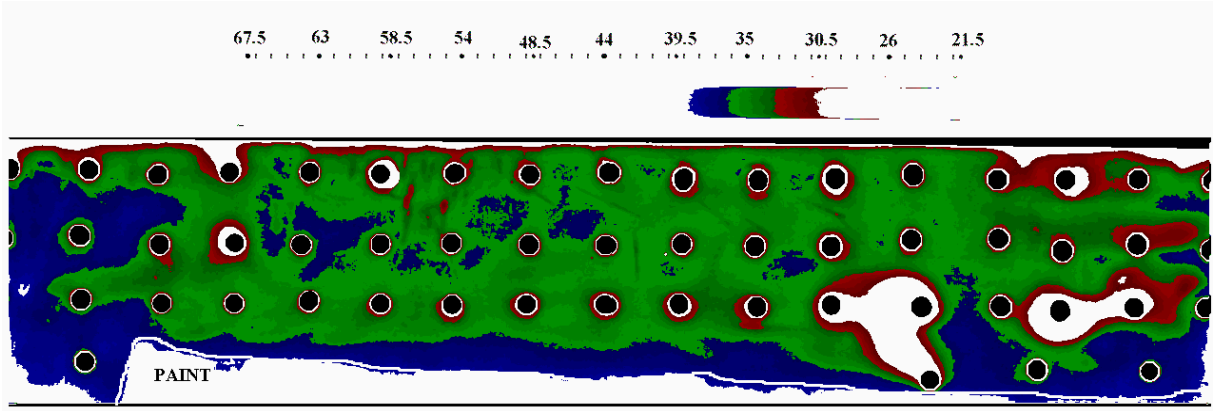
3) Drilling out rivets always has the potential to cause elongated fastener holes. Figure 27-7 gives an example where not only were the fastener holes enlarged to the maximum size but they were almost all elongated. In addition, the skin was found to be corroded and the removal process thinned the skin by up to 37% (white areas). In this case it was deemed appropriate to attach a new skin to this damaged skin, match-drilled into the same elongated fastener holes. On the other hand, one might well consider that enlarging the replacement skin sheet size and also shifting the joint to the next stringer on the remaining original sheet should eliminate such a compromised joint.

Figure 27-7: Elongated Holes from Rivet Removal and Skin Thinned by Corrosion Removal.

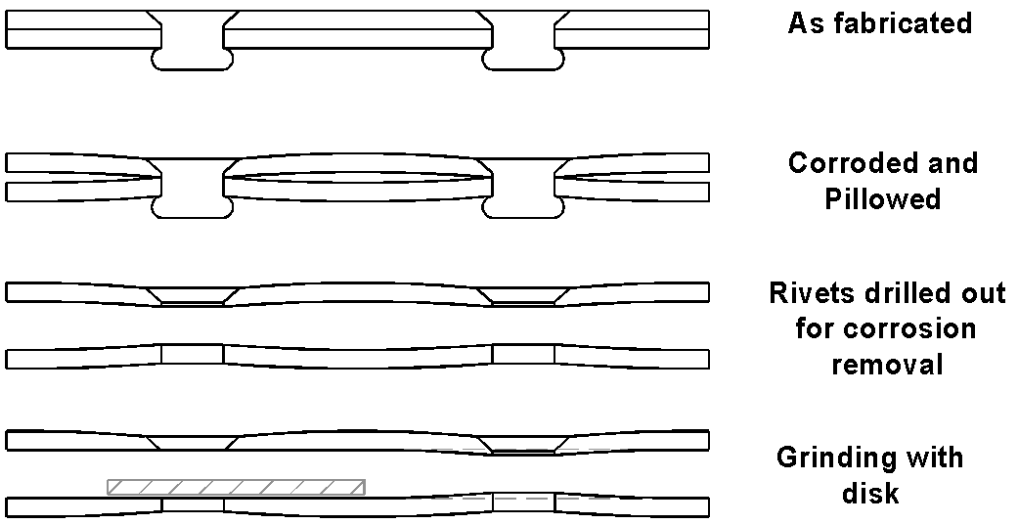
Because corrosion product build-up permanently deforms the skins of a joint (at 6% thickness loss the forces are sufficient to exceed the yield strength of the skin material), and because of the fastener clamp-up, the deformation will occur away from the fastener holes. This means that the first contact of any corrosion removal process will be with the material closest to the fastener holes.

As shown schematically in Figure 27-8, corrosion product removal by grinding, i.e., with rigid abrasive power tools, can cause serious damage to the faying surfaces. This damage could cause high stress concentrations, increasing the risk of premature cracking. Also, if cracks have *already* initiated at the faying surfaces owing to pillowing forces (as predicted by Finite Element Analysis and found during teardowns) then grinding could smear the cracks closed and obscure them from visual and X-ray inspections. Thus faying surface corrosion products are better removed by chemical cleaning.

Figure 27-8: Scenario Showing how Grinding Could Remove Excessive Amounts of Material from Around Rivet Holes.

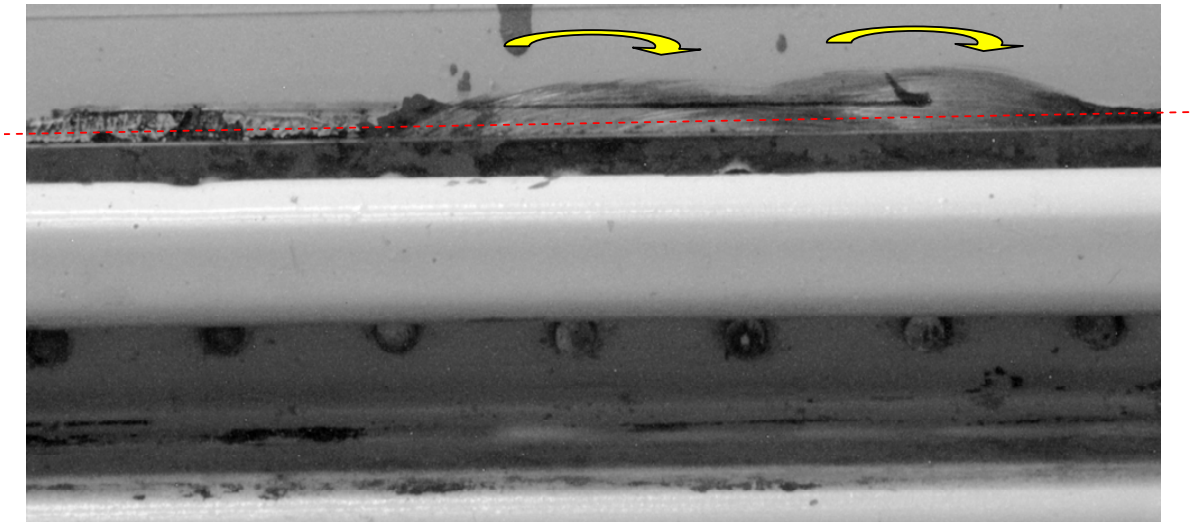
Evidence of the use of a rigid abrasive disc to remove faying surface corrosion is visible extending above the top edge of the inner skin on the inboard surface of the outer skin (red line) of the previously repaired and re-assembled joint shown in Figure 27-9(a).

(a) Rear surface of joint rebuilt after grinding for corrosion removal. Red line – Top of inner skin.

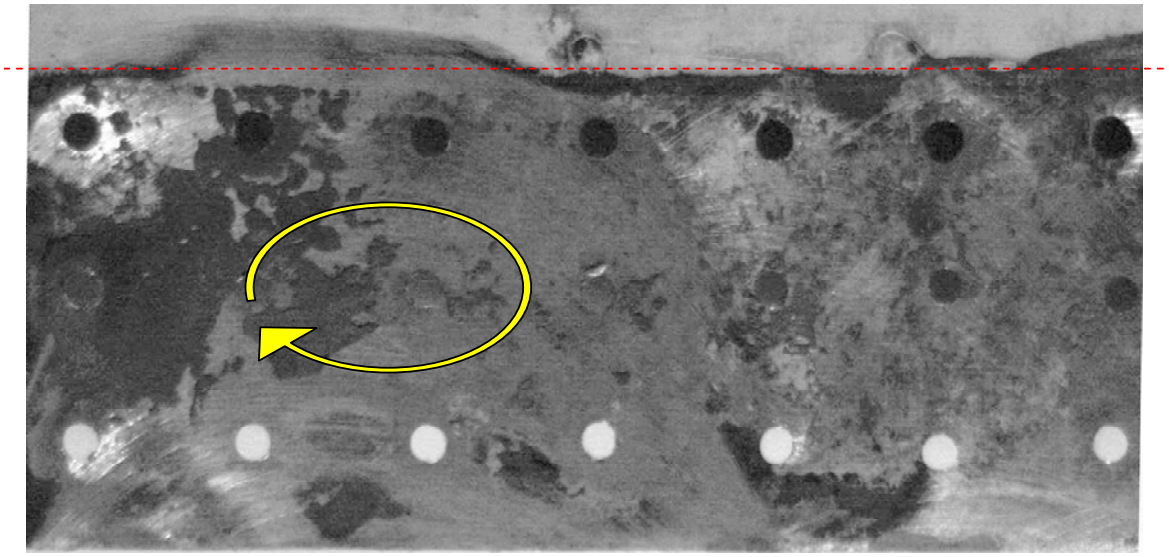
(b) First layer skin, inboard surface, disassembled, showing grinding marks. Red line denotes top of inner skin (removed).

Figure 27-9(b) shows the faying surface of the outer skin from the disassembled joint. The grinding marks indicate that the joint had been previously opened for corrosion removal, and that this was done using a motor driven rigid abrasive disc. The limited access and visibility mentioned above makes it understandable that motor driven discs of a diameter large enough to span the joint might be preferred to manual scraping/ sanding tools. This is despite the fact that there are written warnings that powered grinding operations can generate temperatures sufficient to affect the temper of the aluminum. The only recommended powered corrosion removal tools are rotary files, flap brushes (both impractical in this instance) and *flexible* abrasive discs, see the FAA and Airbus guidelines after Figure 27-10. The point often missed here is 'flexible'. The danger is the unintended damage done as a result of employing non-recommended tools and procedures owing to the difficult accessibility.

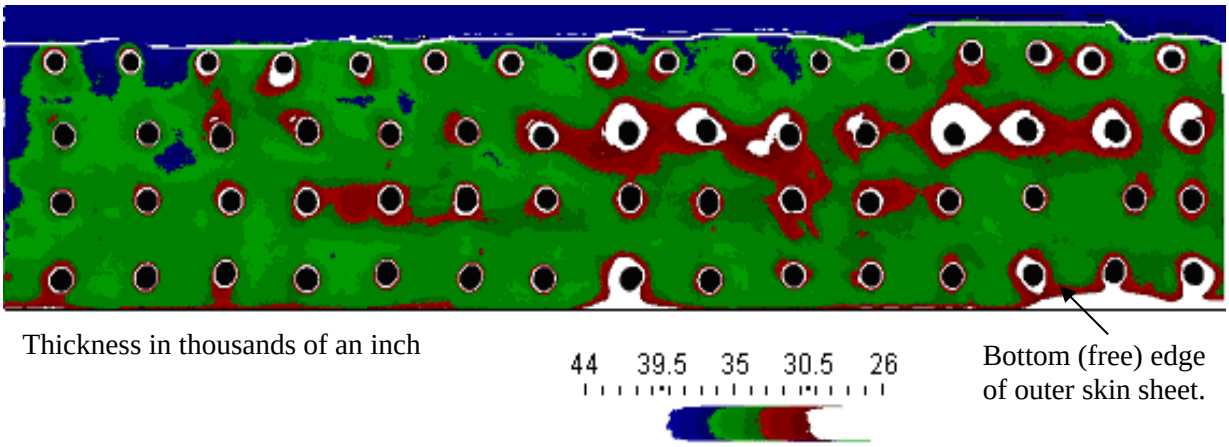
Figure 27-10: Digitized and Colorized X-Ray Thickness Loss Map for Outer Skin.

The selected removal technique, rigid abrasive disc grinding, resulted in significant skin thickness loss and produced knife-edges at fastener holes and at the free edge of the 0.038 inch (0.96 mm) thick sheet. These effects are illustrated by the digitized and false-colored X-ray thickness loss map shown in Figure 27-10: red indicates a range of 20 − 25% loss and white indicates a loss beyond the range of the calibration master. The minimum measured thickness was 0.026 inch (0.66 mm) at the bottom edge, a 34% loss.

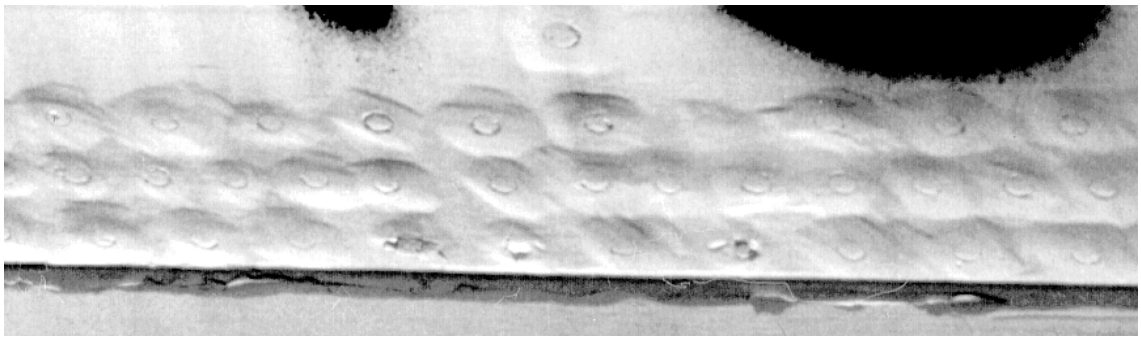
Figure 27-11: Exterior Spot Grinding.

Exterior surface corrosion damage may be exacerbated when addressed with rigid abrasive tools and a lack of appreciation for the damage that can quickly be done. In the case illustrated in Figure 27-11 the effort to remove filiform corrosion damage around rivets succeeded only in grinding the heads off the rivets and thinning the adjacent skin, in some cases completely through the thickness. The minor damage and appearance issues were thus transformed into a completely ruined joint. As with the faying surface

corrosion removal situation, the outer surfaces are pillowed by the internal build up of corrosion products, and attempts to remove exterior surface damage must recognize the danger of removing sound material before the damaged area is cleaned up. Fortunately, this example was seen in an aircraft graveyard, but on the other hand the aircraft must have been flown to get it there.

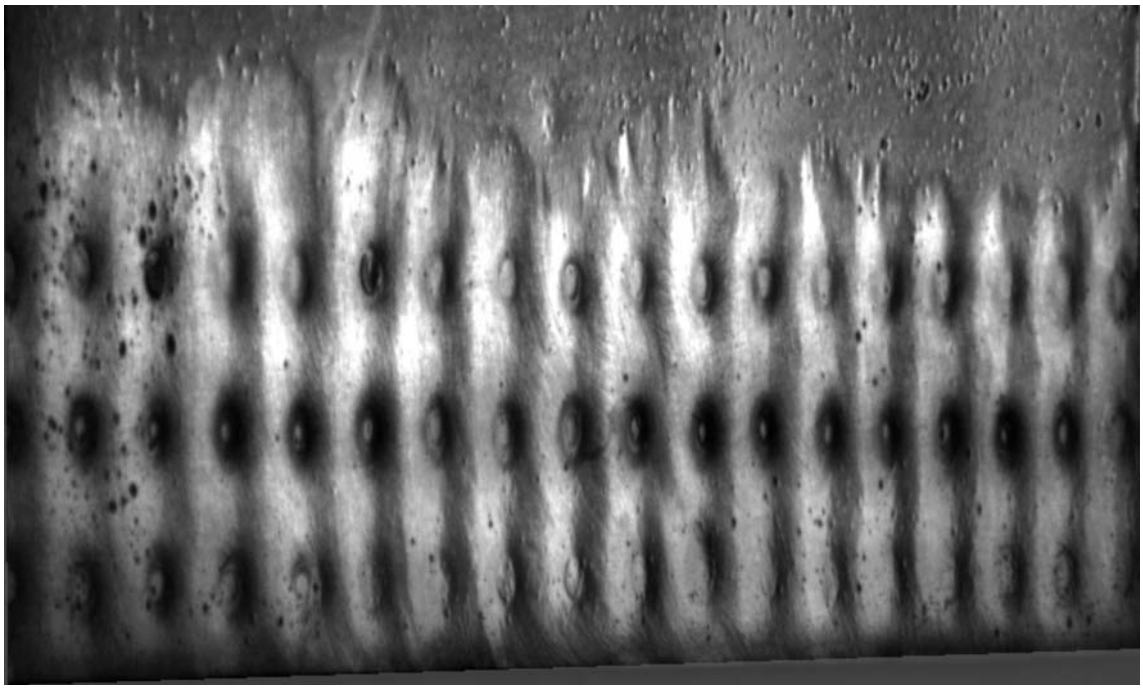
Figure 27-12: DAIS View of Pillowed Skin Suffering Surface Grinding.

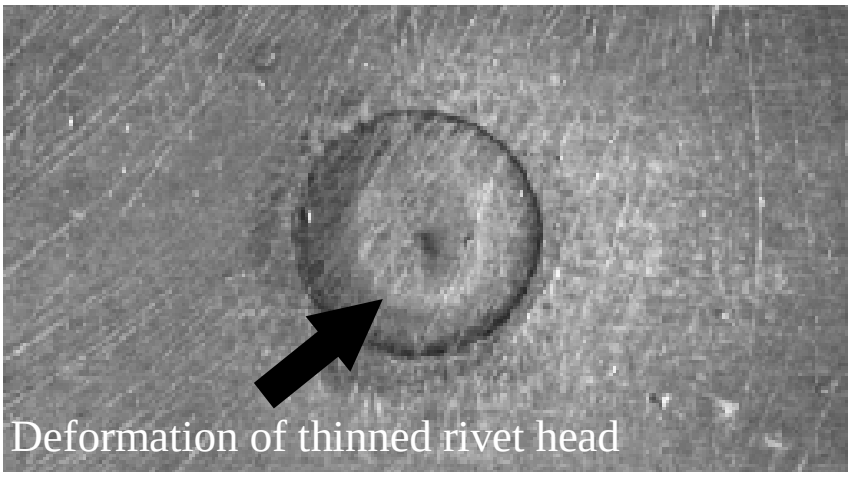
Figure 27-13: Close-Up of Grinding Damage to Rivet Head, Middle Row Rivet, Joint Shown in Figure 27-12.

Figure 27-12 shows a DAIS view of another lap joint that was ground externally while also suffering faying surface corrosion with resulting pillowing. The pillowing complicated the grinding action and the DAIS image illustrates the damage and thickness loss to the skin. Not only was the skin thinned, but more importantly the heads of the rivets were also damaged, in this case most notably in the middle rivet row and as shown in a normal view in Figure 27-13. Clearly, either the grinding should be done after the rivets have been removed or the rivets should be replaced after the surface has been ground.

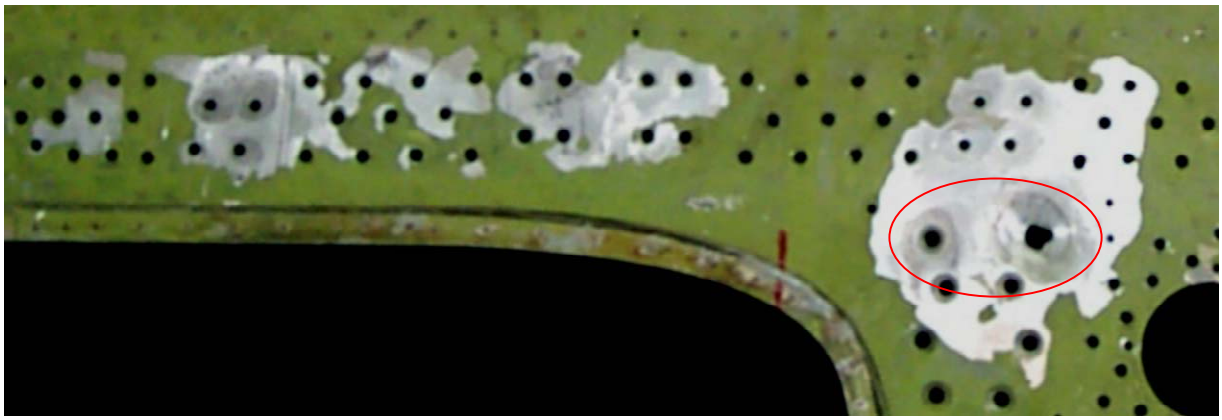
Figure 27-14: Upper Wing Skin with Exfoliation Corrosion Damage at Fastener Holes.

Figure 27-14 gives an example where severe exfoliation corrosion was removed from an upper wing skin plank. Unfortunately, the material removal and blending at two fastener holes (circled) went far beyond the allowed minimum thickness, and this resulted in the entire wing plank having to be replaced.

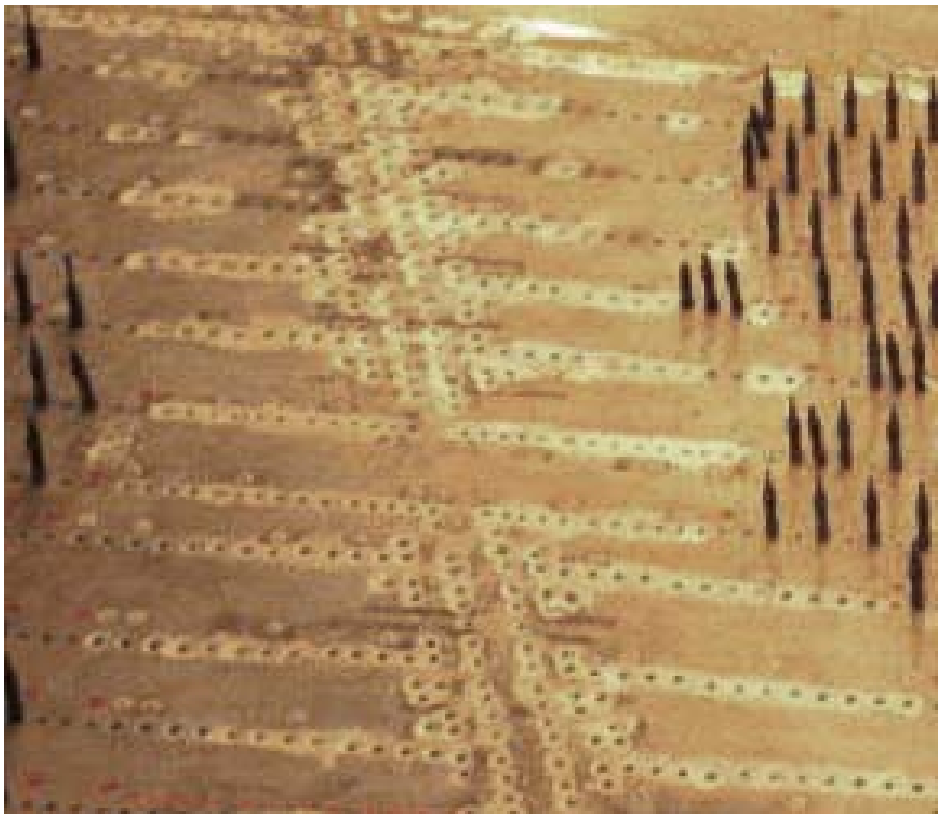
Figure 27-15: Upper Wing Skin with Multiple Sites Ground for Exfoliation Corrosion.

Another example is given in Figure 27-15. At great expense in time and effort almost every fastener site on the upper wing skin has been ground and blended-out to remove the exfoliation corrosion.

Testing [7] of upper wing skin material with similar levels of damage that has not been re-worked has shown that there is no decrease in load capacity or durability (compression-dominant fatigue). One might consider that more damage may be done to the structure by completely removing this form of corrosion; and that it would be better to surface grind to restore aerodynamic smoothness, followed by re-application of the protective coatings and institution of an NDI monitoring plan. This would probably be sufficient to extend the life of the part without the expense of extensive reworking.

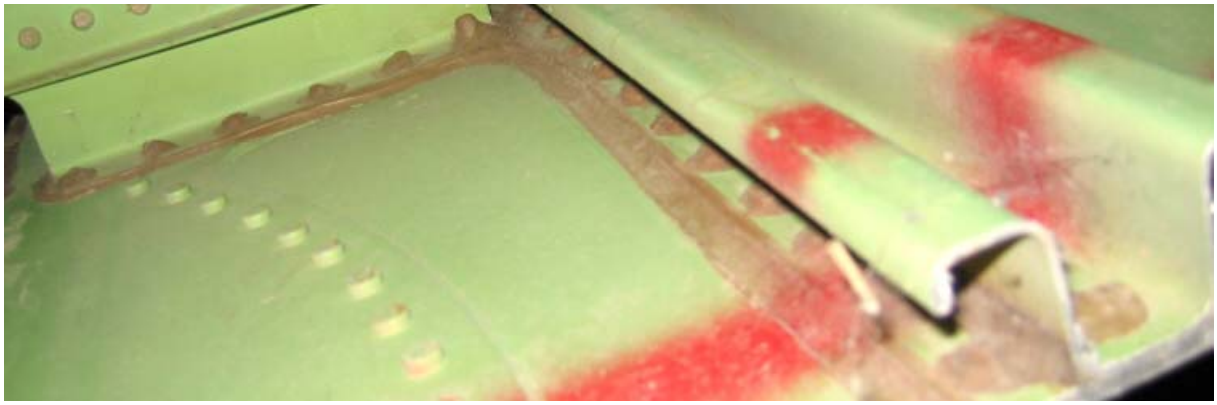
Figure 27-17: Rivet Shop Head and Stringer Edge Sealant Applications.

In response to the heightened awareness of how important corrosion can be for the integrity of ageing aircraft lap joints, some manufacturers mandated a comprehensive sealant program where every internal joint and fastener was potted or received additional sealant. Even the upper and lower edges of the stringer were sealed. This succeeded in only one thing: the moisture that was already in the joint was locked in, and inside corrosion was inevitable. Figure 27-17 is an example: sealants were comprehensively applied to exclude moisture intrusion in an attempt to avoid the development of crevice corrosion. The result was that every section harvested from the fuselage of this retired aircraft suffered corrosion inside the joints.

(a) Lap joint top row fasteners and stringer sealant application.

(b) View along lower surface of stringer on lap joint and body station frame attachment.

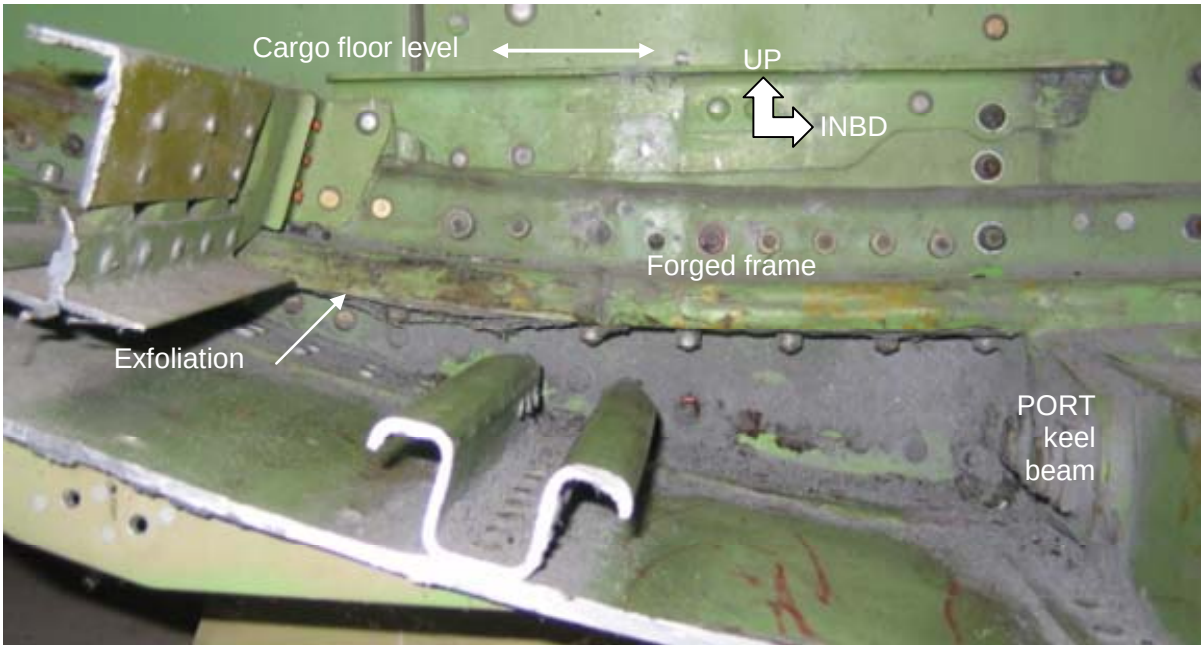
Figure 27-18: Views of Exfoliated Frame Treated with Sealant.

Figure 27-18(a) is a view of the port side of a bilge area in a fuselage where a heavy forged frame passes close to the bottom. The bottom surface of the frame has begun to exfoliate. This is a difficult location to inspect, since it is under the cargo floor and below the flange of the frame.

Figure 27-18(b) is the view of the starboard side of the frame. As may be inferred, exfoliation corrosion of the frame had been discovered previously, and following (any) remedial actions the frame was liberally covered with sealant. This prevented any later assessment of ongoing corrosion and the integrity of the frame. In fact, the area suffered significant further damage: large pieces of the frame could be pulled out from below, although the sealant was in good condition.

(a) View of area below cargo floor at fuselage frame, PORT.

(b) View of area below cargo floor at fuselage frame, STBD.

Maintenance procedures for corrosion damage removal end with the requirement that surface protective coatings be re-applied to the cleaned area (wash primer, primer and possibly paint). There is no mention of encasing the area in sealant. Besides the problems illustrated in Figure 27-16 – Figure 27-18, the sealant would also act as a barrier thus preventing any benefit from CPC applications.

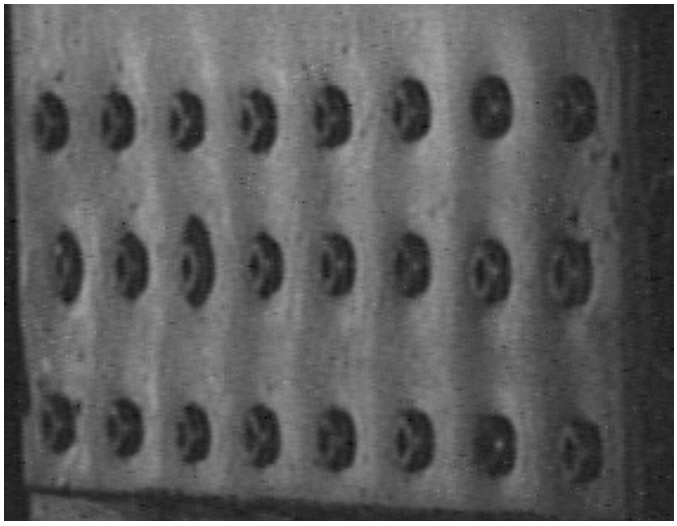
Figure 27-19: Surface Deformations from Excess Sealant in Laboratory Test Lap Joint (Non-Aerospace Fasteners).

On the other hand, a sealant layer is required to be between the inner and outer fuselage skins in order to prevent fretting and achieve pressurization requirements. Care must be taken in applying a thin even layer (recommended 0.02 inch (0.5 mm) thick) otherwise the joined sheets may be deformed by any excess sealant, see Figure 27-19 and Figure 27-20. This deformation will confuse subsequent exterior visual inspections for corrosion pillowing unless the repairs are documented and subsequently referred to before re-inspection.

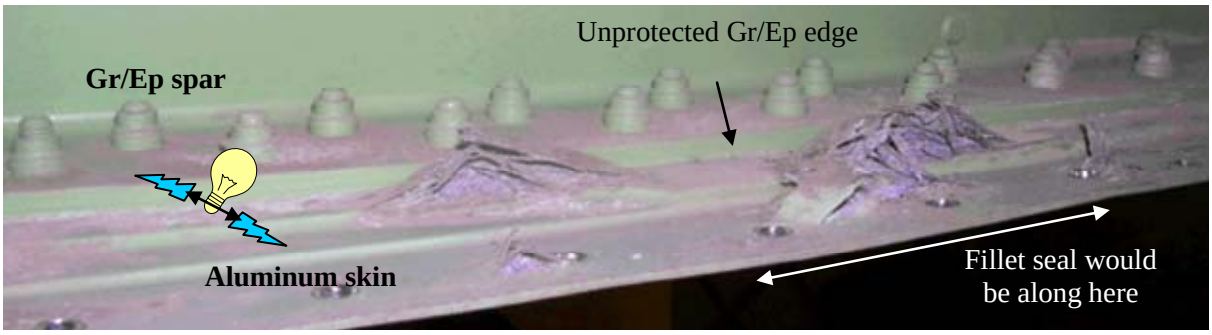
Figure 27-21: Graphite to Aluminum Connection Produces Corrosion.

The Graphite Epoxy (Gr/Ep) framed / aluminum skinned structure shown in Figure 27-21 had the standard glass fiber insulating layer for galvanic corrosion protection. There was also a fillet seal to prevent moisture entering from the outside. However, internal corrosion took place, basically because the edge of the Gr/Ep spar was not sealed, i.e., the glass fiber layer was not wrapped around the trimmed Gr/Ep edge. The corrosion mechanism is as follows: although there was no direct contact between the graphite and aluminum, moisture accumulated internally and bridged between the ends of the graphite fibers and any scratches through the protective coatings on the aluminum skin, thereby completing the electrical circuit.

a) Any graphite fiber patch repairs on metallic surfaces would have to be similarly insulated and edge sealed to prevent similar occurrences of corrosion; and

b) Routine inspections would have to include condition assessments of these features of the repairs.

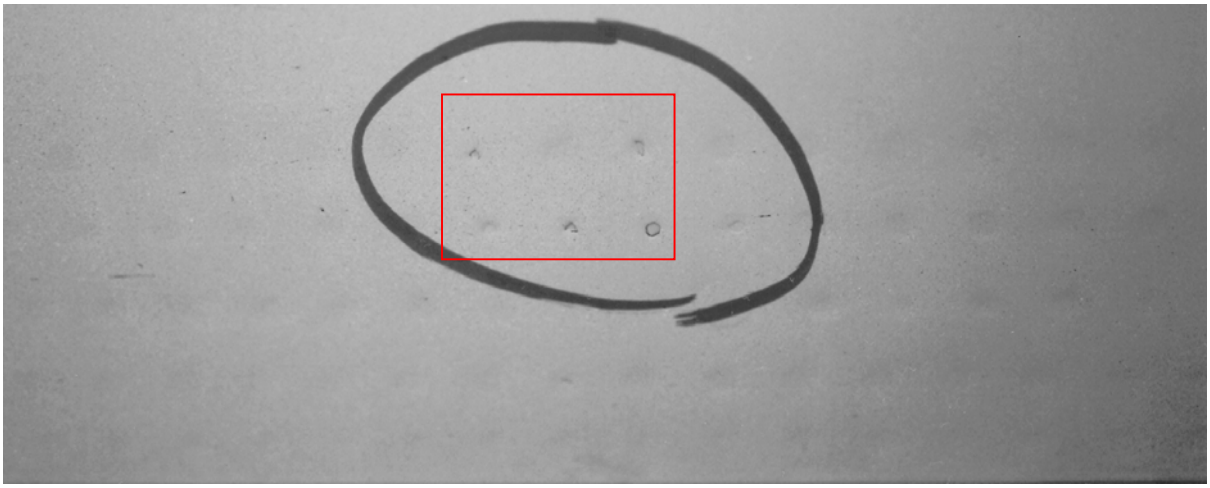
In corrosion situations spot-welded structures fail differently to riveted ones. Owing to pillowing forces, cracks occur in the spot welds and grow towards the surface. The corroded and cracked areas may not be easily visible, even with enhanced techniques such as DAIS, Figure 27-23(b), until the cracks have reached the surface and gone on to crack the paint, see Figure 27-23(a). Dye penetrant or magnetic particle inspections are required to detect the surface-breaking cracks in their early stages. Besides corrosion clean-up, if feasible and necessary, repairs are made by drilling out the cracked spot welds and installing rivets.

(a) Normal view. Cracked paint aids visual detection.

Figure 27-23: Corroded KC-135 Spot Welded Lap Joint with 4 Fractured Welds (Inside Red Boxes).

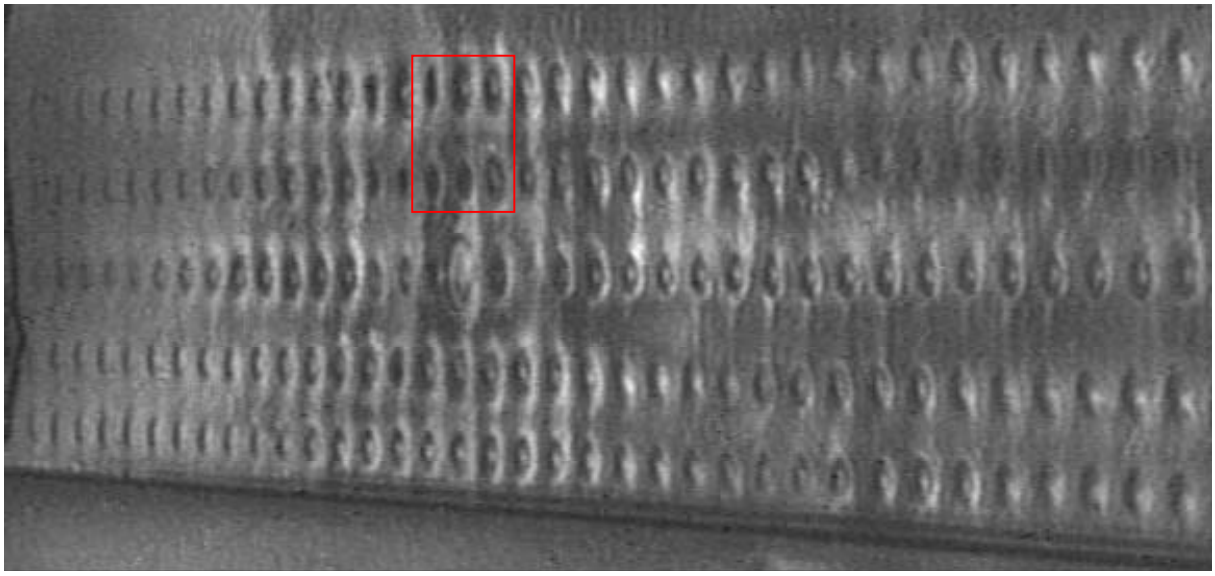
(b) DAIS view shows only subtle difference between normal deformation and corrosion pillowing.

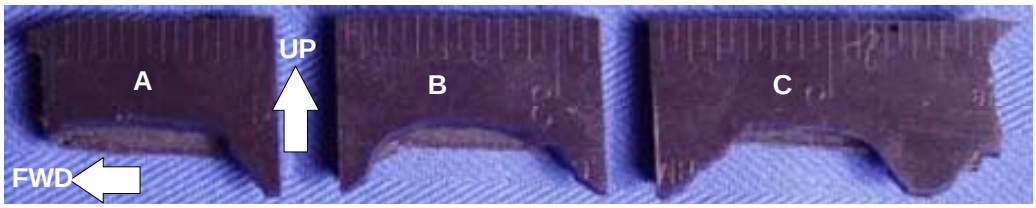
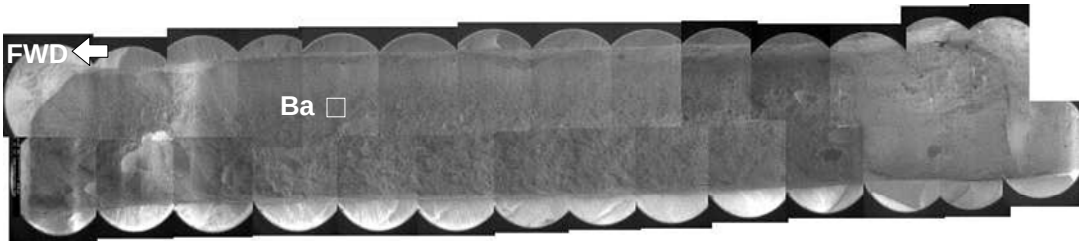
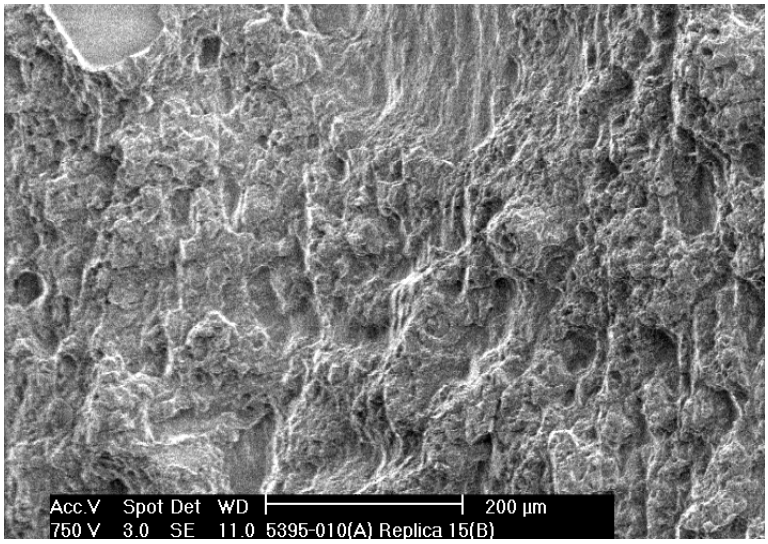
Figure 27-28: Fracture Surface Replica Analysis.

(b) Skin fracture replica sectioned to fit into SEM.

(c) SEM image montage for replica section B. Note selected site Ba.

(d) SEM image of fracture surface at site Ba from failed fuselage skin replica B.
