RTO AGARDograph **AG-AVT-140**

Corrosion Fatigue and Environmentally Assisted Cracking in Aging Military Vehicles

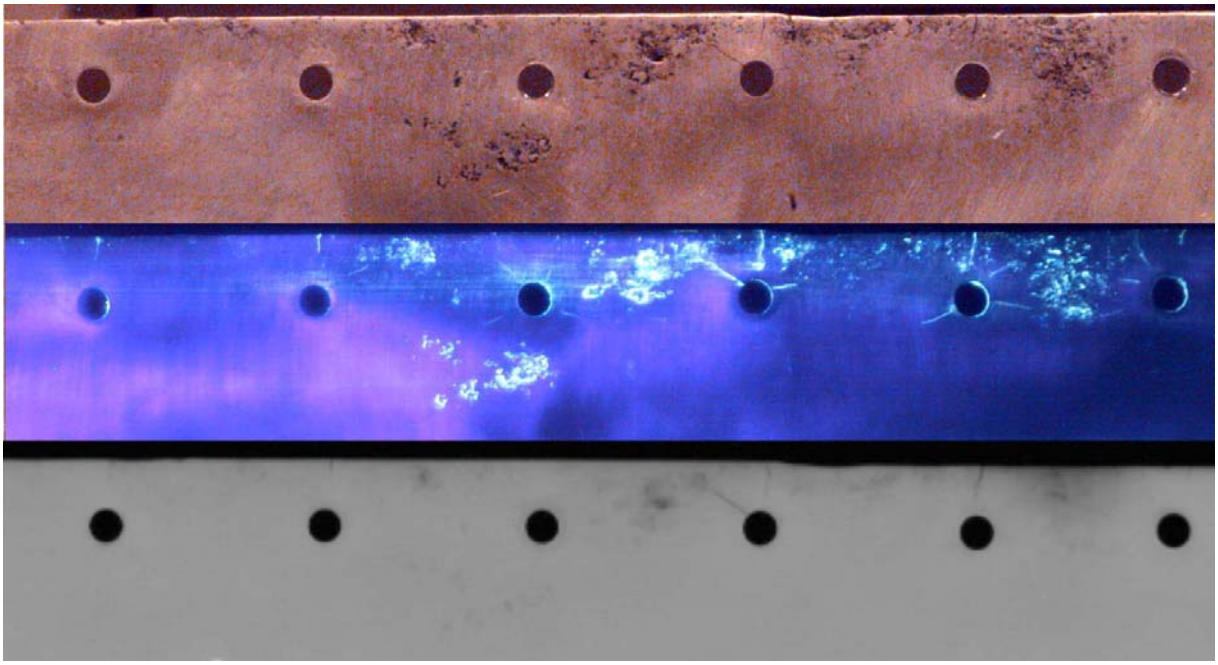
Figure 27-30: Three Views of Inner Surface of a Chemically Cleaned Corroded Skin Exhibiting Pillowing Cracks.

Figure 27-30 is an illustration of crack detection in a chemically cleaned corroded skin that contained pillowing cracks. These cracks were small and non-surface-breaking, i.e., they did not reach the outer surface of the skin. Careful disassembly and cleaning allowed these small cracks to be detected, notably by dye penetrant. Mechanical removal of corrosion products would probably have reduced the number of cracks detected by this technique.

Top: Optical, Middle: Dye penetrant, Bottom: X-ray.

Non-surface-breaking cracks like those illustrated in Figure 27-30 have been predicted by Finite Element Modeling (FEM) of fuselage joint designs. These radiating cracks are caused by tensile forces induced in

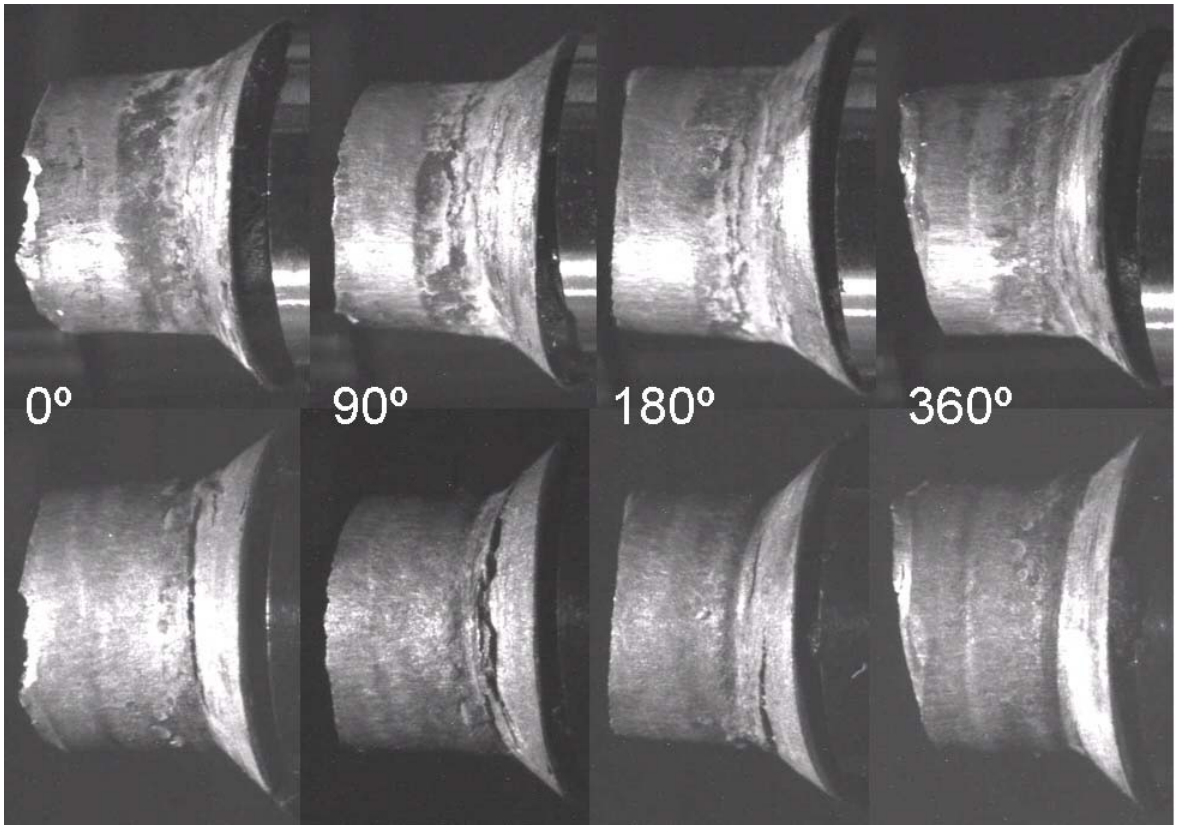
Figure 27-31: Corrosion Pillowing Induced Cracks in a Rivet (Top: As removed; Bottom: Cleaned).

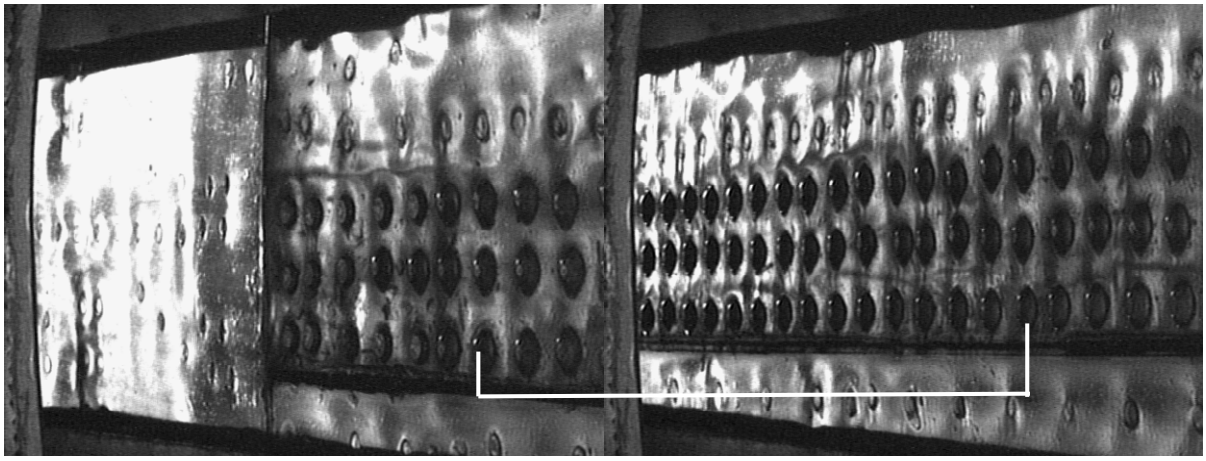
Figure 27-34 is an example of corrosion-induced pillowing from the teardown investigation of a lap joint outer skin. The pillowing was made visible by the D Sight Aircraft Inspection System (DAIS) [10], which enables enhanced visual inspections of intact joints. It was known that the joint had undergone maintenance because of corrosion. This maintenance had included removing the original flush-head rivets and re-installing with protruding-head rivets.

Figure 27-34: DAIS Lap Inspections on the Intact Joint (White Line Shows Specimen in Figure 27-35).

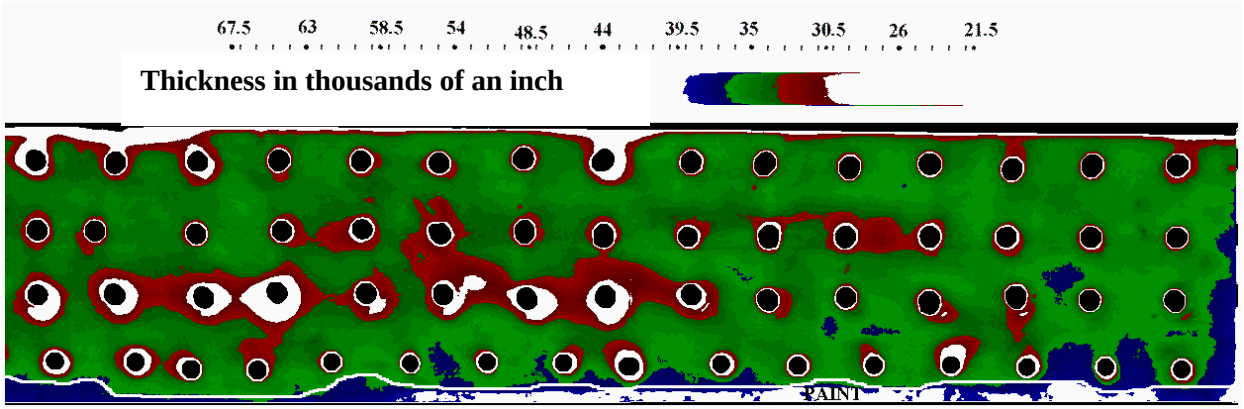
The outer skin inner surface shown in Figure 27-35 was cleaned chemically to remove the sealant and primer. This was followed by X-radiography that included a ramped master calibration tool to enable thickness measurements. The NRC/IAR NDI Analysis™ software was used to obtain the calibration and skin thickness measurements from the digitized image file of the X-ray film, Figure 27-36.

Figure 27-36: X-Ray Thickness Loss Map (Calibration Ramp at Top).

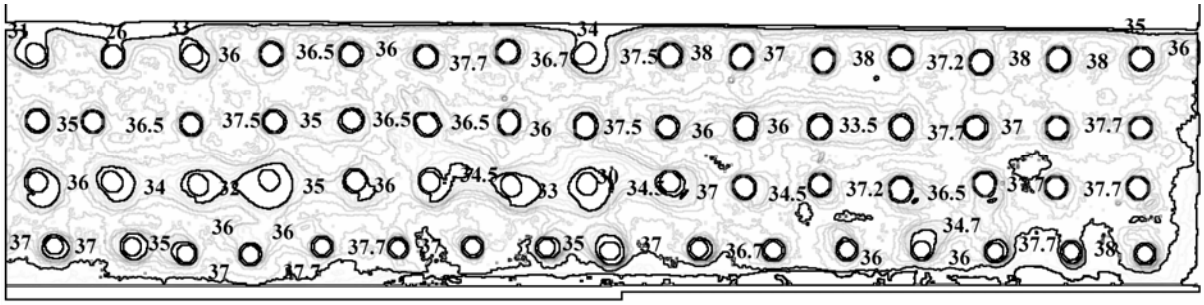
Figure 27-37 shows mechanically made thickness measurements taken nominally midway between fastener holes and also where thinning was beyond the lower limit of the X-ray calibration. The maximum thickness was 0.038 inch. The minimum thickness between fastener holes was 0.030 inch [24% loss], and the minimum thickness at the free edge was 0.026 inch [34% loss]. These losses and the pattern of losses, especially around fastener holes, compromised the skin and would have made it more prone to fatigue damage.

Figure 27-37: Thickness Measurement Map.

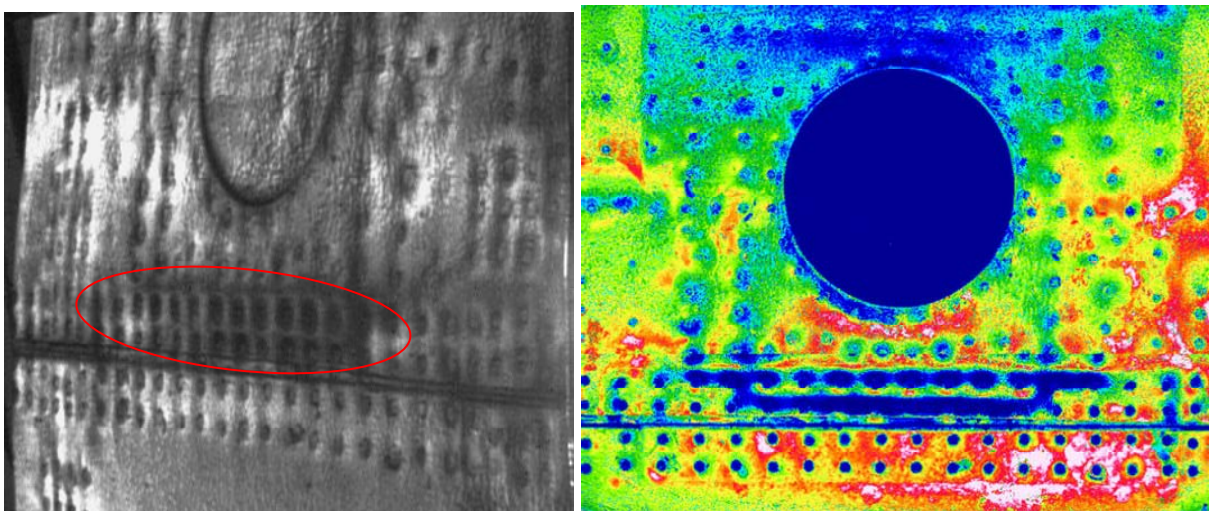
Laboratory DAIS and UT inspections gave the results shown in Figure 27-39. The DAIS inspection indicates corrosion-induced pillowing, and the UT inspection apparently indicates corrosion product build-up along two fastener rows below the access port. However, teardown revealed something totally different. Figure 27-40 shows that a shim had been placed along one bolt row, presumably during maintenance. Tightening of the steel bolts caused the outer skin to buckle, and where it was unsupported by the shim the fastener heads tended to be pulled through the skin. The resulting incomplete clamp-up confused the UT inspection, since air gaps were interpreted as corrosion build-up.

Figure 27-39: Laboratory Inspections Preceding Teardown Both DAIS (left) and UT (right) Indicated Damage in the Upper Skin of the Butt Joint.

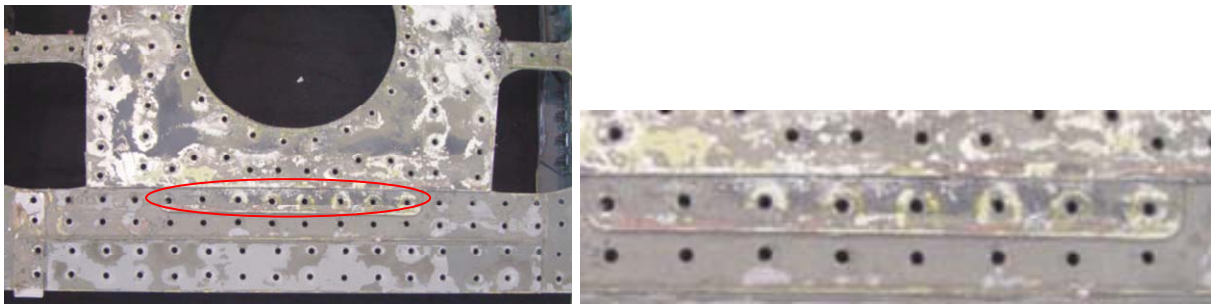
Figure 27-40: A 0.080 Inch (2.03 mm) Thick Shim In-Situ (left, circled), Enlarged (right).

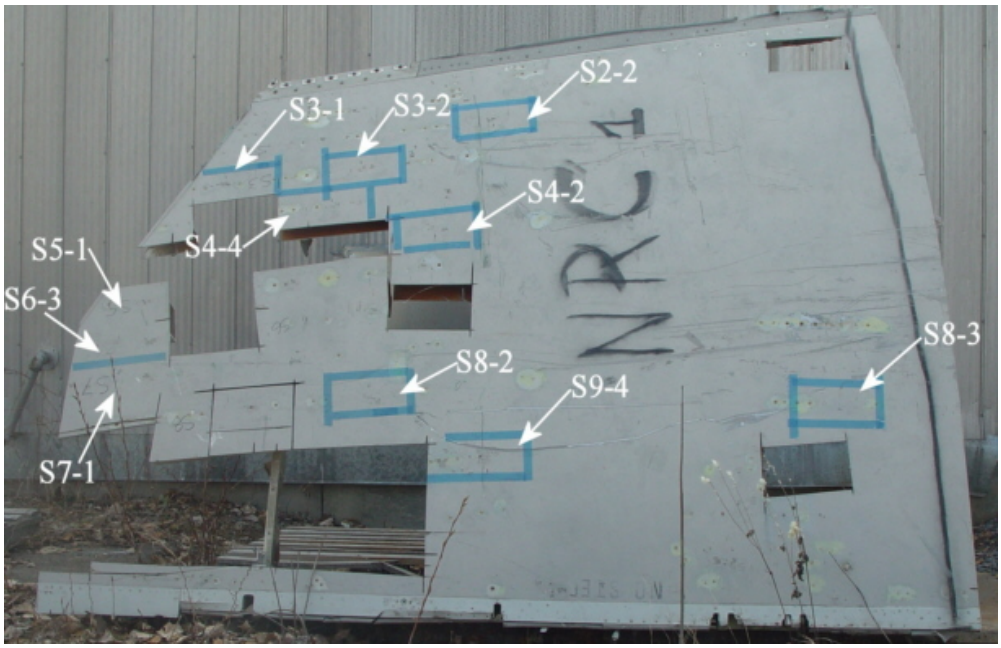
There are very few known collections of aircraft structure. Those that exist have been used successfully to support NDI equipment and technique verification, repair scheme development, damage characterization, and human factors studies. Figure 27-46 shows cut-outs where natural corrosion damage specimens have been extracted from a WFU aircraft wing. The labels show where even more specimens are to be harvested. Thus instead of disappearing into the “recycle-bin” the components and samples in these libraries continue to educate and serve their fleets.

Figure 27-46: Upper Wing Section Being Harvested for Corroded and Undamaged Material.
