EFFECTIVENESS OF ADDITIVES IN IMPROVING FUEL LUBRICITY AND PREVENTING PUMP FAILURE AT HIGH TEMPERATURE

INTERIM REPORT
TFLRF No. 437

U.S. Army TARDEC Fuels and Lubricants Research Facility
Southwest Research Institute® (SwRI®)
San Antonio, TX

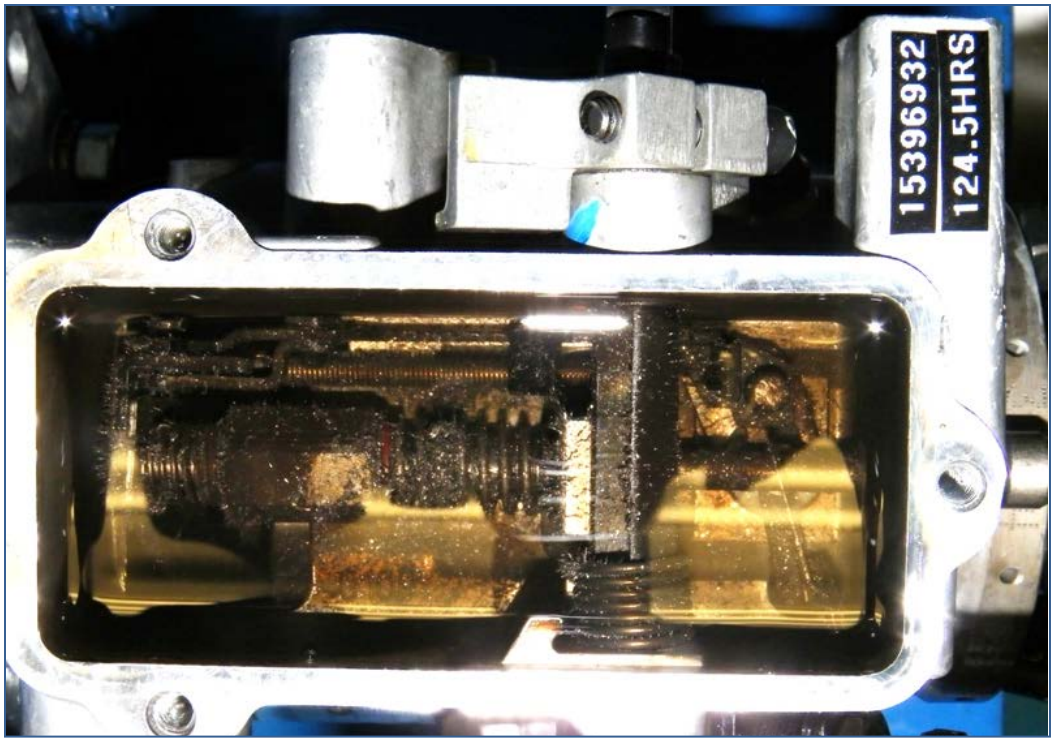
Figure 8. Test 5, Pump 2 (Seized) Governor Linkage Debris

Figure 8 presents the pump 2 governor assembly with the top covers removed to show the wear debris covering the governor linkages. The seizure location on the rotor of pump 2 can be seen in Figure 9. Figure 10 presents the pump 1 governor linkage with wear debris evident. Early failures with untreated Jet A-1 fuel in Stanadyne rotary fuel injection pumps has been repeatable.

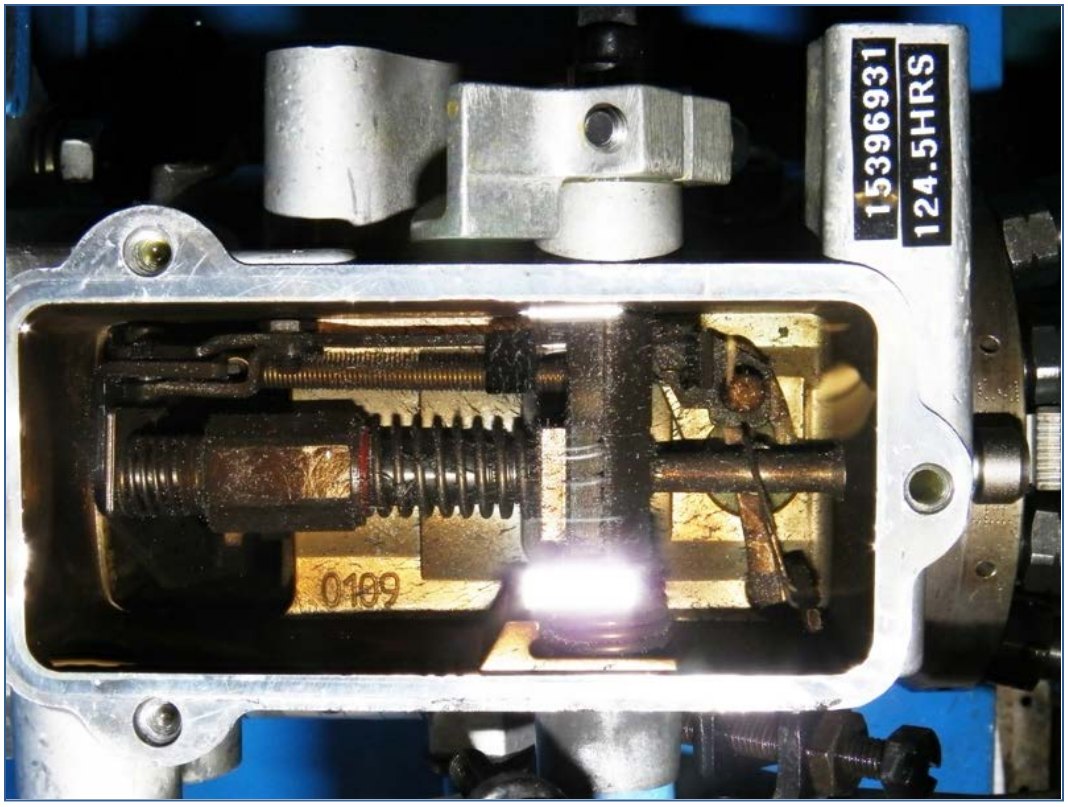
Figure 10. Test 5, Pump 1 (Operating Pump Removed from Testing) Linkage Debris

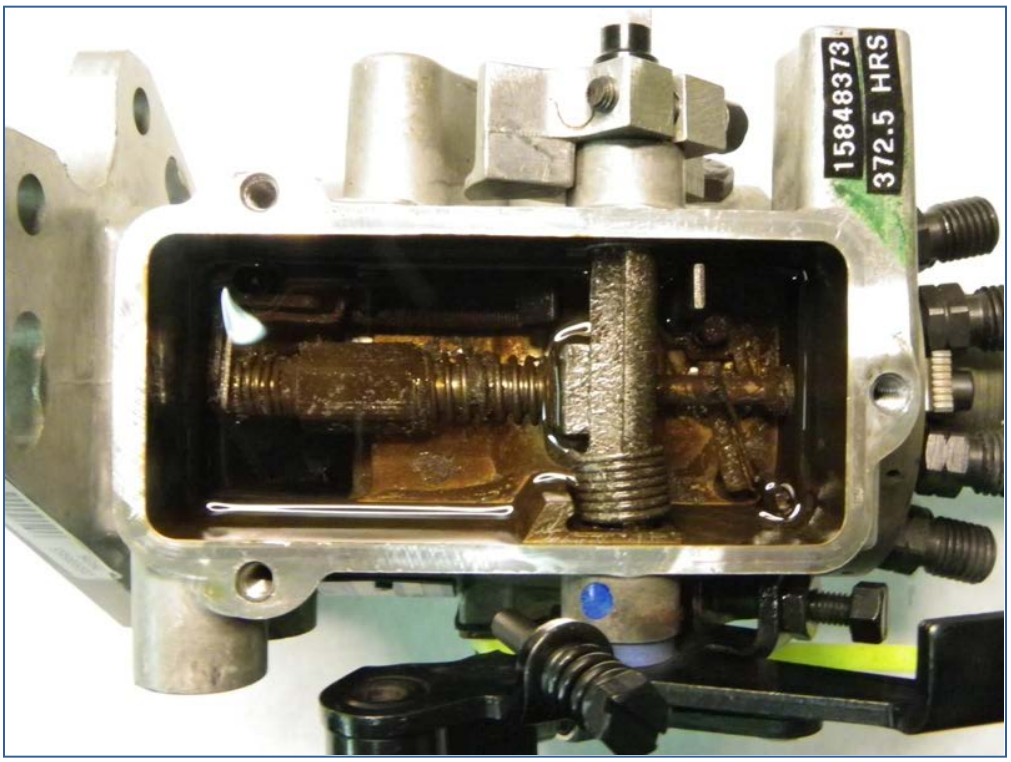
Figure 13. Wear Debris, Pump No. 1, Test 21

Test 21 was conducted using a 50/50 blend of FT-SPK and Jet A-1 fuel additized with DCI-4A CI/LI at minimum concentration of 9 mg/L at temperatures of 170°F (77°C) for a targeted 1,000 pump stand hours. At 372 hours into the test, pump No.2 displayed a notable drop (approx) 25% in the fuel moving average. The test stand was shut down and the governor assembly top cover removed from the pump to inspect for excessive wear. Heavy metal shavings were seen in the solenoid assembly and the pump was removed from the stand to prevent rotor seizure. Test 21 was continued with the operational pump No. 1. The test stand was stopped at 418 hours into the test when the remaining pump became very noisy due to drive tang wear and the fuel moving average had dropped significantly. Figure 13 presents the governor assembly from Pump No. 1 showing heavy wear debris on the linkages. Figure 14 reveals excessive heavy drive tang wear, the associated heavy rotor drive slot wear for Pump No.2 is shown in Figure 15, and the rotor governor weight cage drive plate wear and fractures are seen in Figure 16.

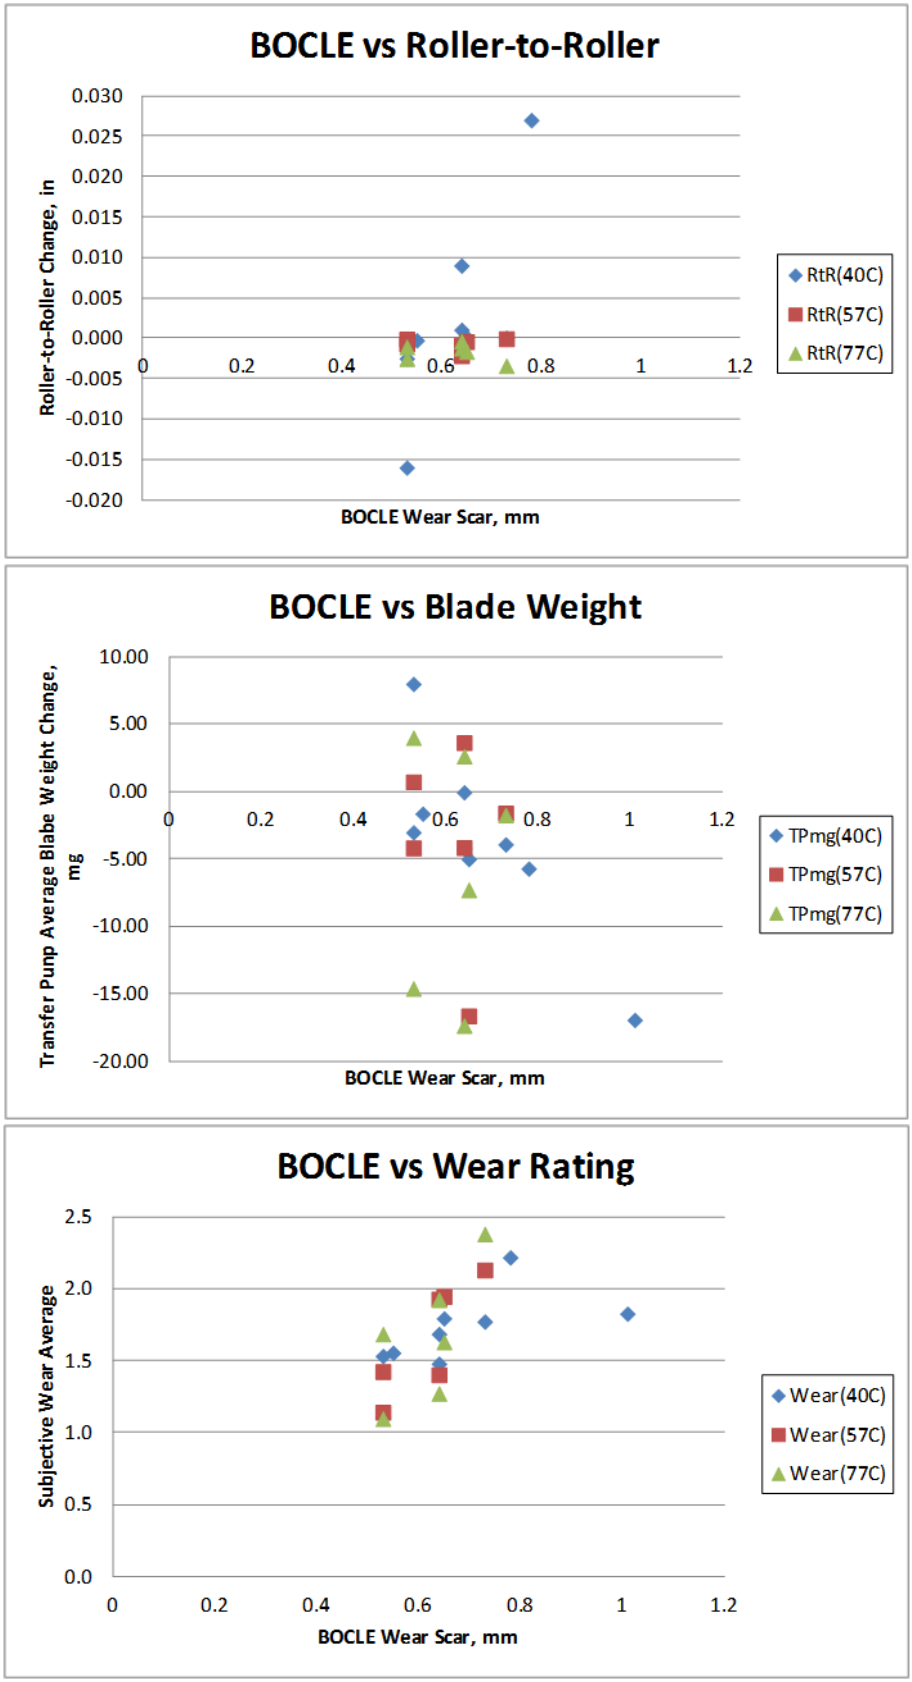
The fuel injection pump test stand wear assessment data for each test condition are plotted against the fuel lubricity bench test wear results. The ASTM D5001 BOCLE data for each test fuel is plotted against the three pump test wear criteria and presented in Figure 17. The pre-test BOCLE wear scar values are plotted in Figure 17 against the two pump average Roller-to-Roller dimension change, the eight blade average transfer pump blade weight change, and the two pump average subjective wear rating at each fuel inlet temperature. The Roller-to-Roller dimension change data at 40°C suggests that at increased BOCLE wear scars, low lubricity fuel, results in a larger dimensional change. The elevated temperature tests do not show the same relationship with the BOCLE data for Roller-to-Roller dimension change. The blade weight change comparison for the BOCLE data, although quite scattered does suggest that increased BOCLE values results in increased blade weight change. The 40°C data again appear to show a stronger trend with less scatter, due to more tests that were performed at 40°C. Of the three wear assessment variables in Figure 17, the subjective wear ratings appear to show a strong trend of increased wear rating with low lubricity fuels, larger BOCLE values, at all test temperatures.

Figure 17. BOCLE Wear Scar versus Wear Parameters and Fuel Temperature

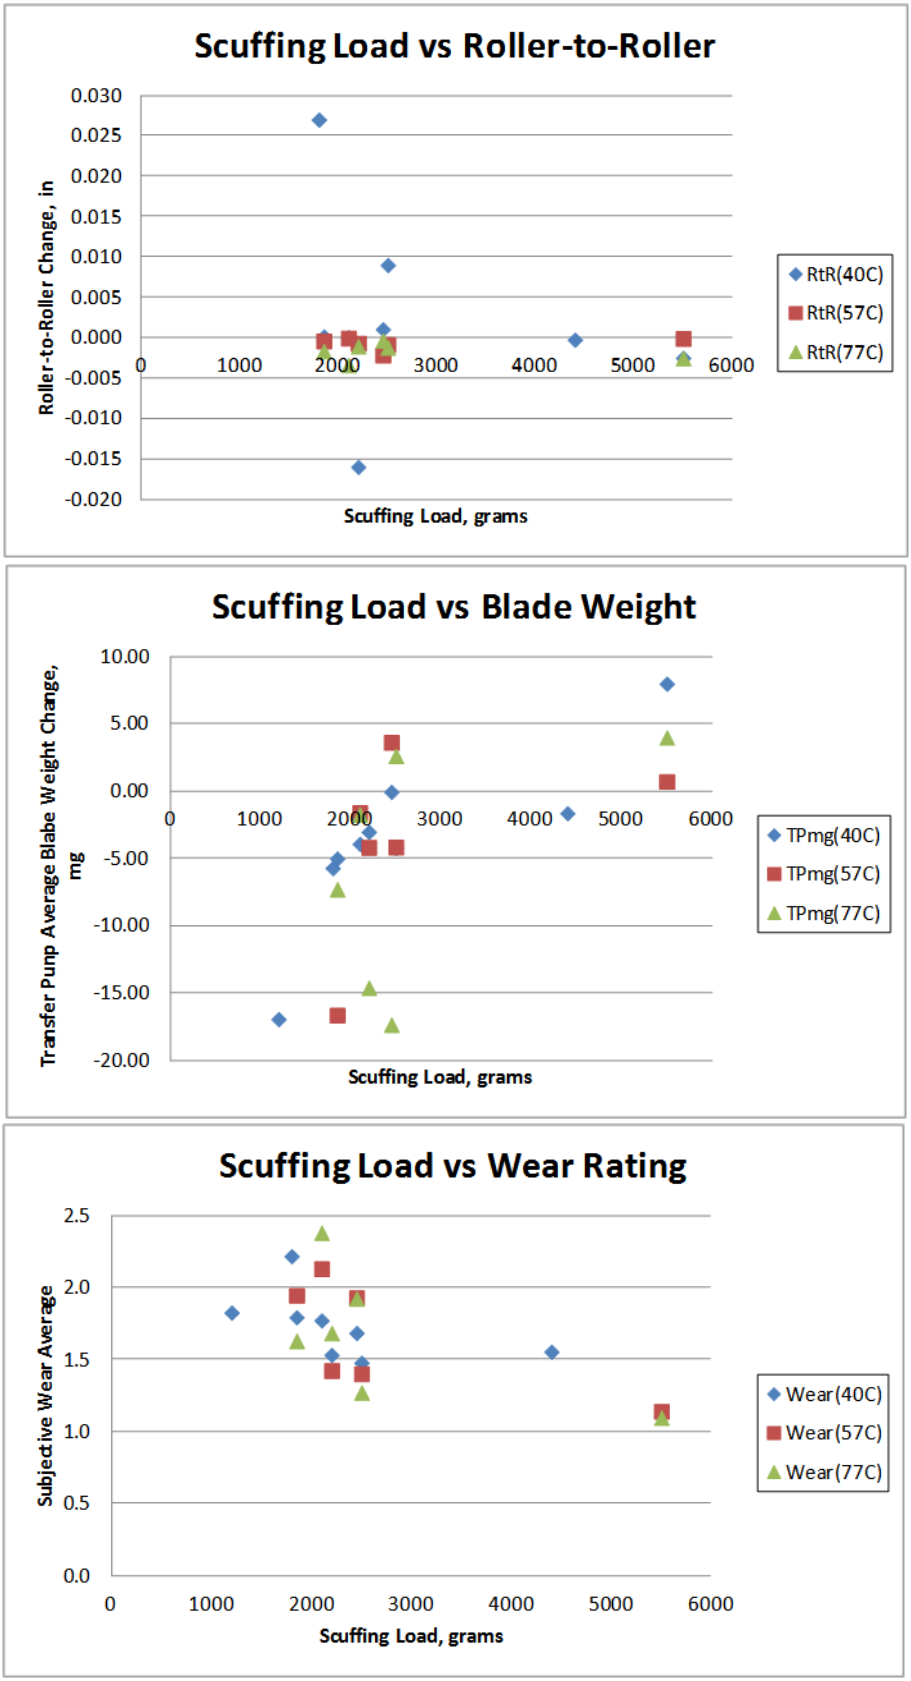
The ASTM D6079 Scuffing Load Wear Test (SLWT) data for each test fuel are plotted against the three pump test wear criteria and presented in Figure 18. The pre-test SLWT loads values are plotted in Figure 18 against the two pump average Roller-to-Roller dimension change, the eight blade average transfer pump blade weight change, and the two pump average subjective wear rating at each fuel inlet temperature. The Roller-to-Roller dimension change data at 40°C trends towards increased SLWT loads, good lubricity fuels, results in a less dimensional change. The elevated temperature tests do not show the same relationship with the SLWT data for Roller-to-Roller dimension change. The blade weight change comparison for the SLWT data, although quite scattered does suggest that increased fuel SLWT loads results in decreased blade weight change. The 40°C again appears to show a stronger trend with less scatter, due to more tests that were performed at 40°C. Of the three wear assessment variables in Figure 18, the subjective wear ratings appear to show a strong trend of increased wear with low lubricity fuels, smaller SLWT loads, at all test temperatures.

Figure 18. Scuffing Load versus Wear Parameter and Fuel Temperature

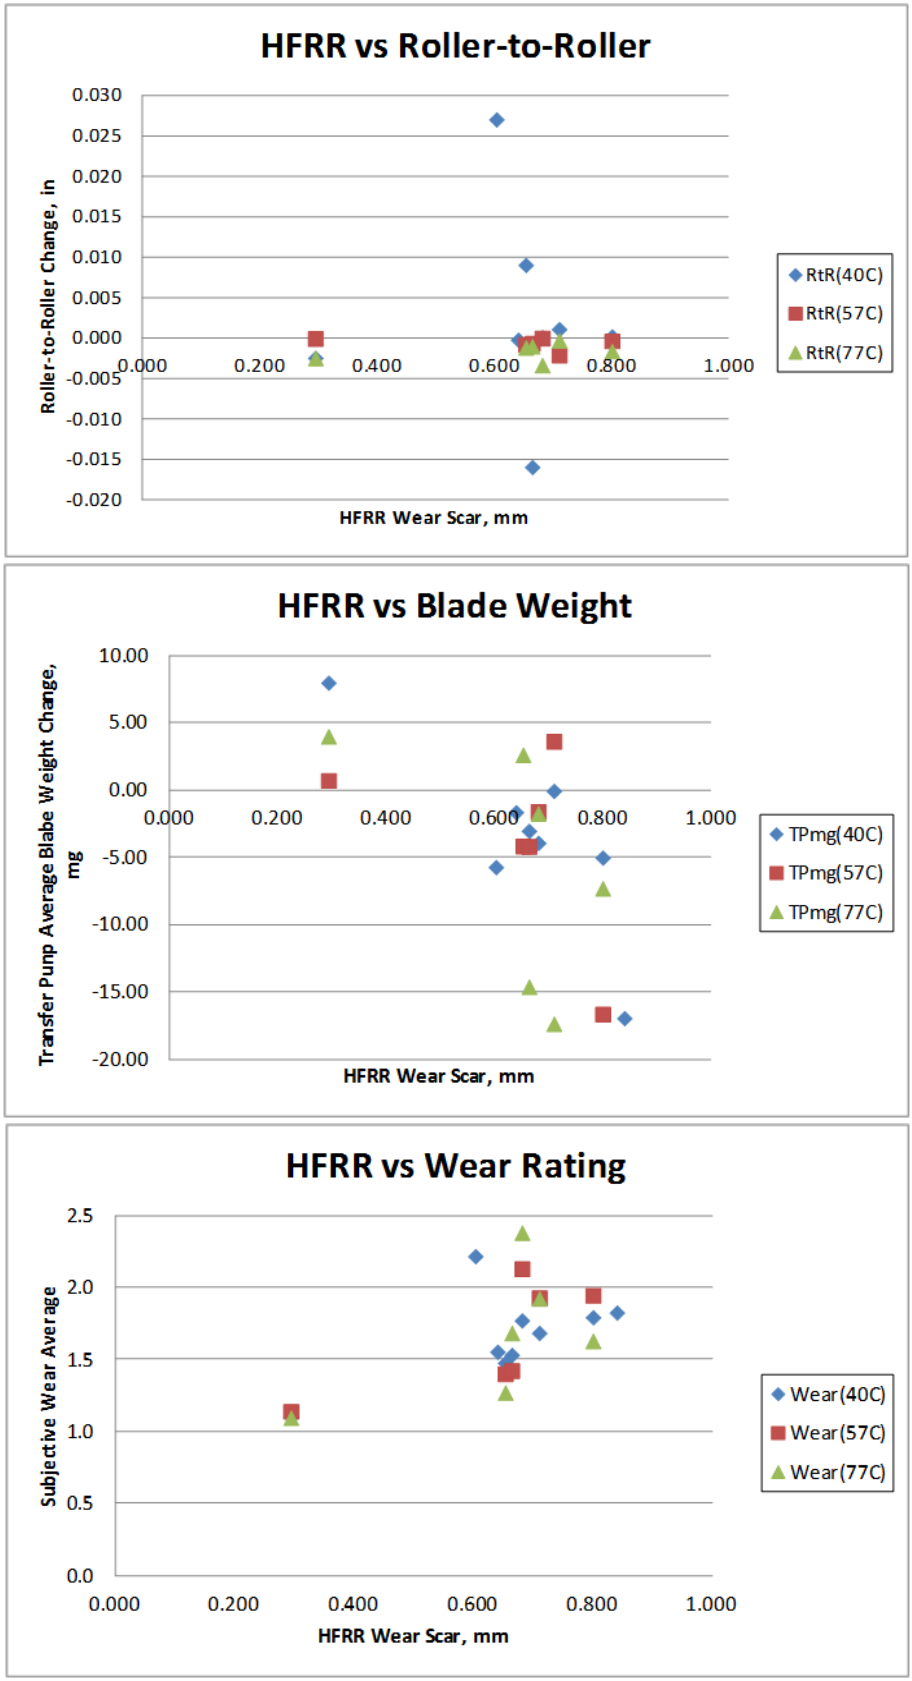
The ASTM D6078 HFRR fuel lubricity data for each test fuel are plotted against the three pump test wear criteria and presented in Figure 19. The pre-test HFRR wear scar values are plotted in Figure 19 against the two pump average Roller-to-Roller dimension change, the eight blade average transfer pump blade weight change, and the two pump average subjective wear rating at each fuel inlet temperature. The Roller-to-Roller dimension change data do not show a strong relationship with the HFRR wear scar data for any fuel temperature. The blade weight change comparison for the HFRR data, although quite scattered does suggest that increased HFRR wear scars result in increased blade weight change at all temperatures. The 40°C again appears to show a stronger trend with less scatter, due to more tests that were performed at 40°C. Of the three wear assessment variables in Figure 19, the subjective wear ratings appear to show a slight trend of increased wear with low lubricity fuels, larger HFRR values, at all test temperatures.

Figure 19. HFRR Wear Scar versus Wear Parameter and Fuel Temperature

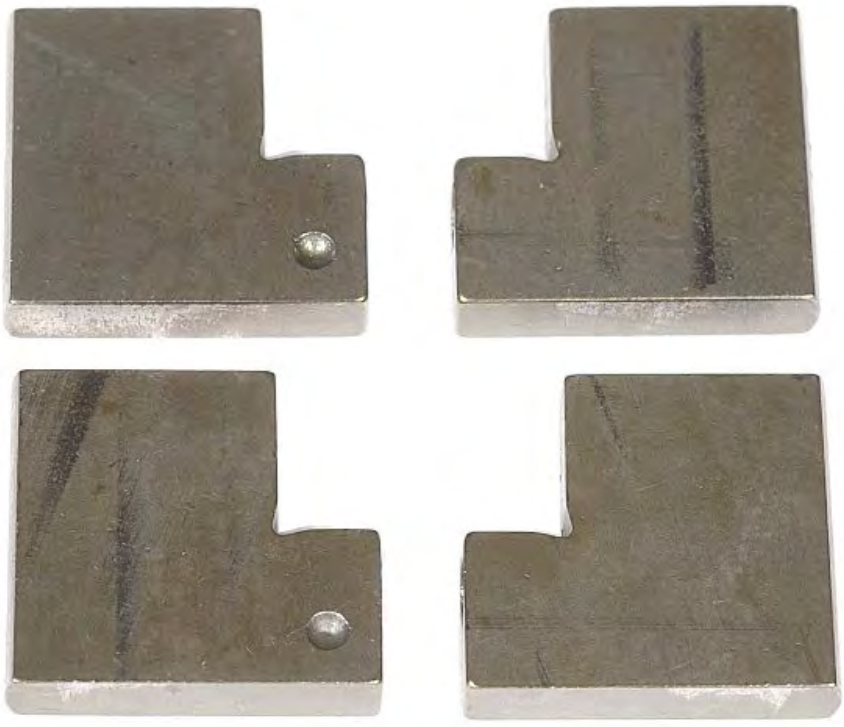
For fuel injection pump SN15293084 there was an average 8.4-mg increase in transfer blade weight over the four blades, a 0.004-inch reduction in Roller-to-Roller dimension, and an averaged subjective wear measurement of 1.043 (0=new, 5=fail). The transfer pump blades are sintered metal, and likely absorbed fuel to gain weight, or gain weight due to fuel deposition. In addition all fuel injectors passed the post test performance checks.

SN15293084 Transfer Pump Blades (Side), After

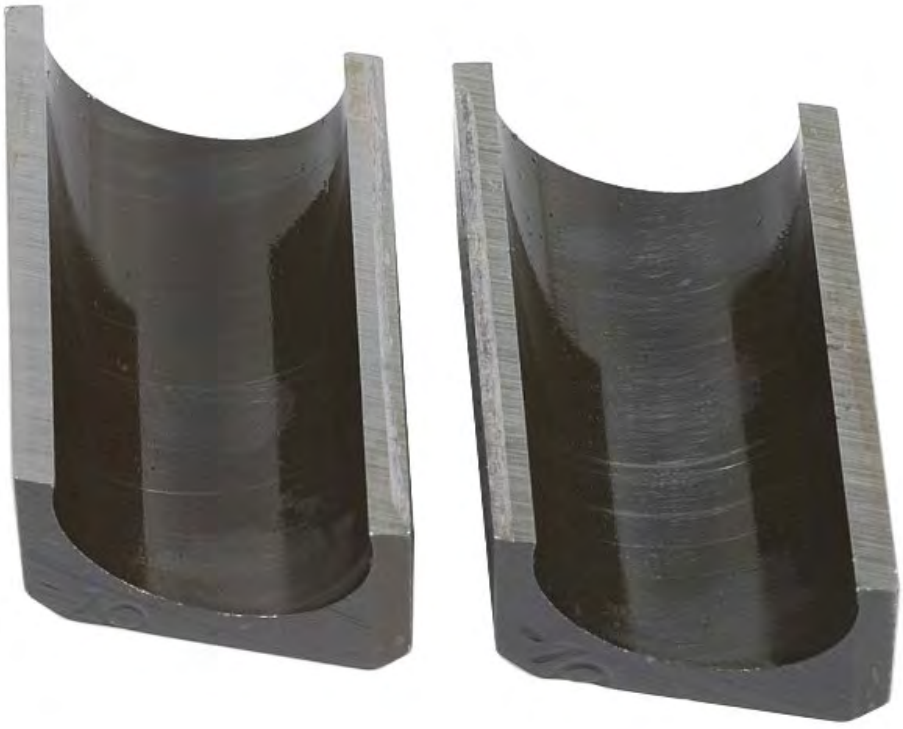
SN15293084 Shoes (Front), After

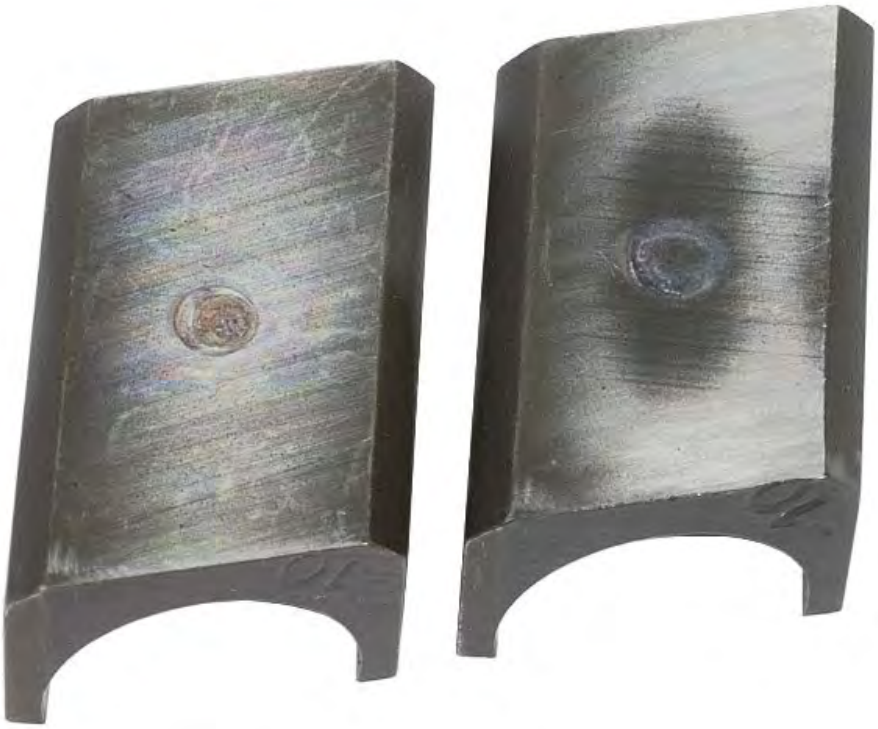
SN15293084 Shoes (Back), After

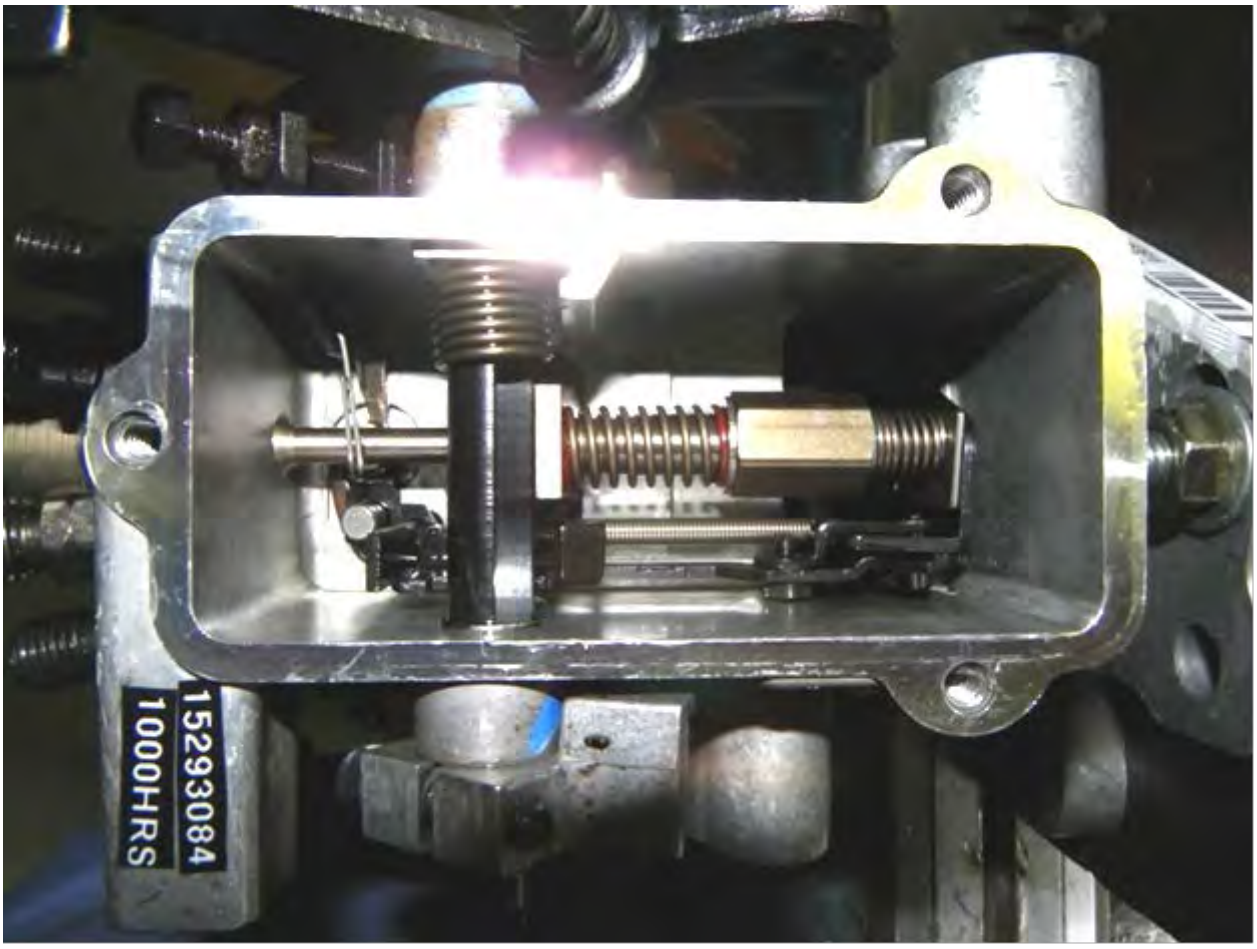
SN15293084 Governor Assembly After

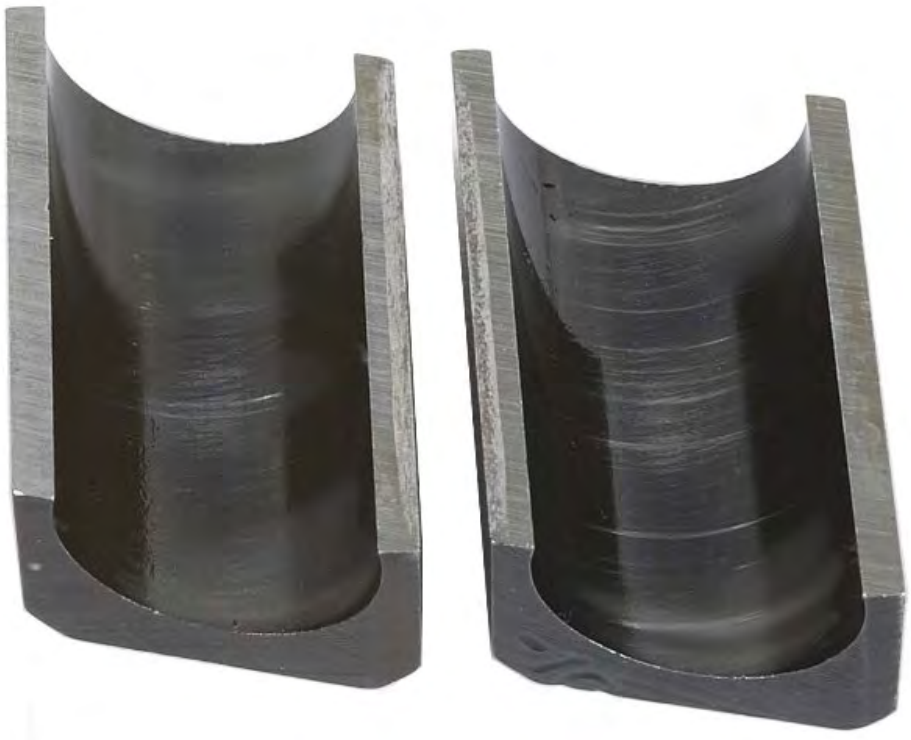
SN15293089 Shoes (Front), After

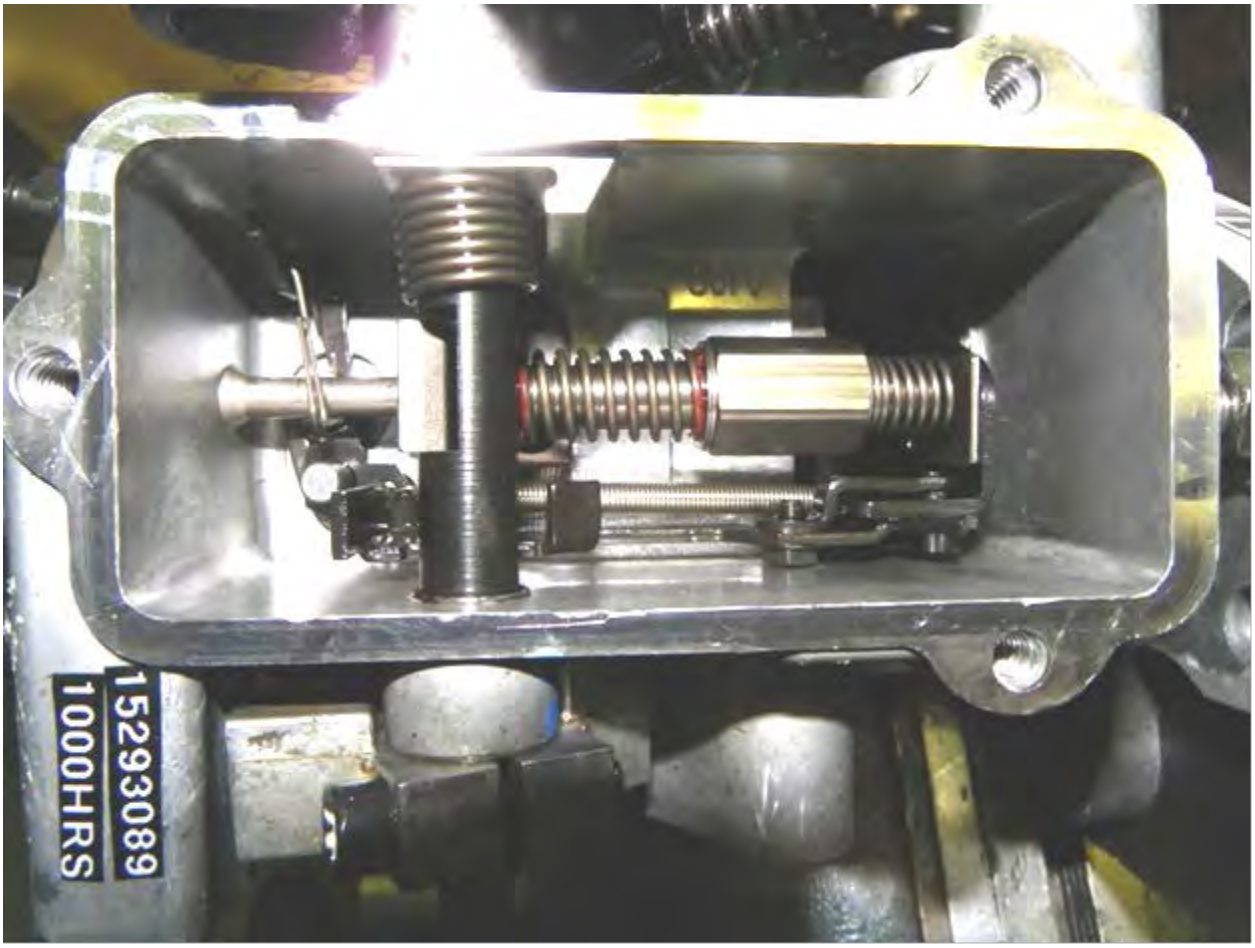
SN15293089 Governor Assembly, After

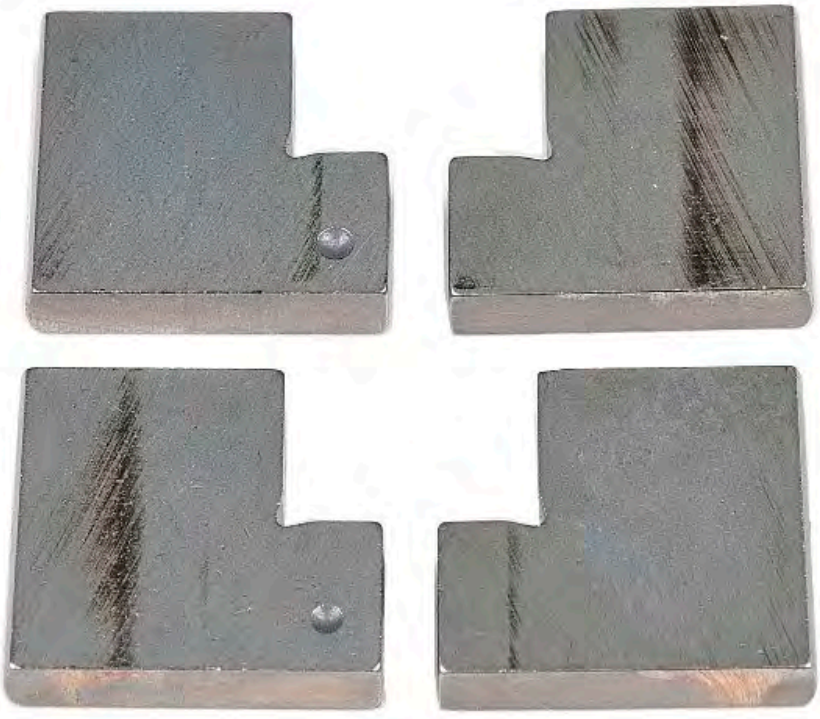
SN15382732 Transfer Pump Blades (Side), After

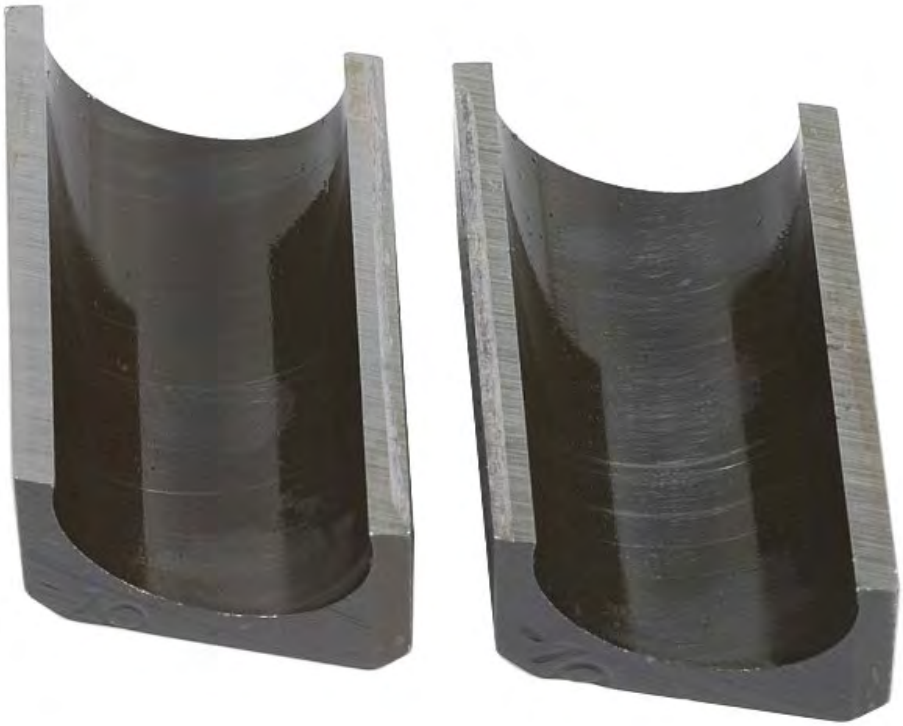
SN15382732 Shoes (Front), After

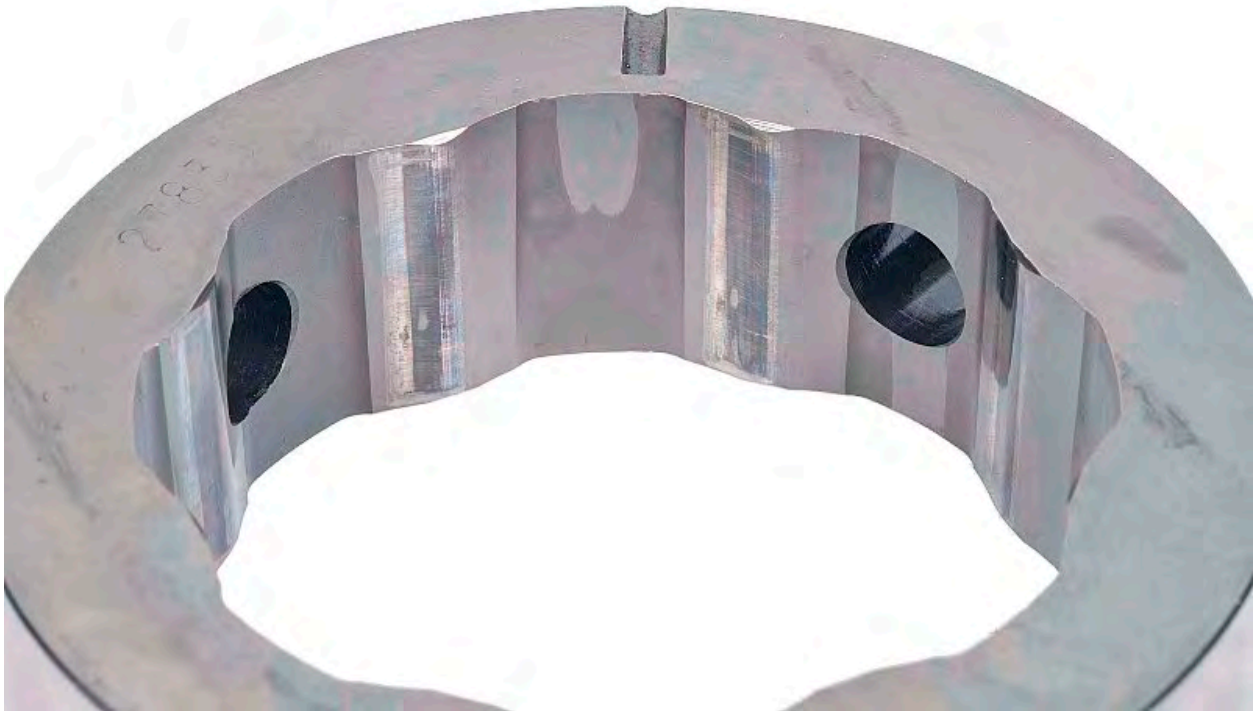
SN15382732 Cam Ring, After

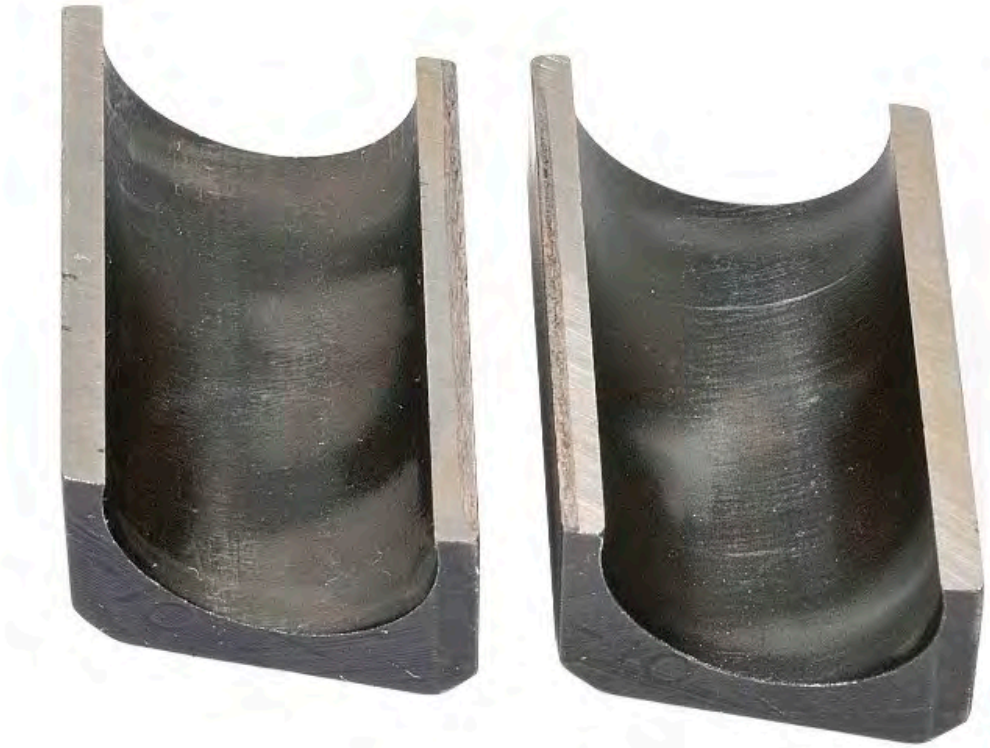
SN15382733 Shoes (Front), After

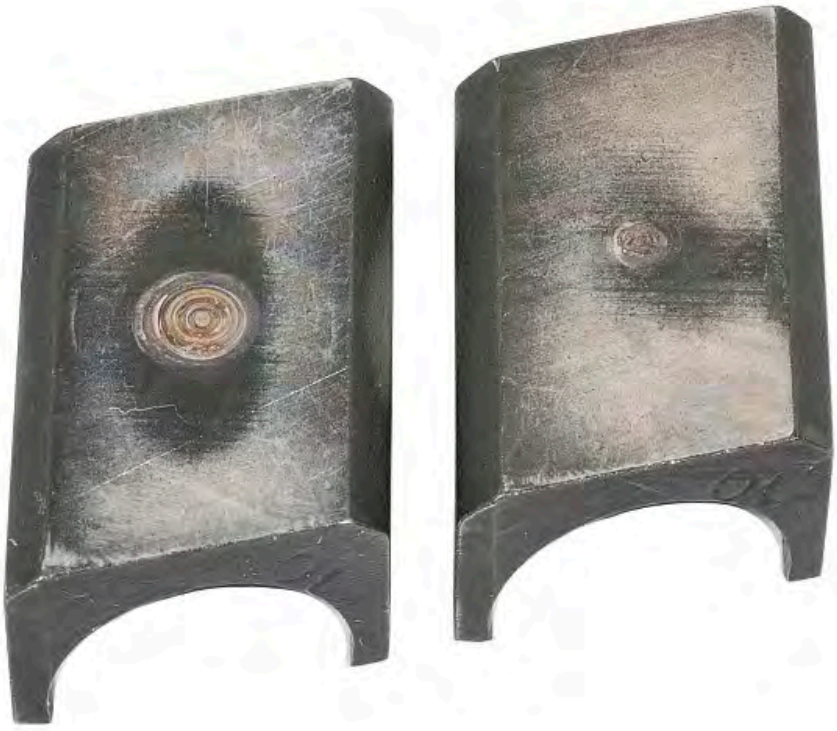
SN15382733 Shoes (Back), After

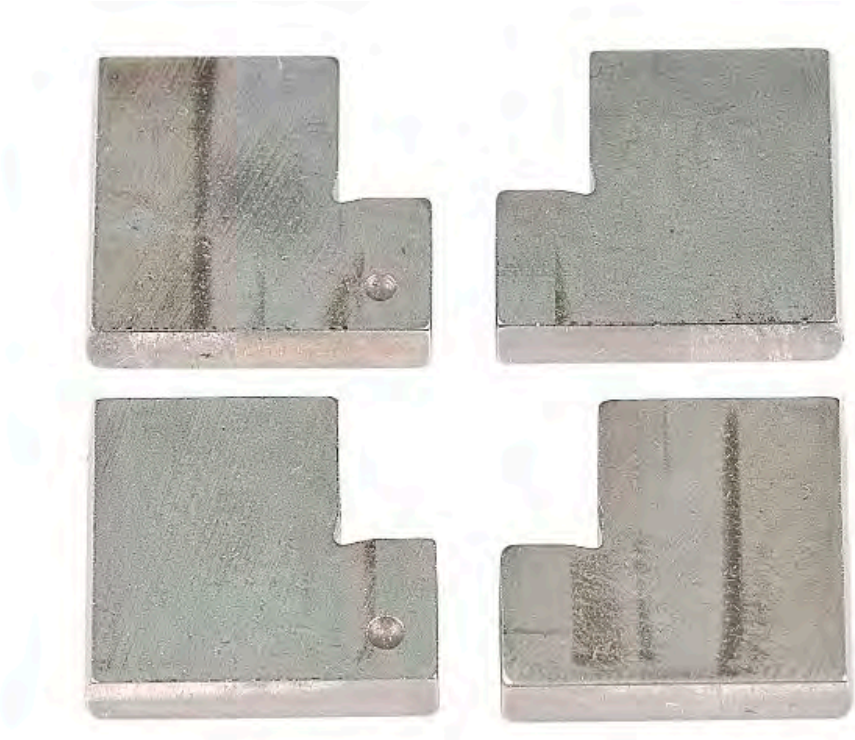
SN15396933 Transfer Pump Blades (Side), After

Part Name	Condition of Part	Rating 0 = New 5 = Failed
BLADES	Polishing wear at rotor slots ans liner contact	1.5
BLADE SPRINGS	No wear	0
LINER	Polishing wear 80% of surface	1.5
TRANSFER PUMP REGULATOR	Light wear mark from rotor contact. Metal flakes on screen	1
REGULATOR PISTON	Black coating. Light polihing in spots	0.5
ROTOR	No wear	0
ROTOR RETAINERS	Wear from rotor contact	1.5
DELIVERY VALVE	Scuffed on one side	3
PLUNGERS	Lightly polished in spots	1
SHOES	Small dimple on left shoe only	1.5
ROLLERS	Darker in color. Normal wear	1
LEAF SPRING	Very light wear from shoe contact	1
CAM RING	Normal polishing from cam ring	1
THRUST WASHER	Light polishing at weight contact	1
THRUST SLEEVE	Normal wear marks from governor pivot fingers	1
GOVORNER WEIGHTS	Light wear from T- washer contact	1
LINK HOOK	All pumps have some degree of wearon governor arm from pivot pin	1
METERING VAVLE	Very light polishing wear	0.5
DRIVE SHAFT TANG	Light polihing marks	1

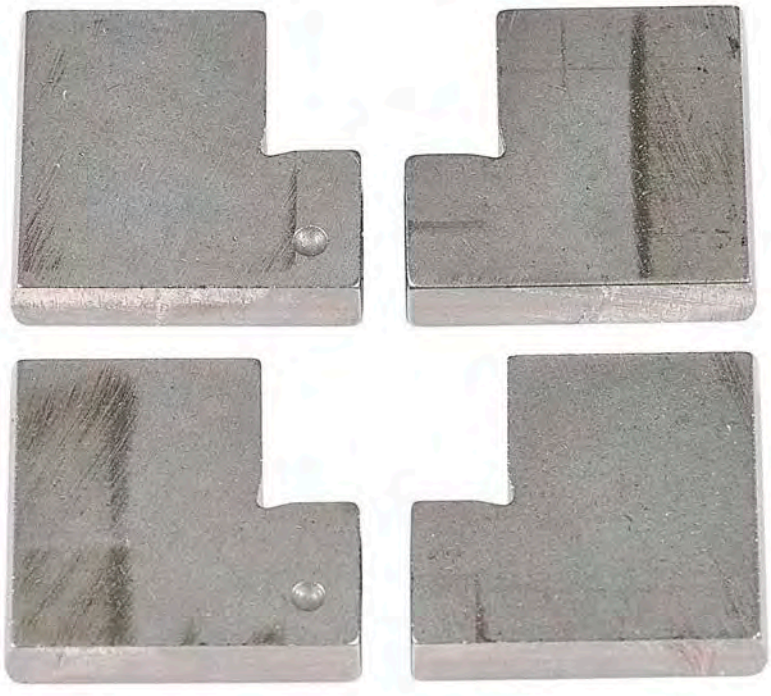
SN15396934 Transfer Pump Blades, After

Part Name	Condition of Part	Rating 0 = New 5 = Failed
BLADES	Polishing wear	1
BLADE SPRINGS	No wear	0
LINER	Polishing wear	1
TRANSFER PUMP REGULATOR	Light wear mark from rotor contact. Metal flakes on screen	1
REGULATOR PISTON	Black coating. Light polishing in spots	1.5
ROTOR	No wear	1
ROTOR RETAINERS	Wear from rotor contact	1.5
DELIVERY VALVE	Scuffed on one side	1
PLUNGERS	Lightly polished in spots	1
SHOES	Light Polishing wear	1
ROLLERS	Normal	1
LEAF SPRING	Very light wear from shoe contact	1
CAM RING	Normal polishing from cam ring	1
THRUST WASHER	Light polishing at weight contact	1
THRUST SLEEVE	Normal wear marks from governor pivot fingers	1
GOVORNER WEIGHTS	Light wear from T- washer contact	1
LINK HOOK	All pumps have some degree of wearon governor arm from pivot pin	1
METERING VAVLE	Very light polishing wear	0.5
DRIVE SHAFT TANG	Light polihing marks	1
DRIVE SHAFT SEALS	Normal	1
CAM PIN	In spec, normal	1
ADVANCE PISTON	Scuffing wear at top, right side	3

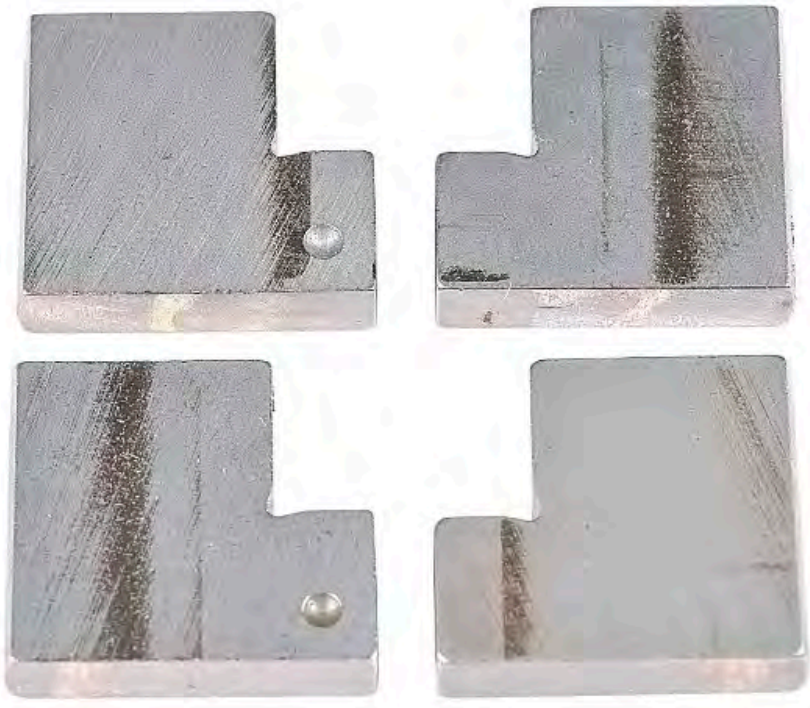
SN15396931 Transfer Pump Blades (Side), After

Part Name	Condition of Part	Rating 0 = New 5 = Failed
BLADES	Polishing wear-rotor slots and liner contact	1
BLADE SPRINGS	Rubbing wear	3
LINER	Rubbing wear	1.5
TRANSFER PUMP REGULATOR	Polishing wear from rotor contact	1
REGULATOR PISTON	Light polishing wear	1
ROTOR	Normal	1
ROTOR RETAINERS	Wear marks from rotor contacts	1.5
DELIVERY VALVE	Polishing wear	2
PLUNGERS	Polishing wear from shoe contact	2
SHOES	wear from rollers, plunger, and leaf spring	4.5
ROLLERS	Scarring and pitting wear	4.5
LEAF SPRING	Wear from shoe contact	2
CAM RING	Scarred on lobes from contact with rollers	4
THRUST WASHER	Polishing wear from weights	1
THRUST SLEEVE	Polishing from linkage hook fingers	1
GOVORNER WEIGHTS	Light wear from T washer	1
LINK HOOK	Worn at pivot spot - polishing on fingers	2
METERING VAVLE	Polishing wear - stained brown	1.5
DRIVE SHAFT TANG	Some wear from rotor contact	1
DRIVE SHAFT SEALS	Normal	1
CAM PIN	0.002 inches out of round	3.5

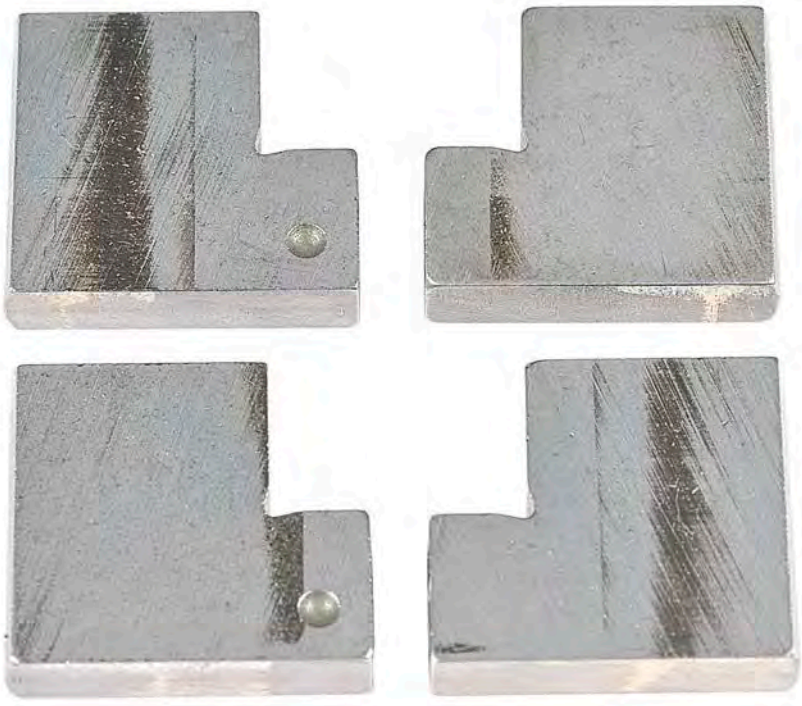
SN15396932 Transfer Pump Blades, Before

Part Name	Condition of Part	Rating 0 = New 5 = Failed
BLADES	Polishing wear-rotor slots and liner contact	1
BLADE SPRINGS	Rubbing wear	3
LINER	Rubbing wear	1
TRANSFER PUMP REGULATOR	Polishing wear from rotor contact	3
REGULATOR PISTON	Light polishing wear	1
ROTOR	Seized	5
ROTOR RETAINERS	Wear scars from rotor contacts	2.5
DELIVERY VALVE	Polishing wear	1.5
PLUNGERS	No scuffing but worn dimples at shoe contact	4
SHOES	Badly worn. Roller slot, plunger and leaf spring contact	5
ROLLERS	Diameter size is smaller from galling wear	5
LEAF SPRING	Deep grove worn into one side from shoe	4
CAM RING	Heavy wear and scarring on lobes	5
THRUST WASHER	Polishing wear from weights	1
THRUST SLEEVE	Polishing from linkage hook fingers	1
GOVORNER WEIGHTS	Light wear from T washer	1
LINK HOOK	Worn at pivot spot - polishing on fingers	2
METERING VAVLE	Polishing wear - stained brown	1
DRIVE SHAFT TANG	Some wear from rotor contact	1.5

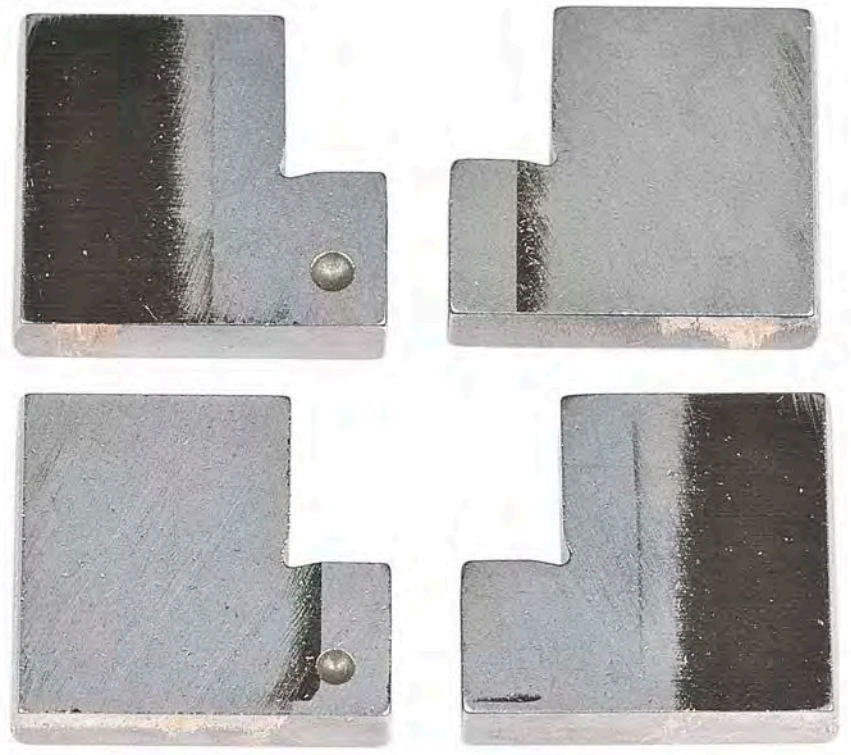
SN15396949 Transfer Pump Blades (Side), After

Pump Type : DB2-5079 (Arctic)		SN: 15396949
Test Condition : Jet A-1 w/25-mg/L NALCO 5403 @ 105°F		Pump Duration : 1000.-hrs.
Part Name	**Condition of Part**	**Rating 0 = New 5 = Failed**
BLADES	Wear at rotor slots and liner contact	2.5
BLADE SPRINGS	Rubbing Wear	1
LINER	Scarring wear on 80% of surface	2.5
TRANSFER PUMP REGULATOR	Wear mark from rotor, light polishing	1.5
REGULATOR PISTON	Polishing wear in various spots	1.5
ROTOR	Wear marks at inlet and outlet ports	2.5
ROTOR RETAINERS	Wear from rotor contact	1.5
DELIVERY VALVE	Polishing wear	2
PLUNGERS	Left - dicolored and worn, right- polishing wear	2.5
SHOES	Dimple on back, light wear marks from leaf spring, scorring from rollers	2
ROLLERS	No wear, but dark lines showing and light pitting	1.5
LEAF SPRING	Wear from shoe contact	2
CAM RING	Polishing wear from rollers	1
THRUST WASHER	Wear from weight contact. Slight groove	1.5
THRUST SLEEVE	Light wear from governor arm fingers	1

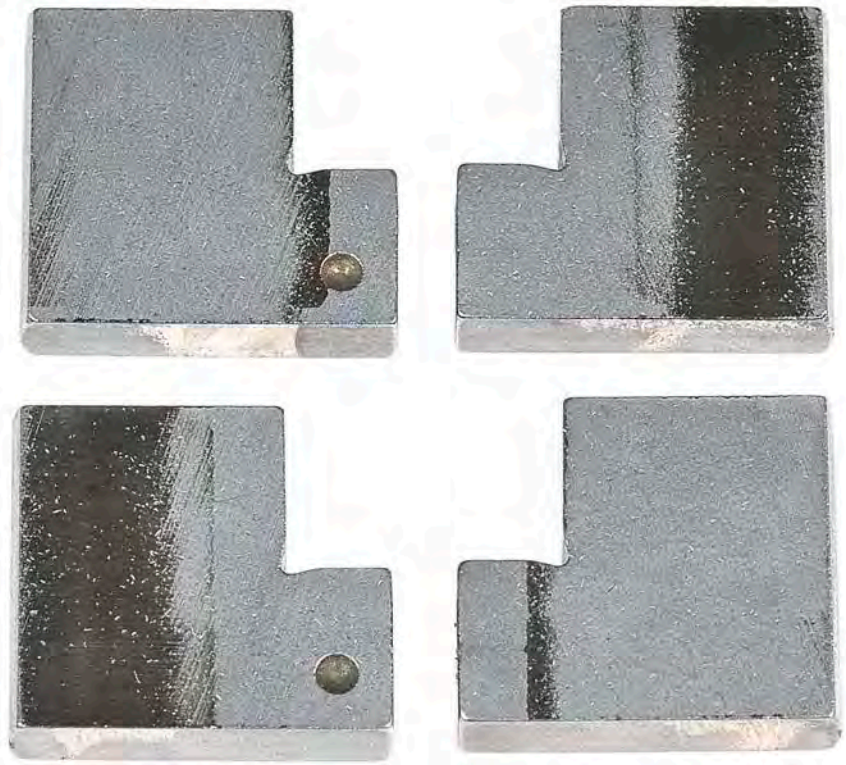
SN15396950 Transfer Pump Blades, After

Part Name	Condition of Part	Rating 0 = New 5 = Failed
BLADES	Wear at rotor slots and liner contact	2.5
BLADE SPRINGS	No wear	1
LINER	Scarring wear on 80% of surface	2.5
TRANSFER PUMP REGULATOR	Wear mark from rotor, light polishing	1.5
REGULATOR PISTON	Scuffing marks at two areas	2
ROTOR	Wear marks at outlet ports	2
ROTOR RETAINERS	Wear from rotor contact	1.5
DELIVERY VALVE	Polishing wear in various spots	1.5
PLUNGERS	Light polighing	1
SHOES	Dimple on back, light wear marks from leaf spring, scorring from rollers	1.5
ROLLERS	No wear - Dark lines	1
LEAF SPRING	Wear from shoe contact	1.5
CAM RING	Normal polishing wear from rollers	1
THRUST WASHER	Polishing wear from weight from weights	1
THRUST SLEEVE	Normal	1
GOVORNER WEIGHTS	Wear from thrust washer contact	1.5
LINK HOOK	Normal	1
METERING VAVLE	Slight polihing wear - Brown stain at helix	1
DRIVE SHAFT TANG	Polishing wear	1
DRIVE SHAFT SEALS	Normal	1
CAM PIN	Normal, in spec	1
