EFFECTIVENESS OF ADDITIVES IN IMPROVING FUEL LUBRICITY AND PREVENTING PUMP FAILURE AT HIGH TEMPERATURE

INTERIM REPORT
TFLRF No. 437

U.S. Army TARDEC Fuels and Lubricants Research Facility
Southwest Research Institute® (SwRI®)
San Antonio, TX

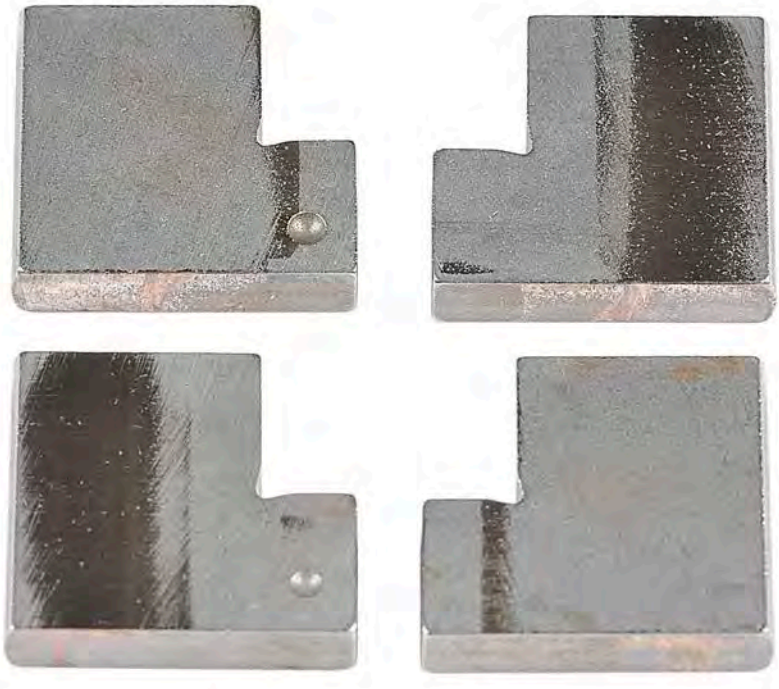
SN15396953 Transfer Pump Blades (Side), After

Part Name	Condition of Part	Rating 0 = New 5 = Failed
BLADES	Wear at slots and liner contact	2
BLADE SPRINGS	Very light wear at spots	1
LINER	70% Wear on surface	2
TRANSFER PUMP REGULATOR	Deposits on inlet side. Scuffing marks	2
REGULATOR PISTON	Deposits and polished in spots	1.5
ROTOR	Wear line at distributor ports	1.5
ROTOR RETAINERS	Wear from rotor contacts	1.5
DELIVERY VALVE	Light polishing wear	1
PLUNGERS	Polishing wear	1.5
SHOES	Medium wear at contact points	1.5
ROLLERS	Discolored	1.5
LEAF SPRING	Wear from shoe contact	1.5
CAM RING	Polishing wear from rollers	1
THRUST WASHER	Polishing wear from weights	1
THRUST SLEEVE	Normal polishing wear from governor fingers	1
GOVORNER WEIGHTS	Wear at foot of weight from thrust washer	2
LINK HOOK	Normal	1
METERING VAVLE	Deposits and light polishing	1
DRIVE SHAFT TANG	Polishing from rotor contact	1
DRIVE SHAFT SEALS	Normal	1
CAM PIN	In spec	1
ADVANCE PISTON	Polishing wear in spots	2.5

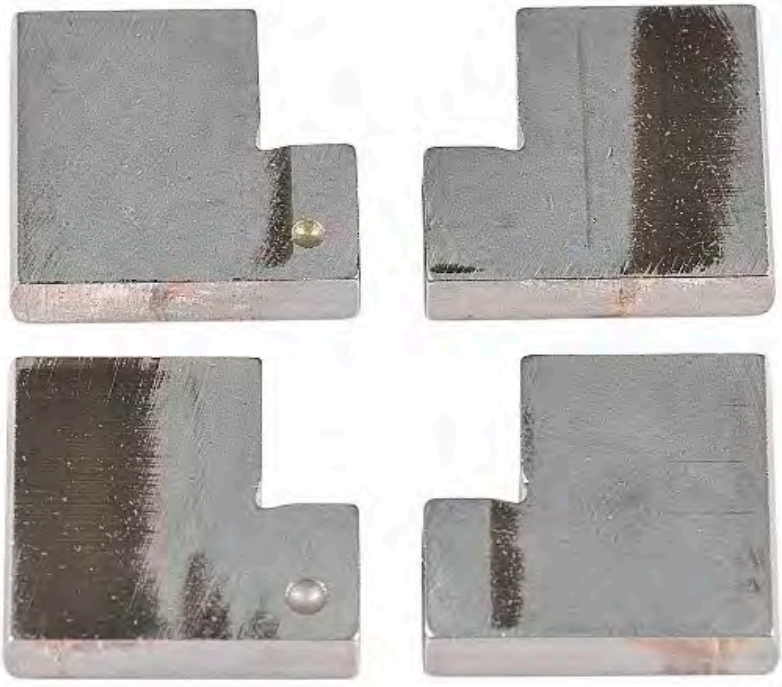
SN15396954 Transfer Pump Blades, After

Part Name	Condition of Part	Rating 0 = New 5 = Failed
BLADES	Wear at slots and liner contact	2
BLADE SPRINGS	Very light wear at spots	1
LINER	80% Wear on surface	2.5
TRANSFER PUMP REGULATOR	Deposits on inlet side. Scuffing marks	2
REGULATOR PISTON	Deposits and polished in spots	1
ROTOR	Wear line at distributor ports	2.5
ROTOR RETAINERS	Wear from rotor contacts	1.5
DELIVERY VALVE	Light polishing wear	1
PLUNGERS	Polishing wear. Discoloration on left plunger	2
SHOES	Medium wear at contact points	1.5
ROLLERS	Discolored	1.5
LEAF SPRING	Wear from shoe contact	1
CAM RING	Polishing wear from rollers	1
THRUST WASHER	Polishing wear from weights	1
THRUST SLEEVE	Normal polishing wear from governor fingers	2
GOVORNER WEIGHTS	Wear at foot of weight from thrust washer	1
LINK HOOK	Normal	1
METERING VAVLE	Deposits and light polishing	1
DRIVE SHAFT TANG	Polishing from rotor contact	1
DRIVE SHAFT SEALS	Normal	1
CAM PIN	In spec	1

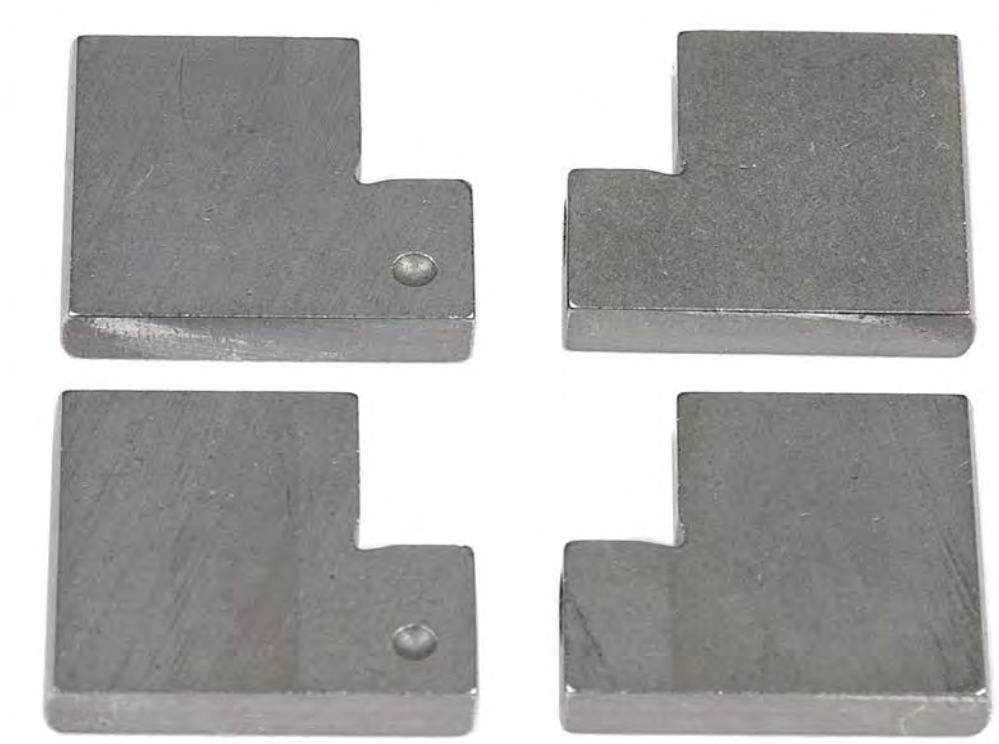
SN15438594 Transfer Pump Blades (Side), Before

Part Name	Condition of Part	Rating 0 = New 5 = Failed
BLADES	Wear at roller slots and liner contact	2
BLADE SPRINGS	Rubbing wear	1
LINER	Wear on 40% of liner	2.5
TRANSFER PUMP REGULATOR	Wear mark from rotor	1.5
REGULATOR PISTON	Polishing wear on two spots	1.5
ROTOR	Heavy wear marks along distributor ports	3
ROTOR RETAINERS	Wear from rotor contact	2
DELIVERY VALVE	Polishing wear	2
PLUNGERS	Polishing wear	2
SHOES	Dimple on back, wear from leaf spring	2.5
ROLLERS	Light pitting and discoloration	2.5
LEAF SPRING	Wear from shoe contact	2
CAM RING	Wear marks from rollers.	1
THRUST WASHER	Wear from weights. Slight groove	2
THRUST SLEEVE	Light wearfrom governor arm fingers	1
GOVORNER WEIGHTS	Wear at foot of weight contact thrust washer	2
LINK HOOK	Normal	1
METERING VAVLE	Light polishing wear	1
DRIVE SHAFT TANG	Light polishing wear	1
DRIVE SHAFT SEALS	Normal	1
CAM PIN	Normal in spec	1
ADVANCE PISTON	Scuffing wear	3
HOUSING	Normal	1

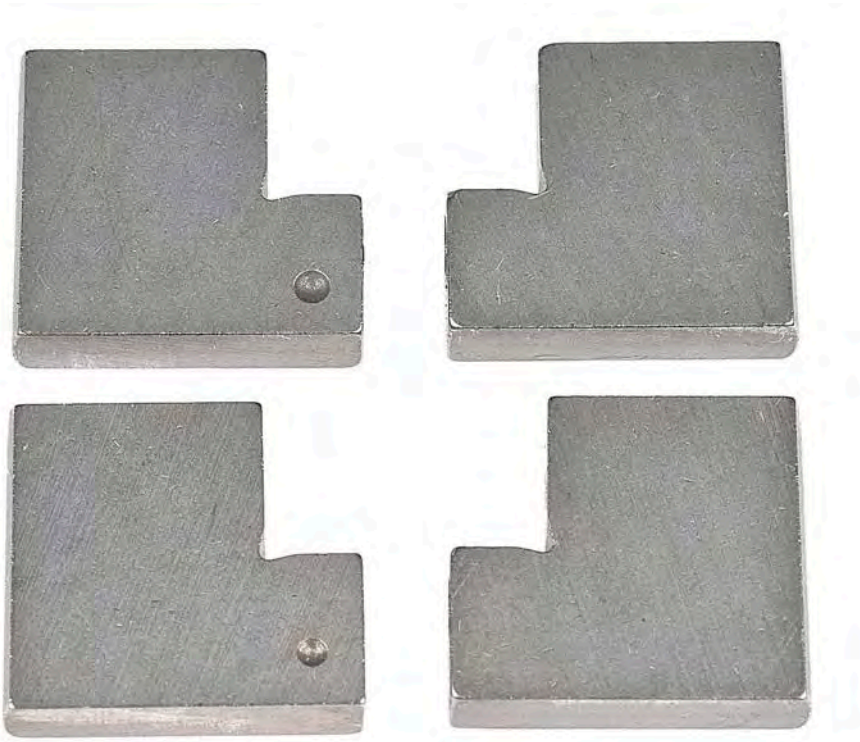
SN15438595 Transfer Pump Blades, Before

Pump Type : DB2831-5079		SN: 15438595
Test Condition : Jet A-1 w/50-mg/L OLI-9070x @ 105°F		Pump Duration : 1000.-hrs.
Part Name	**Condition of Part**	**Rating 0 = New 5 = Failed**
BLADES	Wear at roller slots and liner contact	2
BLADE SPRINGS	Rubbing wear	1
LINER	Wear on 40% of liner	3
TRANSFER PUMP REGULATOR	Wear mark from rotor	1.5
REGULATOR PISTON	Polishing wear on two spots	1.5
ROTOR	Polishing wear at distibutor ports	2.5
ROTOR RETAINERS	Wear from rotor contact	2
DELIVERY VALVE	Broken spring. Polishing wear	2
PLUNGERS	Polishing wear	1
SHOES	Dimple on back, wear from leaf spring	2
ROLLERS	Light pitting and discoloration	2.5
LEAF SPRING	Wear from shoe contact	2
CAM RING	Wear marks from rollers.	1
THRUST WASHER	Wear from weights. Slight groove	2
THRUST SLEEVE	Light wearfrom governor arm fingers	1
GOVORNER WEIGHTS	Wear at foot of weight contact thrust washer	2
LINK HOOK	Normal	1
METERING VAVLE	Light polishing wear	1

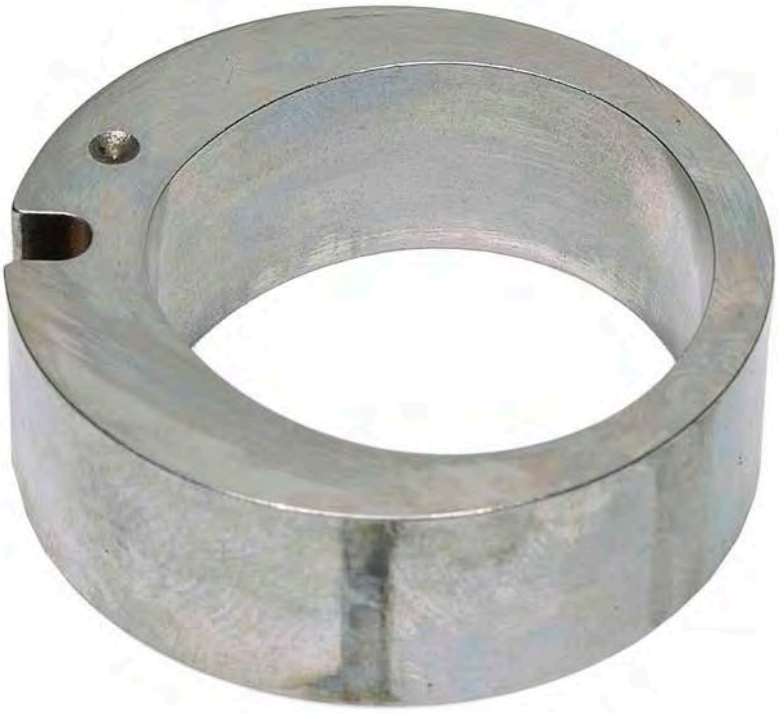
SN15438596 Eccentric Ring, Before

SN15438596 Eccentric Ring, After

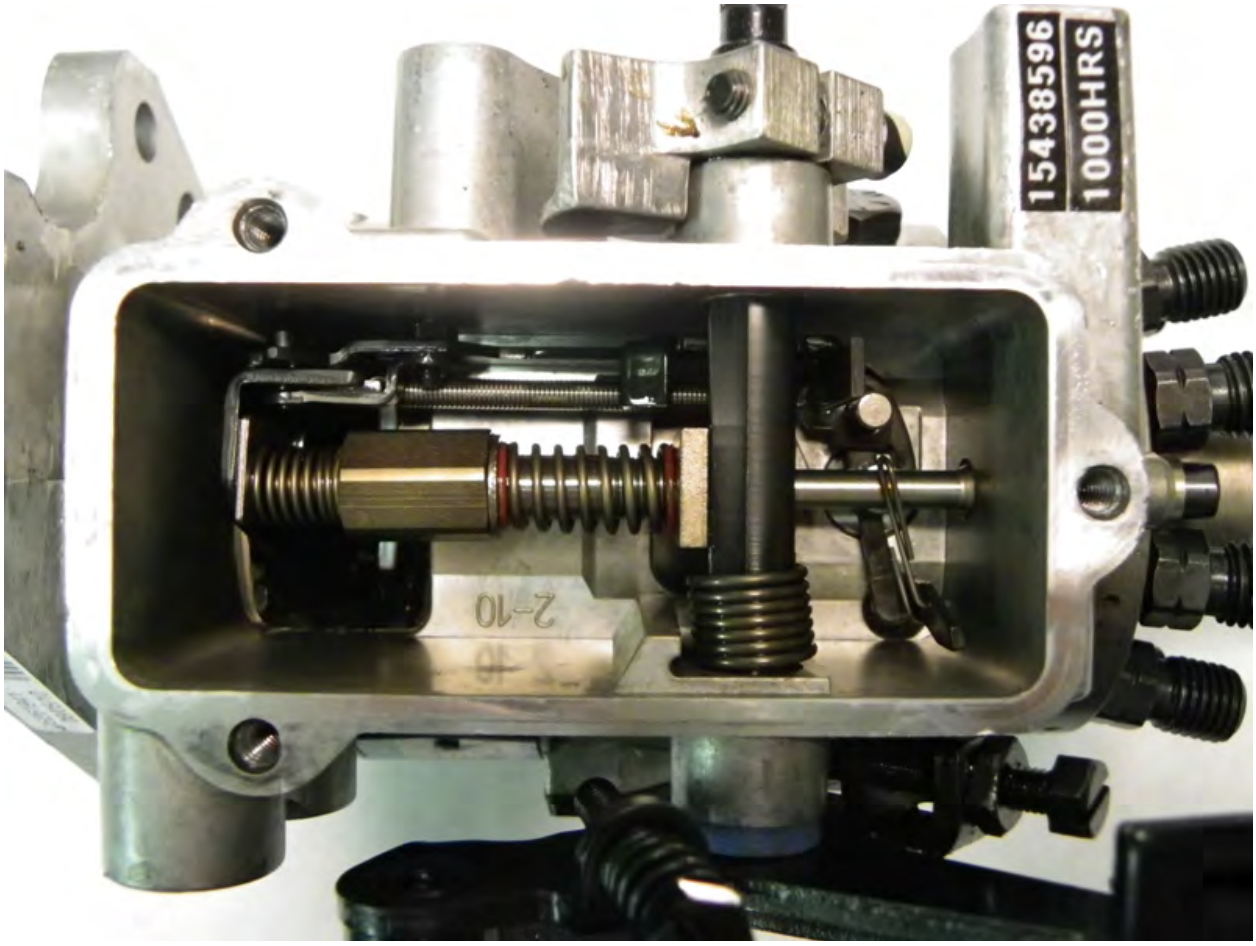
SN15438596 Governor Assembly

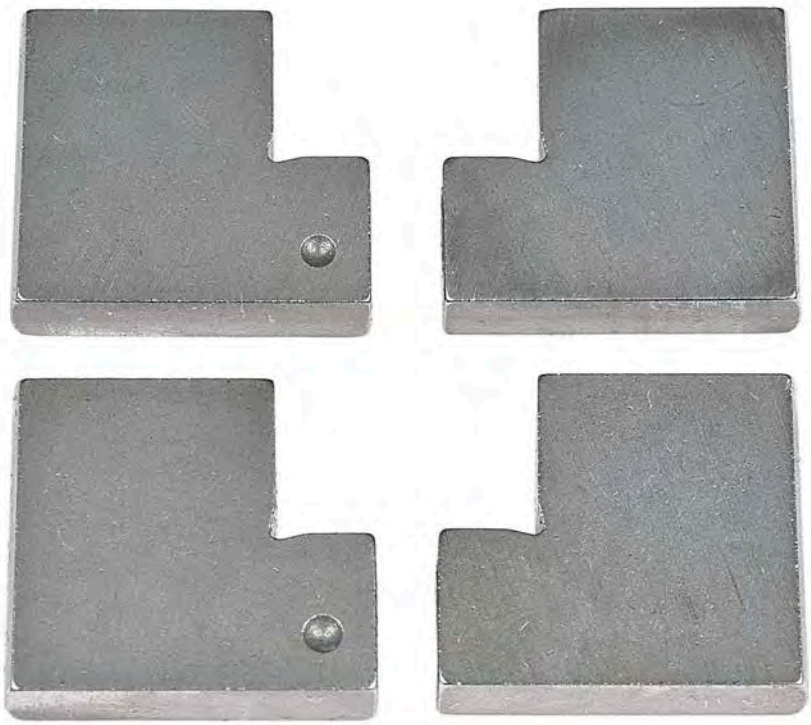
SN15438597 Transfer Pump Blades, Before

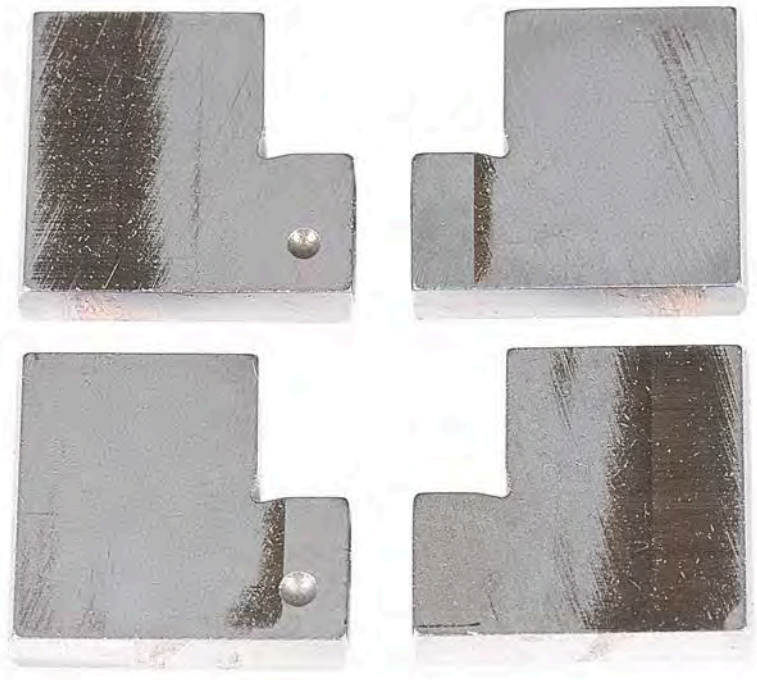
SN15438597 Transfer Pump Blades, After

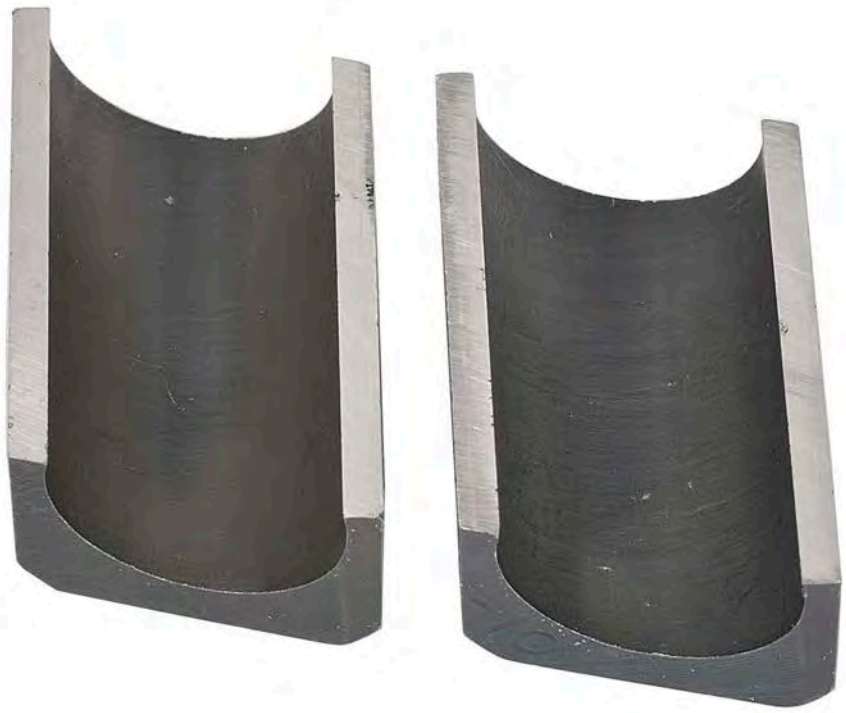
SN15438597 Shoes (Front), Before

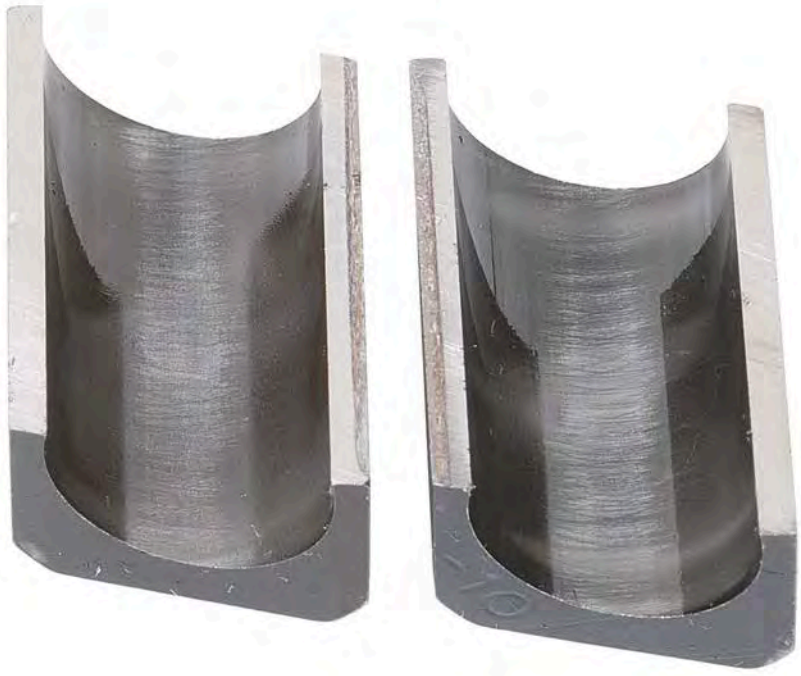
SN15438597 Shoes (Front), After

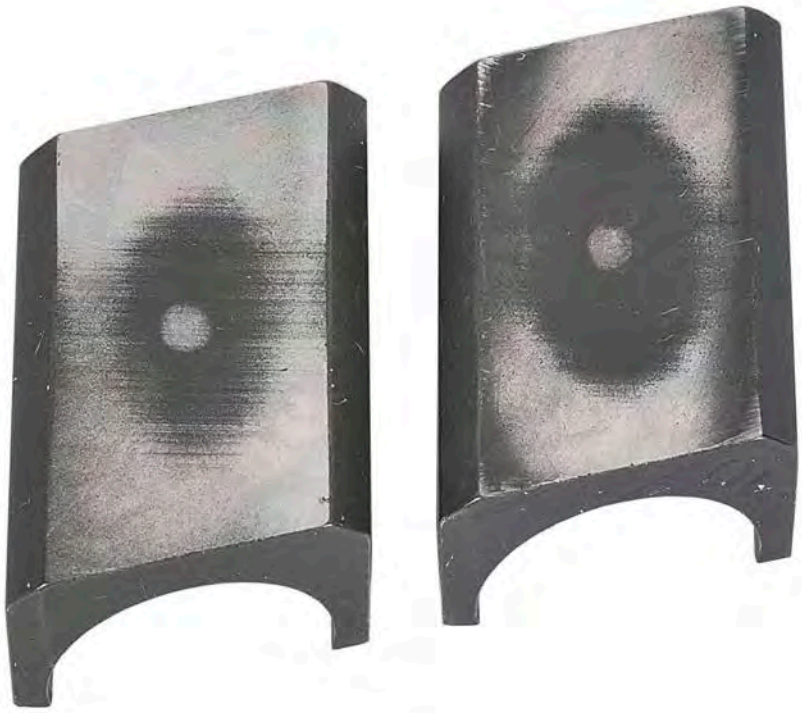
SN15438597 Shoes (Back), Before

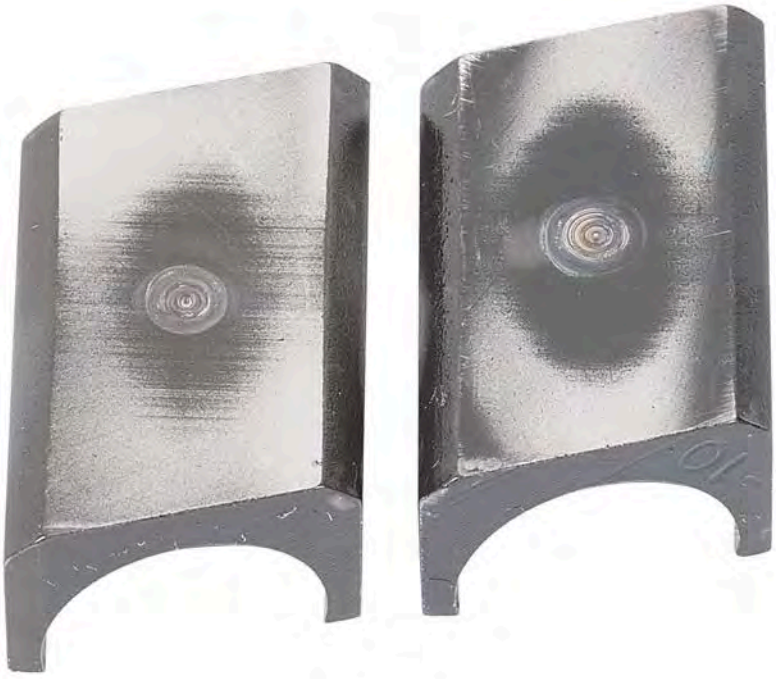
SN15438597 Shoes (Back), After

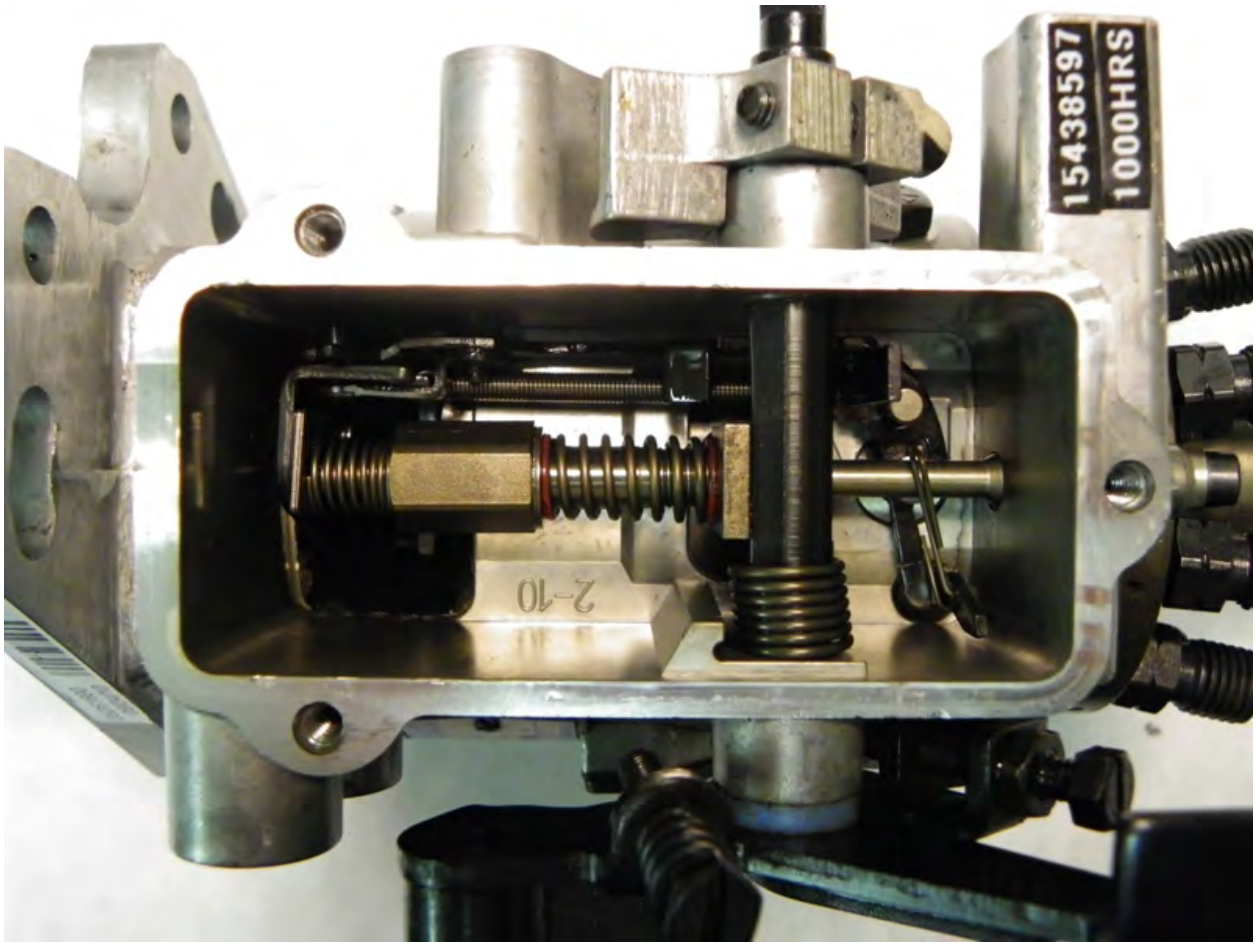
SN15438597 Governor Assembly

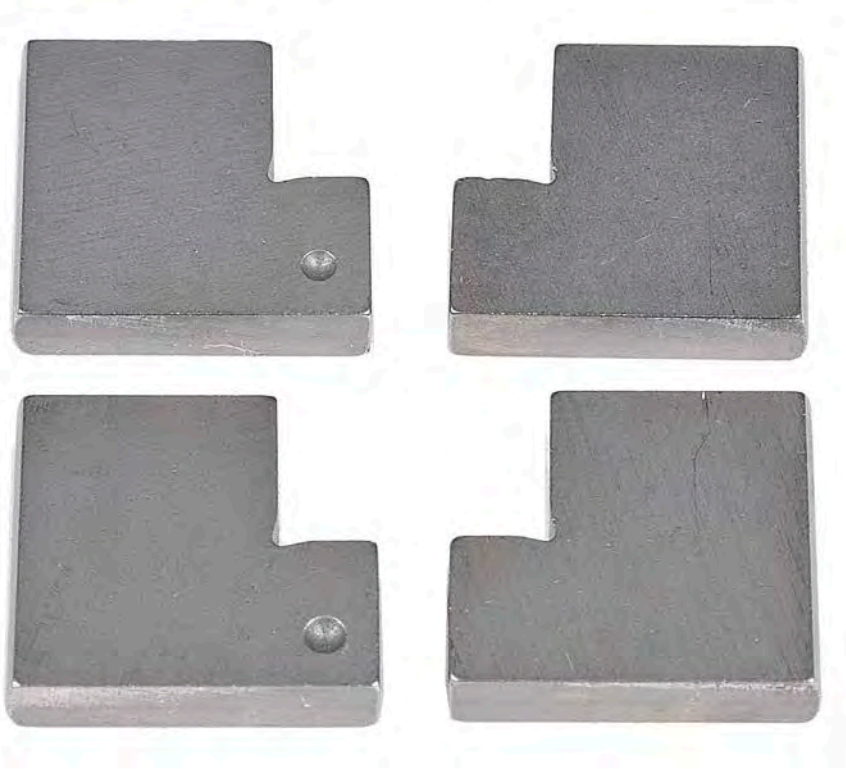
SN15438598 Transfer Pump Blades (Side), Before

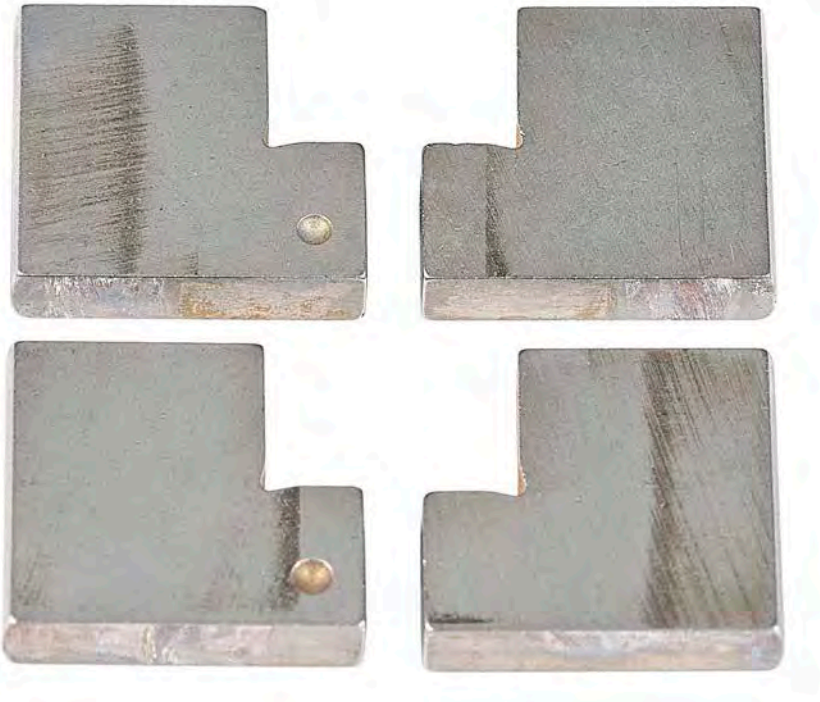
SN15438598 Transfer Pump Blades (Side), After

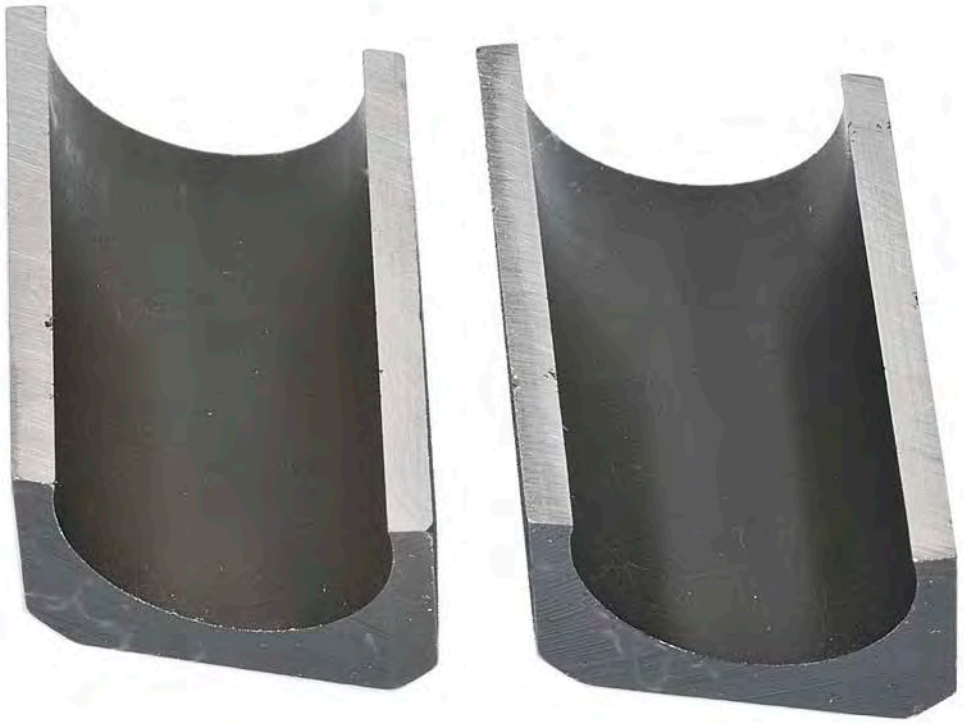
SN15438598 Shoes (Front), Before

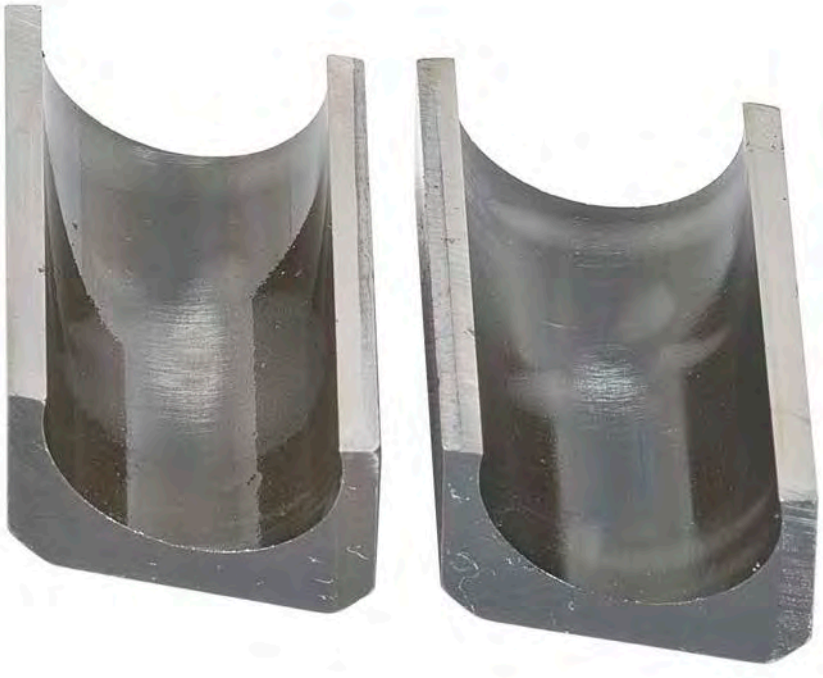
SN15438598 Shoes (Front), After

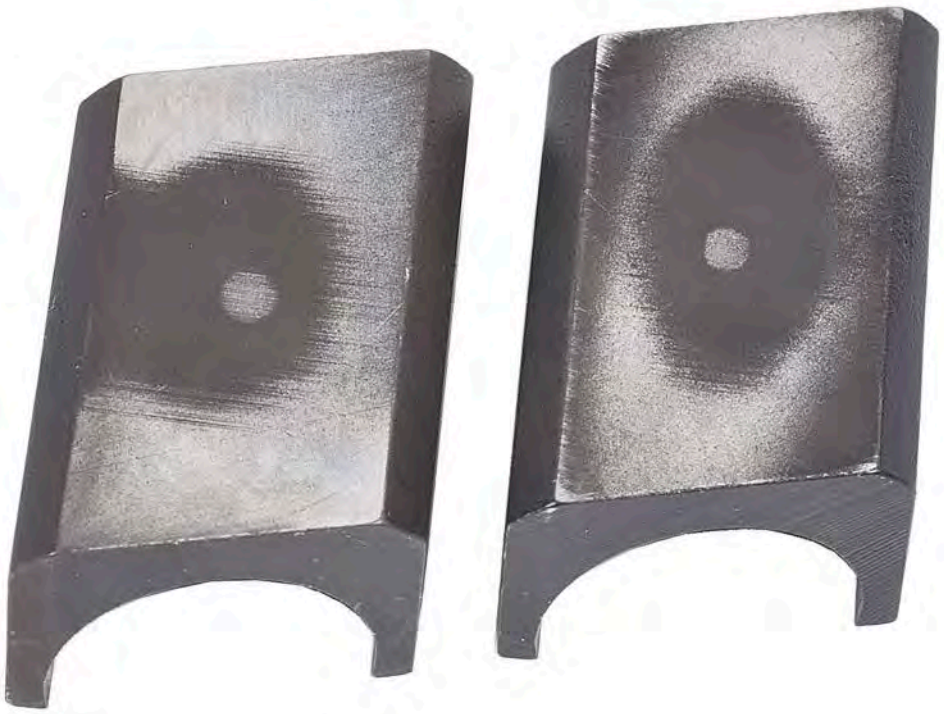
SN15438598 Shoes (Back), Before

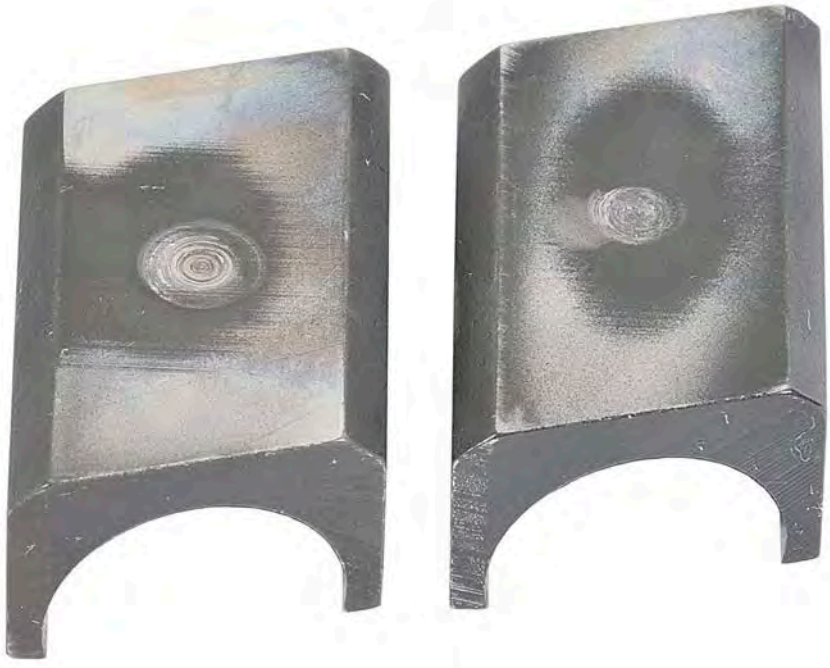
SN15438598 Shoes (Back), After

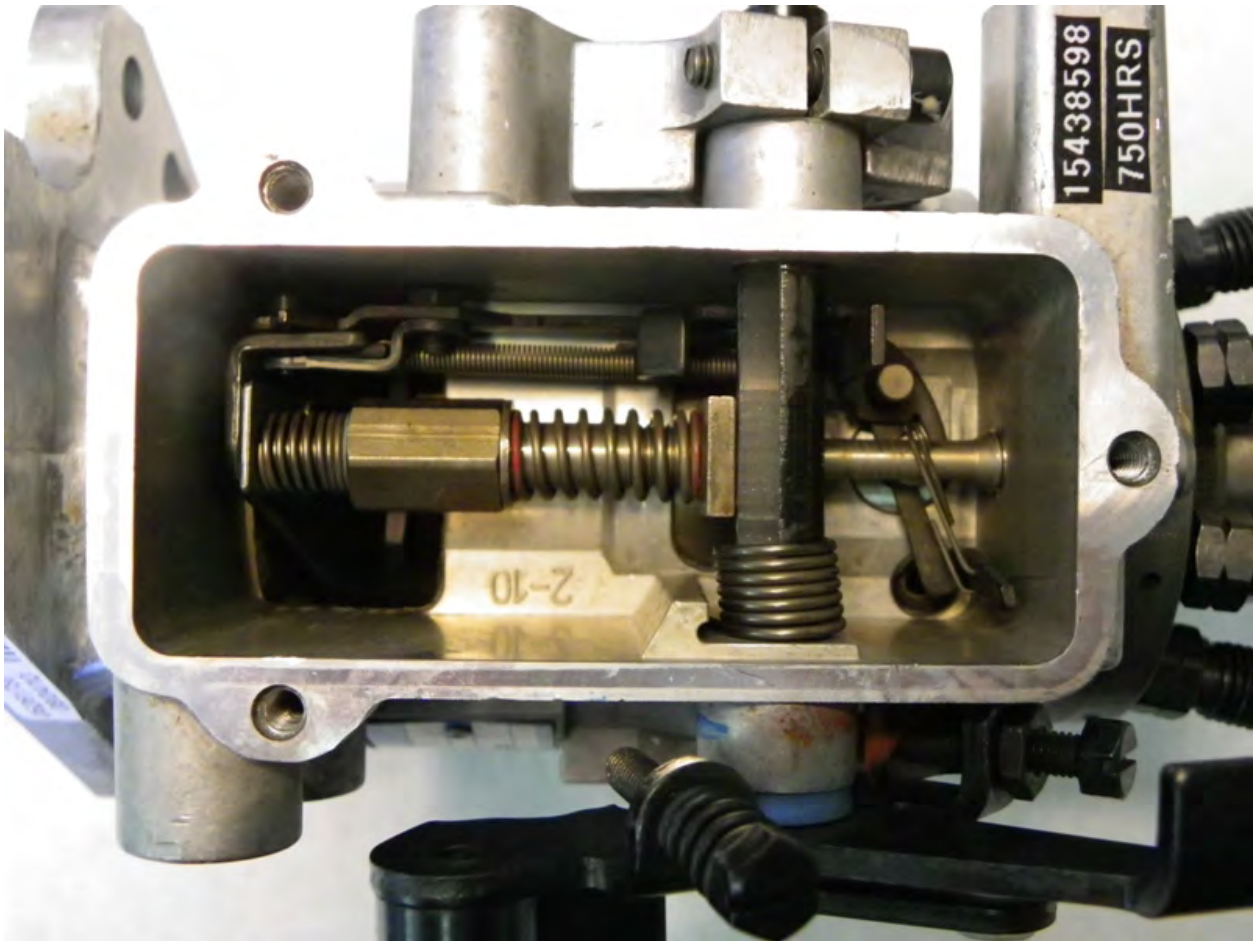
Notes : Pump SN:15438598 - Severe wear in needle bearings caused disintegration of fluorosilicone and viton shaft seals, when test stand was restarted at 750 hrs after fuel drum changed fuel spewed out of pump into gearbox. Pump could not be calibrated.

DRIVE SHAFT TANG	Wear from roller contact	2
DRIVE SHAFT SEALS	Heat from failed shaft needle bearing caused seals to disintegrate	5
CAM PIN	Normal. In spec	1
ADVANCE PISTON	Scarring wear	3
HOUSING	Bearing failed	5
	AVERAGE DEMERIT RATINGS	2.087

SN15438598 Governor Assembly, After

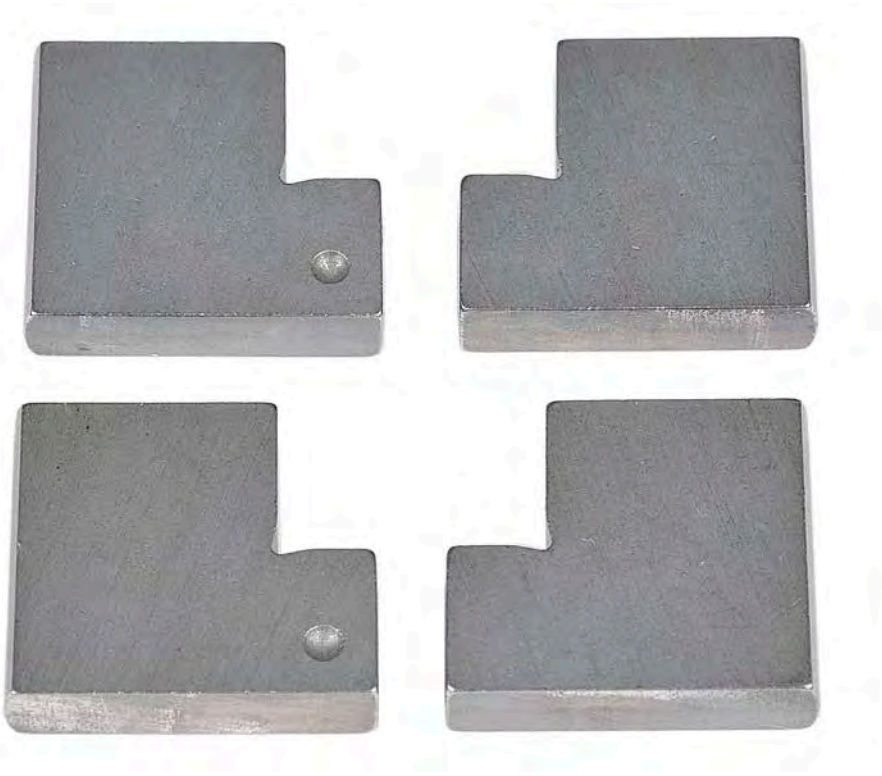
SN15438599 Transfer Pump Blades, Before

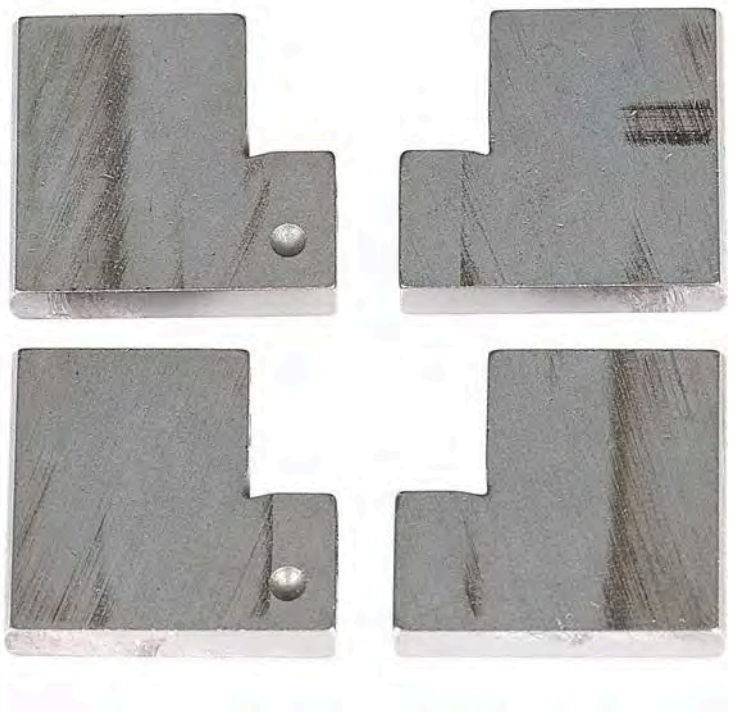
SN158599 Transfer Pump Blades, After

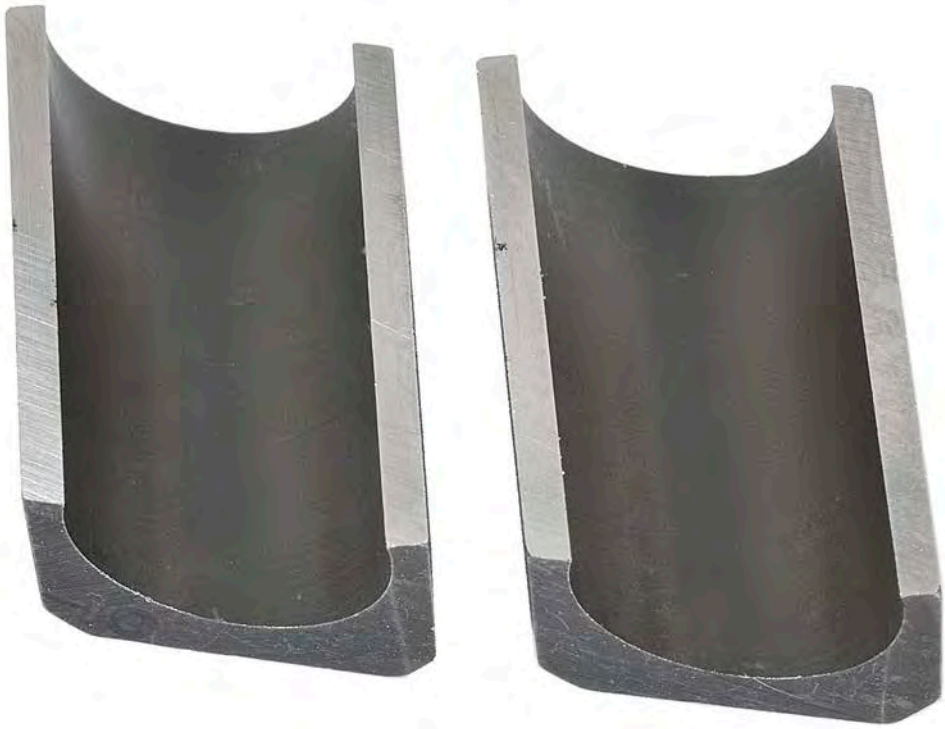
SN15438599 Shoes (Front), Before

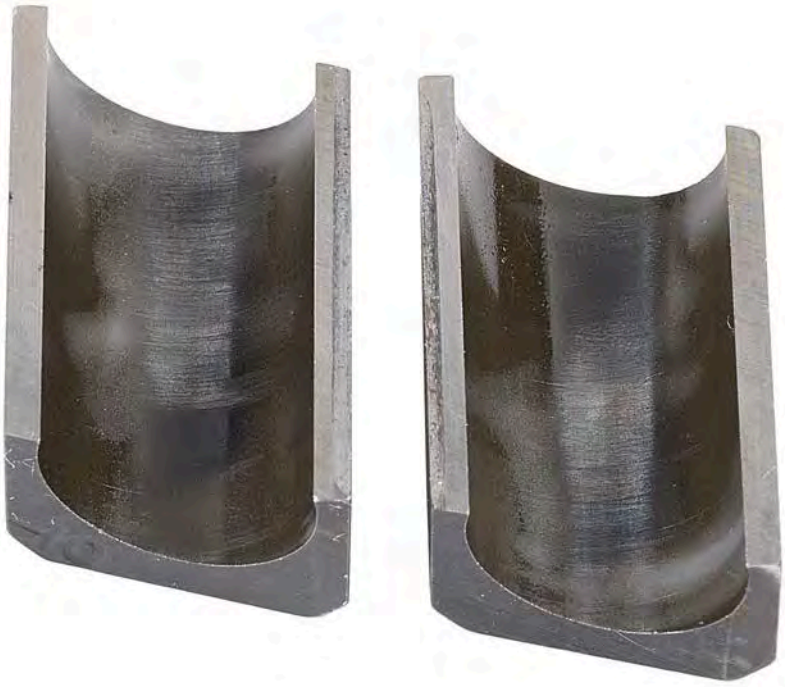
SN15438599 Shoes (Front), After

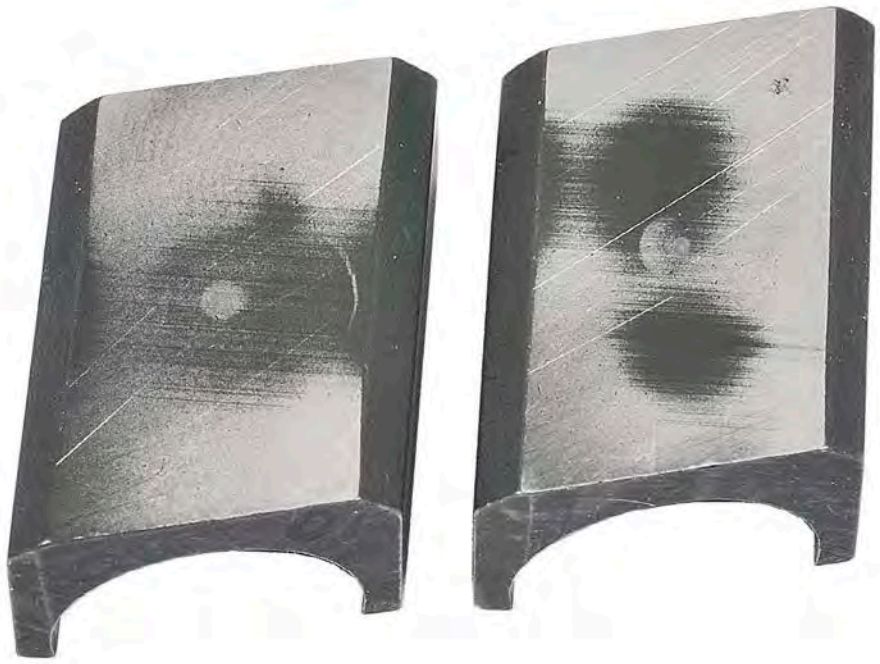
SN15438599 Shoes (Back) Before

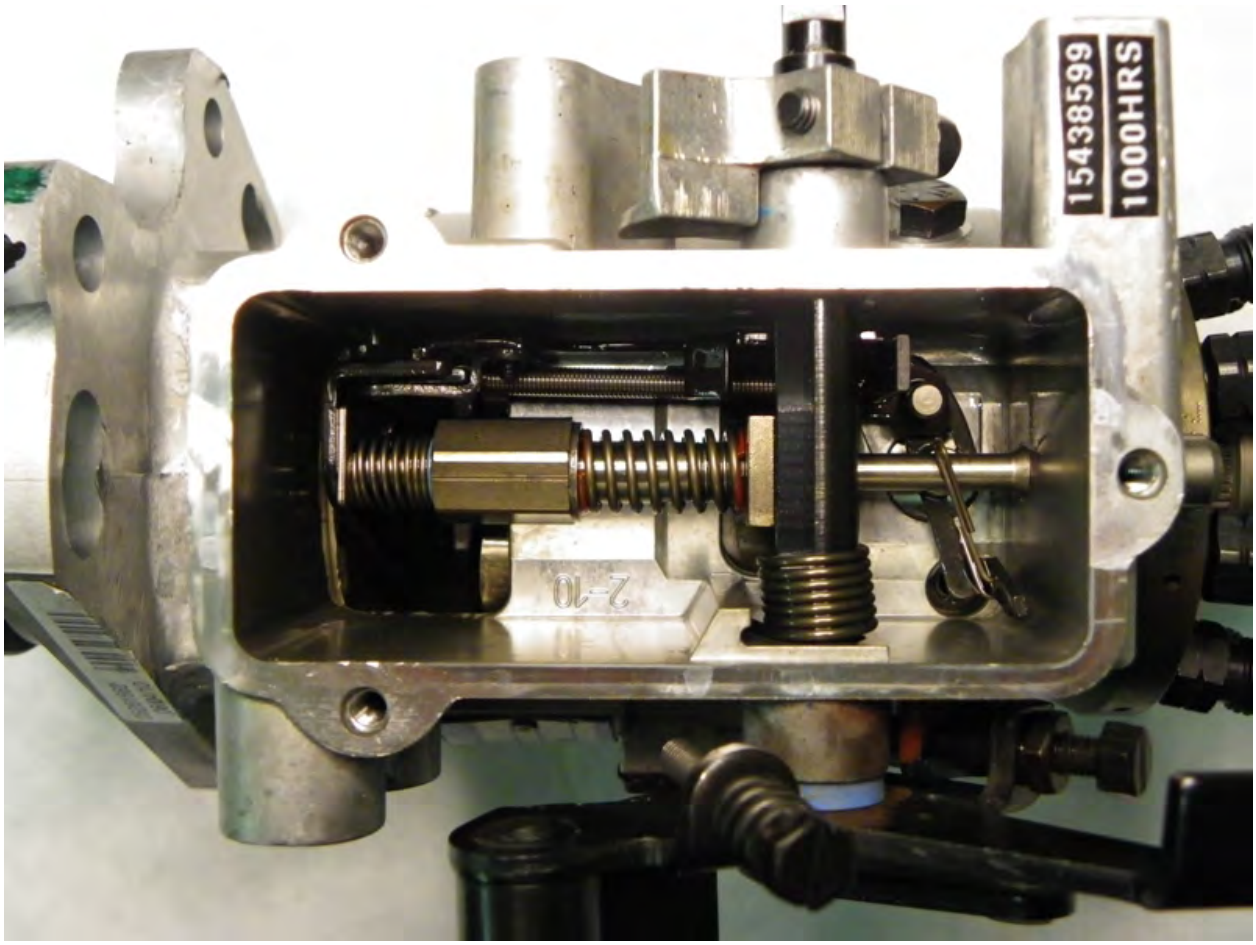
SN15438599 Governor Assembly, After

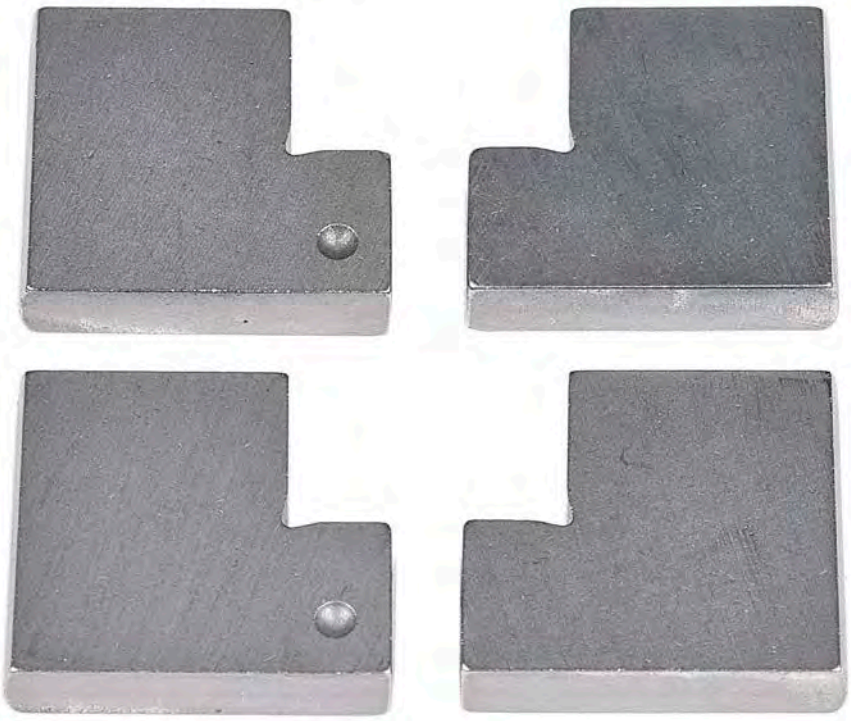
SN15438603 Transfer Pump Blades (Side), Before

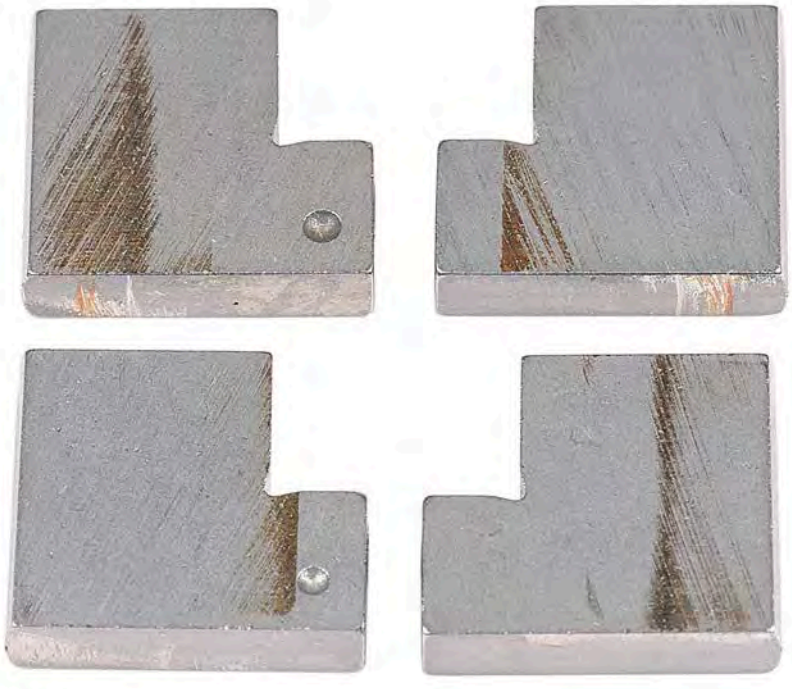
SN15438603 Transfer Pump Blades (Side), After

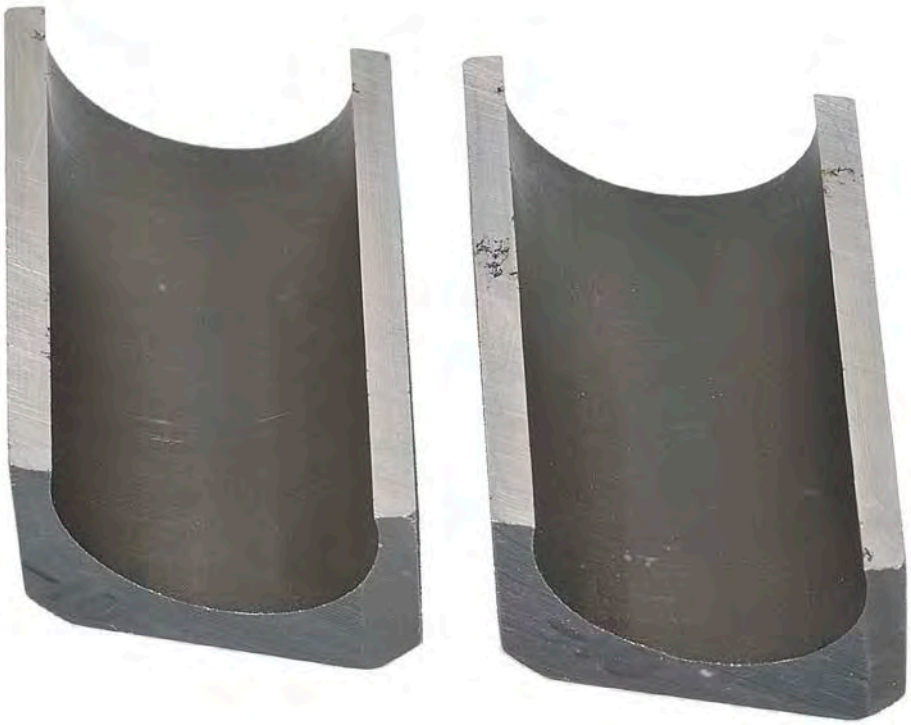
SN15438603 Shoes (Front), Before

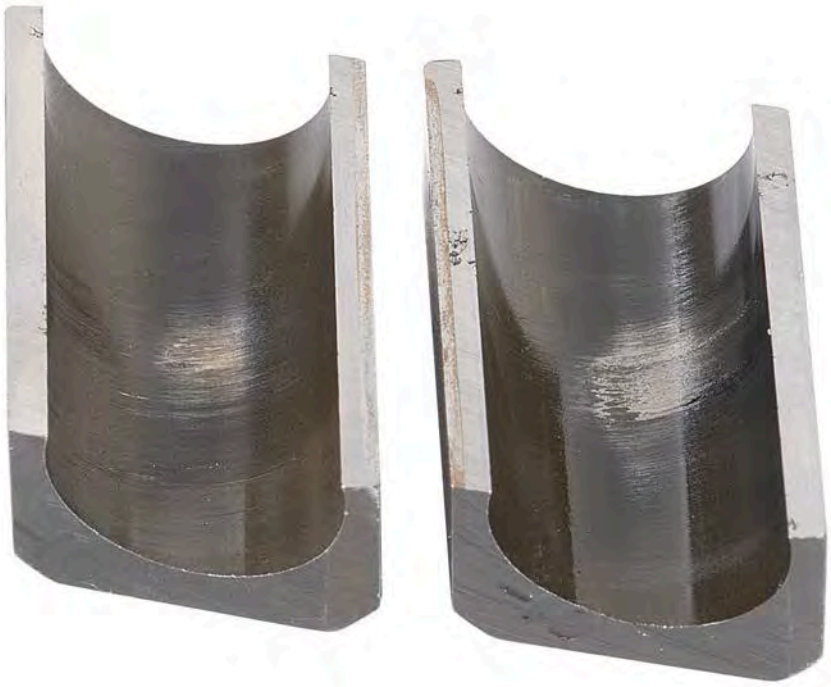
SN15438603 Shoes (Front), After

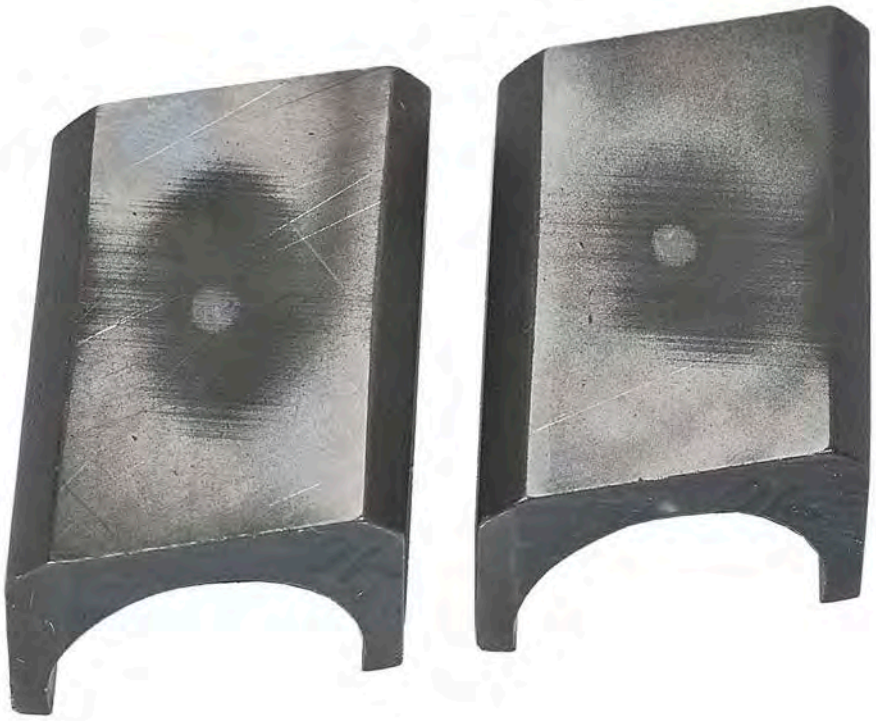
SN15438603 Shoes (Back), Before

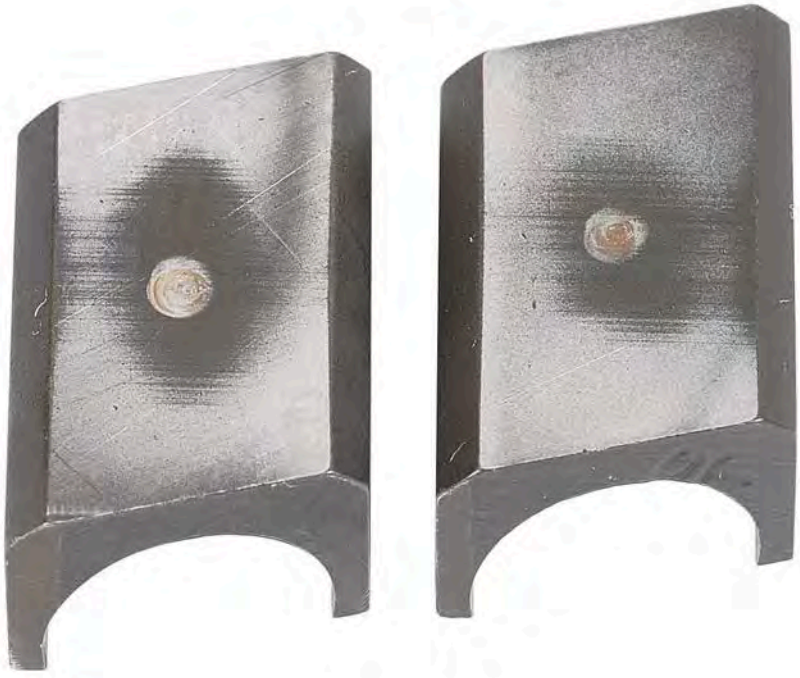
SN15438603 Shoes (Back), After
