EFFECTIVENESS OF ADDITIVES IN IMPROVING FUEL LUBRICITY AND PREVENTING PUMP FAILURE AT HIGH TEMPERATURE

INTERIM REPORT
TFLRF No. 437

U.S. Army TARDEC Fuels and Lubricants Research Facility
Southwest Research Institute® (SwRI®)
San Antonio, TX

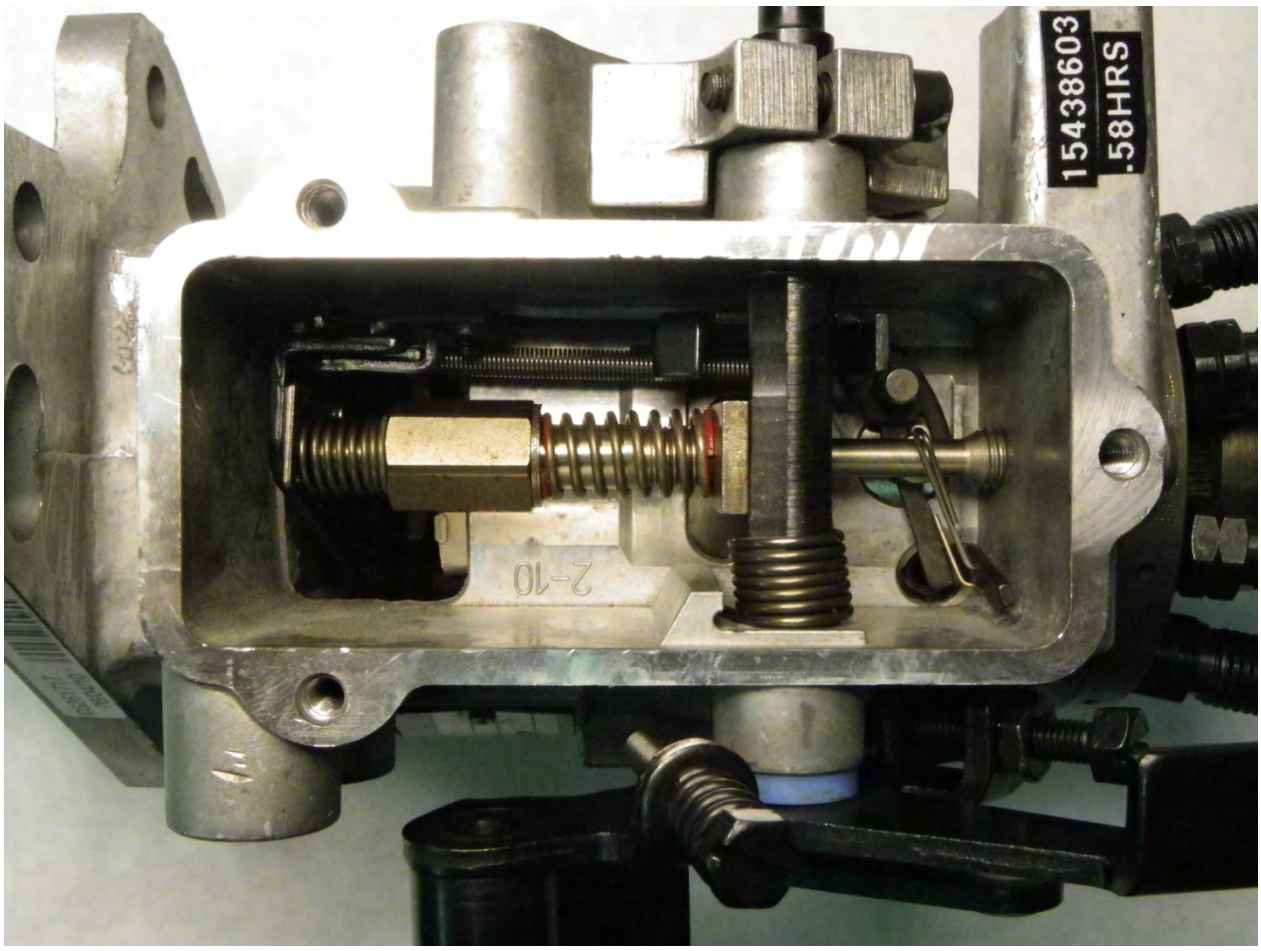
SN15438603 Governor Assembly

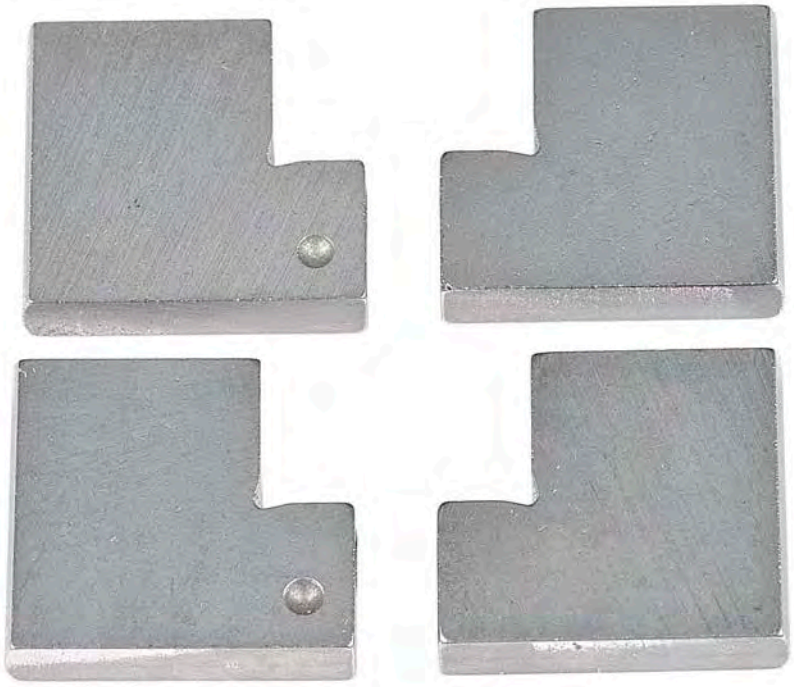
SN15438885 Transfer Pump Blades, Before

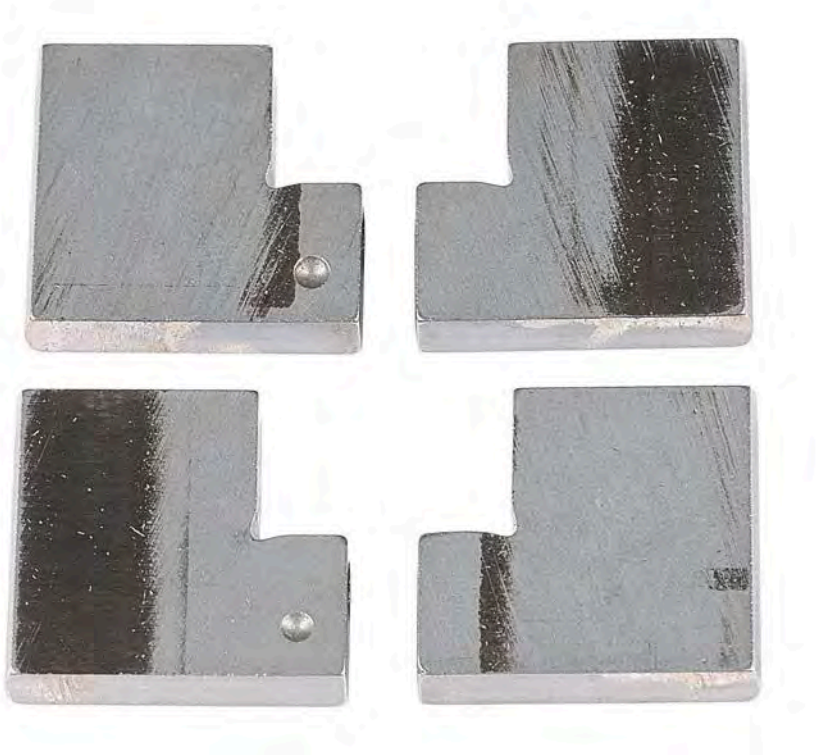
SN15438886 Transfer Pump Blades (Side), After

Part Name	Condition of Part	Rating 0 = New 5 = Failed
BLADES	Wear at rotor slots and liner contact	2.5
BLADE SPRINGS	Rubbing wear	1
LINER	90% Wear	3
TRANSFER PUMP REGULATOR	Wear mark from rotor, light polishing	1.5
REGULATOR PISTON	Polishing wear	1.5
ROTOR	Wear at distributor ports	2
ROTOR RETAINERS	Wear from rotor contact	2
DELIVERY VALVE	Polishing wear	2
PLUNGERS	Polishing wear	2
SHOES	Dimple, light waer from leaf spring contact	2
ROLLERS	Discolored	1.5
LEAF SPRING	Wear from shoe contact	2
CAM RING	Polishing wear	1
THRUST WASHER	Groove from weight contact	2.5
THRUST SLEEVE	Normal	1
GOVORNER WEIGHTS	Wear from thrust washer contact	2
LINK HOOK	Dimple from governor rod	2
METERING VAVLE	Polishing wear	1.5
DRIVE SHAFT TANG	Polishing wear	1
DRIVE SHAFT SEALS	Normal	1
CAM PIN	Normal	1
ADVANCE PISTON	Scorring wear	3.5
HOUSING	Normal	1
	AVERAGE DEMERIT RATINGS	1.761

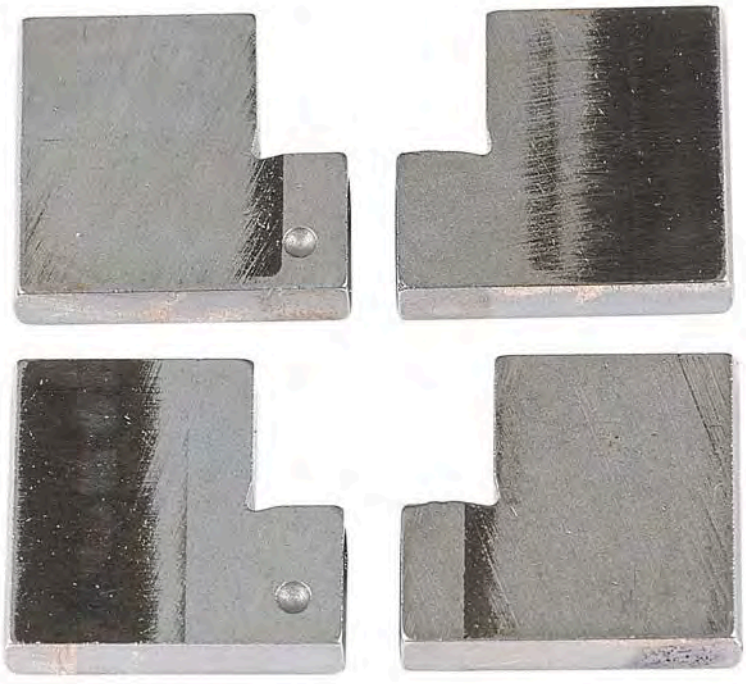
SN15438887 Transfer Pump Blades, After

Part Name	Condition of Part	Rating 0 = New 5 = Failed
BLADES	Wear at rotor slots and liner contact	2.5
BLADE SPRINGS	Rubbing wear	1
LINER	90% Wear	3
TRANSFER PUMP REGULATOR	Wear mark from rotor, light polishing	1.5
REGULATOR PISTON	Polishing wear	1.5
ROTOR	Wear at distributor ports	2.5
ROTOR RETAINERS	Wear from rotor contact	2.5
DELIVERY VALVE	Polishing wear	1.5
PLUNGERS	Polishing wear and light scratces	2.5
SHOES	Dimple, light waer from leaf spring contact	2
ROLLERS	Discolored and light scorring	2.5
LEAF SPRING	Wear from shoe contact	2
CAM RING	Polishing wear	1
THRUST WASHER	Groove from weight contact	2.5
THRUST SLEEVE	Normal	1
GOVORNER WEIGHTS	Wear from thrust washer contact	2
LINK HOOK	Dimple from governor rod	2
METERING VAVLE	Polishing wear	1.5
DRIVE SHAFT TANG	Polishing wear	1
DRIVE SHAFT SEALS	Normal	1
CAM PIN	Normal	1
ADVANCE PISTON	Scorring wear	3
HOUSING	Normal	1
	AVERAGE DEMERIT RATINGS	1.826

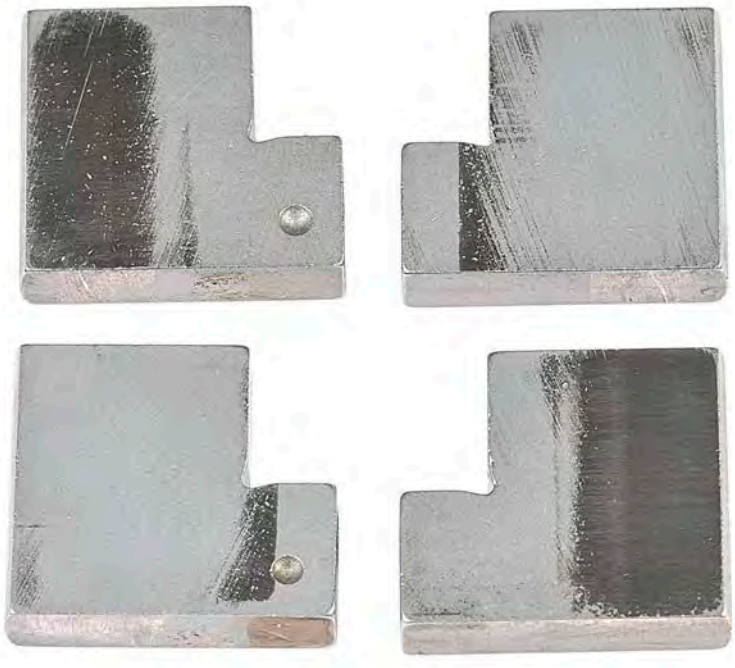
SN15438888 Transfer Pump Blades (Side) After

Part Name	Condition of Part	Rating 0 = New 5 = Failed
BLADES	Wear at rotor slots and liner contact	2.5
BLADE SPRINGS	Rubbing wear	1
LINER	80% Wear	3
TRANSFER PUMP REGULATOR	Wear mark from rotor, light polishing	2
REGULATOR PISTON	Wear with scuffing	2.5
ROTOR	Wear at distributor ports	2.5
ROTOR RETAINERS	Wear from rotor contact	3
DELIVERY VALVE	Polishing wear and light scuffing	2.5
PLUNGERS	Scuffing wear	2.5
SHOES	Dimple, light waer from leaf spring contact	1.5
ROLLERS	Wear marks over 100% of length	3
LEAF SPRING	Wear from shoe contact	2
CAM RING	Polishing wear	1
THRUST WASHER	Groove from weight contact	2
THRUST SLEEVE	Normal	1
GOVORNER WEIGHTS	Wear from thrust washer contact	2.5
LINK HOOK	Dimple from governor rod	1.5
METERING VAVLE	Polishing wear	2
DRIVE SHAFT TANG	Polishing wear	1
DRIVE SHAFT SEALS	Normal	1
CAM PIN	Normal	1
ADVANCE PISTON	Scorring wear	3
HOUSING	Brown deposit stains	1
	AVERAGE DEMERIT RATINGS	1.957

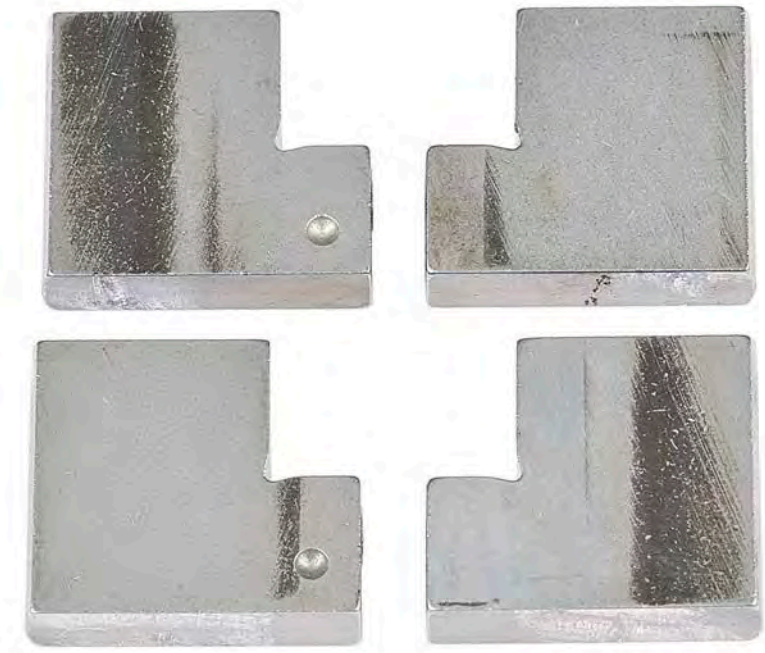
SN15438891 Transfer Pump Blades (Side), After

Part Name	Condition of Part	Rating 0 = New 5 = Failed
BLADES	Wear at rotor slots and liner contact	2
BLADE SPRINGS	Rubbing wear	1
LINER	60% Wear	2
TRANSFER PUMP REGULATOR	Waer mark from rotor, light polishing	2
REGULATOR PISTON	Polishing wear, light scuffing	2
ROTOR	Wear at distributor ports	2
ROTOR RETAINERS	Wear from rotor contact	2.5
DELIVERY VALVE	Polishing wear	2
PLUNGERS	Polishing wear and light scratces	2.5
SHOES	Dimple, light waer from leaf spring contact	1.5
ROLLERS	Discolored and light scorring	1
LEAF SPRING	Wear from shoe contact	1.5
CAM RING	Polishing wear	1
THRUST WASHER	Groove from weight contact	2
THRUST SLEEVE	Normal	1
GOVORNER WEIGHTS	Wear from thrust washer contact	2
LINK HOOK	Dimple from governor rod	1.5
METERING VAVLE	Polishing wear. Light brown deposit	1
DRIVE SHAFT TANG	Polishing wear	1
DRIVE SHAFT SEALS	Normal	1
CAM PIN	Normal	1
ADVANCE PISTON	Scorring wear	3
HOUSING	Light brown stain inside	1

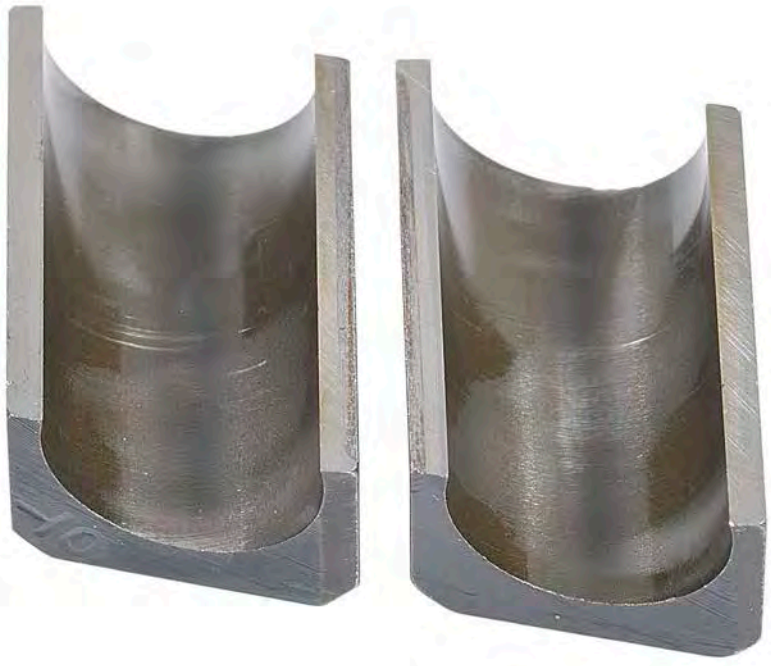
SN15438892 Shoes (Front), After

Part Name	Condition of Part	Rating 0 = New 5 = Failed
BLADES	Wear at rotor slots and liner contact	2
BLADE SPRINGS	Rubbing wear	1
LINER	60% Wear	2
TRANSFER PUMP REGULATOR	Wear mark from rotor, light polishing	2
REGULATOR PISTON	Polishing wear	2
ROTOR	Wear at distributor ports	2
ROTOR RETAINERS	Wear from rotor contact	2
DELIVERY VALVE	Polishing wear	1.5
PLUNGERS	Polishing wear and light scratces	3
SHOES	Dimple, light waer from leaf spring contact	1.5
ROLLERS	Normal	1
LEAF SPRING	Wear from shoe contact	1.5
CAM RING	Polishing wear	1
THRUST WASHER	Groove from weight contact	2
THRUST SLEEVE	Normal	1
GOVORNER WEIGHTS	Wear from thrust washer contact	2
LINK HOOK	Dimple from governor rod	1.5
METERING VAVLE	Polishing wear. Light brown deposits	1.5
DRIVE SHAFT TANG	Polishing wear	1
DRIVE SHAFT SEALS	Normal	1
CAM PIN	Normal	1
ADVANCE PISTON	Scoring wear	3
HOUSING	Light brown stains	1
	AVERAGE DEMERIT RATINGS	1.630

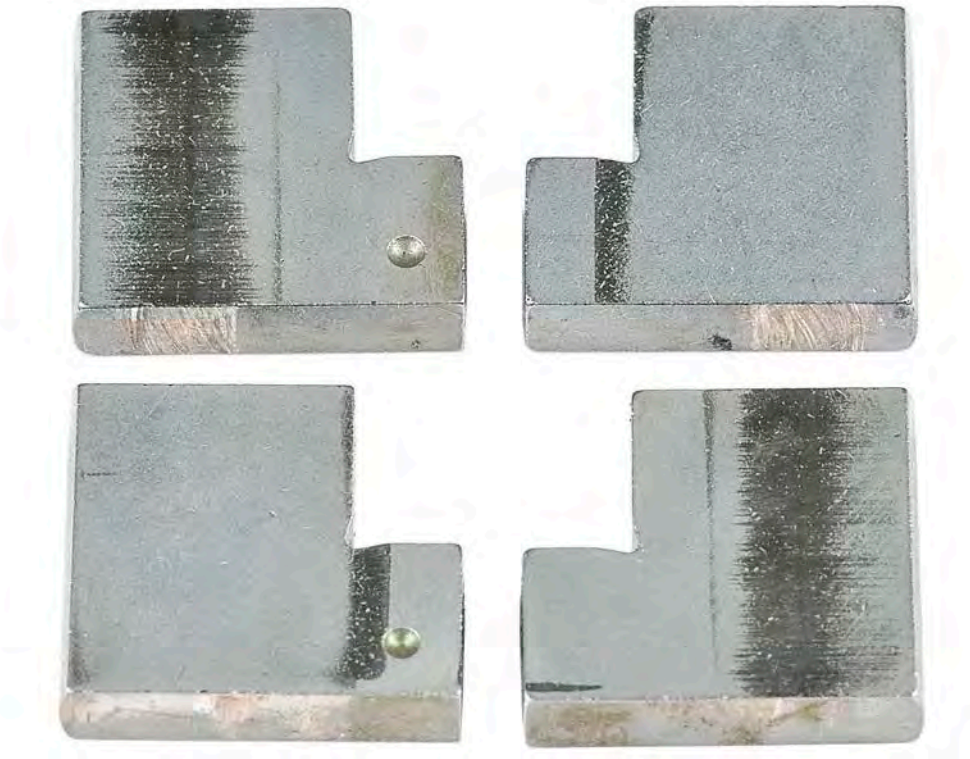
SN15442663 Transfer Pump Blades (Side), After

Pump Type : DB2831-5079		SN: 15442663
Test Condition : FT-SPK /Jet A-1 w/9-mg/L DCI-4A @ 135°F		Pump Duration : 1000.-hrs.
Part Name	**Condition of Part**	**Rating 0 = New 5 = Failed**
BLADES	Wear at rotor slots and liner contact	2.5
BLADE SPRINGS	Rubbing wear	1.5
LINER	80% Wear	4.5
TRANSFER PUMP REGULATOR	Waer mark from rotor, light polishing	2.5
REGULATOR PISTON	Polishing wear, light scuffing	2.5
ROTOR	Wear at distributor ports	2
ROTOR RETAINERS	Wear from rotor contact	2.5
DELIVERY VALVE	Polishing wear	2
PLUNGERS	Polishing wear and light scratces	1
SHOES	Dimple, light waer from leaf spring contact	2
ROLLERS	Light radial scrathes	2
LEAF SPRING	Wear from shoe contact	2
CAM RING	Polishing wear	1
THRUST WASHER	Polishing wear from weight contact	3
THRUST SLEEVE	Normal, brown stains	1
GOVORNER WEIGHTS	Wear from thrust washer contact	2.5
LINK HOOK	Dimple from governor rod	1.5
METERING VAVLE	Spring loose ans worn through. Scuffing wear at helix	4

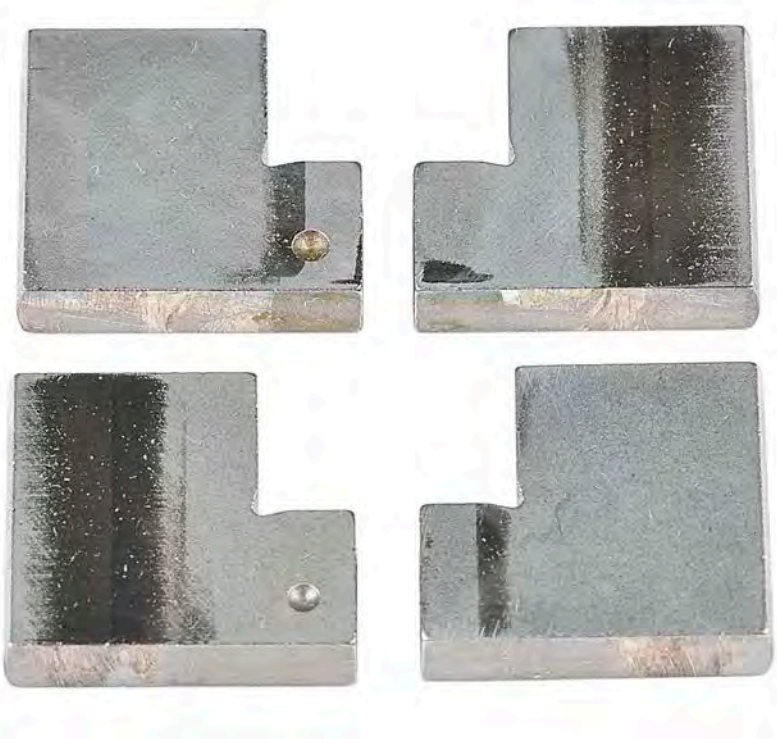
SN15442664 Transfer Pump Blades, After

Part Name	Condition of Part	Rating 0 = New 5 = Failed
BLADES	Wear at rotor slots and liner contact	2.5
BLADE SPRINGS	Rubbing wear	2
LINER	75% Wear	4.5
TRANSFER PUMP REGULATOR	Waer mark from rotor, light polishing	2.5
REGULATOR PISTON	Polishing wear, light scuffing	2
ROTOR	Wear at distributor ports	2.5
ROTOR RETAINERS	Wear from rotor contact	2.5
DELIVERY VALVE	Polishing wear	2.5
PLUNGERS	Polishing wear.	2.5
SHOES	Dimple, light waer from leaf spring contact	2.5
ROLLERS	Light discoloration	1.5
LEAF SPRING	Wear from shoe contact	2
CAM RING	Polishing wear	1
THRUST WASHER	Polishing wear from weight contact	2
THRUST SLEEVE	Normal, brown stains	1
GOVORNER WEIGHTS	Wear from thrust washer contact	2.5
LINK HOOK	Dimple from governor rod	1.5
METERING VAVLE	Spring loose and almost worn through.	4
DRIVE SHAFT TANG	Fretting wear	2.5
DRIVE SHAFT SEALS	Normal	1
CAM PIN	Normal. In spec	1
ADVANCE PISTON	Scorring wear	3
HOUSING	Light brown stain inside	1
