ERDC/CERL TR-15-5

Demonstration and Validation of Corrosion-Mitigation Technologies for Mechanical Room Utility Piping and Cooling-Tower Pumps

Final Report on Project F07-ARCTC01

May 2015

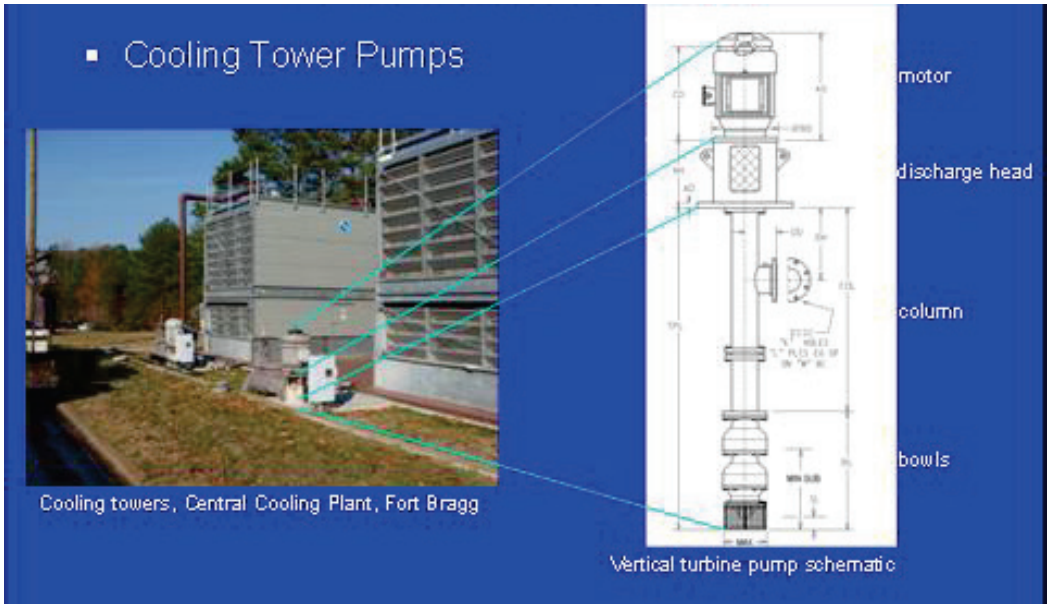
Figure 1. Cooling-tower pump at Fort Bragg and schematic.

The submerged portions of the pumps are composed of two sections: the upper housing, which protects the shaft (i.e., column) and the lower housing, which protects the impellers (i.e., bowls). A schematic showing these sections of the pumps is presented in Figure 1.

The two pump coating systems covered the column and bowl sections, as well as the discharge head; however, the stainless steel was used only for the column section, and a one-coat system was applied to the bowl section of that pump.

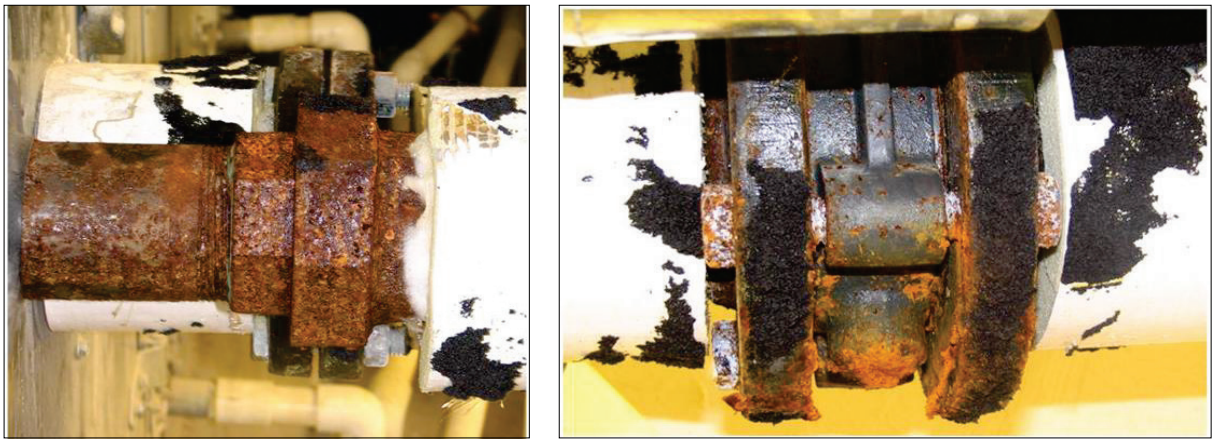
The as-built drawings of Mechanical Rooms A and B were dated 29 November 2004 and 20 April 2006, respectively. Mechanical Room C was reported to be 9 months old. Most of the piping systems in all three rooms were covered with black insulation; some also incorporated a hard white plastic jacket over this insulation. While this system completely encloses each item, large air cavities were noted within the insulation. Humidity apparently infiltrated the cavities and condensed, as indicated by considerable volumes of water released where some of the foam was removed. As would be expected, there was more condensation on the chilled lines than on the hot, and the union joints on the cold lines revealed significant corrosion when exposed. Figure 2 shows the appearance of two such joints.

Figure 2. Union joint in Mechanical Room A, before cleaning.

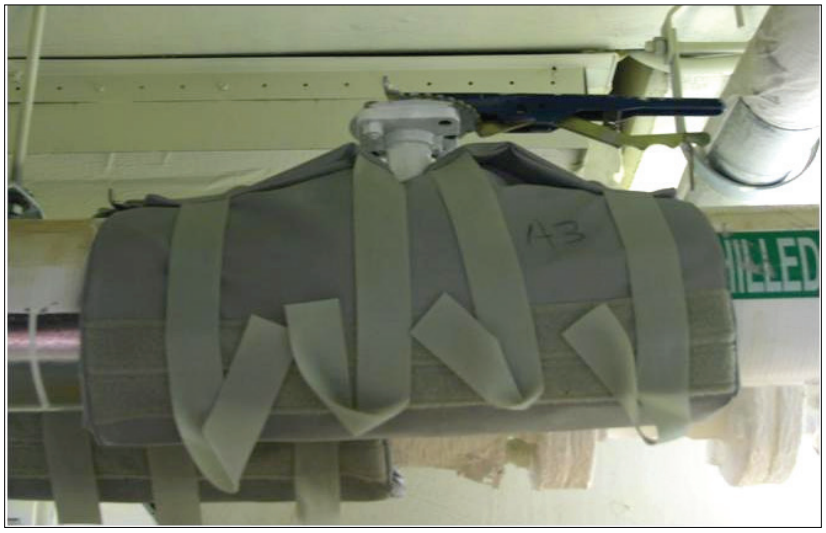
Figure 4. Union joint in Mechanical Room A, coated and wrapped in SpeedWrap.

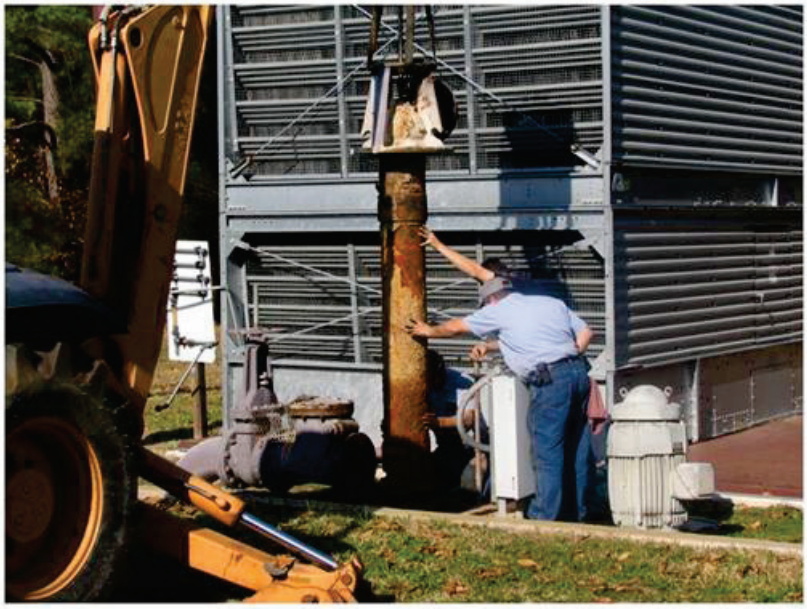
In December 2007 the three demonstration pumps were removed. The column and bowl sections of all three pumps were found to be heavily corroded. The internal mechanisms did not show any corrosion, however. The condition of each pump at the time of its removal is presented in Figure 5 through Figure 8.

Figure 6. Condition of pump housing 3, after removal from sump.

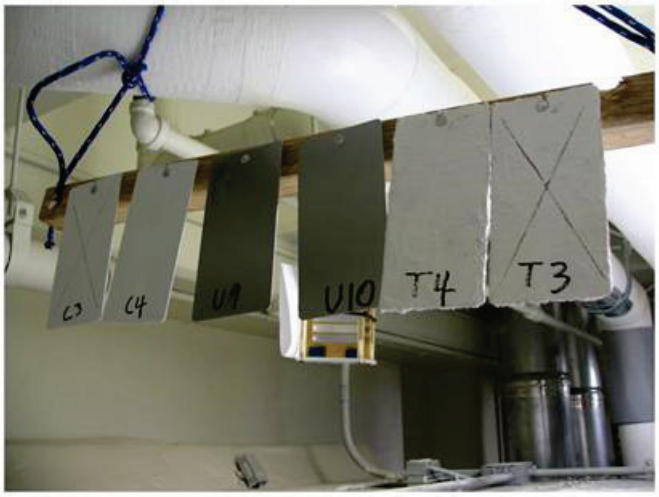
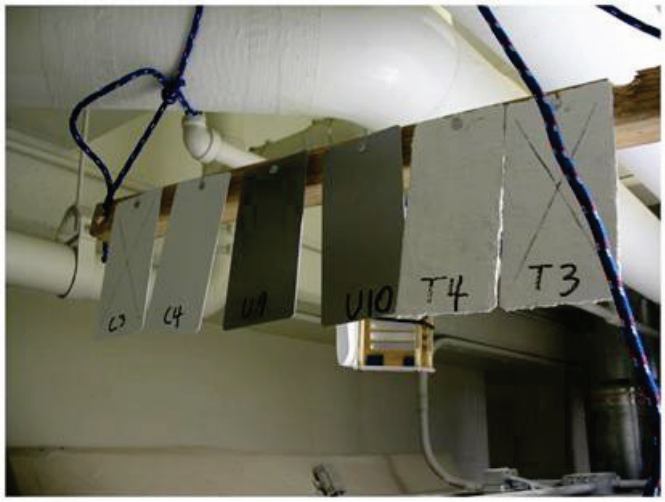
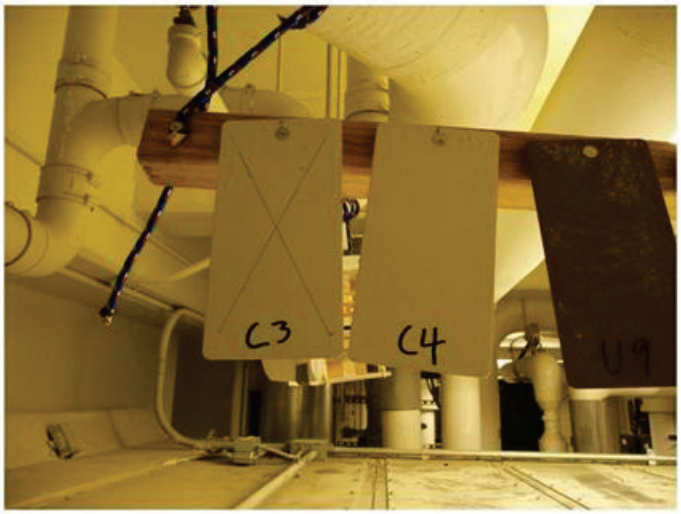
In Mechanical Room A, neither the TC Ceramic-coated coupons nor the Corothane-coated coupons demonstrated any signs of corrosion during the entire evaluation period. All panels received D1654 ratings of 10 throughout the evaluation period (Table 8). Figure 16 demonstrates the pristine nature of the Corothane-coated coupons (C3 and C4) and the TC Ceramic coated coupons (T3 and T4) in Mechanical Room A at 3, 6, 9, 12, and 30 month intervals. As a means of comparison, severe corrosion can be seen on the two uncoated panels (U9 and U10) from the ninth month and onward.

Figure 16. Test coupons in Mechanical Room A exposures at 3 months (a), 6 months (b), 9 months (c), 12 months (d), and 30 months (e).

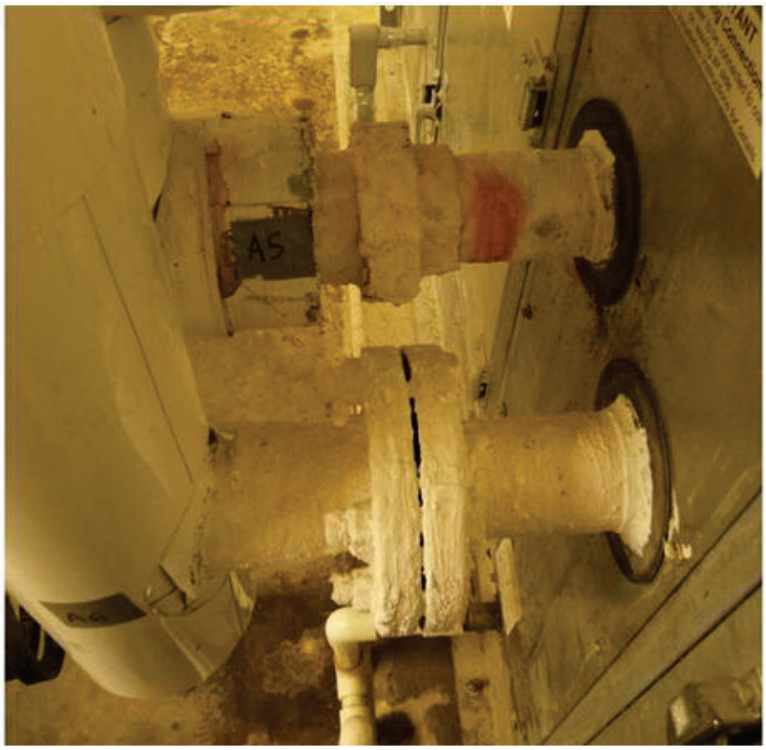
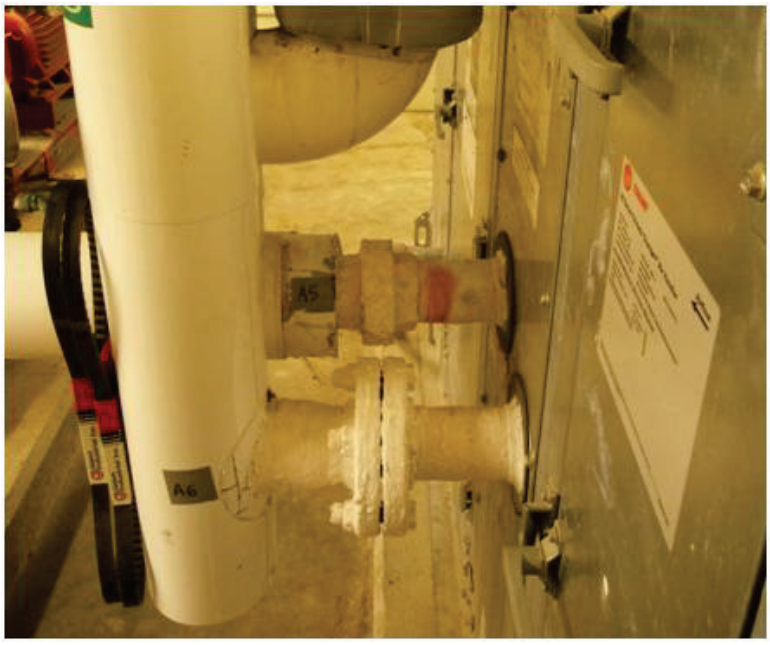
Minimal differences in coating performance were also seen on the coated pipe components in Mechanical Room A. Corrosion was observed only in special cases. For example, two cold-water-line fittings in very close proximity that were coated with TC Ceramic (designated A5 and A6) behaved differently: A5 exhibited rusty discoloration by 3 months of exposure, while A6 did not corrode at all up to 12 months. The rusty discoloration observed on A5 was caused by rusty water dripping down from another fitting. Otherwise, performance was very similar to that of A6, which had nothing dripping down onto it. By June 2010, the wet, rough surface of both fittings had accumulated mold on their rough, damp exteriors, but this did not influence corrosion ratings. These fittings were damp during this evaluation (Figure 18e), with considerable condensation (but not enough to drip or cause significant corrosion). The insulating properties of the TC Ceramic coating were apparently unable to impede condensation on these fittings. The performance of these fittings (A5 is in the rear, A6 is in front) throughout the evaluation period is presented in Figure 17.

Figure 17. Two cold water line fittings coated with TC Ceramic in Mechanical Room A exposures at 3 months (a), 6 months (b), 9 months (c), 12 months (d), and 30 months (e).

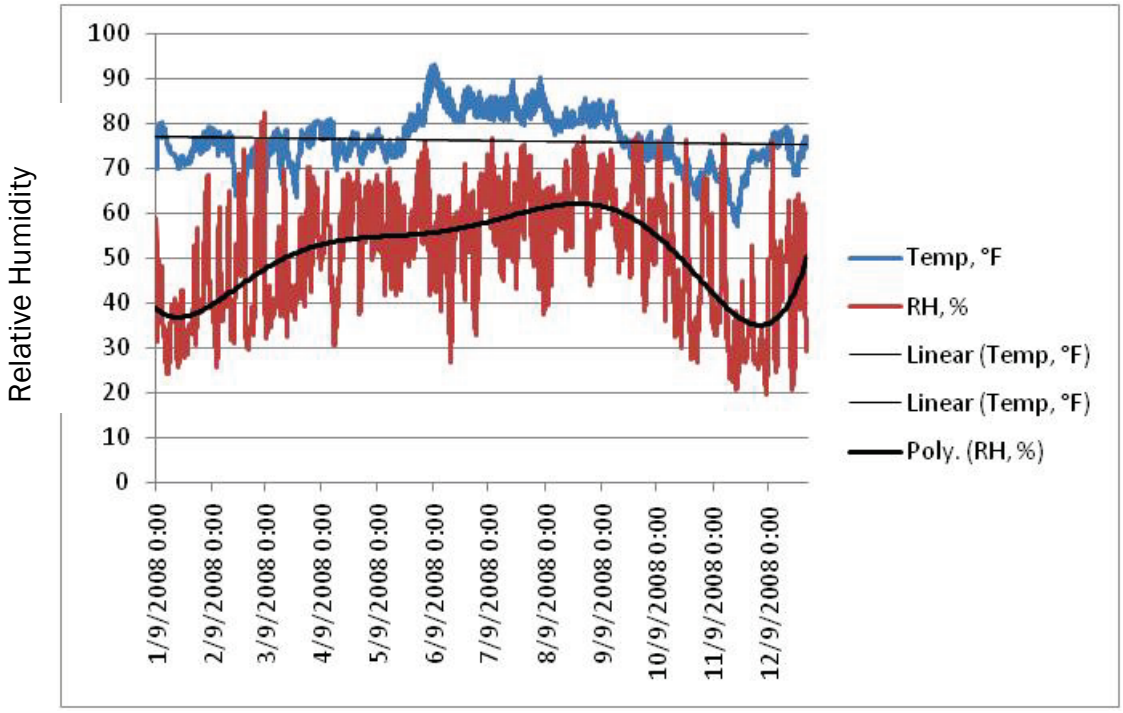
Figure 18. Temperature and humidity data, Mechanical Room A.

As seen by comparing these three figures, the humidity data from Mechanical Room B (Figure 19), where the dehumidifier was installed, appears to be very similar to the data for Mechanical Room A (Figure 18). Thus it is not surprising that significant corrosion was observed in Mechanical Room B. The performance of a cold water line fitting in Mechanical Room B is depicted in Figure 21a – 21e.

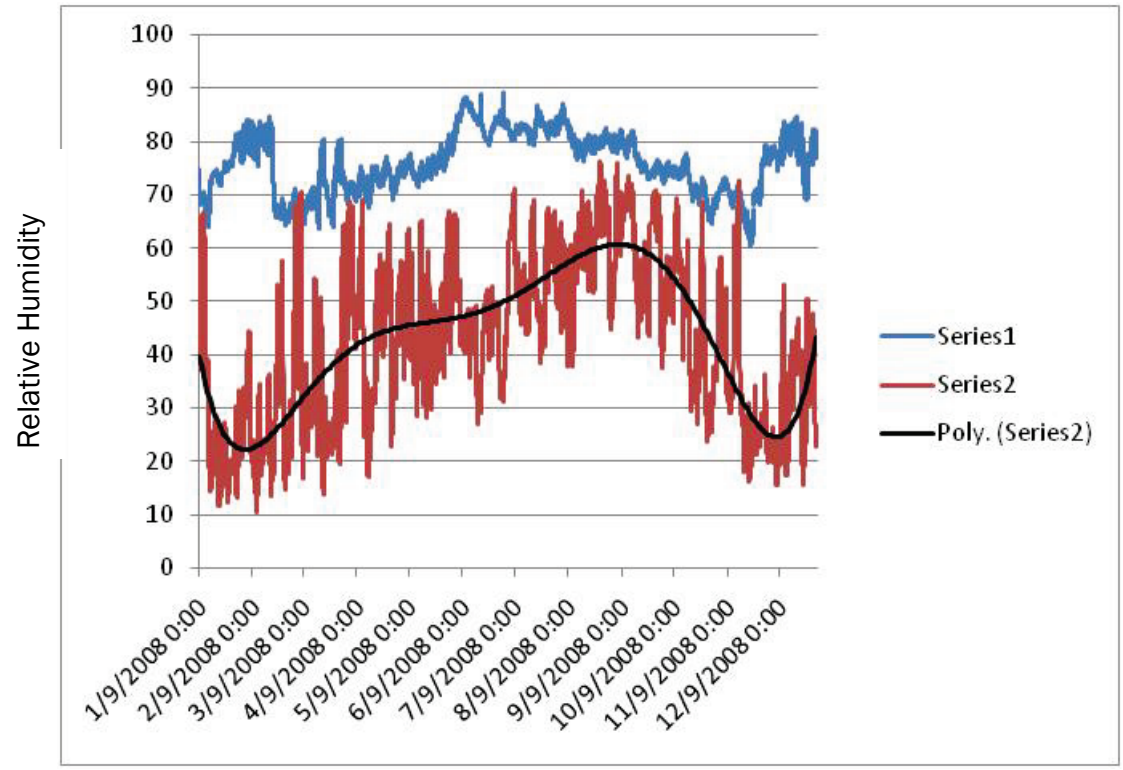
Figure 19. Temperature and humidity data, Mechanical Room B.

In Mechanical Room B, dehumidifier performance appeared to be marginal, and so the dehumidification setting was increased for the summer months — from 8 to 9 (out of 10) in June 2008, and from 9 to 10 in July 2008.

The dehumidification system, although sized for the room by the manufacturer, was unable to consistently keep the humidity in Mechanical Room B low enough to impede corrosion of the union joints. Eventually, it became difficult to confirm that the unit was working properly; the team evaluated the humidity readouts from the data logger (Figure 18 through Figure 20) on a monthly basis to confirm functioning. It is noted that air circulation was minimal in this mechanical room. The fan that was meant to ventilate the room with external air was broken, though the ventilation grating remained open. Humidity control in an interior space is significantly affected by air circulation. If the only circulation was provided by the dehumidifier, and the major source of humidity was condensation, then this would account for the poor humidity control. It is suggested that future efforts involving small dehumidification devices establish a means to confirm proper functioning of the unit over the evaluation period, and also confirm that sufficient air circulation exists within the room to allow the dehumidification unit to function properly.

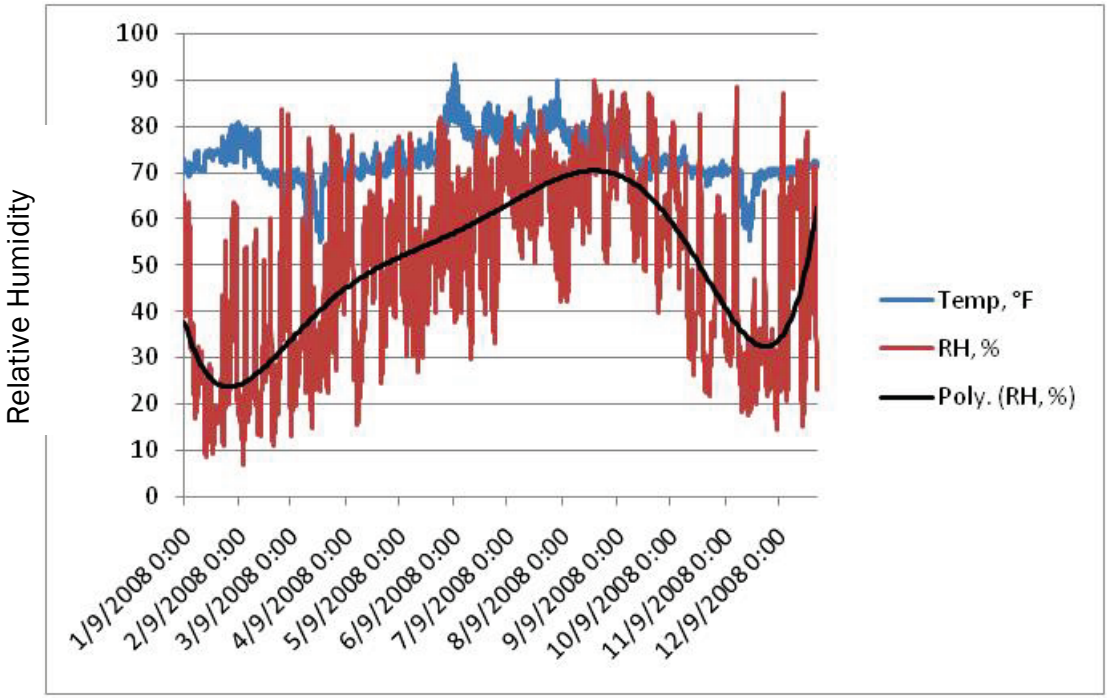
Figure 20. Temperature and humidity data, Mechanical Room C.

Neither the dehumidification system (Mechanical Room B) nor the removable insulation (Mechanical Rooms A and C) appeared to be effective in arresting corrosion on the fittings in the mechanical rooms. The performance of the dehumidification unit was found to be questionable throughout the entire evaluation period, based on the evidence of the data collected. The temperature and humidity readouts from the data loggers in Mechanical Rooms A, B, and C throughout the one year evaluation period are presented in Figure 18 through Figure 20. (Updates were not available for June 2010.)

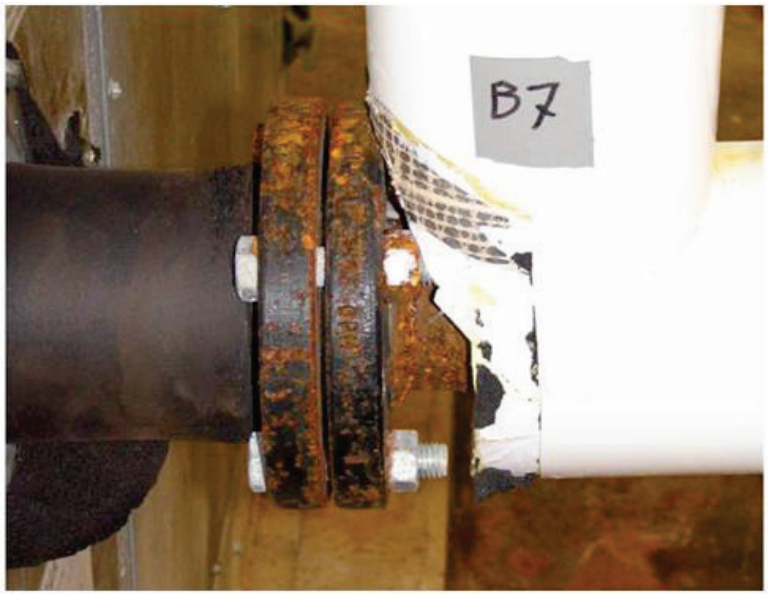
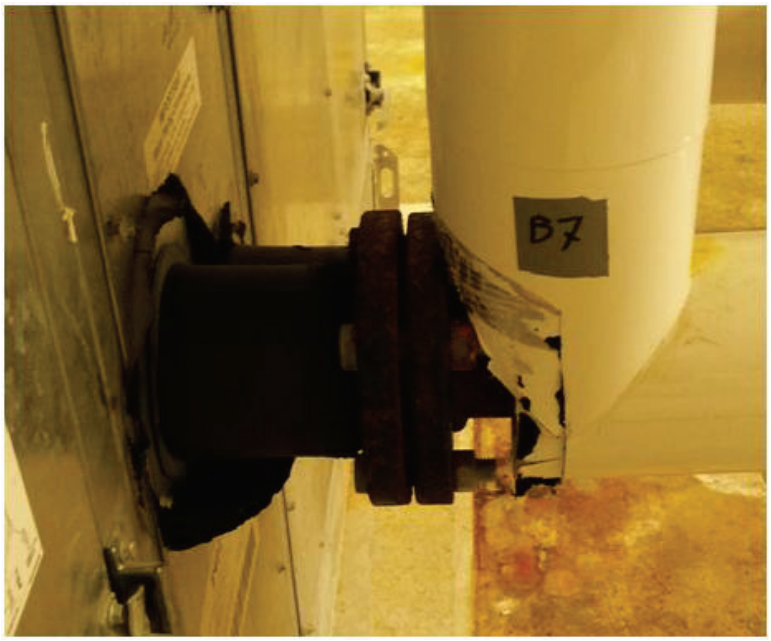
Figure 21. Cold water line fitting in Mechanical Room B exposures at 3 months (a), 6 months (b), 9 months (c), 12 months (d), and 30 months (e).

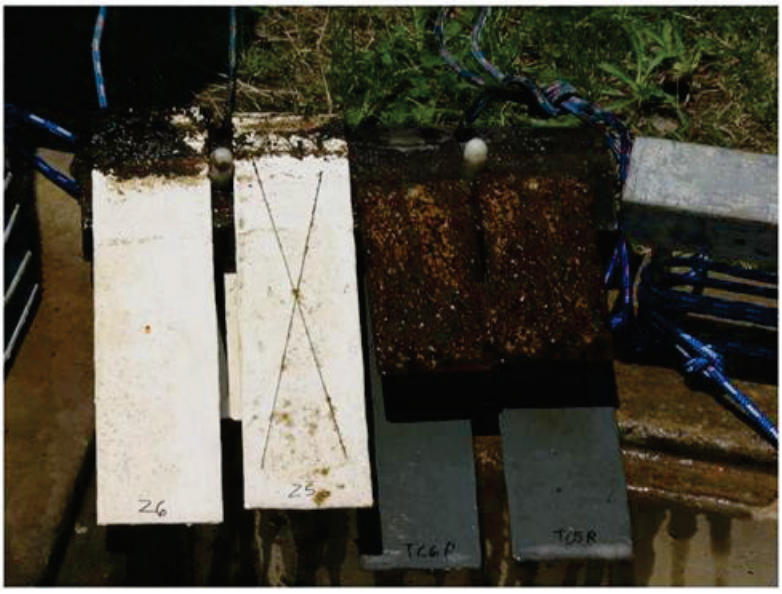
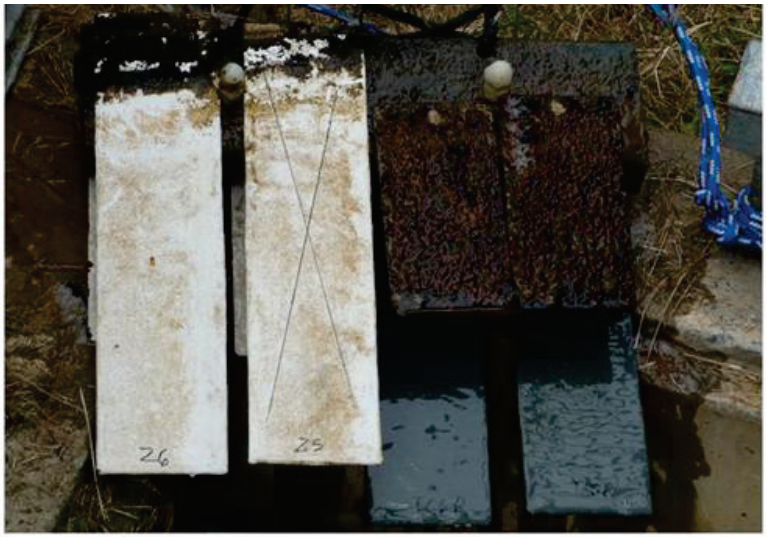
Figure 24. System 21-A-Z and uncoated panels for pump 3 exposures at 3 months (a), 6 months (b), 9 months (c), 12 months (d), and 30 months (e).

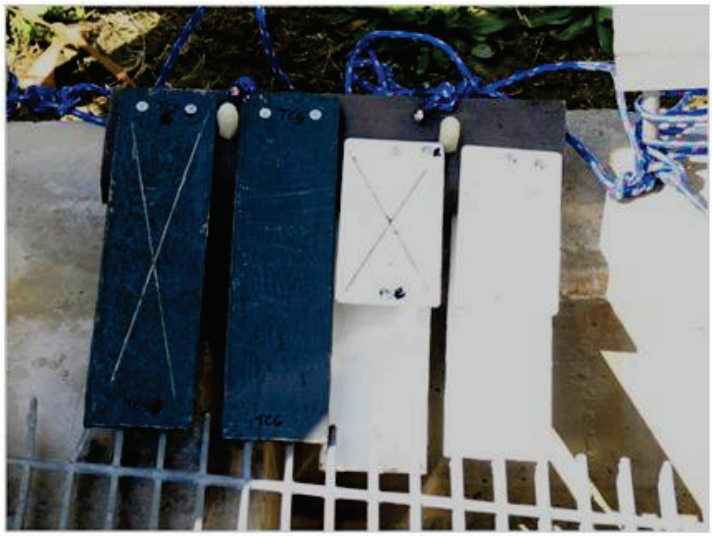
Figure 25. Macropoxy primer-topcoat and primer-only panels for pump 3 exposures at 3 months (a), 6 months (b), 9 months (c), 12 months (d), and 30 months (e).
