FINAL REPORT

Ultraviolet (UV)-Curable Coatings for Aerospace Applications

ESTCP Project WP-0804

August 31, 2012

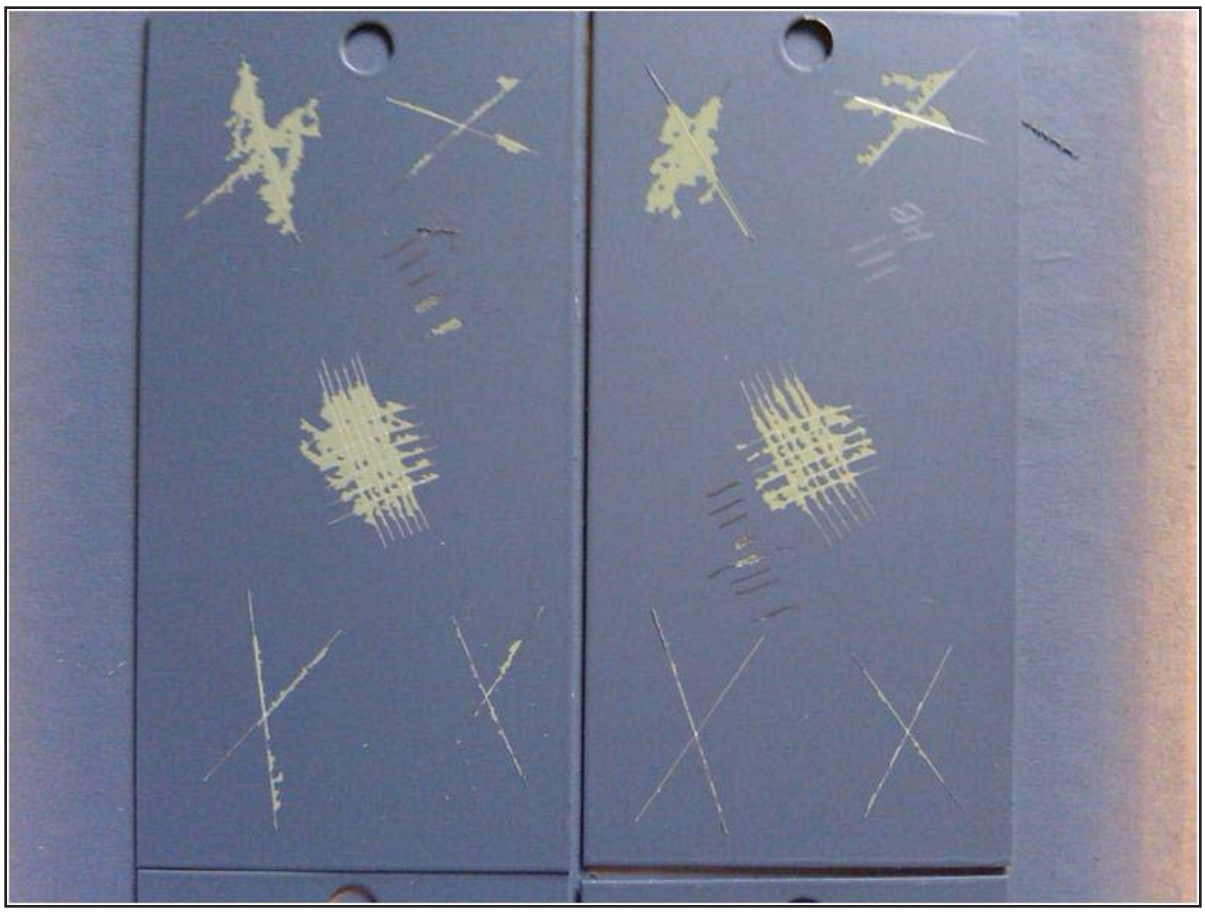
Figure 15. 21GY002 Adhesion Testing at 2 mil coating thickness

The 21GY002 was also applied and cured at a DFT thickness of approximately 3 mils. However, at this thickness the coating experienced a massive wrinkling effect during UV exposure that made it impossible to test, or even to measure an average DFT. Figure 16 shows the 21GY002 at approximately 3 mils of thickness.

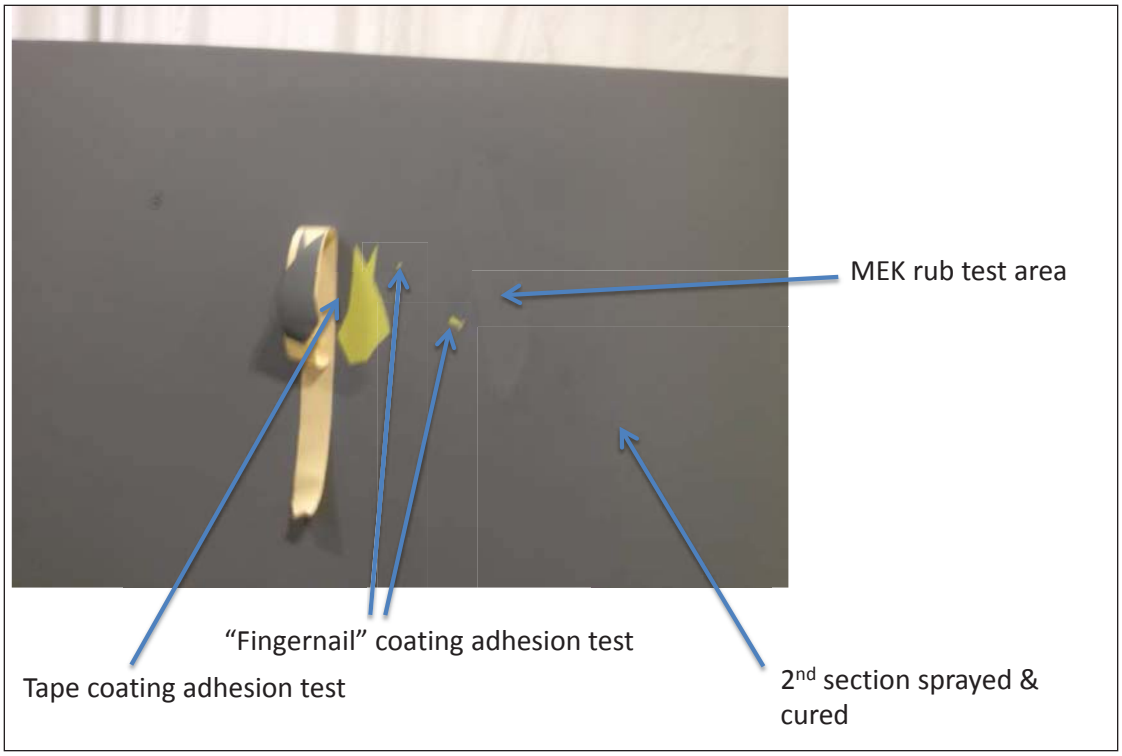
Figure 25. Cure Tests on Second Section

A pencil hardness test was attempted on the second area coated, but could not be conducted due to lack of adhesion between the primer and topcoat. Following the testing failures, the lamp intensity was measured again and was found to be at or above the recommended cure intensities. Based on the total adhesion failures of the coating, the demonstration was halted with the concurrence of the PI and no further spray/cure attempts were made with the remaining coating.

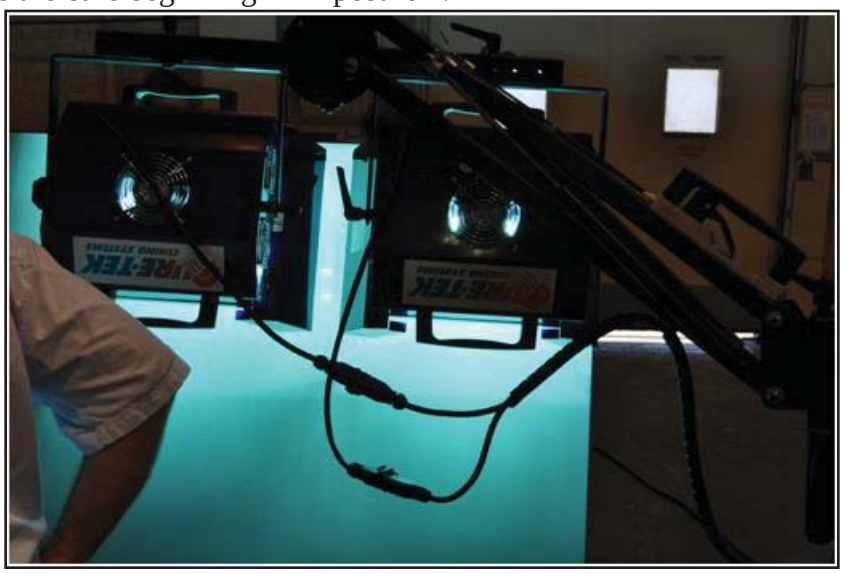
Figure 52. Cure of UV 36173 Gray on Primed Surface
