REPAIR, EVALUATION, MAINTENANCE, AND REHABILITATION RESEARCH PROGRAM

TECHNICAL REPORT REMR-CS-4

REPAIR OF WATERSTOP FAILURES: CASE HISTORIES

November 1986
Final Report

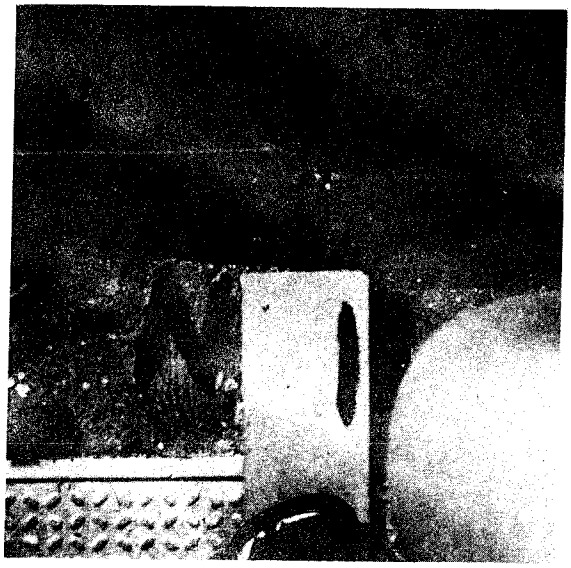
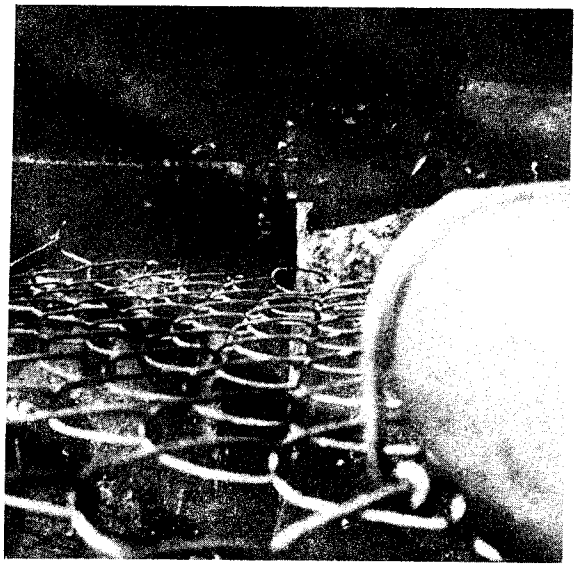
Figure 4. Movement between west gate bay monolith and adjacent monoliths as viewed from top of lock wall, November 1973, Algiers Lock

17. The joints between lock chamber monoliths and those between approach monoliths appeared to be in good condition with no unusual openings or offsets when inspected in 1973. However, joints between the gate bay monoliths and adjacent monoliths showed visual evidence of considerable movement (Figures 3 and 4). Also, there were indications that considerable water passed through the joints between the west gate bay monolith and adjacent chamber monoliths during the recent high water (Figure 5). Gate bay joint movements as measured in October 1973 are shown in Figures 6 and 7. No joint repairs were considered necessary at the time; however, repairs during the next scheduled dewatering in 1978 were anticipated.

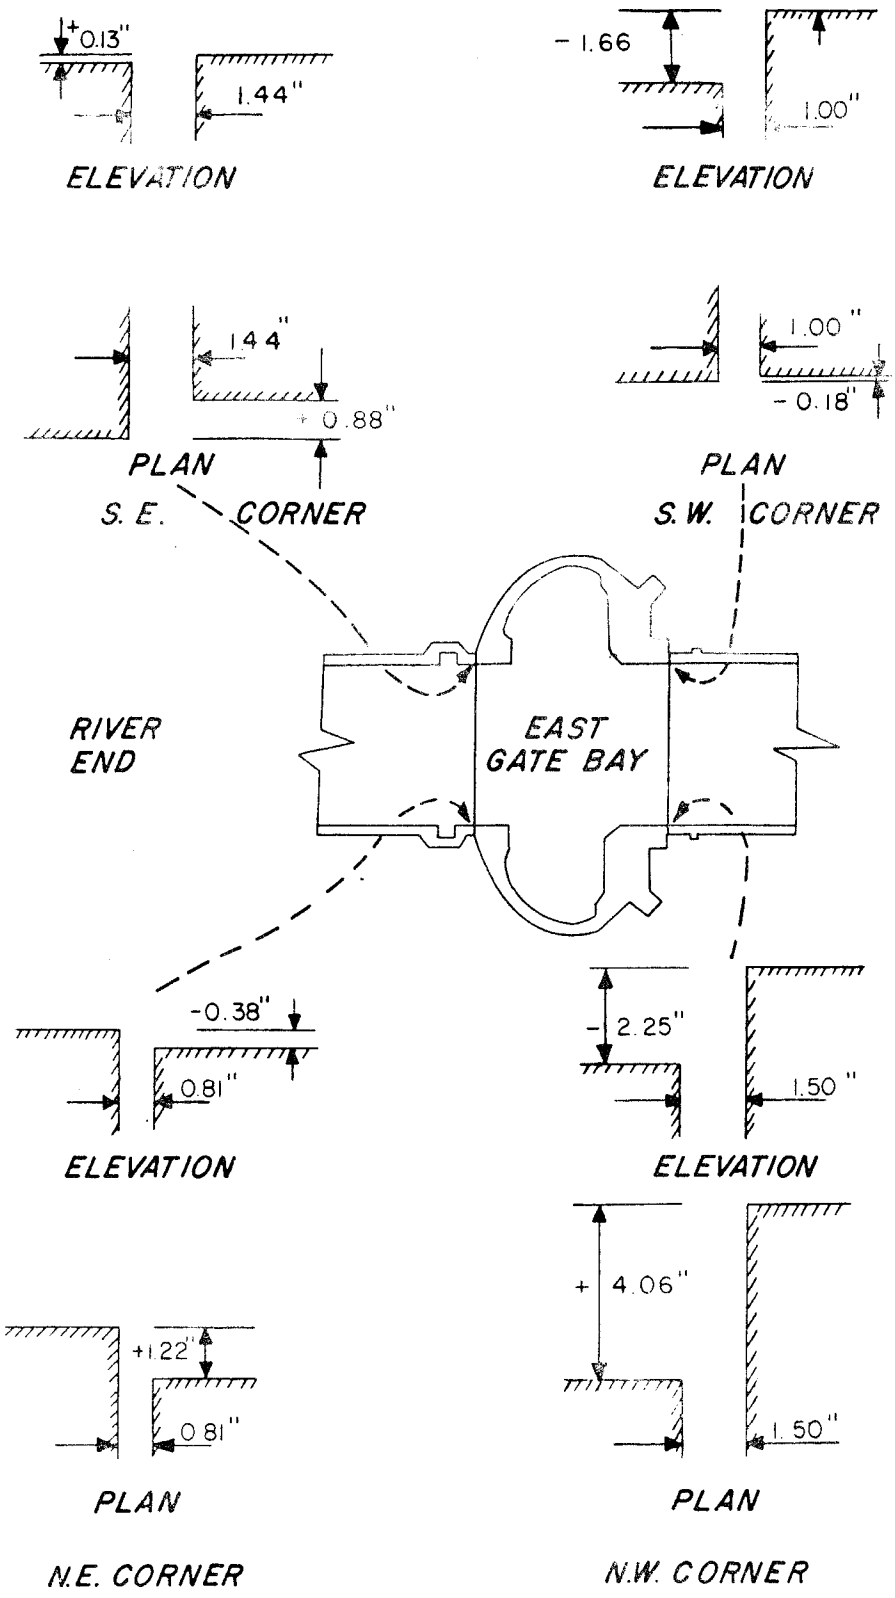
Figure 6. East gate bay joint movements, October 1973, Algiers Lock

14. Longitudinal displacements at the joints between the gate bays and lock chamber increased with time. An opening of 5 in. on both sides of the lock was reported during cold weather in the early part of 1958. Based on a review of performance data through mid-1956 (WES 1959), it was concluded that the longitudinal movement at the joints between the gate bays and lock chamber was the result of seasonal expansion and contraction of the lock due to temperature changes, permitting fill material to enter the joints during contraction of the lock. Differential water loads and relatively poor foundation soils also contributed to the longitudinal movement. In addition, movement of the west gate bay away from the lock chamber may be expected to continue and eventually may cause complete rupture of the waterstops between the lock chamber and west gate bay unless remedial measures are taken. The following recommendations were made as a result of the review:

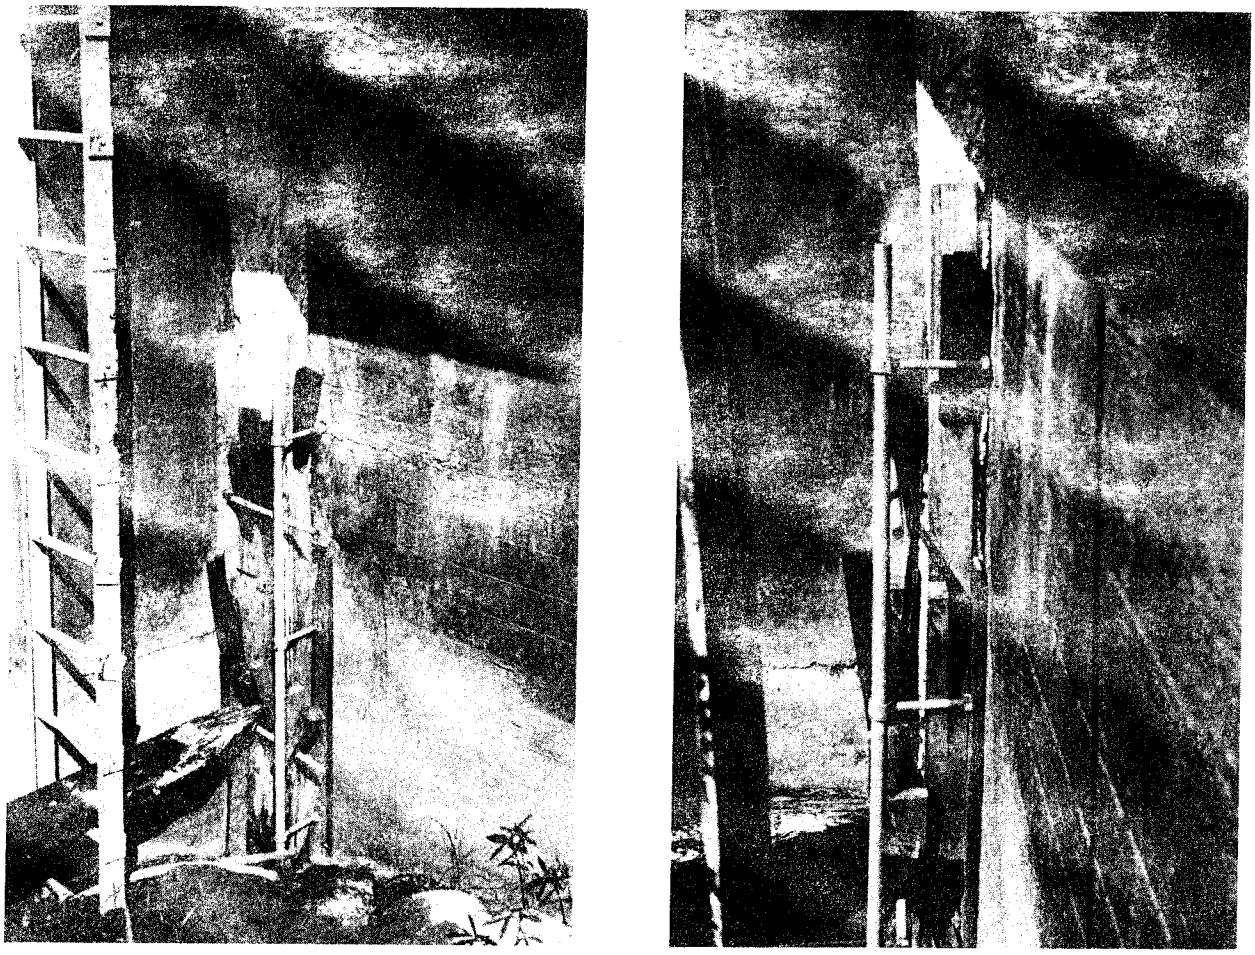
Figure 8. Styrofoam applied over existing rubber waterstop, Algiers Lock

21. The exposed upper portion of the external rubber waterstop installed in 1959 apparently deteriorated with time allowing considerable water leakage through the joint during high water stages. During the high river stages in the spring of 1983, temporary steps were taken to prevent leakage through the deteriorated rubber strip on the south wall. This involved construction of a small wooden cofferdam adjacent to the joint which reduced leakage during high river stages. Leakage was effectively controlled eventually by wedging Styrofoam into and against the opening (Figure 8). In February 1985, partial repairs were made to the landside of the joints in the north and south lock walls between monoliths 35 and 36 by replacing the deteriorated top part of the rubber pad and metal strips with similar materials.

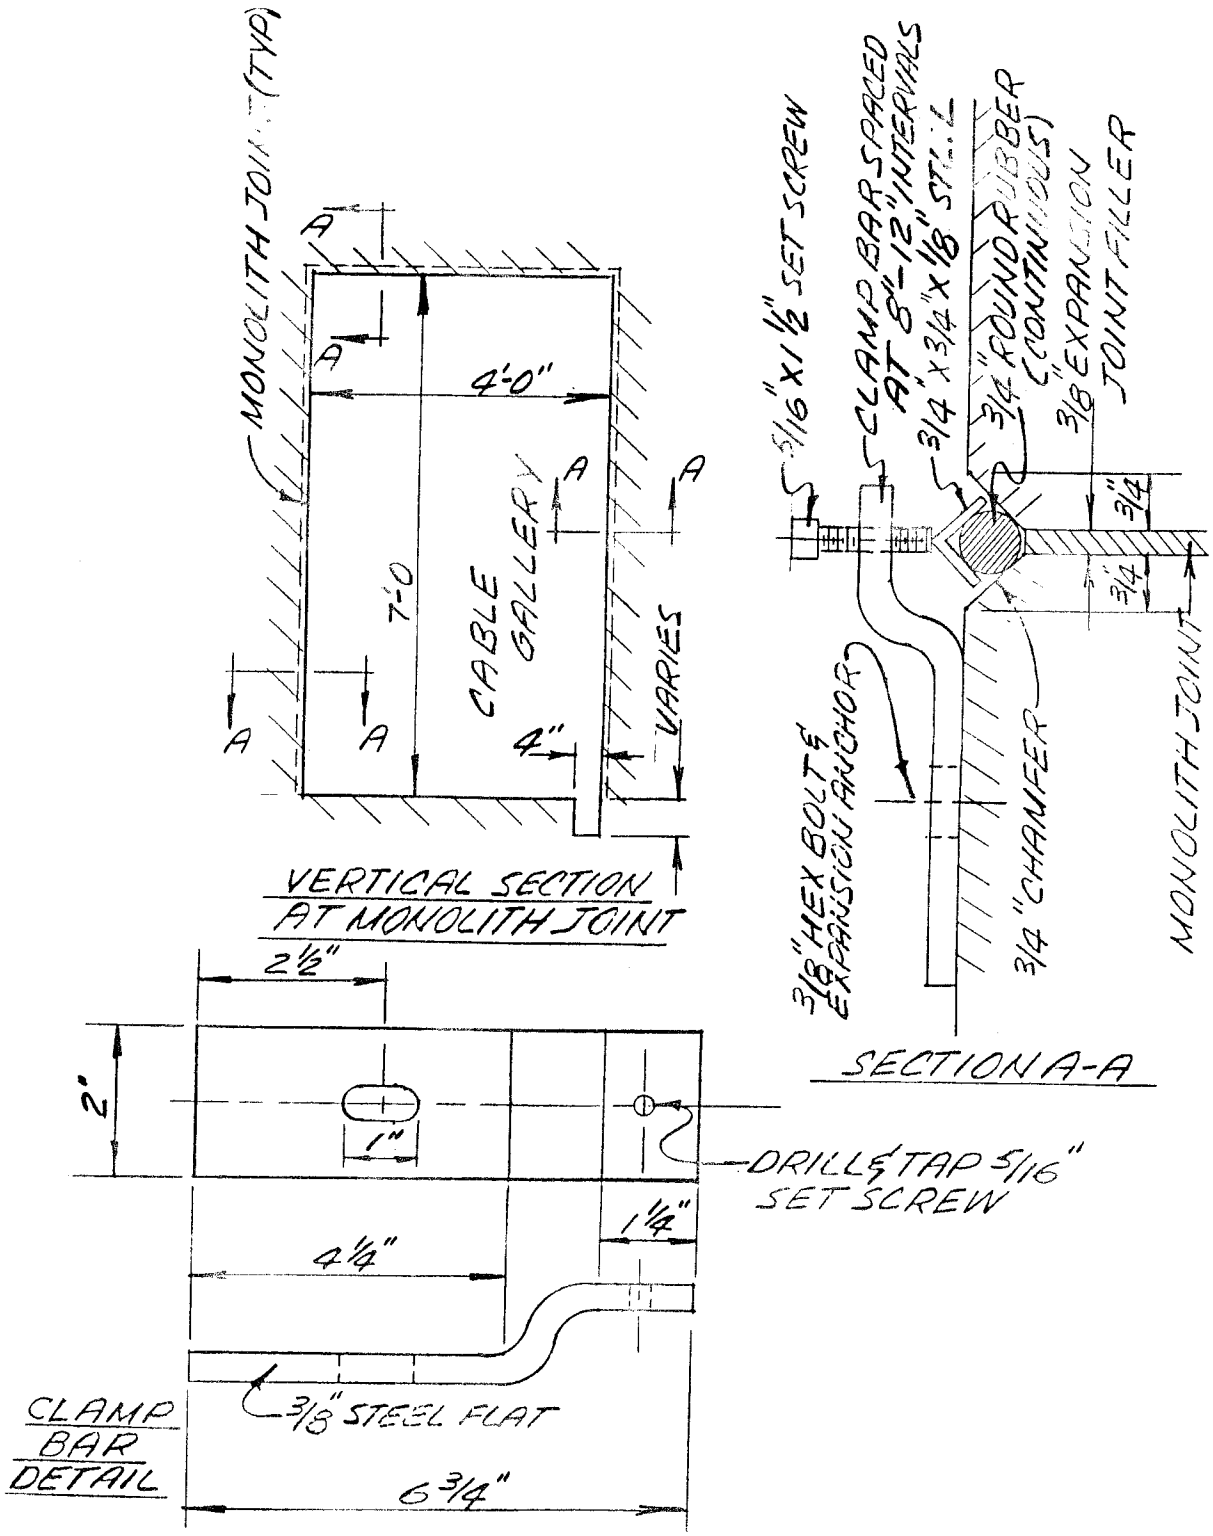
Figure 10. External waterstop design, MacArthur Lock

24. External waterstops were used to repair excessive leakage through 14 monolith joints in the lock cable galleries during the period 1955-60. The joints were prepared for repair by cutting a 3/4-in. chamber around the sides and top of the gallery as shown in Figure 10. Next, 3/8-in. expansion joint filler was inserted in the joint and a 3/4-in.-diameter rubber rod positioned over the joint filler. Clamp bars with set screws were installed on one monolith. The clamp bars were generally spaced 8 to 12 in. apart but were varied to suit physical conditions or obstructions at the monolith joint. A steel angle retainer was placed over the rubber rod and the set screws tightened to hold the rod in place (Figure 11). The steel angles were in three individual lengths (top and two sides), but the rubber rod appears to be continuous for the full length of the joint. Apparently, some later adjusting of the set screws was required after the waterstops were initially installed to stop minor leakage. This procedure has worked quite effectively over the years because no maintenance, other than that of priming and painting exposed steel surfaces, has been required.

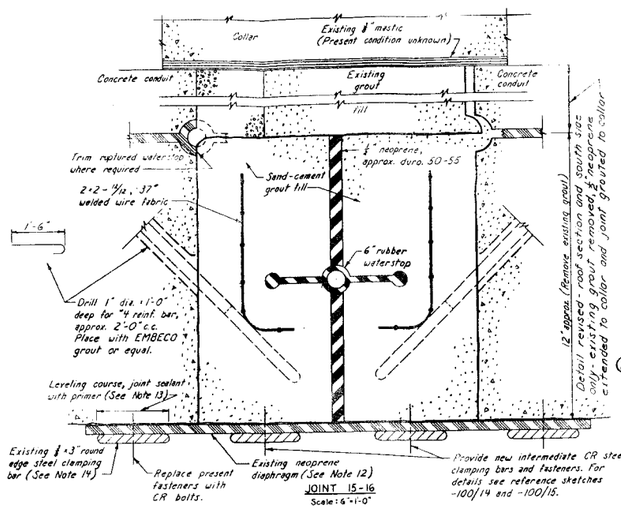
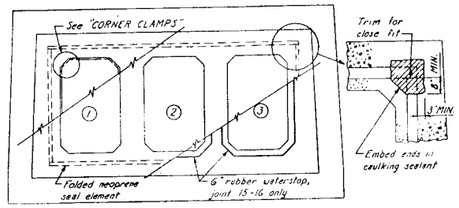
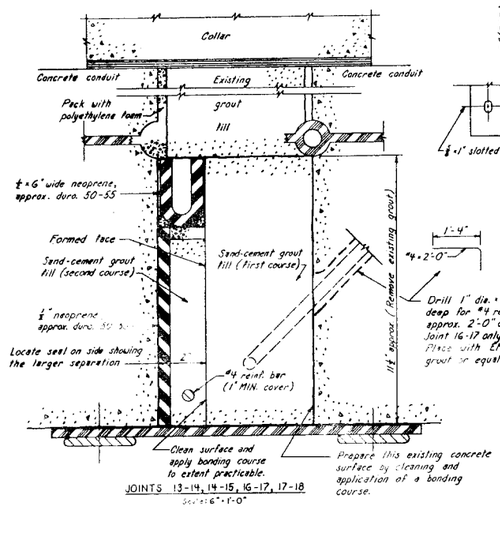
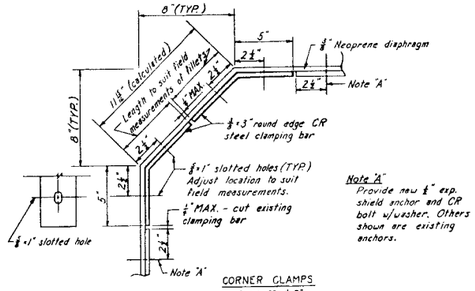
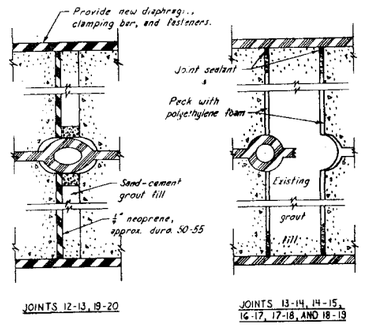
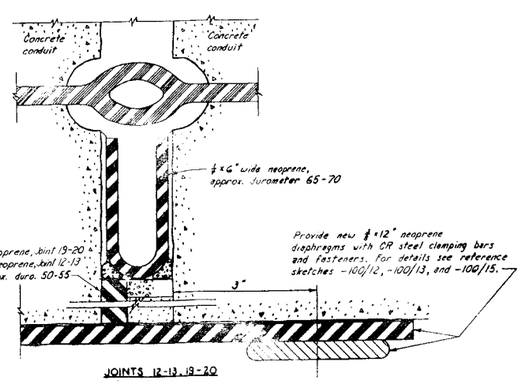
Figure 13. Repair details, Kirwan Dam

settled about 4.1 ft and elongated 1.89 ft. This resulted in the opening of a number of joints with a maximum joint opening of 12-3/4 in. Major repairs were required on eight joints and seven joints required minor remedial measures to repair ruptured waterstops and reseal the joints. This work was accomplished by the Operations and Maintenance (O&M) Branch.

27. Several repair techniques were used depending on the width of the joint opening. Details of the various repair techniques including material specifications are shown in Figure 13. A new 6-in. rubber waterstop was installed in the joint (15/16) with the maximum opening. Where joint openings were in the range of 1 to 7 in., a 1/2- by 6-in. neoprene seal element shaped in a "U" configuration was placed in the joint as a replacement waterstop. Following placement of polyethylene packing at the convex fold of the seal element, the joint was filled with a sanded cement grout. A 3/8- by 12-in. neoprene diaphragm was then anchored across the joints. Those joints with smaller openings were typically repaired with caulking sealant.

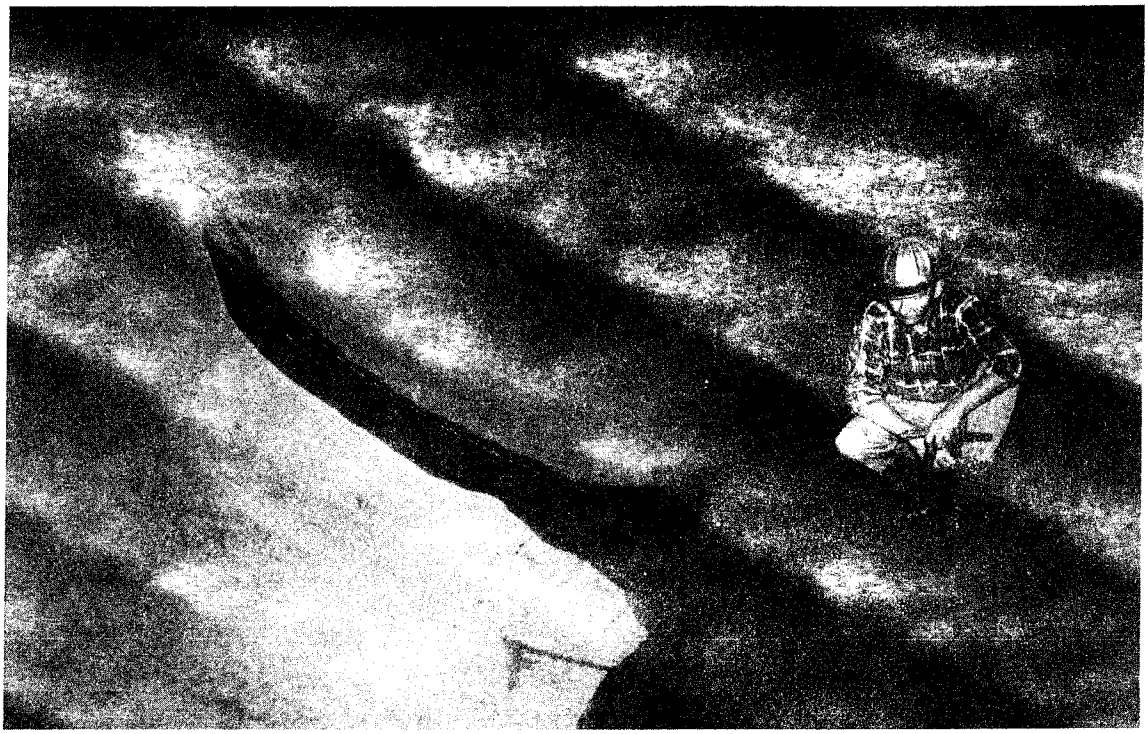
Figure 16. Leakage at conduit joint 4/5, Sardis Dam, 1966

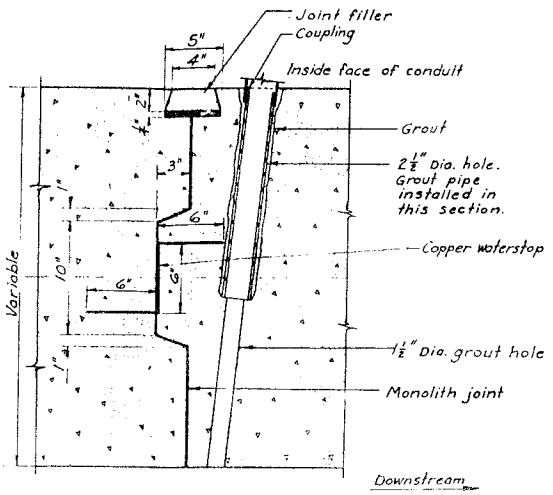
Figure 20. Original location of grout holes, Sardis Dam

47. Nine joints (transition/monolith 1, 1/2, 2/3, 3/4, 4/5, 5/6, 6/7, 14/15, and 15/16) were selected for additional grouting in September and October 1972 (US Army Engineer District, Vicksburg 1972). The location of the grout holes initially selected was 5 in. downstream of the centerline of the joints, approximately 2 ft in elevation above the conduit invert (Figure 20). The 2-1/2-in.-diameter holes were drilled 5 in. downstream of the joint on a 10- to 20-degree angle from the vertical. As reinforcing steel was encountered in most holes after a few inches penetration, minor relocations were necessary. Eight of the 22-in.-deep grout nipple holes were drilled and the 1-1/2-in. inside diameter grout nipples grouted in place. After quick shut-off valves were installed, attempts were made to penetrate the remaining conduit thickness with 1-1/2-in.-diameter holes, but only one hole was successfully completed. Reinforcing steel was encountered in the others and they were abandoned. The hole locations were changed to 0.8 ft downstream of the joints with similar results. The abandoned holes were plugged by filling with a thick cement grout, allowing the grout to set, screwing a cap onto the grout nipples and filling the remaining depressions with grout flush with the inside surface of the conduit.

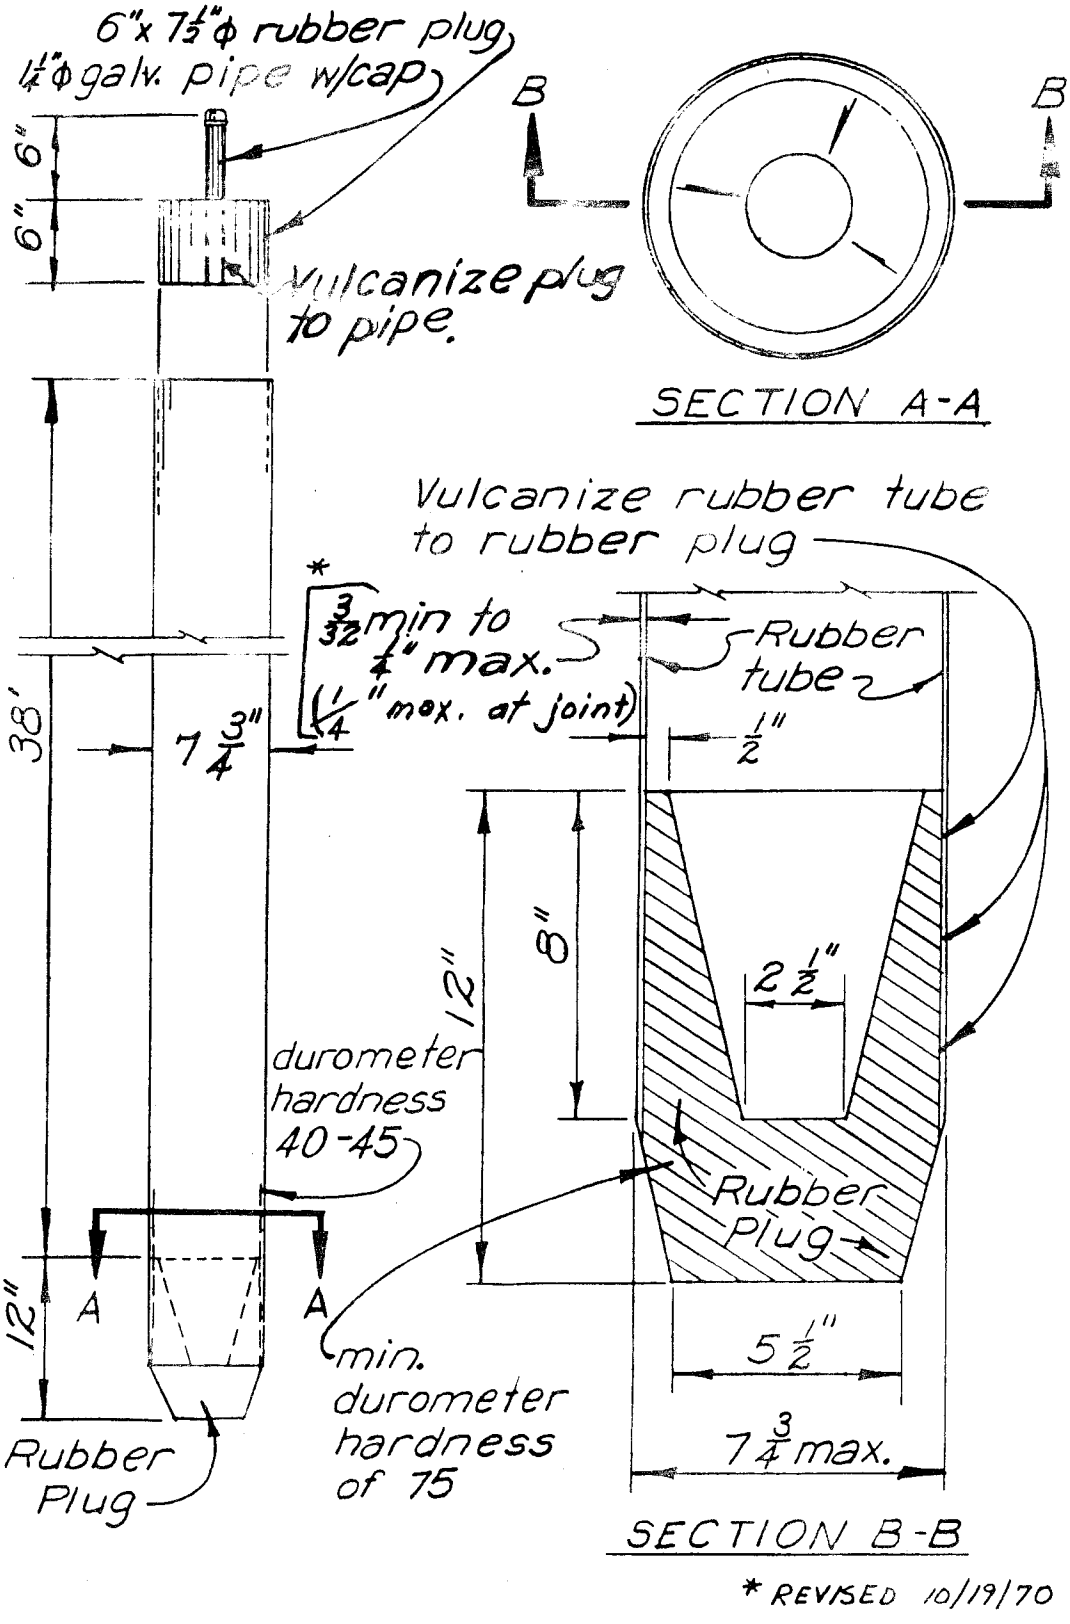
Figure 25. Waterstop detail, Lock and Dam No. 3, Arkansas River

76. During the fall and winter of 1970 the cooler weather caused the concrete training walls to contract. The foam rubber tubes previously installed as waterstops in the training wall joints had lost their resiliency by crushing and did not expand to fill the holes. Leakage was observed at the joint between the dam and the first upstream training wall monolith. Piezometers with tips near the joints began to indicate higher water levels. This trend continued throughout the winter.

74. A visit was made to several rubber specialty companies in the Houston, Texas, area in search of one that could manufacture tubes 40 ft in length and of sufficient diameter to fill the existing core holes. It was found that rubber tubing of the specific size and length required was not available as a standard item, but such tubing could be manufactured by at least two companies in Houston. Murray Rubber Company could manufacture the tubes by joining two 20-ft sections of ethylene-propylene-diene-monomer (EPDM) synthetic rubber formed and cured on a steel mandrel. The tubes would be 7-3/4-in. outside diameter with 1/8-in. wall thickness. The wall thickness at the joint would be greater than 1/8 in. and less than 3/16 in. The joint would be as strong as the other section of the tubing. The rubber for manufacture of the tubes would have a Young's modulus of approximately 500 psi and a durometer hardness of 40-45. The EPDM polymer was recommended because of its resistance to deterioration due to weather, water, and temperature. Details of the tube are shown in Figure 25.

77. Waterstops were installed in April 1971 as a permanent repair measure. Each temporary waterstop was removed by drilling with a 7-5/8-in. roller rock bit. The new waterstop consisted of a 40-ft length of 7-3/4 in. outside diameter synthetic rubber tubing with approximately 1/8-in. wall thickness. The tubes were fabricated with hard rubber plugs in the lower end. The tubes and 40-ft lengths of drill rod were placed in the drilled holes with a crane. The tubes were backfilled by pumping a heavy fluid through the drill rods. This fluid was designed to weigh approximately 150 lb/cu ft and to remain permanently fluid. The fluid was mixed in the proportions shown below.

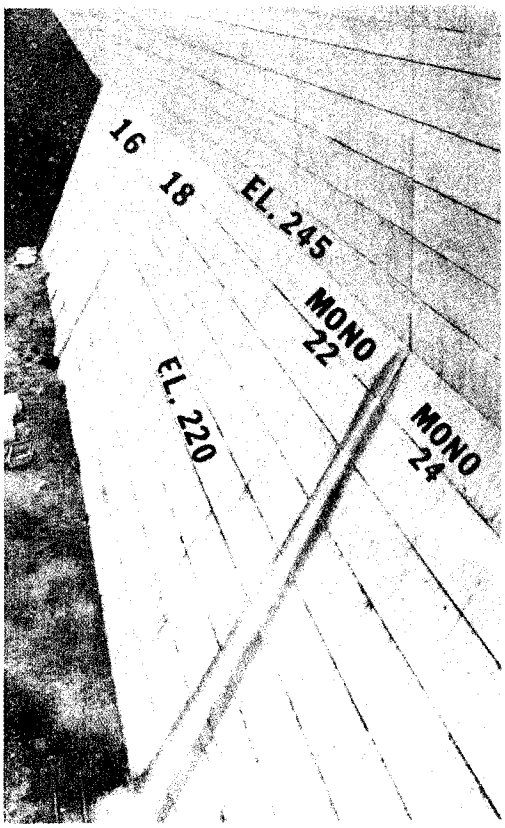
84. In October 1972, leakage was noted at monolith joints 10/12, 12/14, 16/18, 22/24, 24/26, and 28/30 for the landside lock wall and at 21/23, 23/25, 25/27, and 27/29 for the riverside wall. All except monolith joints 10/12, 12/14, and 22/24 had been repaired in May 1971. Leakage from the landside lock wall with the lock full of water is shown in Figure 28. Leakage apparently entered the landward backfill and some subsidence was reported.

a. Overall view

b. Closeup of monolith joint 22/24

Figure 28. Landside lockwall leakage, John Day Lock, October 1972

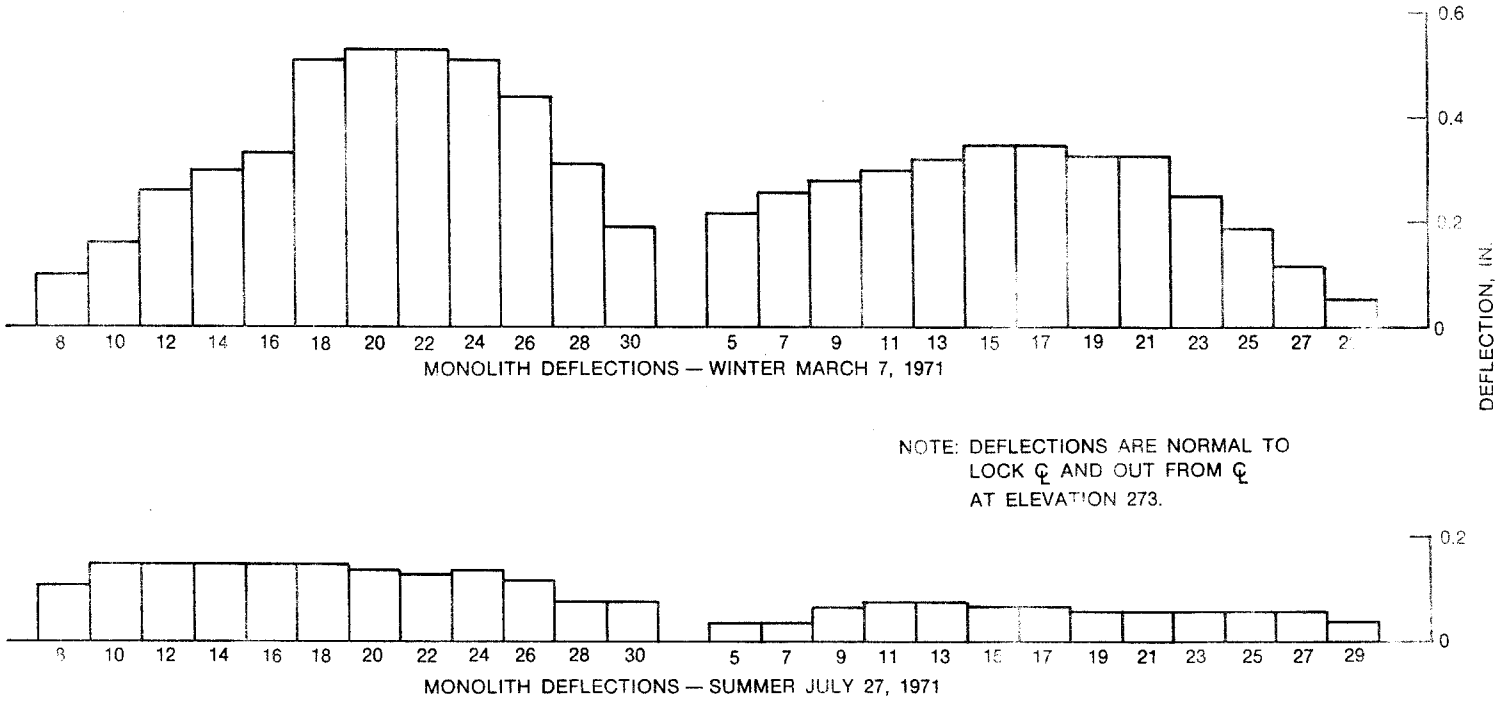
Leakage from monoliths 16/18 and 22/24 appeared on the surface of the back side of the wall at elevations 220 and 245 ft, respectively. Measured deflections in excess of 1/2 in. were reported for individual lock monoliths (Figure 29).

Figure 29. Monolith deflections due to lockage water loading, John Day Lock

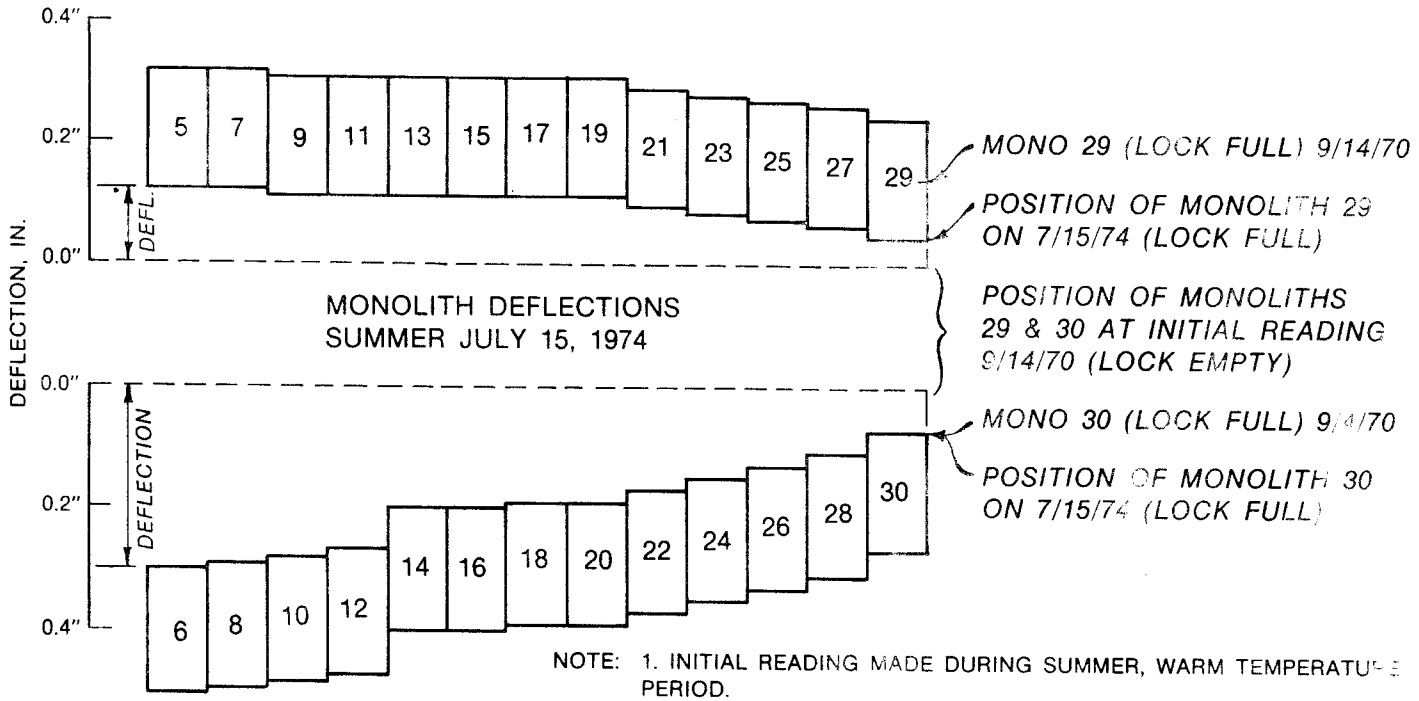
Figure 30. Lock monolith deflections, summer conditions, John Day Lock

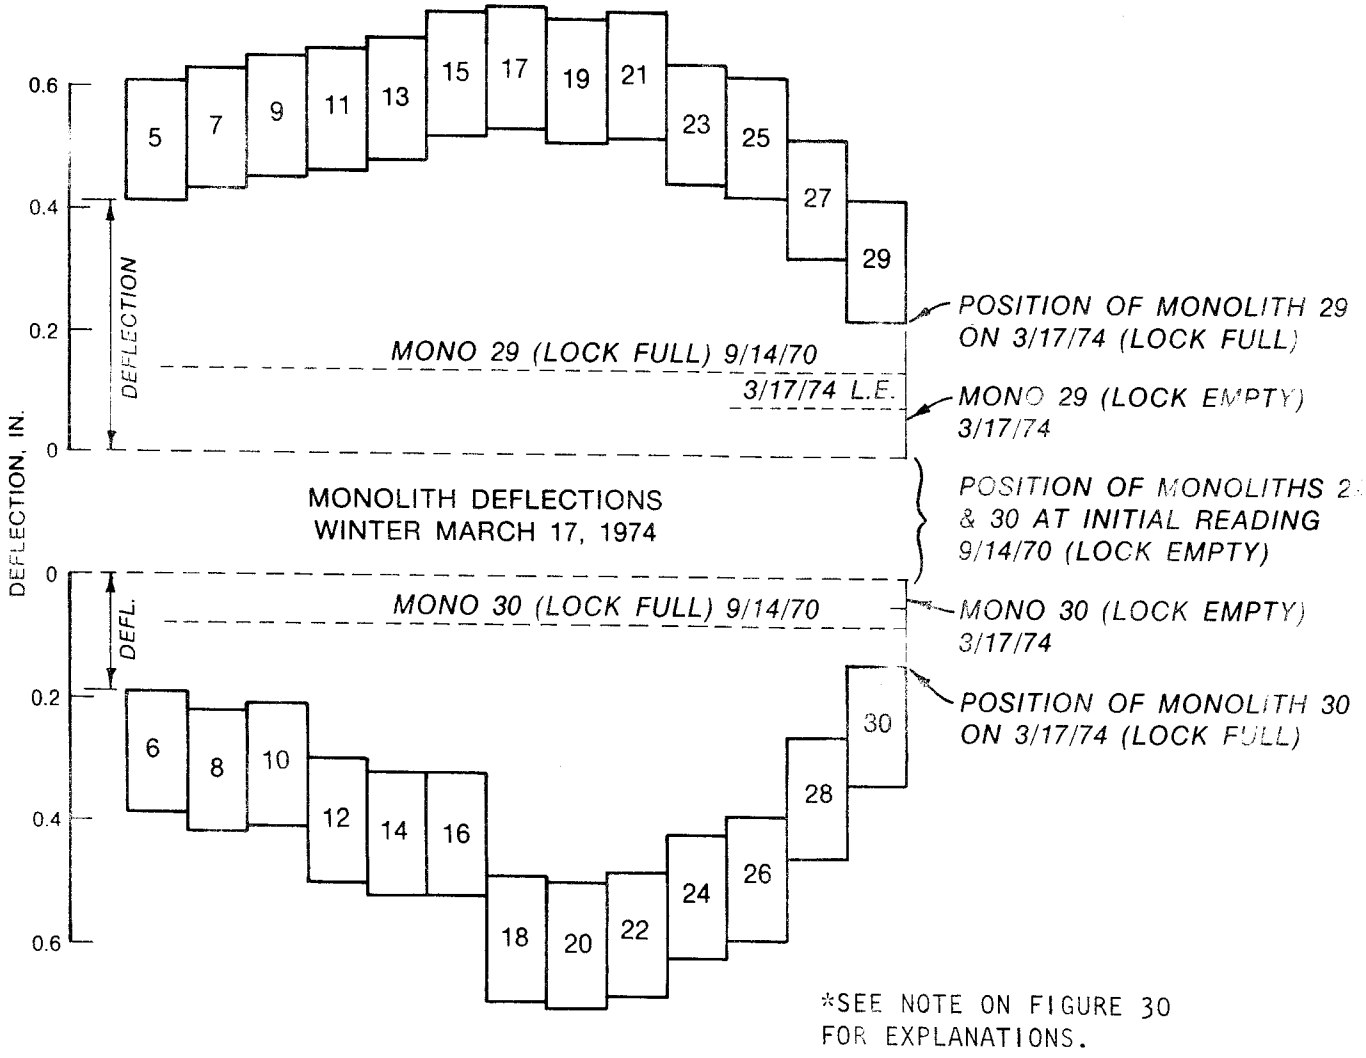
Figure 31. Lock monolith deflections, winter conditions, John Day Lock

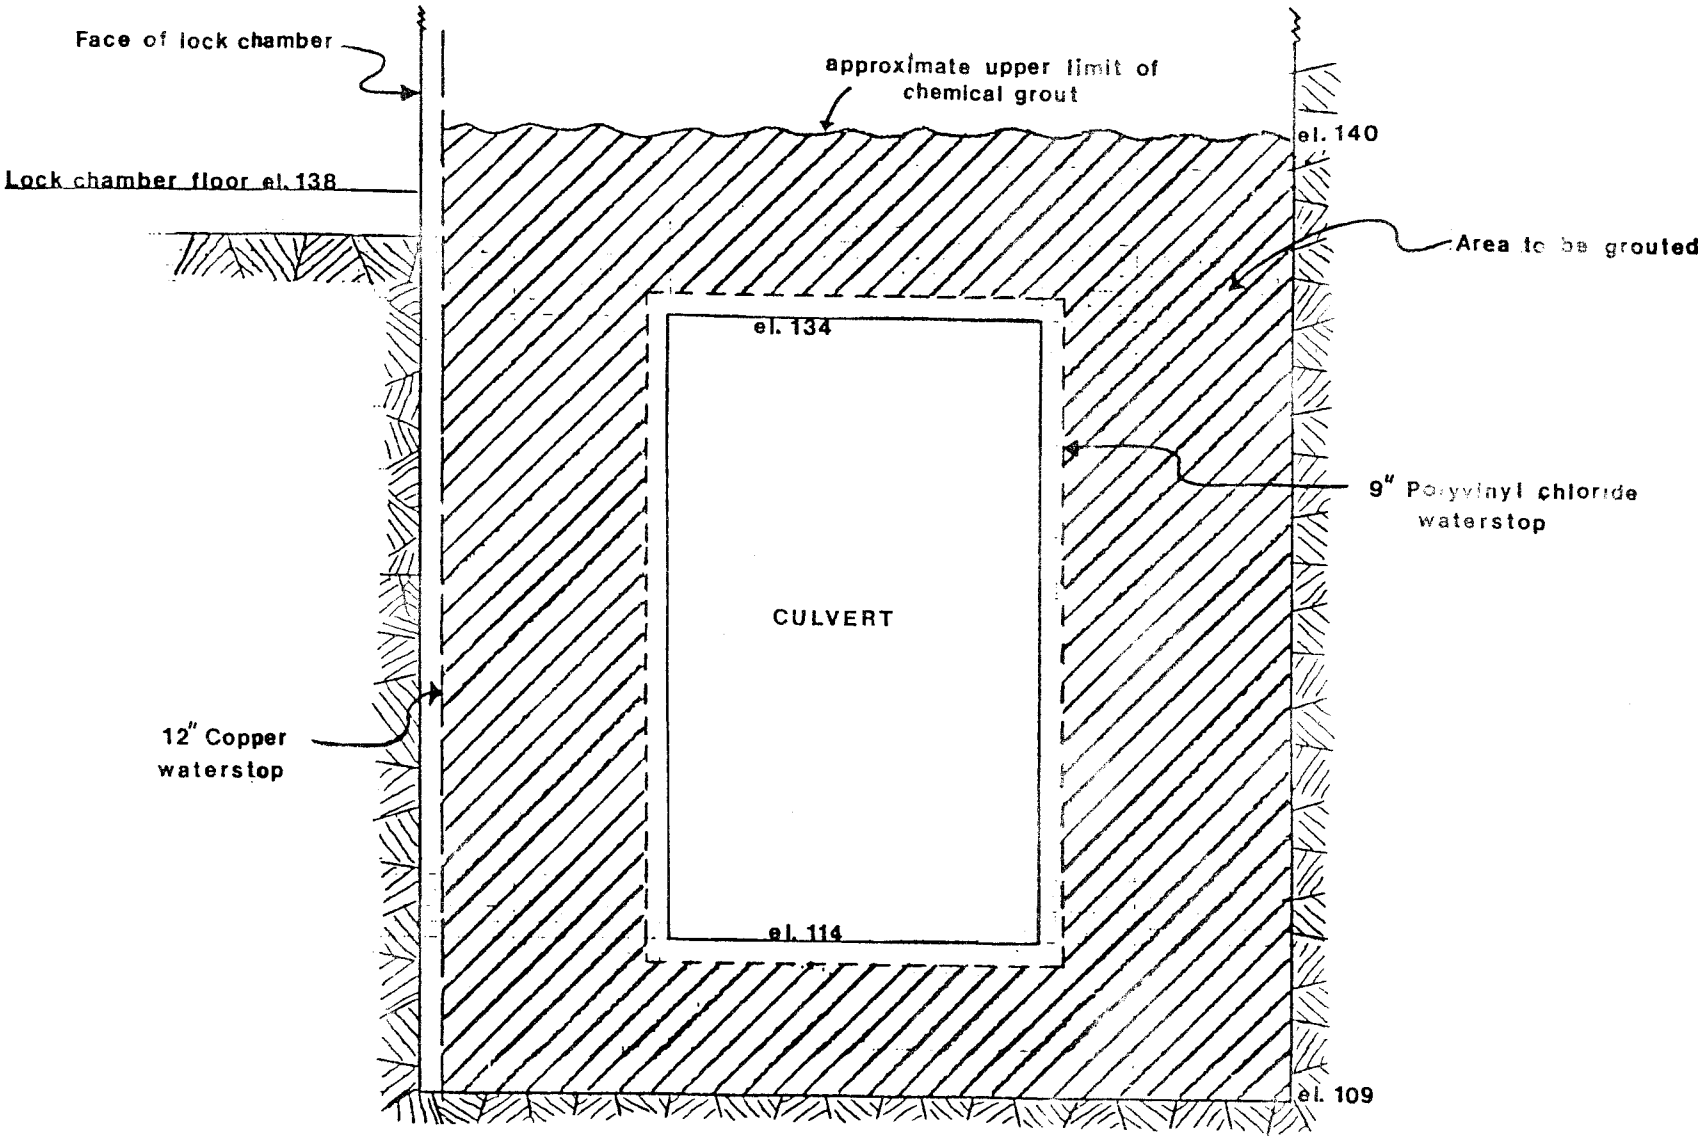
Figure 32. Detail of culvert area to be grouted, John Day Lock

92. Monolith joints 28/30, 18/20, 16/18, 14/16, 12/14, and 10/12 in the north (landside) emptying and filling culvert (Figure 32) were repaired in 1982 using chemical grout. Also, a crack in the ceiling of monolith 10 between joint 10/12 and the bulkhead slot was chemically grouted.

93. EX-size drill holes were evenly spaced around the culvert approximately 1 ft from the joint. Holes were drilled from inside the culvert at an angle of 65 degrees to intersect the joint behind the existing waterstop. All drilling was done by the Government.

94. 3M Company's hydrophilic polyurethane gel (CR-250) was specified for the repair. The polymer grout was mixed at a ratio of 1 gal polymer to 7.75 gal of water. An accelerator (CR-251) and a shrinkage control agent (CR-252) were added to the fluid grout. Also, diatomaceous earth (Celite 209) was added in the amount of 6 percent by weight of the fluid grout. Unoiled oakum saturated in hydrophilic polyurethane foam (CR-202) was used on joints 10/12 and 28/30 to control the flow prior to injections of the CR-250 grout.

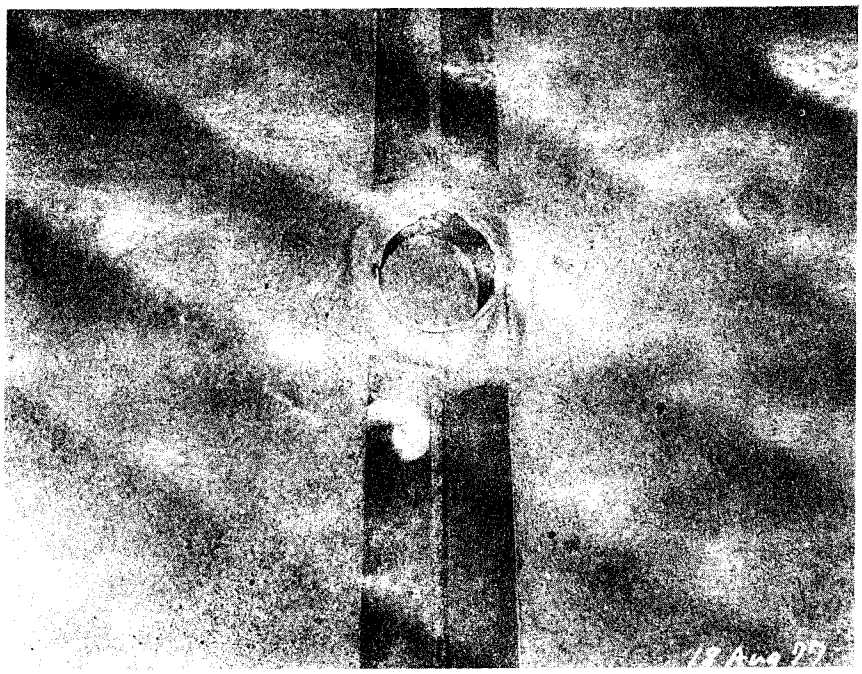
111. The drill hole was filled on 12 August 1977 by discharging the hydrophobic sand directly from the transit mixer into the hole (Figure 39). Approximately 35 cu ft of hydrophobic sand was used. Excess sand was stored at the lock. By 17 August, the sand had settled about 5 ft and the hole was refilled. The sand appeared to settle about 1/4 in. with each lockage (Figure 40). On 24 August, the sand was about 5 in. below the surface and the hole refilled. On 2 September, the sand was down about 9 in. and the hole was again refilled. During October 1977, a 6-in.-diameter hole 118 ft deep was drilled 7 ft from the lock face to be used as an observation well to check the effectiveness of the material as a waterstop. On 29 November, the sand was down about 15 ft in the test hole. When the lock was filled, the water in the observation well rose almost as fast as the water in the lock. When the lock was full, the water was within 15 ft of the deck. The water was also running over the top of the sand in the test hole. The water was running fast enough to be clearly heard and seen flowing through the joint looking down both holes from the deck. Since that time, sand has continued to be washed out of the test hole through the joint into the observation hole.

Figure 40. Settlement of hydrophobic sand in drill hole after three lockages, Ice Harbor Lock

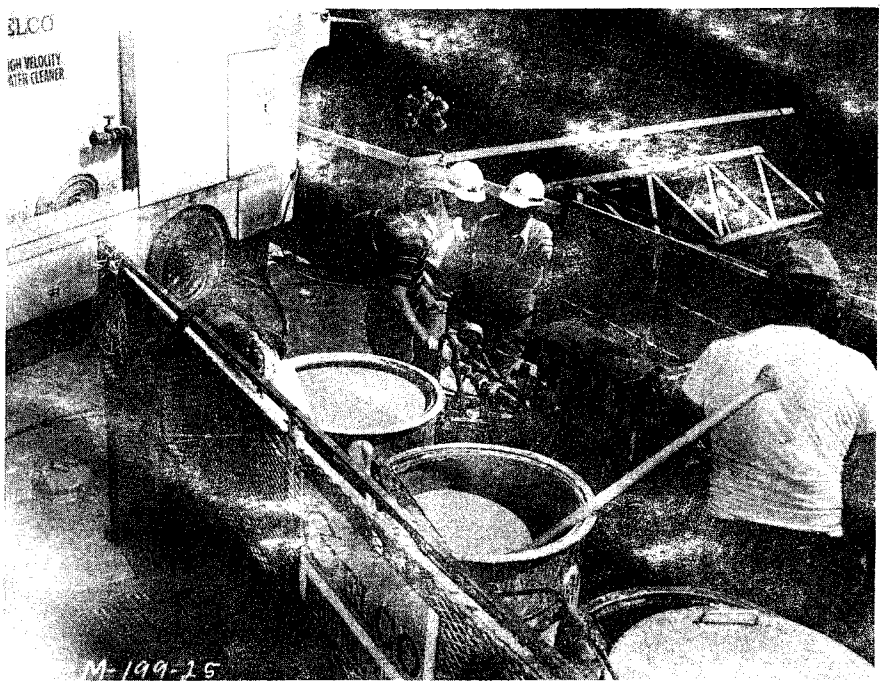
Figure 41. Mixing and pumping equipment for acrylamide grouting, Ice Harbor Lock

114. The drill hole was grouted on 17 August 1977. The packer was inserted into the hole to about 150 ft below the surface. Two separate solutions of grout materials were mixed (Figure 41) and then pumped separately through two hoses (Figure 42) which were connected to a mixing nozzle suspended below the packer. The grout was pumped in 10-ft stages. This necessitated stopping grout injection while the packer was being moved and then resuming pumping. The top 30 ft of the grout was diluted by water in the hole. This material was removed from the hole using a high-velocity water cleaner and the section of the hole was regrouted. Grouting was accomplished while the lock water was at tailwater level. A view of the completed repair is shown in Figure 43.

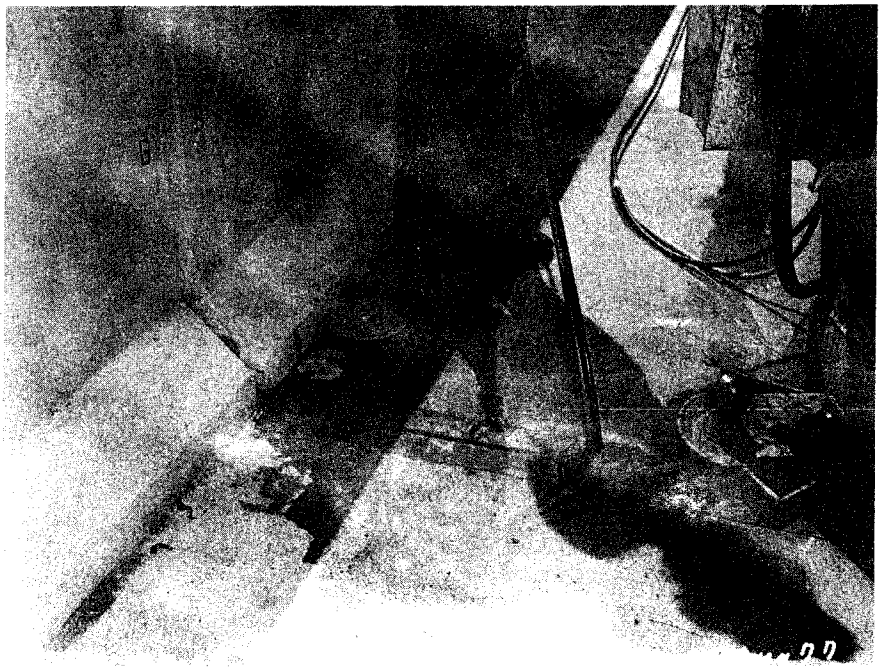
Figure 42. Double injection lines used to pump both acrylamide grout solutions to the bottom of drill hole, Ice Harbor Lock

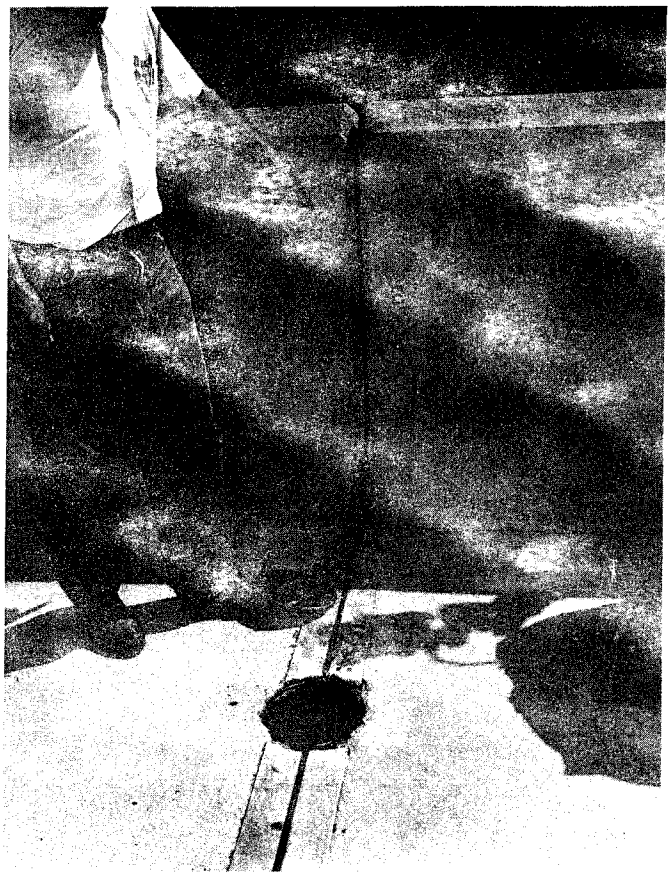
Figure 43. Drill hole filled with acrylamide grout, Ice Harbor Lock

115. The grout still looked good when inspected on 2 September. An observation hole was drilled 4 ft landward of test hole in October 1977. On 29 November 1977, the water level was measured at 95 ft below deck with the lock filled. The water level was below the end of a 100-ft tape before the lock was filled; depth to tailwater was about 108 ft. The AM-9 was still in the test hole to within an inch of the top.

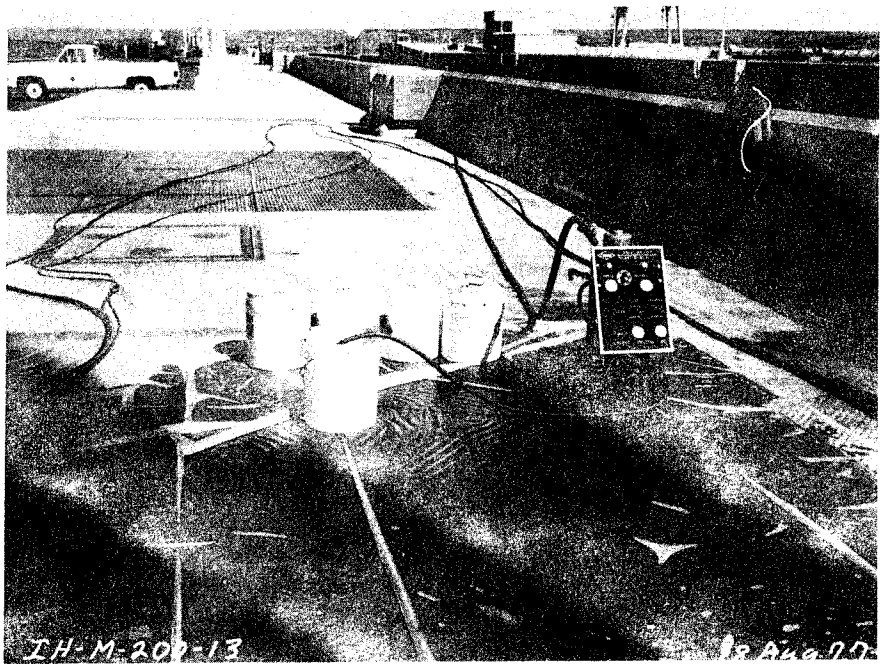
Figure 44. Polyurethane grout installation with proportioning pump, Ice Harbor Lock

118. The drill hole was grouted on 18 August 1977 (Figure 44). A 6-in. packer built for this test would not fit into the 6-in. drill hole, so a shorter aluminum sewer grouting nozzle was used. The grouting was started at the bottom of the 120-ft hole and was being raised in stages when a boat lockage through the navigation lock raised the water surface in the hole very quickly. This caused the grout to flow around the packer through the joint and set above the packer. The packer was stuck in the hole about 60 ft from the surface with about 15 ft of the material above the packer. The retrieval equipment would not raise the packer, so the 3/8-in. steel cable and the rubber hoses attached to the packer from the hole and the 3/8-in. cable broke.

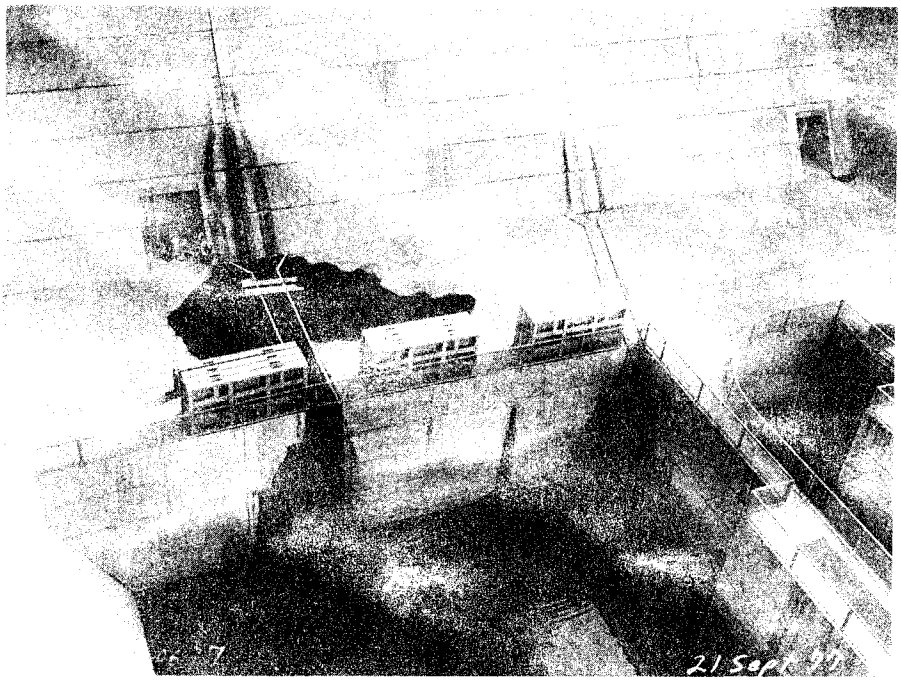
Figure 46. Leakage through north nonoverflow monolith joints, Ice Harbor Dam
