REPAIR, EVALUATION, MAINTENANCE, AND REHABILITATION RESEARCH PROGRAM

TECHNICAL REPORT REMR-CS-4

REPAIR OF WATERSTOP FAILURES: CASE HISTORIES

November 1986
Final Report

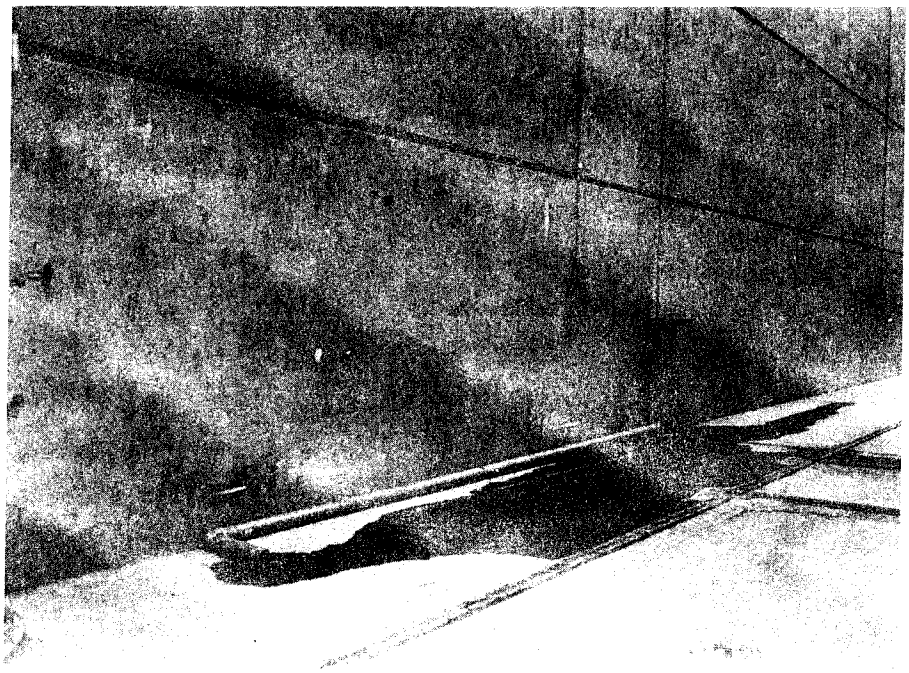
125. Leakage of varying intensities was reported between monolith joints of the different bays in the powerhouse. As would be expected, the amount of leakage varies with the seasons. Garden-type hoses are used at the joints in the powerhouse interior to help divert leakage and control it from flowing onto the generator floor. Joint 1/2 leaks every winter, joint 2/3 has leakage that runs through the hose fairly regularly, and joint 4/5 started leaking when the additional powerhouse units were watered up. Leakage at the outside transformer deck is substantial and is contained in metal troughs and pipes (Figure 47). It was noted that if the pipes were to freeze or if the leakage increased considerably during the winter, a problem of ice buildup and possible flooding of the transformer deck could occur.

Figure 47. Trough and piping to help contain monolith joint leakage in powerhouse, Ice Harbor Dam

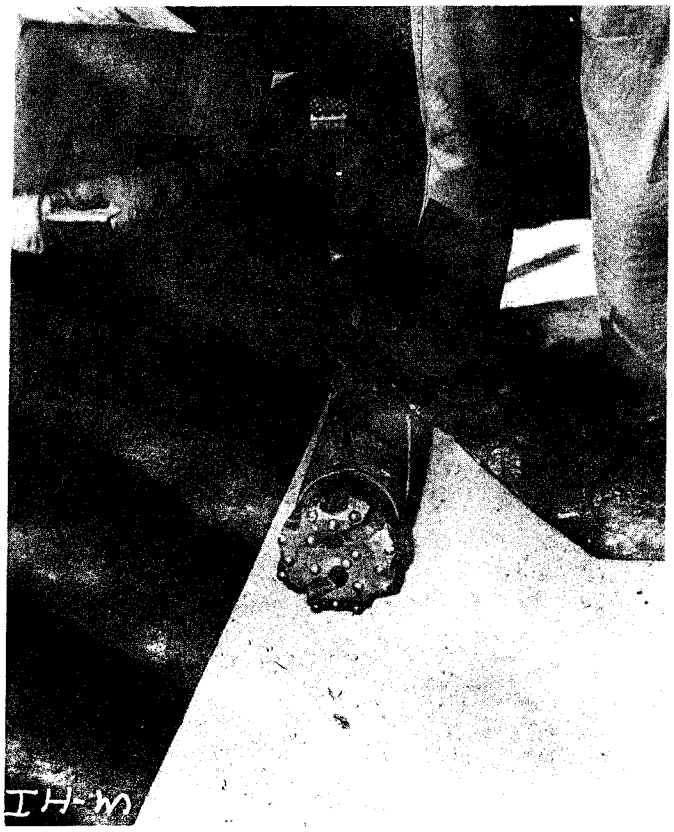
Figure 49. Equipment used to drill holes along monolith joints for remedial waterstops, Ice Harbor Lock

into bedrock (Figure 49). The drill holes were filled with an impermeable flexible chemical grout. Greatly decreased flow of water into the landside fill from the navigation lock joints was attributed to the waterstop repair. Visible contraction joints showed no sign of leakage when inspected in November 1980. Lock monolith displacements, as measured by extensometers, remained unchanged from the previous inspection in 1977.

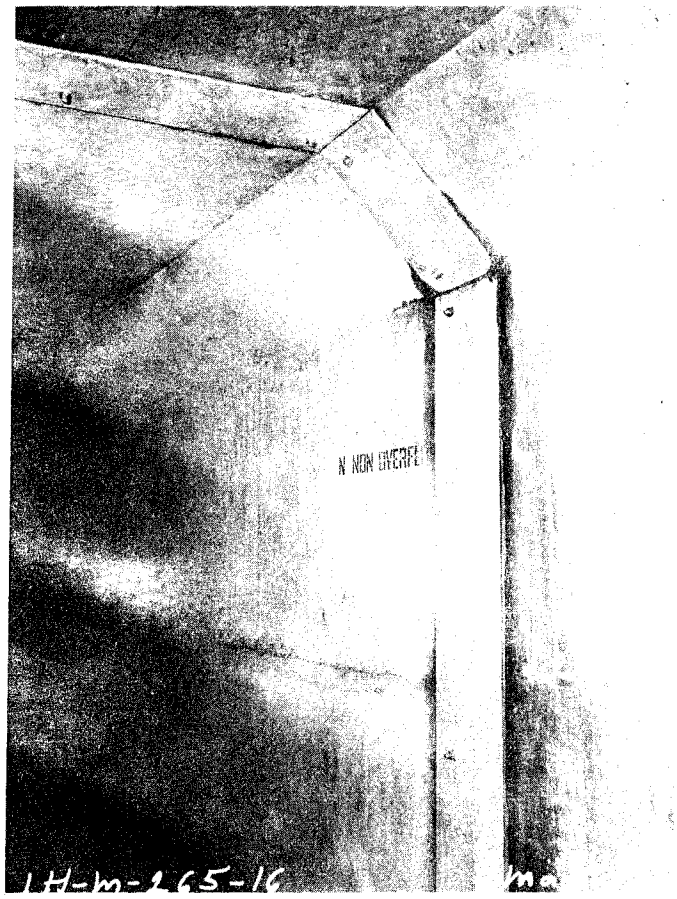
Figure 50. Steel backup plate installed at nonoverflow monolith joint 1/2, Ice Harbor Dam

128. Major leakage into the north nonoverflow dam was eliminated by the 1978 installation of chemical grout vertical waterstops similar to those installed in the navigation lock. Backup plates that were installed during the grouting operation are to be replaced in the next repair contract. The plates, which are bolted along one side in one monolith (Figure 50), were bolted so tightly against the neoprene pad behind the plate that the plate was sprung, eliminating any possibility of sealing the joint from water leakage and grout extrusion. It was suggested that the steady water seepage into the

gallery occurring in November 1980 could be eliminated by the installation of an effective backup plate system. Extensometer measurements have been taken since November 1972 to monitor adjacent monolith movement at elevation 453 ft in the nonoverflow dam and powerhouse dam. They indicated relative movements were less than 0.1 in. in November 1980.

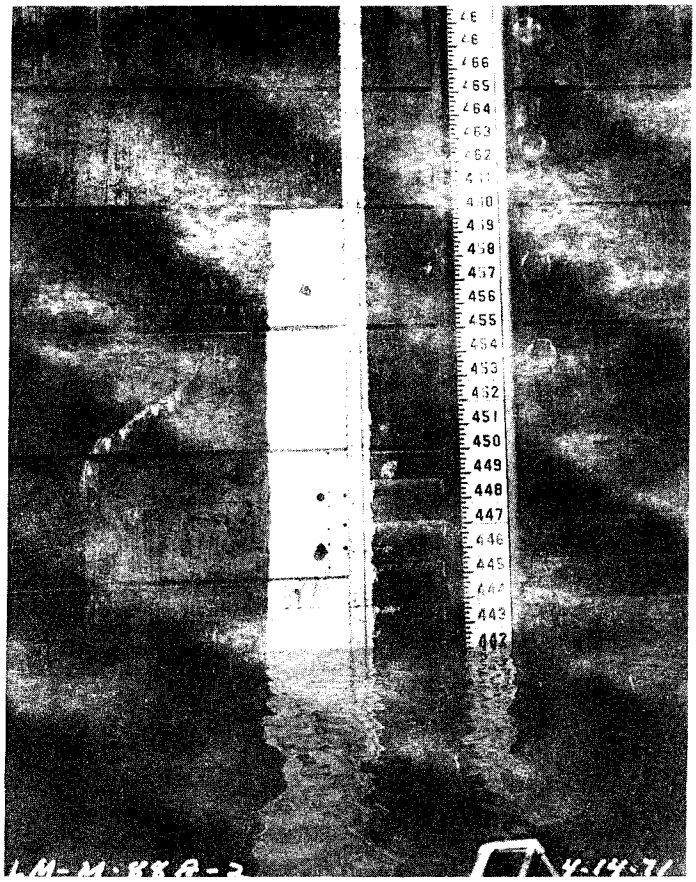
Figure 54. Joint 26/28 repairs, Lower Monumental Lock

139. Leakage through gate monolith joints 25/27 and 26/28 was repaired by contract while the lock was dewatered in November 1970. A neoprene membrane epoxied to the concrete surface and retained by stainless steel cover plates was used for the repair (Figure 54). The areas which appear gray in Figure 54 have been treated with two coats of an epoxy, Colma-Kote M,

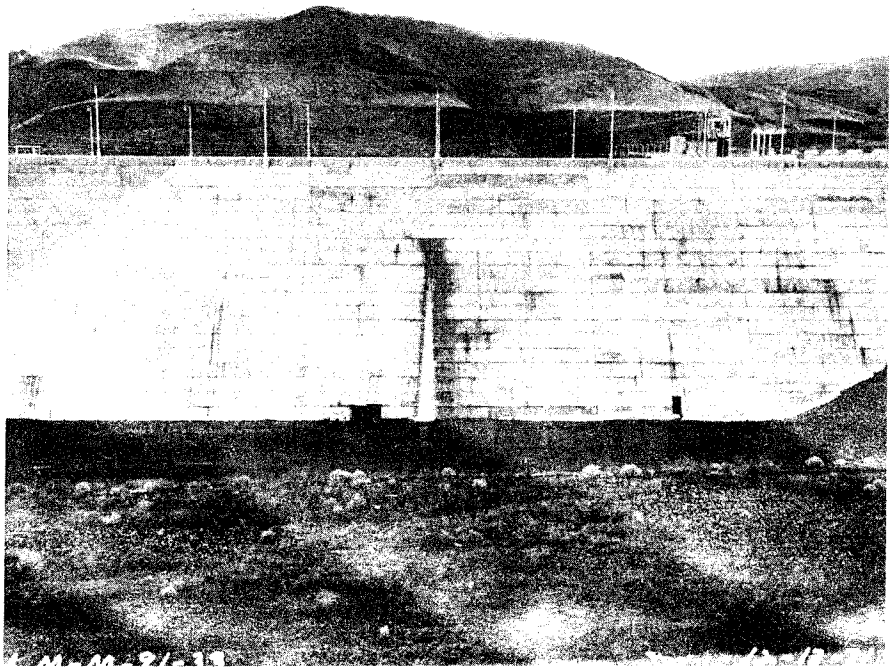
manufactured by Sika Corporation, to form a temporary membrane over areas of deteriorated concrete adjacent to the joint. In September 1971, it was reported that the epoxy showed signs of deterioration and also that the concrete deterioration appeared progressive, as evidenced by increased flows through joints 26/28, 25/27, and 18/20 (Figure 55).

b. Joint 18/20. Concrete along the joint was spalling apparently due to relative movement between the monoliths which caused shear forces at the lock wall surface. The joint had leaked

Figure 55. Leakage through joint 18/20 with full lock chamber, Lower Monumental Lock, December 1971

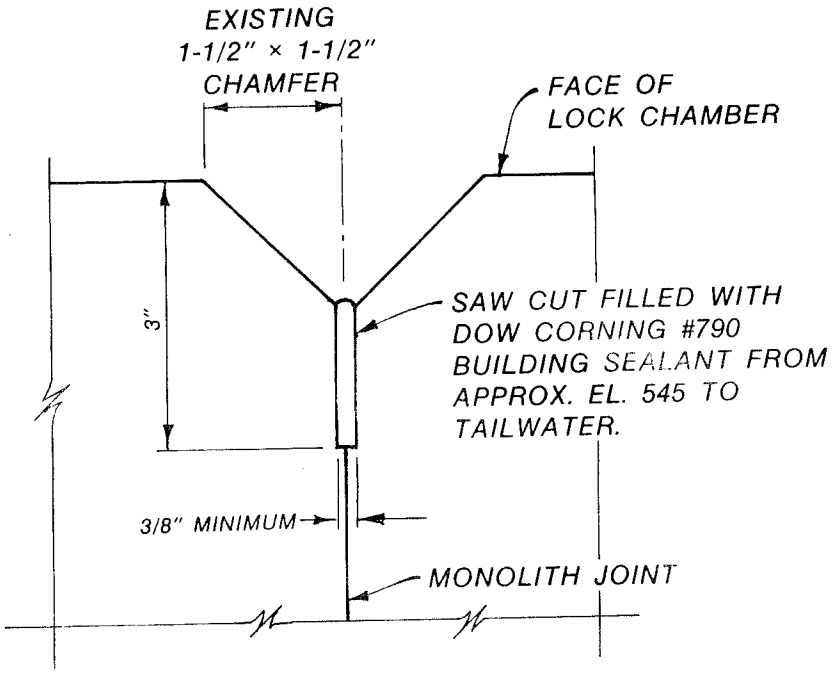
significantly in the past and was repaired by District personnel in March 1975. A groove 3/8 in. wide and 1-1/2 in. deep was sawed along the joint and filled with Dow Corning 790 building sealant (Figure 56). The sealant was applied during a period when the lock was out of operation for approximately 24 hr. Cost of the repair was approximately $2,000. The sealant was tightly bonded and totally filled the sawed groove which was inspected during the December 1976 condition survey. However, there was some leakage through the joint from elevation 470 ft to the ground. Since the sealant was only applied down to the existing tailwater elevation, the leakage may have been coming through the joint below this level. Regardless of the reason, the leakage was much less than occurred prior to installing the sealant.

Figure 56. Caulked joint repairs, Lower Monumental Lock

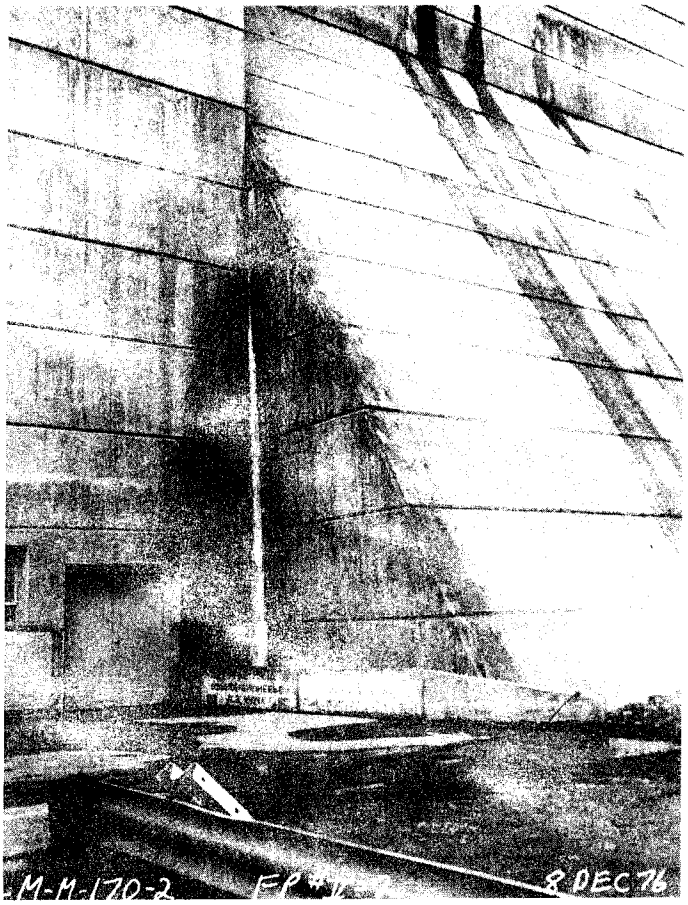
Figure 57. Joint 26/28 leakage, December 1976, Lower Monumental Lock

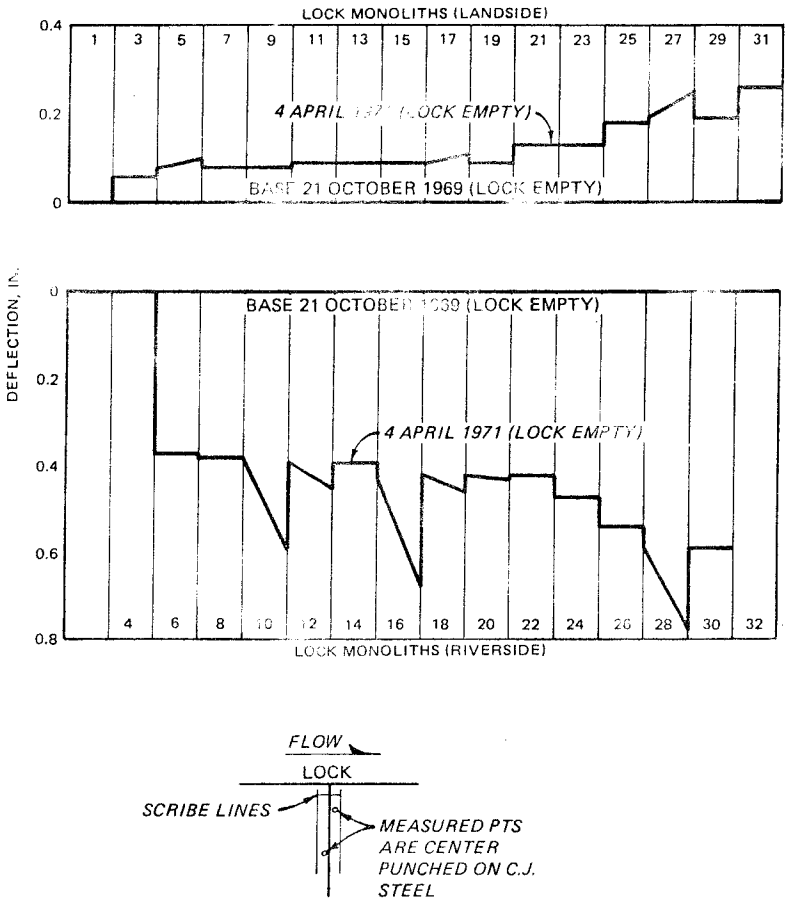
Figure 60. Lock monolith deflections, Little Goose Lock

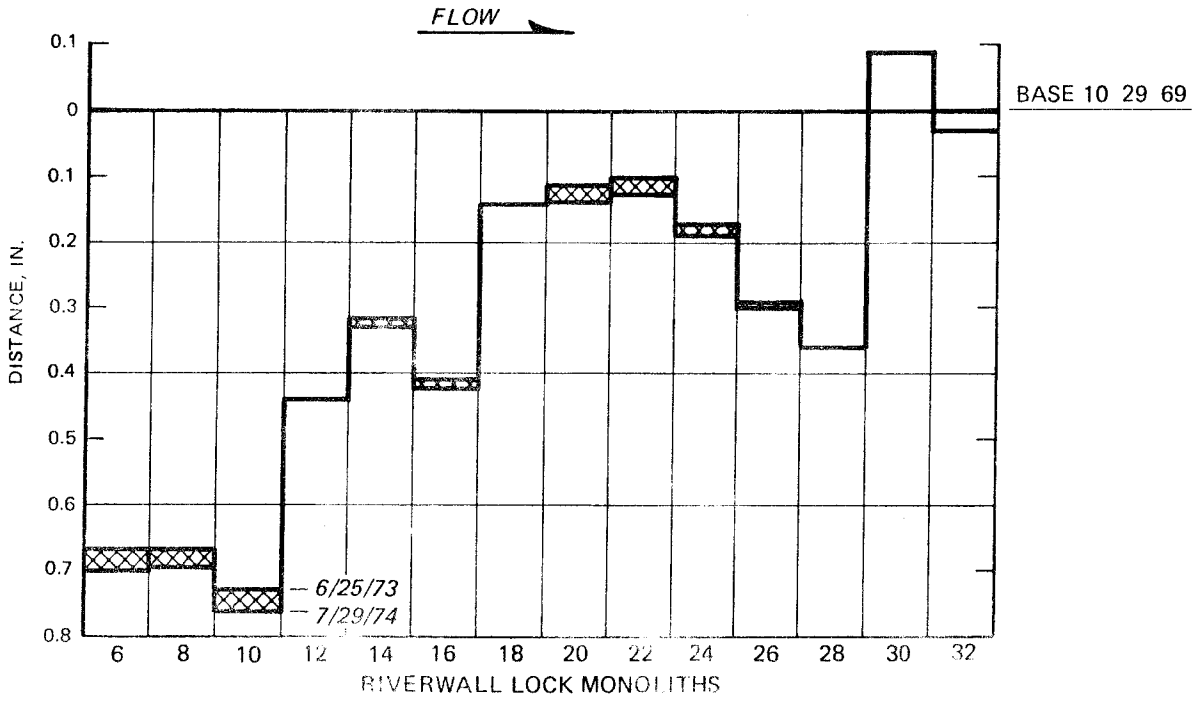
Figure 61. Permanent deflections measured with lock chamber empty, Little Goose Lock

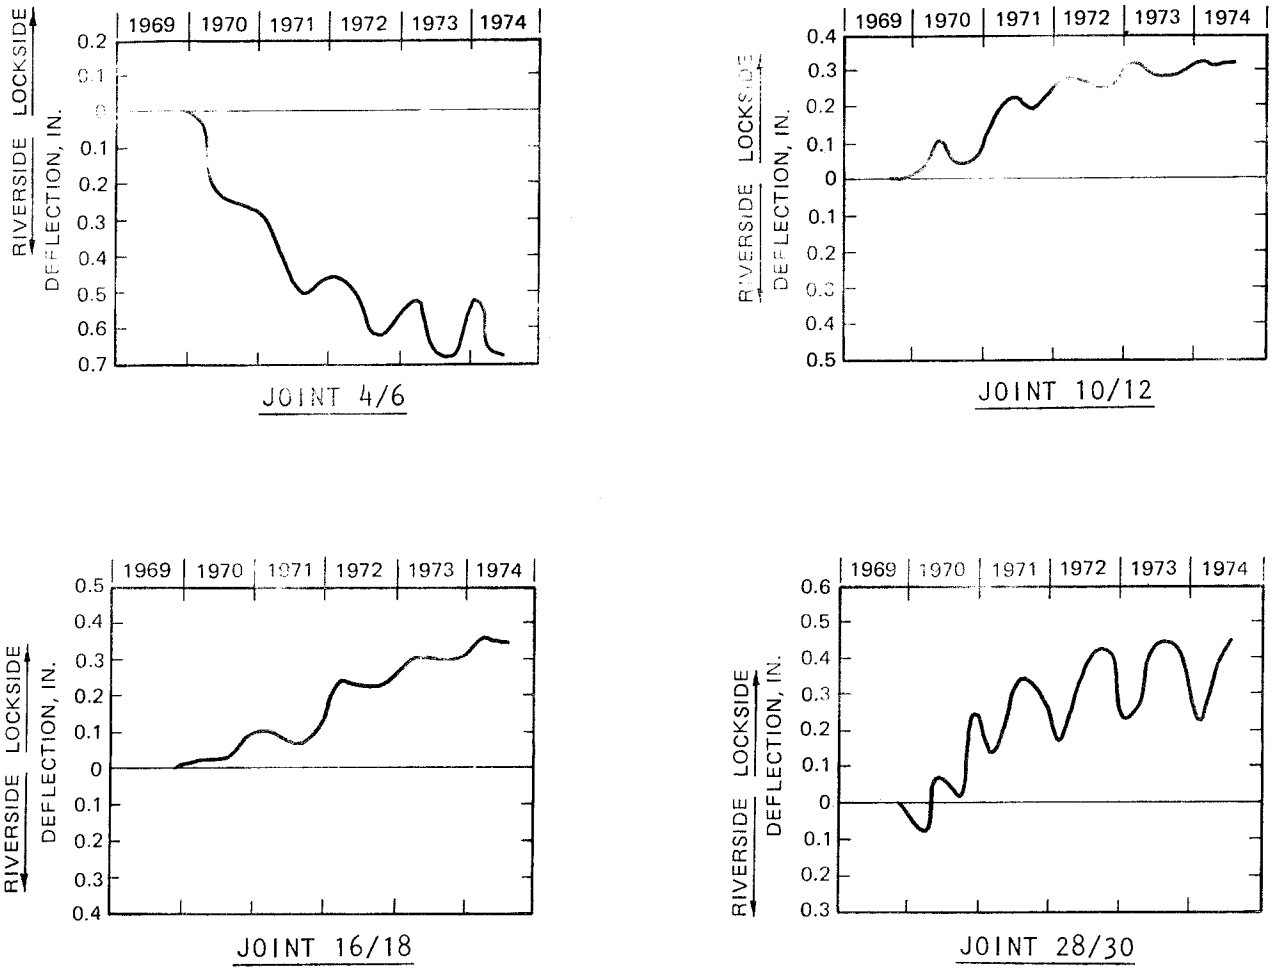
(Figure 62). Total failure of the waterstop at monolith joint 4/6 was reported as a result of the relative displacement between the adjacent monoliths. When the lock was filled, water leaked through the joint and spilled [illegible] deep into the parking area near monolith 6 (Figure 63). Most of the other monolith joints exhibited varying rates of leakage.

Figure 62. Maximum relative displacements of lock monoliths, Little Goose Lock

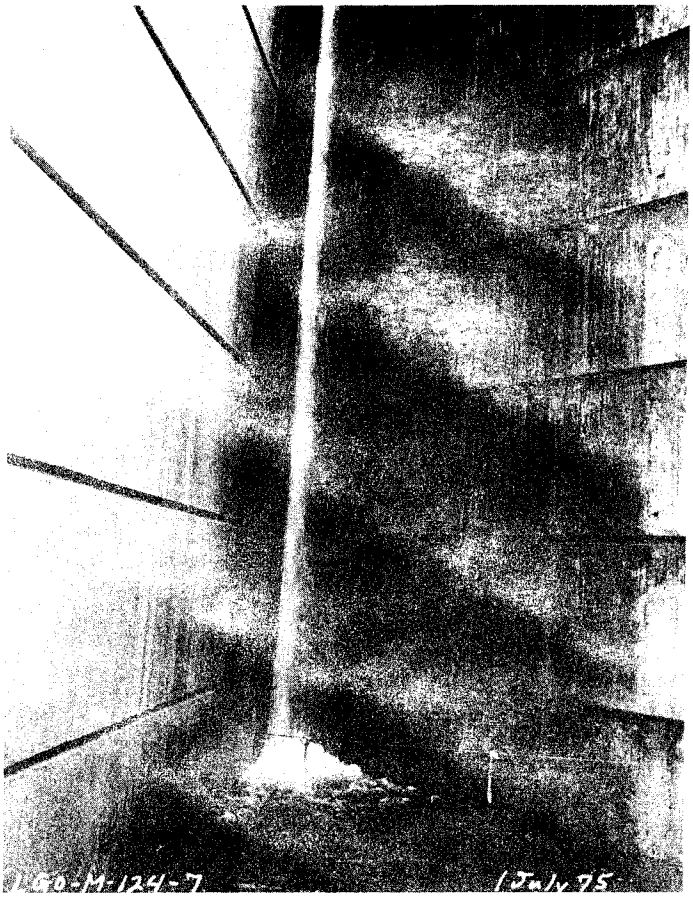
Figure 63. Monolith joint 4/6 leakage, July 1975, Little Goose Lock

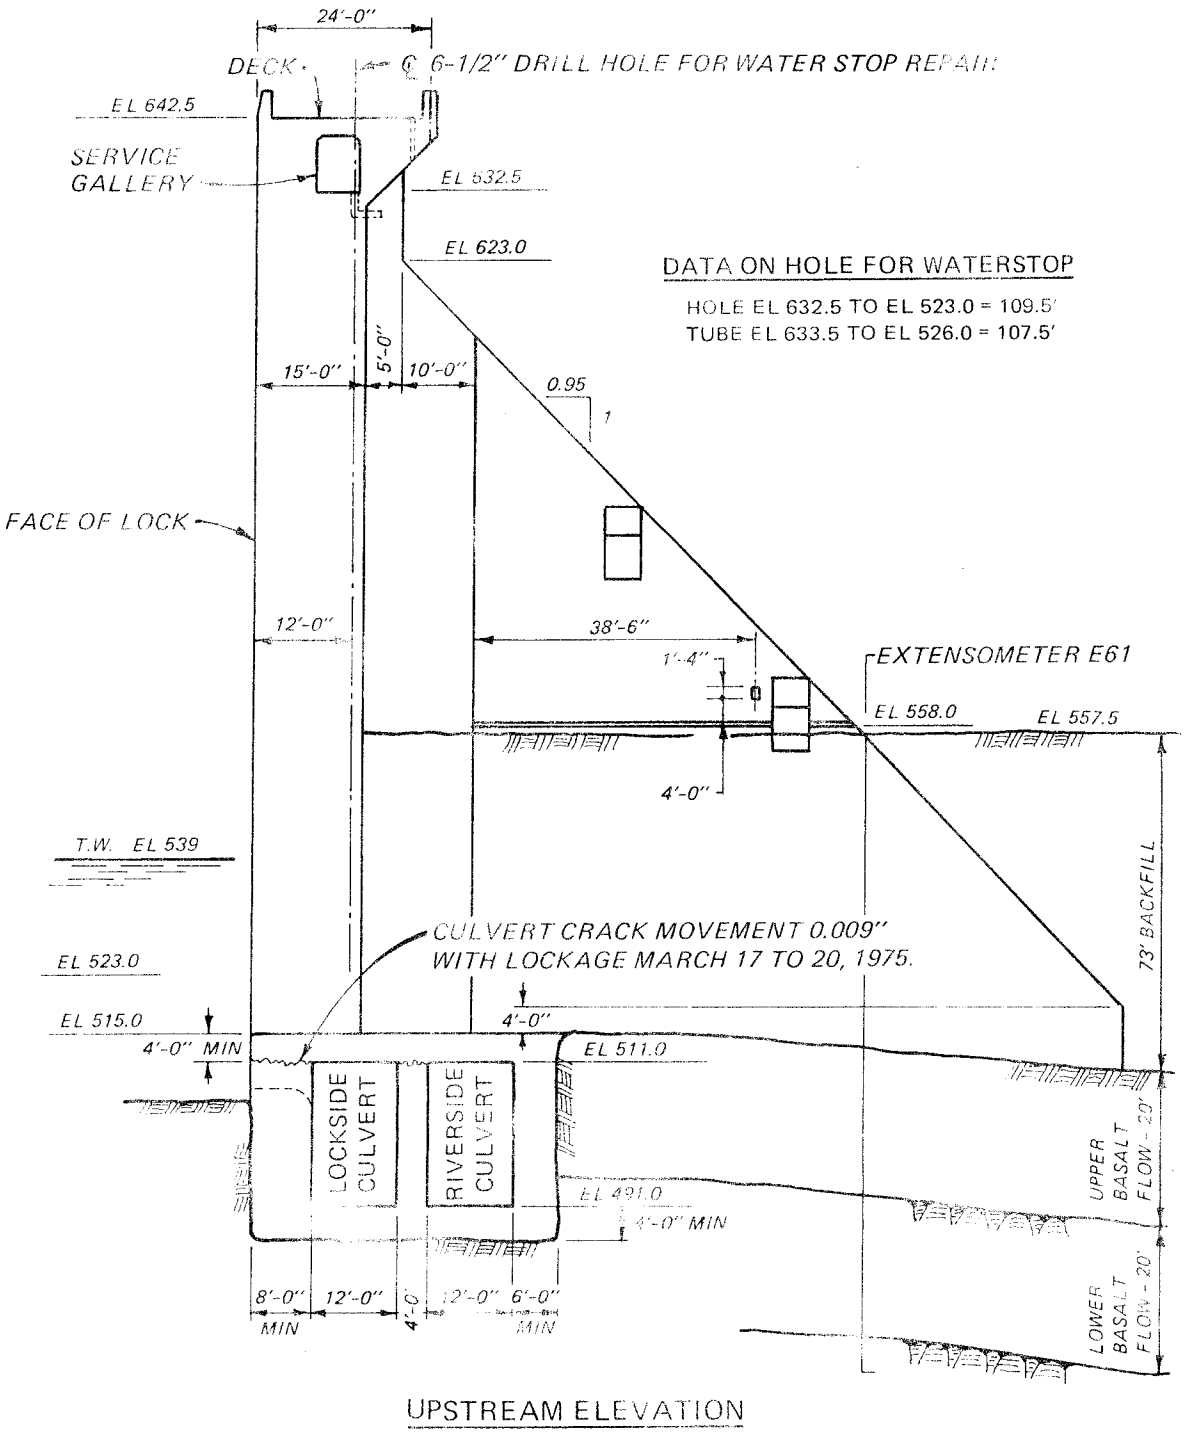
Figure 64. Location of trial waterstop repair, Little Goose Lock

148. A trial foundation grouting program was initiated in 1975 in an effort to stabilize the lock monoliths. Monolith No. 6 was selected for the trial grouting. In 1976, a trial waterstop repair was made along monolith joint 4/6. A report describing both trials was prepared (US Army Engineer District, Walla Walla 1978). Since the original waterstops were located 9 ft from the lock face, exposing and repairing these waterstops was not considered practical. Surface-type waterstops were considered unacceptable because (a) they had not been permanent or 100 percent effective when used previously on similar locks in the Walla Walla District and (b) structural design considerations required the waterstop to be located about 9 ft back from the lock face. Therefore, a hole drilled along the joint and filled with an elastic material was selected as the repair method for the trial repair. The purpose of the trial repair was to demonstrate that a hole could be successfully drilled along the joint and to evaluate different impermeable fillers for the hole. The trial was accomplished with Corps equipment and personnel. The drill hole was located 12 ft from the lock face, 3 ft behind the original and failed copper waterstop (Figure 64). This position required drilling the holes through the underlying service gallery. The drill hole through the deck and to below the service gallery was 10 in. in diameter and was accomplished by diamond drilling. This allowed cutting all embedded metals until the hole was into the mass concrete. Upon completion of the diamond drilling work an 8-in. pipe was placed in the hole. A Winter-Weiss rotary drill was set up on the deck. The drill was equipped with a down-the-hole pneumatic hammer which drills a 6-in. nominal diameter hole. Special precautions were taken for maintaining hole alignment. Generally, there was constant surveying of the drill mast for vertical position from two directions and the hole was drilled using a reduced drilling speed. The hole was completed in three shifts and then thoroughly washed to remove all drill cuttings and fines. The total cost of the drilling phase was $6,050.

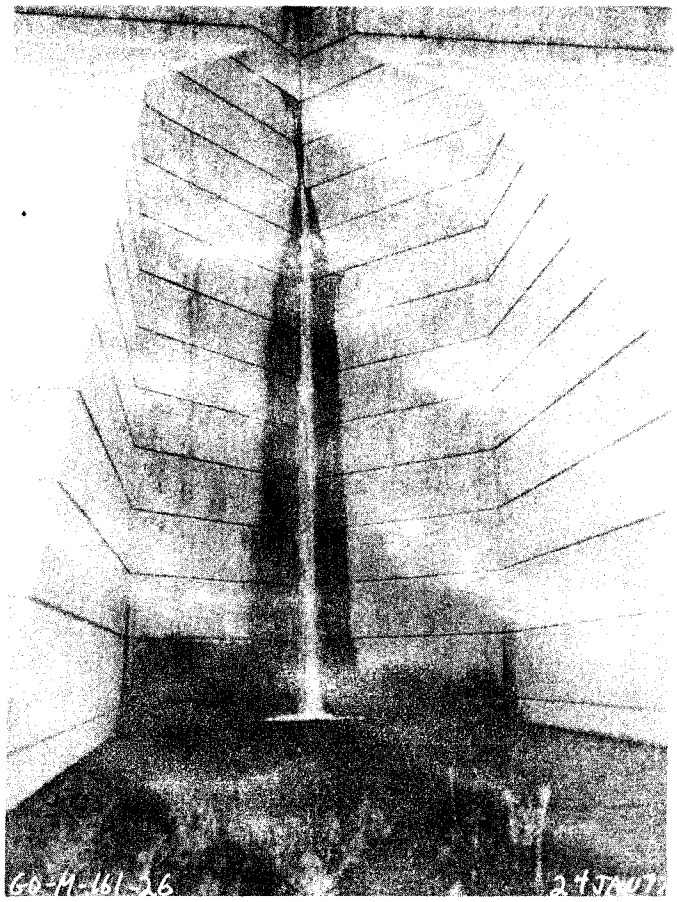
Figure 65. Monolith joint 10/12 leakage before and after repair, Little Goose Lock

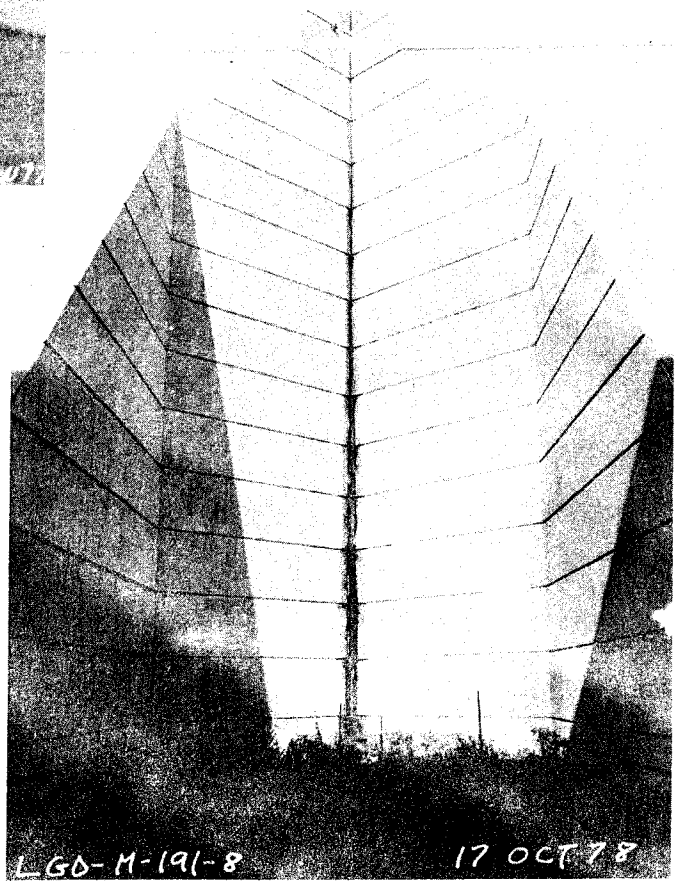
Figure 66. Monolith joint 11/13 leakage before and after repair, Little Goose Lock

152. Based on the Ice Harbor and Little Goose trial repairs, the drill hole with elastic filler method was selected to reestablish monolith joint waterstops at Little Goose Lock. Repairs were accomplished under contract in 1978 by drilling a 6-in.-diameter vertical hole along the joints from the deck to about 5 ft into bedrock and then filling the holes with AM-9 chemical grout to create a cast-in-place waterstop. This repair stopped an estimated 95 percent of the leakage. Leakage at selected joints before and after repair is shown in Figures 65 and 66.

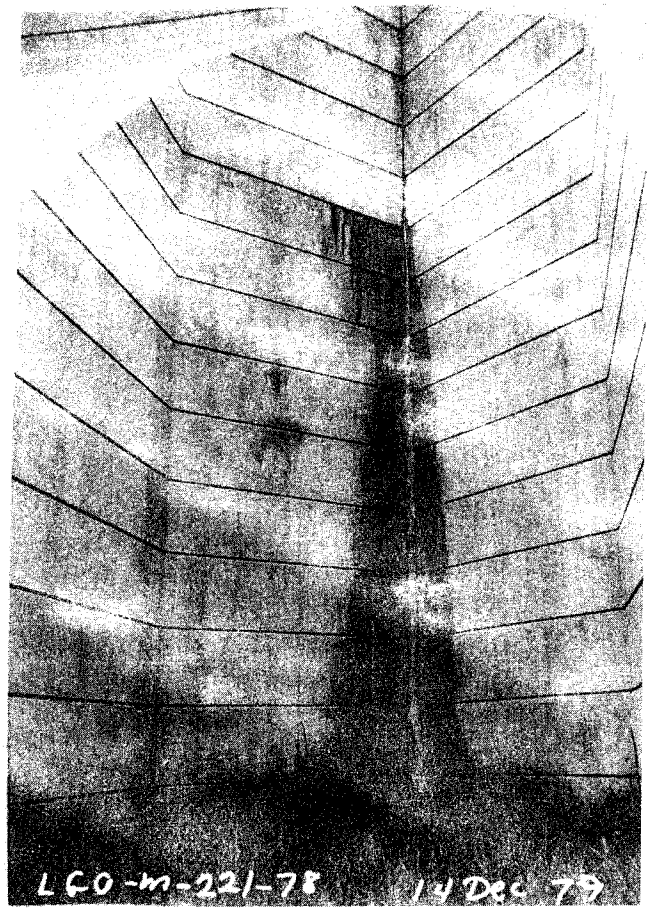
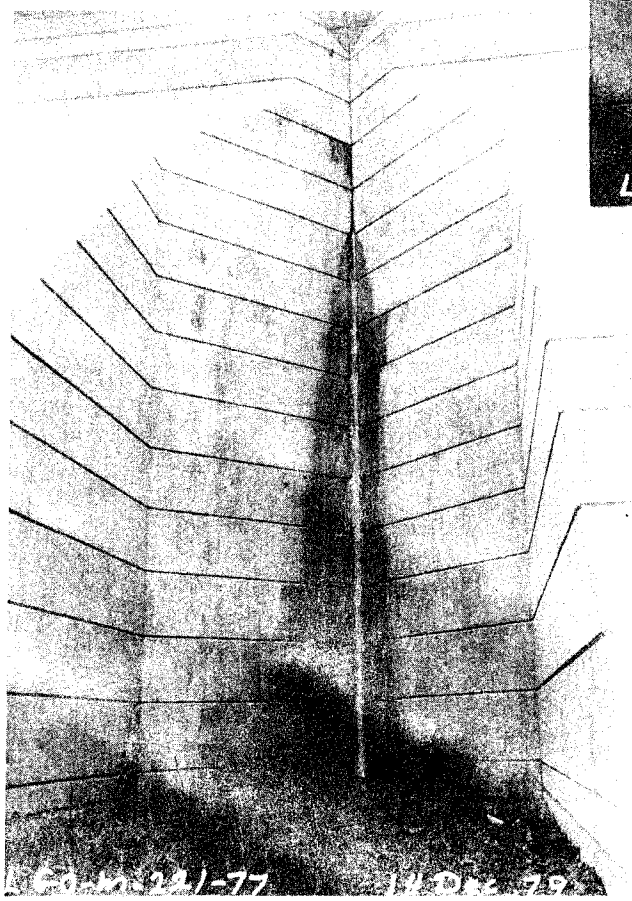
153. Based on an inspection in August 1979, it was reported that several monolith joints exhibited small amounts of leakage (Figure 67) and would probably require regrouting in the future. It was suggested that one of the advantages of this repair system is that regrouting could be done easily and economically by an experienced chemical grouting crew. Other observations reported during this inspection included:

Figure 67. Monolith joint leakage, Little Goose Lock, December 1979

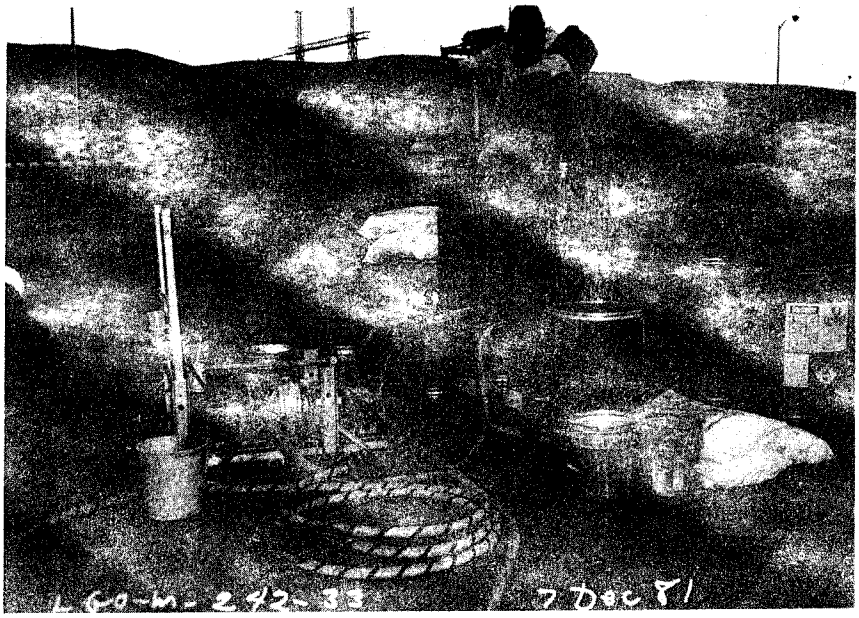
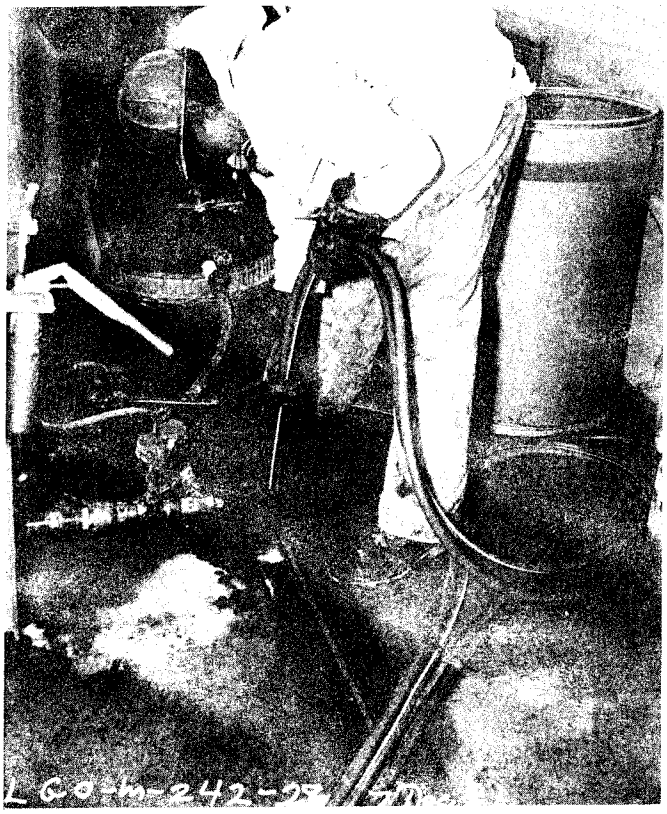
Figure 69. Acrylamide grouting operations, Little Goose Lock

157. Drill holes along monolith joints 15/17, 22/24, and 24/26 were flushed and filled with approximately 300, 350, and 250 gal of acrylamide grout, respectively. Photographs of the grouting operation are shown in Figure 69. At one point, the grout line stuck in the monolith joint 24/26 hole

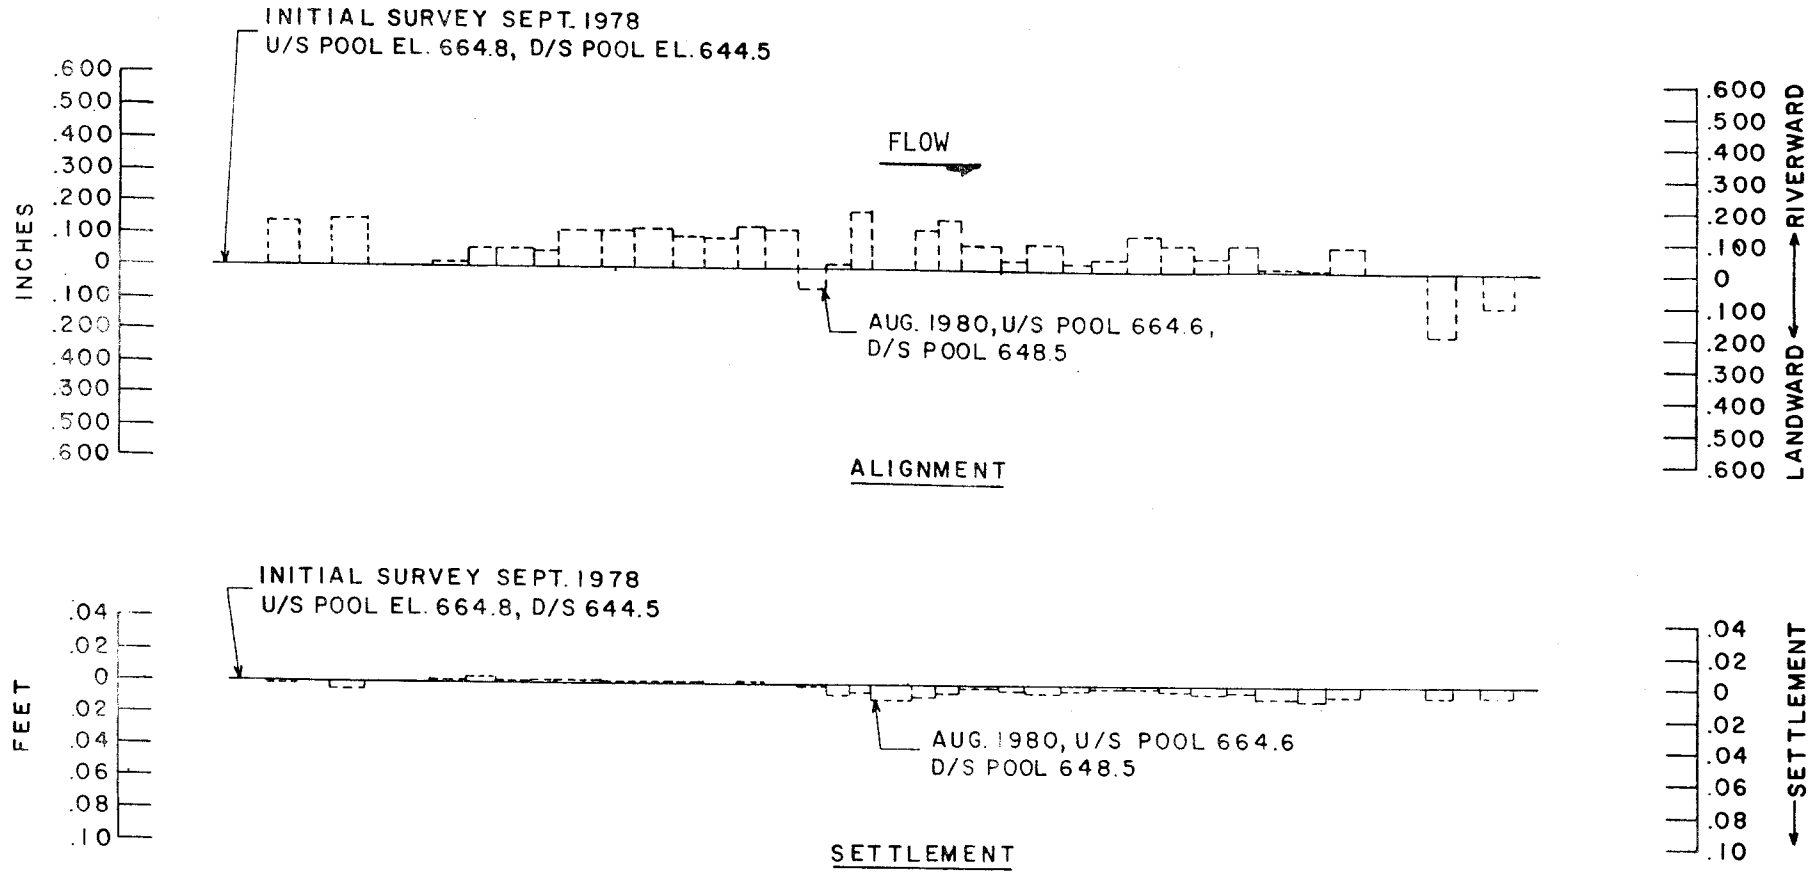
and then filling the drill hole with a hot-pour bituminous material (Pennsylvania Department of Transportation asphalt sealer J-1). It was reported in 1981 that the repair appeared to be performing satisfactorily. However, the sealer was very soft and expanded and contracted excessively. When the temperature was cool, the filler was down in the hole, and during a hot period, the filler expanded and pushed out cold patch material previously placed to fill the hole (Figure 71). This was considered to be undesirable by District personnel and it was recommended that other materials be investigated for sealing joints in the future. Alignment and settlement data for the middle wall is shown in Figure 72.

Figure 72. Alignment and settlement of middle wall, New Cumberland Locks

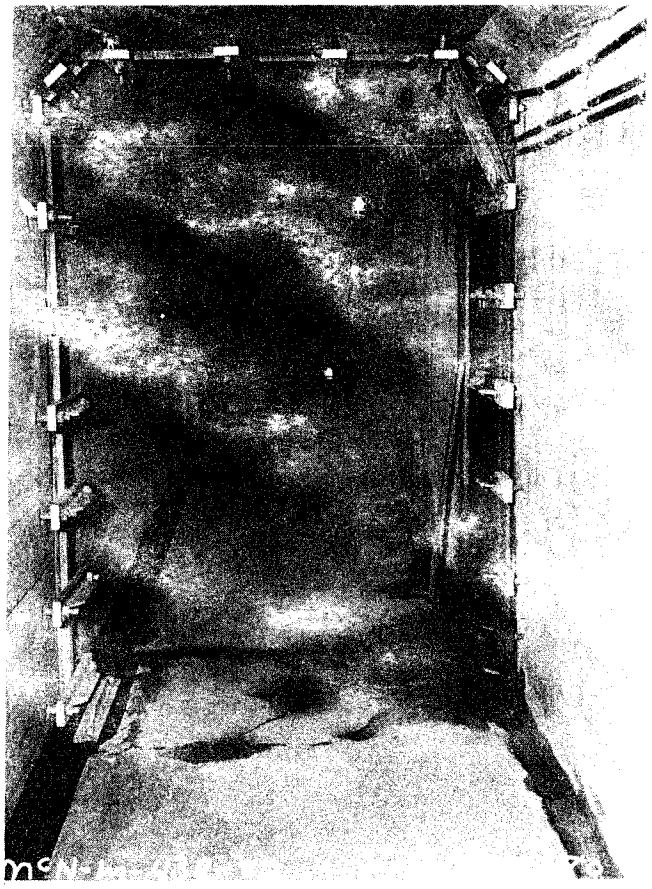
170. Leakage in the cross-over gallery at the construction joint between the lock's upstream sill block and the north overflow dam was again reported in October 1974. Progressive waterstop failures in the lock drainage and grouting galleries resulted in excessive leakage at the upstream sill. In 1978, leakage flooded the pump room damaging equipment to an extent that much of it required replacement. A surface-type gasket held in place by compressed steel bars bolted to the gallery walls (Figure 74) was used to control the leakage.

Figure 74. Surface-type waterstops, McNary Lock, 1980

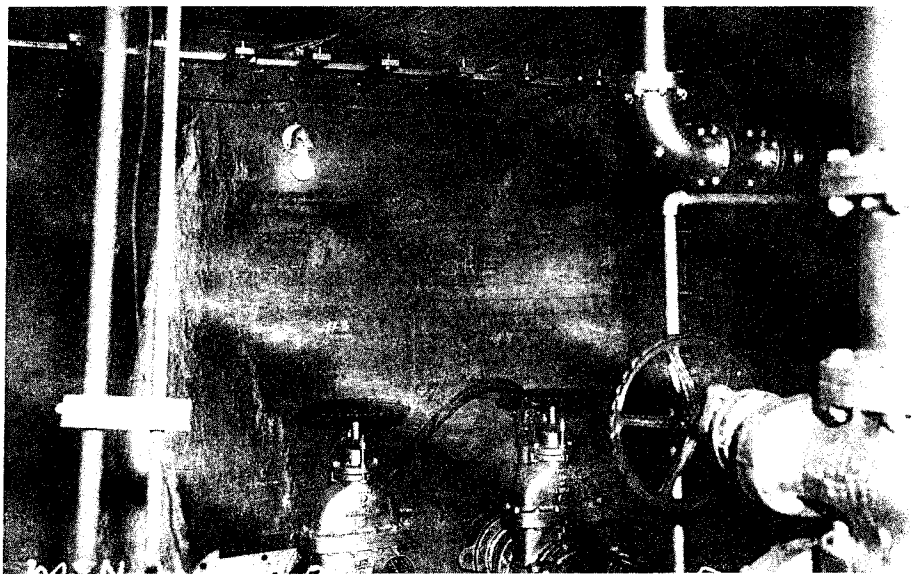
a. Joint 4/6 in the drainage gallery

b. Joint 6/8 in the lower pump room

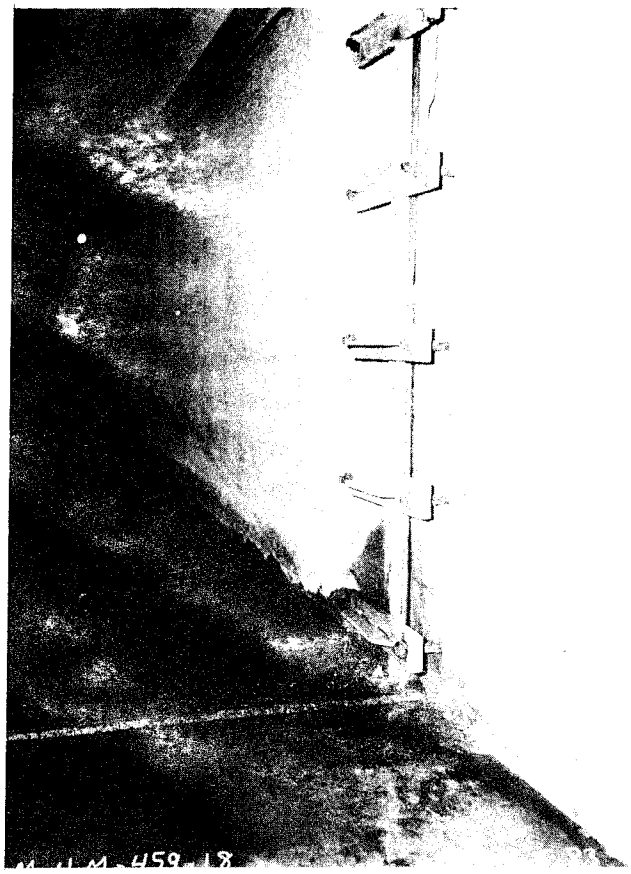
172. Joint leakage remained essentially unchanged at the next periodic inspection in 1983. A surface-type waterstop installed in the cross-over gallery at the joint between the downstream sill block and lock monolith 38 (Figure 75) continues to provide an adequate seal against leakage.

Figure 75. Surface-type waterstop, McNary Lock, 1983

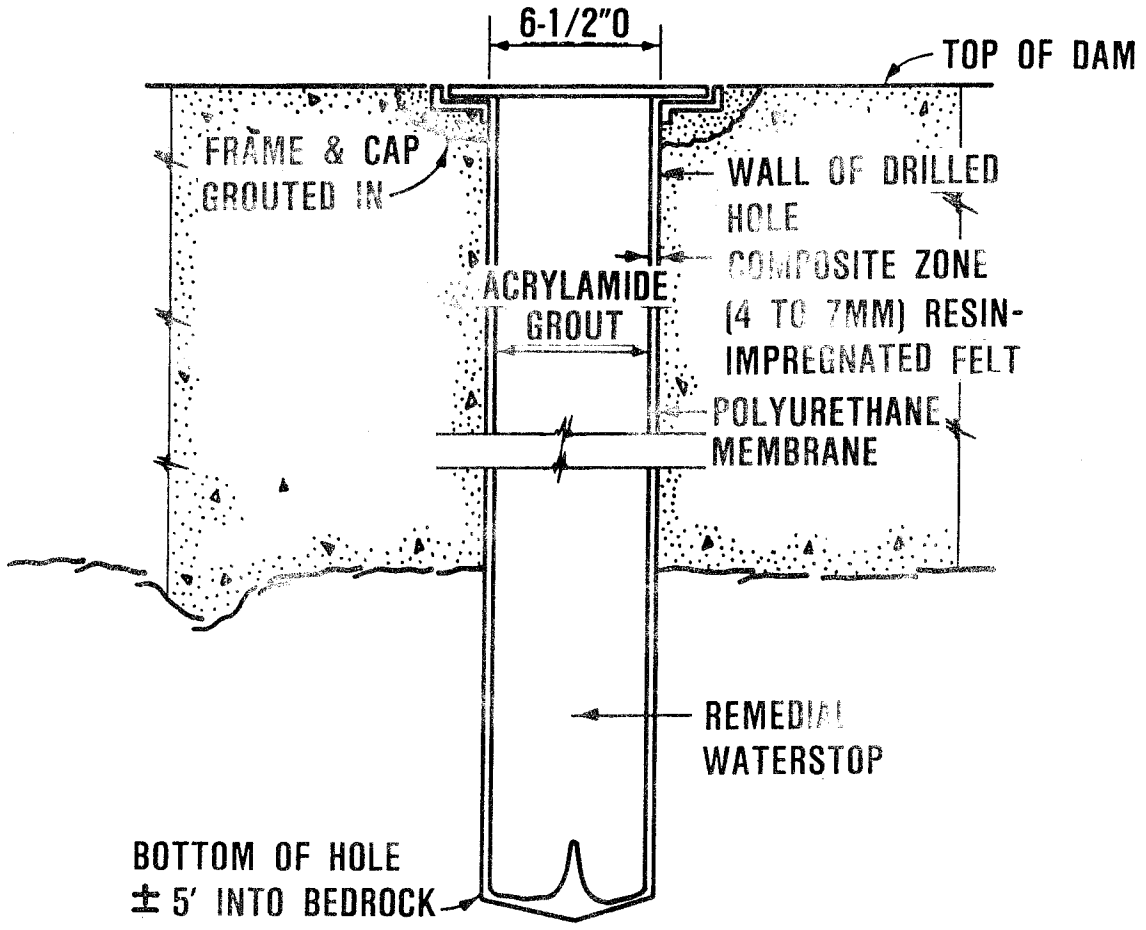
Figure 105. Completed remedial waterstop, Pine Flat Dam

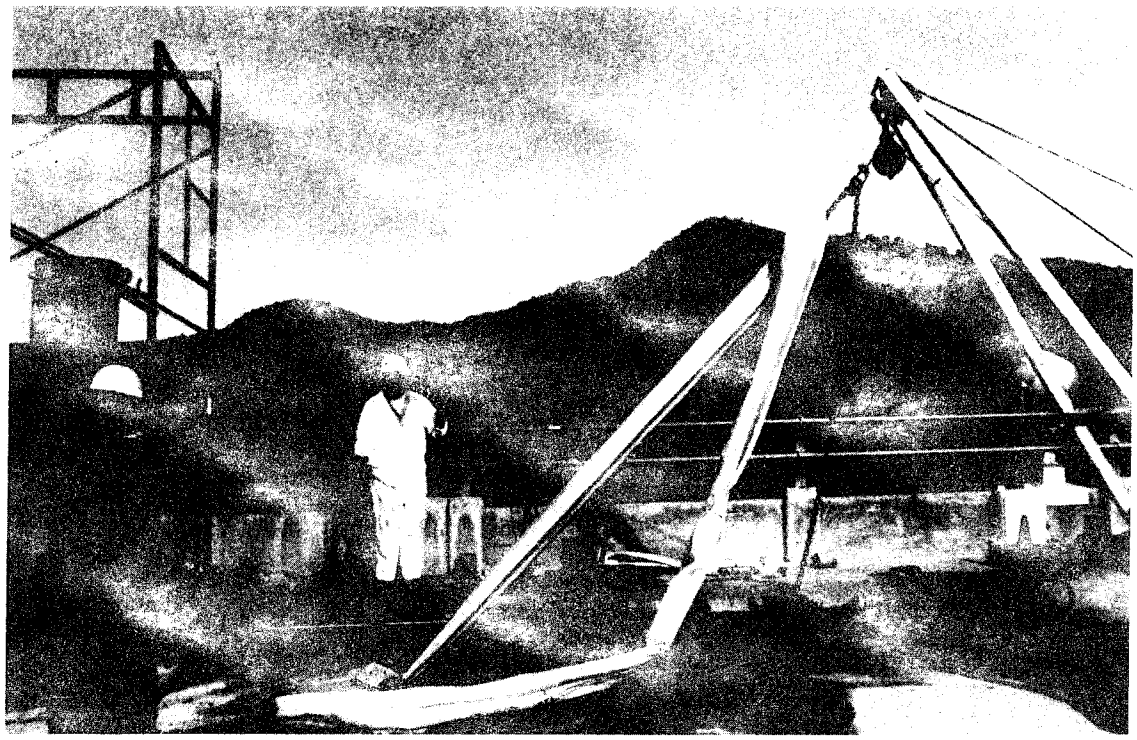
198. An examination of the liner indicated that a stitched seam had failed at a hole depth of approximately 145 ft. This allowed the water to

Figure 106. Removing the aborted tube from hole 29/30, Pine Flat Dam

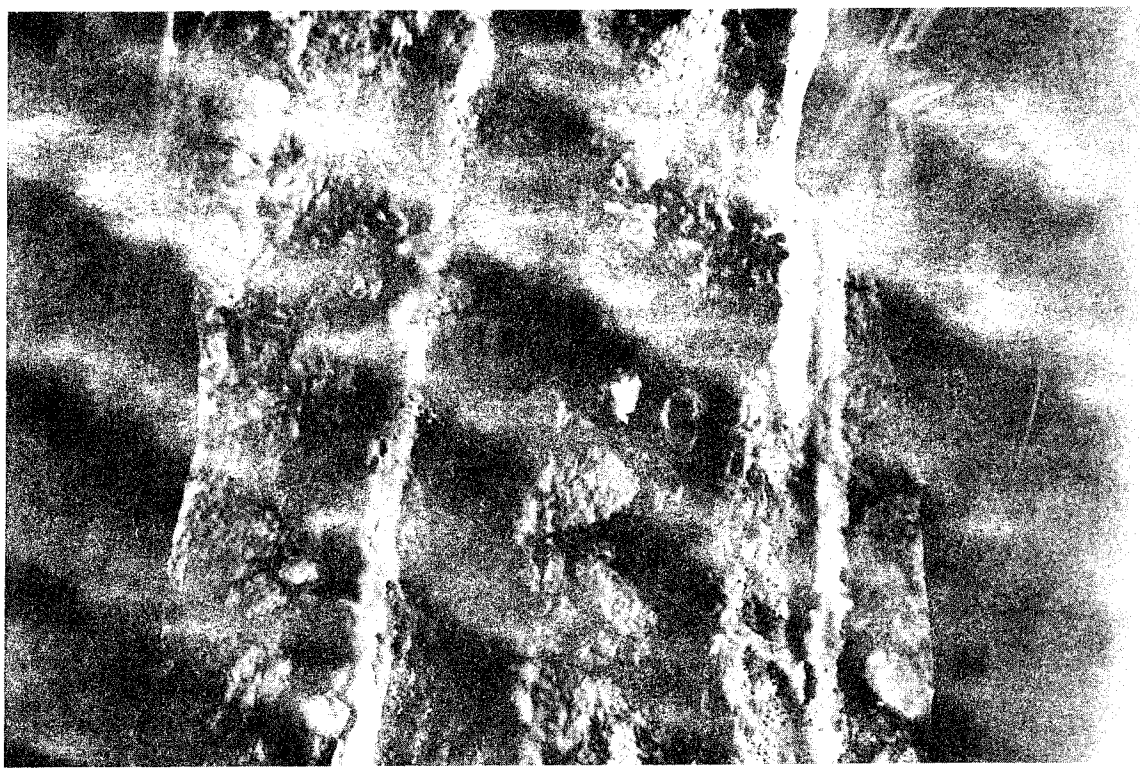
Figure 107. Dissected portion of the failed liner tube, Pine Flat Dam
