REPAIR, EVALUATION, MAINTENANCE, AND REHABILITATION RESEARCH PROGRAM

TECHNICAL REPORT REMR-CS-4

REPAIR OF WATERSTOP FAILURES: CASE HISTORIES

November 1986
Final Report

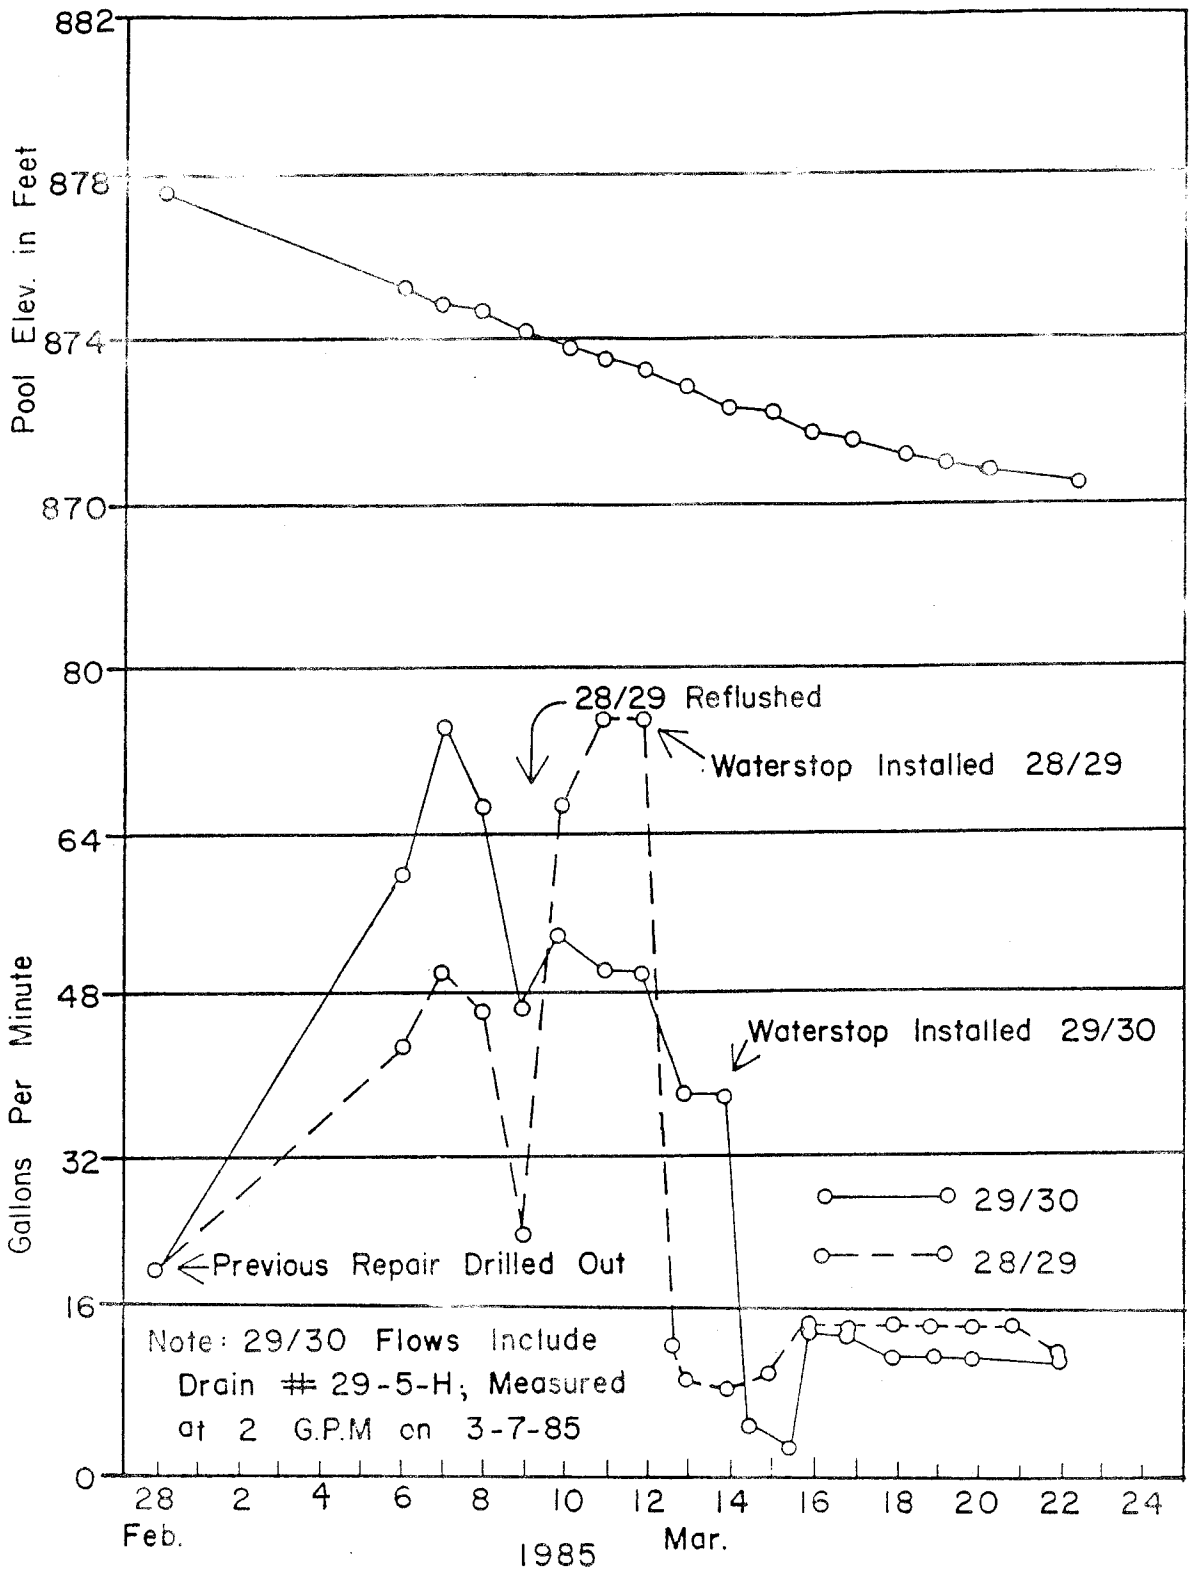
204. Historically, maximum flow through the three joints totals approximately 800 gal/min with a reservoir pool at elevation 950 ft. The reservoir pool level during the repair project ranged between elevation 880 and 870 ft (Figure 111) with a total flow of approximately 150 gal/min prior to repair. Of this total less than 1 gal/min was contributed by hole 30/31. Following installation of the remedial waterstops, total flow was stabilized at approximately 25 gal/min. As in most structures of this type, it is difficult to isolate leakage through monolith joints from that which is passing through horizontal lift joints. It is not known how much, if any, of the leakage into the drain was a result of openings in the lift joints. Results of this project indicate that the majority of flow has been through the vertical joints, yet it cannot be concluded that all of the flows are from the vertical joints.

205. It should be noted that flows prior to remedial waterstop installation are affected by work being performed in the holes. The previous grout plug presumably restricted leakage below what might occur without obstruction. However, removal of the grout created particles which were washed into the joint and again restricted flows. The flushing operations removed much of those particles and the flows increased, as can be seen in Figure 111, between 28 February and 7 March. A reversal of the trend on 7 March is due to limited flushing on 7 March which apparently only agitated the grout particles causing them to flow into the joints. A more thorough flushing on 9 March using drilling foam removed particles from the joints and flushed them out of the holes. This caused the flow through joint 28/29 to reach a level of approximately 75 gal/min.

206. Flow through joint 29/30 peaked at 75 gal/min on 7 March (Figure 111). On 8 March, the aborted installation reached a depth of 145 ft (elevation 825 ft) before the tube was removed. The fluorescent dye test performed in May 1984 indicated a zone of leakage between elevations 870 and

Figure 111. Joint leakage rates, Pine Flat Dam

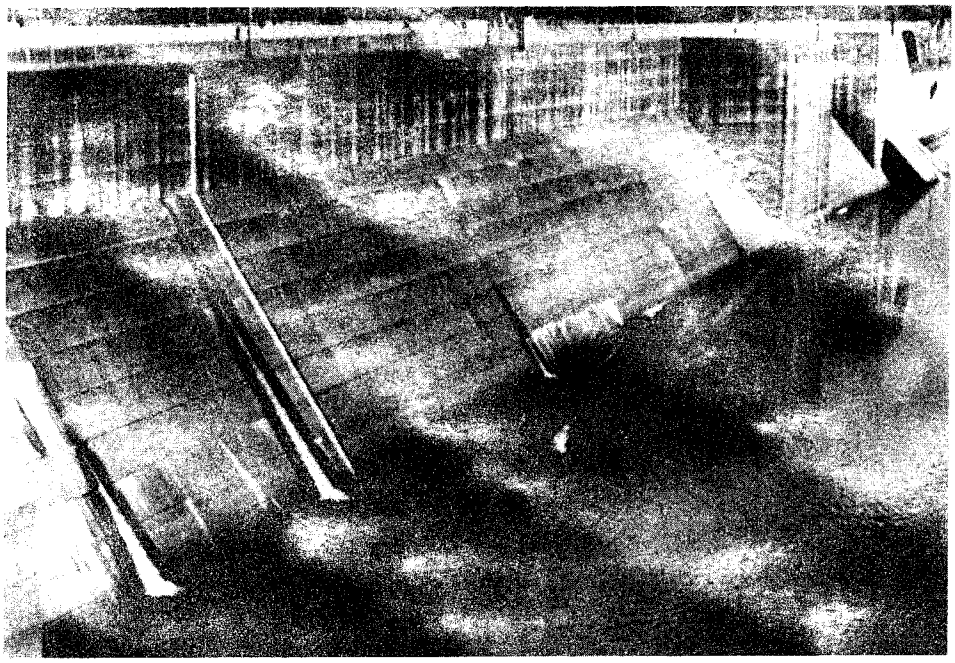
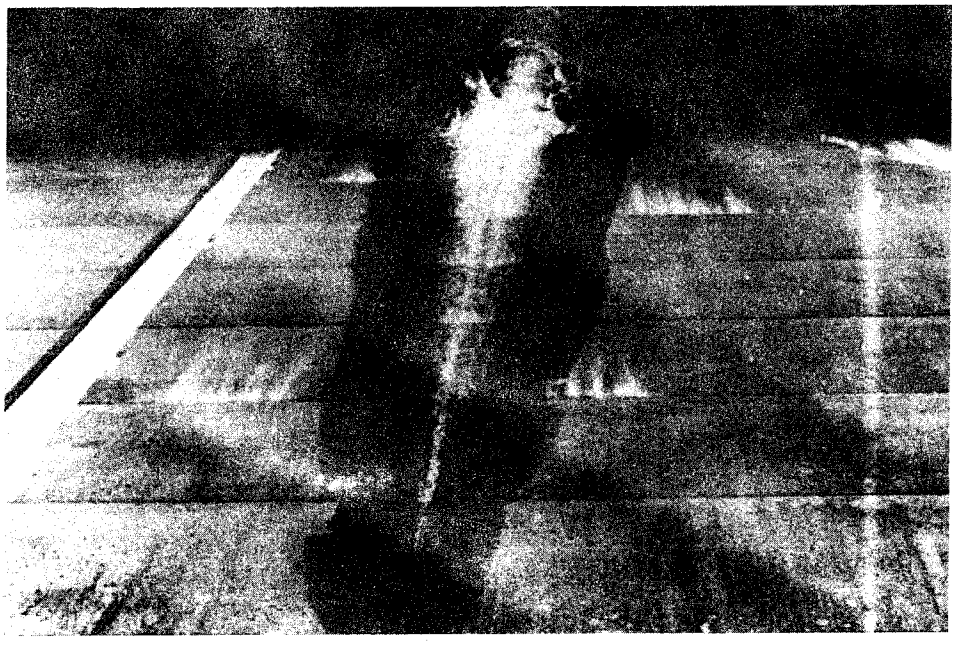
209. The Dardanelle Lock had six vertical monolith joints that had been leaking since 1975. The leakage only occurred during cold wintertime conditions. They were first investigated in January 1977 when the leakage had increased significantly (Figures 113 and 114). Observation and dye tests proved that water from the lock chamber, both at low and full chamber, was passing through the monolith joints. Defective copper waterstops were the probable cause of the leakage. Visual leakage existed at river wall monolith joints R7/8, R8/9, R10/11, R13/14, R18/19, and land wall joint L21/22. Monolith joints R18/19 and L21/22 are located at the lower miter sill and leakage through these joints entered the lock wall grouting galleries and then to the lower miter sill cross-over gallery where sump pumps are located. Total inflow during full lock chamber (wintertime) increased from 75 gal/min in January 1977 to 382.2 gal/min in January 1981. The sump pumps were taxed to the maximum and were modified several times to handle the high inflow.

a. View of riverward lockwall taken from dam looking downstream

b. Close-up of largest leakage

Figure 113. Leakage through monolith joints with lock chamber at upper pool level

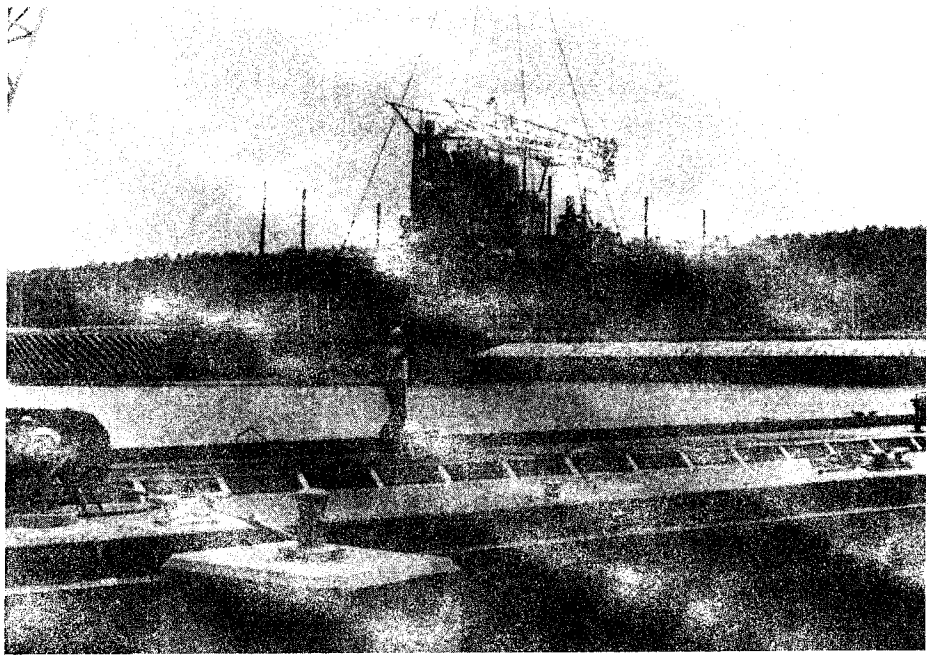
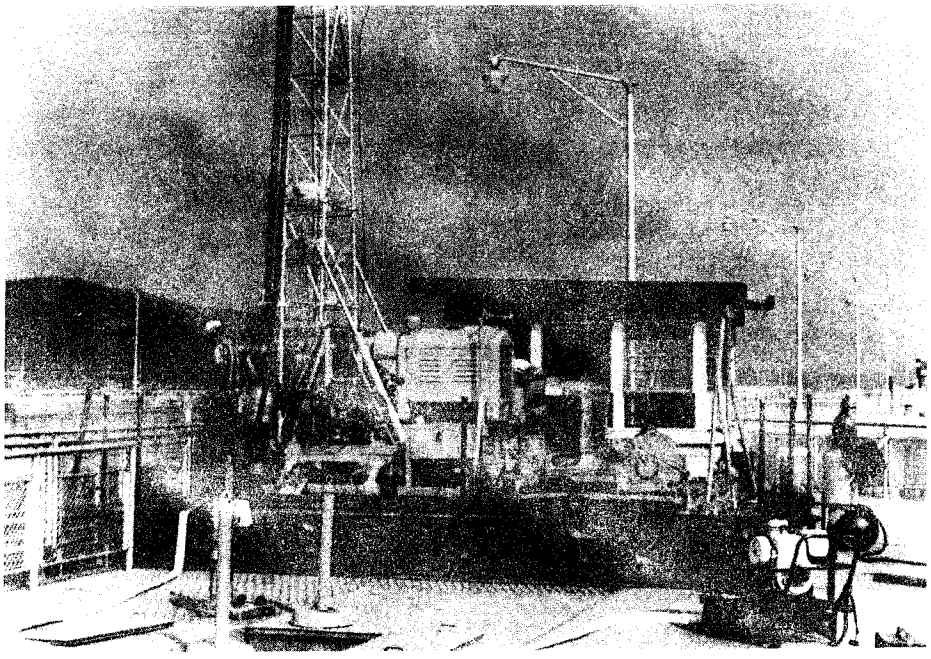
Figure 116. Drilling operations, monolith joint L21/22

213. Both holes went to a depth of 82 ft which bottomed 1-2 ft into foundation rock (sandstone). The core holes were started on location, centered across the monolith joint by means of an anchored metal template. Difficulty was encountered on the first hole (L21/22, landward lock wall) when the core lost the monolith joint at 41.2 ft. At 51.2 ft the drill hole was stopped when it was judged that the drill hole completely left the joint. Attempts were made to straighten the drill hole with no success and the hole was abandoned. A wireline core barrel (4.827-in. hole, 3.345-in. core) was obtained to complete the project which produced better results in drilling a plumb hole.

214. Vertical drill rig alignment was monitored during drilling by two transits located at right angles to each other. Sightings were made on the drill head quill and on the drill rod to ensure vertical drilling. Slight leveling of the rig was necessary during drilling operations because of settlements due to vibrations. As the coring progressed, the extracted core was studied for joint alignment (Figure 117). Plumbness of the cored hole above the waterline was easily checked by a plumb bob and flashlight. After a depth of about 20 ft, plumbness of the hole was checked every 5 ft by a device designed out of necessity. The device was a pencil-shaped plumb bob and a can with the bottom lined with modeling clay. The can (slightly smaller than the hole, perforated, weighted with washers in the clay bottom, and suspended by two nylon strings) was very slowly lowered to the bottom of the hole, ensuring correct orientation. The plumb bob was lowered to the bottom and suspended through a hole in a template placed on top of the hole. The plumb bob was stopped 1 ft above the bottom, allowed to plumb for 5 min, and then allowed a free fall into the clay making an indentation. The total procedure was repeated a second time as a check. This method will indicate deflection of the bottom of the hole in relation to the top of the hole, and direction of the deflection. A hole that has deflected can be straightened generally. However, this procedure should be attempted only by experienced personnel. Briefly, in a vertical hole that has deflected to the right, the drill rig and drill stems should be moved vertically to the right (same as the deflection).

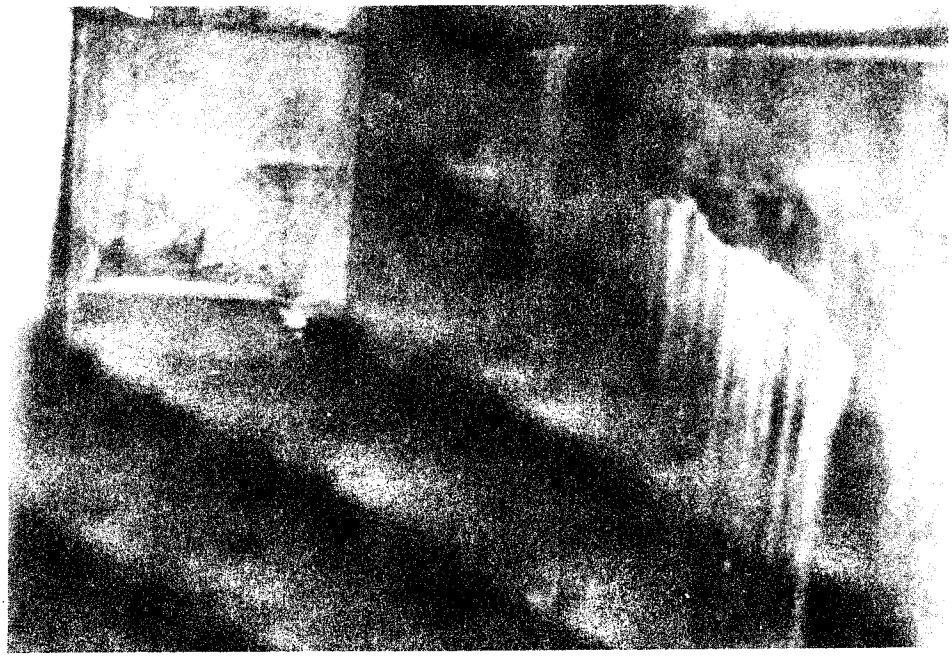
Figure 119. View of monolith joint R18/19 after installation of waterstop

220. The new waterstops reduced the leakage into the galleries by at least 95 percent. Photographs of the leakage before and after waterstop installation are shown in Figures 114 and 119.

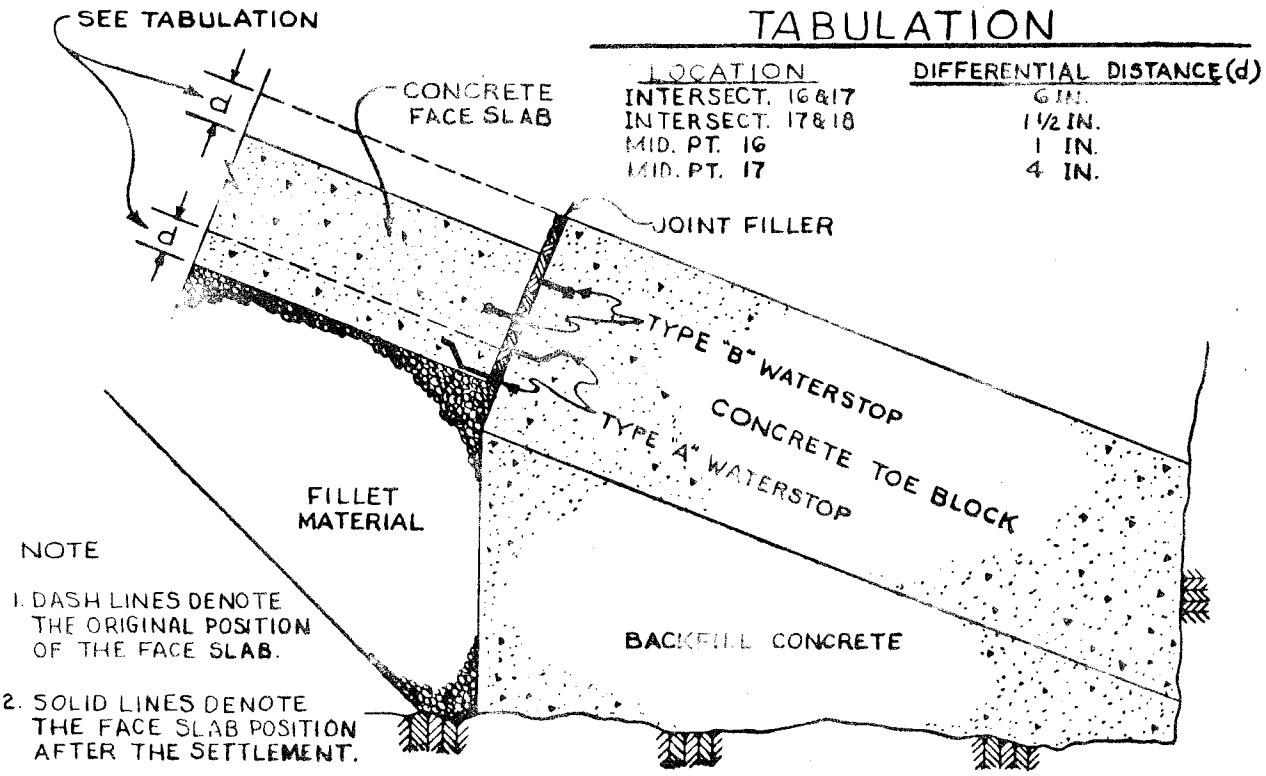
Figure 121. Displacement between face slabs and toe block, R. D. Bailey Dam

b. A seepage area was identified in the perimeter joint extending from the middle of lane 16 to lane 18. The elevation of this seepage area varied from approximately elevation 920 ft to elevation 975 ft. Suction was quite strong at several isolated points. Also in this area the face slabs had settled about 6 in. at the intersection of lanes 16 and 17, and the toe block (Figure 121).

most probable cause of the distress was consolidation of the fillet material, aggravated by the introduction of water, under head, into the fillet zone. Potential entry paths for the water included (a) a known discontinuity in the waterstops, (b) defective or damaged waterstops, (c) a defective cutoff wall, and (d) waterstop failure due to excessive consolidation of fillet material upon application of load. Considering the condition of the distressed area of the dam together with the performance requirements, it was also concluded that the dam was functioning as designed and that there was no cause for concern for either rapid or progressive failure.

230. It was recommended that a mixture of concrete sand and clay be fed into seepage areas to fill any voids behind the face slab and cover the distressed areas. This was accomplished in December 1981 by lowering bags filled with the sand and clay mixture down the face of the dam by a cart and having divers empty the bags in the distressed areas. After the mixture was placed, no flow through this area could be detected.

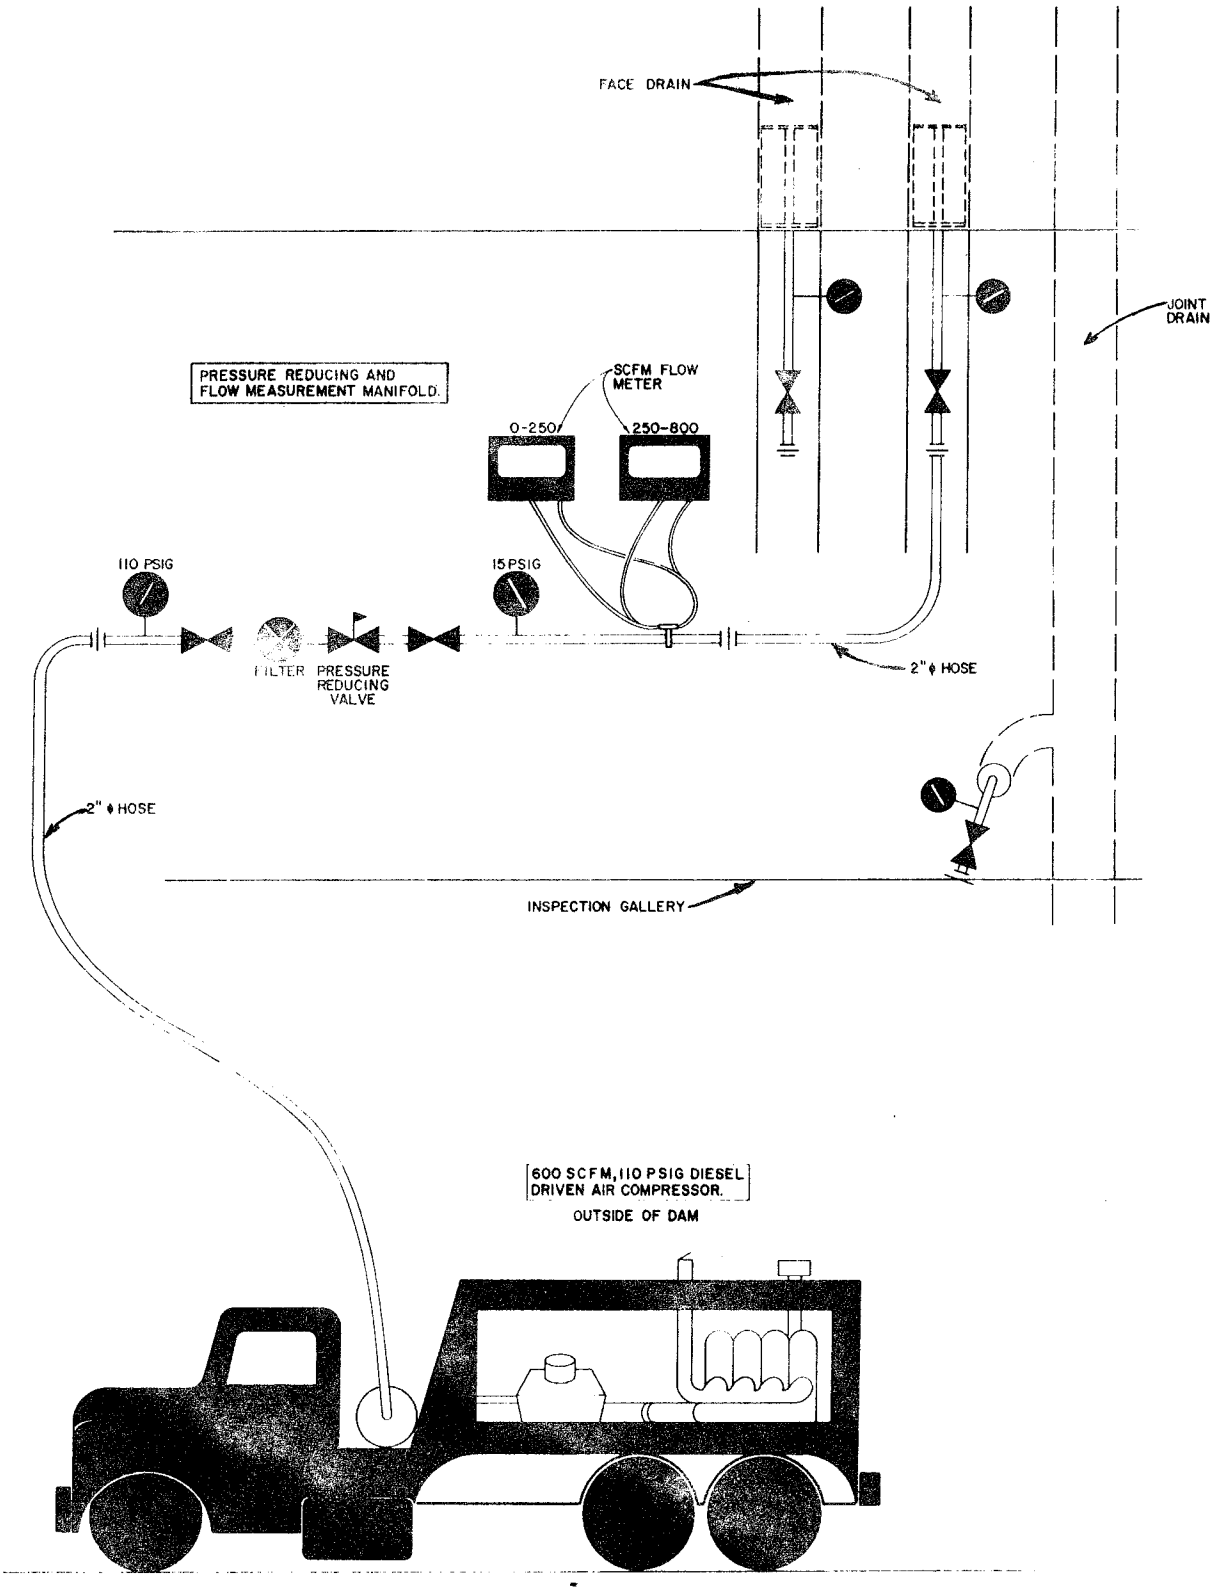
Figure 132. Schematic of air test equipment, Richard B. Russell Dam

258. Compressed air test. The purpose of the air test was to eliminate from further testing the drains that were not suspected of leakage and to identify the drains that had probable major leakage for more intensified testing. This test was chosen to precede the following tests because of its short set-up time and fast operation. The test involved sealing the bottom of the face and joint drains, sealing the top of the joint drains, piping compressed air into a face or joint drain, and measuring the amount of air flow necessary to maintain a constant pressure within the drain. The compressed air test equipment was configured as shown in Figure 132. The air test performed on Richard B. Russell Dam was successful in eliminating 38 percent of the 182 drains from further testing. Most of the drains eliminated were in the nonoverflow sections of the dam. The test also showed, because of the interconnection of drains, that the horizontal lift lines had voids that could possibly reach to a vertical contraction joint and the face of the dam.

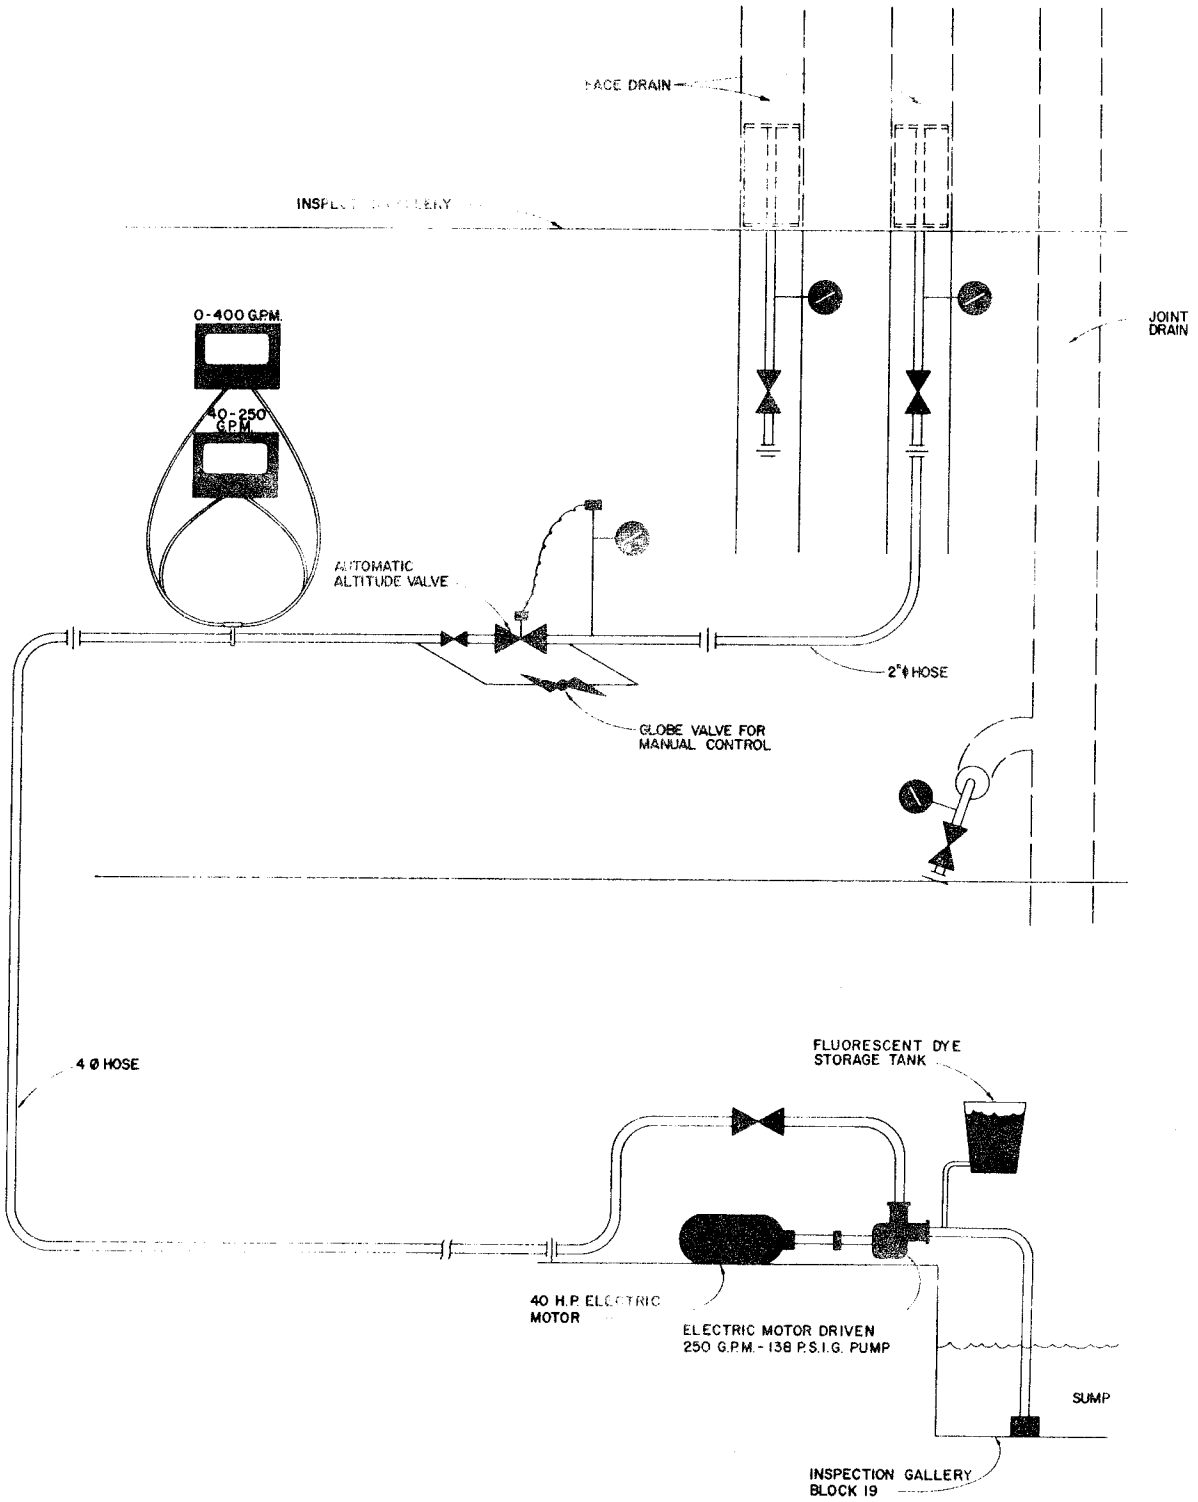
Figure 133. Schematic of water test equipment, Richard B. Russell Dam

261. Water test. The water test was performed on drains which, according to the results of the air test, had the greatest potential for leakage. The purpose of the water test was to attempt to determine the location of the seepage. The water test consisted of sealing the bottom of the drains with packers and then filling the drains with green water in incremental steps. At each step, the flow required to hold water at that given level was measured. Concurrently, a video camera team was suspended over the side of the dam to observe and to record evidence of leakage, noting locations and elevations. The water test equipment was configured as shown in Figure 133. Almost all of the leakage, as observed from outside the dam by the camera crew, occurred at the contraction joints. This leakage ranged from a mere trickle to a steady stream squirting several feet from the face of the dam. In some cases, leakage was observed from these joints on the downstream face as well as the upstream face. On occasion, leakage was also observed at: lift lines, the area around the intake gates and penstocks, as well as at cracks and joints in operating and inspection galleries. Video recording of the water test, using a 12-power zoom lens, provided the most revealing and successful data regarding the exact locations of leakage on the face of the dam. However, this method obviously could not document the internal voids and leakage paths indicated by the testing.

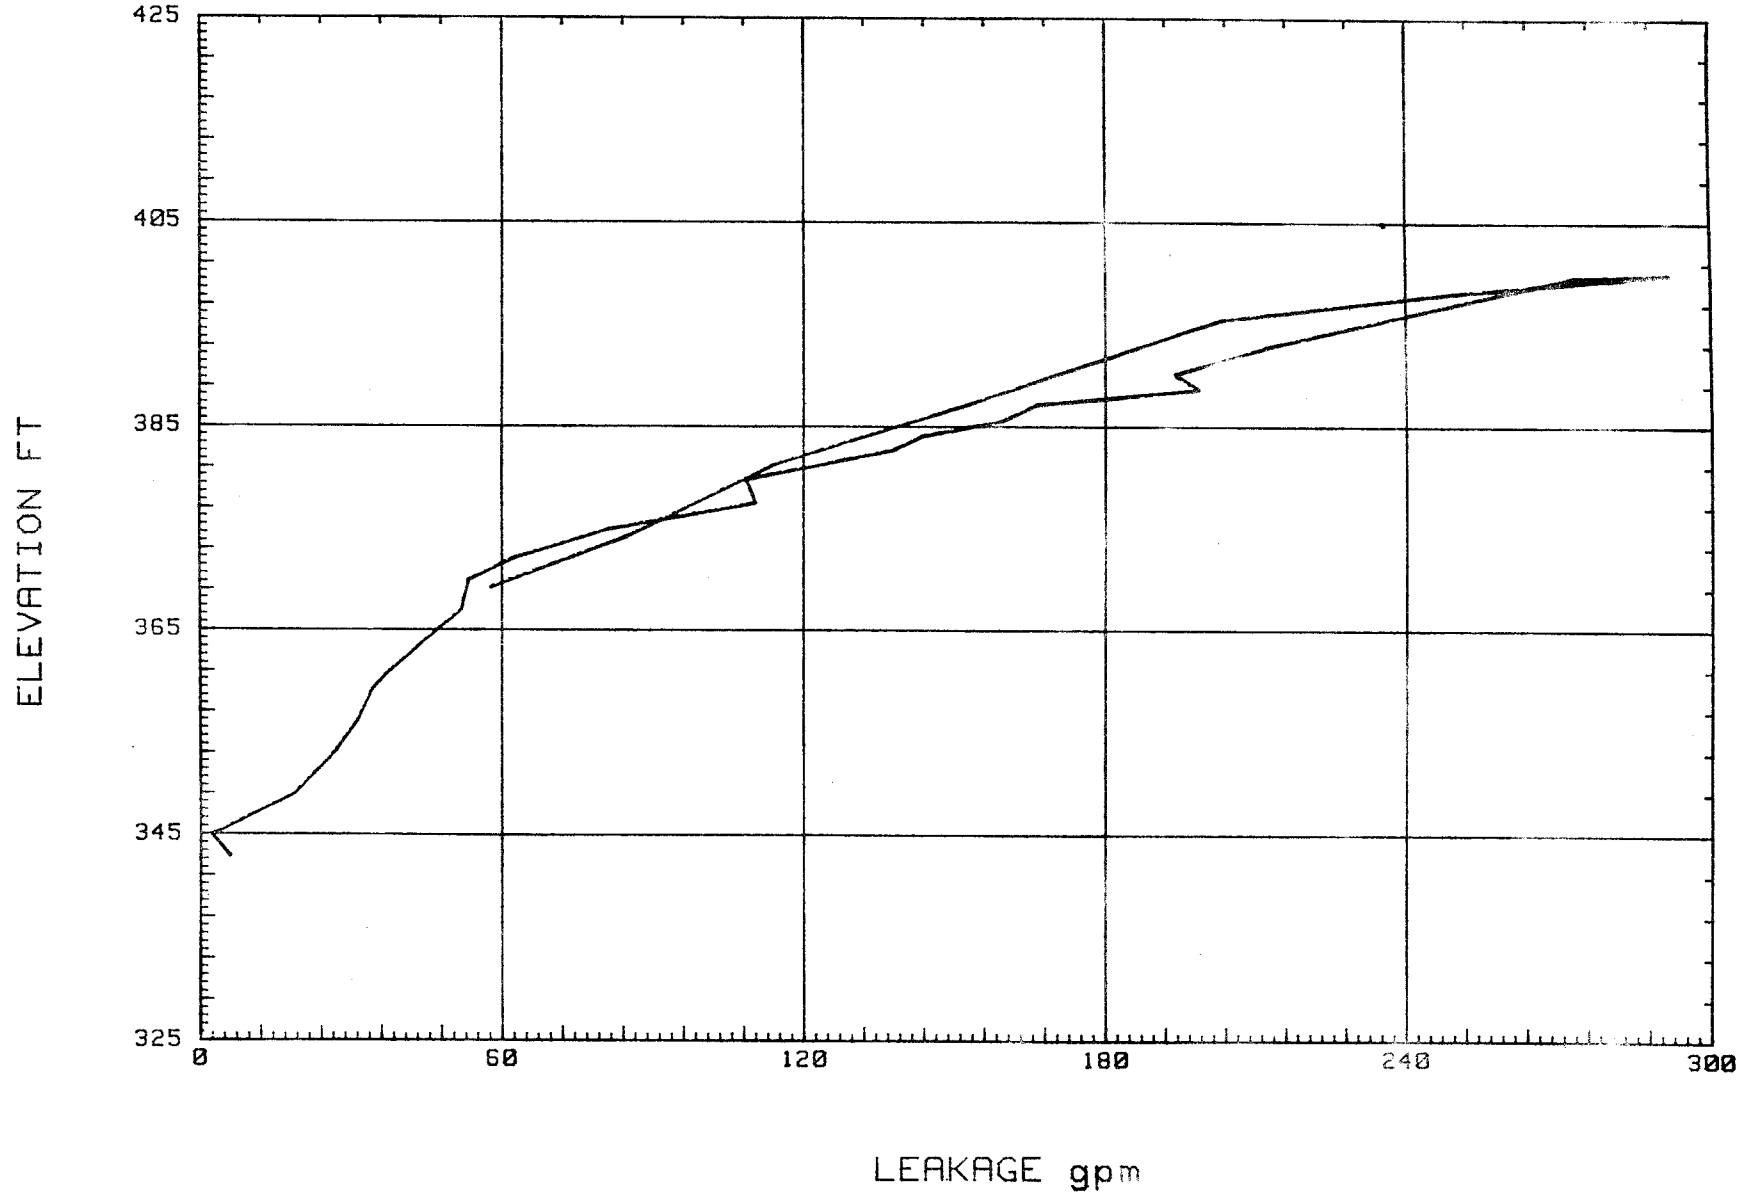
Figure 136. Leakage measurements, Richard B. Russell Dam, 6-15 June 1983

270. After test repairs on the five joints were completed, the pool was again raised to elevation 400 ft to evaluate the effectiveness of the repair. The sluice gates were closed on 6 June 1983 when the lake was at elevation 342.1 ft. As the lake level began to rise, leakage was measured at approximately 5-ft intervals until the lake reached elevation 400 ft on 10 June. The sluices were opened 11 June, and the lake was allowed to fall. The monitoring process continued through 15 June, as the lake stabilized at elevation 360 ft, with results as shown in Figure 136.

271. The maximum leakage measured (292 gal/min) was less than one-half the leakage measured during February 1983 with the lake at the same elevation. Also, leakage into the drains near four of the five grouted joints was either eliminated or drastically reduced. Face drain 19a was not affected by sealing joint 18/19; this leakage was believed to be entering from below the bottom of the seal (elevation 347.5 ft).

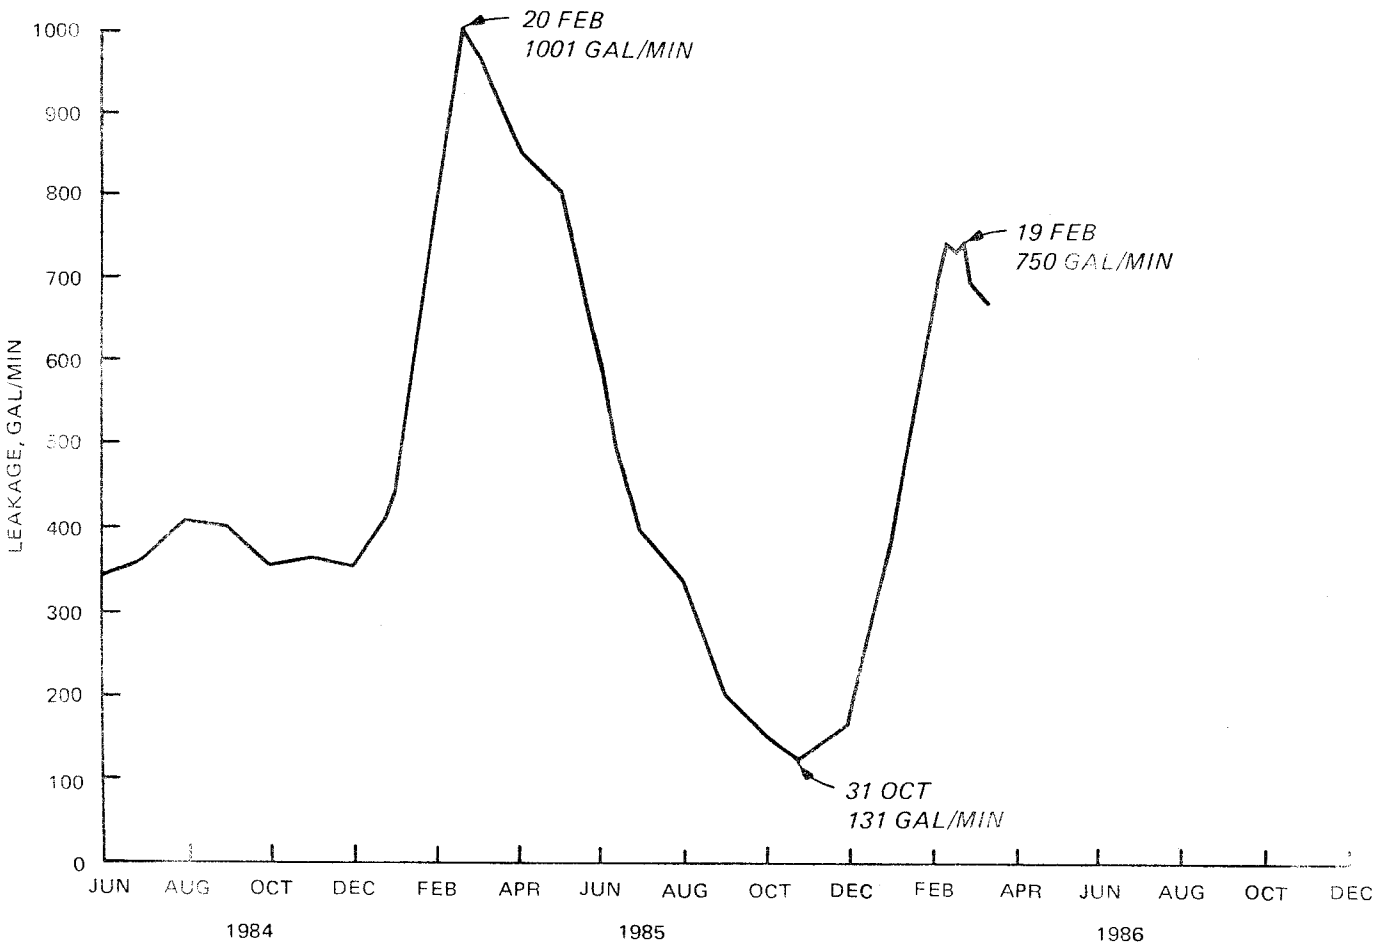
Figure 143. Results of leakage measurements, Richard B. Russell Dam

repairs, a maximum leakage of 1,001 gal/min was recorded on February 20, 1985 followed by a steady decline to 131 gal/min on October 31, 1985 (Figure 143). In 1986, the maximum leakage of 750 gal/min was recorded on February 19. Continued measurements and observations are planned through another winter cycle. Based on experience at other dams, it is believed that the formation of calcium carbonate will further reduce the leakage.

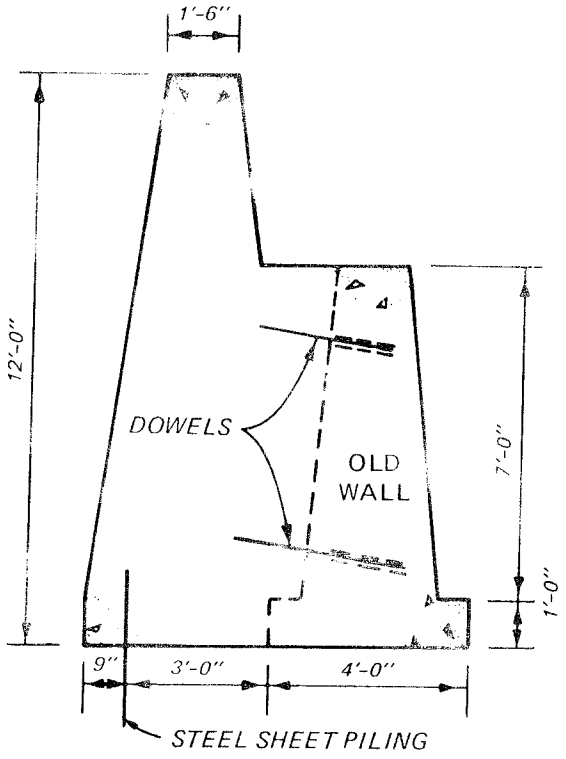
Figure 158. Typical wall section, Caruthersville Floodwall

309. The floodwall is located at Caruthersville, Mo., along the right bank of the Mississippi River. The 2,990 ft of concrete gravity wall was constructed in 1932. Approximately 2,000 ft of the floodwall incorporates an old wall which was constructed sometime prior to 1932 (Figure 158). A 3/8-in.-thick steel plate, 1 ft wide and 12 ft long, was used as a waterstop in each vertical joint between monoliths (Figure 159). An asphaltic compound was applied to that half of the plate in one monolith to prevent bond to the concrete, and a vertical slot was provided at that edge of the waterstop to accommodate movement of the plate. The joint on each side of the steel plate was filled with an asphalt-impregnated fiber joint filler.

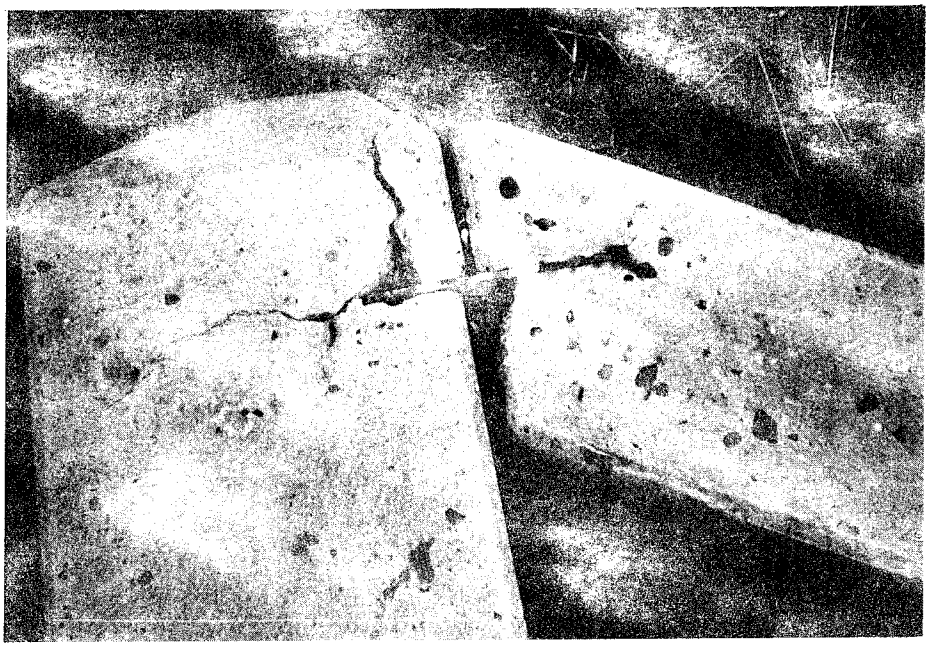
Figure 160. Typical concrete cracking and spalling around the steel plate waterstop, Caruthersville Floodwall
