Technical Note No. Met.46

ROYAL AIRCRAFT ESTABLISHMENT, FARNBOROUGH

Final Note on the Relative Suitabilities of D.T.D.303 and D.T.D.327 Rivets for D.T.D.118 Magnesium Alloy Sheet

S. Ackroyd, B.Sc.
and
H.C. Cooks, Ph.D., F.R.I.C.

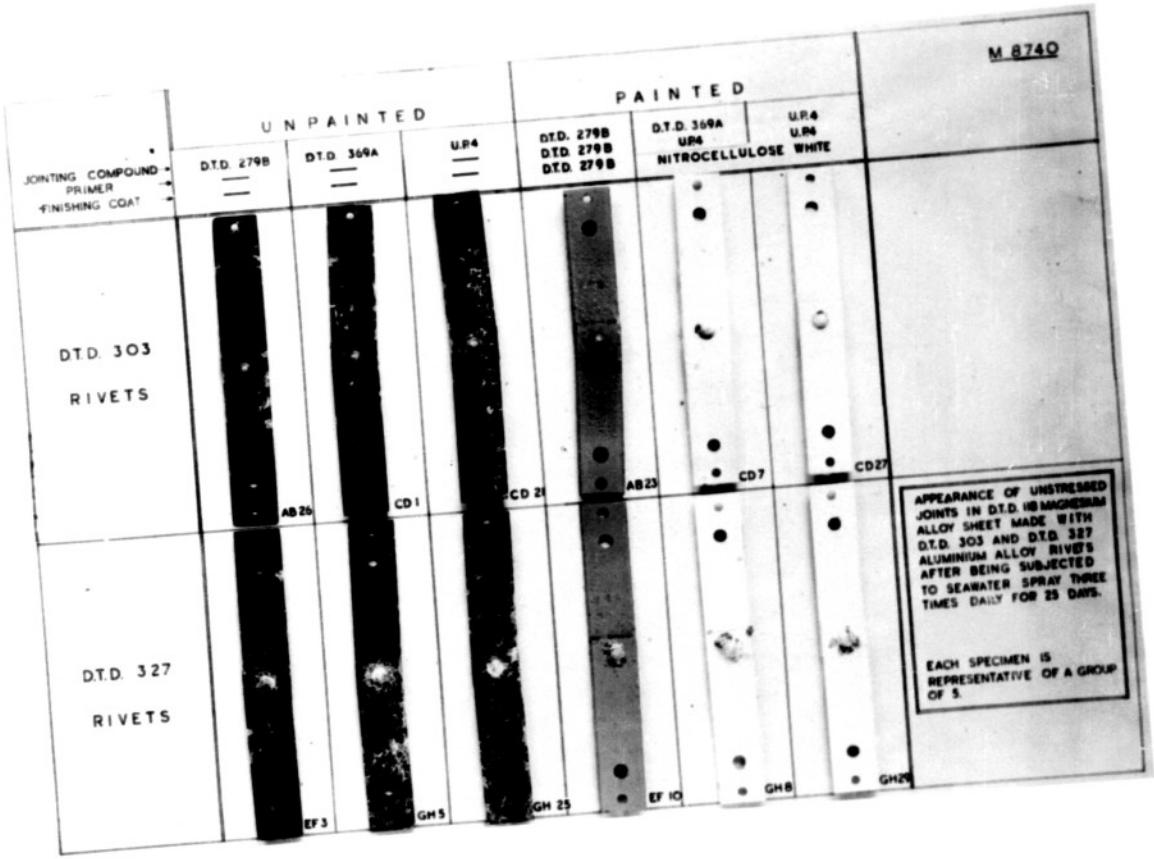
FIG. 1

From the beginning of the test it became increasingly apparent that with every painting scheme and with the unpainted specimens, the amount of corrosion products, both on the rivet head and on the sheet near the rivet, was considerably greater with the D.T.D.327 rivets than with the D.T.D.303 rivets. This feature can be seen in the photographs (Figs.1-4).

Fig.1 shows a representative from each group of five single riveted unstressed specimens after 25 days corrosion.

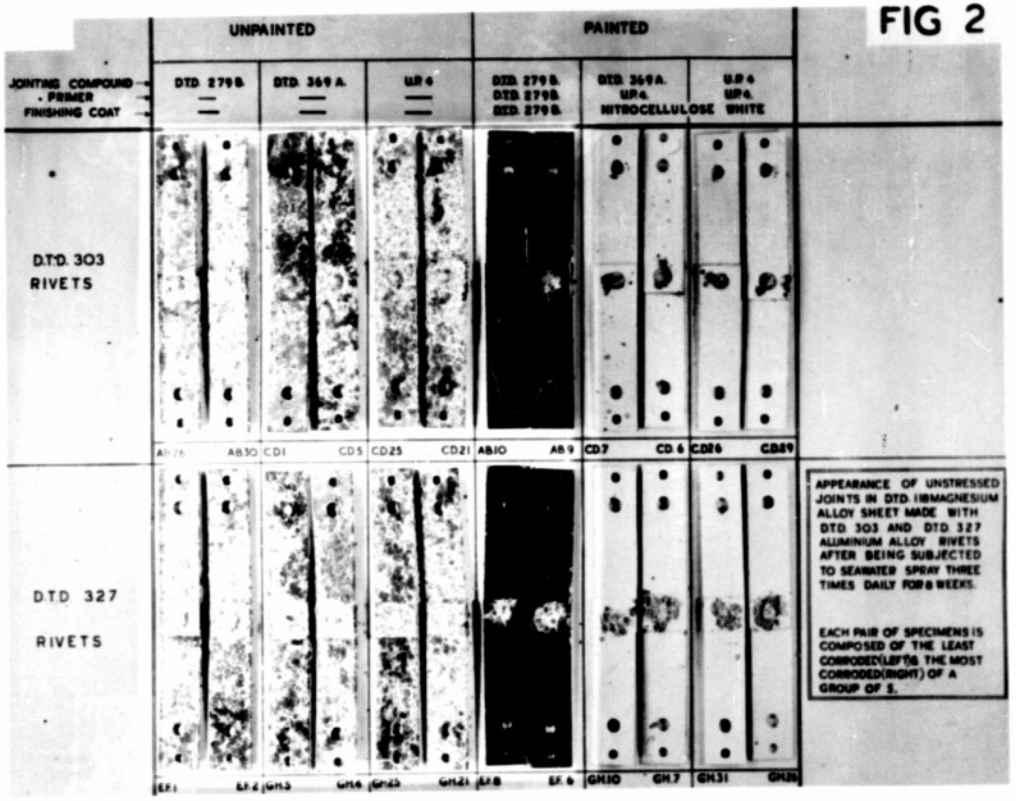
FIG.2

Fig.2 shows the (visually) most corroded and least corroded of each group of five single riveted unstressed specimens after eight weeks corrosion.

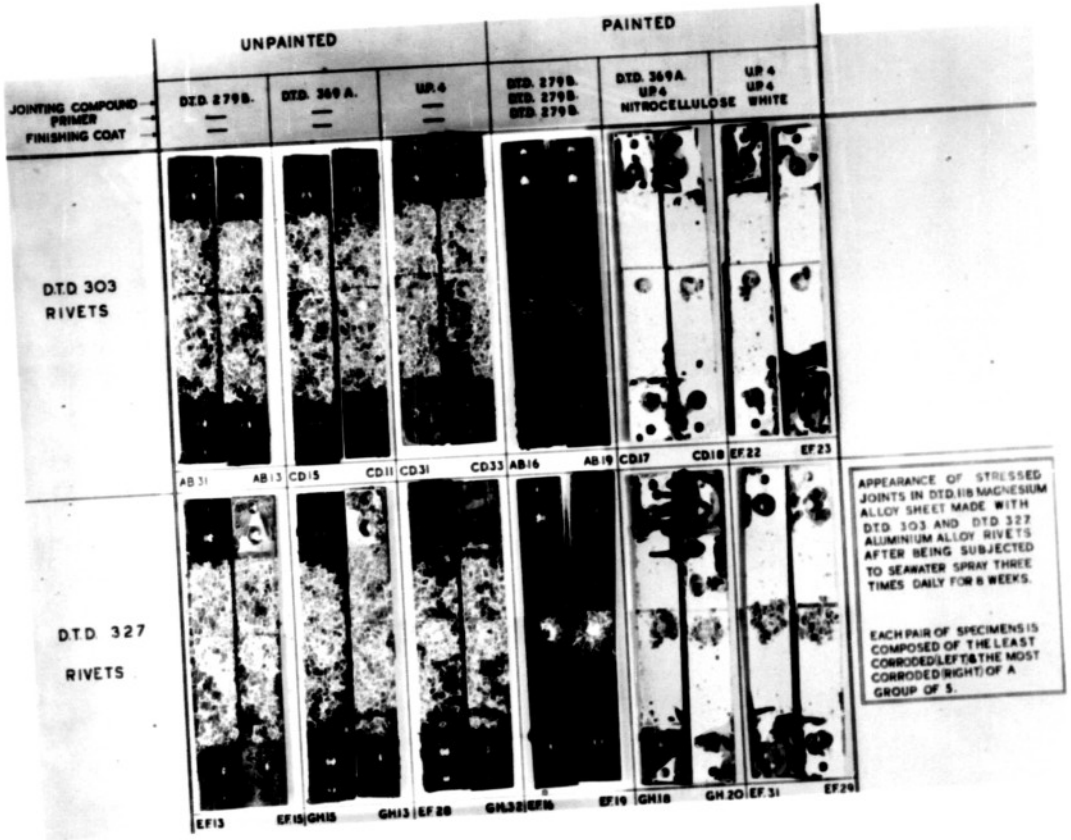
FIG. 3

Fig.3 shows the same as Fig.2, but for the stressed specimens. (The markings at each end of these specimens are due to paint from the magnesium alloy links, and not to corrosion.)

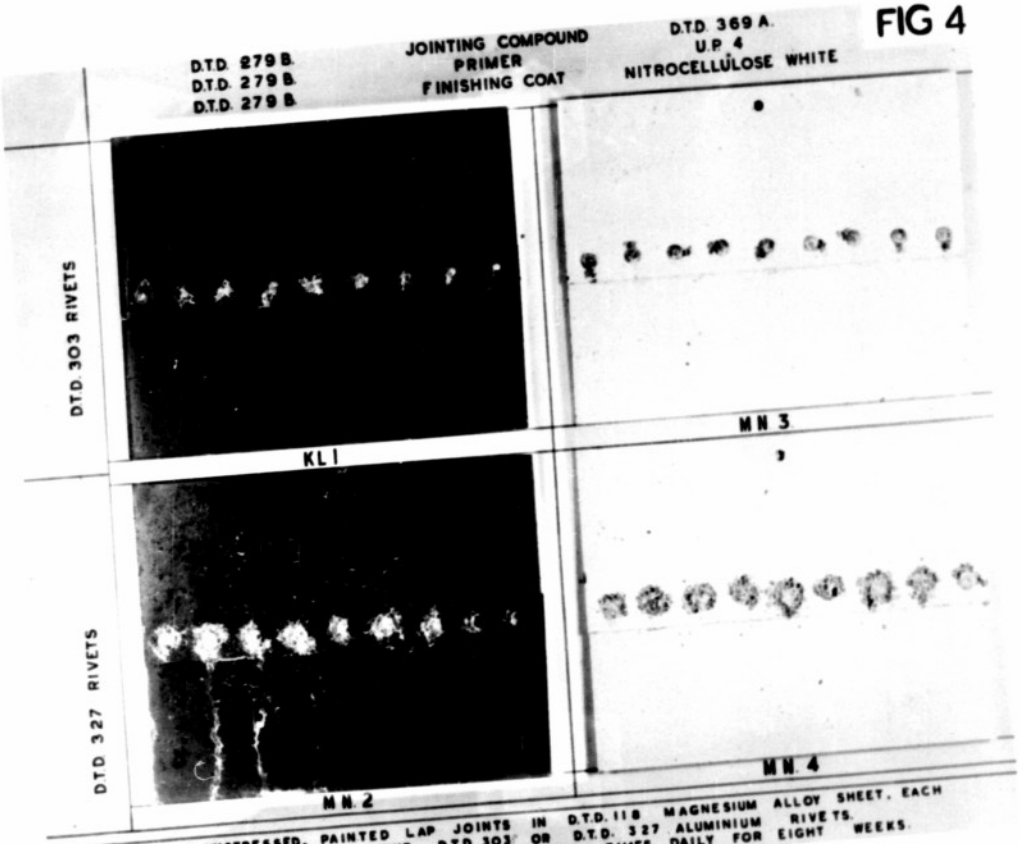
FIG. 4

Fig.4 shows four of the large painted specimens after eight weeks corrosion.

APPEARANCE OF UNSTRESSED, PAINTED LAP JOINTS IN D.T.D. 118 MAGNESIUM ALLOY SHEET, EACH MADE WITH A SINGLE ROW OF NINE D.T.D. 303 OR D.T.D. 327 ALUMINIUM RIVETS. THE JOINTS WERE SUBJECTED TO SEA WATER SPRAY THREE TIMES DAILY FOR EIGHT WEEKS.
