FINAL REPORT GRAPHITE COMPOSITE LANDING GEAR COMPONENTS TECHNICAL DISCUSSION VOLUME I

HERCULES INCORPORATED, SYSTEMS GROUP
BACCHUS WORKS, MAGNA, UTAH

TECHNICAL REPORT AFFDL-TR-77-20, VOLUME I

FINAL REPORT FOR PERIOD FEBRUARY 1973 - FEBRUARY 1977

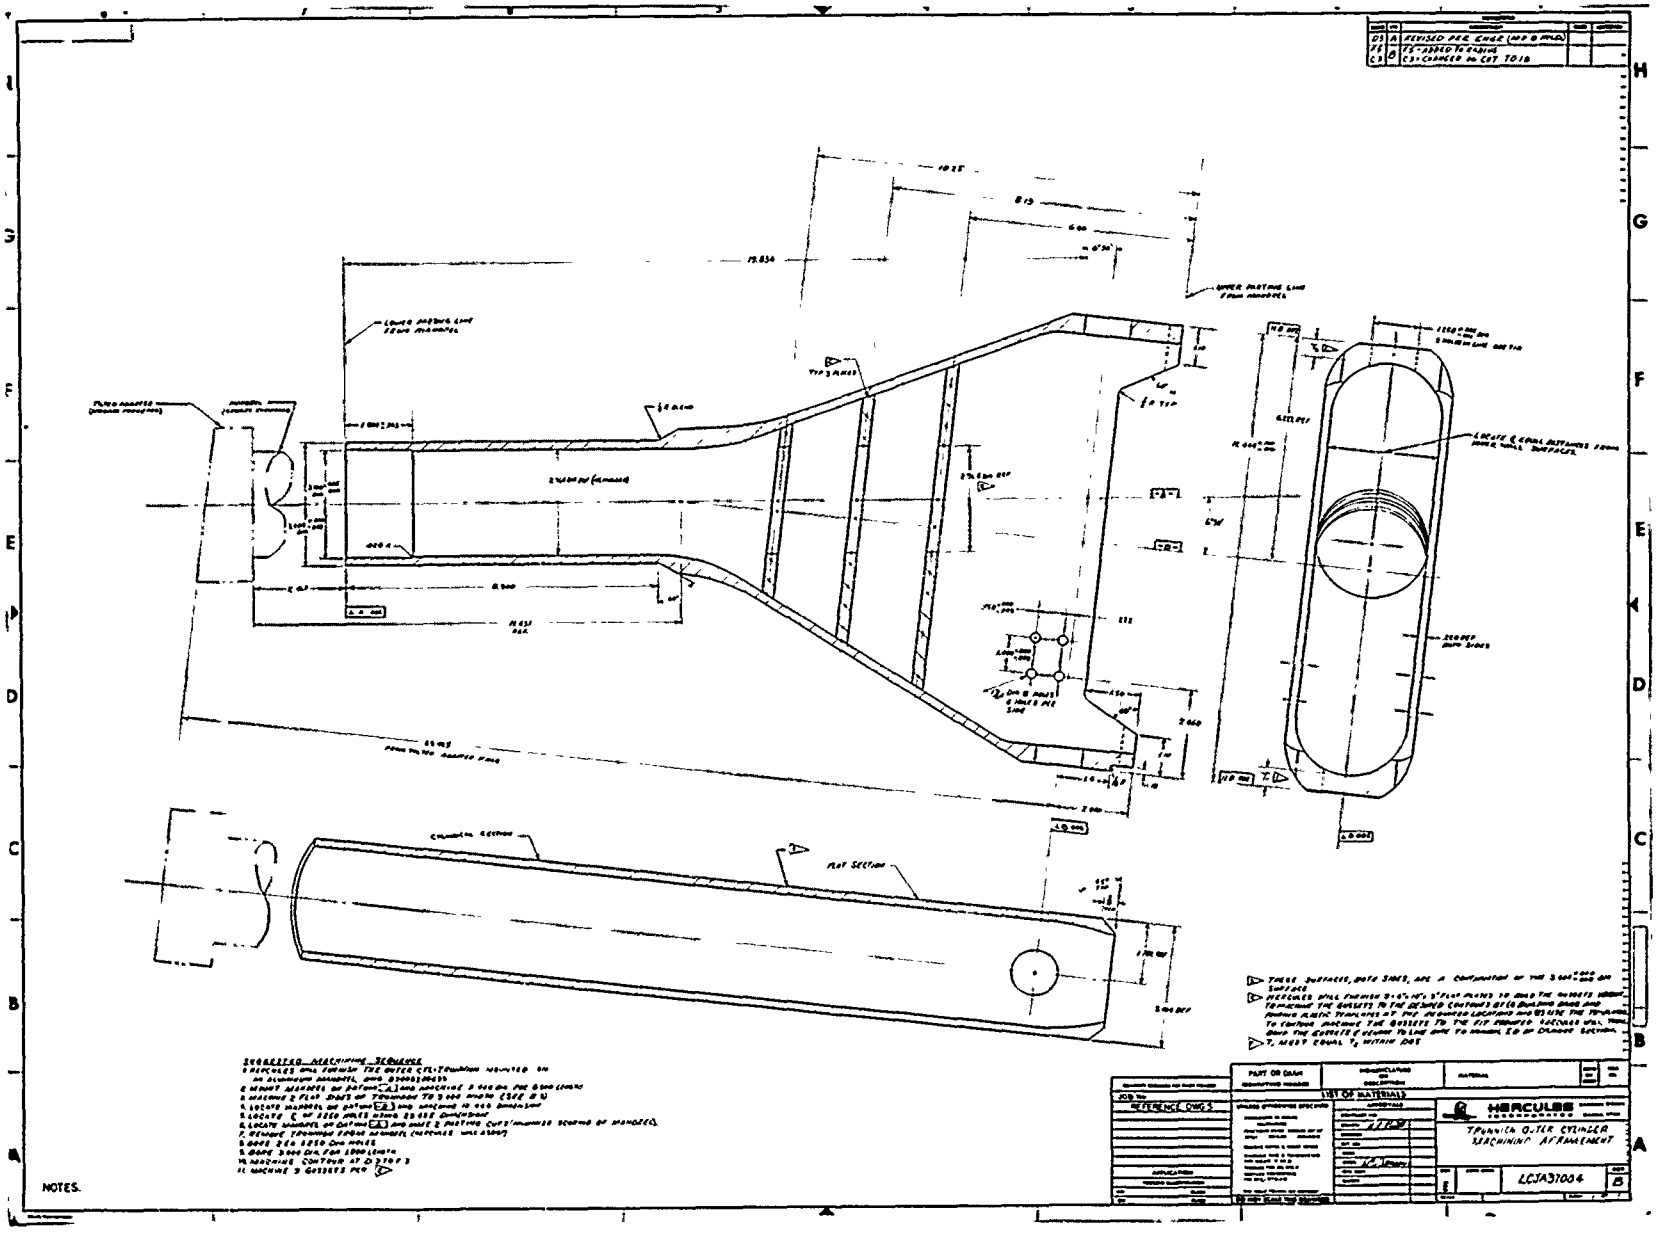
Figure 9. Design 2, A37B Graphite Composite Outer Cylinder/Trunnion

The second design outer cylinder/trunnion was fabricated from 3501-5/AS prepreg because the 2525 system had become a nonstandard prepreg. This version is shown in Figures 9 and 10. (Note the flat sides of the trunnion area where material was removed.)

After successful retraction tests, this second composite gear failed prematurely during load testing. Inspection of the components disclosed a severe wrinkle in the outer cylinder in the outer cylinder/trunnion transition area.

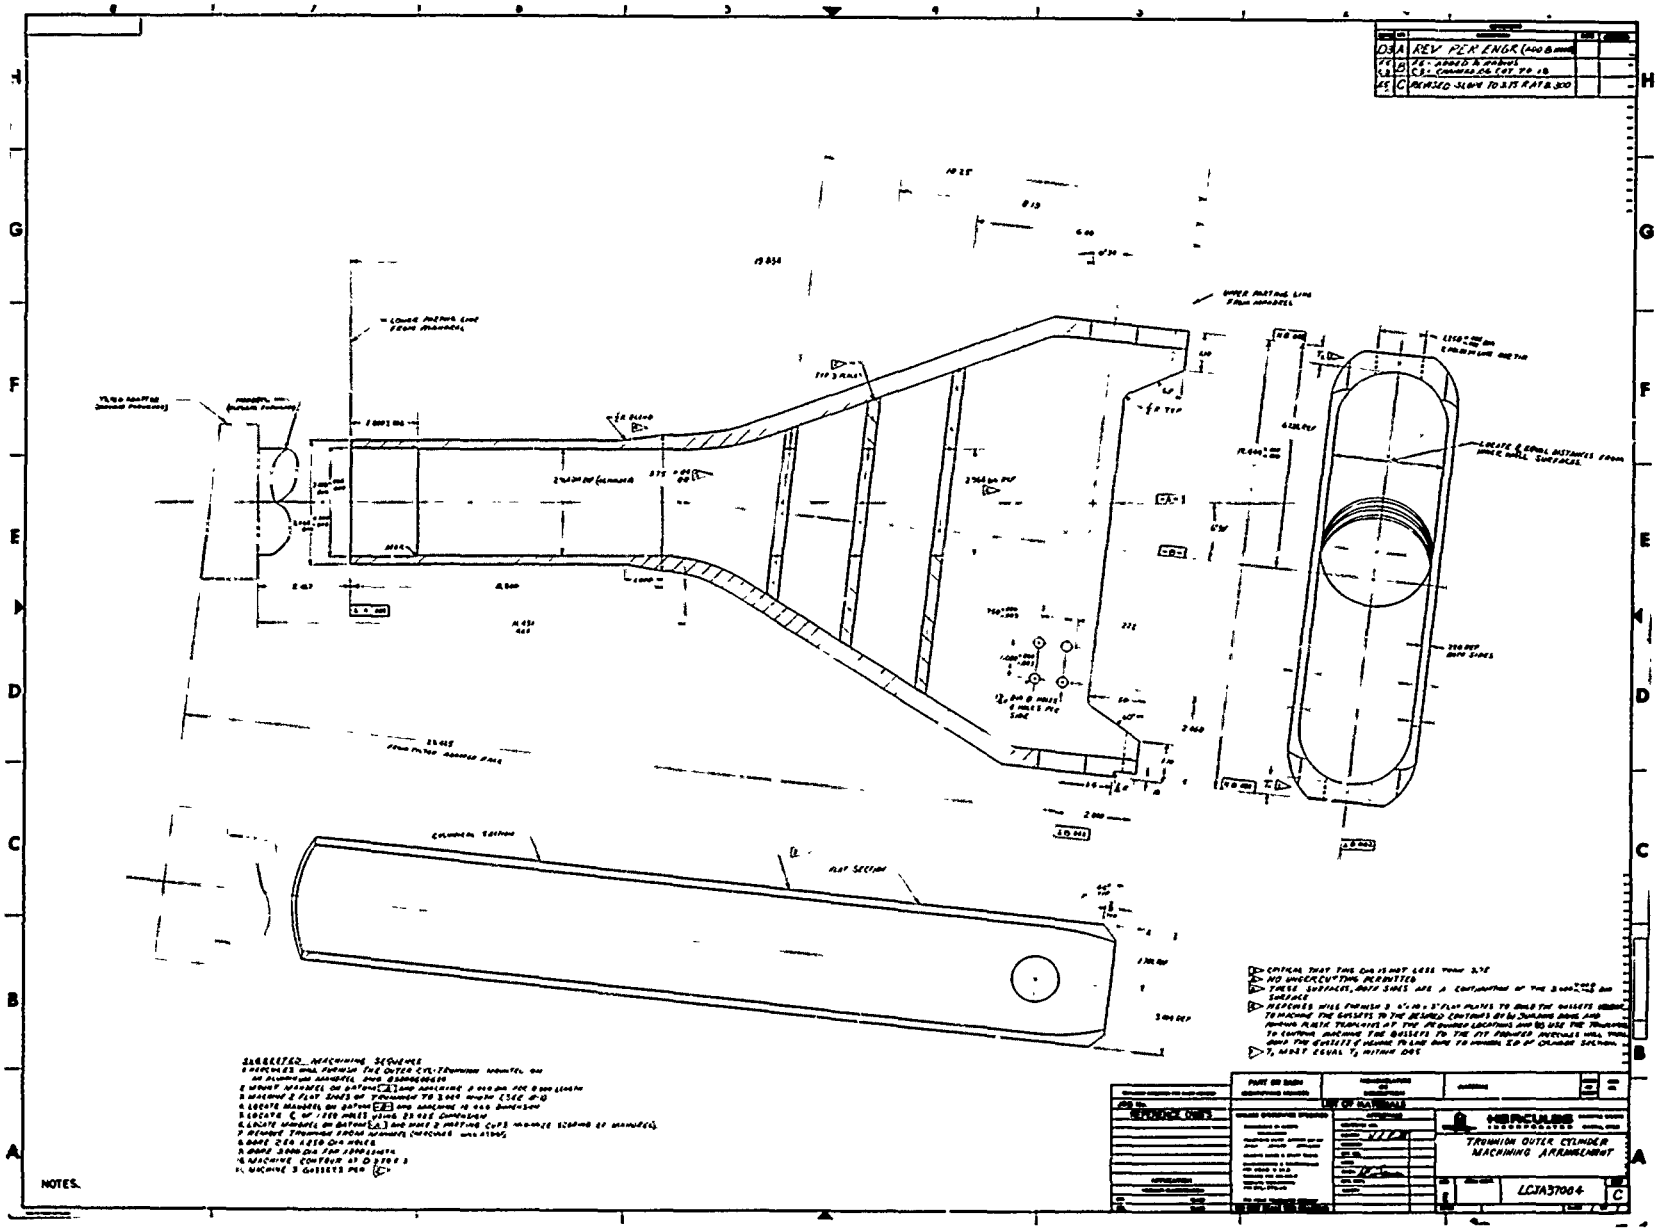
Figure 11. Modified Second Design of A37B Graphite Composite Outer Cylinder/Trunnion

A modified version of the outer cylinder/trunnion second design was fabricated from 3501-5/AS prepreg and machined. The modification consisted of a more gradual transition from the outer cylinder to the trunnion. (See Figure 11.) In addition, improvements in the fabrication process produced an outer cylinder/trunnion assembly of excellent quality.

A review of the test data after failure of the modified second design during 150 percent load testing (springback mode) indicated that failure was probably due to interlaminar shear under machined plies at the neck of the trunnion. (Material had been machined away to meet envelope requirement.)

A third (final) design, a refinement of the modified second design, was performed using 3501-6/AS prepreg.

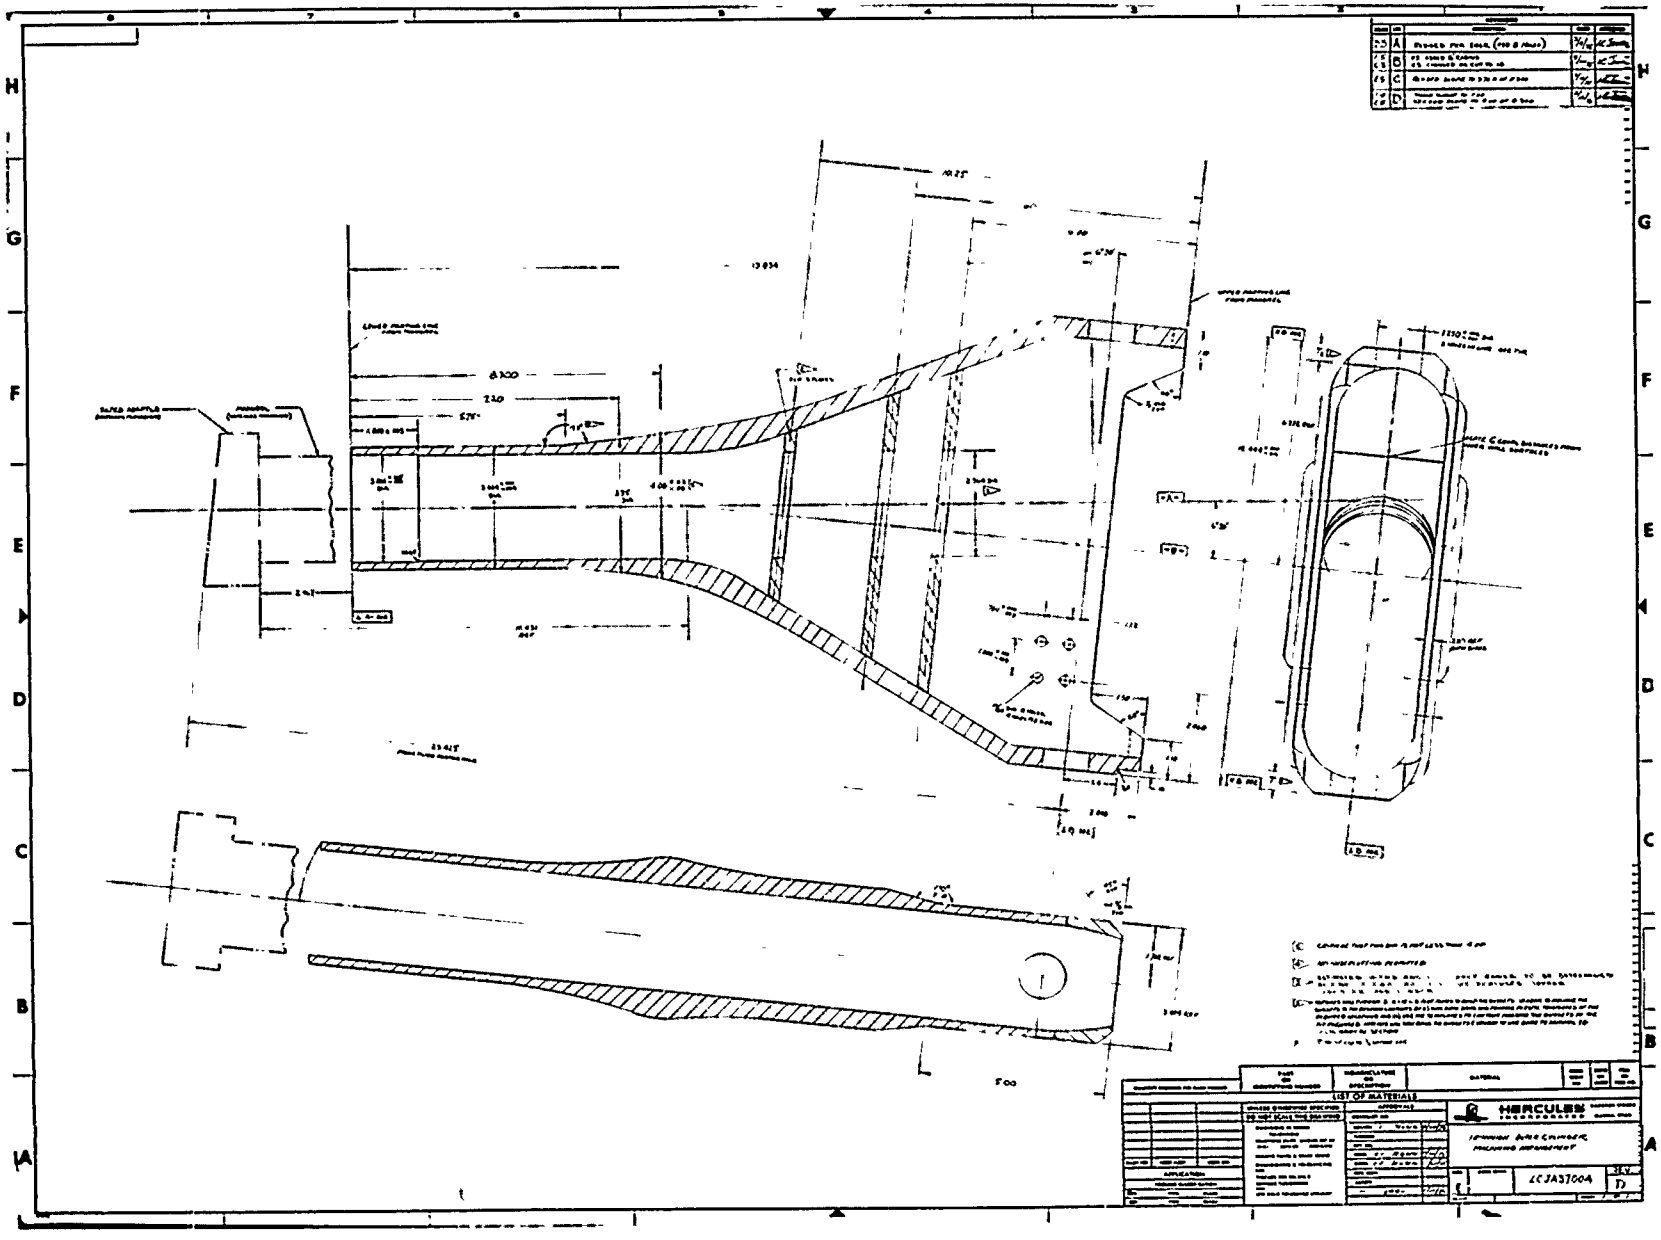
Figure 12. Third Design of A37B Graphite Composite Outer Cylinder/Trunnion

The final design (Figures 12 and 13) had additional material added to the outer cylinder/trunnion area, and the side brace attachment location was lowered. This latter design demonstrated a weight savings of 21 percent over the production gear. Although this design does not have a retraction capability, test data show it to be capable of withstanding the load tests. Figure 2 is a front view of this design.

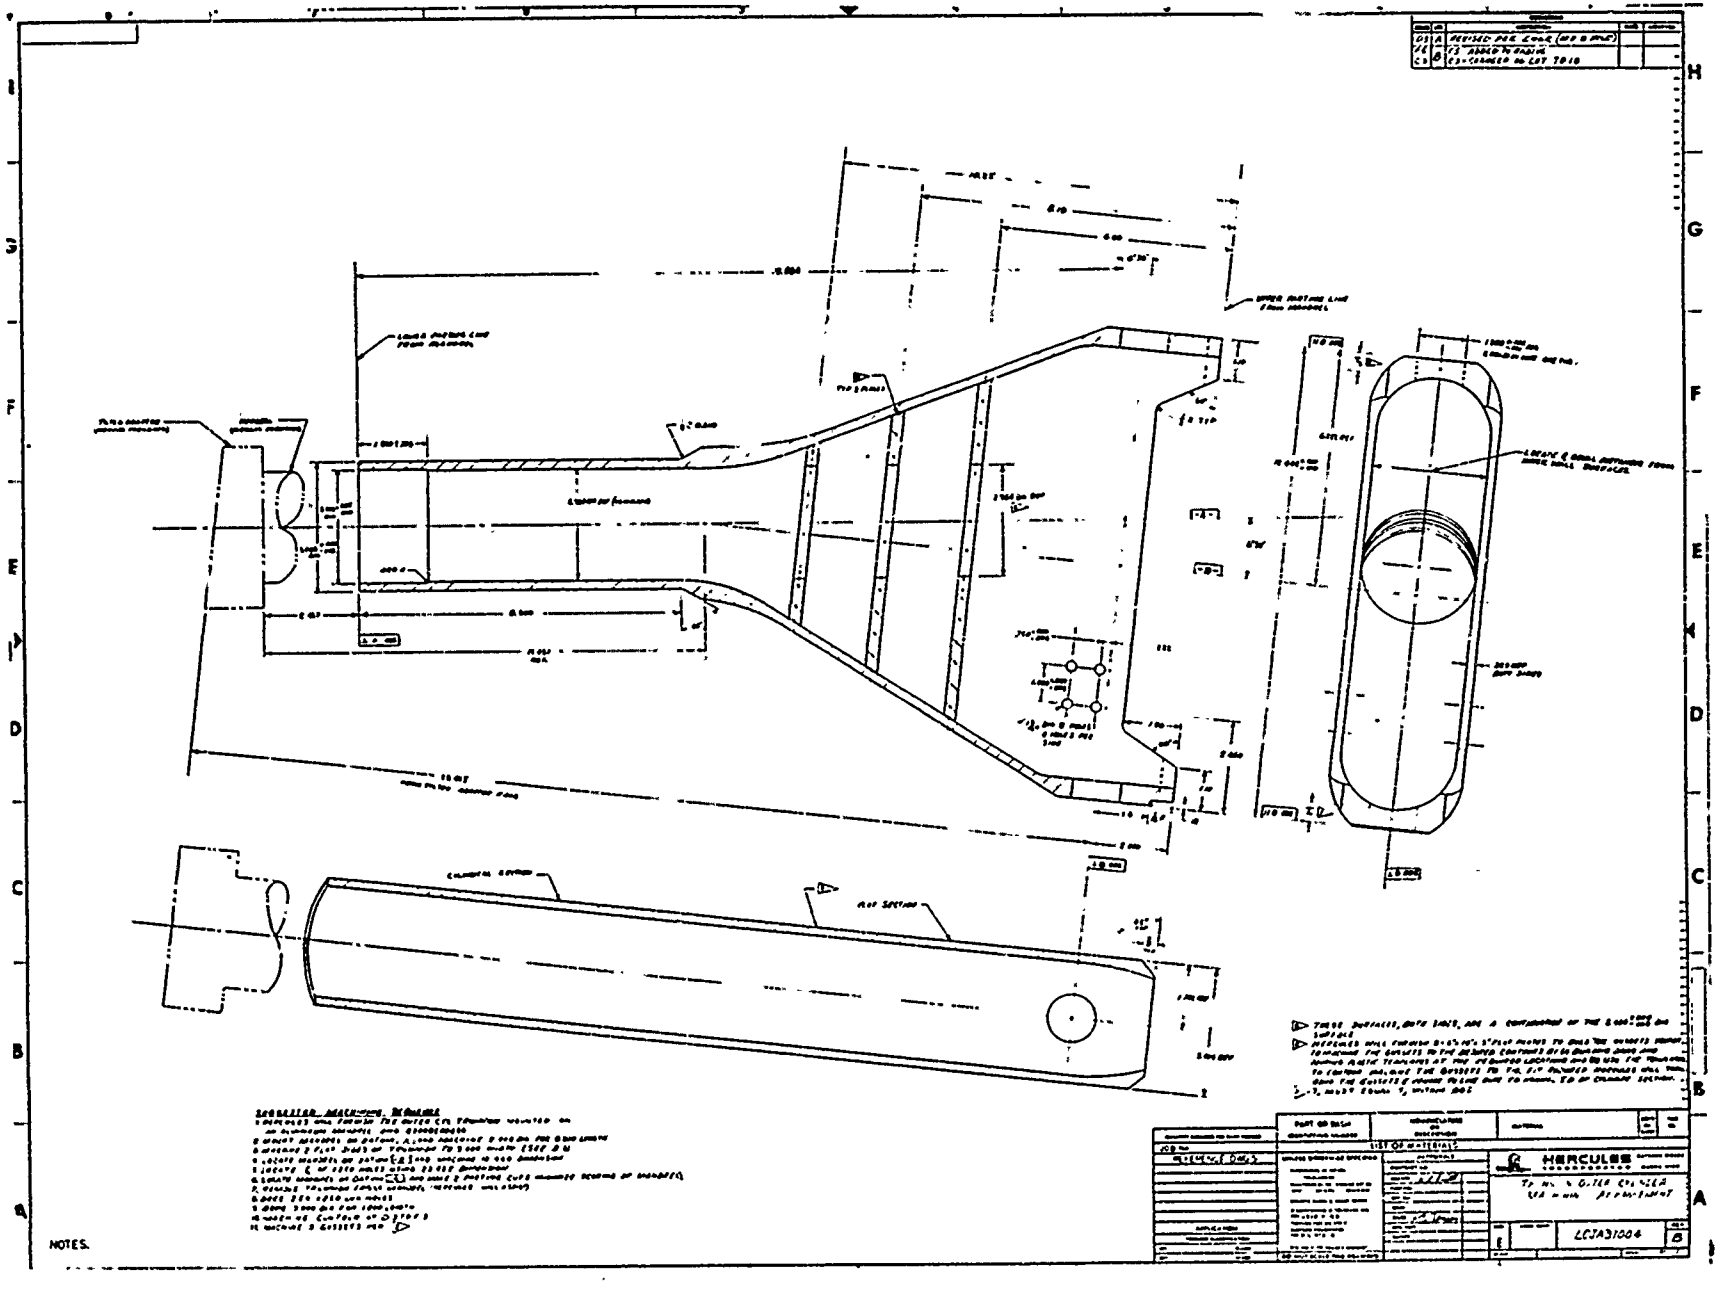
Figure 45. Second Design Machined Configuration (Drawing LCJA37004, Rev B)

The machined configuration of this second design is shown in Figure 45. Due to envelope restrictions for retraction tests, it was necessary to machine the exterior flat areas of the trunnion faces, which resulted in significant material being removed in the flare area between the cylinder and trunnion.

In addition, it should be noted that the transition from the cylinder diameter to the trunnion neck was steep. Trunnion depth (outside face-to-face dimension) on this second design was 3.404 inches, compared to 4.05/5.12 inches on the first design.

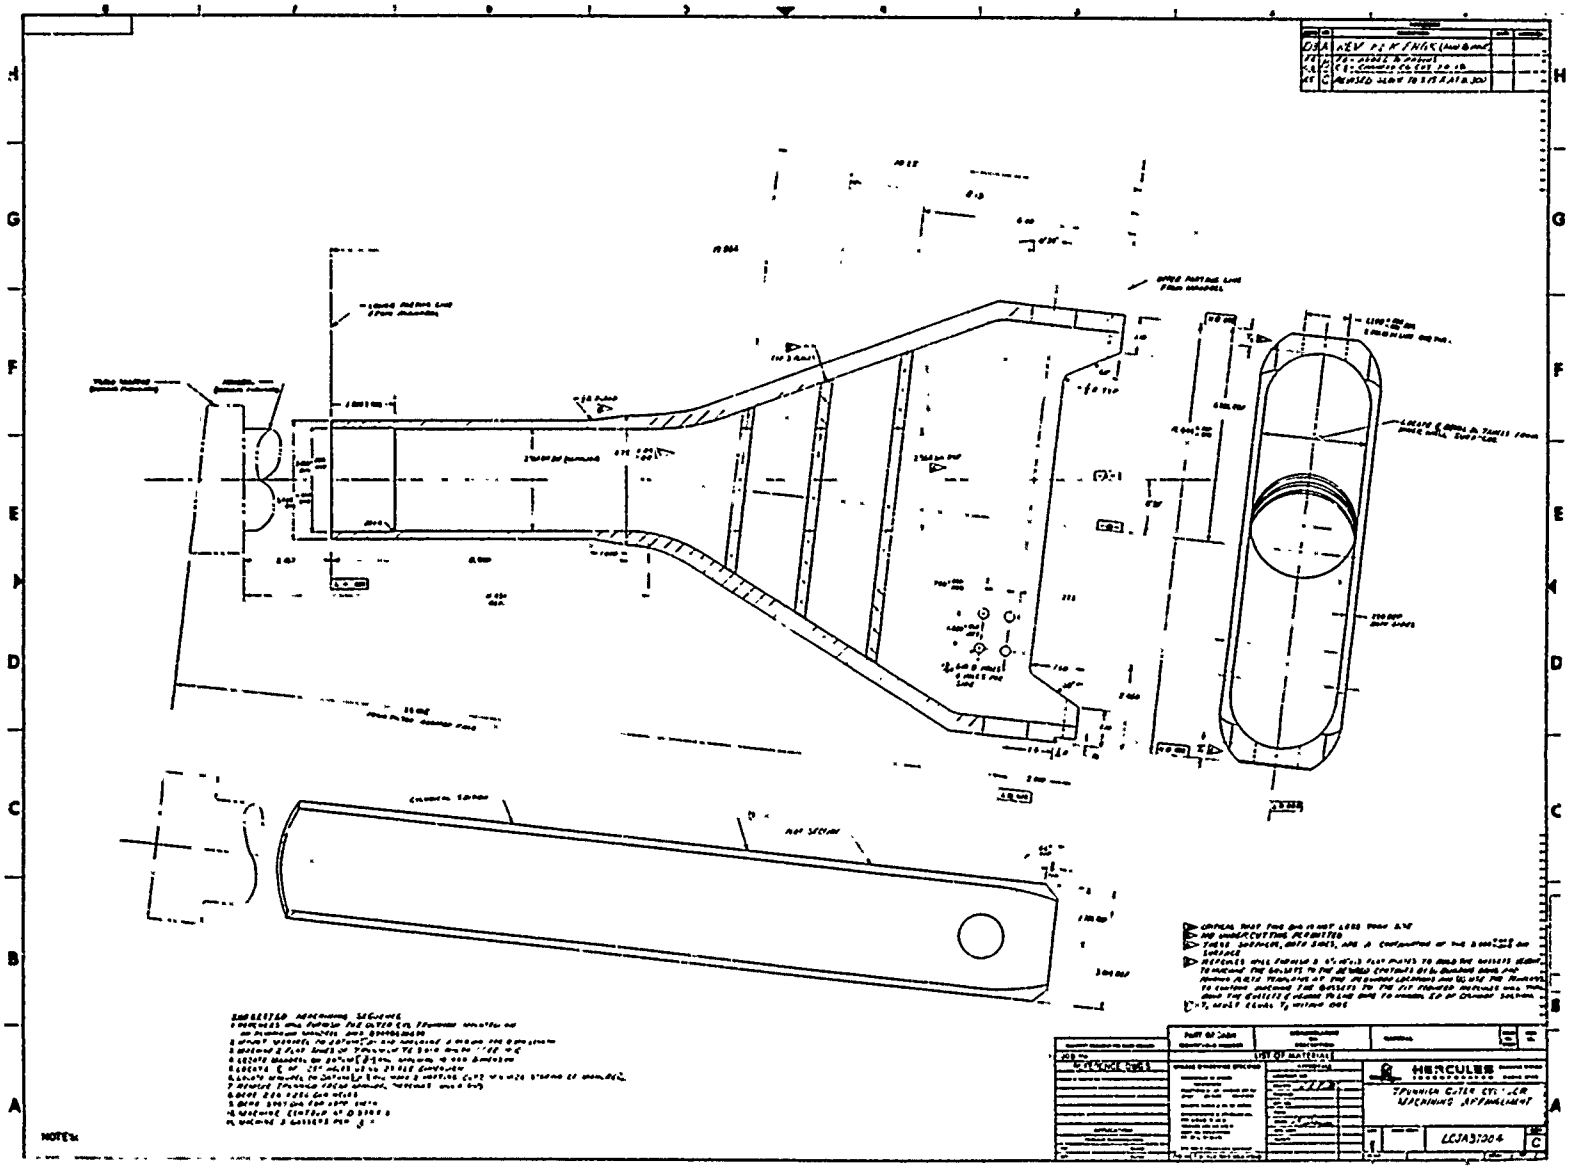
Figure 46. Modified Second Design Machined Configuration
(Drawing LCJA37004, Rev. C)

Machining was performed in accordance with Figure 46. Note that the modified transition from the cylinder OD to the trunnion flare is more gradual than in the previous part.

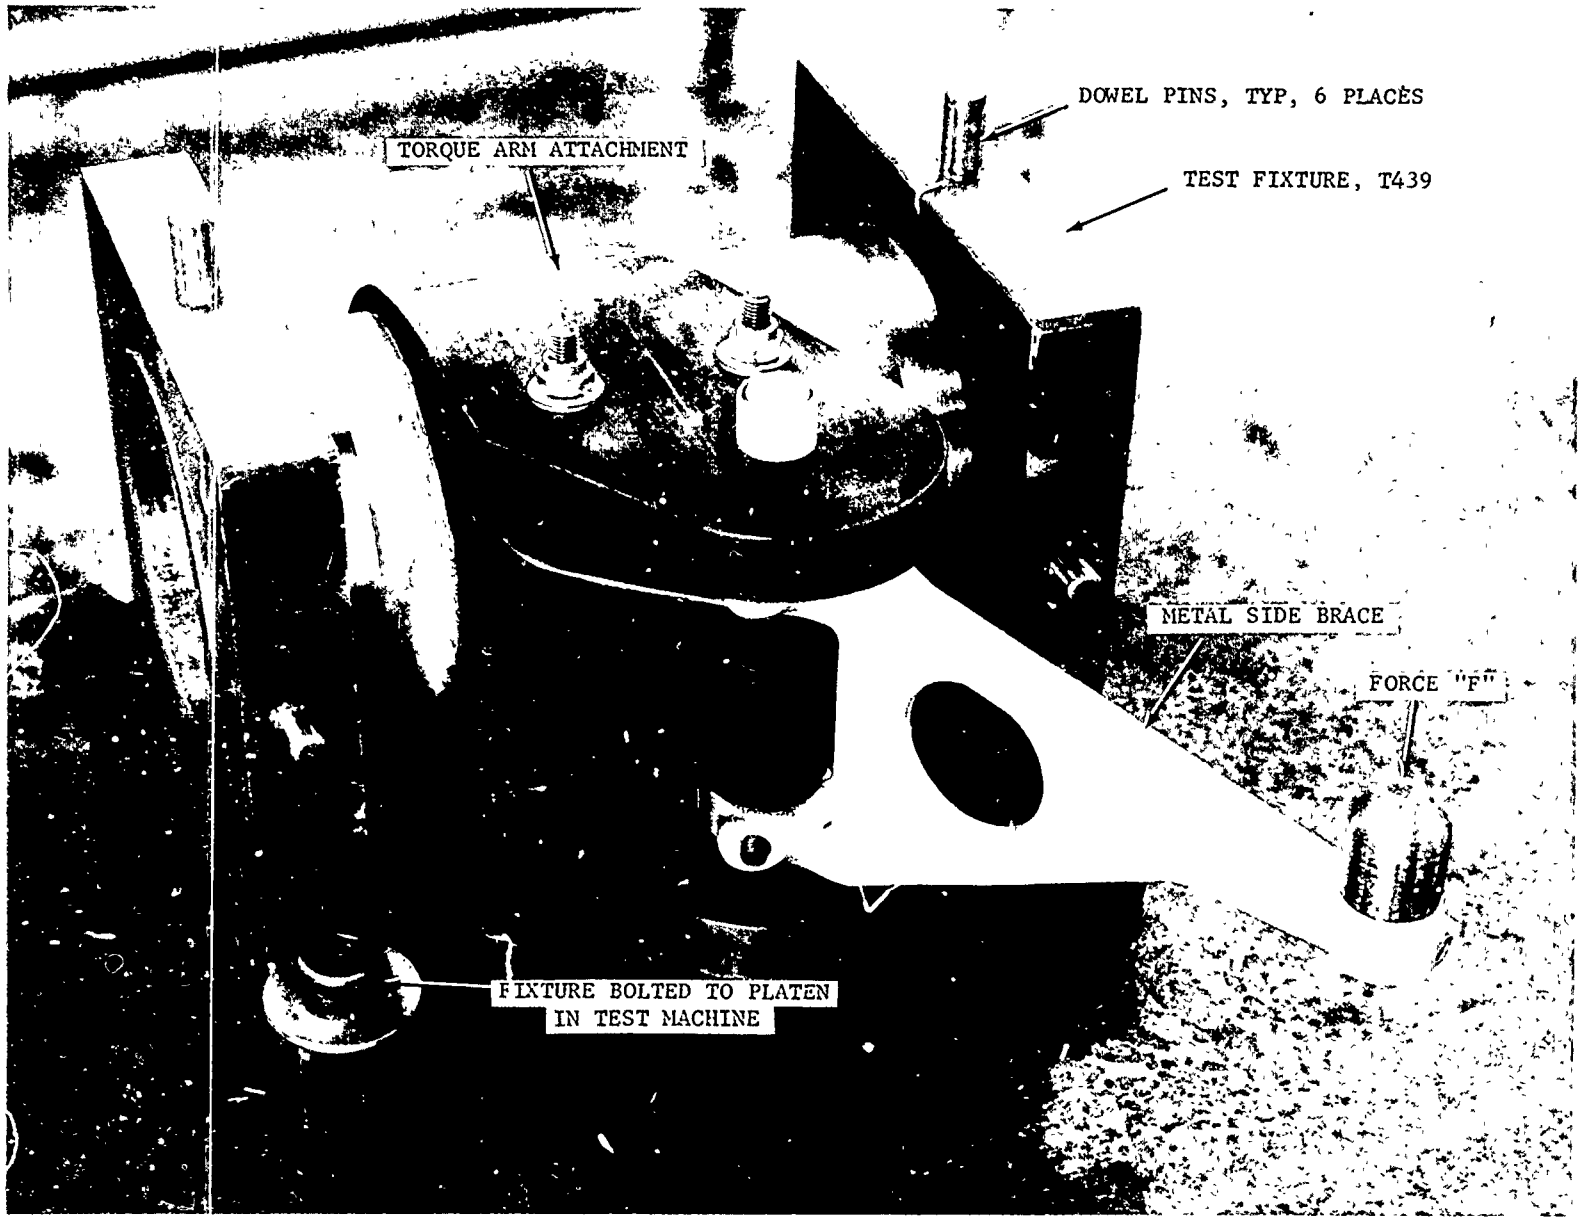
Figure 56. Torque Arm Attachment Test Arrangement

The actual test was as follows: all loading conditions were the same as the plan except that at 11,600 pounds a dowel pin sheared in the test fixture (Figure 56), and the test was stopped. The 11,600 pound load at which the test was stopped was 119 percent of the ultimate load of 9700 pounds.

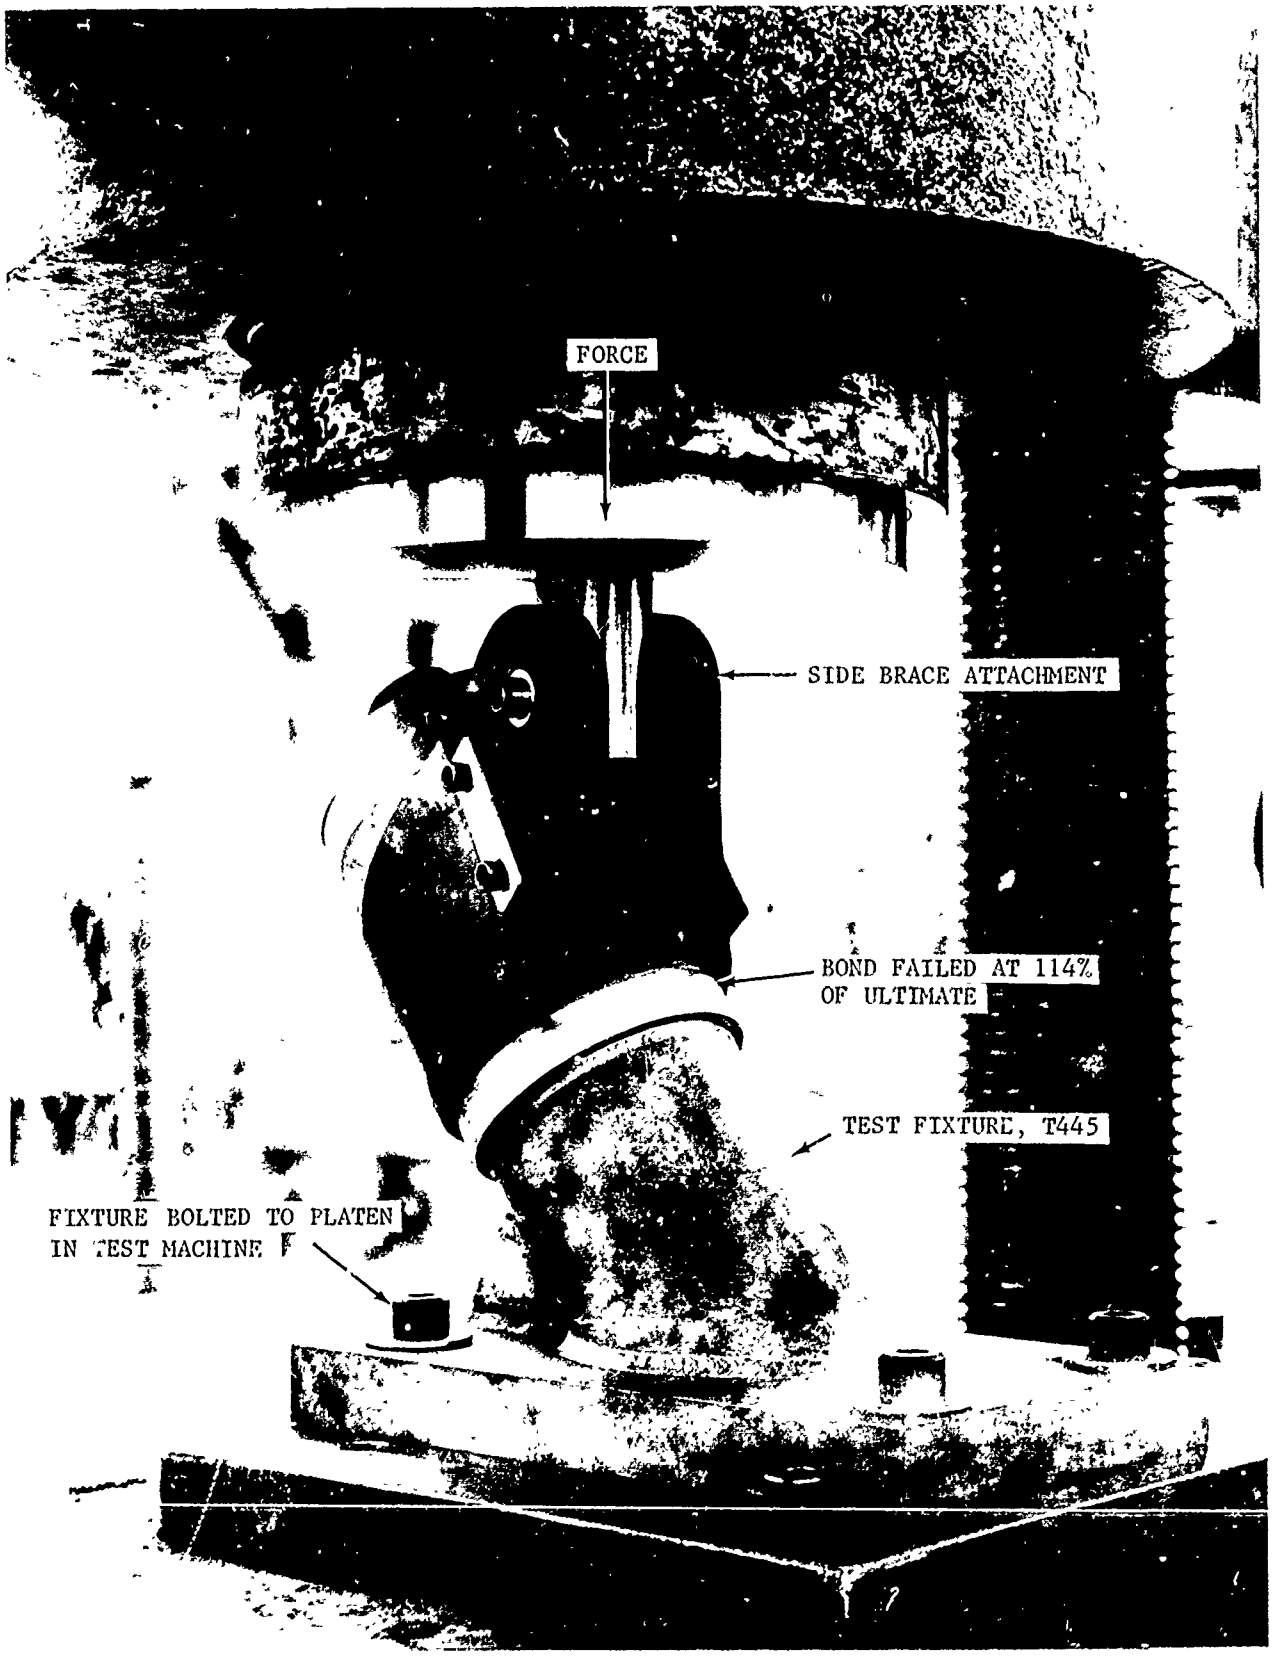
Figure 60. Side Brace Attachment Compression Test Arrangement

(2) Compression (second) - All loading conditions were the same, except that at 33,525 pounds the resin bond failed between the side brace attachment and the stem (Figure 60), and the test was stopped. The 33,525 pound load at which the bond failed was 114 percent of the ultimate load of 29,306 pounds.

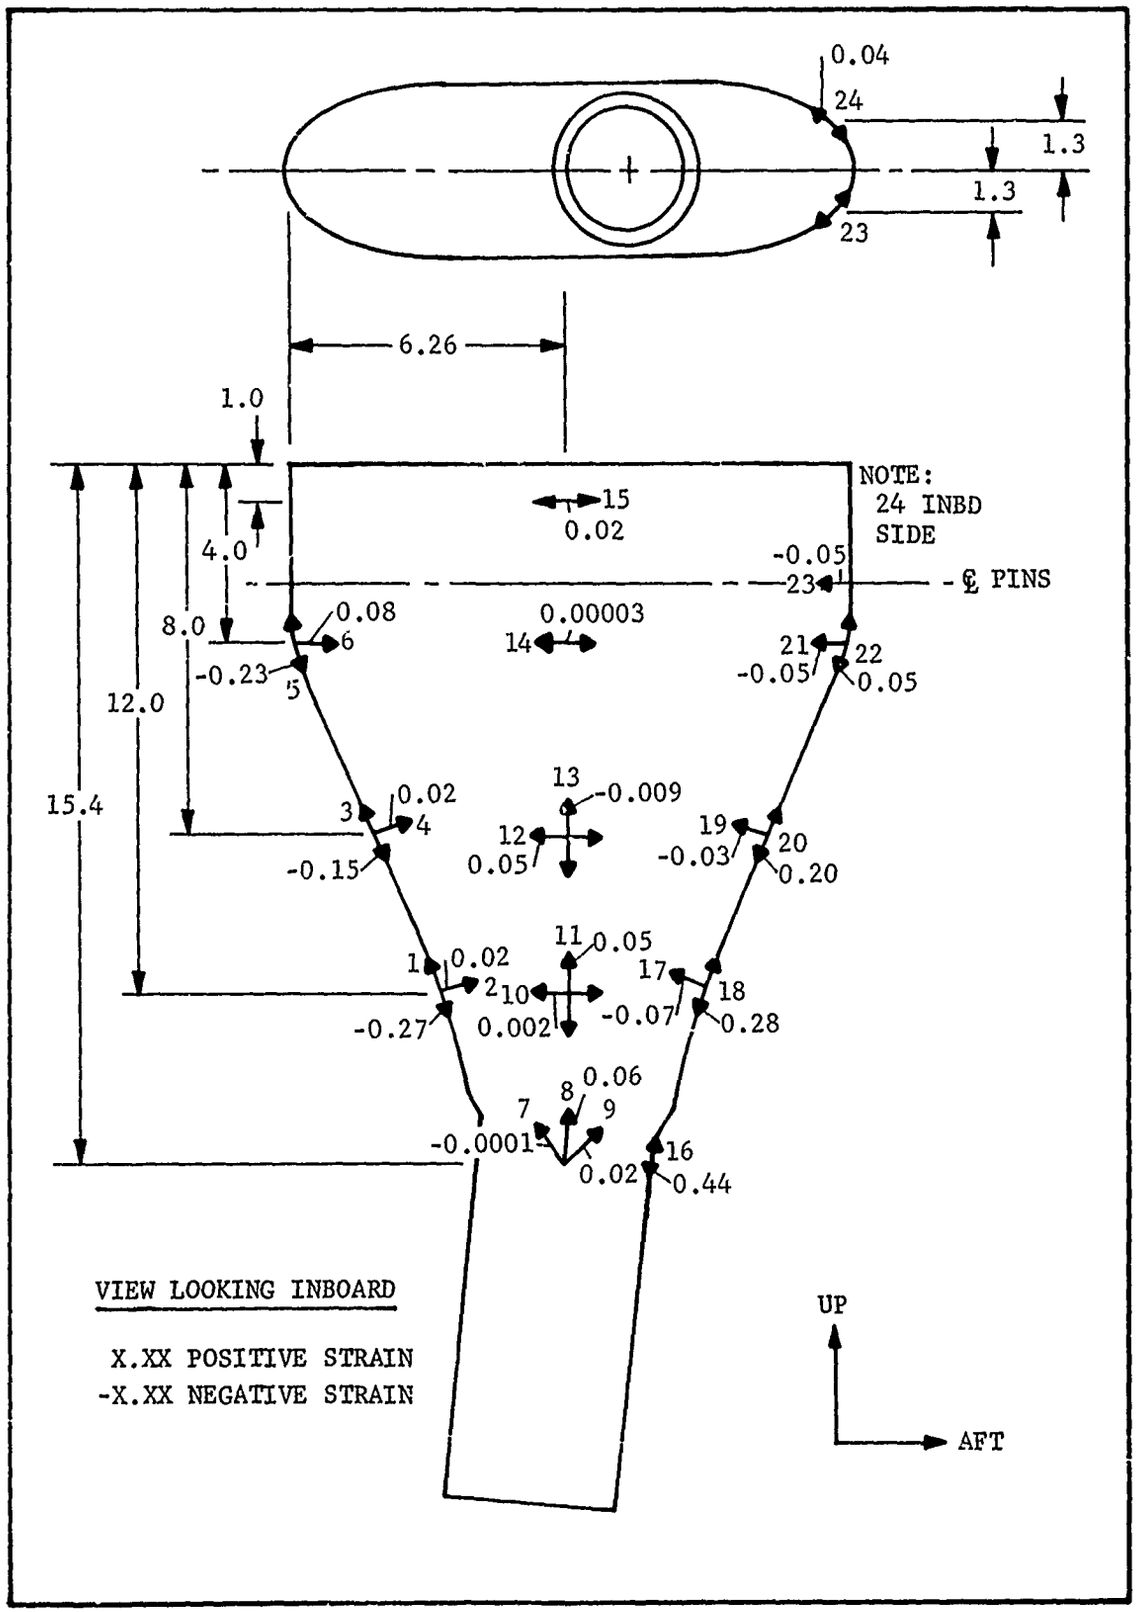
Figure 64. Strain Gage Locations, Condition 3 100% Limit Load

Figure 64 presents the strain gage location and the strains recorded during 100 percent limit load testing in Condition 3. Maximum strain was 0.44 percent under strain gage number 16. During 150 percent limit load testing, this gage again recorded the maximum strain, which was 0.533 percent of Condition 3 loading.
