**TWENTY-FIRST**

**PROGRESS REPORT**

**THE FIRESTONE TIRE & RUBBER CO.**

**105 MM BATTALION ANTI-TANK PROJECT**

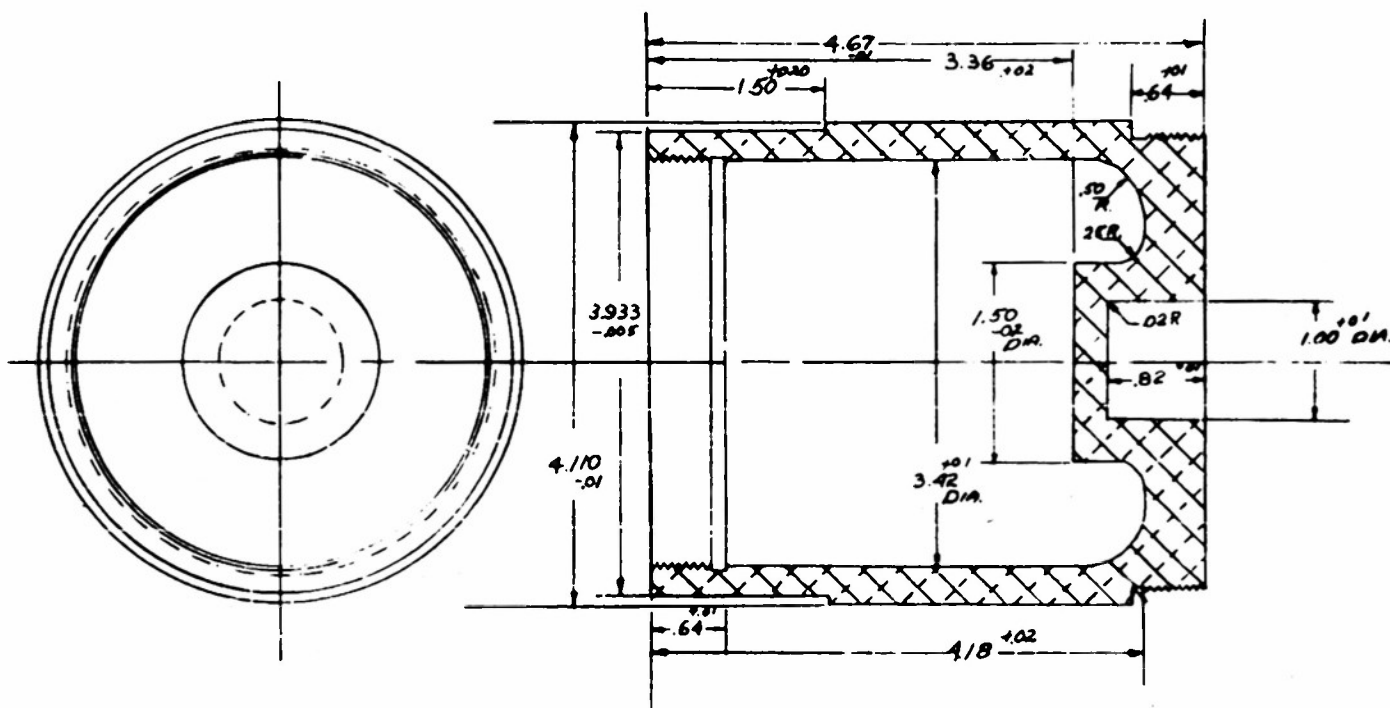
Fig. 2. Projectile Gas Chamber.  
Firestone Drawing No. DRB 168-3.

In a severe strength test, a T-119 projectile was fired from the 105mm Howitzer, M2A1. Signs of fragments were found in a yaw card placed near the gun muzzle. The recovered fragments indicated that the initial failure was caused by collapse of the projectile gas chamber. (See DRB 168, Figure 2). A simple strengthening of this chamber should result in a projectile capable of surviving howitzer launching.

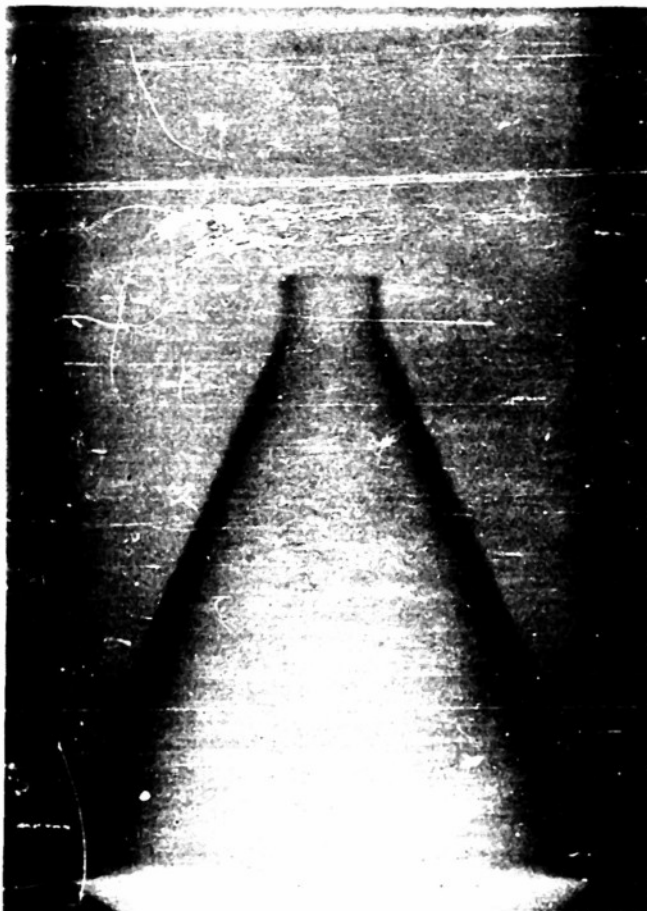
Fig. 14. Radiograph of Tapered-Wall Cone.

A penetration of 17.64 inches of mild steel at 7.5 inches standoff and zero rev/sec is normal for the control round tested, as indicated, without a long spitback tube. The penetration of 19.16 inches, measured for the tapered wall cones, represents a substantial improvement in performance. Since it is not known that the degree of taper employed in this test is optimum, further tests are being planned.
