SEA VENOM MK. 20 WK. 379  
(GHOST 3)

RADIO ACCEPTANCE TRIALS

10th Part of Report No. AAEE/868/1.

A. & A.E.E. Ref.: AAEE/411/77/Radio.  
M. O. S. Ref.: 39th Joint Meeting Ministry of Supply, Admiralty,  
A. & A.E.E., dated 10th October, 1951.  
Period of trials: 20th April, 1953 to 1st September, 1953.

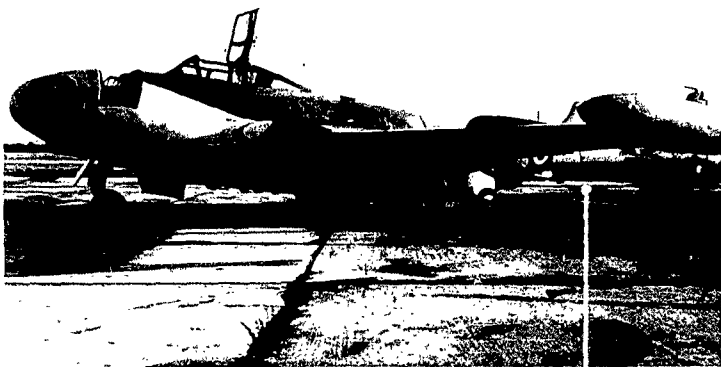
FIG.1.

7.1.4. The aerial type 228 was mounted on the starboard boom, 2 feet from the trailing edge of the wing (Fig. 2). The aerial type 229 was mounted under the port wing, 3 feet 3 inches from the wing tip tank (Fig. 1).

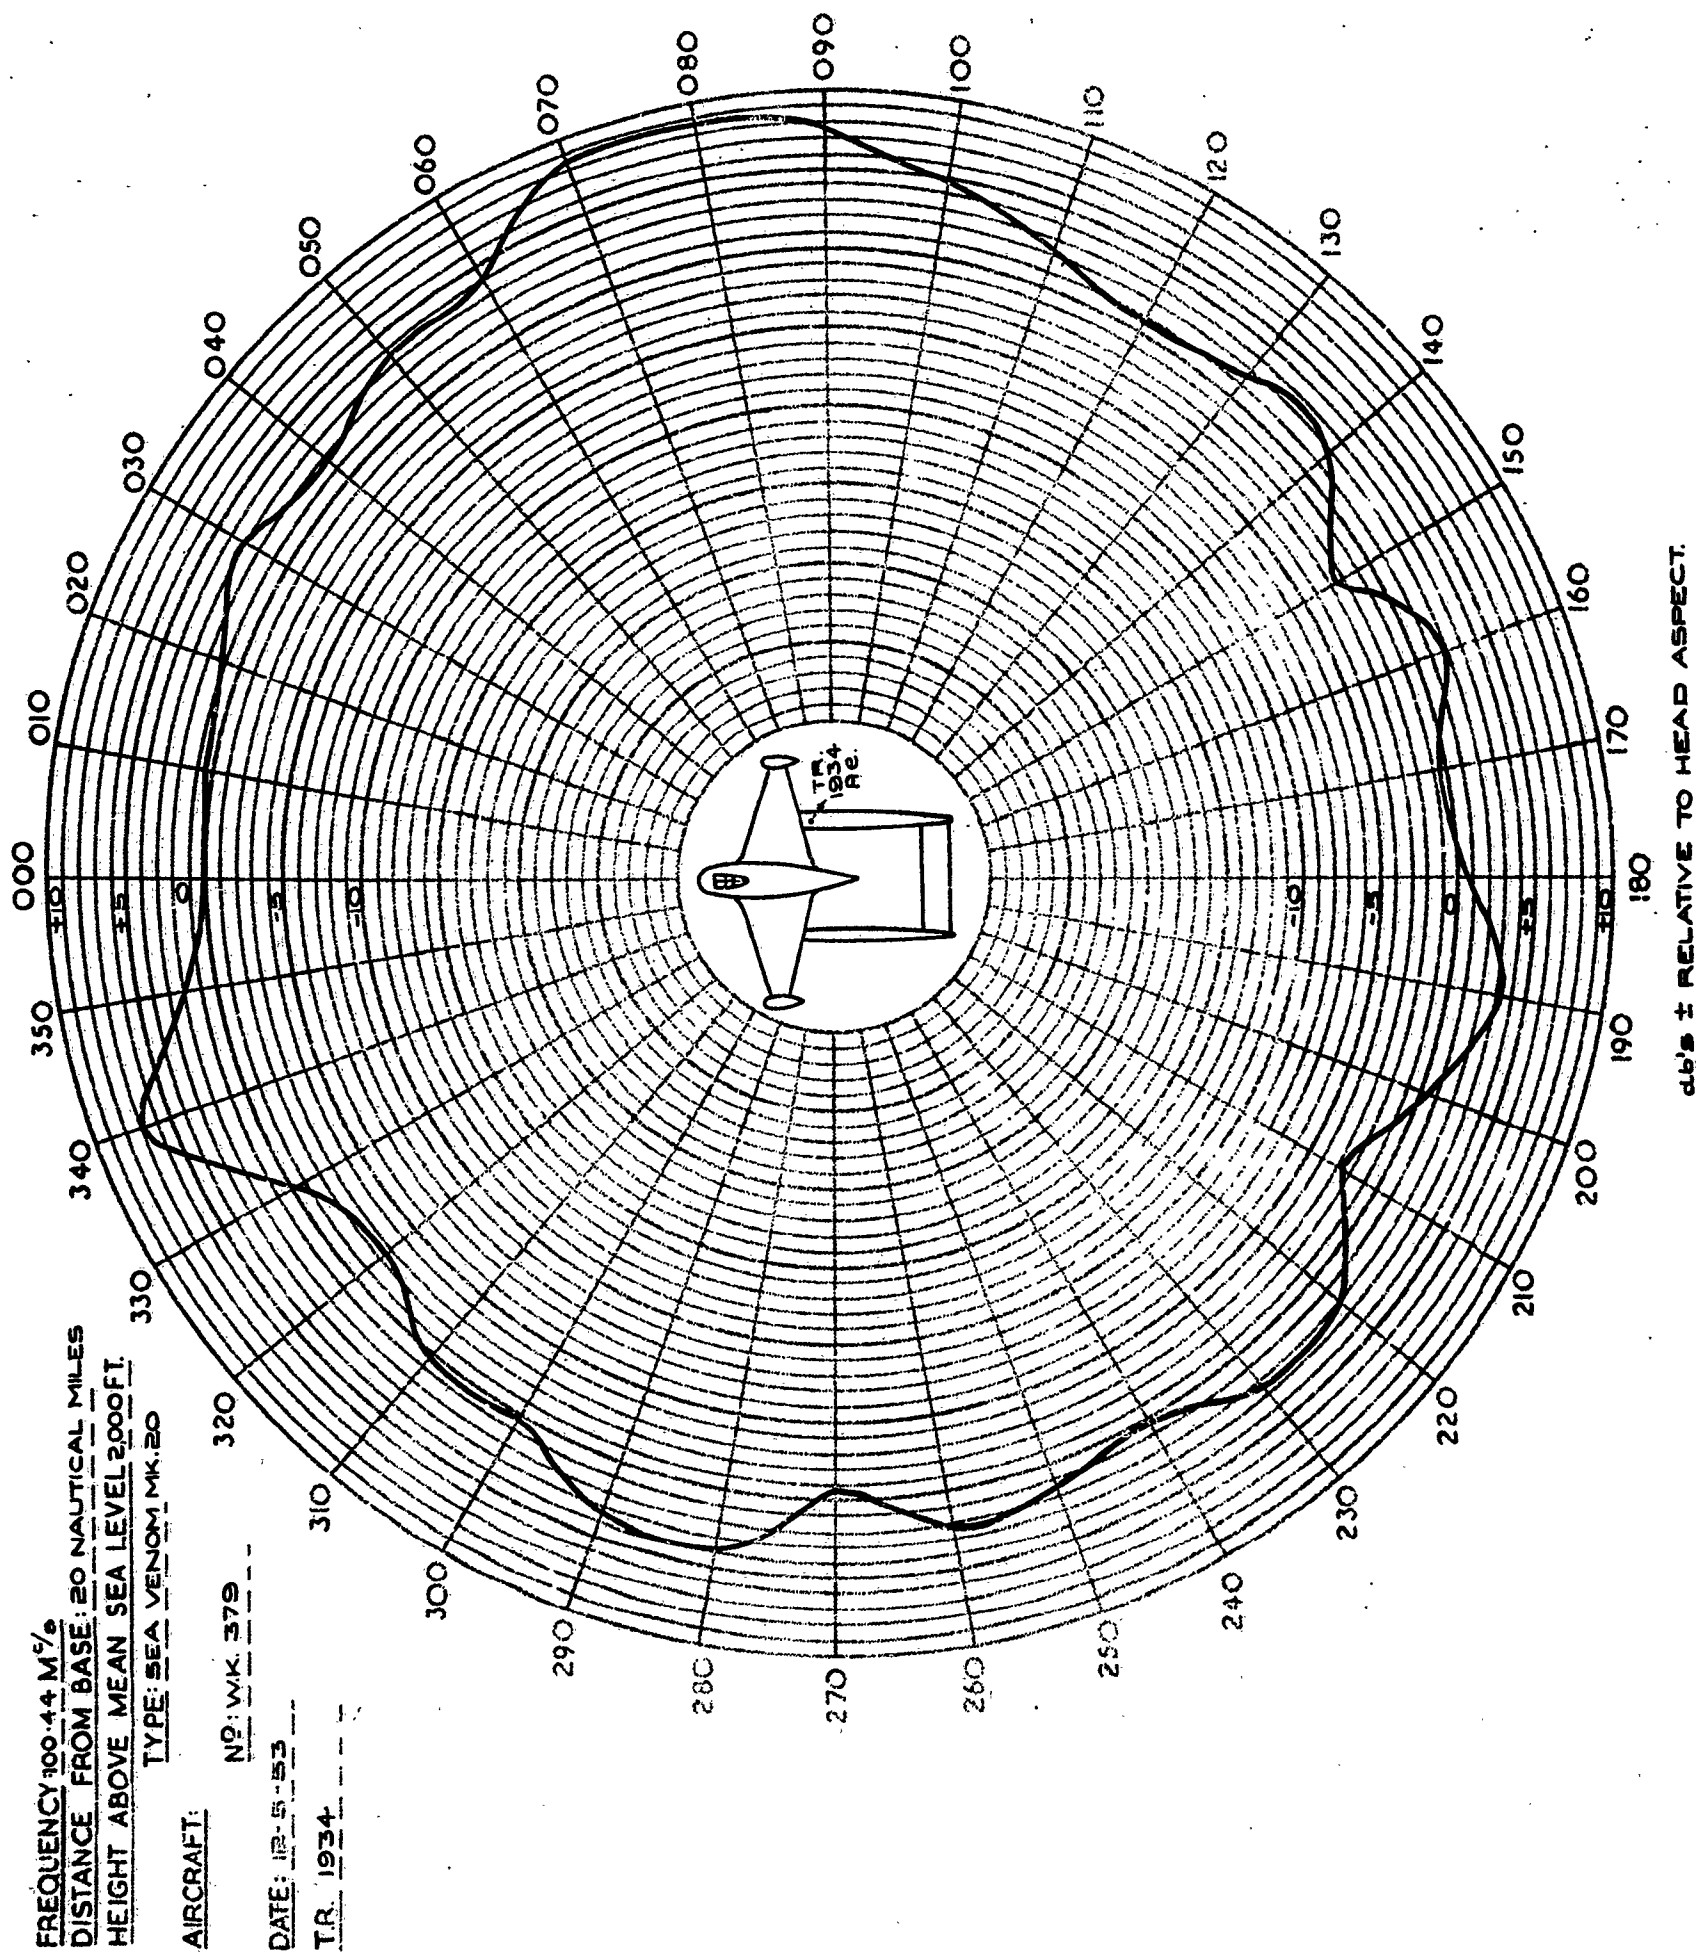
FIG. 9

7.3.1. Polar Diagrams. The results of the polar diagram runs are given in Figures 9 and 10 and are satisfactory.

V.H.F. POLAR DIAGRAM  
 OF  
 AERIAL SYSTEM TYPE 228
