NAVORD REPORT 2830

INVESTIGATION OF PREMATURES EXPERIENCED
IN MAJOR CALIBER PROJECTILES

27 JULY 1953

U. S. NAVAL ORDNANCE LABORATORY
WHITE OAK, MARYLAND

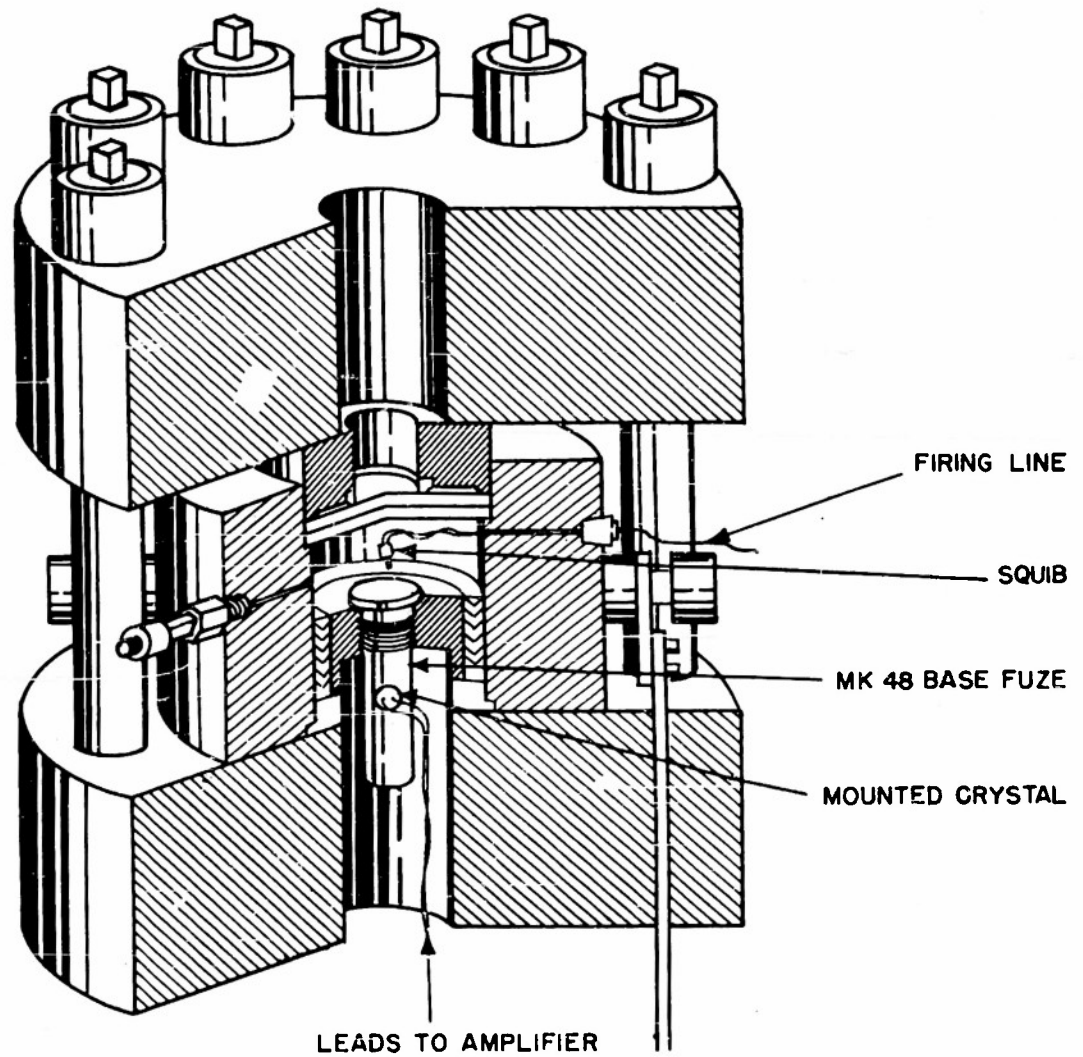
FIG. 2 DYNAMIC PRESSURE PULSE GENERATOR
(THUNDERMUG)

10. The Dynamic Pressure Pulse Generator (Thundermug), Figure 2, is a laboratory apparatus which subjects components to be tested to pressure-time characteristics similar to pressure pulses created in firing a gun. It consists of a cylindrical firing chamber closed at one end with a gasketed adapter in which a fuze may be mounted, and at the other by a heavy diaphragm. A black powder charge is fired in the chamber electrically, through leads in the cylinder wall. The pulse rise rate is controlled by the grain size of the black powder, the peak pressure jointly by the size of the charge and the thickness of the diaphragm which ruptures, and the pressure decay rate by the size of the aperture through which gases are expelled

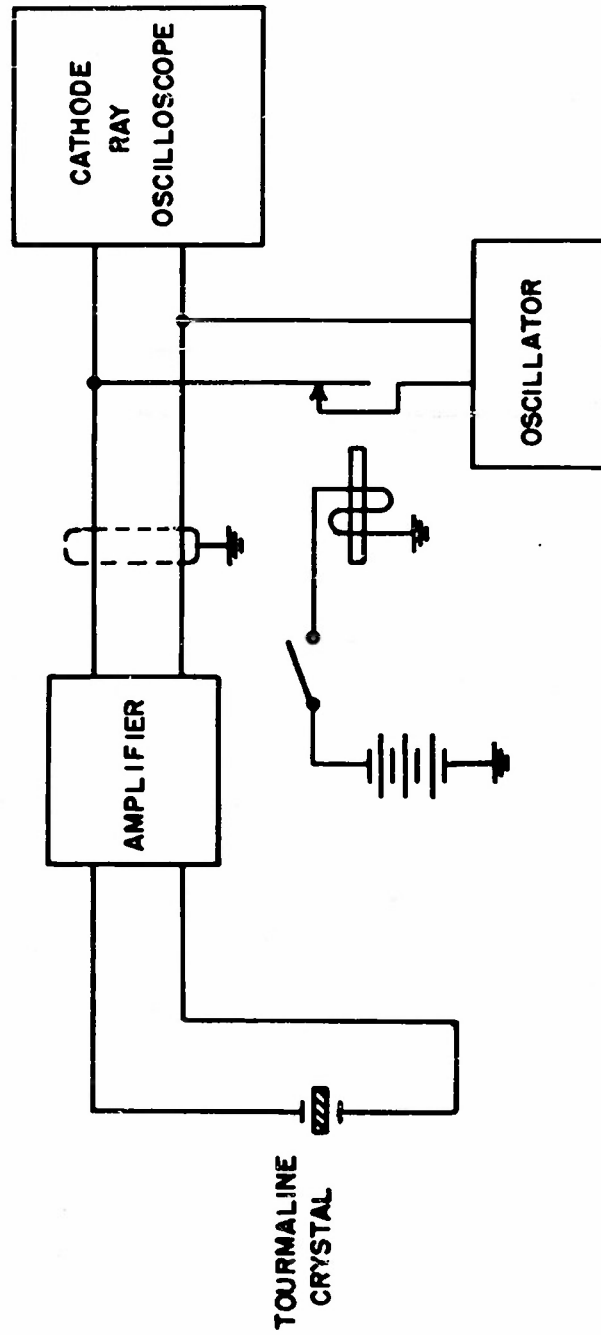
FIG. 5 INSTRUMENTATION FOR RECORDING GAS LEAKAGE

16. A Keithley Phantom Repeater was used as an impedance matching device between the crystal and the CRO (Figure 5). The time constant of the input circuit was increased by shunting the repeater with a .005 ~~μ~~ farad capacitor.
