NAVORD REPORT 3670

A STUDY OF THE EFFECTS OF STATIC ELECTRICITY ON LOW INPUT ENERGY
ELECTRIC INITIATORS OF THE CARBON BRIDGE TYPE

5 AUGUST 1954

U. S. NAVAL ORDNANCE LABORATORY
WHITE OAK, MARYLAND

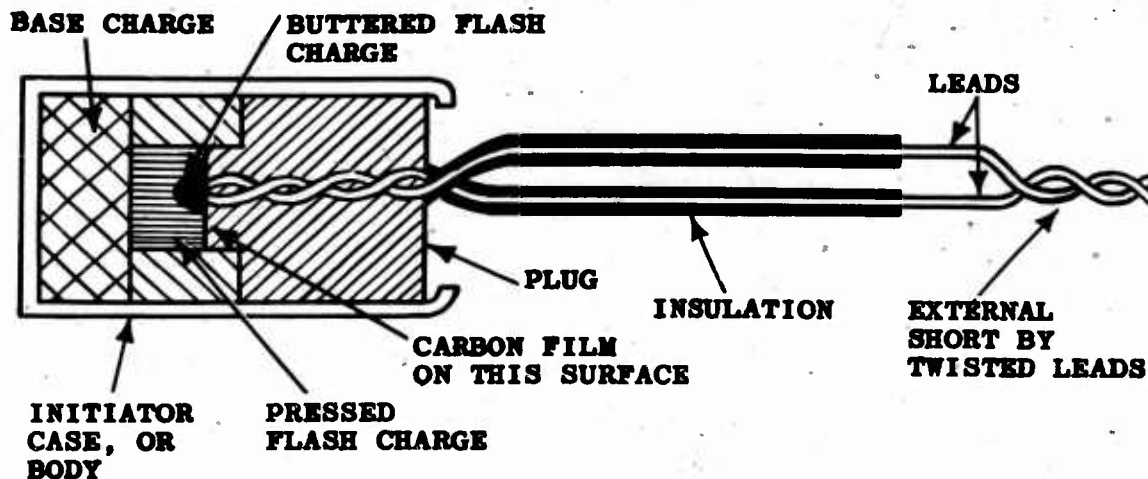
FIG. 11 PHYSICAL ARRANGEMENT OF A CARBON BRIDGE INITIATOR

41. An understanding of the various ways in which electrical energy can induce an explosion will provide a logical basis for the application of the fundamental principles of safe handling. Figure 11 is a schematic representation of a carbon bridge electro-explosive device. In normal use, the primer is fired by applying electrical energy of suitable properties to the leads from which has been removed the external electrical short.

The circuit is completed through the carbon film on the face of the plug. The electrical energy is dissipated in the carbon film, heating it enough to cause ignition of the flash charge.

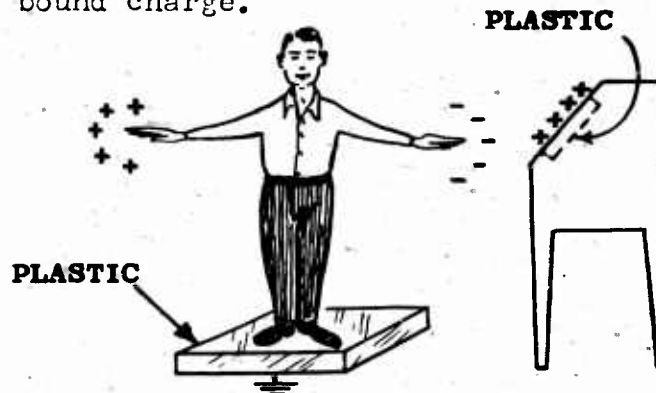
FIG. 15 CAPACITIVE INDUCTION

58. In addition to the accumulation of a charge by friction and by transfer, a charge can be formed by induction. The operator need not touch a bound charge but instead approach fairly closely to become in turn charged. As in Figure 15, electrons will move toward or away from the portion of the body closest to the bound charge in an attempt to neutralize the field of the bound charge. The displacement of electrons within the operator's body will cause a charge distribution to form on portions of the body farther away from the bound charge. This distribution will be of the same polarity as that of the bound charge.

59. There has been reported an instance of initiation of a carbon bridge primer which can be attributed to capacitive induction. The circumstances were said to be as follows:
