ARMOUR RESEARCH FOUNDATION  
of  
ILLINOIS INSTITUTE OF TECHNOLOGY  
Technology Center  
Chicago 16, Illinois

RESEARCH AND DEVELOPMENT OF LAMINATED  
GLASS AIRCRAFT WINDSHIELDS

Report No. 36

September 26, 1952

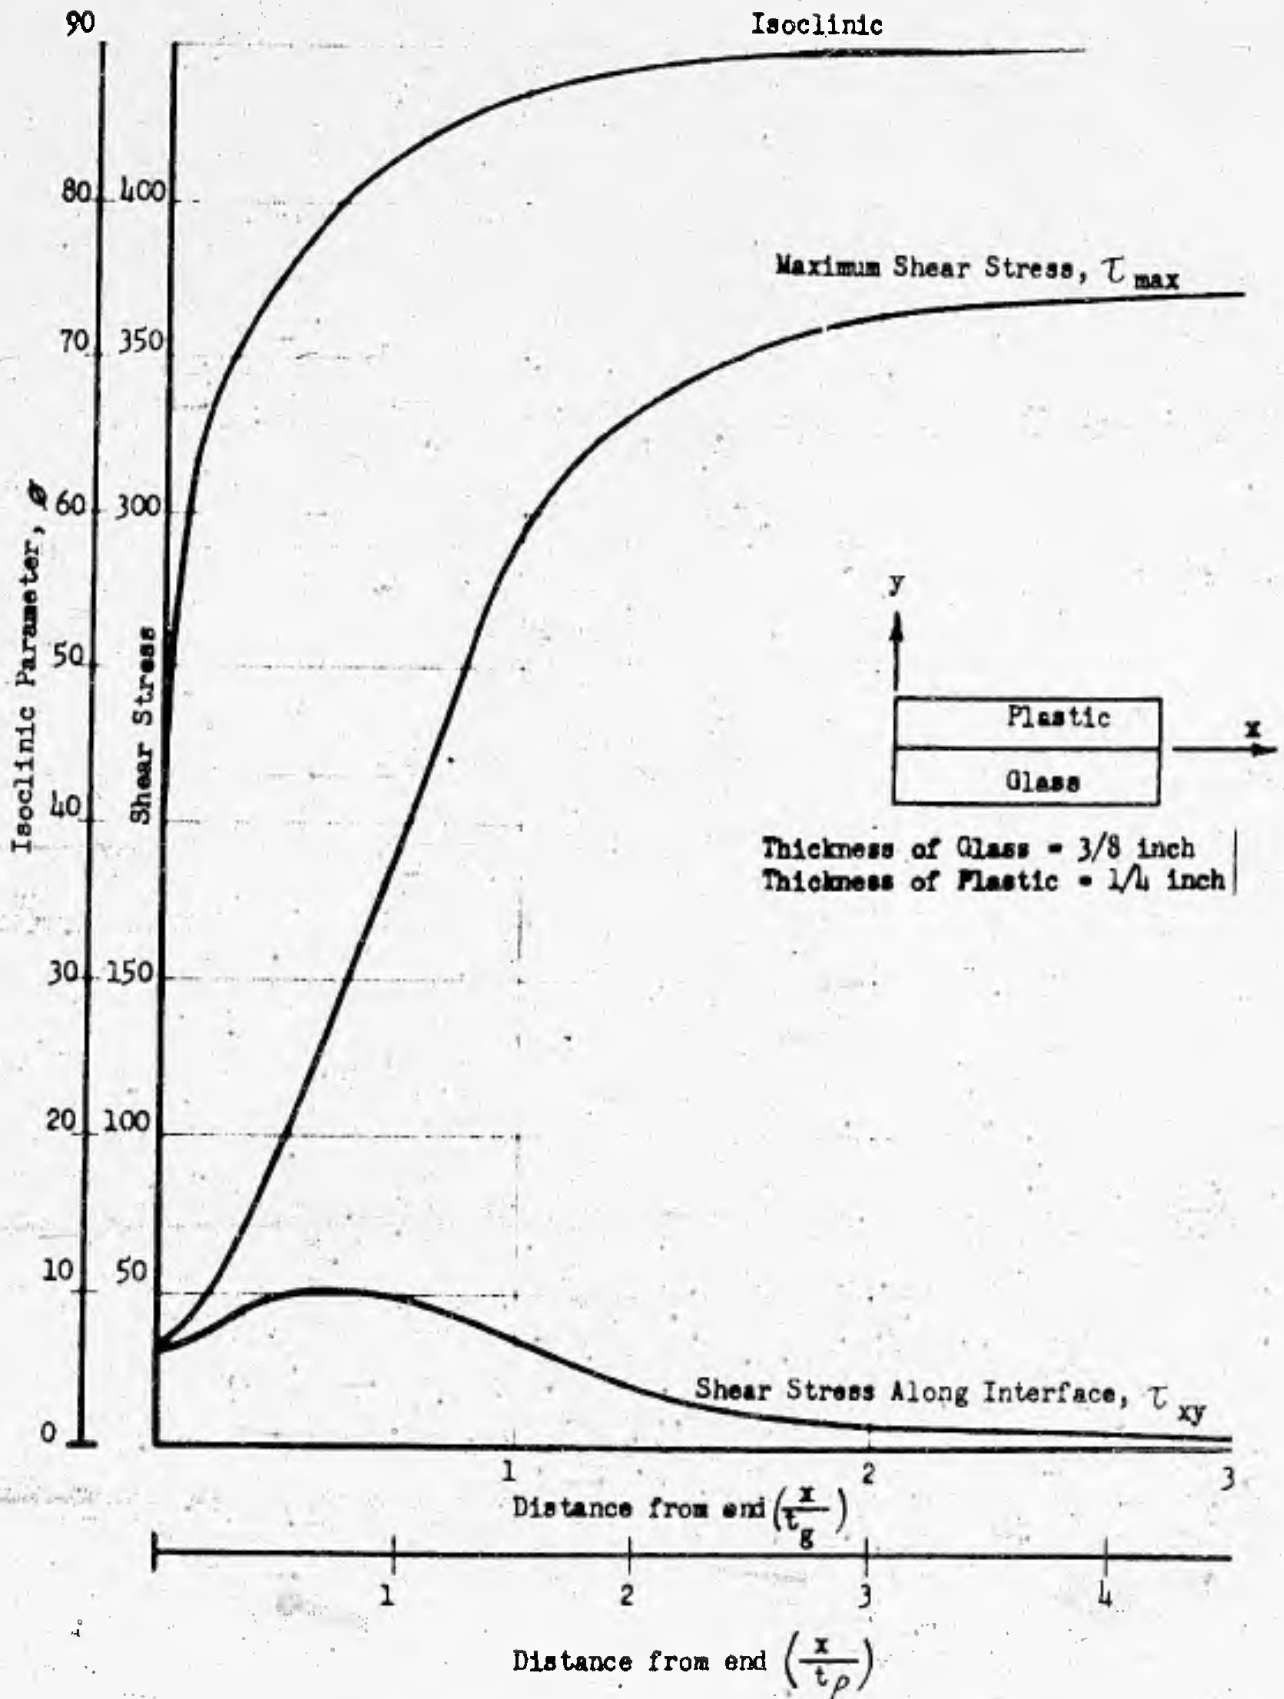
**Fig. 2** ISOCLINIC PARAMETER AND SHEAR STRESS DISTRIBUTION IN TWO-PLY (GLASS-PLASTIC) LAMINATE OBTAINED FROM PHOTOELASTIC TESTS

Figure 2, which represents the stress distribution in a two-ply beam subjected to low temperatures, shows the maximum shear stress parallel to the interface to have a strikingly low value (50 psi) and to be distributed over a fairly large region near the ends of the beam. These results are puzzling in the light of failures obtained in outwardly identical beams at temperatures which were but a few degrees (10 - 15 degrees) below that maintained during the collection of the photoelastic data. Clearly, the photoelastic results are in error. The error may be attributed to the possibility that in a wide (2. inch) model the directions of the principal stresses in the glass change markedly from plane to plane along the optical axis of the polariscope.

(Data taken when the beam was at a uniform temperature of  $20^{\circ}$  F. below a  $40^{\circ}$  F. reference temperature.)

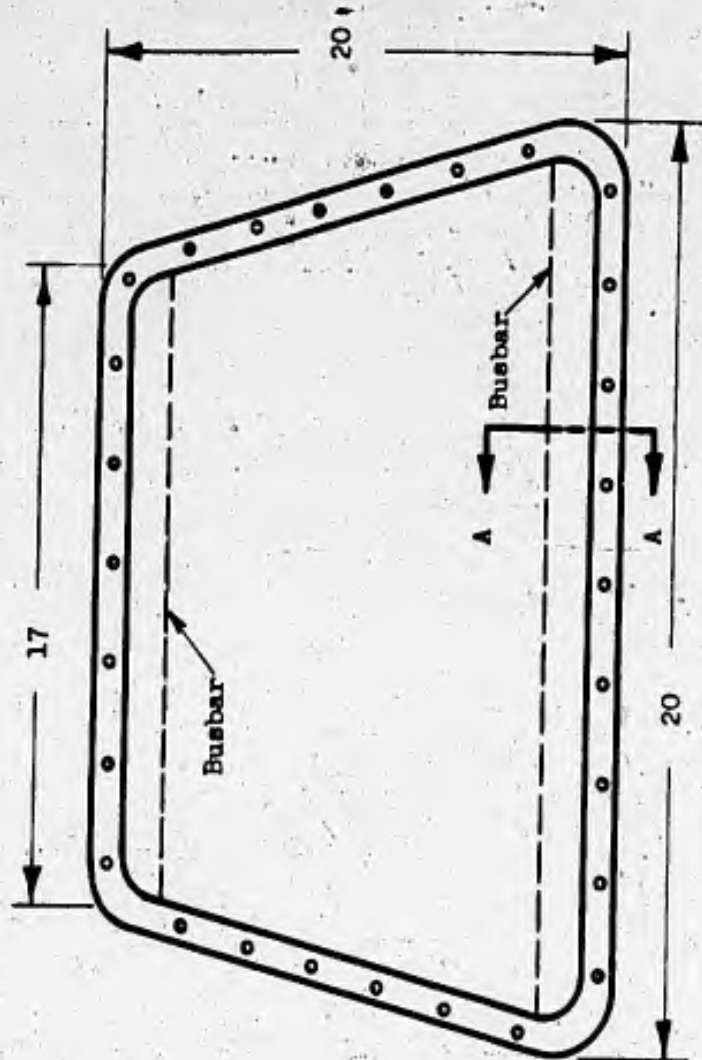
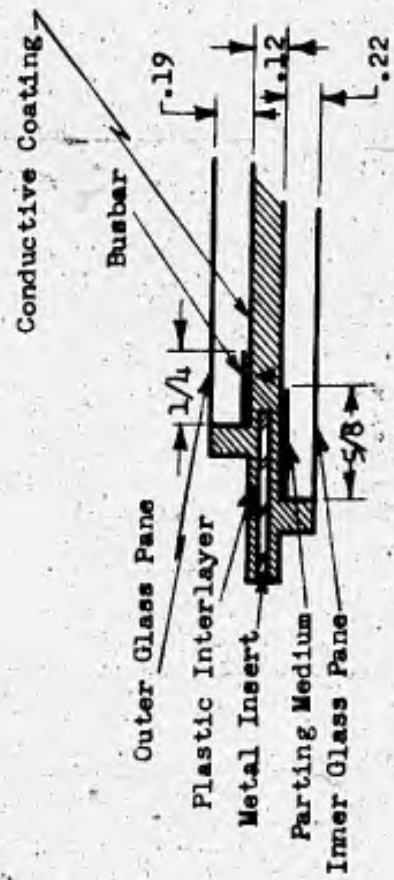
Fig. 3 TYPICAL FEATURES AND DIMENSIONS OF A COMMERCIAL, THREE-PLY, ELECTRICALLY HEATED WINDSHIELD

Most windshields which contain an electrically conductive coating at the inner surface of the outer pane are flat and trapezoidal in shape. Features of construction and approximate dimensions of such a windshield are illustrated in Fig. 3; in many respects, this windshield is typical of the electrically heated windshields now in service.

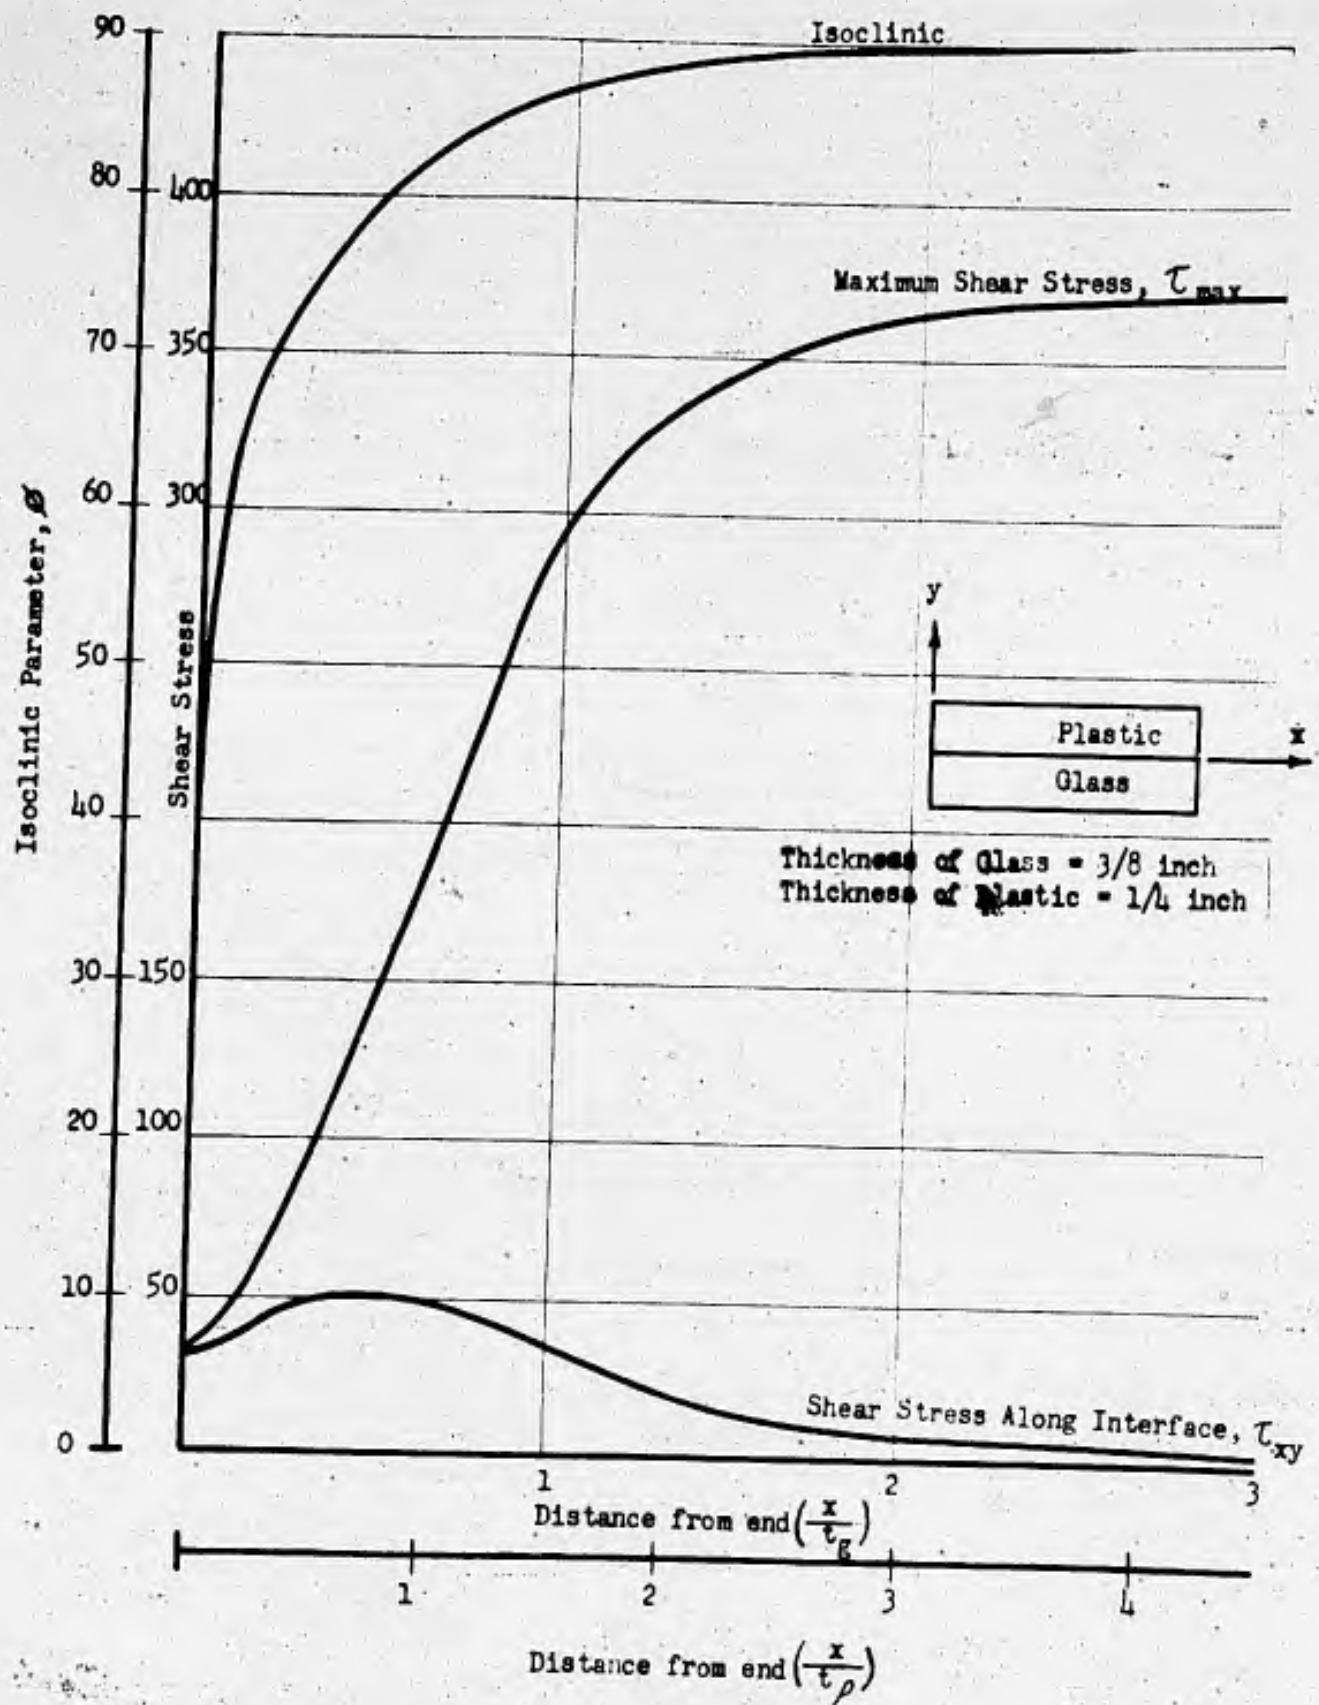
**Fig. B-1** ISOCLINIC PARAMETER AND SHEAR STRESS DISTRIBUTION IN TWO-PLY (GLASS-PLASTIC) LAMINATE OBTAINED FROM PHOTOELASTIC TESTS

For the purpose of these tests it was found more convenient to sketch the isochromatics and isoclinics than to record them photographically; results for the two-ply laminate are shown in Fig. B-1. Perhaps the most striking feature of these results is the fact that the indicated values are extremely low, much lower than would be expected from the fact that the glass is known to fail at temperatures only 10 or 15 degrees lower. Two possible explanations might be advanced: from the fact that failure by chipping of the glass seems to occur at higher temperatures when there is reason to suspect the quality of the bond between plastic and glass, it might be assumed that there are isolated spots of good bond which carry the entire load, thus producing local stresses which are high enough to cause glass failure while the average stress seen by the polariscope remains very small. More probable, however, is the hypothesis that the stress distribution is such that the directions of the principal stresses in the glass change markedly from layer to layer along the optical axis of the polariscope. Such stress distributions are not suitable for examination by the usual techniques of two-dimensional photoelasticity.

(Data taken when the beam was at a uniform temperature of 20° F. below a 40° F. reference temperature.)

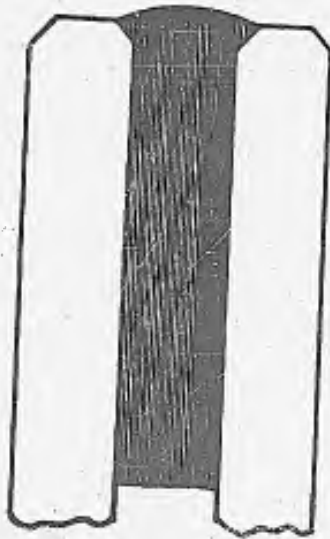
FIG. D-15 EDGES OF GLASS COMPANIES' AND ARF BEAMS

2. While the edges of the glass panes used in commercial beams were beveled, the edges of the plates used in the laboratory-laminated specimens were straight (see Fig. D-15). The edges of the square-cut glass panes contained a few visible cracks and possibly many microscopic cracks.

(1) stresses at the square edge differ from stresses at the beveled edge, and (2) cracks already existing at the square edge are points of stress concentrations and, consequently, will grow under comparatively low applied stresses.

In general, beams laminated by ARF developed considerably more local edge cracks and other damage than the commercially prepared beams. Also, failures of ARF laminated beams generally occurred at higher temperatures than those of commercial beams where comparable samples were tested.

Beam Laminated at ARF

Beam Supplied by  
Glass Companies
