ARMAMENT RESEARCH AND DEVELOPMENT
ESTABLISHMENT

A.R.D.E. REPORT (S) 26/55

Investigation of Accidental Explosion of 1000 lb.
Bomb at R.A.F. Station Marham

D.E. Jarrett (S.2)

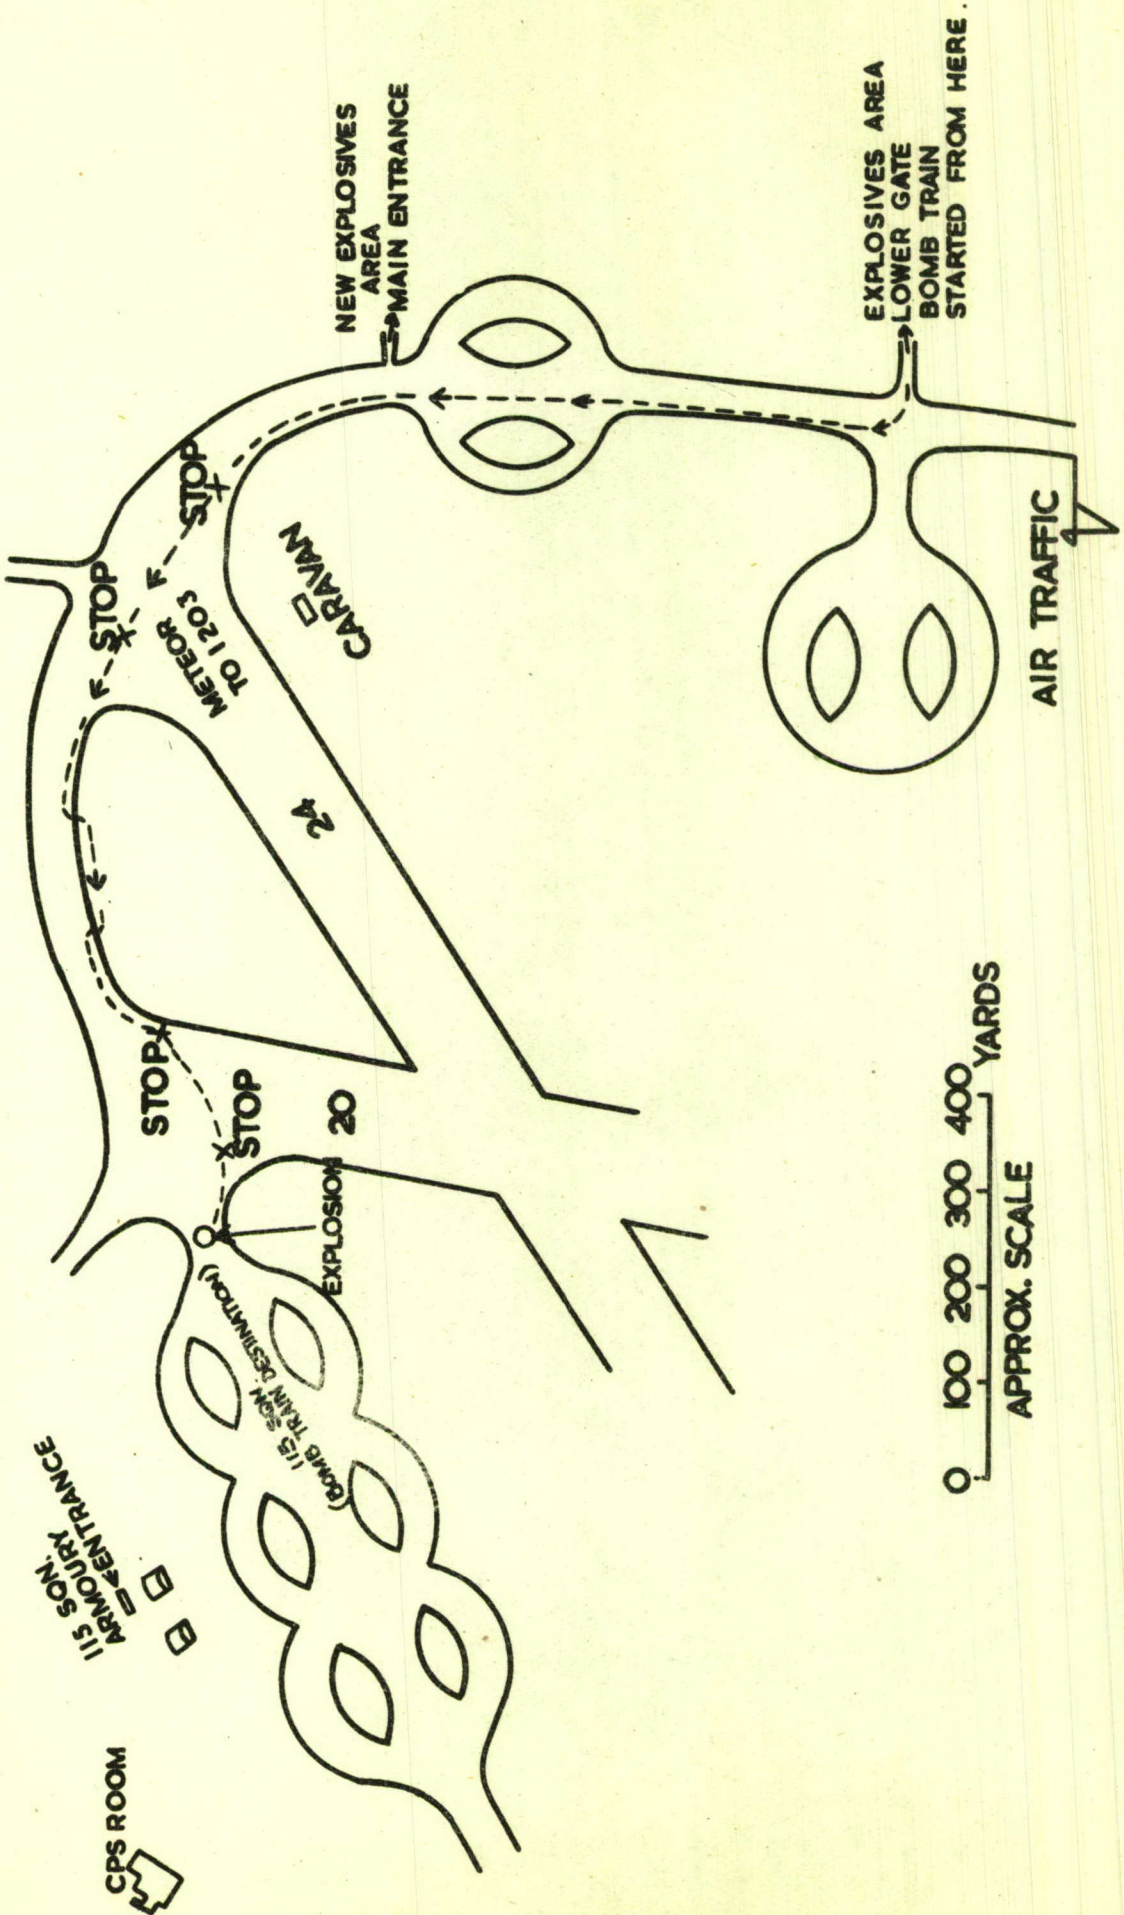
"At 12.00 hours on 20.9.54 a tractor towing two loaded bomb trolleys was being driven from the explosive area towards No.115 squadron dispersal area. The route of the tractor is shown in Fig.1. There were four bombs on the forward trolley and two in the rear position on the rear trolley. About three quarters of the way across runway 24 the tractor stopped for about 30 seconds and then carried on. About 50 yds. beyond runway 24 the driver took the bomb train on the grass for an unknown period, then returned to the perimeter track. The rear bombs were noted at this point by the Station Commander as having moved slightly but not to a dangerous position. The driver continued on the perimeter track until entering runway 20 where he stopped and got down to examine the bombs on the trolleys. He then drove very slowly across runway 20 and stopped again on the other side. At this point the bombs were observed on the rear trolley, by an aircrew member, to be off the trolley cradles. The driver started slowly toward 115 squadron dispersal when an aircraft had passed and had reached a position about one third of the distance across the perimeter track when there was an explosion (12.08 hours). Four unexploded bombs were found in the area." (photographs 7 and 8).

FIG. 1 GROUND PLAN OF BOMB INCIDENT, MAR. RAF. 28 46 2 NO. OCT. '54

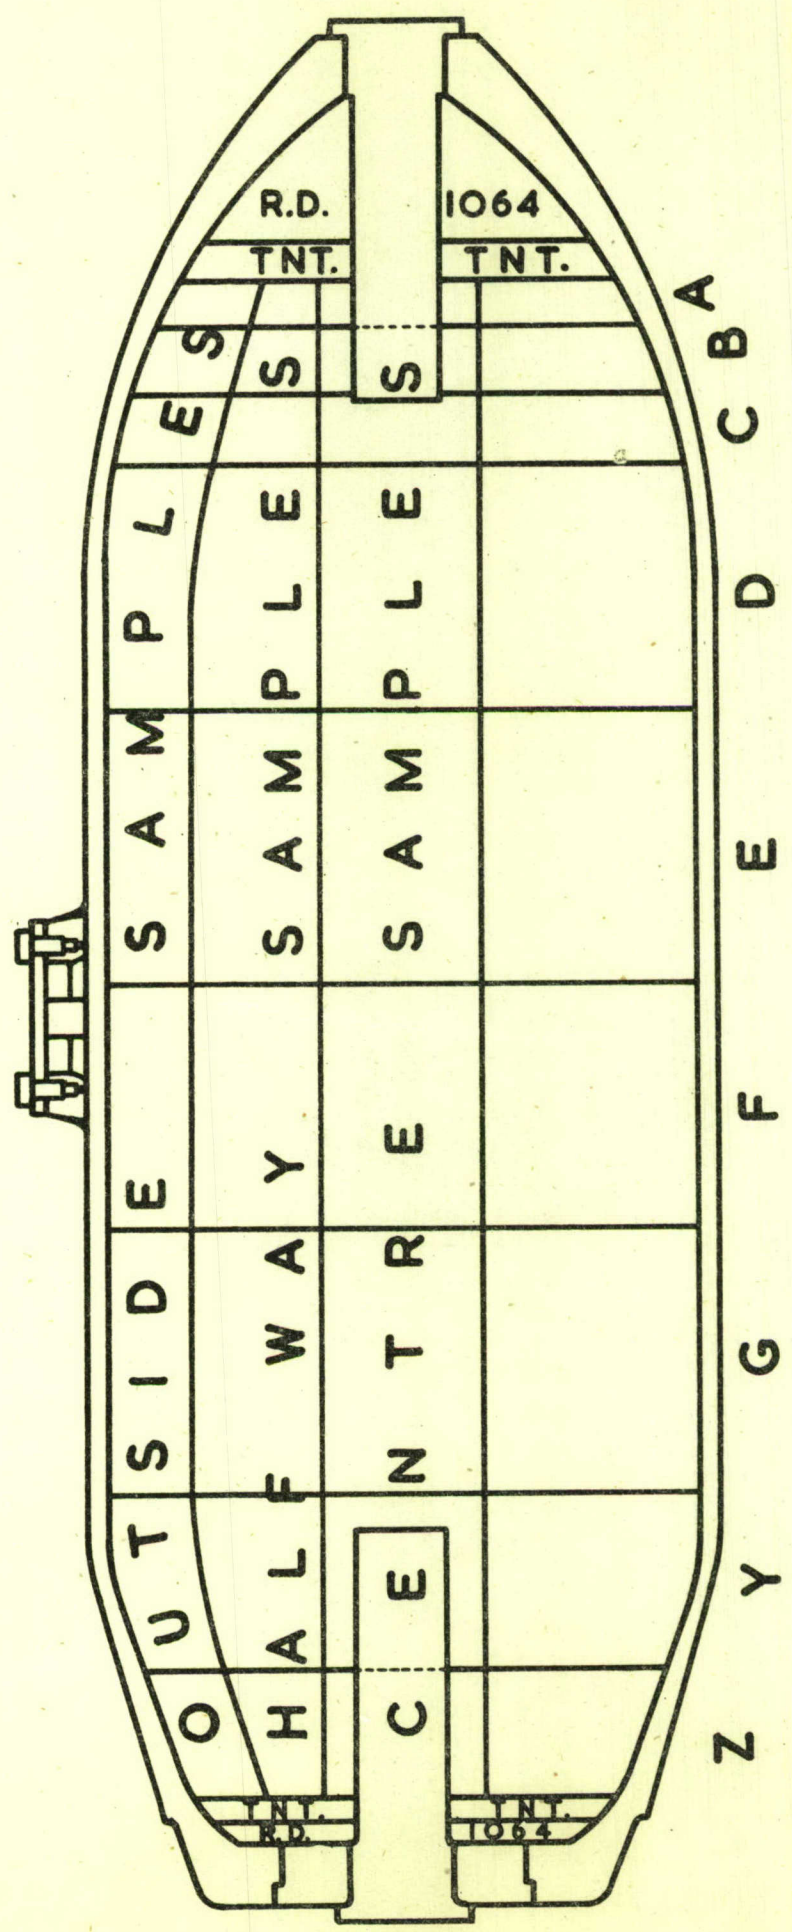
FIG. 3 ANALYSIS OF FILLING. BOMB 72.

The figures for RDX and beeswax percentage given in the last four tables are also shown in Figs.3 - 6 superimposed on a diagram of the bomb.

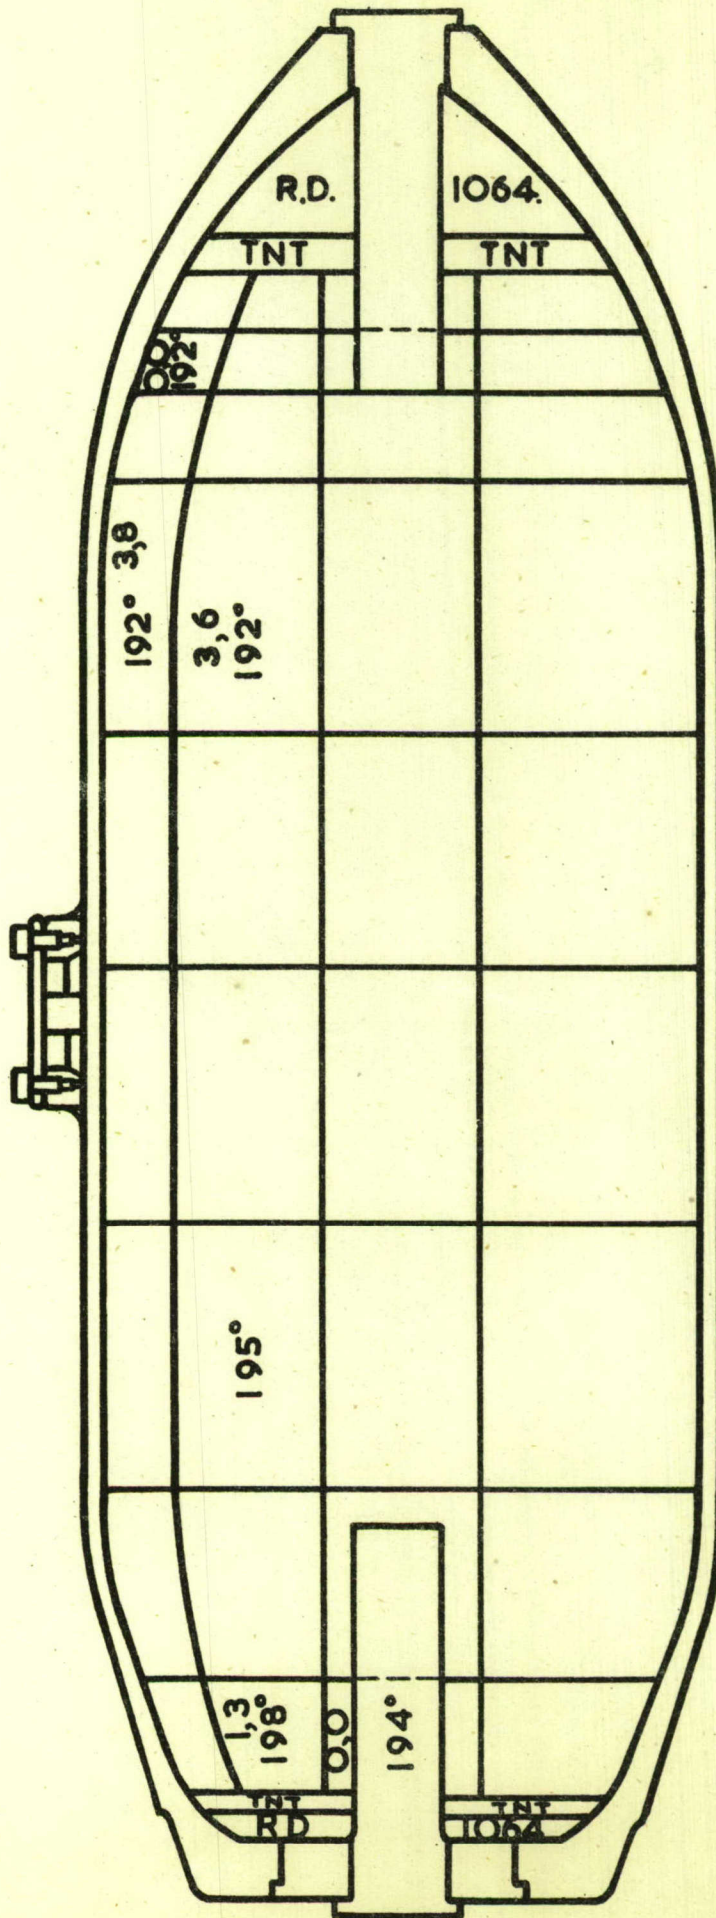
FIG 8 IGNITION POINTS IN °C. BOMB 106.

Ignition points were also determined for these samples. They are shown in Table 8 and plotted together with the sensitivity results on diagrams of the bombs in Figs. 7 - 10.

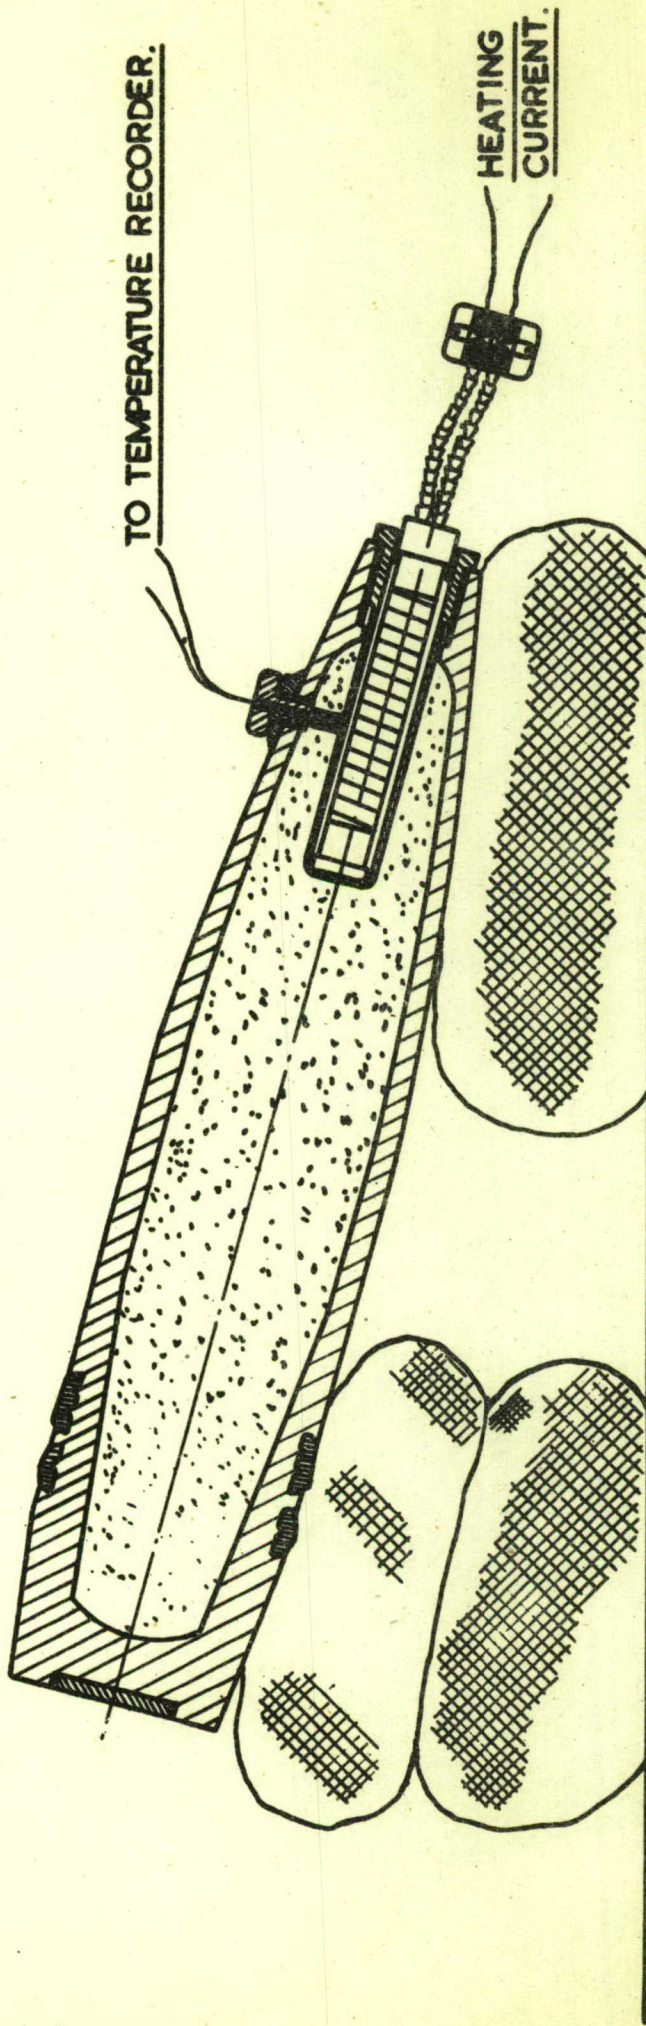
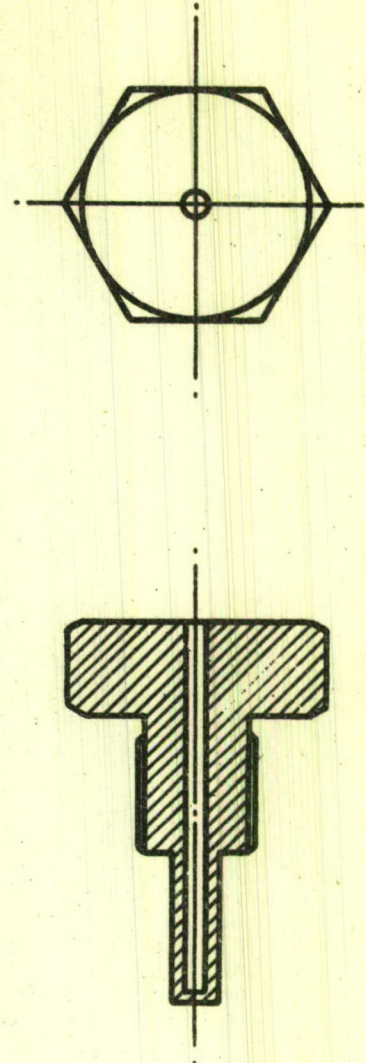
FIG. 13. HEATING TRIAL — R.D.X./T.N.T. IN 5.5" SHELL.

A graph of the temperature record of the last two trials is shown in Fig.13.

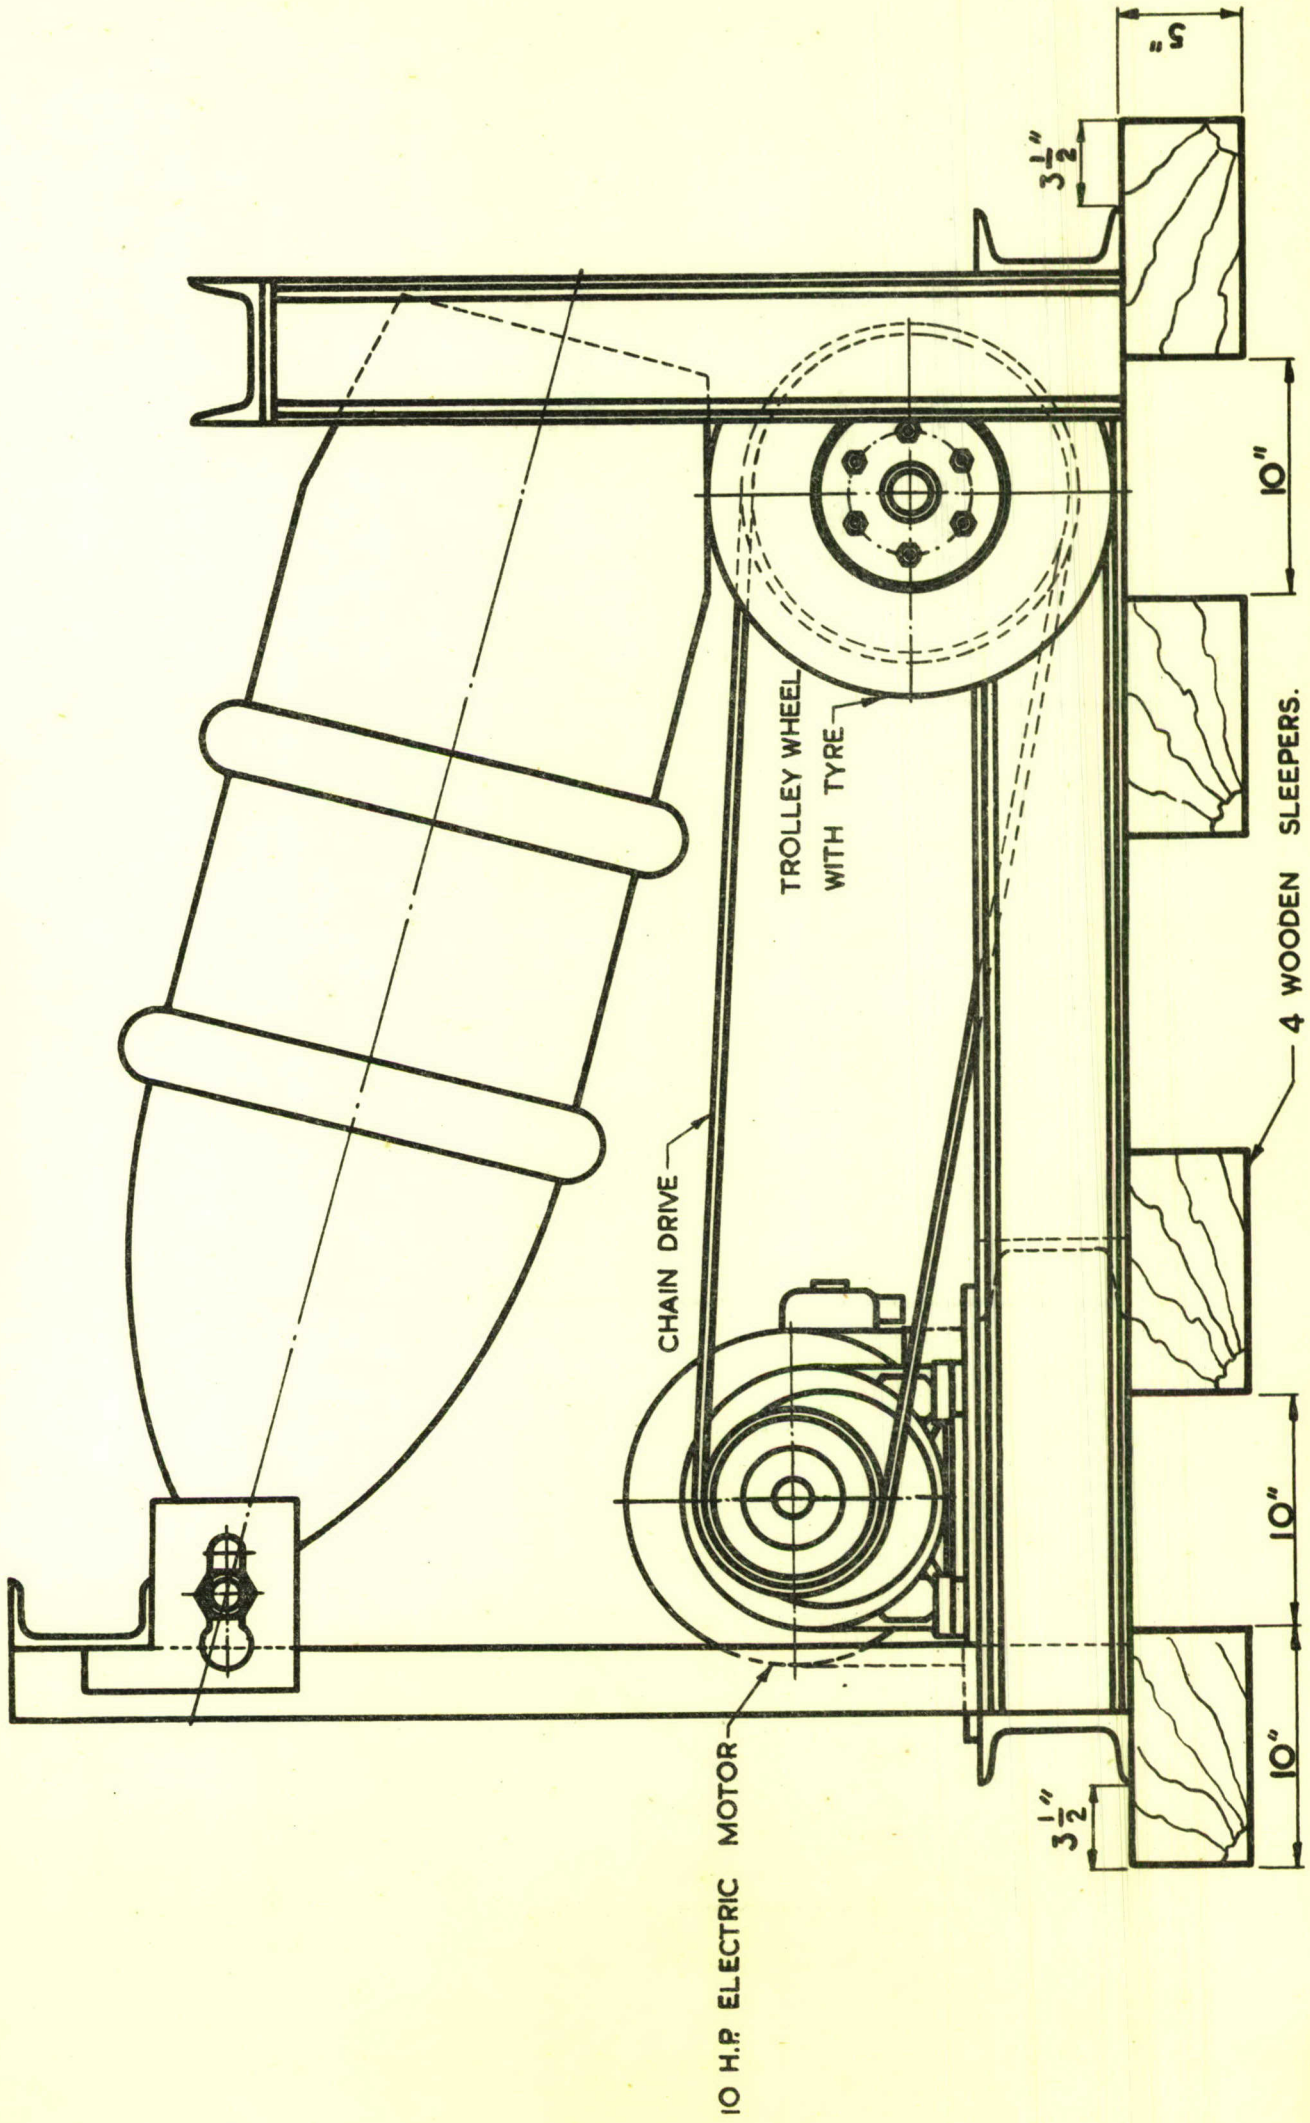
FIG.19 FULL SCALE FRICTION TRIAL.

The temperature rise shown by the thermocouples was plotted and is shown in Fig.19. A first straight portion occurred while the mud was being removed from the tyre. The characteristic drop in temperature occurred after approximately one minutes effective heating, at an unusual low temperature which indicates that thermocouples 2 and 3 were not in the region of maximum reaction. Thermocouple 1 showed no drop in temperature and the rapid rise suggests that this thermocouple was in contact with the bomb wall at the region of maximum temperature and that the explosive melted away, leaving it surrounded by an air or gas pocket. The temperature subsequently recorded was that of the bomb wall due to friction plus heat of decomposition rather than that of the explosive.

FIRESTONE BOMB TROLLEY TYRE ROTATING AT
132rpm. AGAINST 1000lb., MC Mk VII BOMB FILLED RDX./TNT.

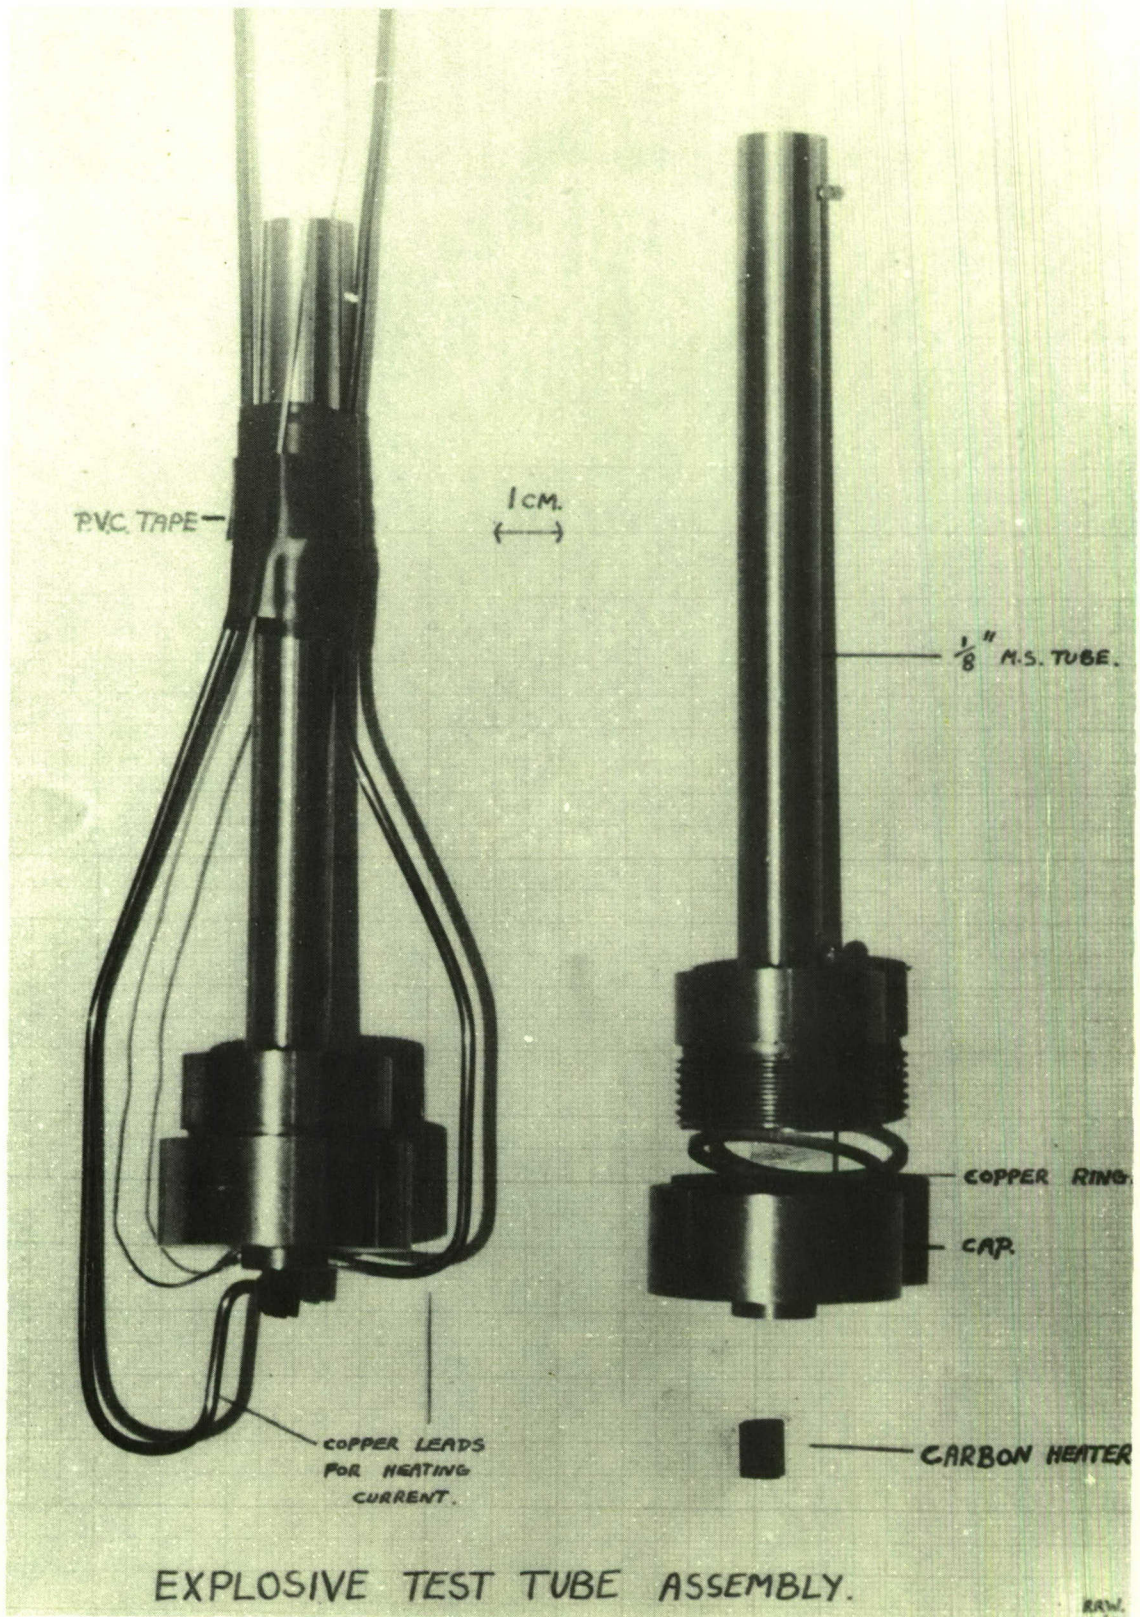
22. Tubes used for small scale heating trials of RDX/TNT

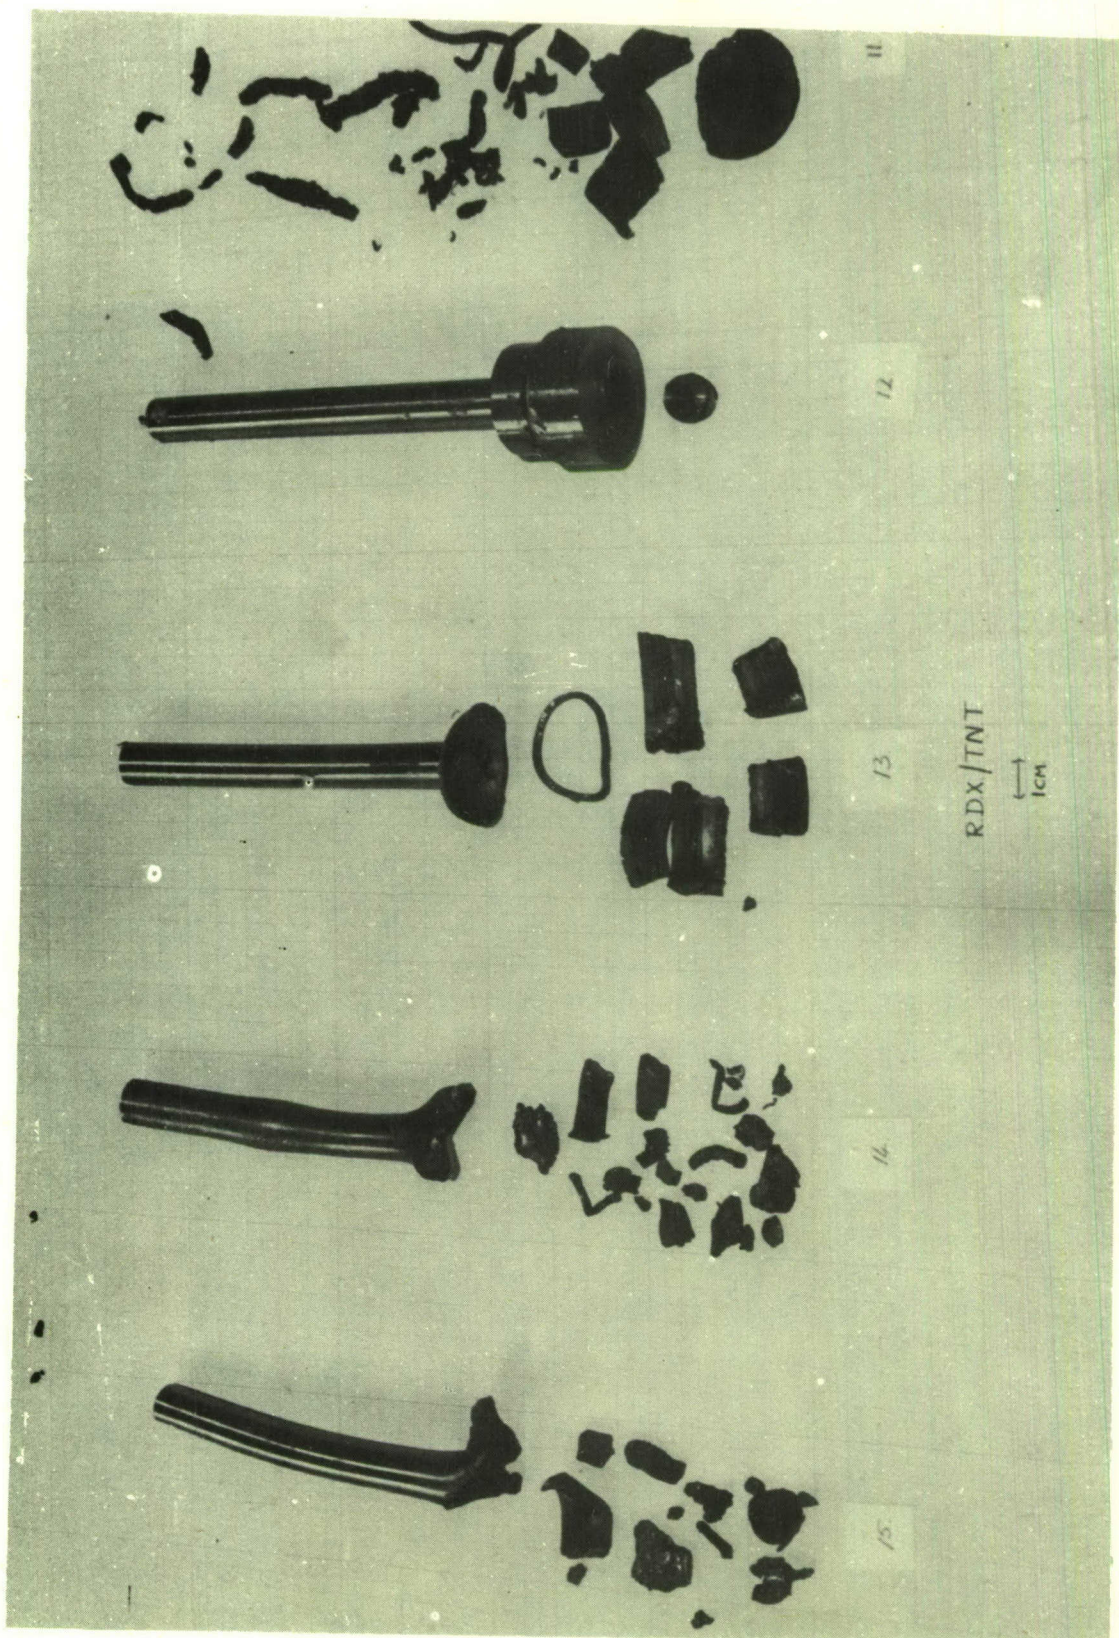
23. Fragments from small scale heating trials of RDX/TNT

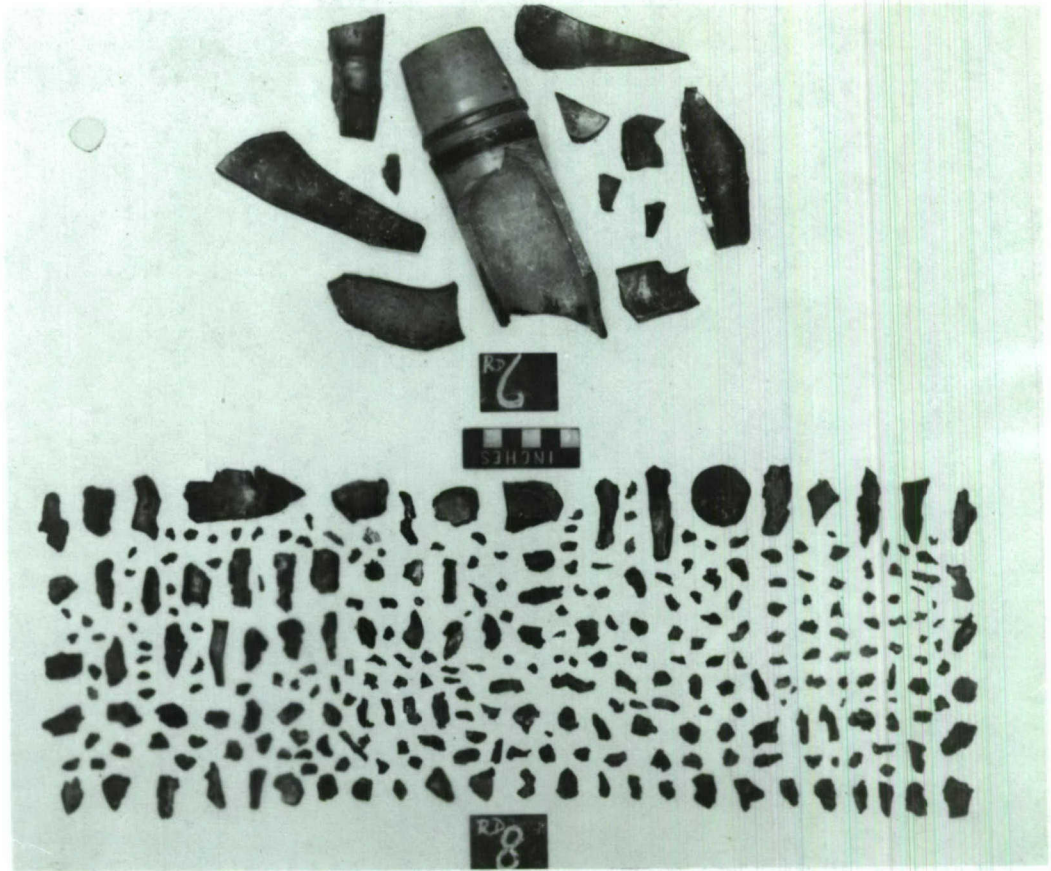
24. Fragments from 5.5 in. shell heating trials

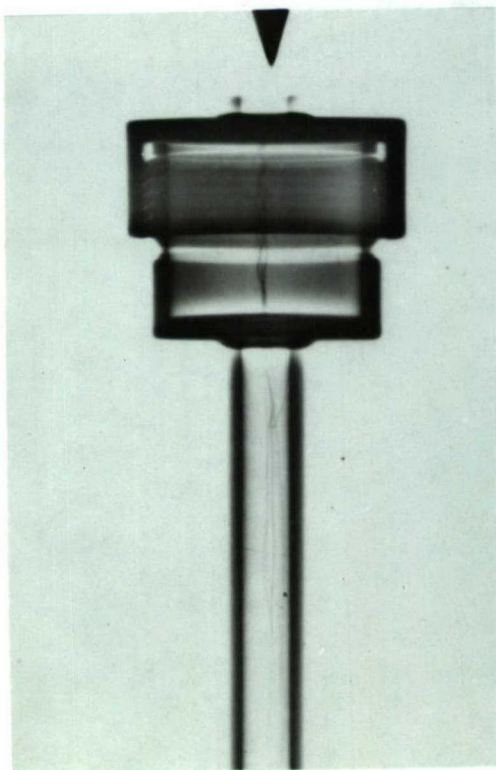
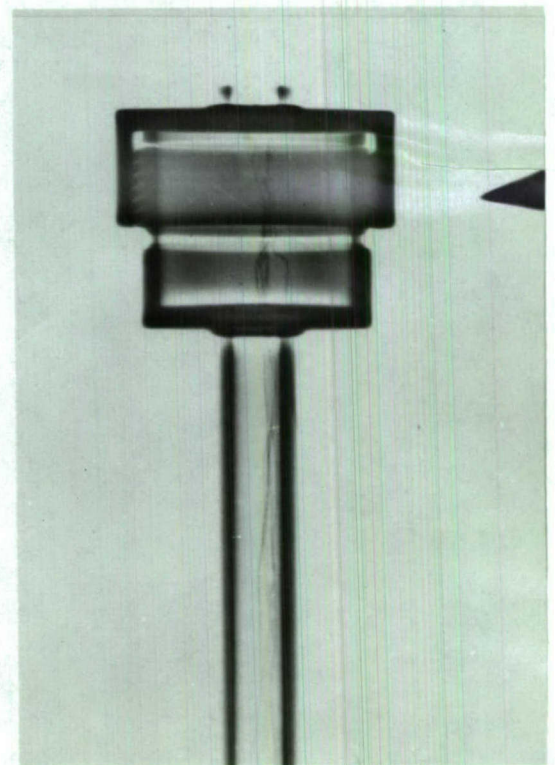
A further trial was carried out in which the position of four thermocouples was determined by radiography (photographs 25, 26). The first thermocouple (A) was in the steel tube below the heater as before, the second (B) was inside the tube at the surface of the explosive, the third (C) and fourth (D) 1/8 in. and 1/4 in. below the surface. The temperature record for this trial is shown in figure 11. After 13.75 minutes a partial detonation occurred. The energy input was maintained at a constant value during the trial and it was observed that both thermocouples B and C showed a marked decrease in temperature after approximately 10 minutes heating. Thermocouple D, the temperature of which lagged well behind, did not show this decrease. This type of curve is repeatable, and it was found that after this decrease, the rate of rise of thermocouple C was much greater than would be accounted for by the external heat input. The suggestion is that the discontinuity in the curve indicates the commencement of decomposition of the explosive filling under the particular conditions and that this decomposition increases in vigour until an explosion or detonation occurs.

25. X-ray photograph showing thermocouple in small scale heating trials of RDX/TNT

26. X-ray photograph at right angles to Fig. 25

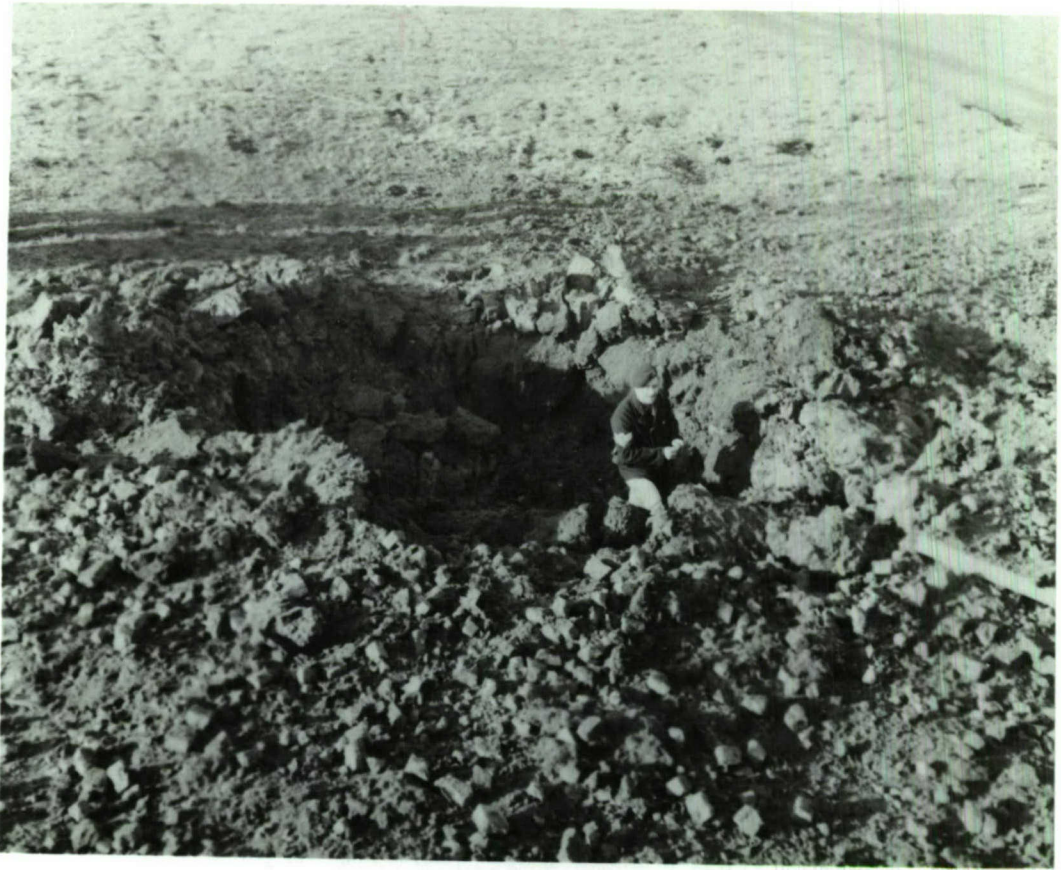
31. Crater from detonation of 1000 lb. bomb at Shoeburyness

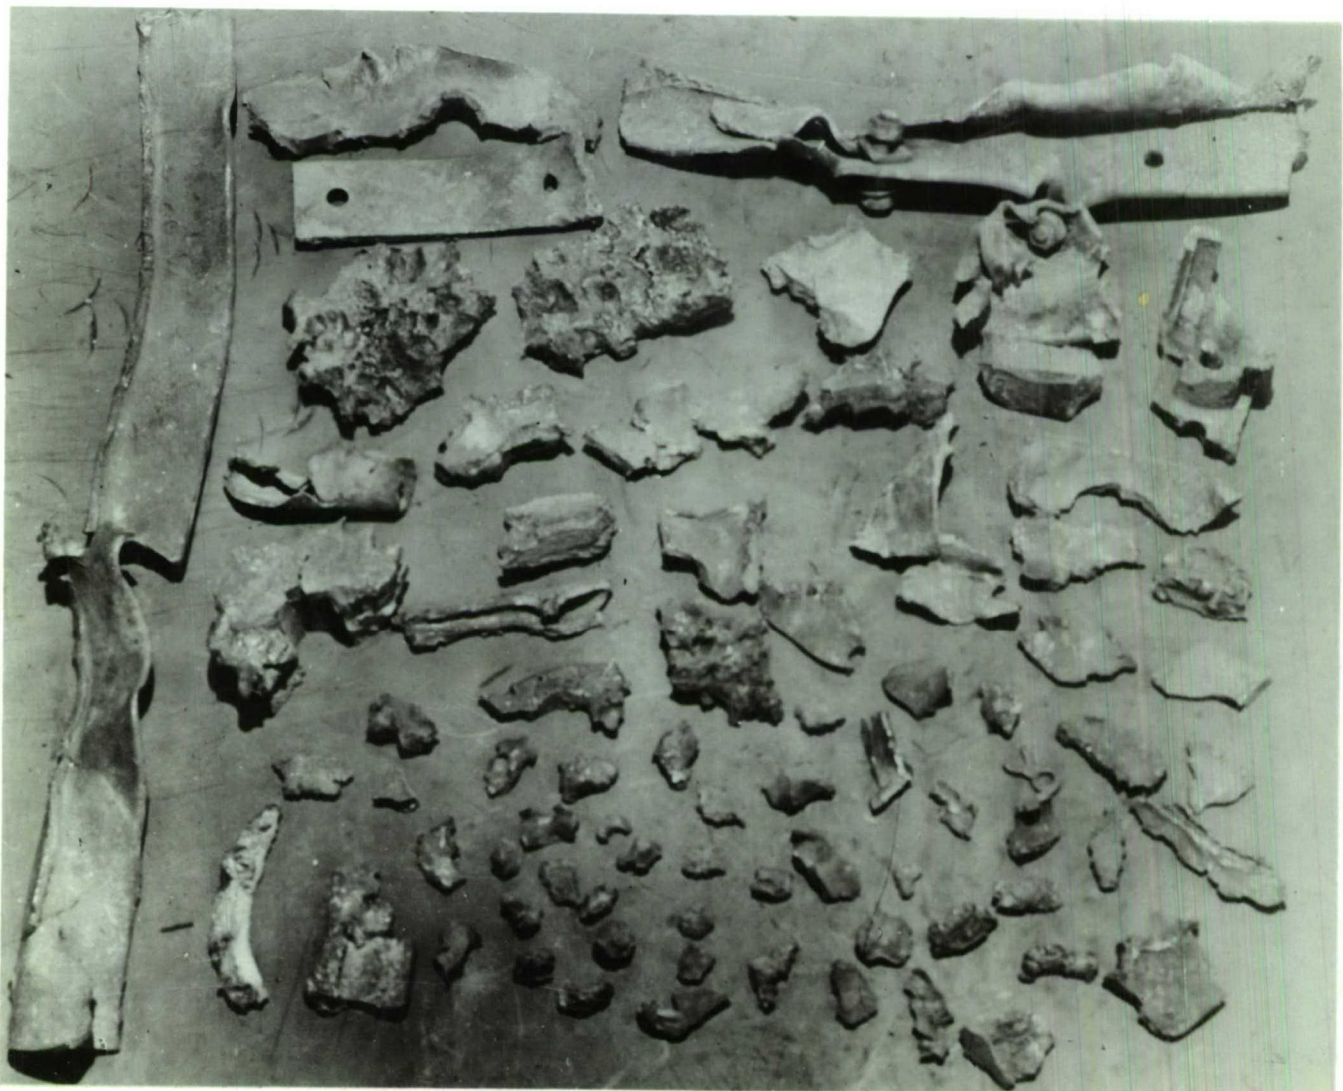
32. Fragments of apparatus recovered from crater after detonation of 1000 lb. bomb at Shoeburyness
