# ROHM & HAAS COMPANY

REDSTONE ARSENAL RESEARCH DIVISION

Report of Fatal Explosion - March 28, 1958

CONTRACT NO. DA 01-021-ORD5135

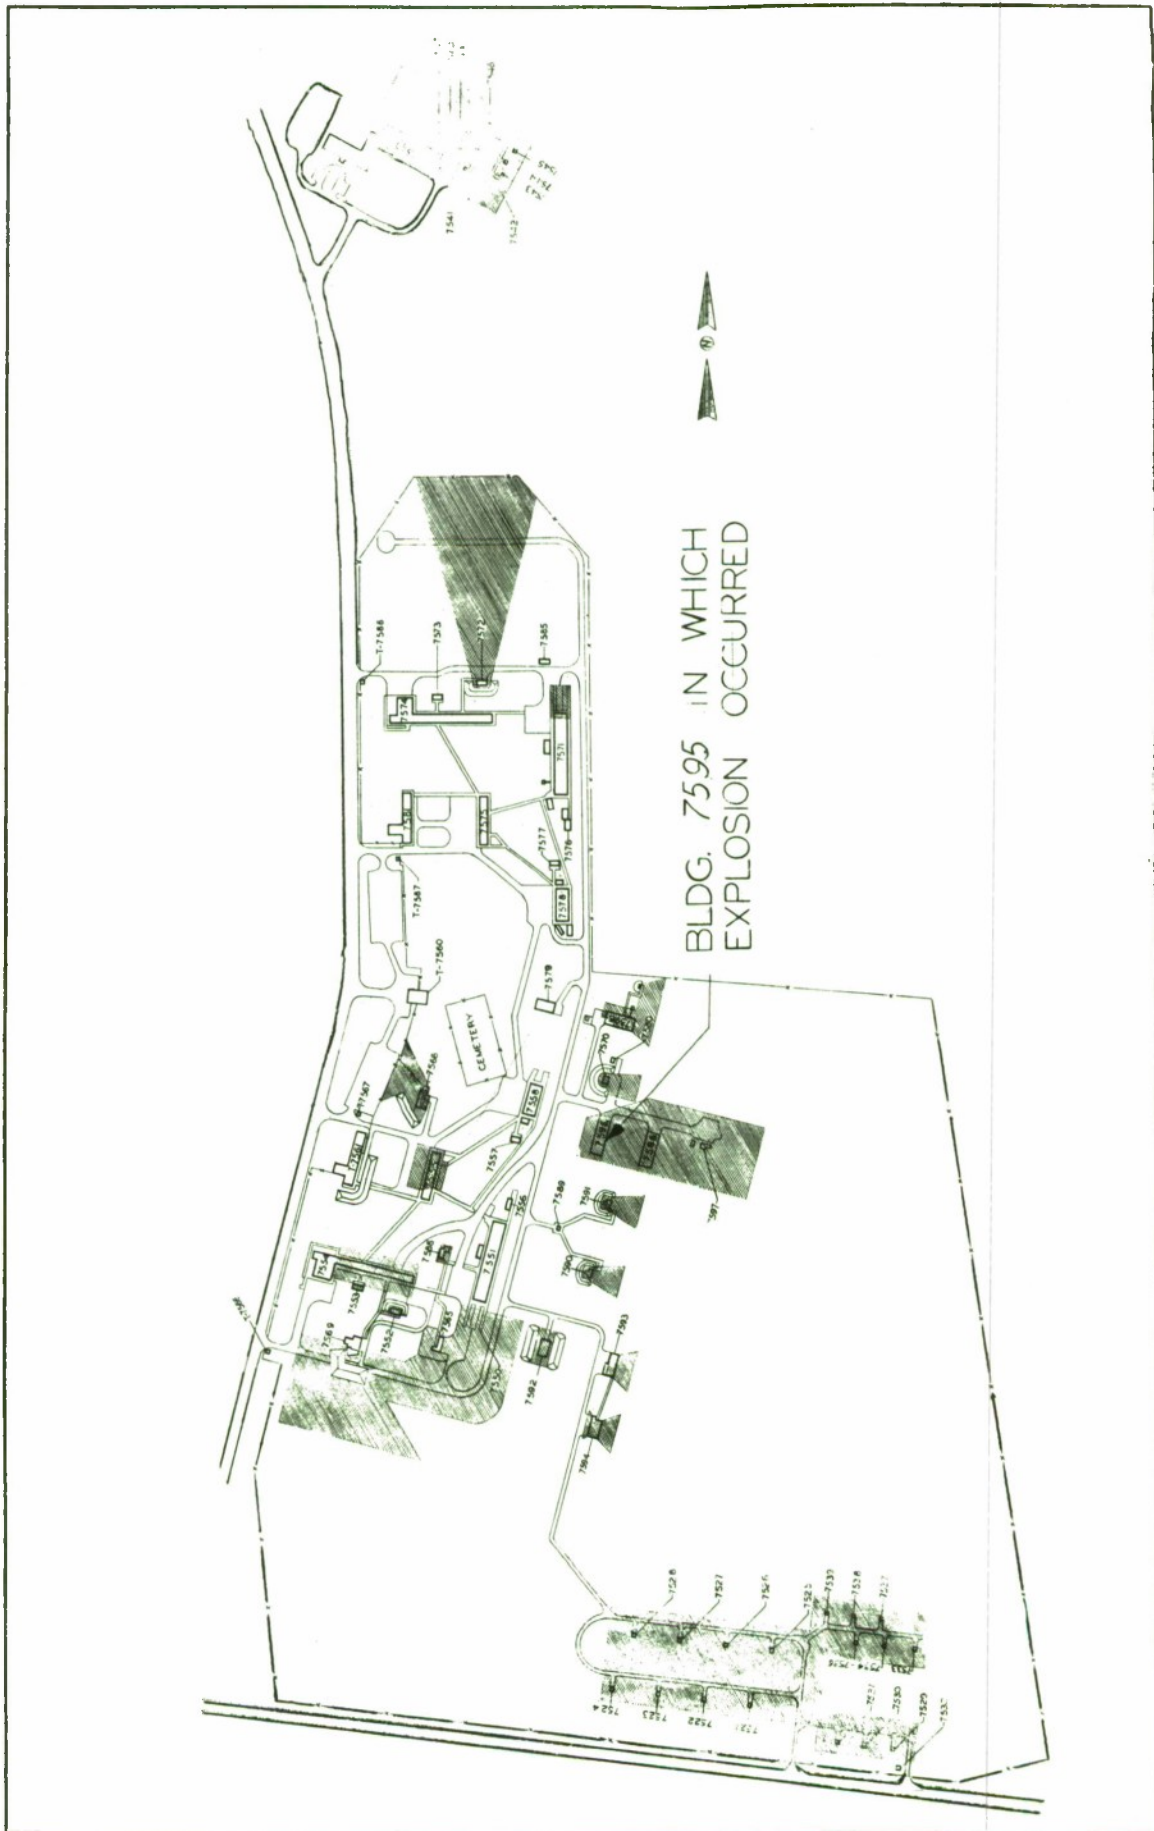
At 12:59 p.m. on Friday, March 28, 1958, an explosion occurred in a mixer bay of Building 7595 in the Rohm & Haas Company area (Fig. 1) at Redstone Arsenal, Alabama. This explosion resulted in fatal injuries to one man and in burns and cuts requiring the hospitalization of a second man.

Fig. 1 Plot plan of area occupied by the Redstone Arsenal Research Division. Shaded portions represent hazardous areas to which access is restricted; they are not inter-line distances.
