WADC TECHNICAL REPORT 53-192

## MECHANISM OF RAIN EROSION

Part XIII. Mechanism Studies on Neoprene Coatings

*Olive G. Engel*

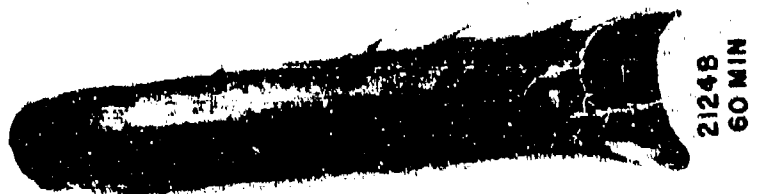
Specimen 2123 B was tested for 20 min under the same conditions of velocity and rain rate. Microscopic inspection of this specimen also revealed a scattering of small round holes in the coating down the leading edge. The chevron pattern in the neoprene at the low-speed end of the specimen was more distinct. There was a coating bubble at about the center of the leading edge and a humpy structure at the high-speed end indicating loss of adhesion. There was some abrasion or tearing away of the surface layer especially at the high-speed end. There were also some sutures or cracks in the coating mainly at the high-speed end of the specimen.

Specimen 2124 A was tested for 40 min under the same conditions of velocity and rain rate. Microscopic inspection of this specimen again revealed a scattering of small round holes down the leading edge. The chevron pattern in the neoprene at the low-speed end

FIGURE 12 - ERUDED SPECIMENS THAT WERE COATED WITH SODIUM B 21-76 PROTEIN

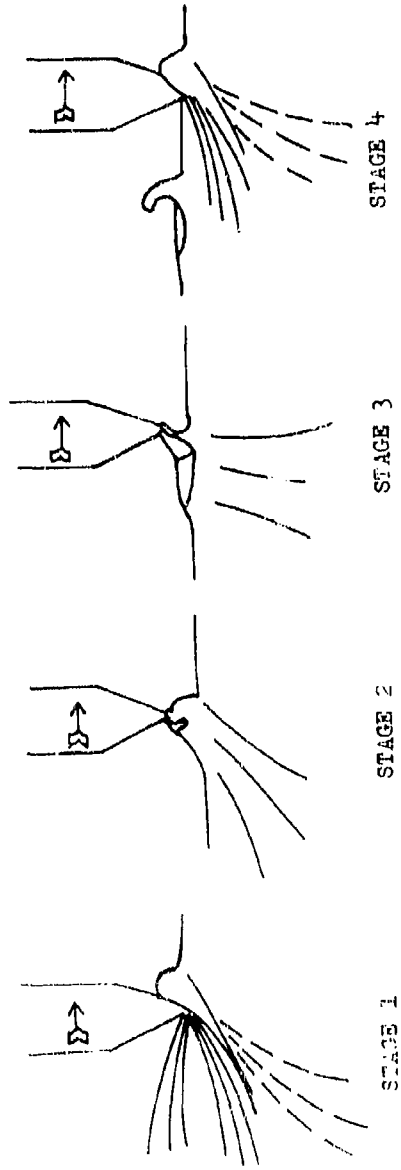
The abrasion of rubber is also a "stick-slip" process. Schallamach [4,5,6] has found that the abrasion trace left by a needle on a pure gum vulcanizate rubber is not continuous. It consists of isolated pits or tears; the surface material between the pits or tears is undamaged. In regard to the abrasion caused by a needle, Schallamach postulated that (a) the needle pricks a small hole in the rubber, and, as the needle moves, a bulge of rubber is built up in front of it; eventually, (b) the needle moves over this bulge simultaneously pulling out a thong of rubber that breaks either at its root or at the needle tip. Step (a) is the "stick"-step and step (b) is the "slip"-step. See Figure 20. The mechanism of needle abrasion postulated by Schallamach depends on two factors, namely, the bulge of rubber must adhere by friction to the tip of the needle against the pull of the elastic forces, and the tensile properties of the material must admit of large deformation without failure.

FIGURE 2C A SCHEMATIC REPRESENTATION OF THE "STICK-SLIP" PROCESS OF RUBBER ABRASION

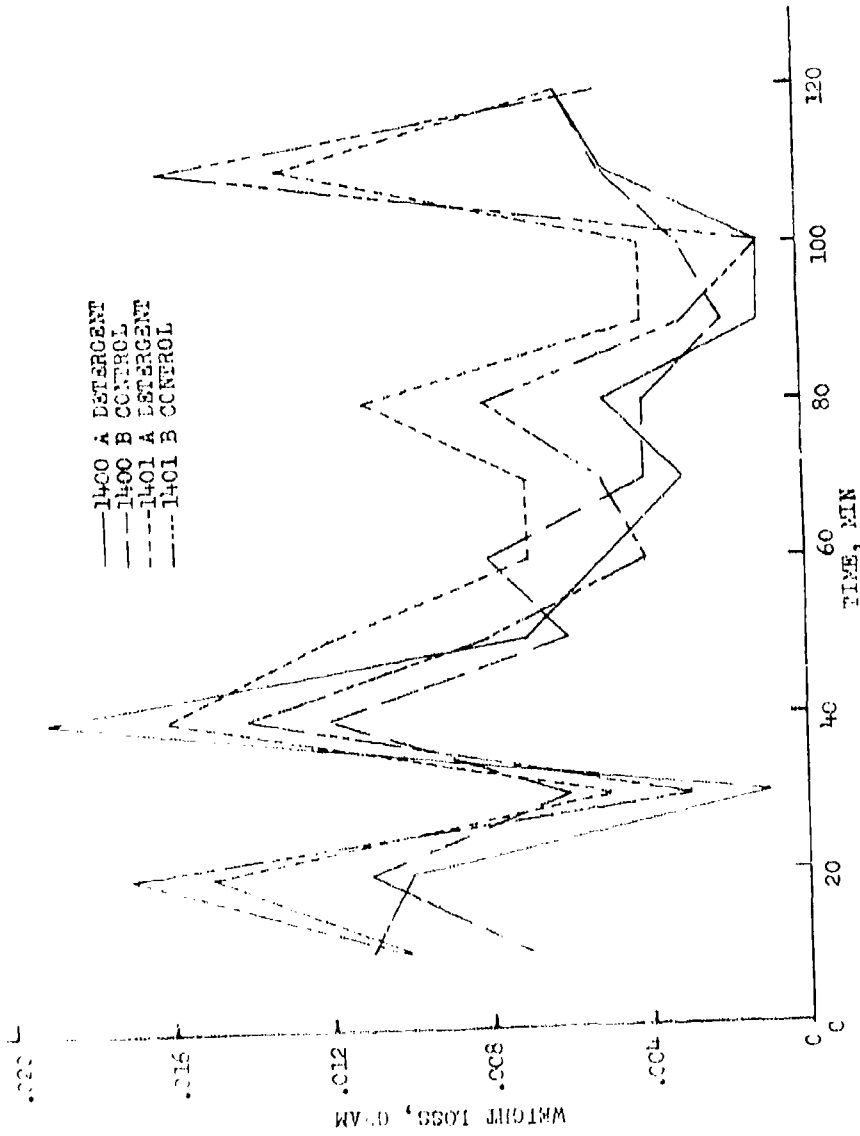
FIGURE 23 WEIGHT-LOSS-VERSUS-TIME CURVE FOR FOUR NEOPRENE COATED SPECIMENS  
 TWO OF WHICH WERE TREATED WITH DETERGENT DURING TEST

From Figure 23 it can be seen that the weight loss sustained by the specimens in equal intervals of time is not constant. During the first two hours of test, peak losses occurred in the intervals 10 to 20 min, 30 to 40 min, 70 to 80 min, and 100 to 110 min. This seems to indicate that there are preparation periods, in which little or no erosion loss occurs, followed by periods in which loss is accomplished. The preparation periods may be characterized by the development of structures without loss of material, such as coating bubbles, which are later torn open with loss of material. The development of surface cuts, cracks, or tears without loss of material may, similarly, be followed by a tearing away of small pieces of the coating when the water from additional impinging drops is driven into them, or by the falling away of pieces of coating material from between circumscribing cracks.

The rain-erosion of neoprene coatings is a two-step process consisting of periods of preparation in which little loss of material occurs followed by periods of erosion or loss of material. This is clearly shown in the graphs of Figure 23 and 25. The gradual development of a network of ozone-type cracks with eventual breaking away of material between circumscribing cracks is such a two-step process.

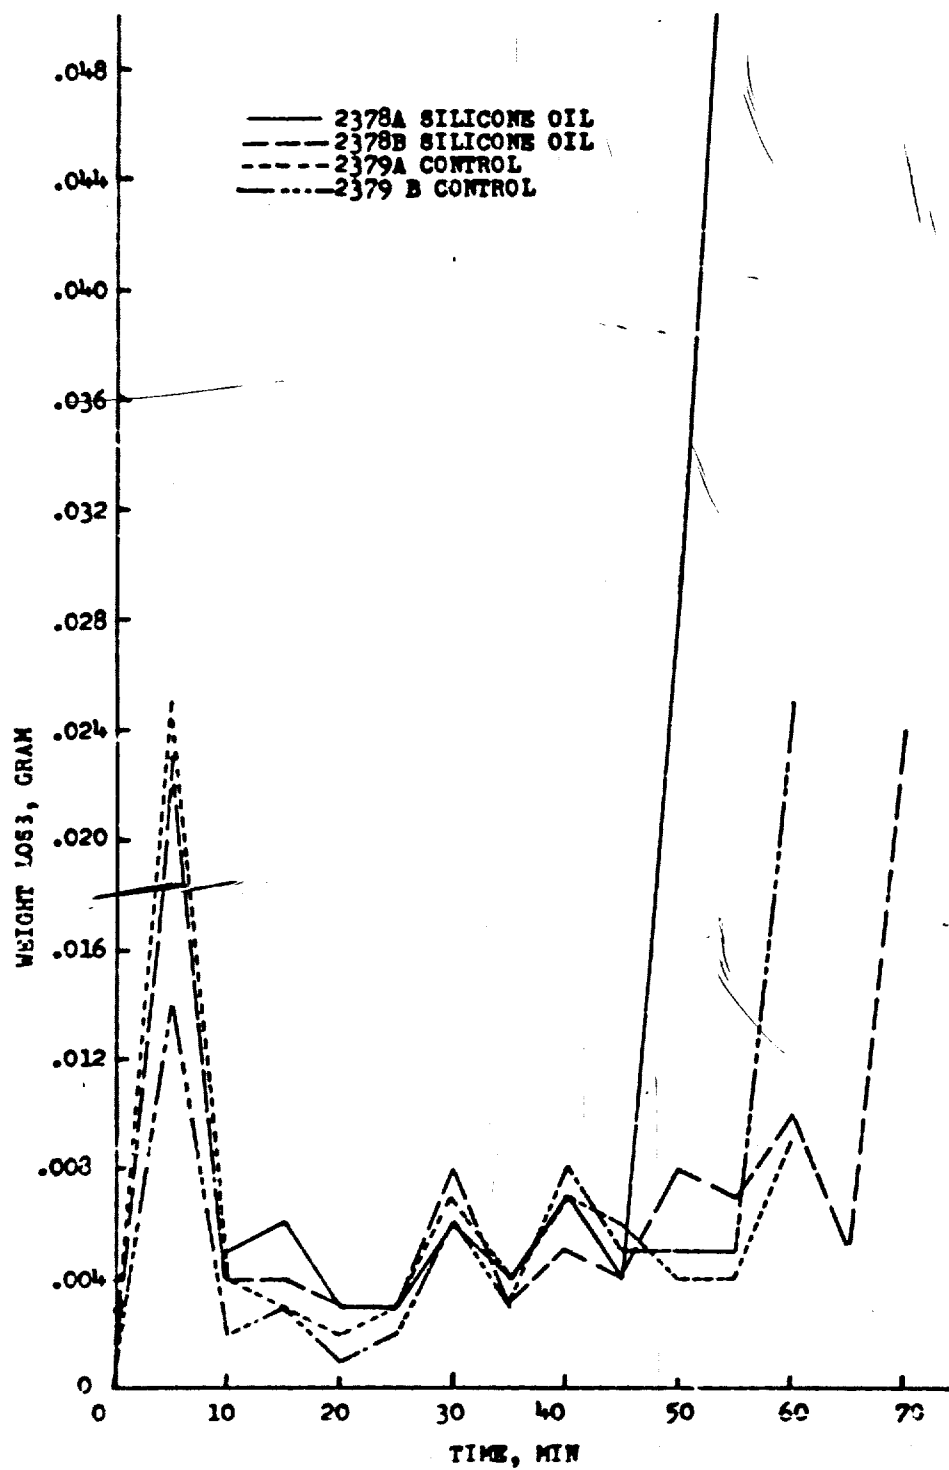
FIGURE 25 WEIGHT-LOSS VERSUS TIME CURVE FOR FOUR NEOPRENE COATED SPECIMENS TWO OF WHICH WERE COATED WITH SILICONE OIL DURING TEST

Microscopic examination of the specimens led to the conclusion that the type and degree of damage that was sustained by the oil-treated specimens and by the control specimens was about the same. In general, it consisted of a dim chevron pattern at the low-speed end of the specimen and of broken out spots at the low-speed end which increased in density toward the high-speed end until at the high-speed end there was a swath down the center of the specimen from which a complete layer of coating material had been removed. There was evidence of crack formation in the coating at both ends of the specimens.

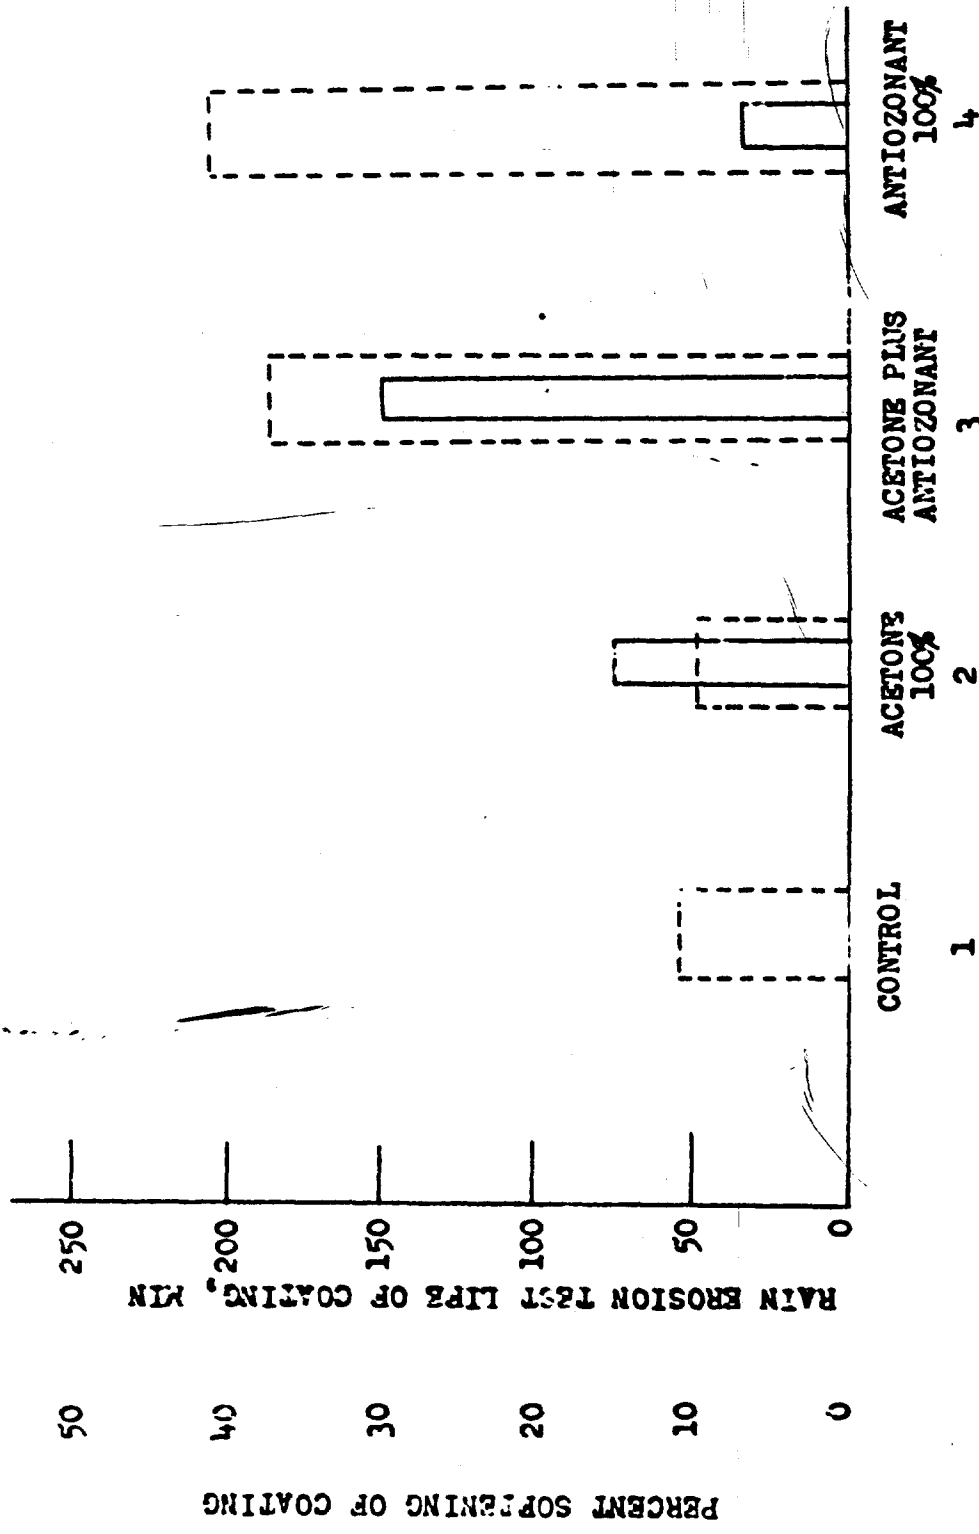
The Cornell Aeronautical Laboratory reported that the neoprene coatings were softened by the antiozonant alone, by acetone alone, and by the solution of antiozonant in acetone. For the three reagents that were used to treat the coatings, the greatest swelling and softening resulted from the use of antiozonant-acetone solution and the least swelling and softening resulted from the use of 100 per cent antiozonant. Their data are presented graphically in Figure 26.

Treatment of the neoprene with 100 percent acetone had no effect on its rain-erosion test life. The acetone evaporated very rapidly. Softness of the neoprene coating that resulted from the use of 100 per cent acetone vanished with the acetone. Therefore, whatever effect the softening of the neoprene had on its rain-erosion test life must be determined from the results obtained on treatment with the acetone-antiozonant solution and treatment with 100 per cent antiozonant. A comparison of bar graph 3 with bar graph 4 in Figure 26 indicates that a 30 per cent softening of the coating is associated with a 180-min test life when acetone plus antiozonant was used whereas a 7 per cent softening is associated with a 220-min test life when antiozonant only was used. From these data it cannot be concluded that test life was determined by the softness of the coating. Furthermore, Beal, Lapp, and Wahl [17] have concluded that "in the neoprene rubbers tested, those with the greatest resiliency, lowest permanent set, and high Durometer hardness, had the best resistance to rain erosion". Softness would therefore not appear to be the correct explanation. It has been suggested that the

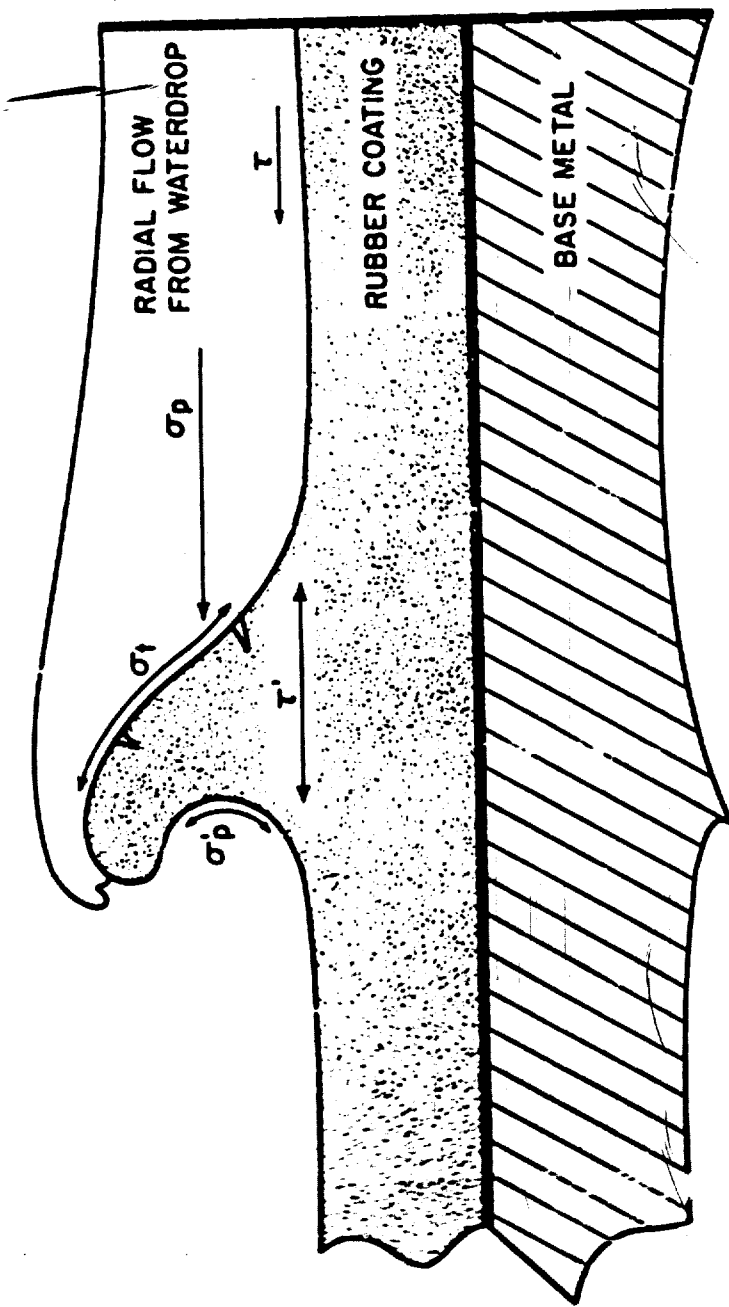
When the liquid from a drop that is flowing radially runs over a surface protrusion it exerts forces against the protrusion that are opposed by the restraint of the bonding of the protrusion to the underlying layers of material. Pressure,  $\sigma_p$  of Figure 27, is exerted against the protrusion by the flowing liquid. The pressure that is exerted by the liquid tends to move the protrusion along the planar surface of the solid and results in a shear stress,  $\tau$  of Figure 27, at the base of the protrusion. The flow of the liquid results in the shear stress  $\tau$  that was discussed above.

The pressure exerted by the liquid also results in a turning moment that tends to bend the protrusion over. The turning moment is the integrated cross product of the compressive force exerted by the liquid and the elevation of the protrusion above the planar surface of the solid at the point where the force is applied. As the protrusion bends, a tensile stress,  $\sigma_t$  of Figure 27, appears on the side of the protrusion against which the compressive force is applied and a compressive stress,  $\sigma_c$  of Figure 27, appears on the opposite side of the protrusion. If the force exerted by the rapidly running liquid is sufficiently great or if the protrusion has a sufficient elevation above the planar surface, failure may occur. Whether the protrusion is simply bent over, whether it is broken off, or whether part of the solid material below the surface is torn out with it depends on the strength of the material and on where failure occurs first. Likely points of failure are marked with notches in Figure 27.

FIGURE 27 STRESSES THAT RESULT WHEN A WATERDROP RUNS OVER A SURFACE PROTRUSION

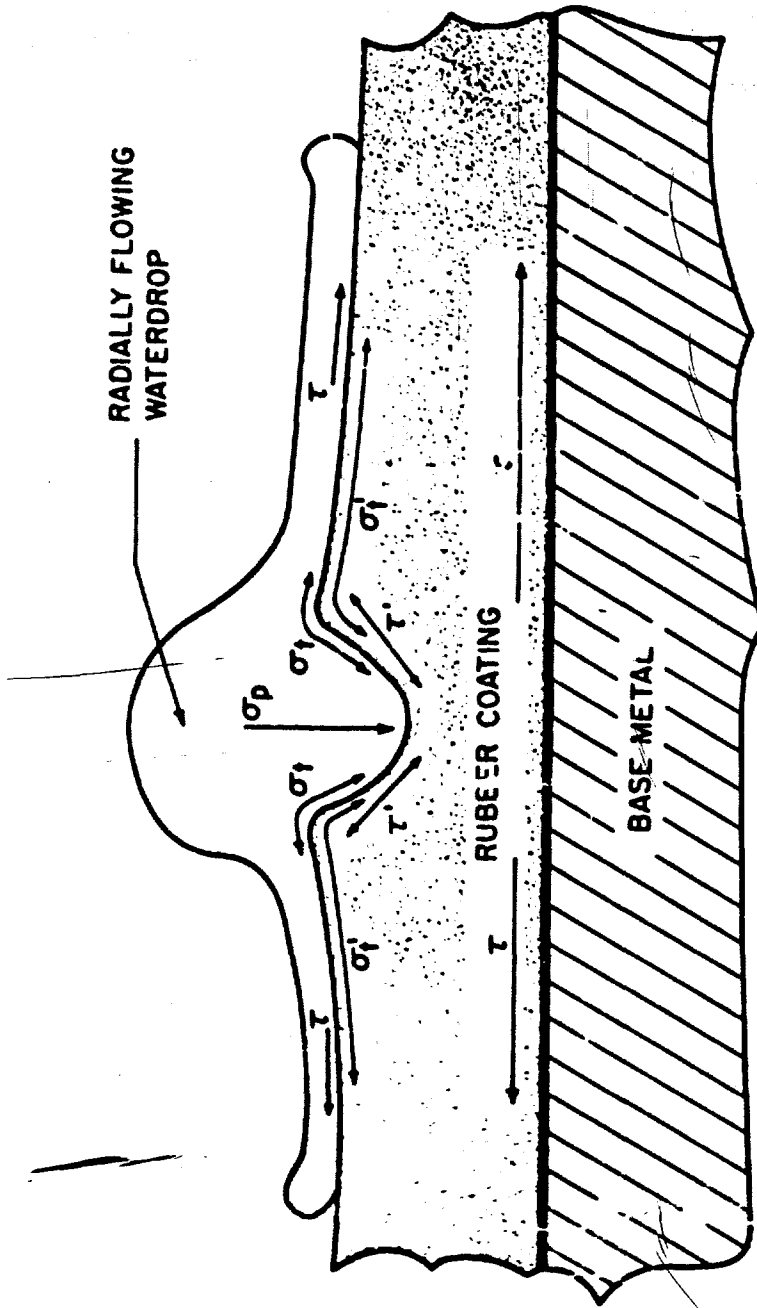
If a waterdrop impinges against a rubber-like material the effect of the compressive stress,  $\sigma_p$  of Figure 28, which is the direct result of the collision, is to compress the solid material at the point of impingement. The local compression results in a dimple or cup-shaped cavity. Tensile stresses,  $\sigma_t$  of Figure 28, appear in the sides of the dimple and especially in the knee in the solid material at the rim of the dimple. If these tensile stresses are sufficiently great tears may form in the surface layers of the solid material. The material that formerly occupied the volume that now forms the hollow of the dimple is displaced. It is moved radially outward and upward around the dimple and this results in a shear stress,  $\tau$  of Figure 28.

FIGURE 28 STRESSES THAT RESULT FROM THE COLLISION OF A WATERDROP WITH  
A RUBBER-COATED SURFACE

The radial flow of the liquid of the drop imposes a radial tensile stress,  $\sigma_t$  of Figure 28, and a shear stress  $\tau$ , which was discussed above. In the case of very thin rubbery coatings it is possible that the shear stress  $\tau$  may be transmitted through the coating to the primer bonds, which hold the coating to the base metal, and that it may cause failure of the primer-to-rubber or of the primer-to-metal bond. See pictures 2(c) and 3(c) of Figure 10 and the discussion relating to these pictures.
