NAMC-AEL-1625 14 DEC 1959

CALIBRATION AND QUALIFICATION TESTS  
OF McCULLOCH YO-100-4 ENGINE  
FOR ROTORCYCLE USE

FINAL REPORT ON  
BUAER PROJECT TED NAM-PP-2648.1  
BY  
C. W. SHEARER

Final Report NAMC-AEL-1625  
on  
BUAER Project TED NAM-PP-2648.1

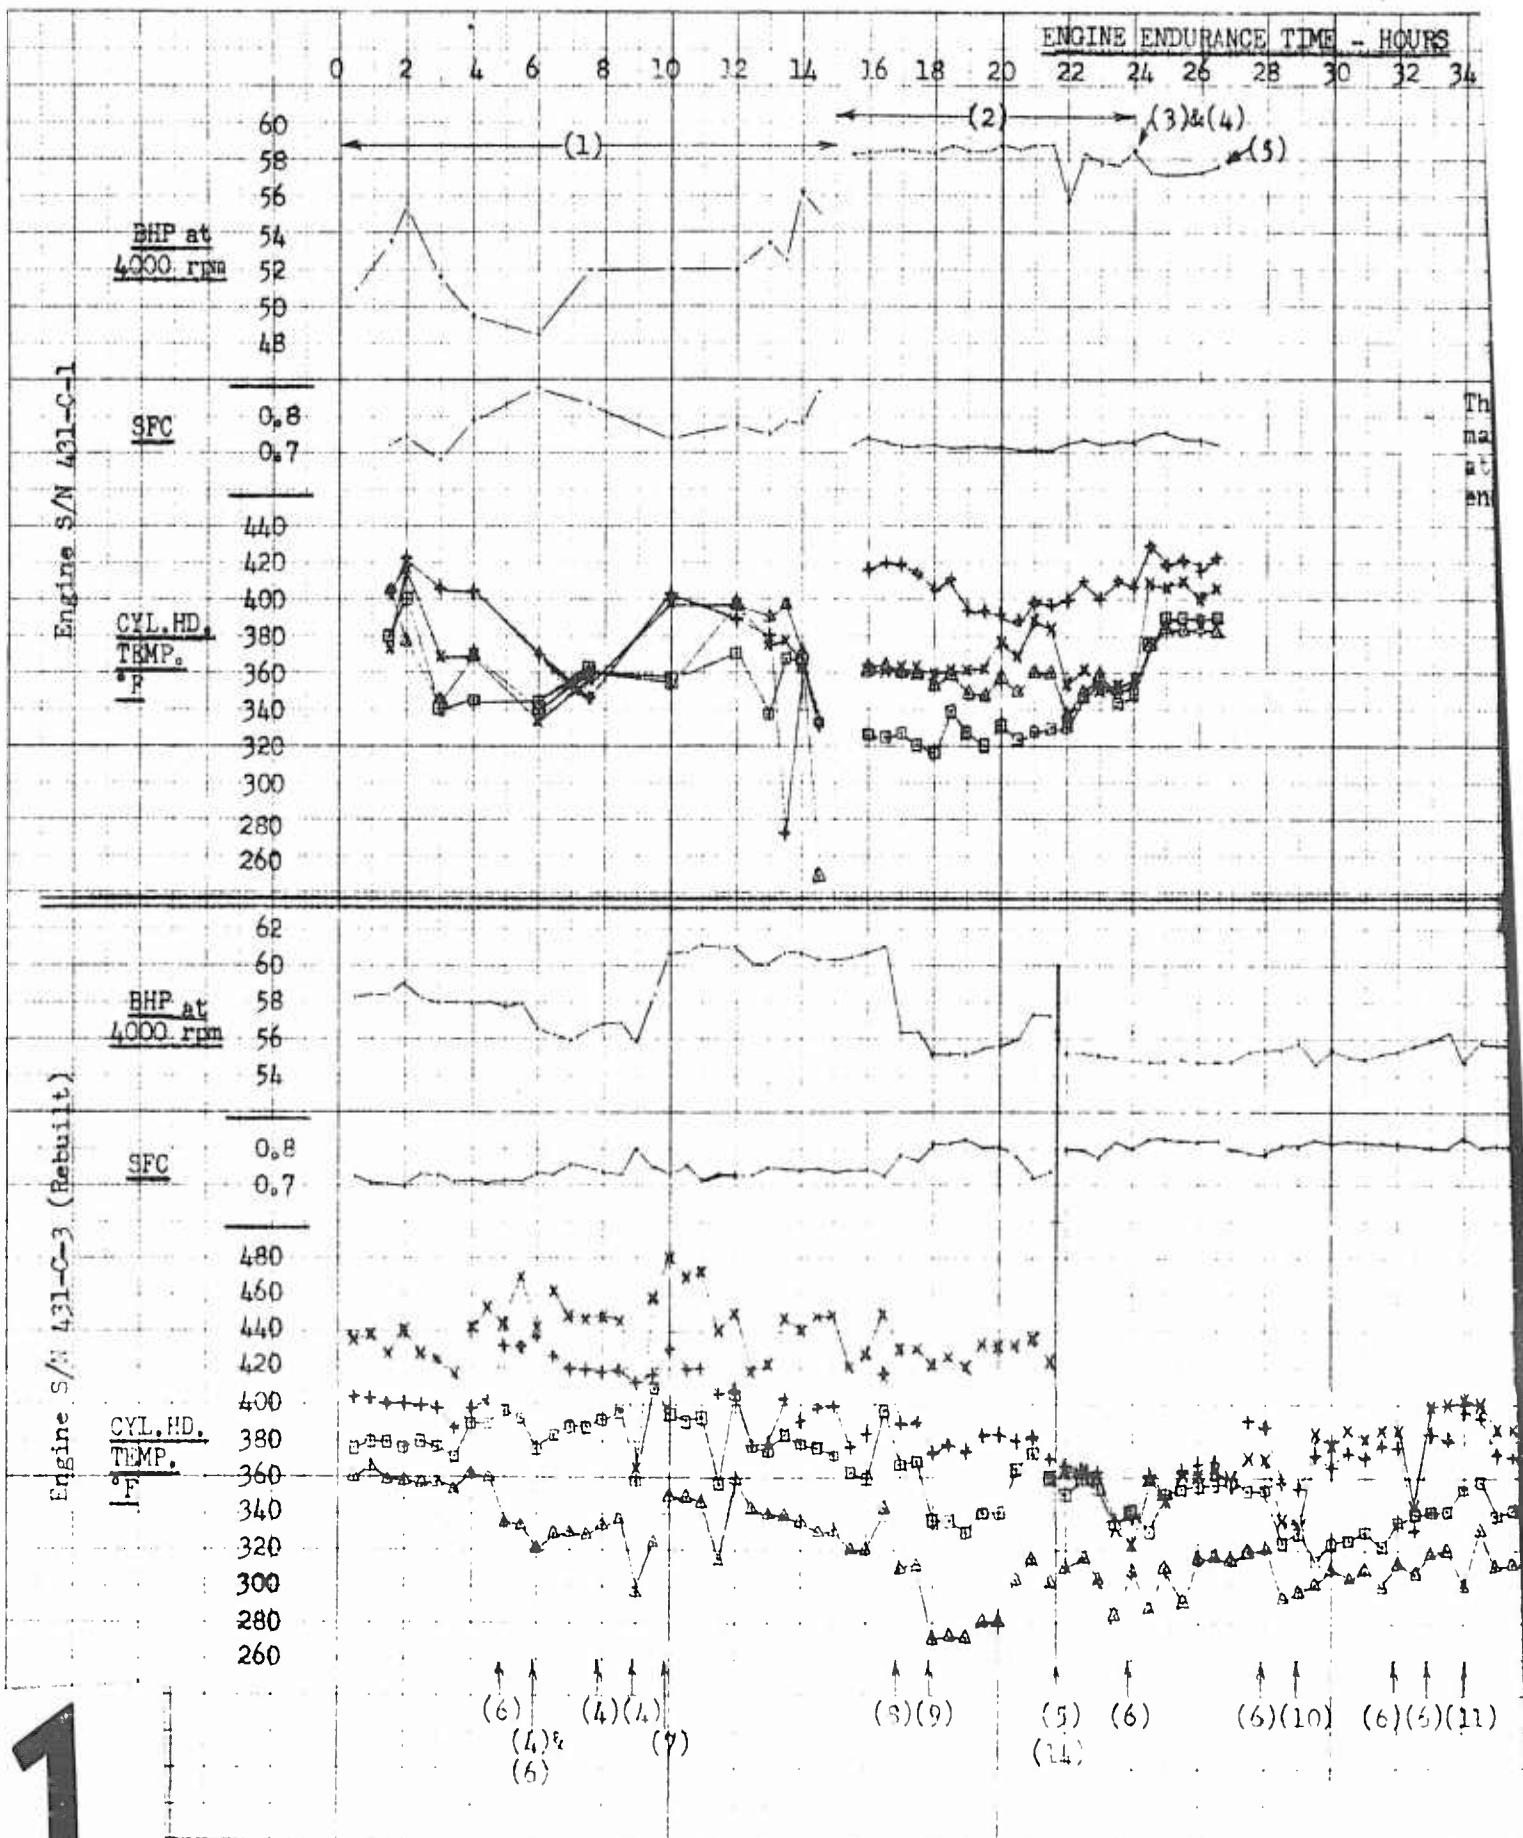
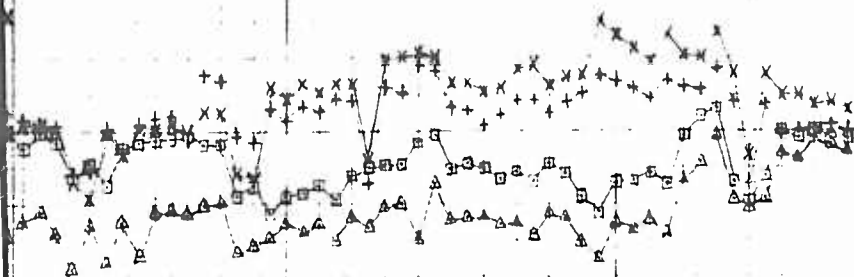
PLATE 2

Plate 2 shows the maximum brake horsepower, specific fuel consumption and cylinder head temperature values at 4000 rpm obtained at each half-hour cycle of the endurance runs. Also shown on Plate 2 are numerical symbols indicating notable conditions existing, changes made, and failures experienced during the cyclic endurance tests. Symbol (1) designates values obtained at 4000 rpm during 33 hours of total engine running time of Serial No. 431-C-1. These 33 hours were used attempting

- Δ- No.1 Cylinder Head
- No.2 " "
- + - No.3 " "
- x- No.4 " "
- (1)- 15 hours of miscellaneous tests of engine credited toward endurance time.
- (2)- No Governor overspeed control load.
- (3)- Governor installed on engine.
- (4)- Carburetor throttle and fuel metering adjusted.
- (5)- Engine failure.
- (6)- Exhaust manifold repaired.
- (7)- Stub Stacks installed.
- (8)- Exhaust manifolds installed.
- (9)- Carburetor fuel enriched.
- (10)- Governor overspeed control failure.
- (11)- Spark Plugs cleaned and regapped.
- (12)- Four reconditioned Spark Plugs installed.
- (13)- Replaced Magneto.
- (14)- No. 4 cylinder and piston replaced and the cyclic test continued.

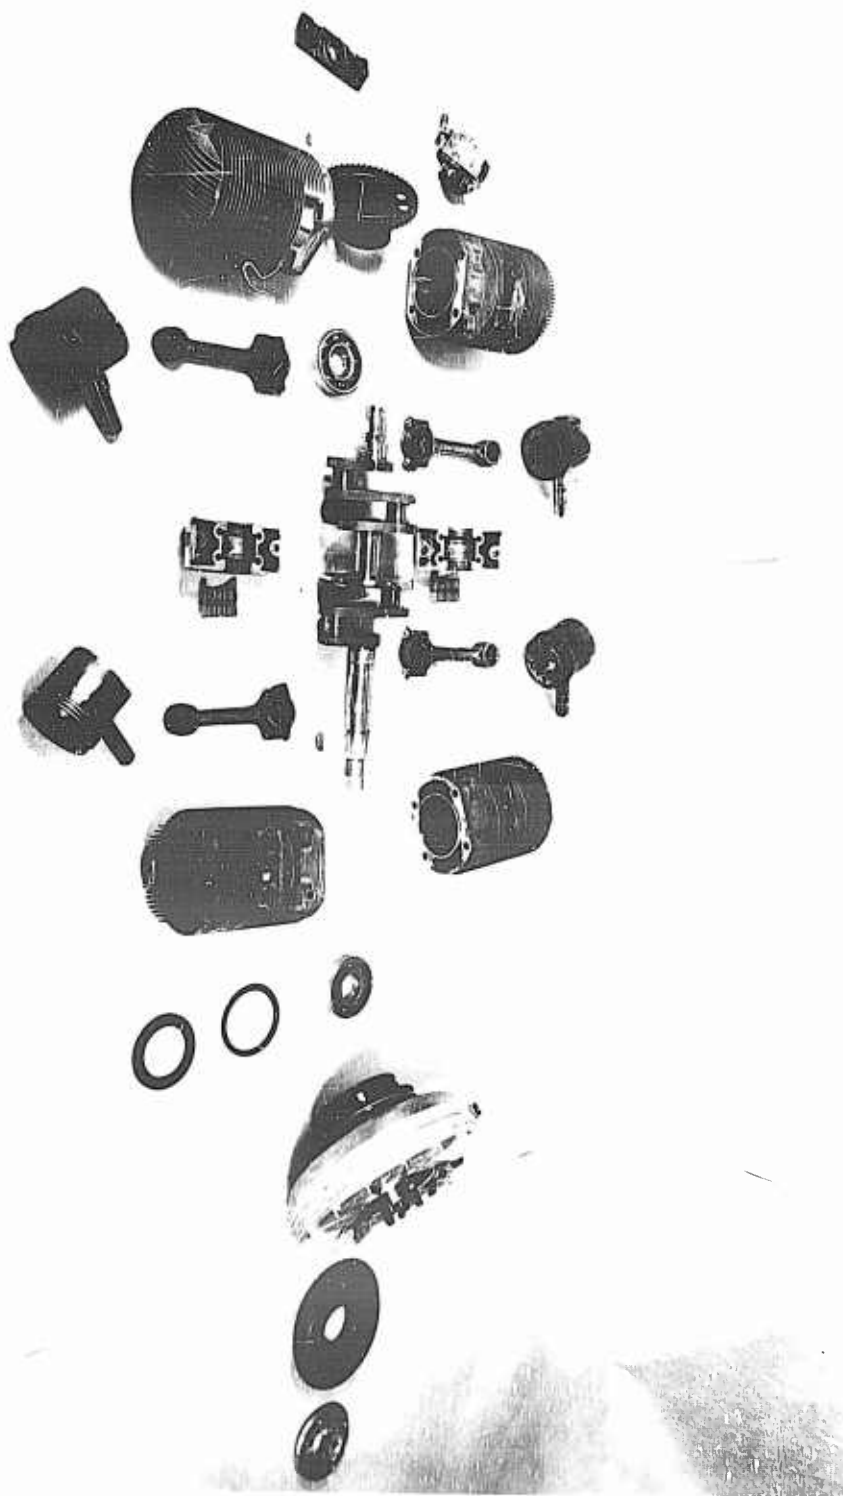
PLATE 14

e. Engine Serial No. 431-C-3 (rebuilt) was completely disassembled after the third cylinder retention failure. Visual inspection of the bearings, rods, cylinders, journals, etc. showed them to be in satisfactory condition. A Magnaflux inspection of the steel parts and a Zyglo inspection of the aluminum crankcase showed no incipient failures. Plates 14 and 15 are photographic views of the disassembled engine after the final teardown inspection.

McCULLOCH YO-100-4 ENGINE, EXPLODED VIEW OF POWER SECTION COMPONENTS

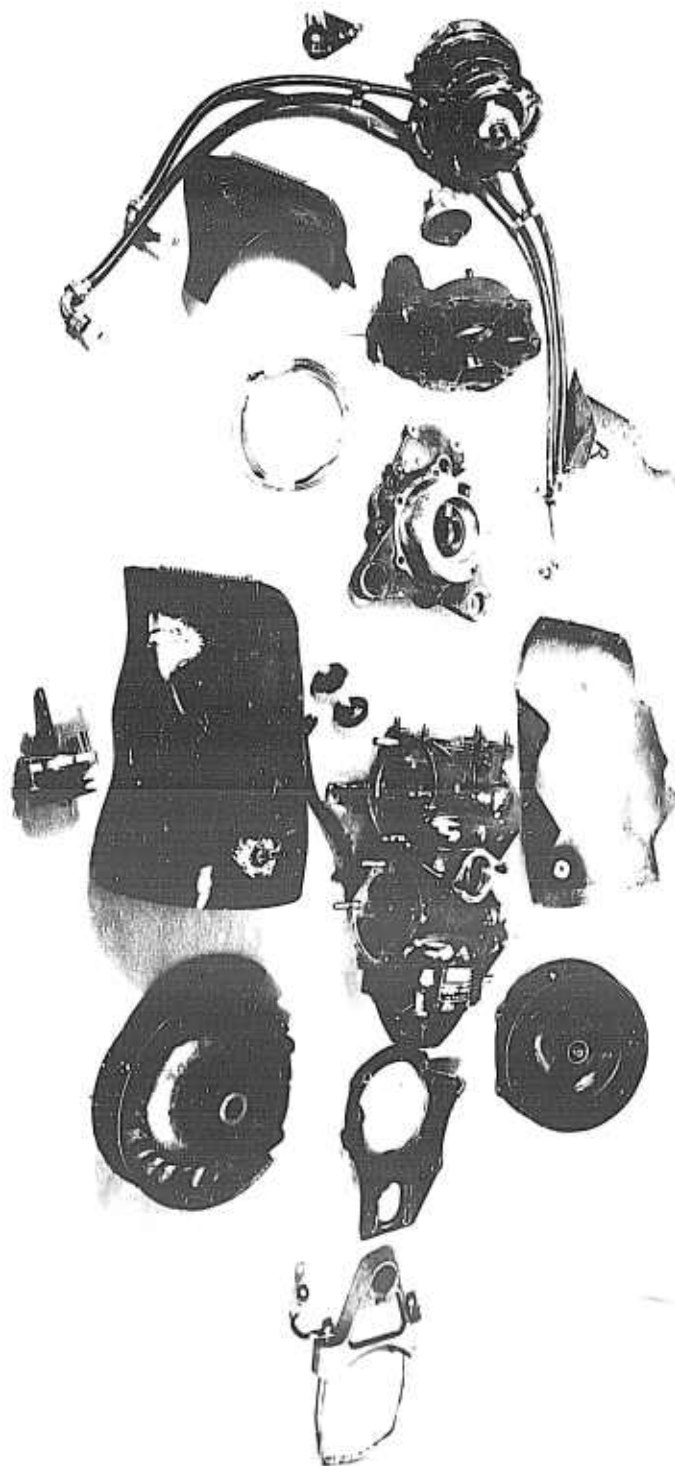
MCCULLOCH YO-100-4 ENGINE, EXPLODED VIEW OF COMPONENTS

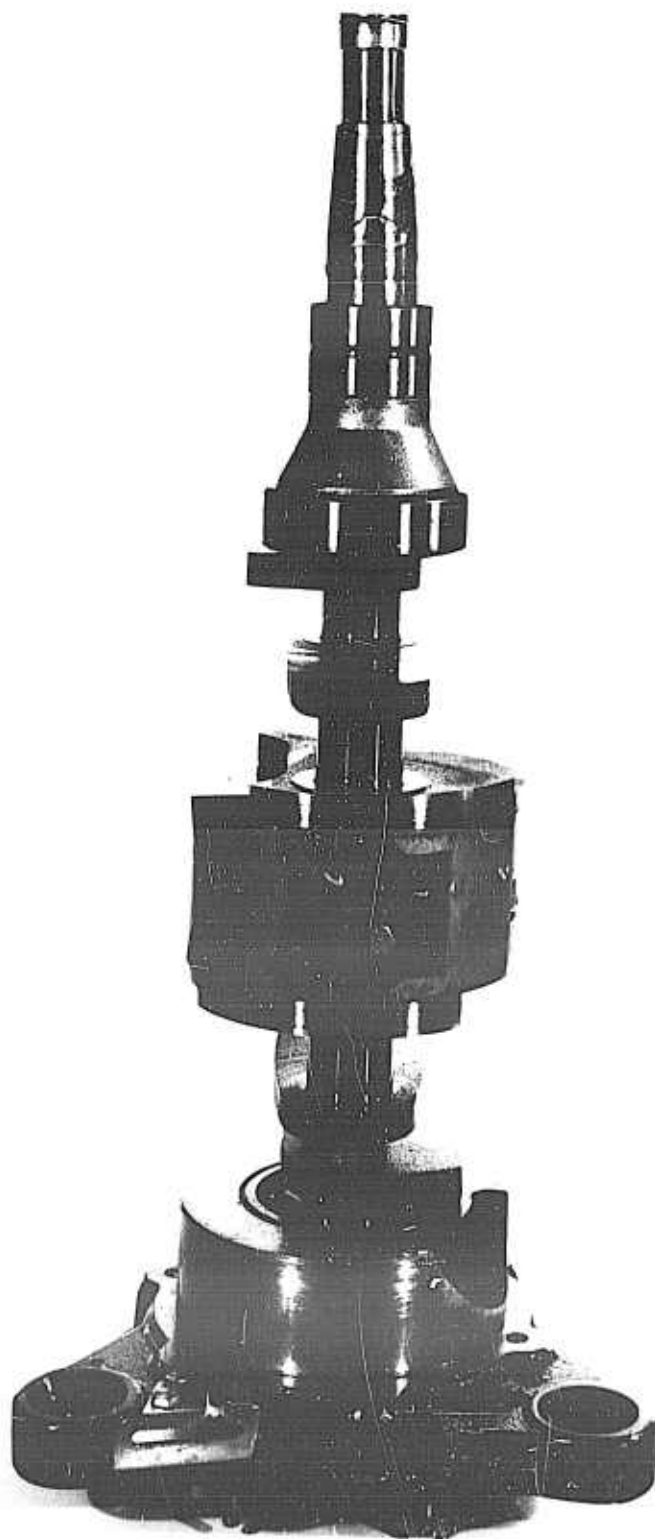
PHOTO NO: CAN-310127(L)-5-58

CRANKSHAFT ASSEMBLY OF McCULLOCH 0-100-4 ENGINE

5. It is, therefore, recommended that the design, fabrication, and assembly of the engine and its components be reviewed with regard to the elimination of notch effects, proper bearing contacts, and misalignment.
