27 December 1960

U. S. NAVAL CIVIL ENGINEERING LABORATORY  
Port Hueneme, California

# CORROSION SURVEY OF STEEL SHEET PILING

Type C Final Report

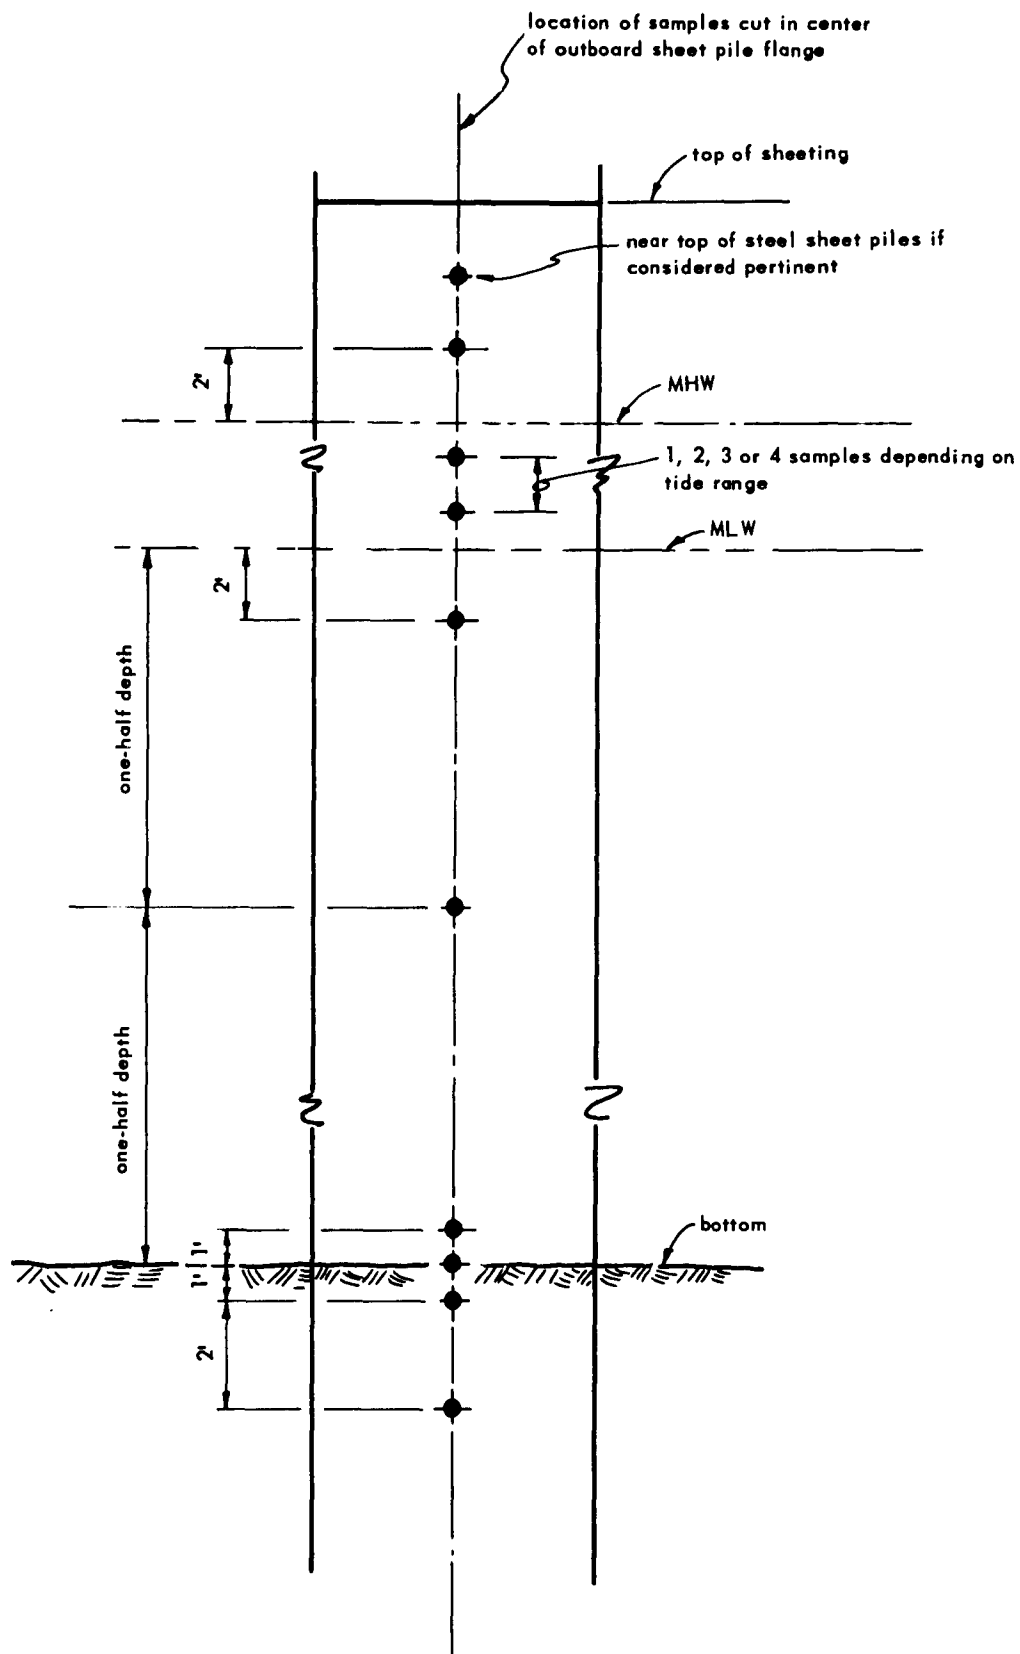
Figure 3. Location of samples cut to determine thickness of steel sheet piling.

Figure 3 shows the location along the piling where samples were to be cut.
