U. S. NAVAL CIVIL ENGINEERING LABORATORY
Port Hueneme, California

Technical Note N-360

CORROSION STUDIES ASSOCIATED WITH AN AIR
BLAST CLOSURE UNIT

30 July 1959

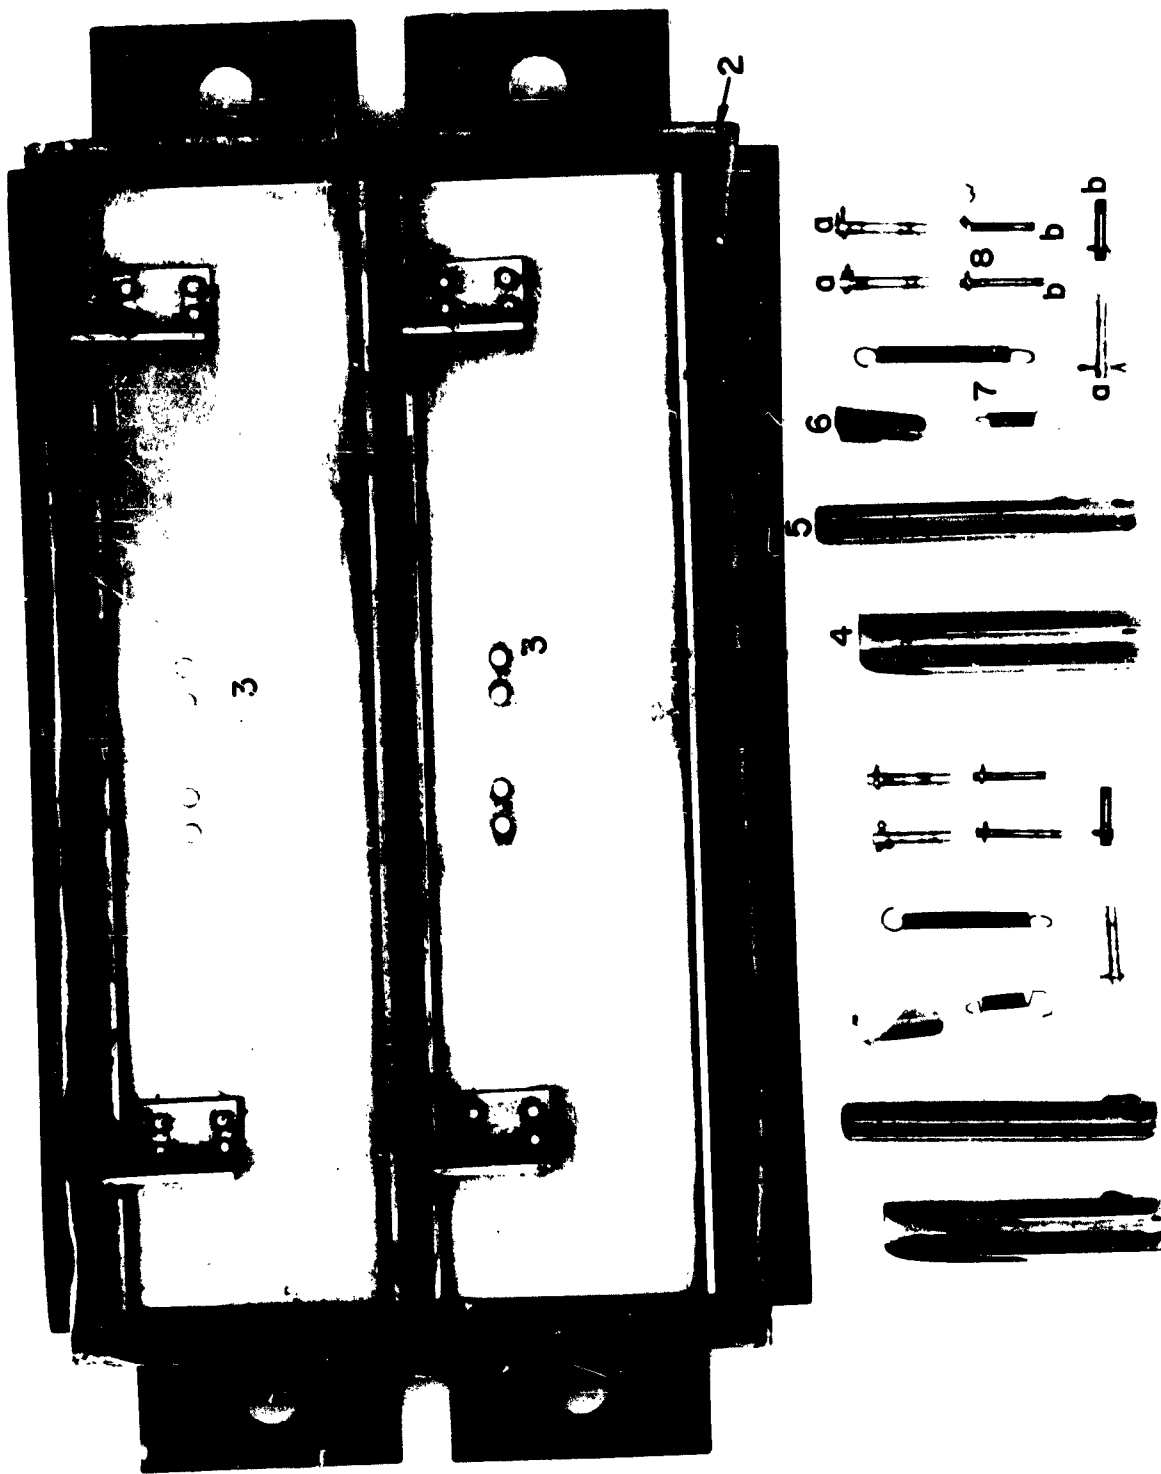
Figure 1. Moving parts of Closure Unit before exposure, View 1.

1. Use neoprene foam rubber for the gasketing material (2), Figures 1, 2, and 3.
2. Fabricate the louver frame, (1) Figures 1, 2, and 3, and brackets (11a, 11b) Figures 3 and 21, from 6061 aluminum alloy.
3. All supporting pins (8) and cotter pins (9), Figures 16, 17 and 18, should be heavily cadmium plated (0.001 inch) and grease coated with an inhibited soft grease such as AN-C-124a, AM3 Type II.
4. All metal springs should be coated with an inhibited soft grease such as AN-C-124A, AM3 Type II.

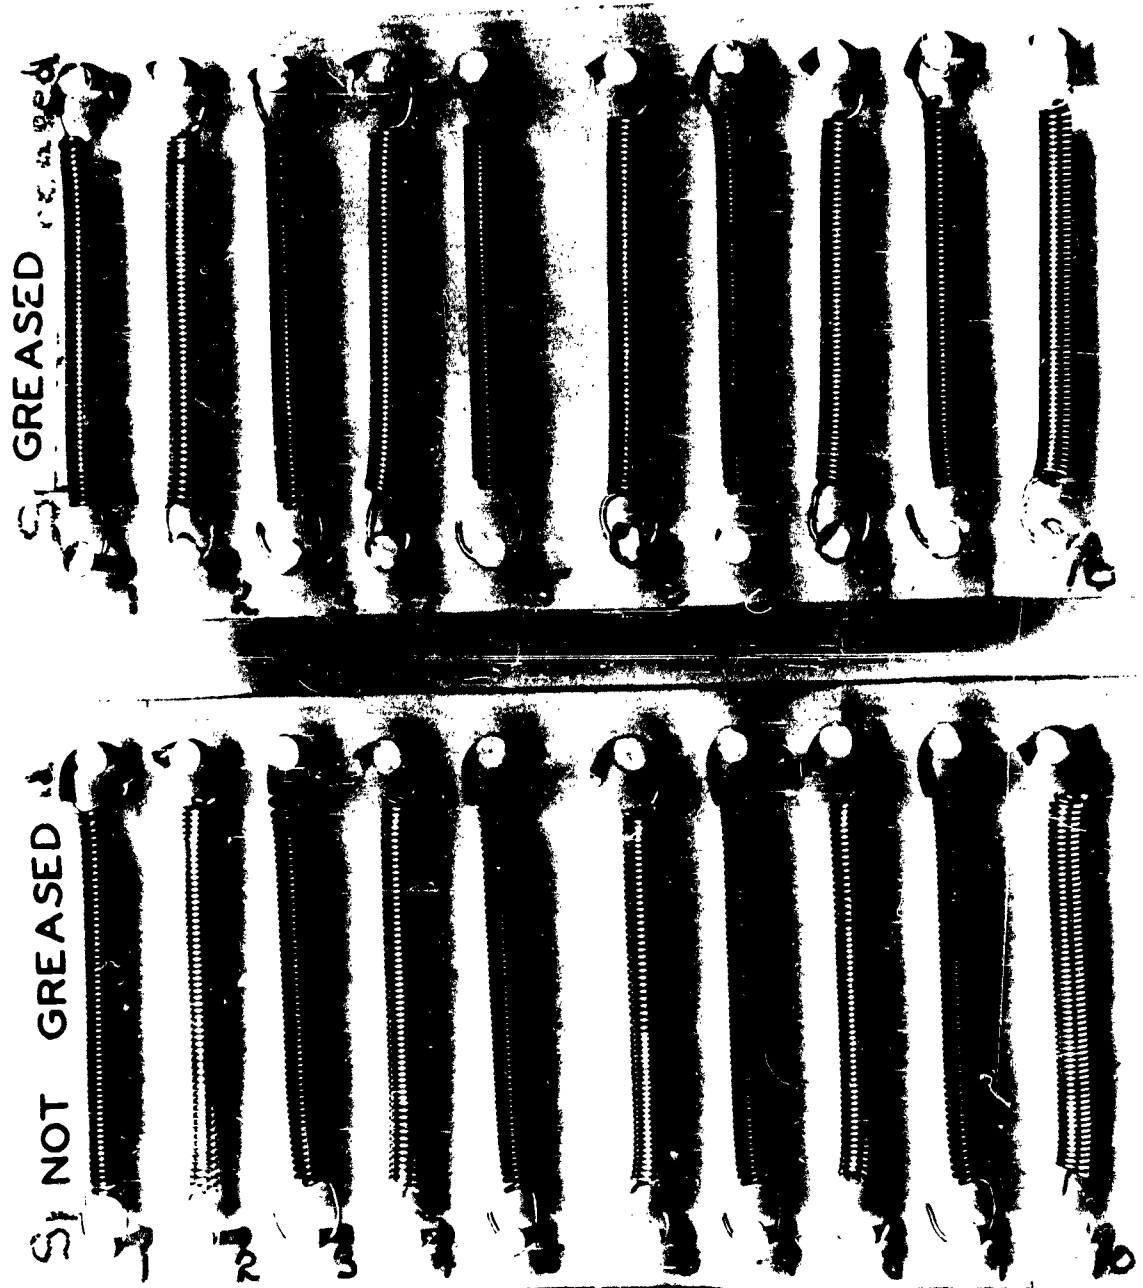
Test springs were formed from 0.033 inch piano wire and closely resembled the large spring in the closure unit in size and length. Forty springs were prepared and twenty of these were cadmium plated. A soft film inhibited grease (AN-C-124a - AM3 Type II) coating was applied to ten of the plated and ten of the unplated springs. The springs were then placed in specimen holders in such a way that five plated and five unplated test springs were in each of four specimen holders. One sheltered (Figure 9) specimen holder contained grease coated springs and one (Figure 10) contained ungreased springs. Greased and ungreased springs were also placed on unsheltered specimen holders. (Figure 11)

Figure 11. Test springs in unsheltered specimen holders, before exposure.
