WADD TECHNICAL NOTE 60-296

## F-102 HIGH-ALTITUDE FLAMEOUTS IN AND AROUND THUNDERSTORMS

Project Nr 201A(1)

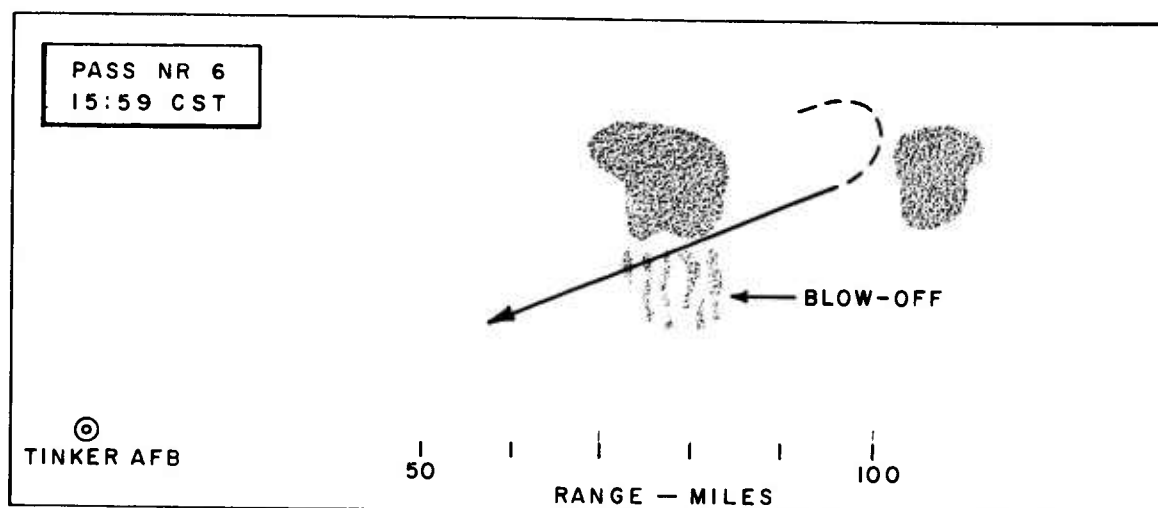
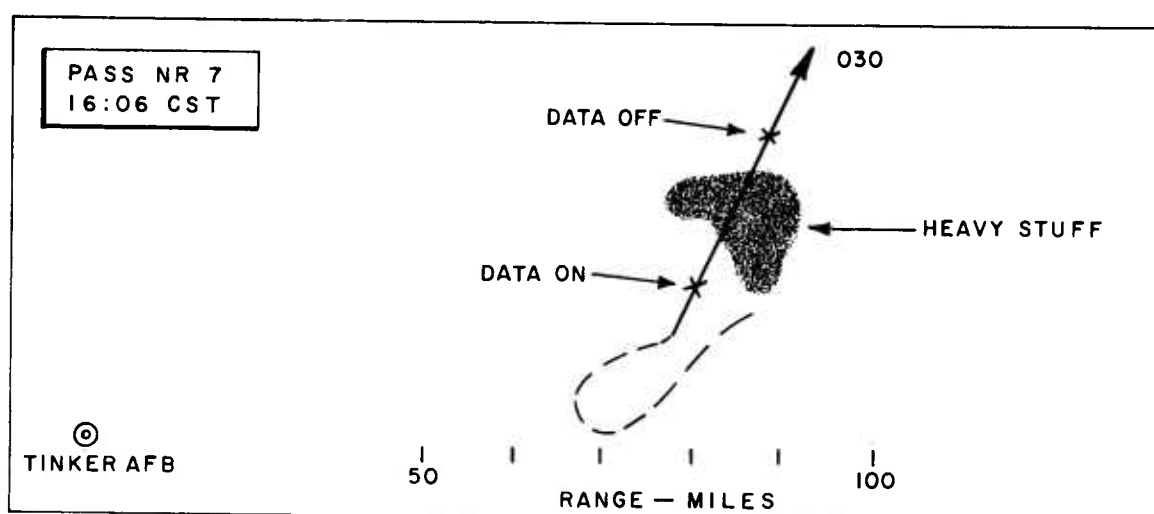
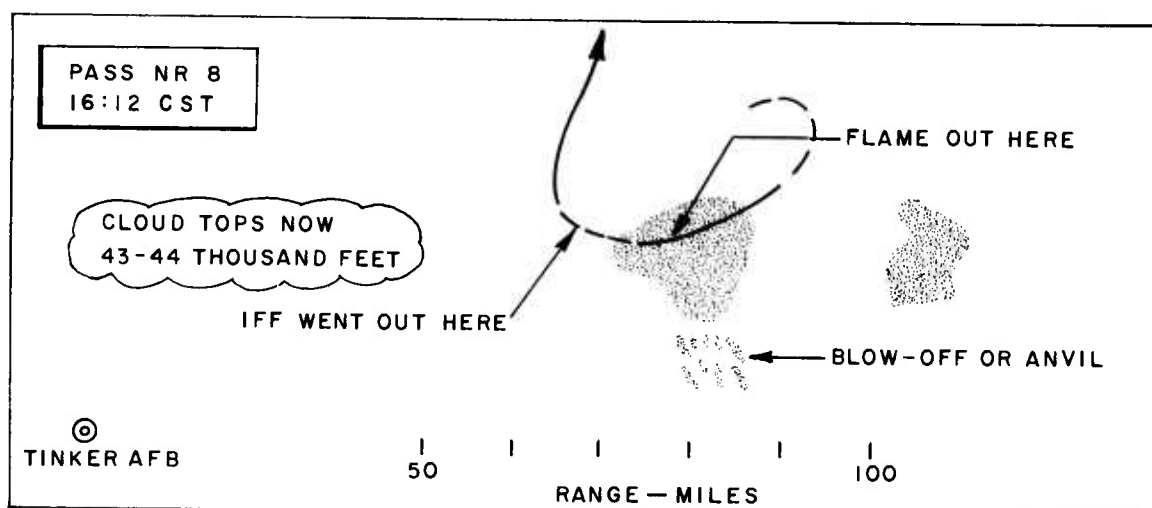
Figure B5. (Continued)

A typical F-102A flight - 27 May 1960:

15:45 - Heading 210° at 38,000 feet. Experienced moderate turbulence and some moisture. After four stalls the airspeed dropped off 40 knots. RPM hung up at 78 percent for a while and then gradually increased to 79 percent. Fuel flow was stuck at 1500 PPH, EGT 400°, EPR 1.75. The aircraft broke out of the storm at 36,000 ft and engine recovery from this point was good. 23 stalls were experienced. They were not as strong as previous stalls but were spaced close together causing a rapid loss of EPR and RPM.
