TR-959

AN INVESTIGATION OF THE DYNAMICS
OF THE ELECTROLYTE DISTRIBUTION SYSTEM
IN THE PS502-502A POWER SUPPLY

24 July 1961

DIAMOND ORDNANCE FUZE LABORATORIES
ORDNANCE CORPS ● DEPARTMENT OF THE ARMY
WASHINGTON 25, D. C.

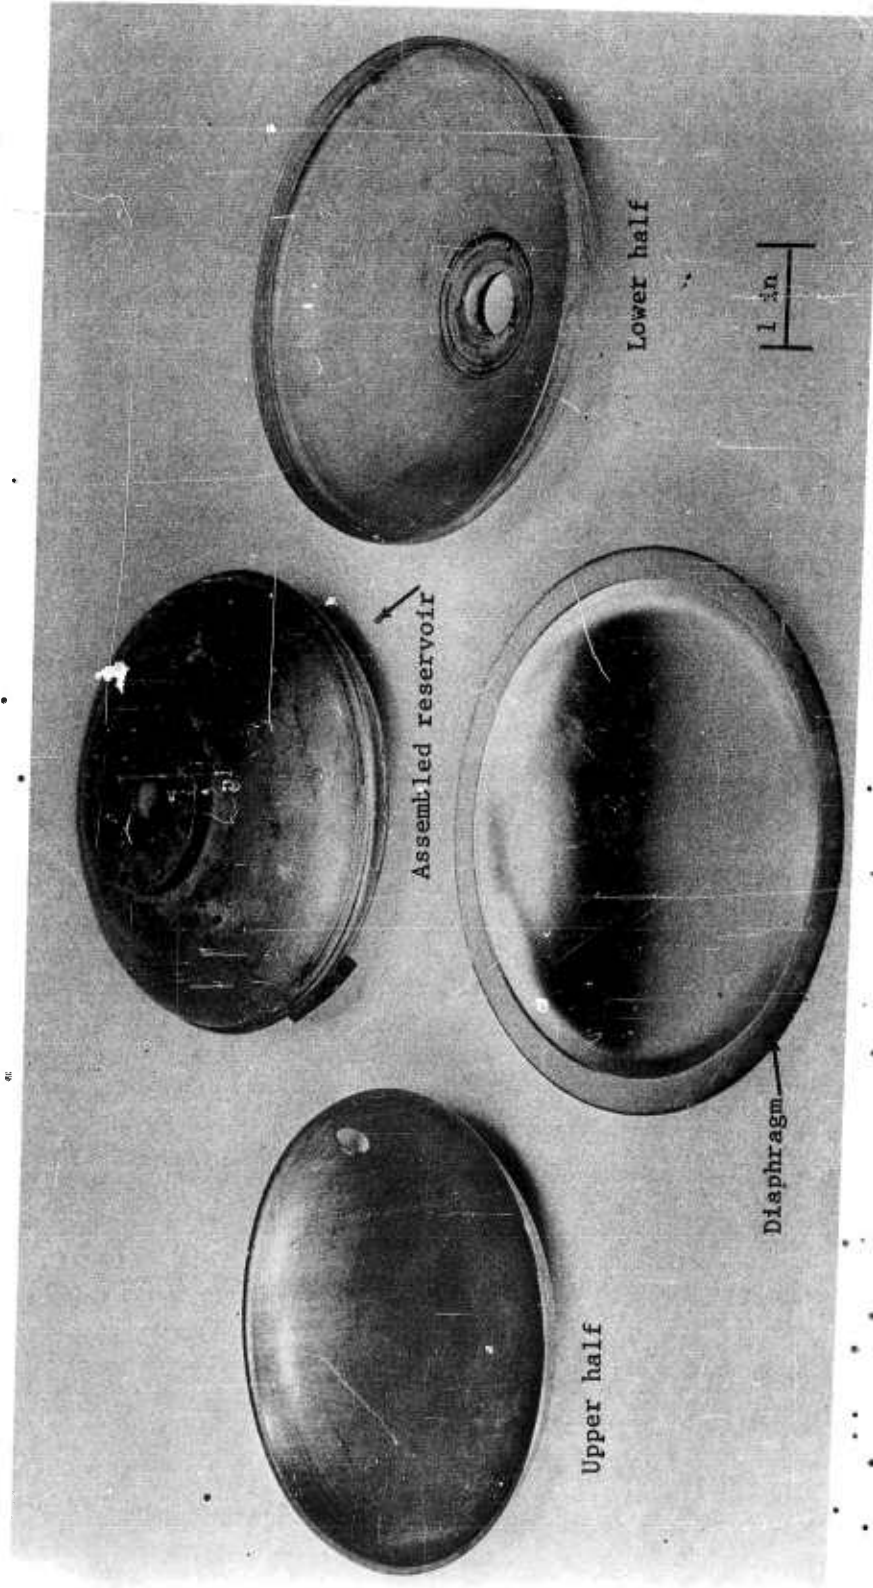
Figure 1. Reservoir components.

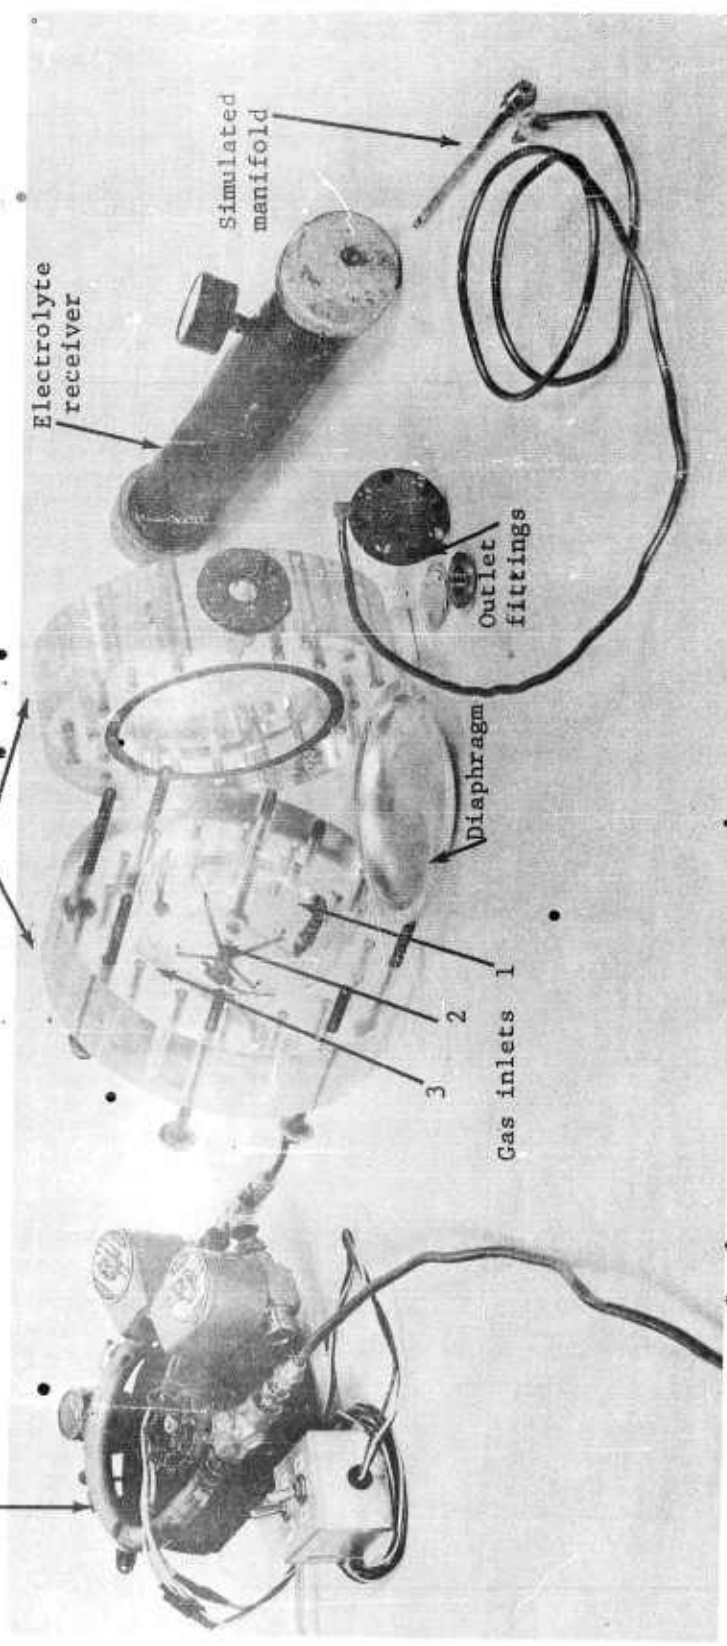
2.1 Setup A. Two lucite discs, 7.50 in. in diameter and 2.0 in. thick were constructed with one face of each machined to the same curvature as the inner surfaces of the reservoir (fig. 8). Inlet and outlet holes were drilled, and suitable fittings were attached. (Several inlets are shown in figure 8; only one was used at any one time and the unused ports were blocked.) The diaphragm is clamped by its rim between the flat surfaces of the lucite discs and rests in the upper half of the simulated reservoir.

Figure 8. Experimental setup A, disassembled.

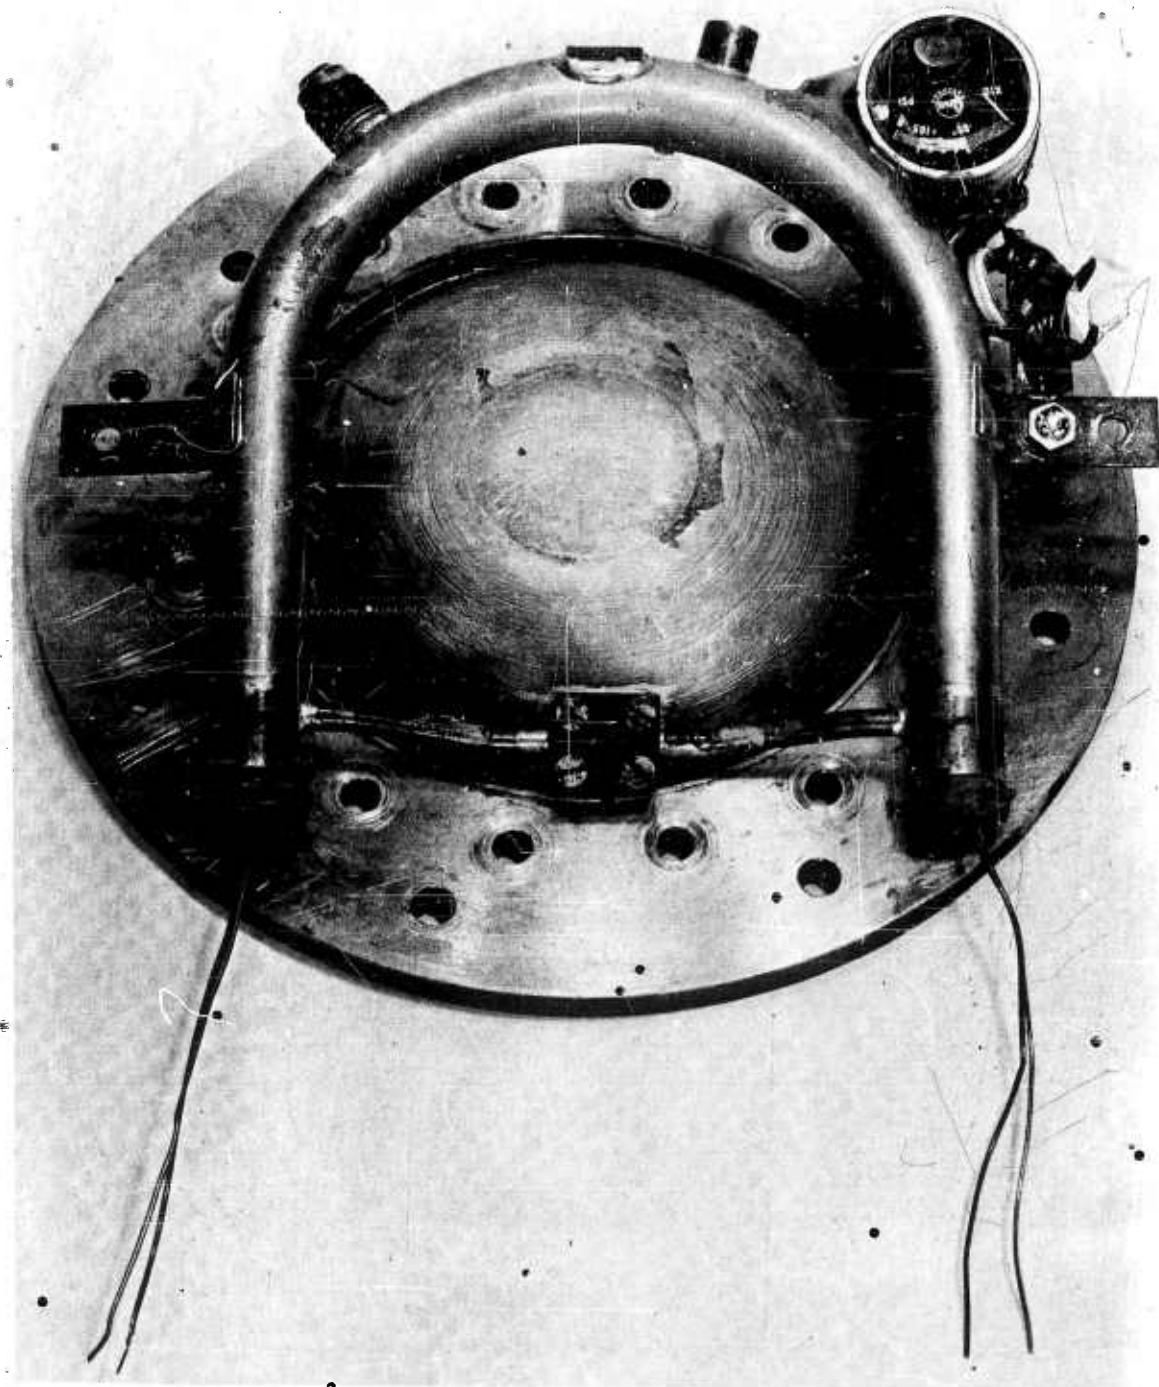
Figure 9. Top half of simulated electrolyte reservoir, with battery activator (setup B).

A number of experiments were performed in which the diameter of the gas inlet was reduced. The connector on the activator (fig. 9) was milled and a small brass disc containing the orifice(s) was pressed into the recess. The purpose of this modification was to reduce the extremely high-pressure blast of the activator squibs. The peak pressure at the gas inlet before diaphragm and electrolyte displacement takes place is calculated to be 7000 psi. This pressure is quickly dissipated as the gas cools and expands into the reservoir, but not before the diaphragm is stressed and begins to fold improperly.

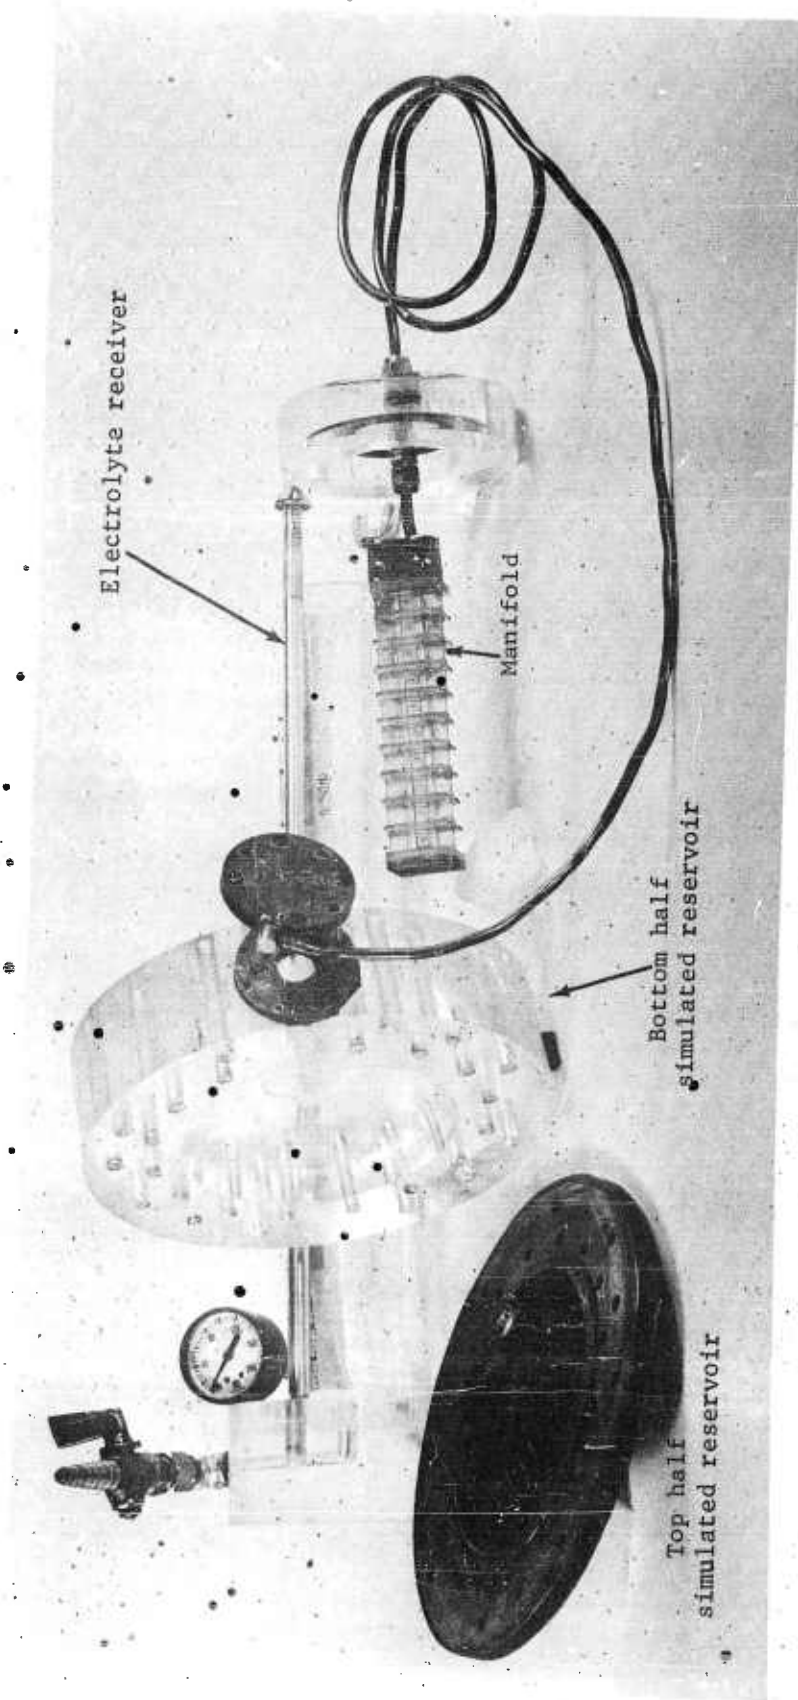
2.2 Setup B. To simulate the reservoir more closely, the top lucite disc was replaced by a metal upper half. Figure 9 shows the upper half with an activator mounted on it. Photography now had to be from the liquid side. The exit port was moved from the center of the lower half to one edge, out of the field of view (fig. 10 and 11). The metal electrolyte receiver was replaced with a transparent one so that flow rates could be measured. A clock was included, and the diaphragm, electrolyte receiver, and clock were photographed together. Films made with this setup were of higher quality because smoke from the squibs could not obscure the view of the diaphragm.

Figure 10. Experimental setup B, disassembled.

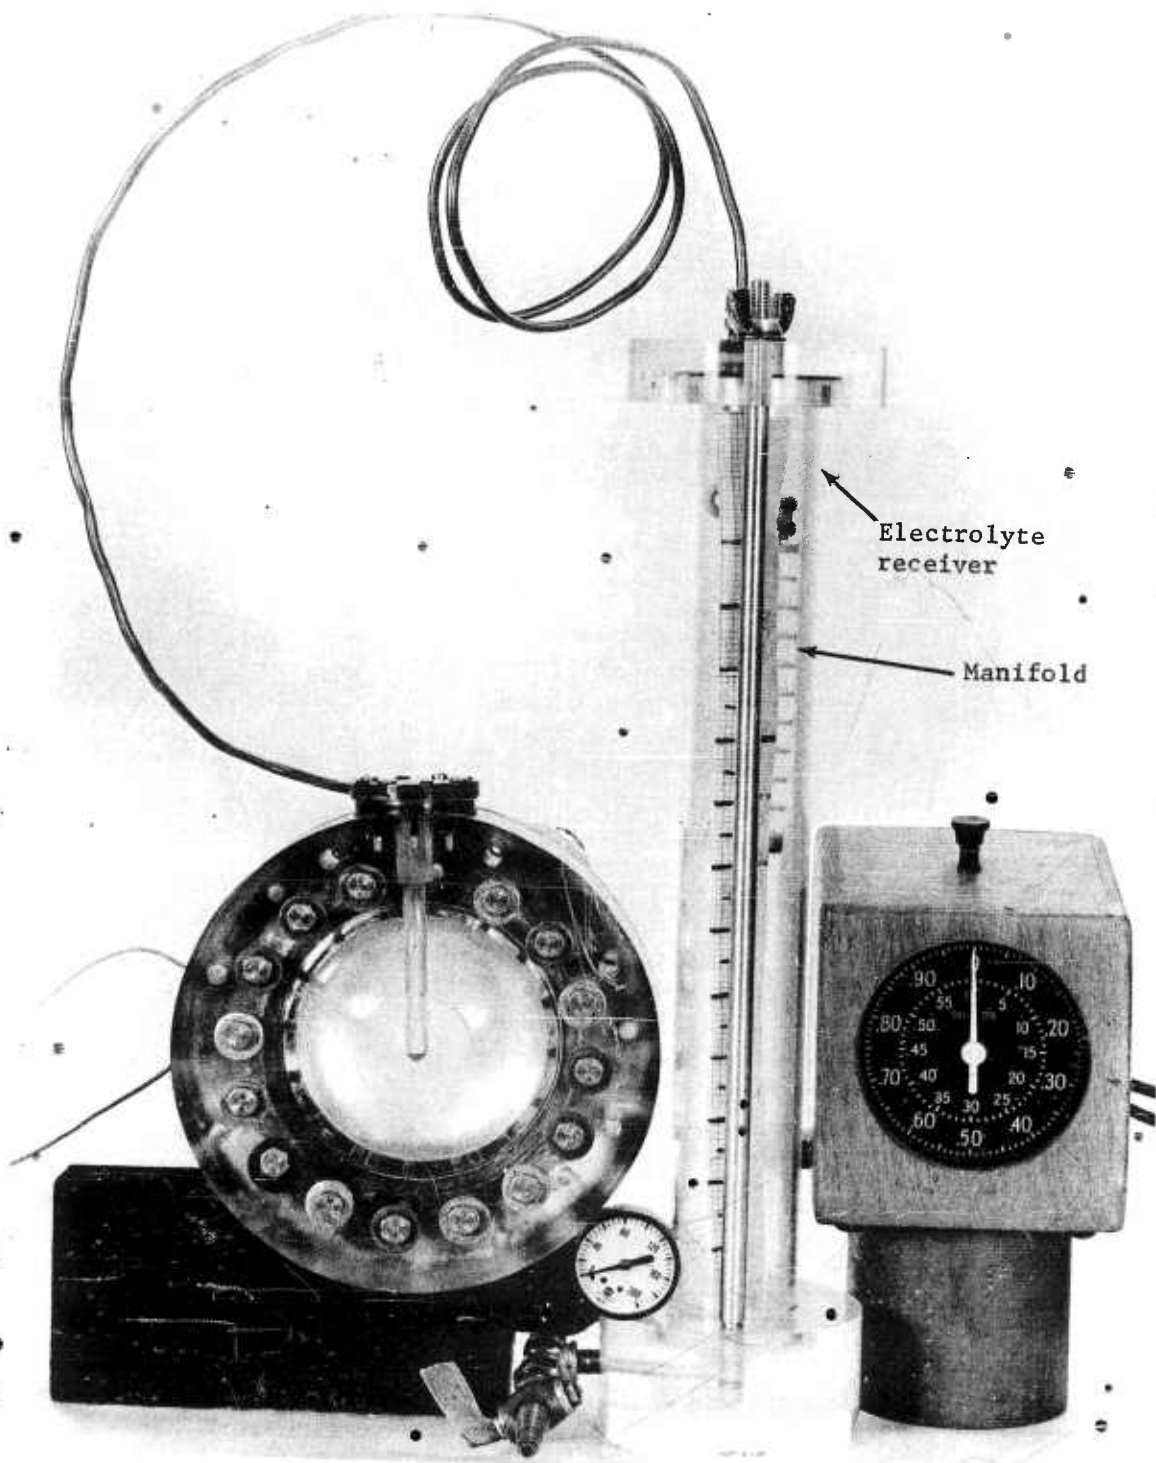
Figure 11. Experimental setup B, assembled.

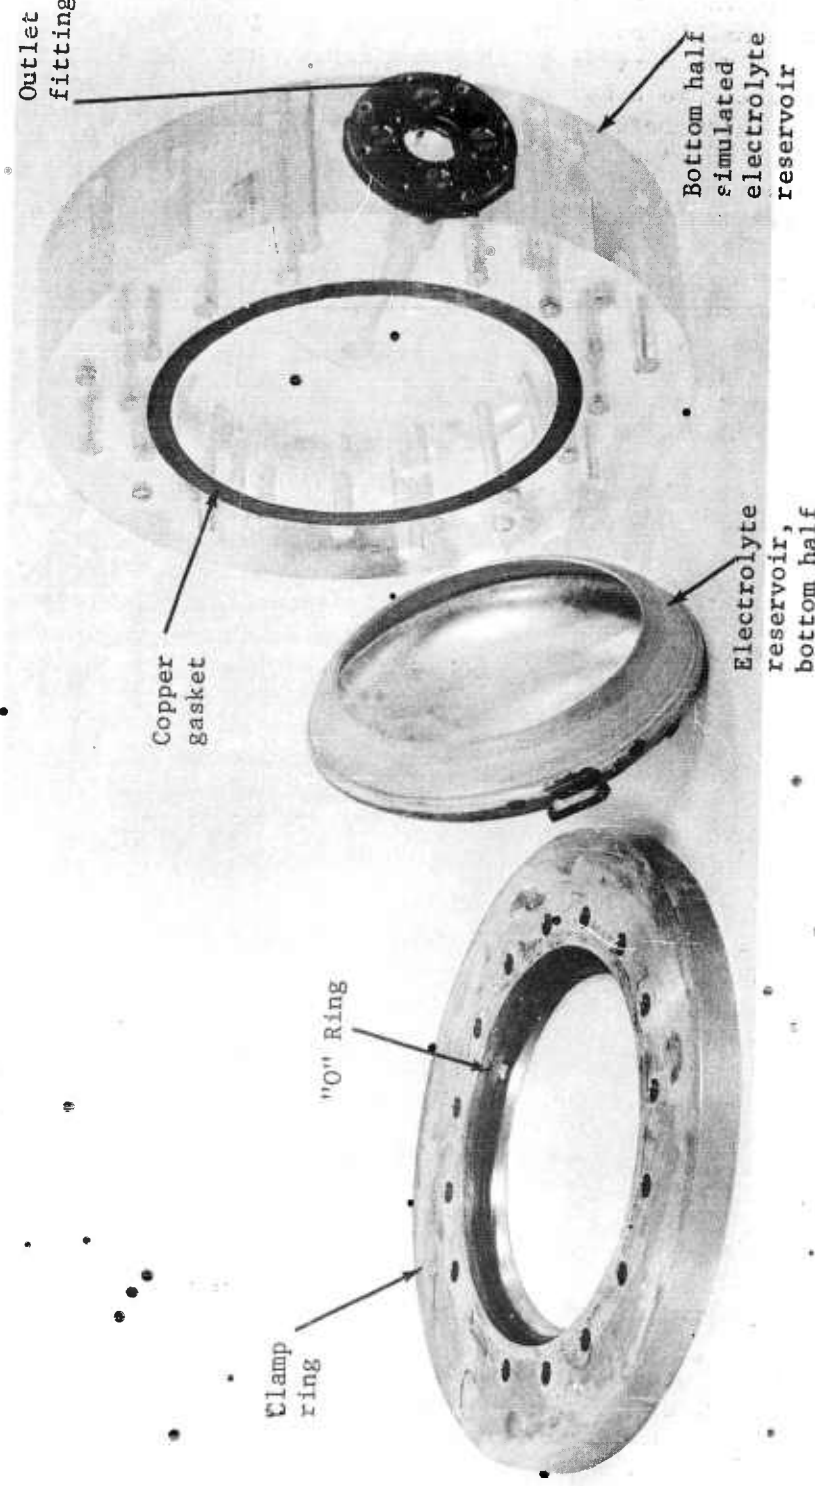
2.3 Setup C. A third setup was used so that photographs of diaphragms assembled in actual reservoir shells could be made. Reservoirs from unfired batteries were modified by removing most of the lower half. They would then be placed in the transparent lower half. Sealing was accomplished by O-rings while the reservoir was held in place by a rigid ring (fig. 12).

Figure 12. Experimental setup C.
