**U.S. ARMY**  
**H-25 HELICOPTER DROP TEST**  
**22 October 1960**

By  
James W. Turnbow, Ph.D.

TREC  
Technical Report 60-76

March 1961

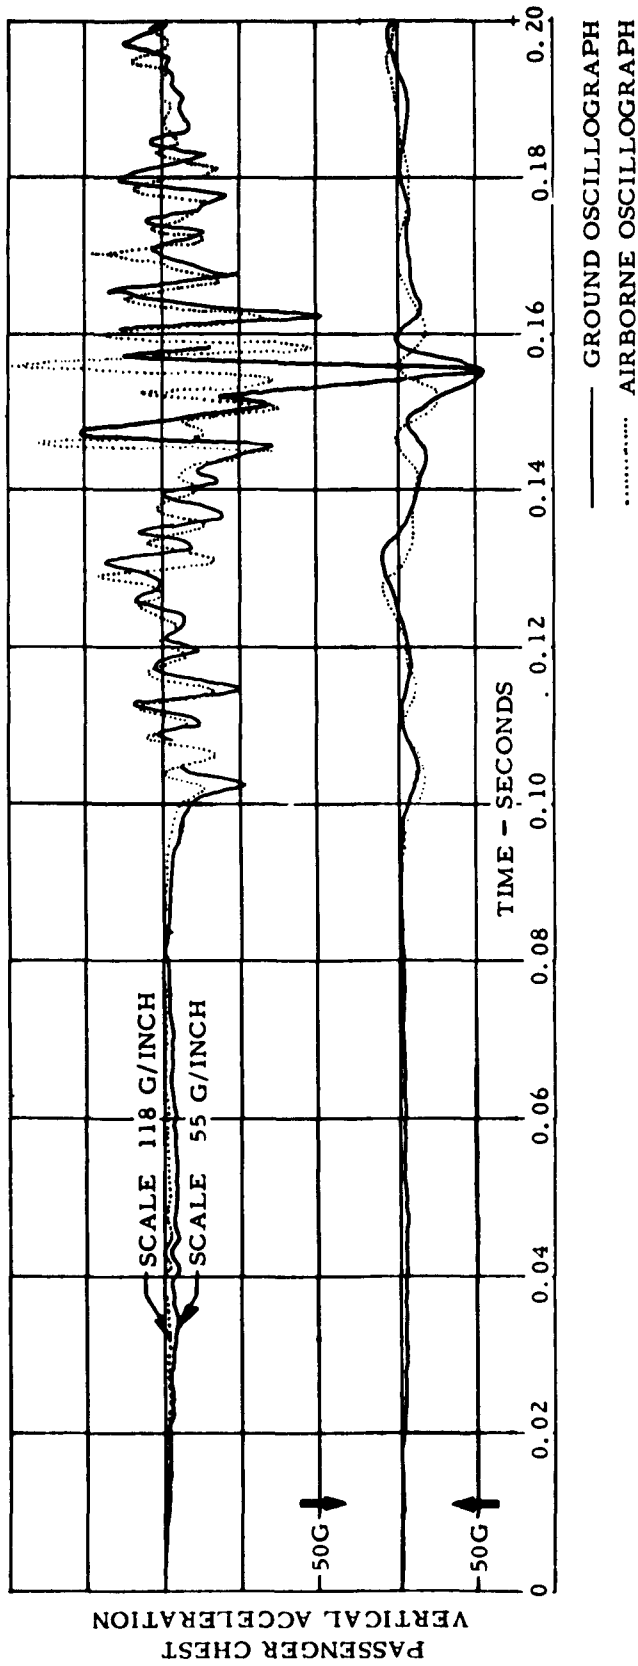
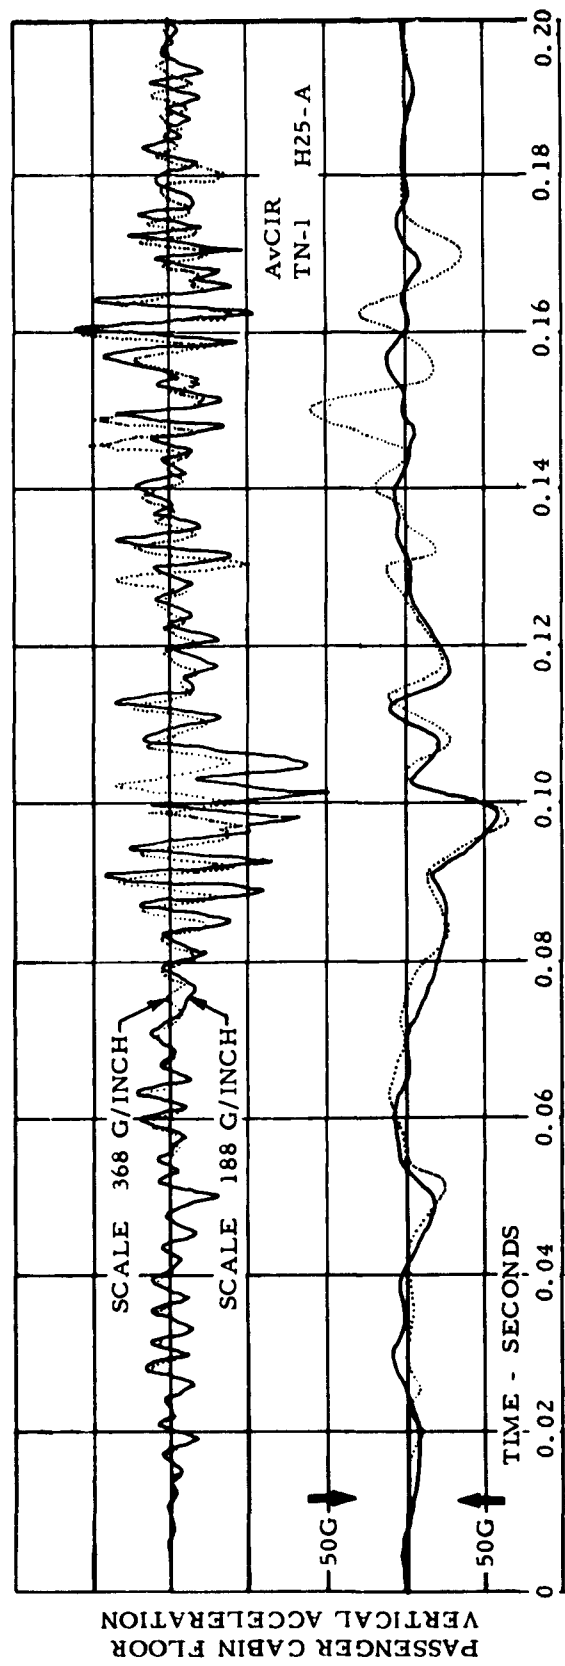
Figure 30. Comparison of Ground and Airborne Recording

Examination of the airborne instrumentation recording system following the crash found this equipment to be operable. The shock absorption devices had apparently functioned to properly protect the equipment and allow its operation during the test. A study of the ground and airborne oscillograph records later showed certain discrepancies in the airborne records. (See Figure 30.)

after impact to necessitate the temporary withholding of publication of eight channels of data recorded only on the airborne recorder. These channels are indicated in Table I and Figure 10. In Figure 30, both the original and smoothed acceleration-time curves (for ground and airborne recording) are shown for the passenger cabin floor and passenger chest accelerations. The first serious discrepancy in both cases is seen to occur at about 0.13 second. A plot of the lateral, longitudinal, and vertical accelerations of the airborne instrument package, given in Figure 31, shows that, at 0.128 second, a severe disturbance in the longitudinal acceleration record occurred. This disturbance was not a true acceleration, however, and was probably due to a poor connection at the emergency-disconnect in the umbilical cord at the crane. This disturbance at 0.128 second was clearly evident in eleven of the airborne recorder channels, although to a much lesser degree in all cases except for the fuel tank pressure record. Only minute evidence of this disturbance was observed in the other ground-recorded data.
