**CRASH INJURY BULLETIN**

**MODIFICATIONS TO THE PASSENGER SEAT-BELT  
TIEDOWN ATTACHMENTS IN THE**

**U.S. ARMY HU-1 SERIES BELL IROQUOIS HELICOPTER**

TCREC Technical Report 62-45

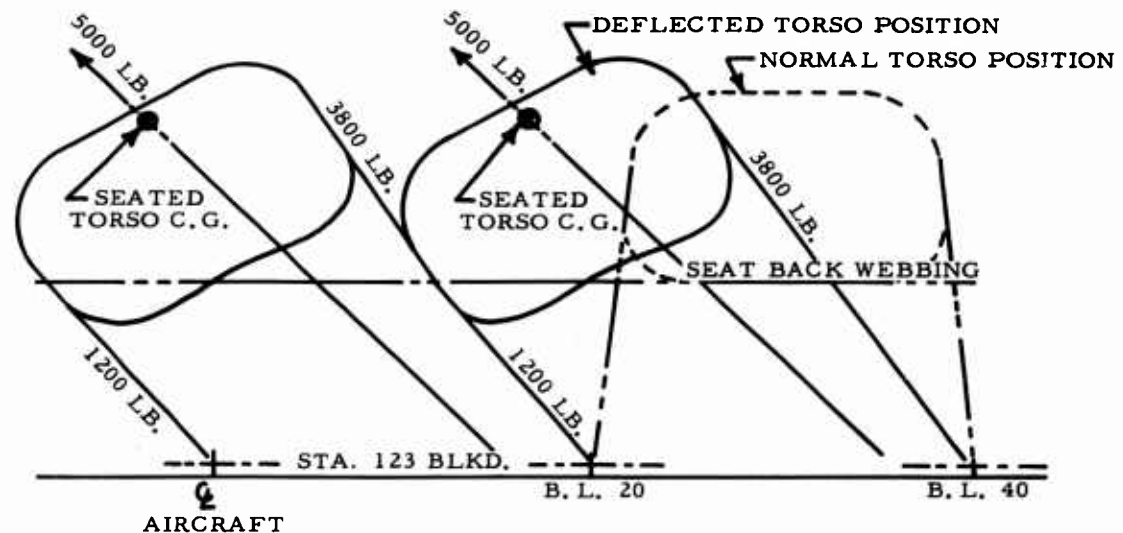
TOP VIEW

The three parts analyzed in this appendix are shown in Figure 10 of this report. It is assumed that the majority of helicopter accidents will exert crash forces within a 45-degree angle from the longitudinal axis of the aircraft; the most critical lap belt loading would be at 45 degrees because of the unequal loading as shown in the sketch below:

The human torso (as outlined by the pelvic extremities) would move approximately to the position shown. It is very difficult to determine the exact position of the belt with the applied load shown because of the unknown lateral resistance of the seat back, but the assumption is made that the lateral load would tear the seat back webbing and the belt would align itself as shown. The belt as shown has stretched a total of 10 inches, which is the average value determined from 2-inch-wide belt tests; tests have indicated that 3-inch-wide belts would deflect approximately 6 inches. The amount of deflection should not materially affect the distribution of belt loads.

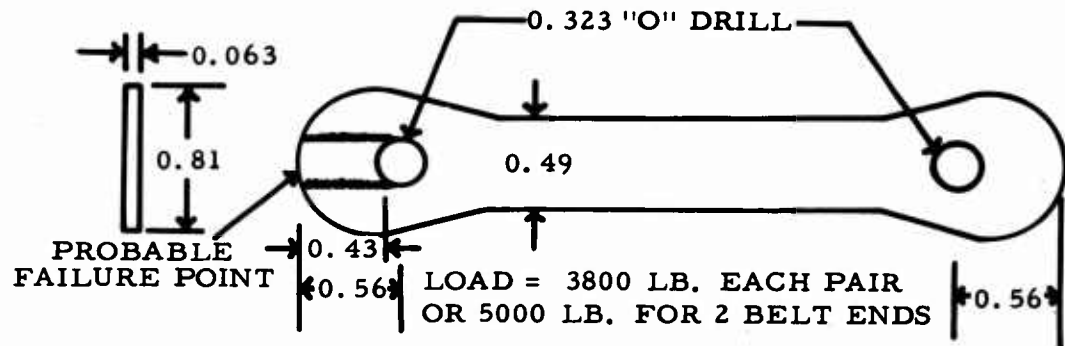
The following stress check is based on Annealed 301 Steel:

$$S_s = \frac{1900}{.43(.063)(2)} = 35,000 \text{ psi} \quad \text{M. S.} = \frac{40,000}{35,000} - 1 = .14$$

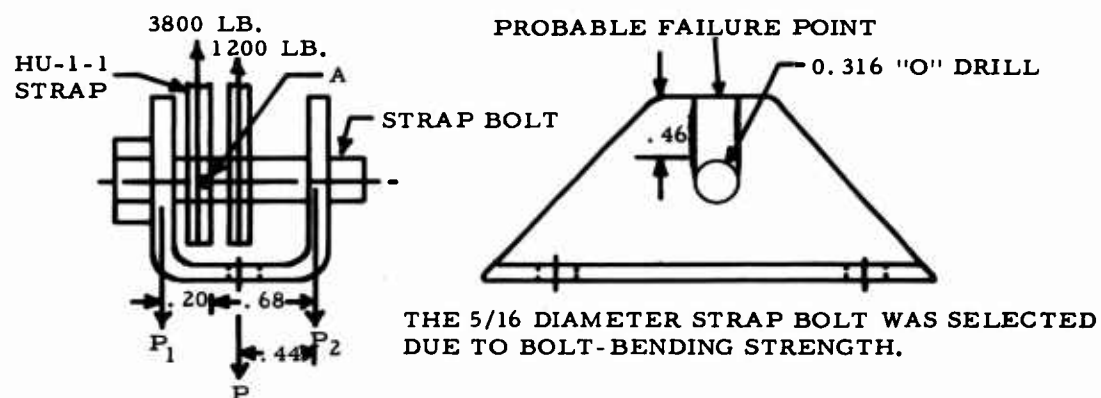
The following stress check is based on the use of annealed 301 steel.

$$P_1 + P_2 = 5,000 \text{ lbs.}$$

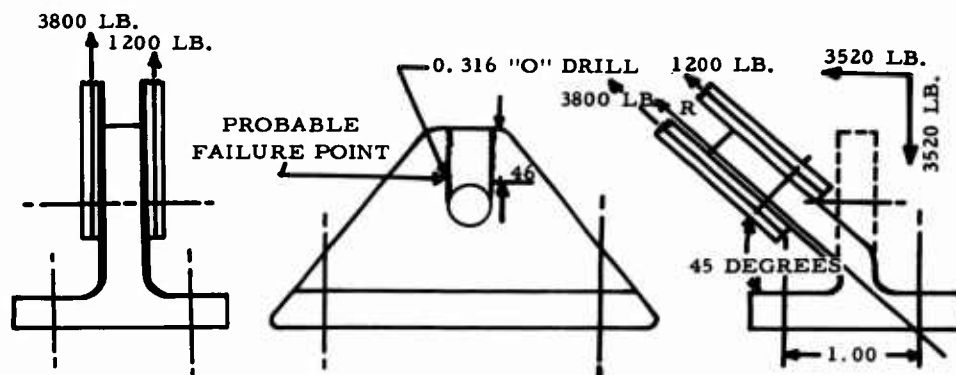
STRESS CHECK MADE ON 1020 MILD STEEL:

Check of 3/16-Inch-Diameter Tiedown Bolts:
