### COATING STUDIES AT KWAJALEIN, KANEHOE, AND PORT HUENEME

U. S. NAVAL CIVIL ENGINEERING LABORATORY  
Port Hueneme, California

Y-R007-08-001

C. V. Brouillette, R. L. Alumbaugh

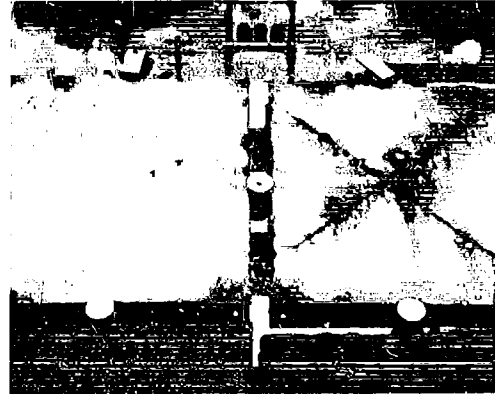
Kwajalein, 4-1/2 years

This vinyl system failed because of blistering and rusting along the scribed mark at Kwajalein after 4-1/2 years and was removed from test. The scribed panel at Kaneohe has only a few blisters (2/F) and light rusting after 5 years, and the scribed panel at Port Hueneme has no blisters after 5-1/2 years.

The unscribed panel at Kaneohe after 5 years and at Port Hueneme after 5-1/2 years was rated 10; the unscribed panel at Kwajalein was rated 9 after 4-1/2 years. The first signs of failure on the unscribed panel at Kaneohe and Port Hueneme were found at edges and corners. Coating breakdown has also occurred at pinhole breaks in the coating.

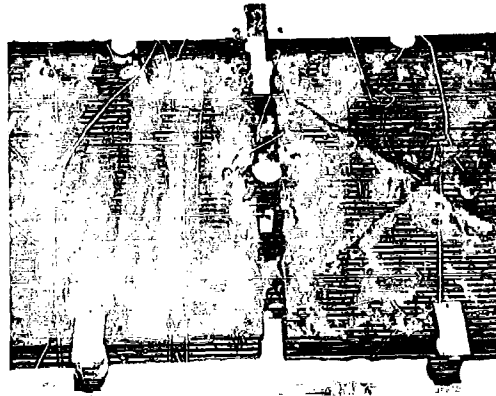
Kwajalein, 4-1/2 years

The scribed panel failed at Kwajalein after 4-1/2 years, because of blistering, and was removed from test. Blistering had occurred over about 60 per cent of the plain surface and was rated 2/D along the scribed mark. After 5 years at Kaneohe, blistering along the scribed mark was rated 2/MD, and 10 after 5-1/2 years at Port Hueneme. Overall protection was rated 8 at Kaneohe and 10 at Port Hueneme.

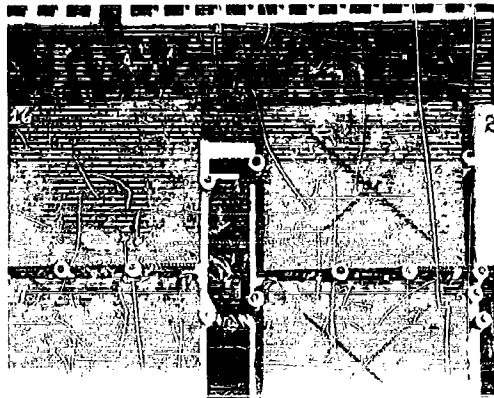
Port Hueneme, 5-1/2 years

The general appearance of this coating was good, and the protection being given to both the scribed and unscribed test panels after 5 years exposure at Kaneohe and 5-1/2 years at Kwajalein and Port Hueneme was rated 10. Very light rusting had appeared in the scribed marks, but no blistering had occurred.

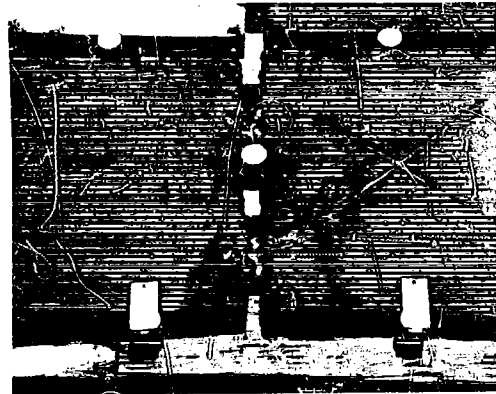
Kwajalein, 4-1/2 years

The scribed panel was removed from exposure after 4-1/2 years at Kwajalein. Blistering along the scribed mark and edges was rated 2/MD and more than 40 percent of the panel surface showed rusting and blistering. At Port Hueneme, after 5-1/2 years, the scribed panel was rated 10. At Kaneohe, after 5 years, the protection rating was 9 and blistering was rated 2/F.

The protection to the unscribed panel at Kwajalein after 5-1/2 years was rated 7 because of large blisters (rated 2/D) around the edges. At Kaneohe after 5 years, the protection to the panel was rated 8 and edge-blistering 2/F; at Port Hueneme the over-all rating was 10 after 5-1/2 years.

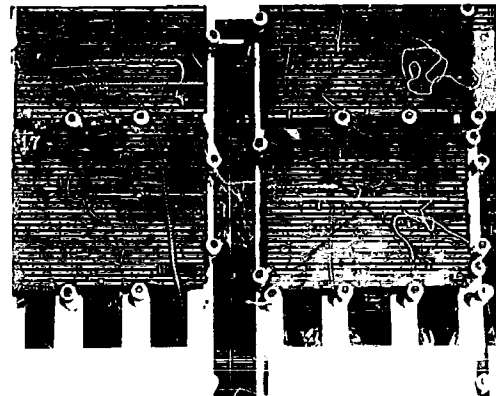
Port Hueneme, 5-1/2 years

Chalking was moderate and was rated 6.

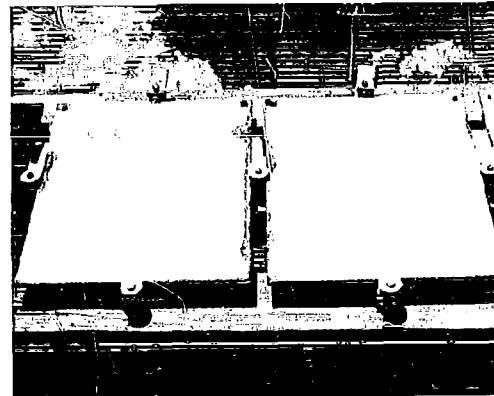
Kaneohe, 5 years

At Kwajalein, the protection after 2 years was rated 0, and the panels were removed from test. At Kaneohe after 5 years, the protection was rated 9 (edge-rusting), and at Port Hueneme, after 5-1/2 years, the rating was 10. No rusting was observed along the scribed mark at either Kaneohe or Port Hueneme.

Zinc salts were present over most of the surface of the test panels.

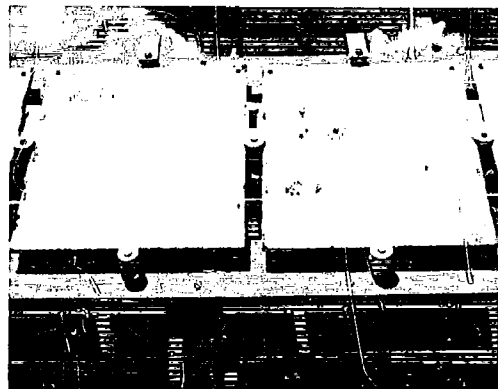
Kaneohe, 5 years

The aluminum-coated test panels at Kwajalein were removed from test after 2 years. They were showing rusting over most of their surface, and the scribed panel was almost completely rusted. After 5 years at Kaneohe, the scribed panel was showing rust and the corrosion products of aluminum over most of the surface and was rated 7; the unscribed panel was rated 9.

After four years exposure at Kaneohe, the back or underneath sides of the panels were covered with rust accumulation and the protection was rated 2. Rusting on the backs had not occurred at Port Hueneme; however, aluminum corrosion salts were present.

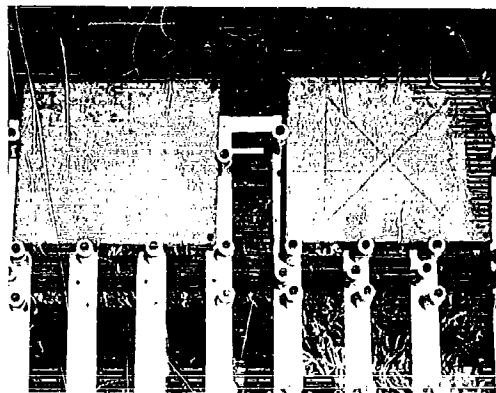
Port Hueneme, 5-1/2 years

At Port Hueneme after 5-1/2 years, both panels were rated 10. A small amount of aluminum corrosion products covered the surface of these panels.

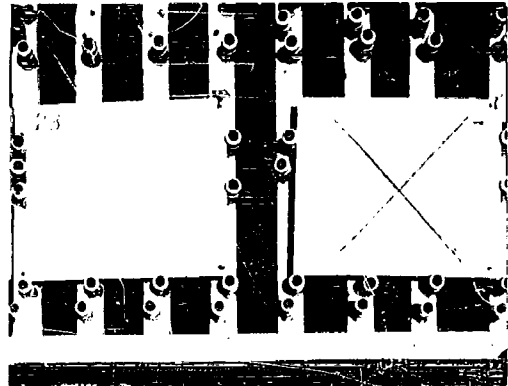
Port Hueneme, 5-1/2 years

The scribed panel coated with Saran failed after 3 years at Kwajalein because of blistering along the scribed mark. At Kaneohe after 5 years, blistering along the scribed mark and edges was rated 2/MD, and at Port Hueneme after 5-1/2 years, the blistering was rated 4/M.

The protection to the unscribed panel at Kwajalein after 5-1/2 years was rated 8 because of slight blistering at edges and pinhole rusting over the surface. No blistering had occurred on the unscribed panel at Kaneohe; but many very small pinhole rust spots were present, and the panel protection was rated 9. At Port Hueneme, the panel was rated 10 after 5-1/2 years.

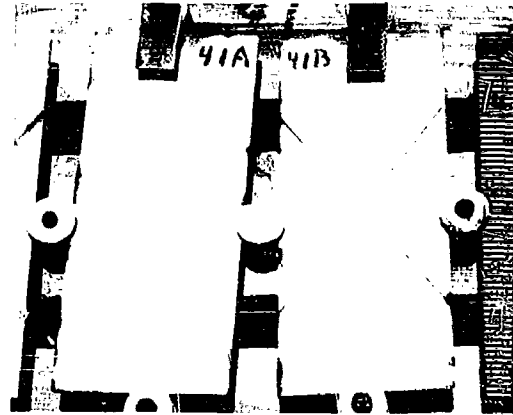
Kwajalein, 1-1/2 years

The protection of the unscribed panel was rated 9 at Kwajalein because of blistering and rusting at the edges; no failure of the coating was observed at Port Hueneme, and the coating was rated 10.

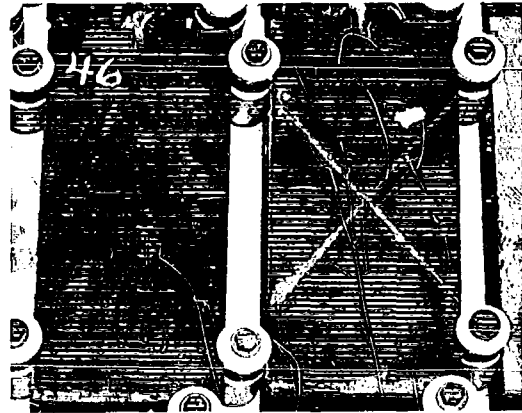
Port Hueneme, 2 years

The scribed panel at Kwajalein after 1-1/2 years had dense blistering along the scribed mark, rated 2/D. There was heavy rusting in the scribed mark, and the overall protection was 7. After 2 years at Port Hueneme no blistering had occurred, and this panel was rated 10.
