HUGHES TOOL COMPANY · AIRCRAFT DIVISION
Culver City, California

Report 285-18 (62-18)

HOT CYCLE ROTOR SYSTEM
MATERIALS & PROCESSES

March 1962

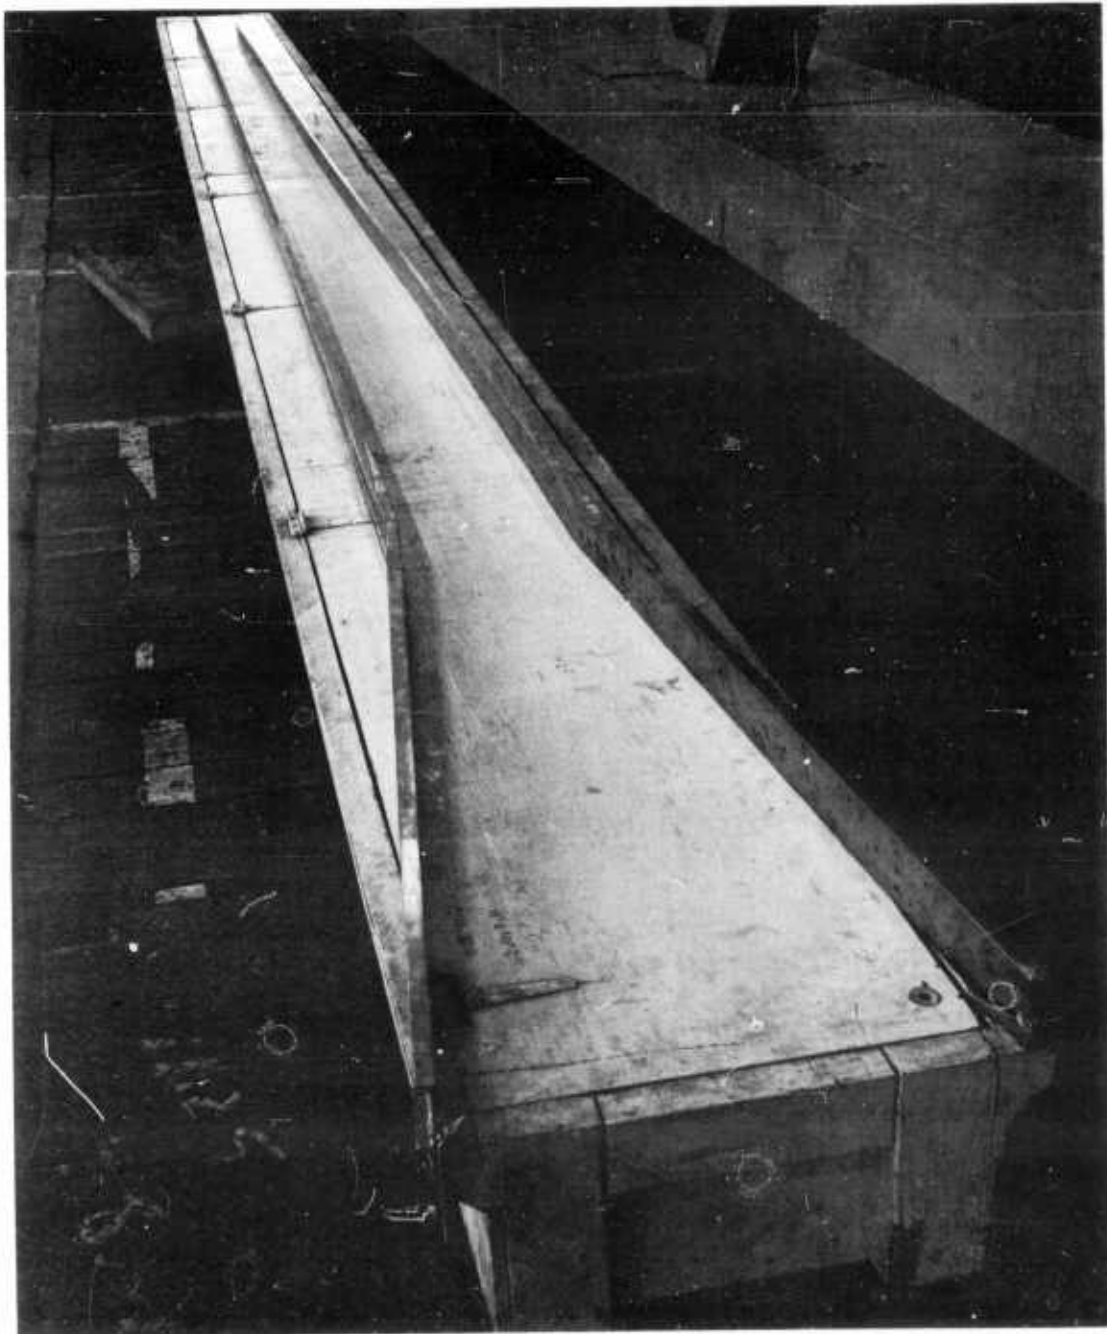
Figure 2.1-2. Blade Spars - Titanium

The spars were bent and twisted as required after machining while at a temperature of between 900 and 1000°F. The maximum time at this temperature was held to one hour. Following the forming operation, the spars were stress relieved at 1000° + 30°F for 4 to 4-1/2 hours with a furnace atmosphere slightly oxidizing. After stress relieving the rear spars were shot peened with an intensity of 0.004 to 0.006 using an Almen "A" strip measured with a No. 2 gage. Finished spars are shown in Figure 2.1-2.

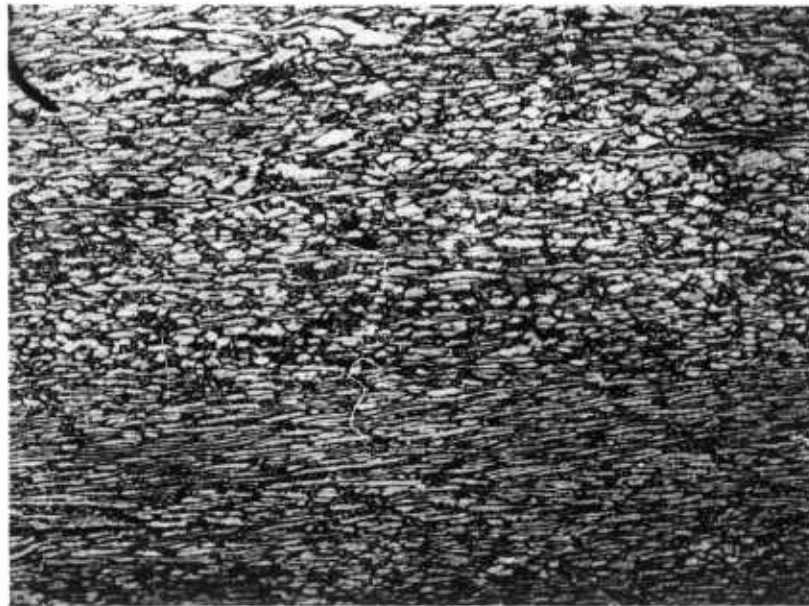
Figure 2.1-1. Photomicrograph of Spar Material

The material was annealed and warm rolled, and was used in that condition. Grain size was from 7 to 8 with normal alpha structure. A photomicrograph is given in Figure 2.1-1. Other static and fatigue properties are reported in Reference 1.

Titanium 6Al-4V
Magnification 100x
Normal Alpha Structure
Grain Direction Longitudinal To Spar

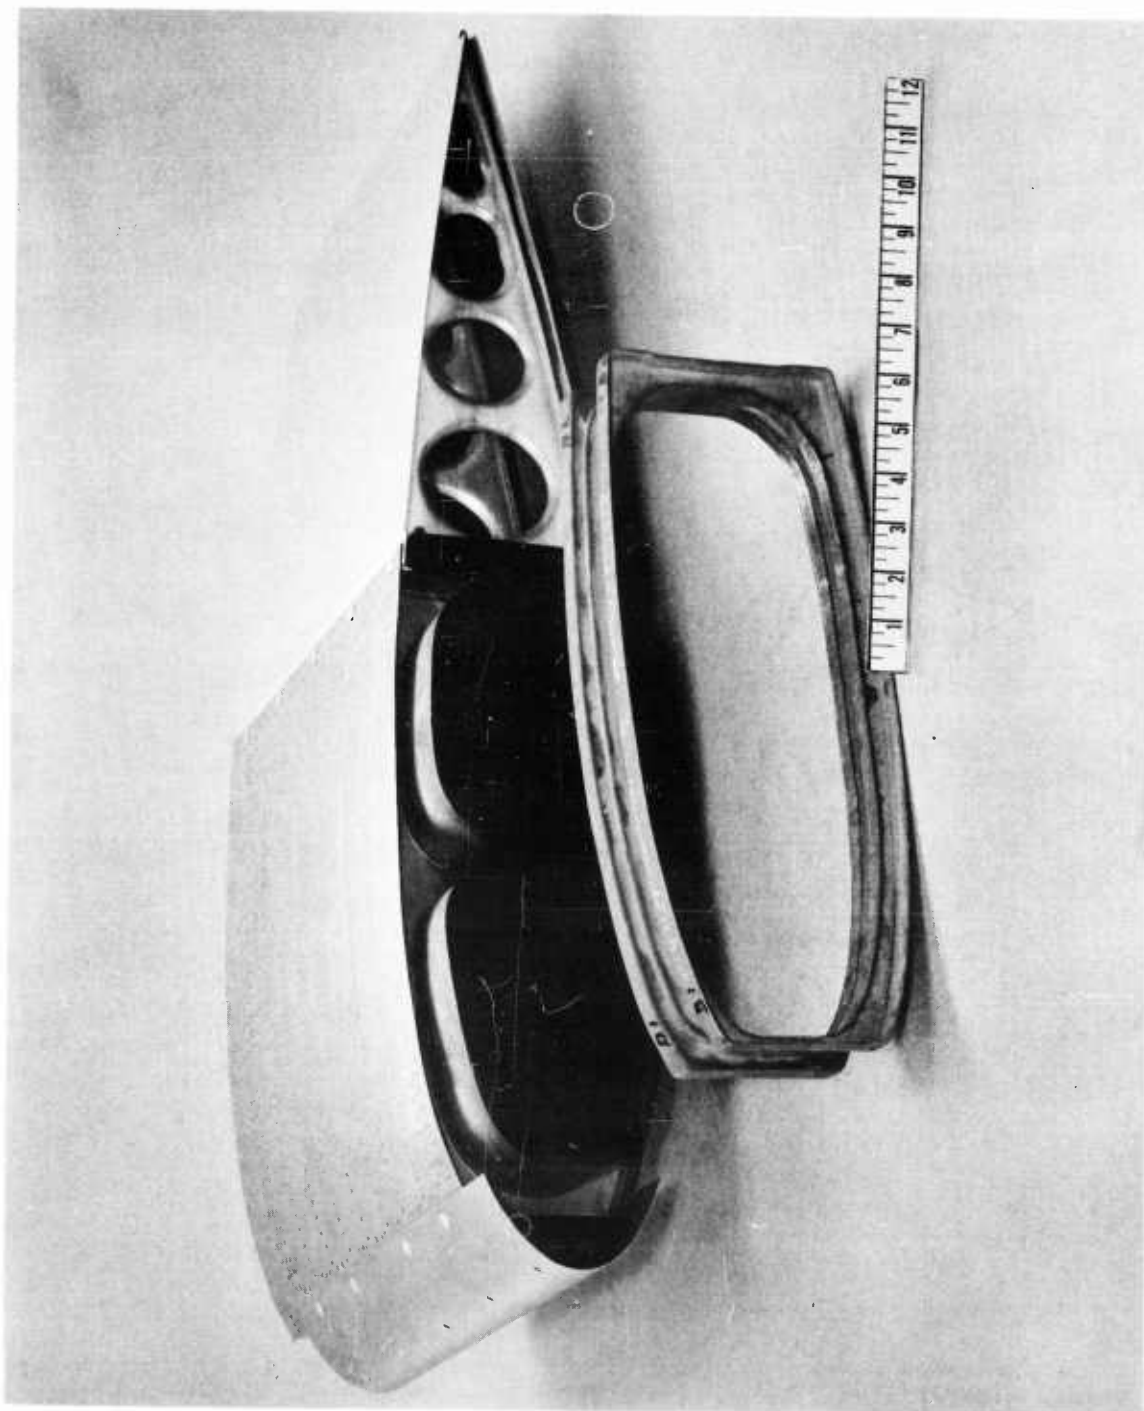
Figure 3.1-1. Typical Blade Cross Section and Electroformed Flexible Coupling

Figure 3.1-1 shows a typical blade cross section and flexible coupling. After finalization of the blade segment design, a primary decision was necessary as to the method of attaching the components; either spot and rollwelding or brazing. Samples of both brazed and spotwelded segments were tested. Both specimens proved equally good in the Screening Fatigue Test (Reference 2). The decision to use the spotwelded design was based on greater availability of dependable fabricators in the Los Angeles area and the resulting opportunity to more closely control the work as it was in process.

Spotwelding of the blade segments proceeded smoothly after all of the certifications and preliminary testing in the weld fixtures was done. However, some difficulty was initially encountered in welding of the Rene' 41 material. Spotwelding the thin materials used in the segments requires equipment having the ability to closely regulate the various weld parameters, since satisfactory welding can only be obtained within very narrow margins of weld time, heat and electrode pressures. Limited data was available on the welding of Rene' 41 materials; however, it was not applicable to the thin materials (0.012 inch) used in this application. Preliminary weld testing was done in order to determine the conditions required for obtaining quality welds. Line power factor conditions were found to have an important influence on the welding results. Following the initial development period, during which machine settings and type of welding equipment were established, consistent and excellent welds were obtained. The final welding schedule is given in Table 3.1-1. The segment shown in Figure 3.1-1 is a production spotwelded assembly, while Figure 3.1-2 shows a typical Rene' 41 rib.

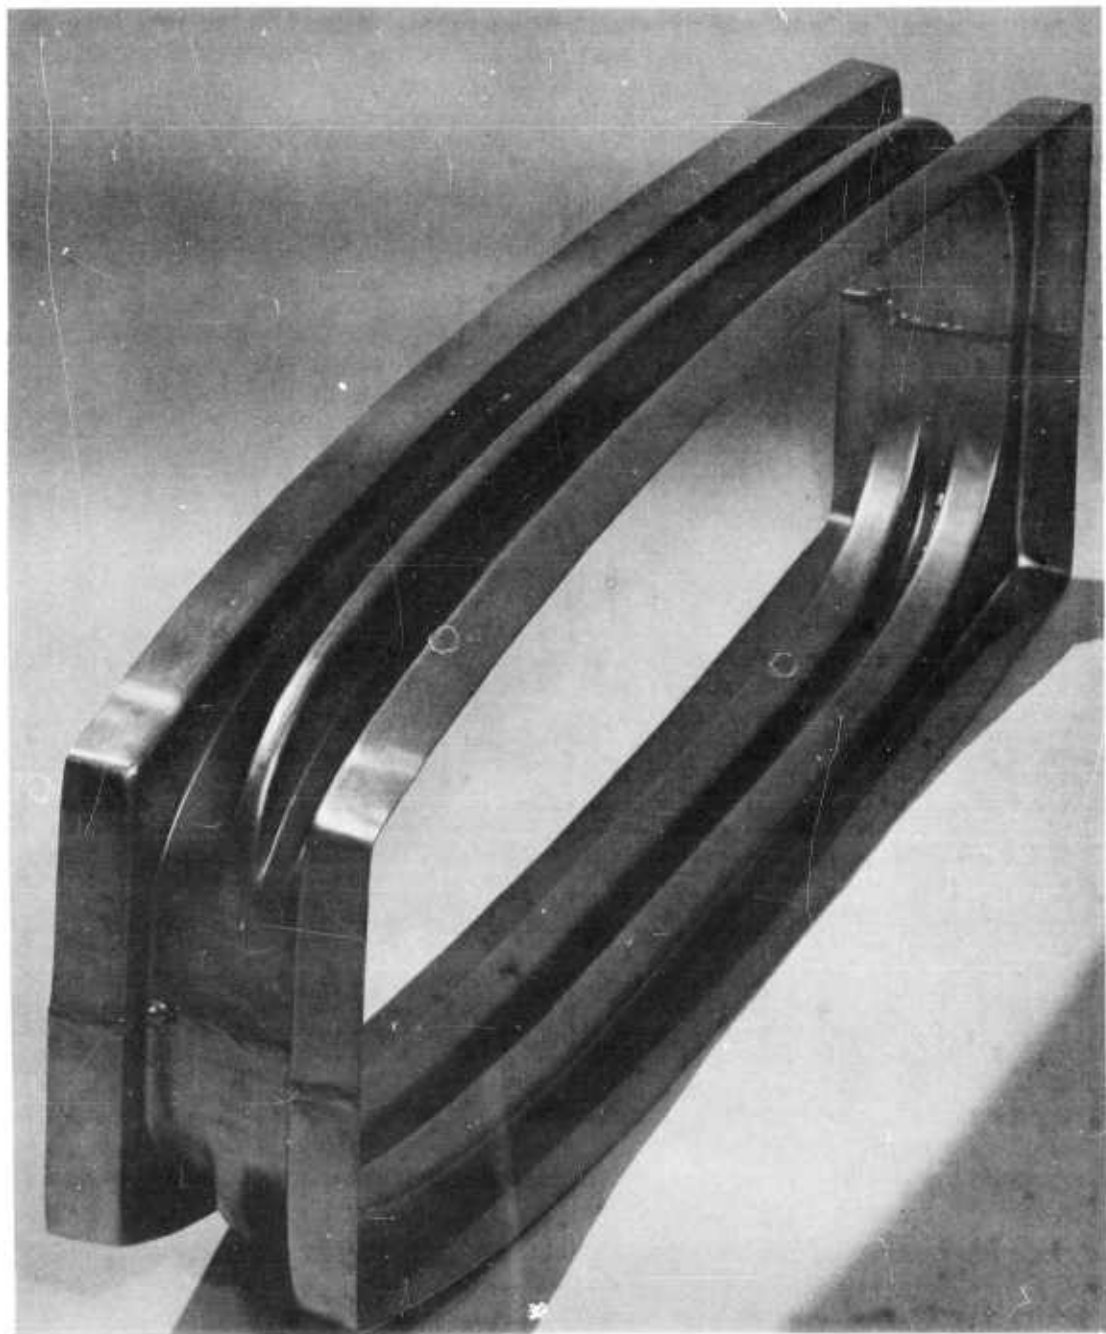
Figure 3.3-1. Preliminary Sample of Drop Hammered Inconel "X" Flexure

The flexible coupling is a complex cross section where flexibility is required in one direction and stiffness in the other. The part was made in two halves and joined at the chord plane, as shown in Figure 3.3-1, by fusion welding with the tungsten inert arc method using Inconel X filler. Parts were then placed in a fixture and tie straps resistance welded to the upper and lower sides of the sections. Before spotwelding the parts were liquid honed in the area where the welding was to be performed. In order that the surfaces to be welded would not be contaminated, marked pieces of platers tape were attached adjacent to the weld area and these were used to index the welds.

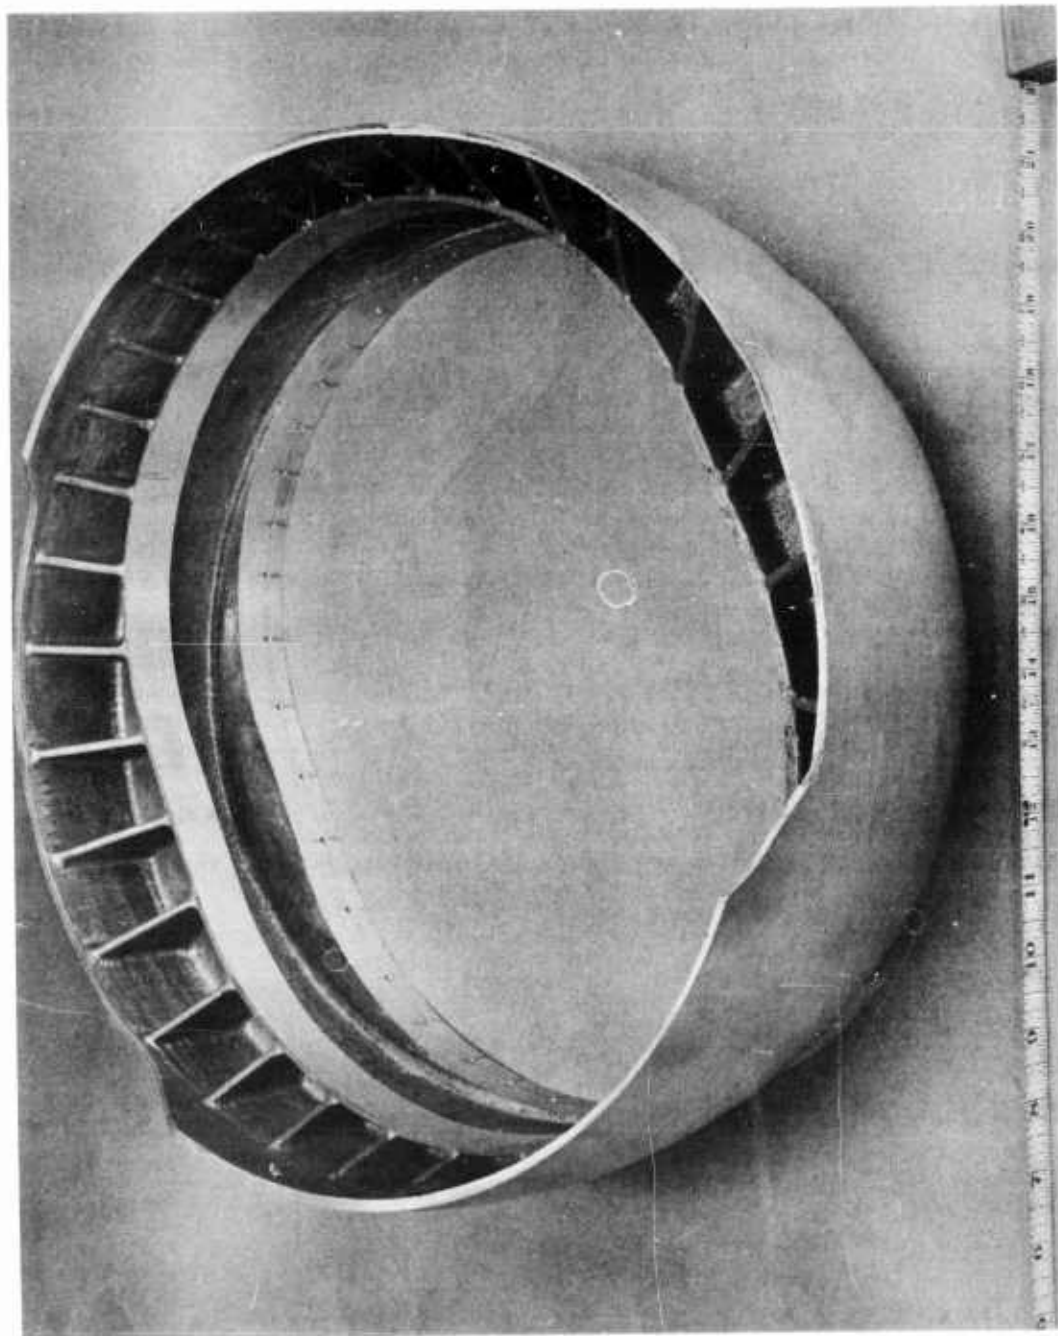
Figure 3.4-1. Blade Feathering - Flapping Bearing Ball, prior to honing and chrome plating

On each blade there is a feathering-flapping bearing consisting of all aluminum alloy ball (Figure 3.4-1) in contact with a teflon-faced outer race. Because of the complex internal configuration, the ball was cast. For wear resistance, the aluminum ball was chromium plated with a dense, moderately hard coating. On the ball of the initial test bearing, the chromium plate was applied directly to the aluminum surfaces without a base coat. After approximately one month exposure to outdoor atmospheric conditions, blisters were found on the upper surface. Examination revealed a typical aluminum corrosion beneath the chromium plating.

In order to prevent this condition on parts for the whirl-test blades, an extensive investigation was conducted regarding the experience of platers and chrome-on-aluminum users. No experience could be found with chromium plating on cast materials, but considerable exposure has been accumulated for chromium plated directly on aluminum alloy forged bar stock, without a base coat, and used extensively on landing gears for fighter and bomber planes. Findings of the investigation led to the conclusion that casting porosity, and thoroughness of cleansing of the plating preparatory solutions were major factors in producing the corrosion and blisters. It was therefore decided to produce finer grained castings and to chrome plate directly on the aluminum as before, but with much more careful control of the process.
