HUGHES TOOL COMPANY · AIRCRAFT DIVISION
Culver City, California

Report 285-9-8 (62-8)

HOT CYCLE ROTOR SYSTEM
RESULTS OF COMPONENT TEST PROGRAM

FINAL REPORT

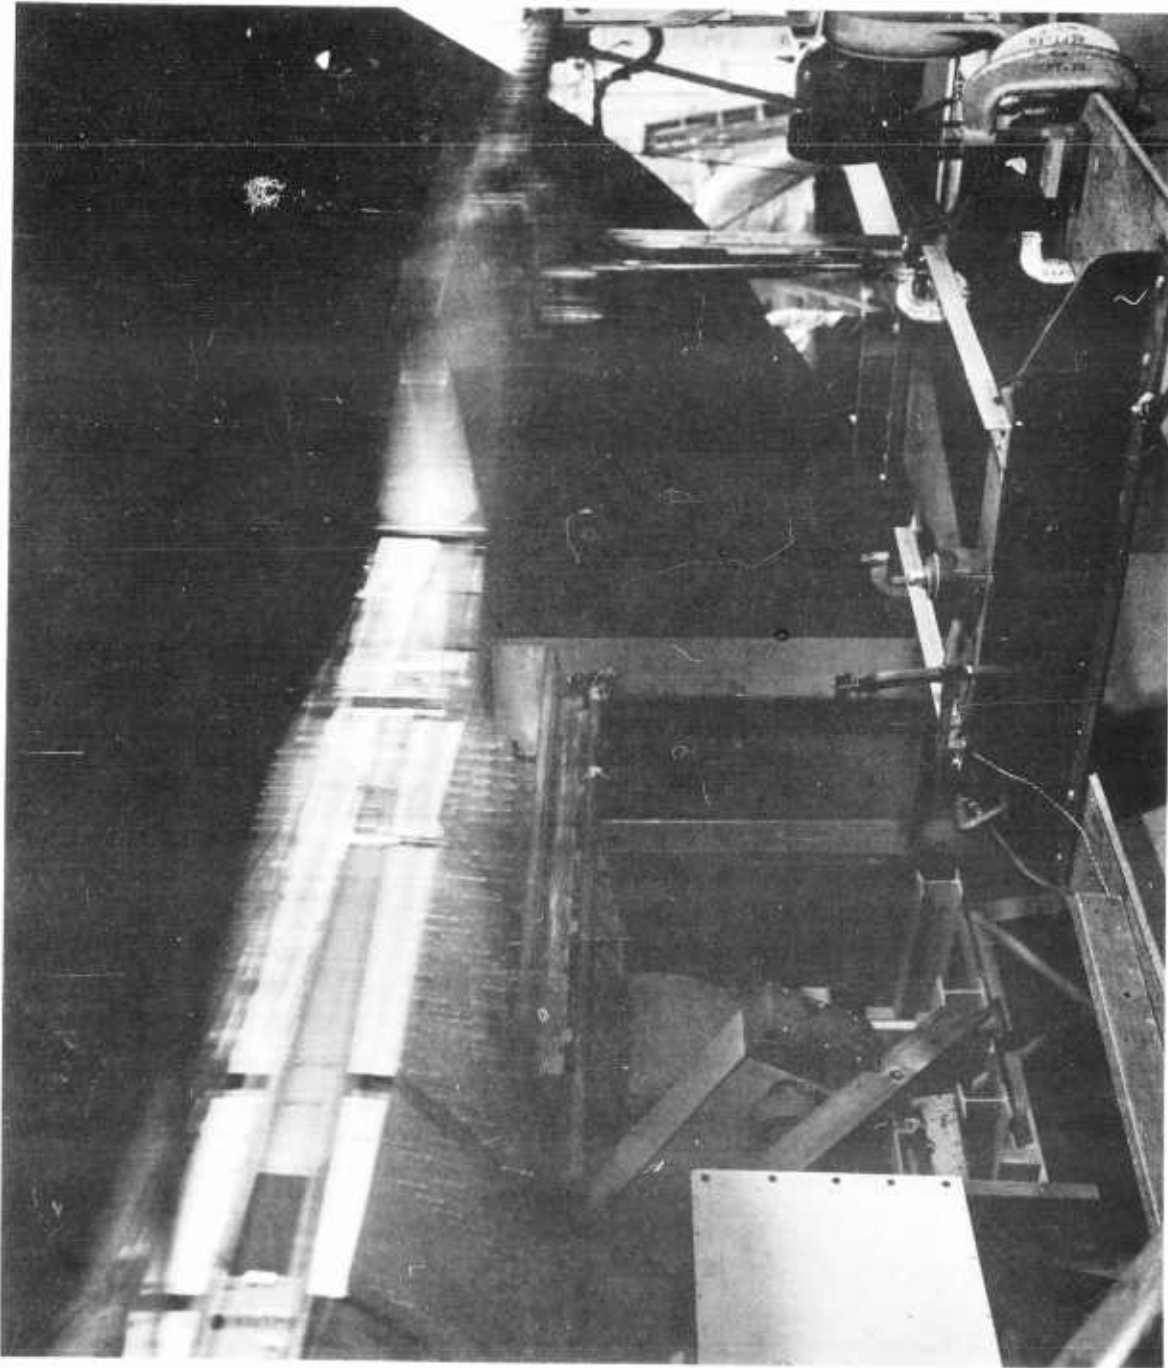
Figure 3-11. Fatigue Test Blade Assembly -- Test in Progress, View Looking Outboard at Rear Spar

a. The test blade assembly was subjected to the test load conditions. Figures 3-11, 3-12 and 3-13 show the test blade assembly during the test. The temperatures attained within the duct area are shown in Figure 3-4. The bending moment distribution along the spars is shown in Figure 3-5.

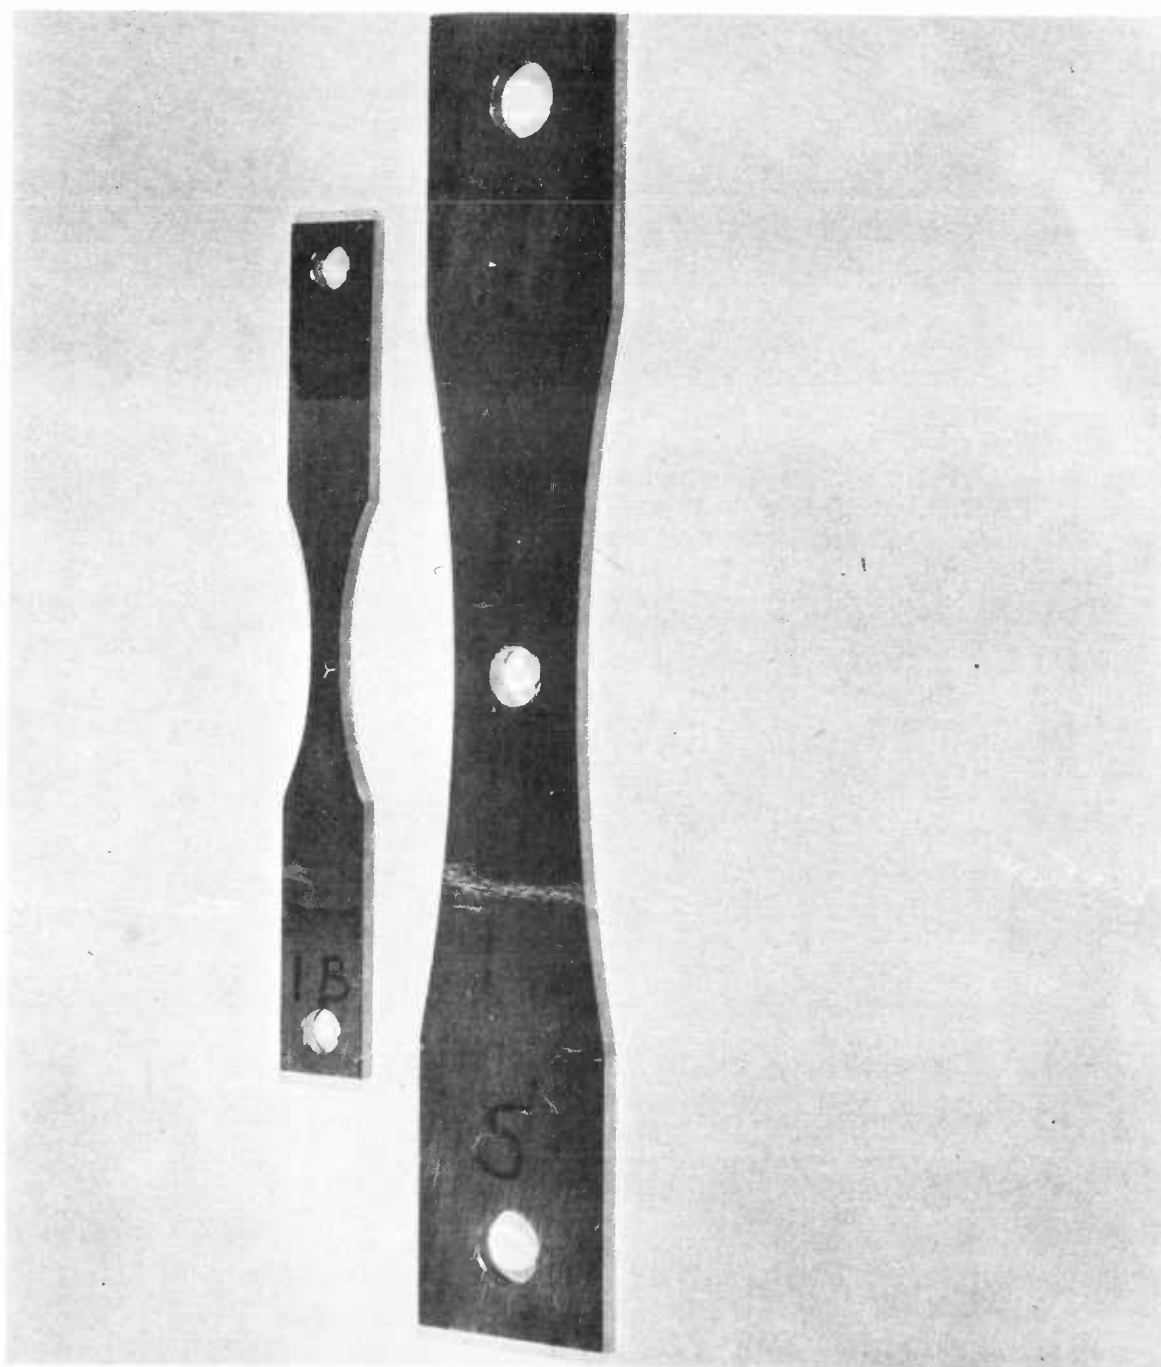
Figure 3-24. Aft Spar Titanium Fatigue Specimen Configuration

b. Fatigue Coupon Tests. Fatigue specimens were machined from material adjacent to the fracture area in a longitudinal direction. The specimens were subjected to tension-tension type loading in a resonant-beam fatigue machine. Two types of specimens were tested. The first type consisted of smooth specimens to check the endurance limit of the aft spar. The second type of specimens contained a hole at the reduced section. This hole was machined with a burr in an attempt to duplicate the hole conditions in the test spar. Other specimens of this type were radiused with a rubber impregnated abrasive to compare the fatigue life of the two hole conditions. The two specimen configurations are shown in Figure 3-24. The two hole conditions are shown in Figures 3-25 and 3-26.

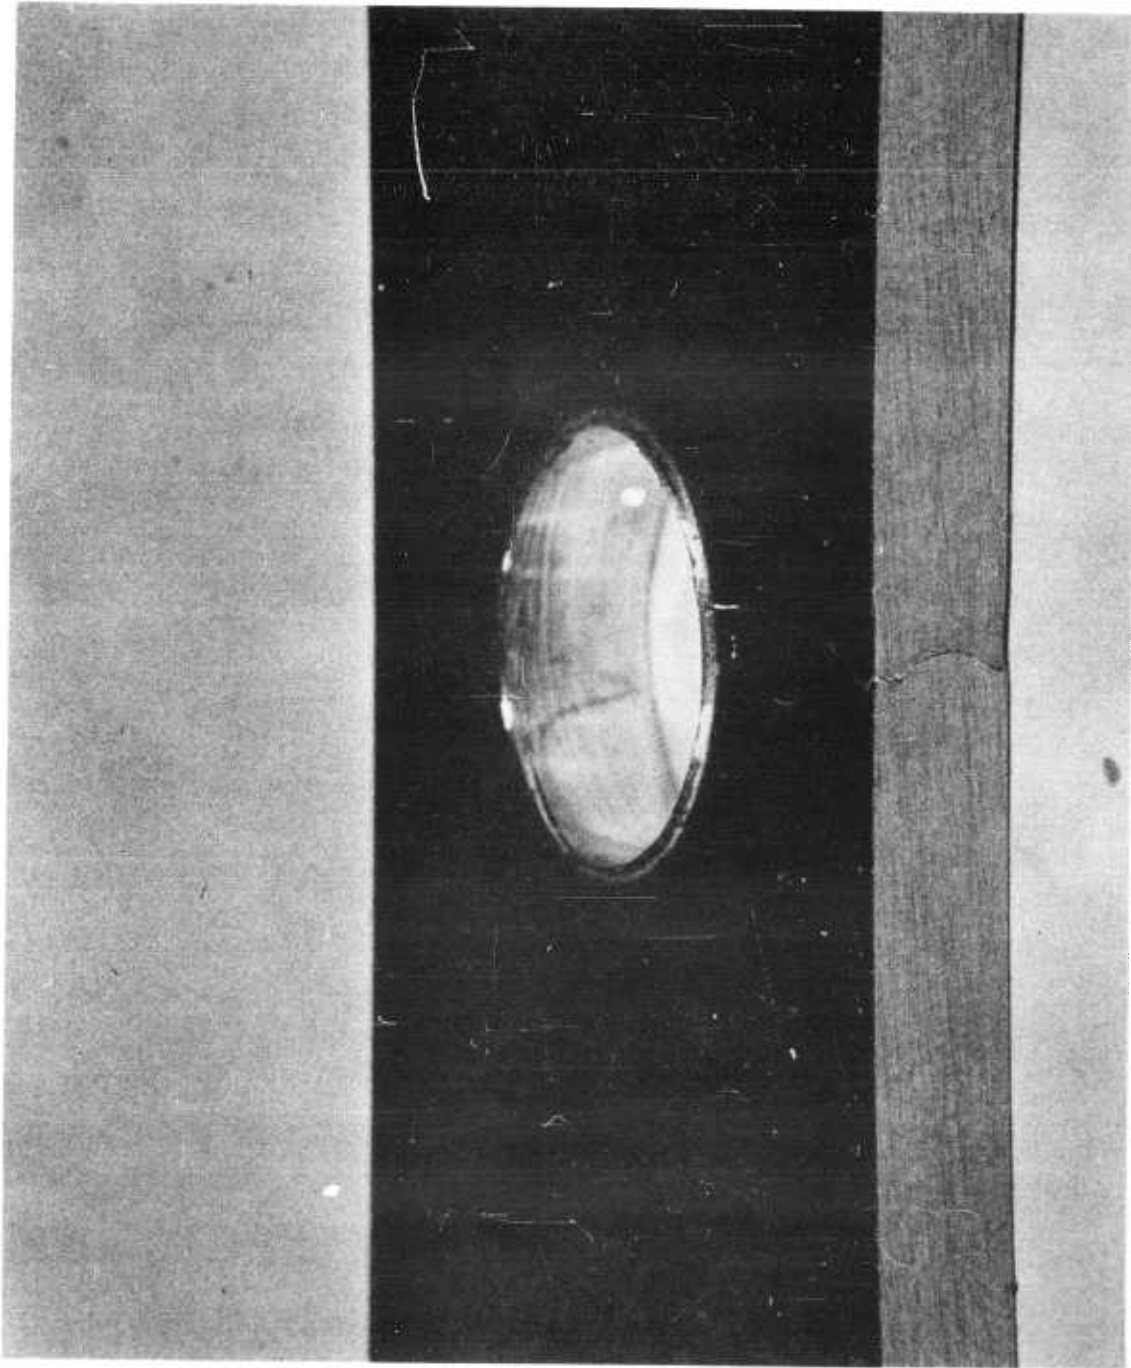
Figure 3-25. Typical Hole with Burr Titanium Fatigue Specimen

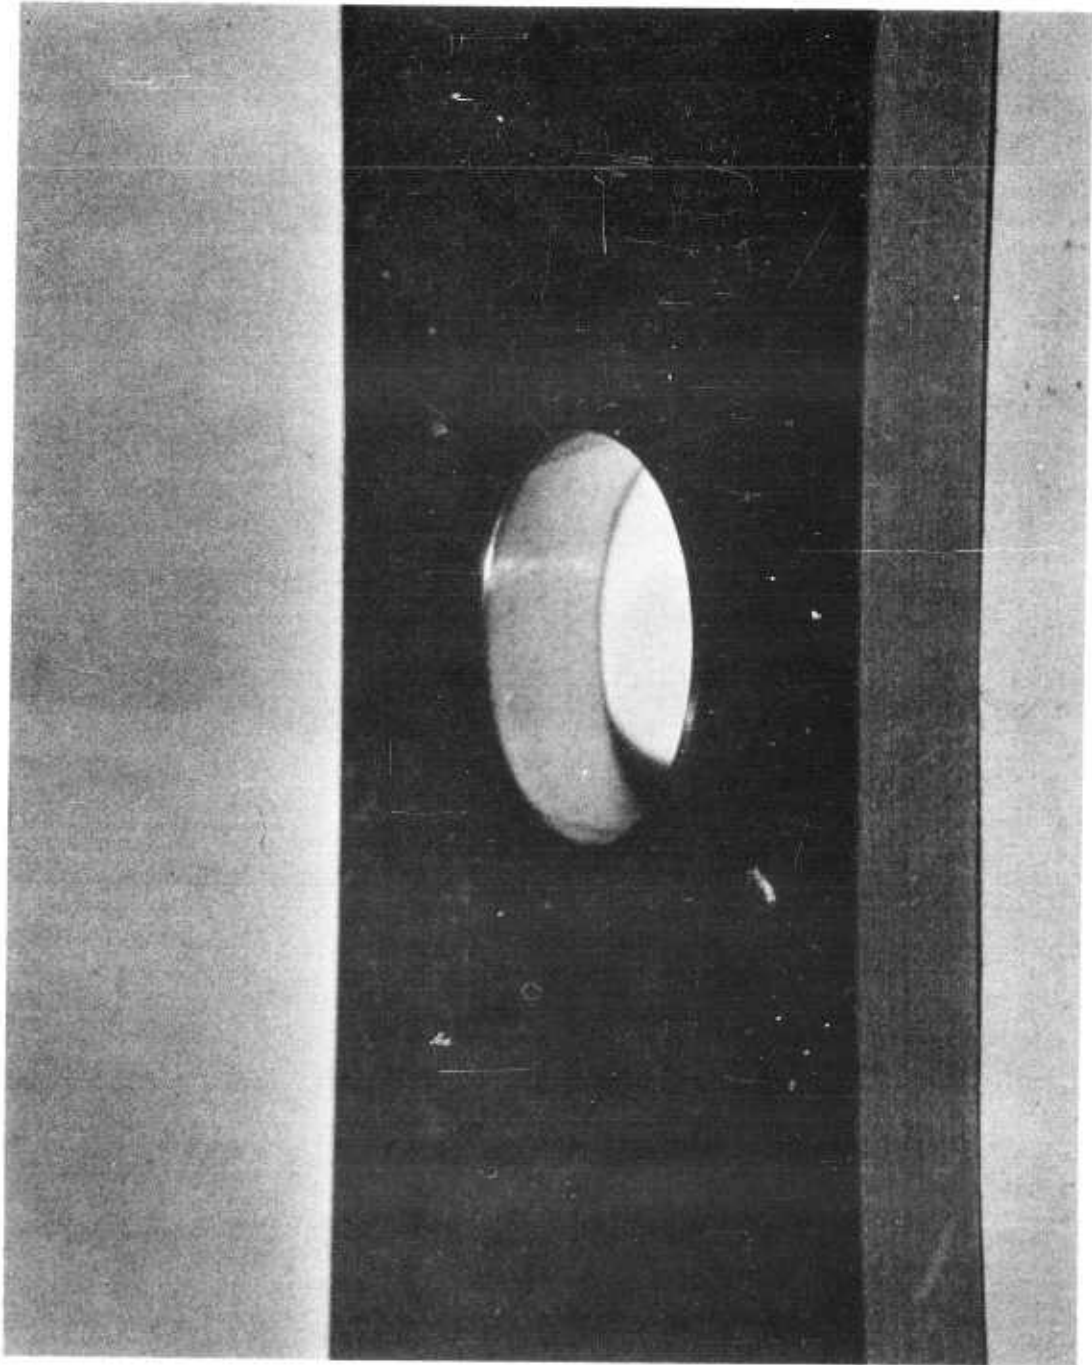
Figure 3-26. Typical Polished Hole Titanium Fatigue Specimen

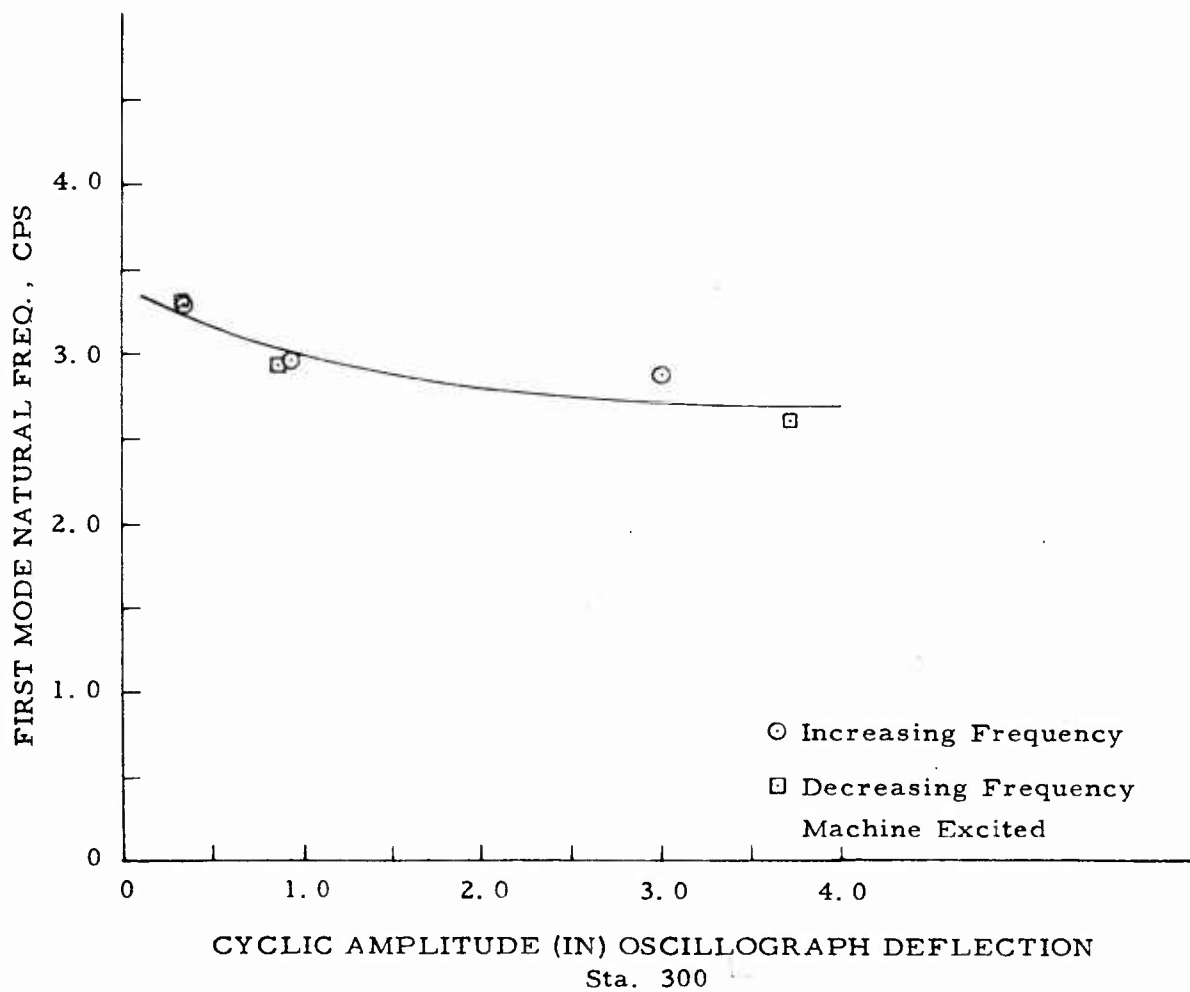
Figures 4-1 and 4-2 present the first and second mode natural frequencies respectively. It can be seen that the natural frequency is reduced by an increase in amplitude. This effect is assumed to arise from the slip joint configuration of the blade section. For small amplitudes of vibration, some of the slip joints probably do not move, resulting in an increase in blade stiffness and, hence, in frequencies. It can be seen that the first mode frequencies vary from 2.6 to 3.3 cps and the second mode frequencies vary from 8.7 to 11.1 cps. When applying these frequencies to predictions of operating natural frequencies, a correction must be made for the reduction in modulus of elasticity of the titanium spars from the room temperature

Figure 4-1. Hot Cycle Rotor First Mode Flapwise
Natural Frequency Vs. Amplitude

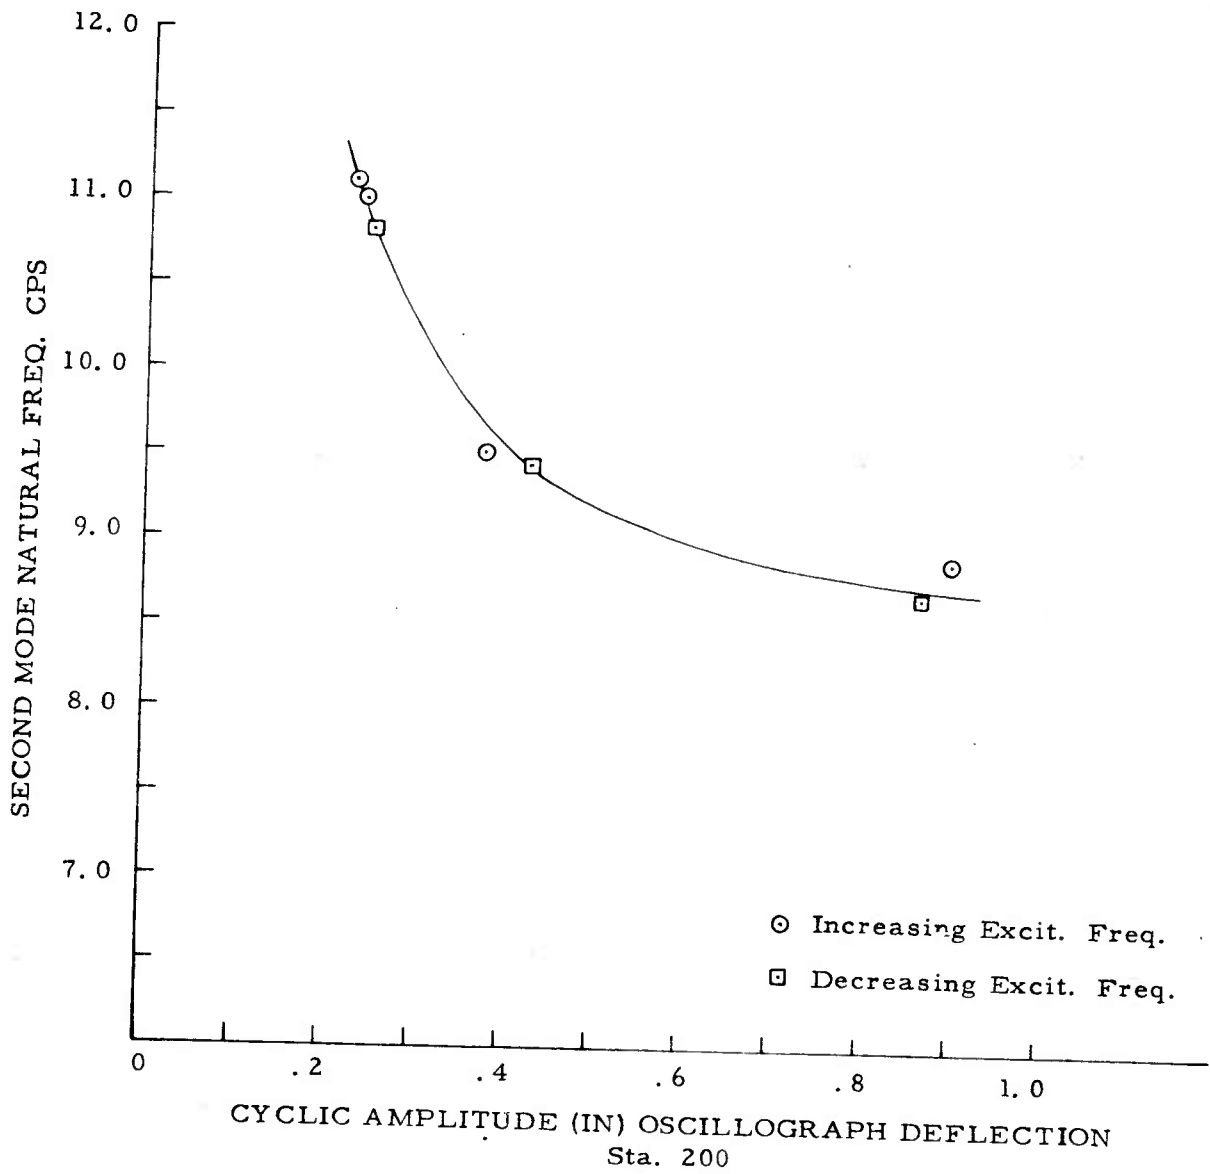
Figure 4-2. Hot Cycle Rotor Second Mode Flapwise
Natural Frequency vs Amplitude

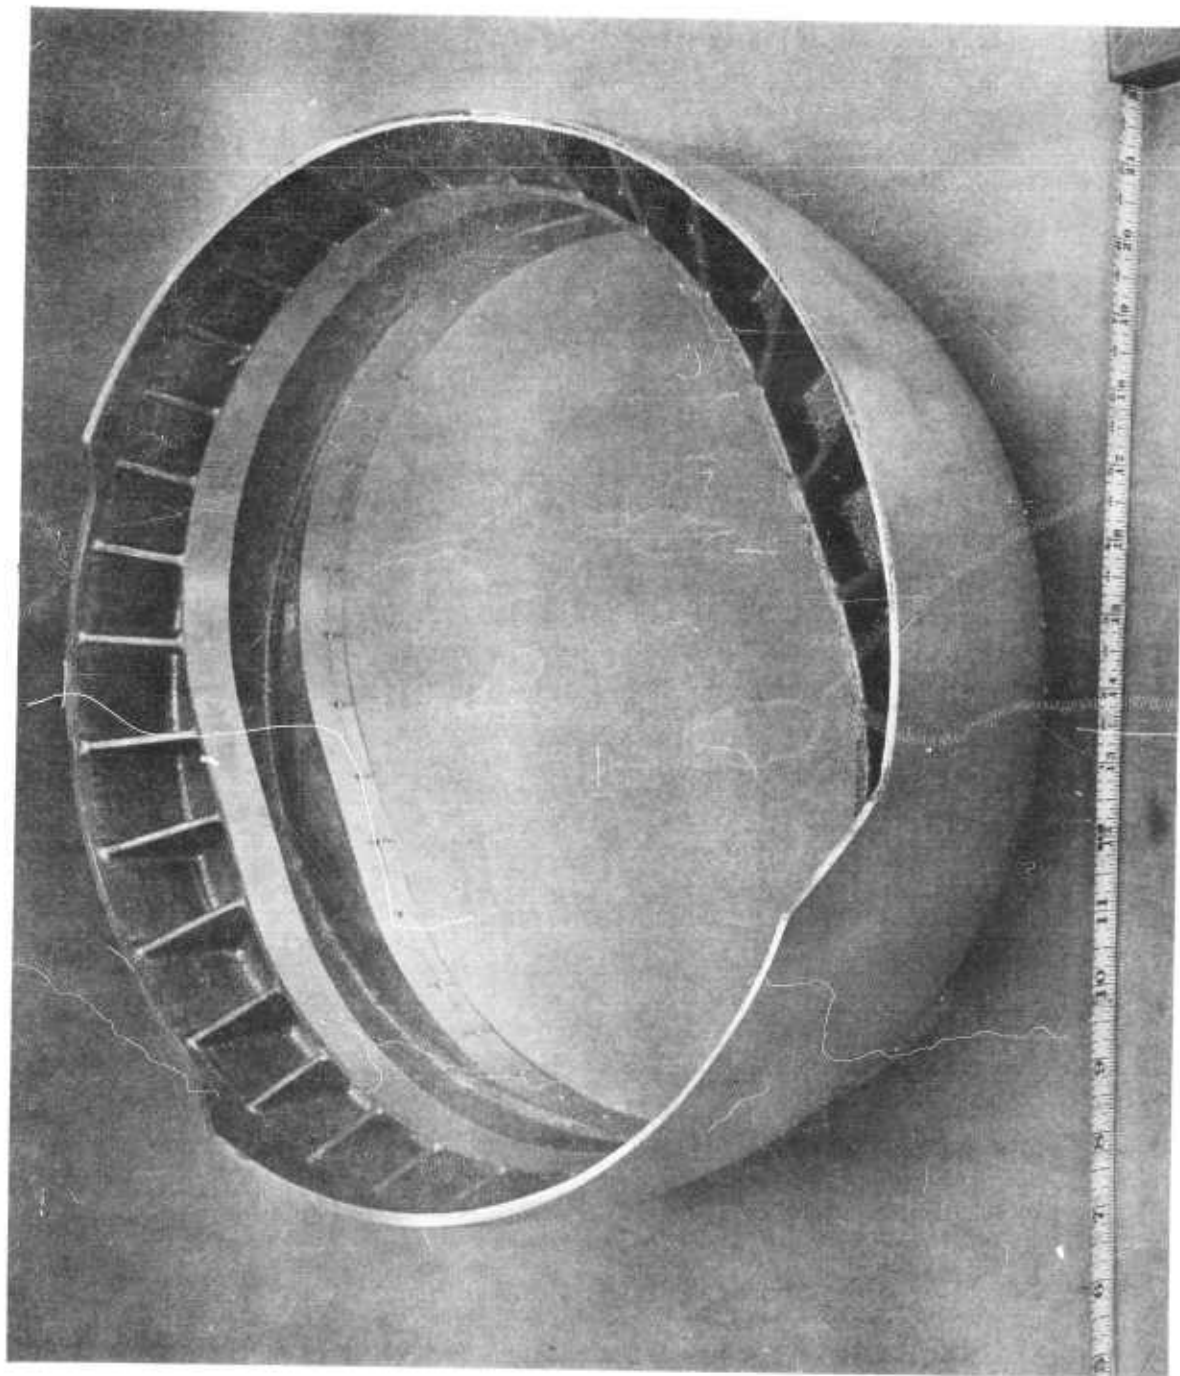
Figure 7-8. Bearing Ball

The spherical bearing and retainer was subject to 26.5 hours of cycling. Inspection of the bearing and Fabroid bonded retainer revealed that a small amount of flaking of teflon fibers had occurred. No indication of increased clearance or damage of any kind was noted. The bearing and retainer after test is shown in Figures 7-5, 7-6, 7-7 and 7-8.
