NRL Memorandum Report 1383

ABYSSAL CORROSION AND ITS MITIGATION PART II. RESULTS OF A PILOT TEST EXPOSURE

B. W. Forgeson, L. J. Waldron, M. H. Peterson,
and B. F. Brown

December 1962

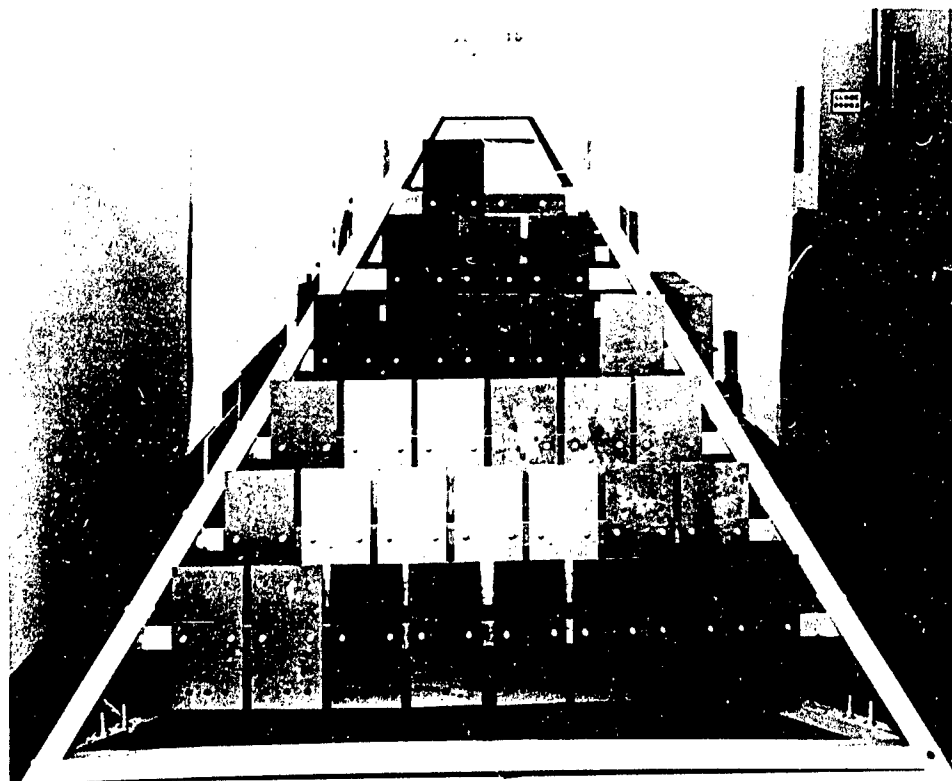
| COMPONENT | DEPTH | MATERIAL | CORROSION | FOULING |
|---|---|---|---|--|
| (7) Main Exposure Vehicle and Center Rack | 5700' | Aluminum 6061-T6 vinyl coated. | <u>Slight</u> - some corrosion of edges where coating was thin. Coating in excellent condition. Some crevice corrosion at Aluminum fasteners. | <u>None</u> |

Fig. 3 - Main exposure rack of corrosion test array

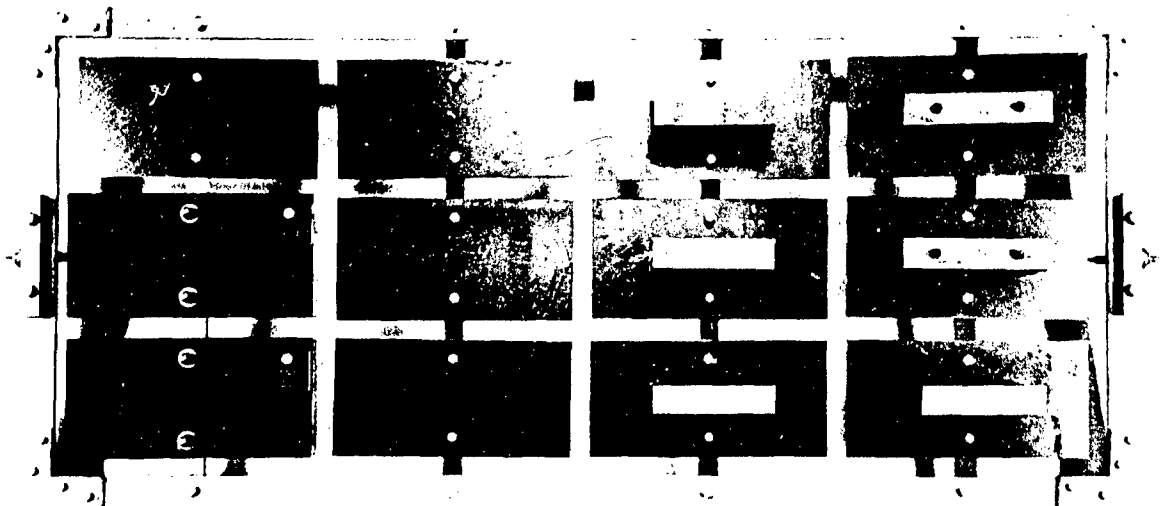
| COMPONENT | DEPTH | MATERIAL | CORROSION | FOULING |
|---|---|---|---|--|
| (10) Bottom Rack | 5750' | Aluminum 6061-T6 vinyl coated. | <u>Slight</u> - some corrosion of edges where coating was thin. Coating in excellent condition. Some crevice corrosion at Aluminum fasteners. | <u>None</u> - No visible marine life - slight amount of calcareous ooze from bottom adhering to rack. |

Fig. 5 - Bottom exposure rack
