The objectives were to obtain information on the mechanics of tunnel damage and on the loading and response of various tunnel liners. The ultimate use of such information will be the development of improved design procedures for underground protective construction in rock.

Generally, the results indicated that the measured values of the various shock parameters were within the preshot estimates. The damage at the closest and farthest test drifts was about as expected; however, the damage at the intermediate-range drift was somewhat greater than expected. Data recovery and the results of the electronic and mechanical measurements

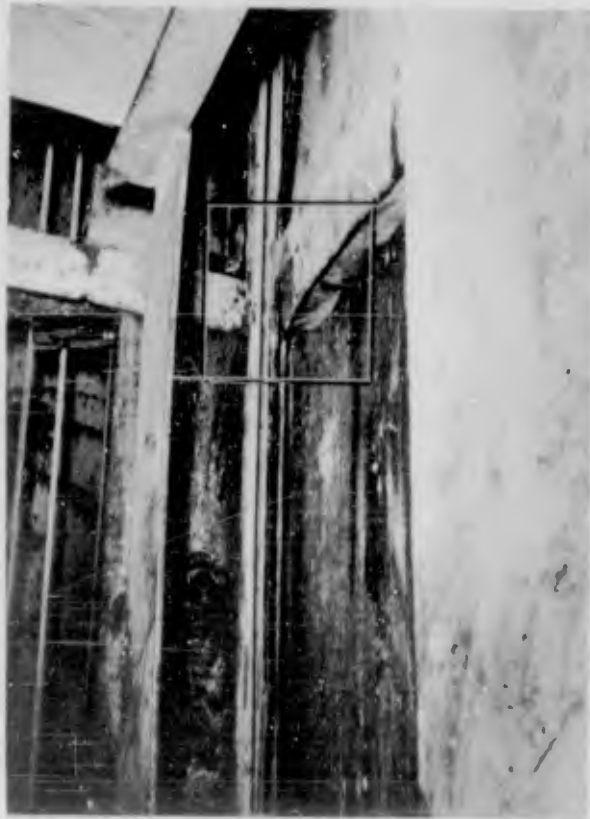
3.1.1 Damage to Access Shaft, Station 1500. Postshot damage was noted at all depths of the shaft. In general, it was noted that the upper half of the shaft sustained heavier damage than the lower half. Many of the bearing sets (see Figure 2.2) were permanently distorted, as shown in Figures 3.1, 3.2, and 3.3. Some of the standard sets were distorted, due to loads imposed by broken rock from the walls. The latter sets generally returned to their original shape upon removal of the broken rock.

Figure 3.1 Shaft Sta
3+75, NE corner of
bearing set. (H&N-AEC
62-1241-2, 1962).

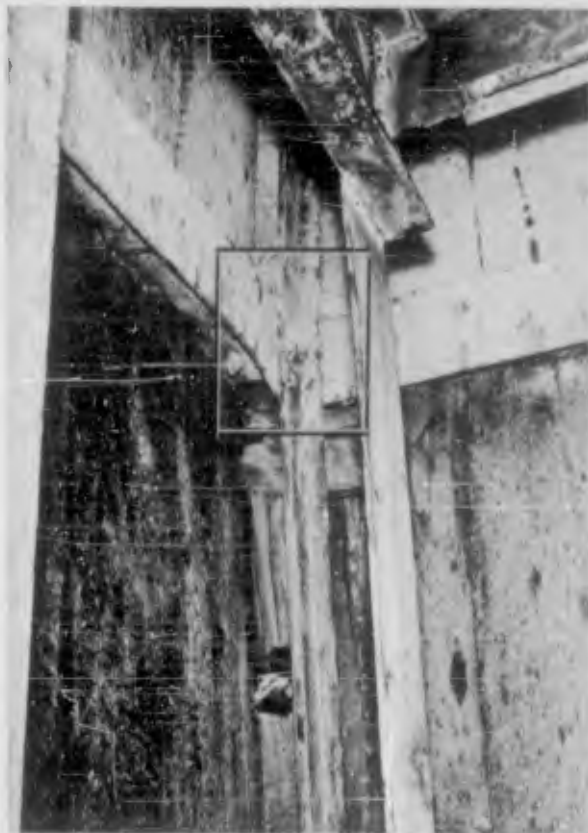
Figure 3.2 Shaft Sta
3+75, SE corner of
bearing set. (H&N-
AEC 62-1241-3, 1962).

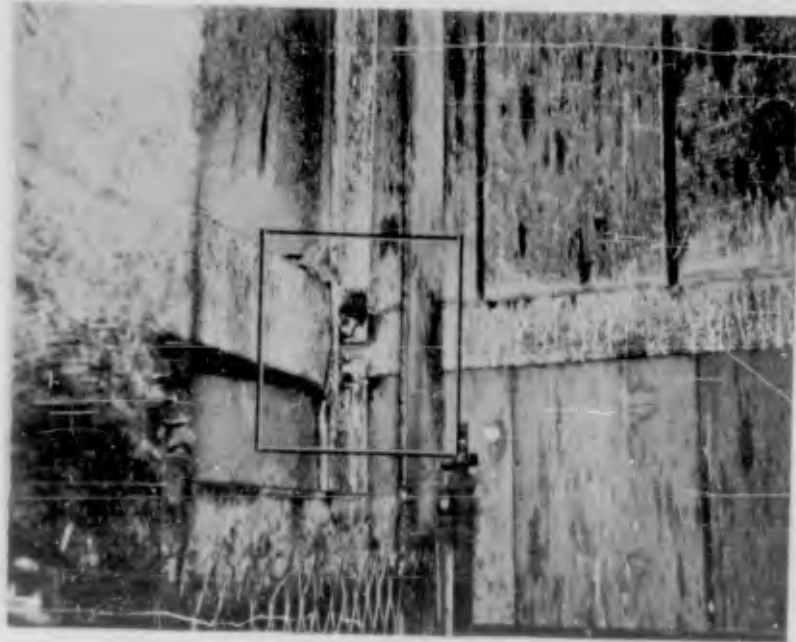
Figure 3.3 Shaft Sta 1+35, NW corner of elevator compartment. Note deformation of WF set and hanger angles. (H&N-AEC 62-1241-6, 1962).

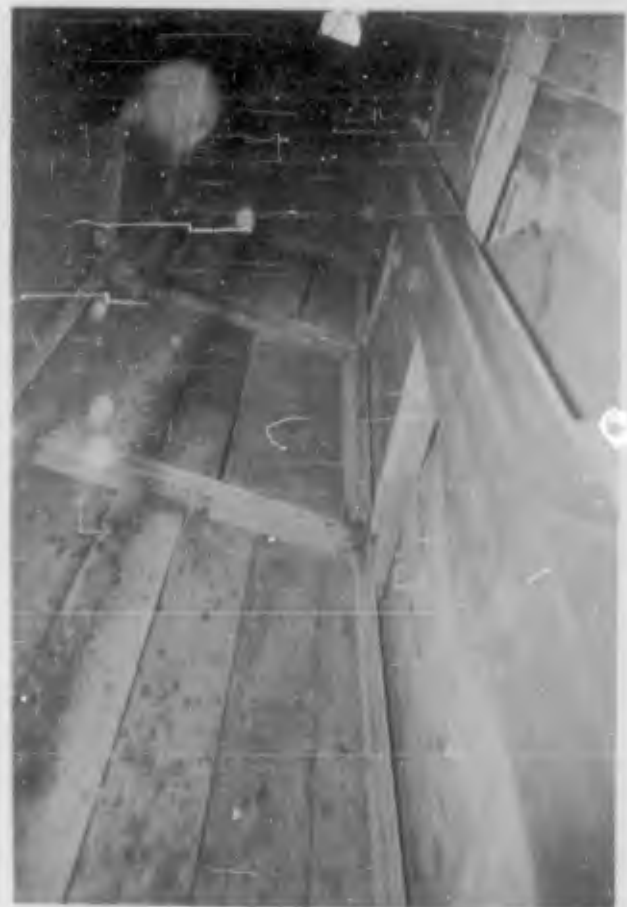
Several sets were displaced horizontally, resulting in misalignment of the shaft as shown in Figure 3.4. Differential vertical motions between sets caused tension in the hanger angles. As a result, many of the hanger angles sheared the bolts at points of connection to bearing sets. Because of the resulting postshot misalignment between the bolt holes in the sets and in the hanger angles, it was necessary to weld the hanger angles to the sets, as can be seen in Figures 3.5 and 3.6.

Figure 3.4 View looking up from Sta 1+48 in shaft. Note displacement of sets (DASA - NOU 150-02 NTS-62).

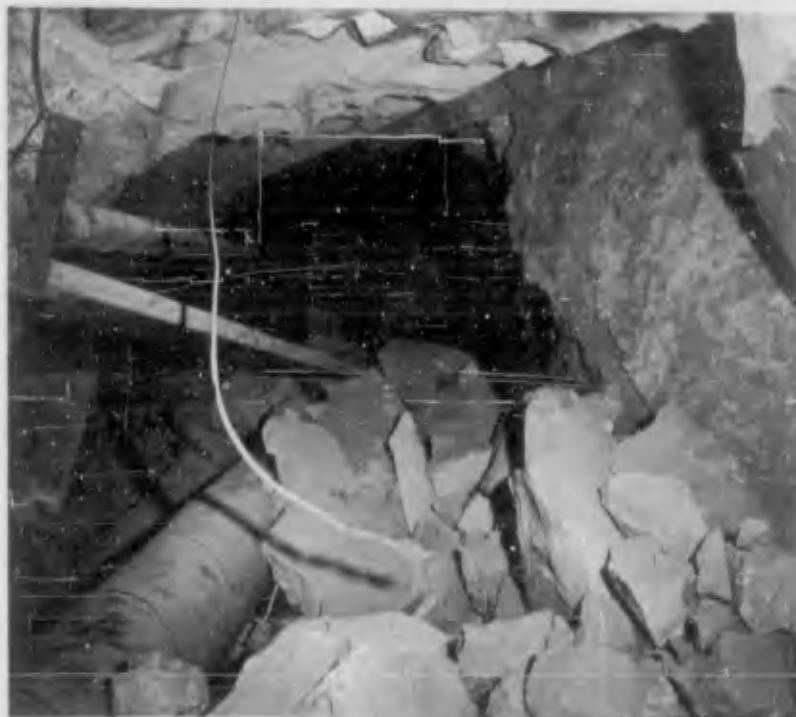
Generally, the broken rock was found to be more finely crushed as the re-entry advanced to the north, as seen by comparing the average size of material in Figure 3.9 with that in succeeding photographs. The exceptions to this observation occurred at the intersections of the access tunnel with B and C

Figure 3.9 Rock fall, Sta 2+60, approximately 545 feet from zero point, looking south (DASA - NOU 167-04 NTS-62).

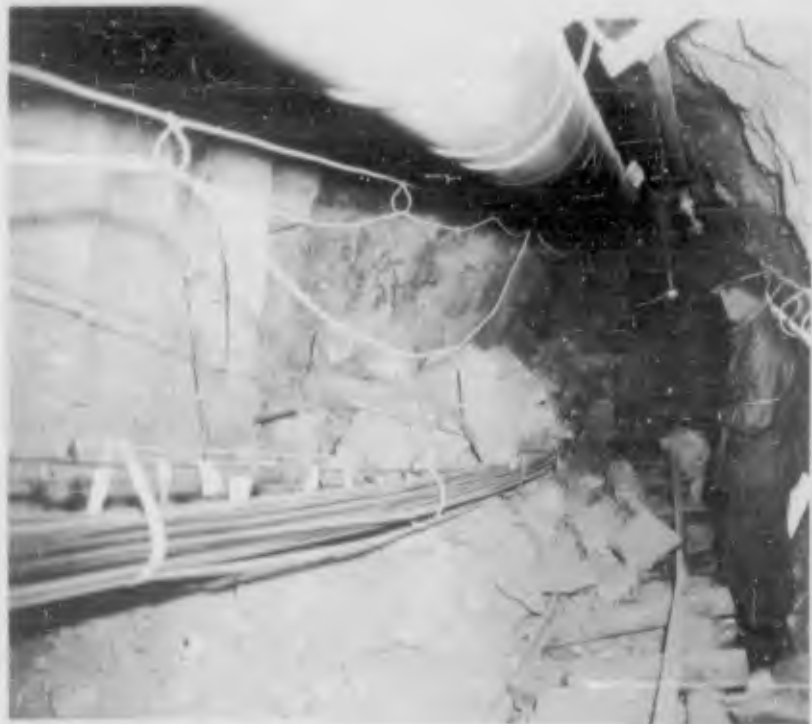
Drifts. At these intersections large slabs were encountered along with finer material. Figures 3.10 through 3.23 are comparative photographs (pre- and postshot) illustrating the damage at various points in the access tunnel. It should be noted that the apparent changes of rock color between some of the pre- and postshot photographs are due to differences in photographic techniques followed. The rock did not change in appearance as a result of the detonation.

Figure 3.11 Access tunnel from Sta 2+10, approximately 595 feet from zero point, looking north (post-shot) (DASA - NOU 160-02 NTS-62).

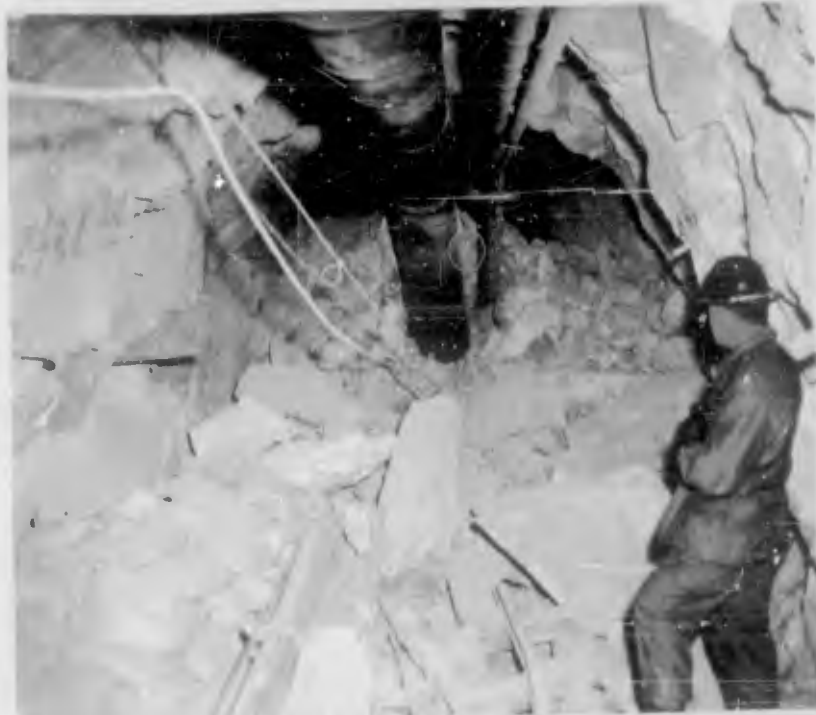
Figure 3.13 Access tunnel from Sta 2+30, approximately 575 feet from zero point, view to north (post-shot) (DASA - NOU 160-01 NTS-62).

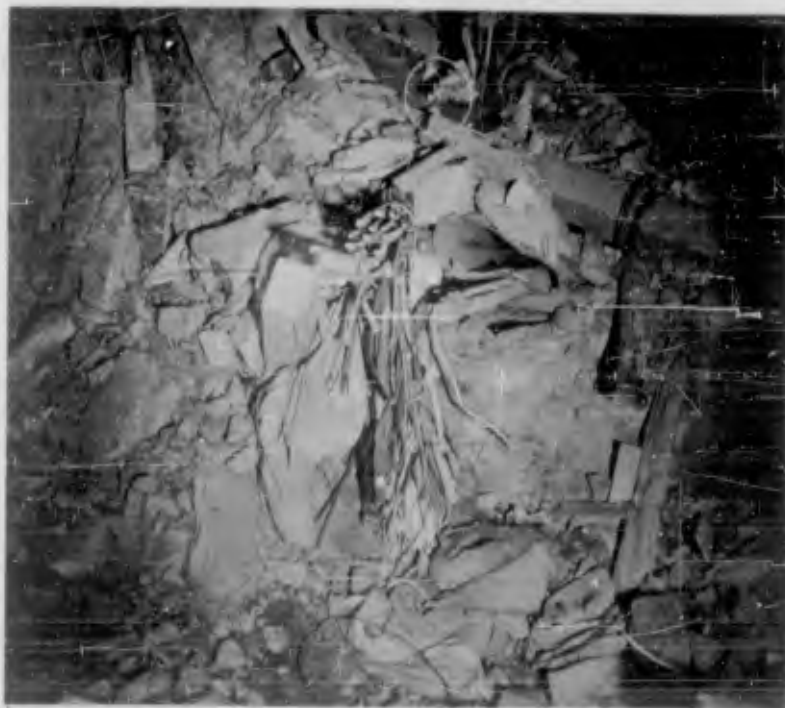
Figure 3.15 Access tunnel from Sta 2+90, approximately 515 feet from zero point, view to north (post-shot) (DASA - NOU 179-04 NTS-62).

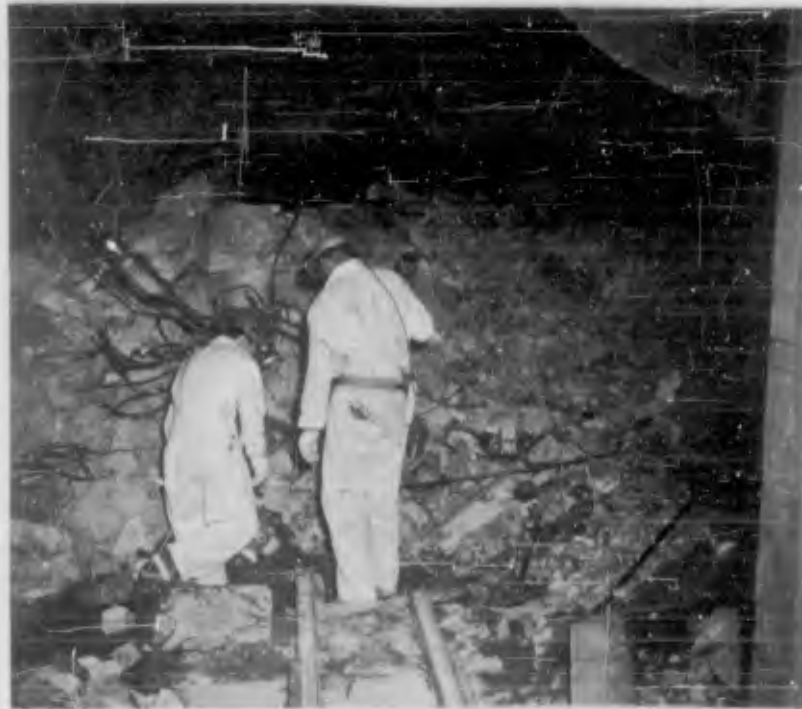
Figure 3.17 Access tunnel from Sta 3+50, approximately 460 feet from zero point, view to north (post-shot) (DASA - NOU 206-01 NTS-62)

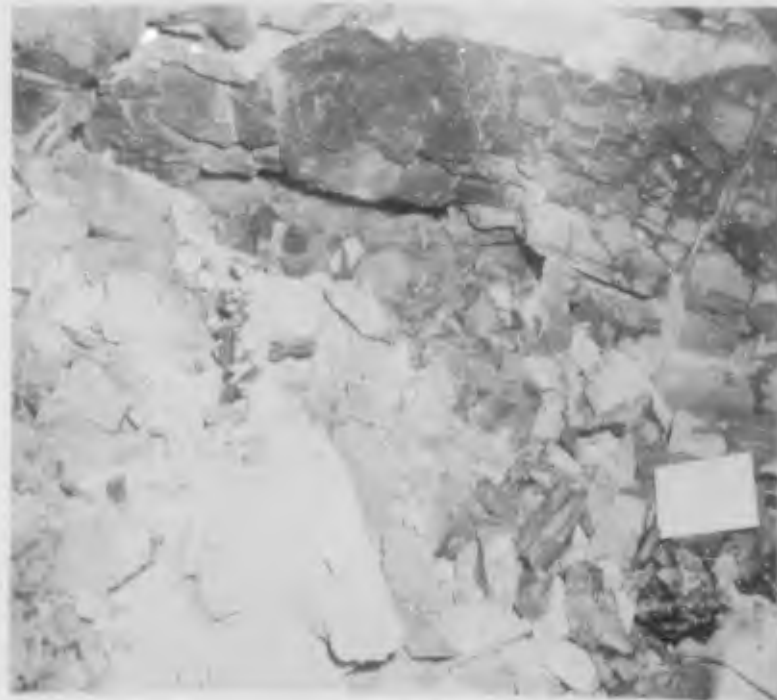
Figure 3.19 Access tunnel from Sta 4+00, approximately 410 feet from zero point, view to north (post-shot) (DASA - NOU 208-05 NTS-62).

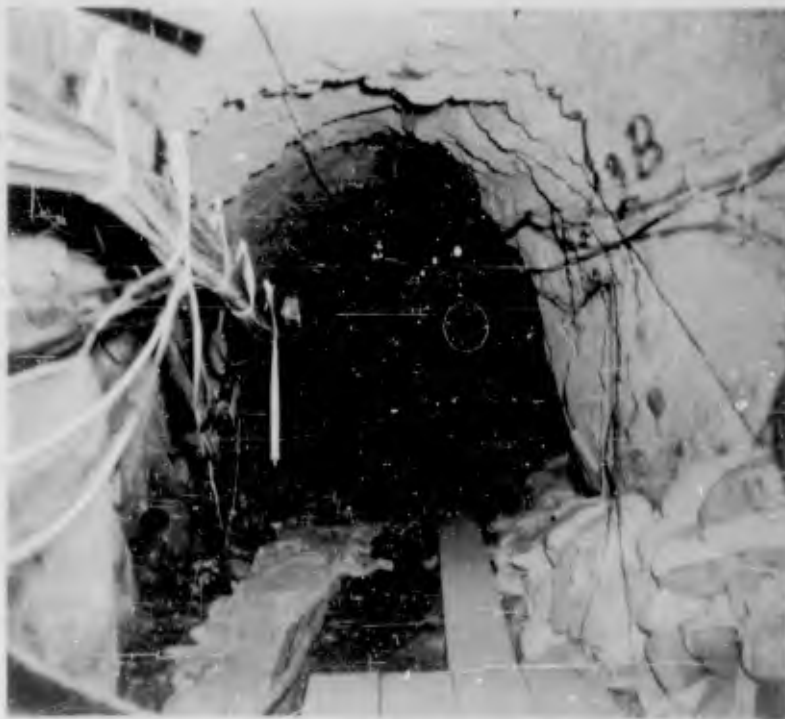
Figure 3.21 Access tunnel from Sta 4+85, approximately 325 feet from zero point, view to north (post-shot). Note crushed timber sets (DASA - NOU 365-05 NTS-62).

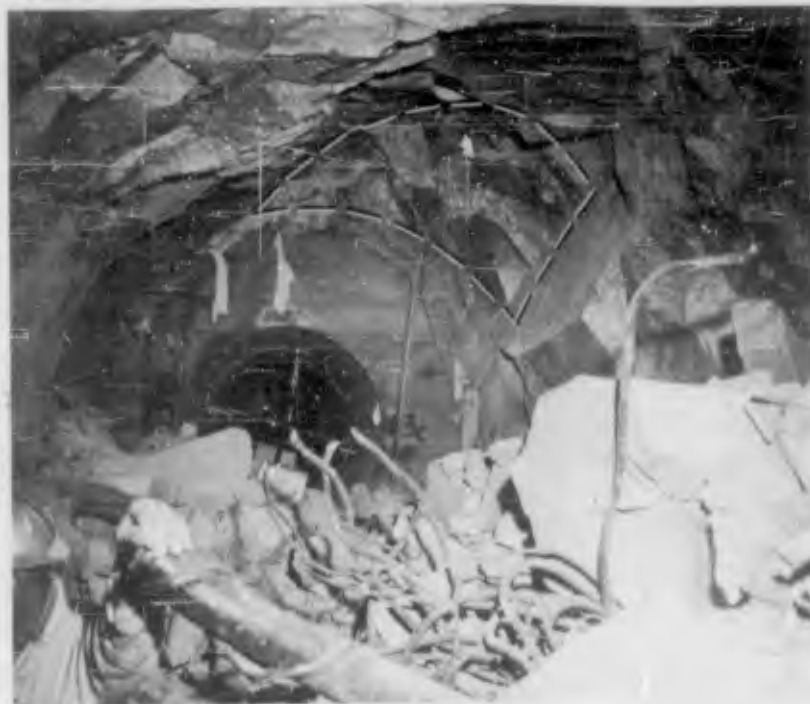
When the bulkheads were removed, the crack pattern at the ends was found to be similar to C3c, shown in Figure 3.24.

Figure 3.24 Test Section C3c (postshot) (DASA - NOU 339-09 NTS-62).

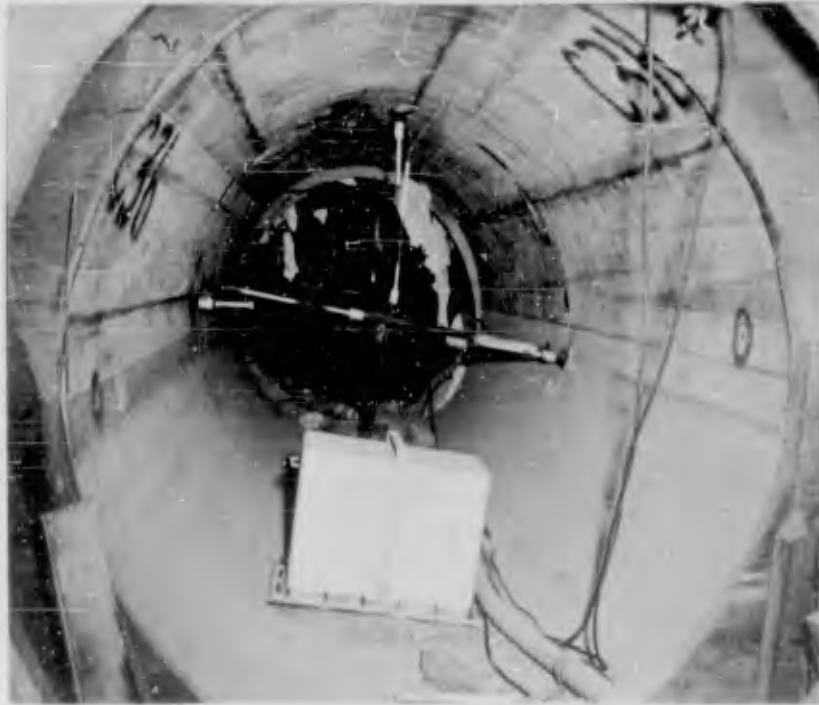
Figure 3.26 C3c, inside surface crack patterns

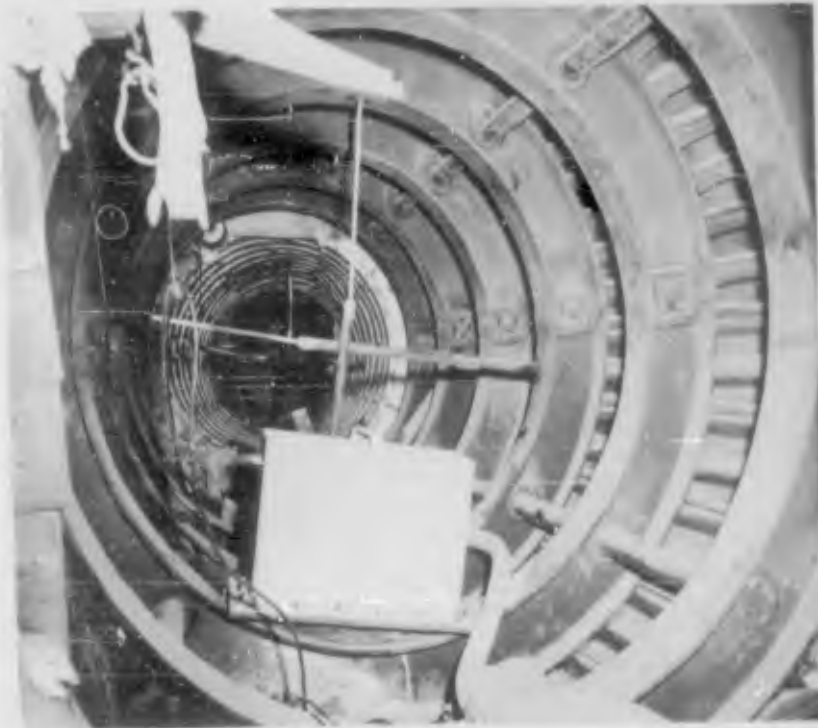
Figure 3.30 Close-up C4a. Note distorted steel decking (DASA - NOU 227-10 NTS-62).

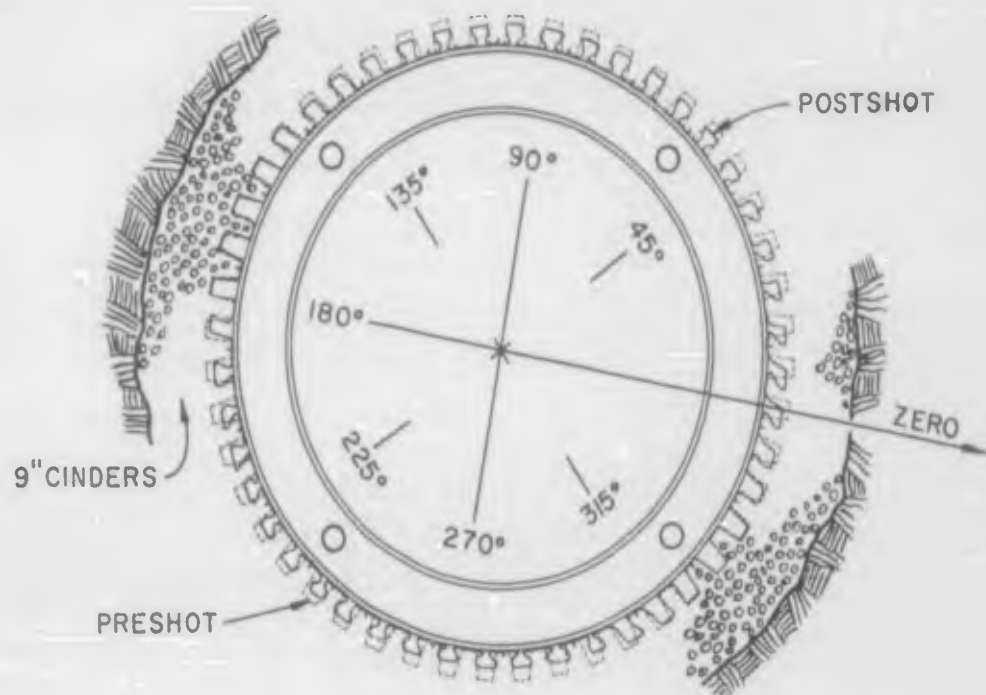
Figure 3.32 C4a, typical liner deformations at midspan between wide-flange rings.

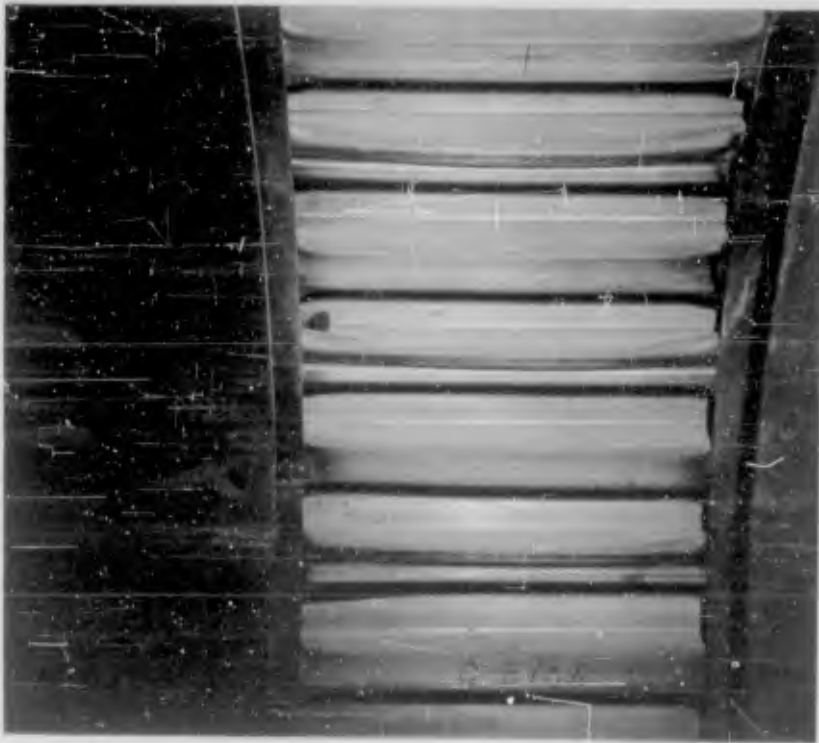
Figure 3.33 C4a, typical liner deformations at wide-flange rings.

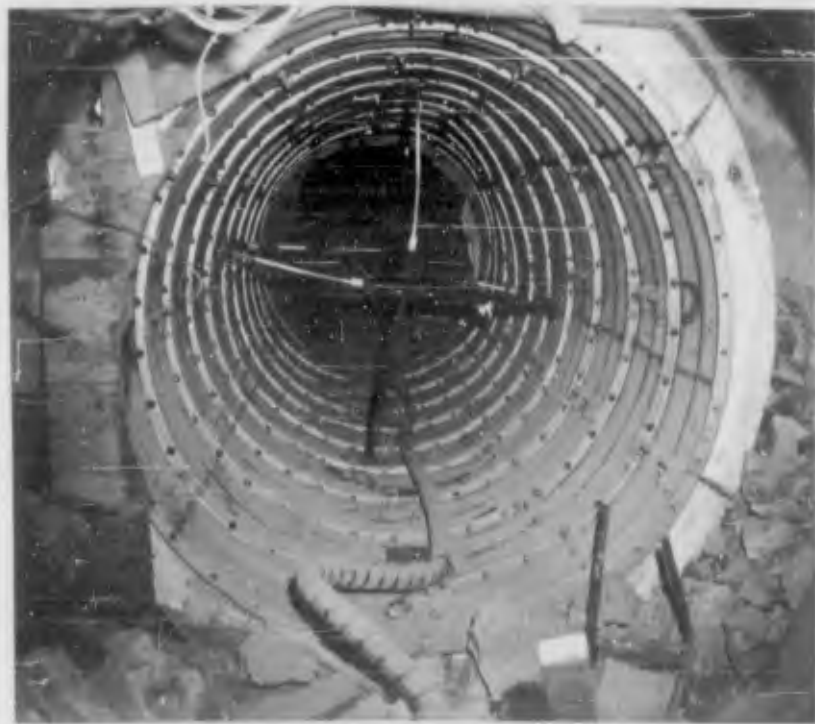
Figure 3.34 Close-up C4b. Note distorted steel decking (DASA - NOU 228-01 NTS-62).

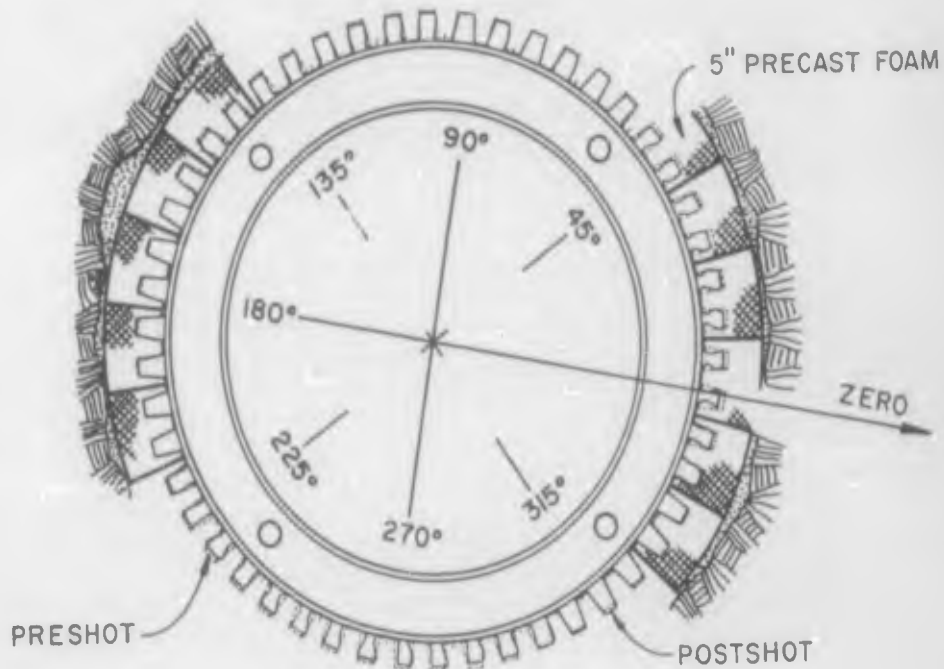
Figure 3.36 C4b, typical liner deformations at midspan between wide-flange rings.

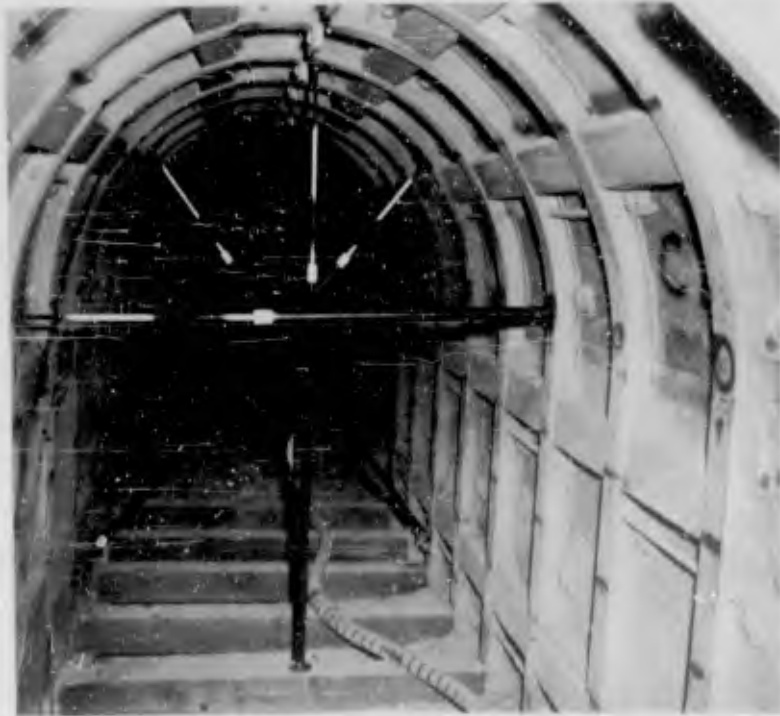
Figure 3.37 C4b, typical liner deformations at wide-flange rings.

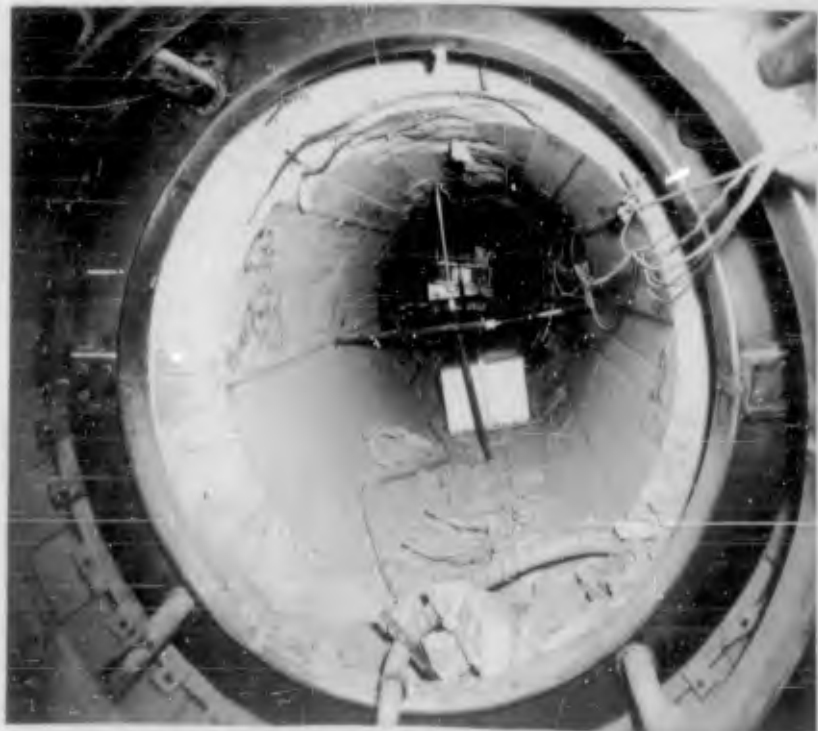
Backpacking. Figure 3.47 illustrates the postshot condition of C4c. The steel wide-flange set suffered no visible distortion. The three-inch-thick wood lagging exhibited minor cracks at several locations. The cracks were concentrated between 30° to 60° and 180° to 225° .

The diameter-change scratch gage at 0° to 180° appeared straight. However, the scratch gage spanning 90° to 270° broke off at both ends. This gage was found in the position shown in Figure 3.47.

Figure 3.47 Test Section C4c (postshot) (DASA -
NOU 228-08 NTS-62).

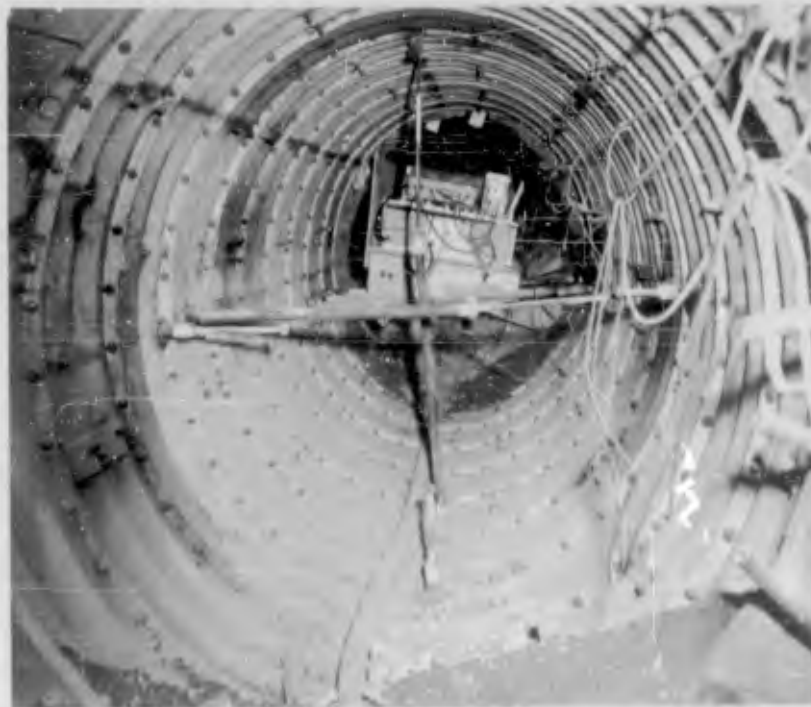
Figure 3.49 illustrates the crack and breakage pattern on the inside surface of the liner.

Figure 3.49 C3a, inside surface crack patterns.

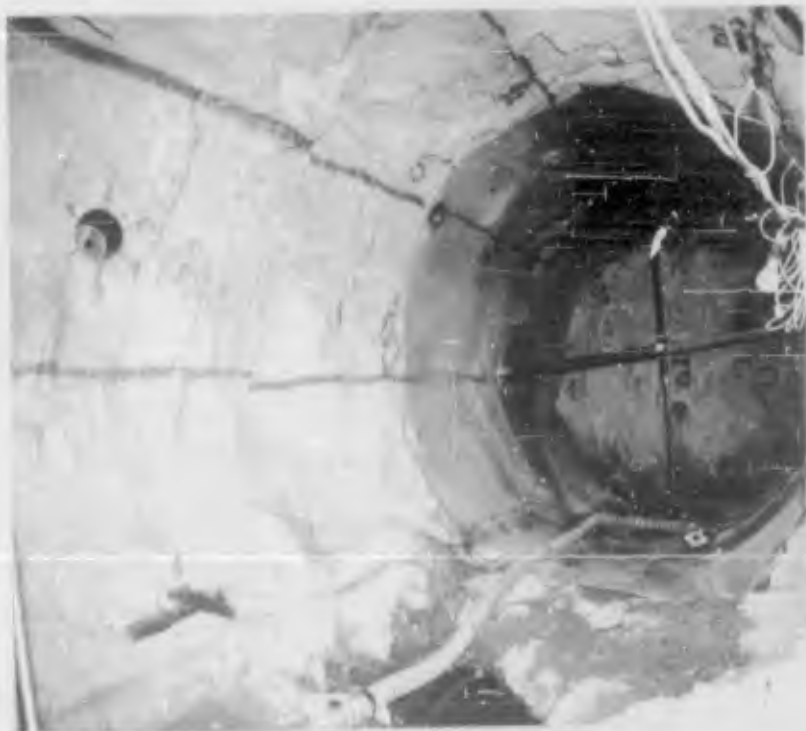
Figure 3.50 Test Section C6c (postshot) (DASA - NOU 228-03 NTS-62).

With Nine-Inch Cinder Backpacking. Figure 3.50

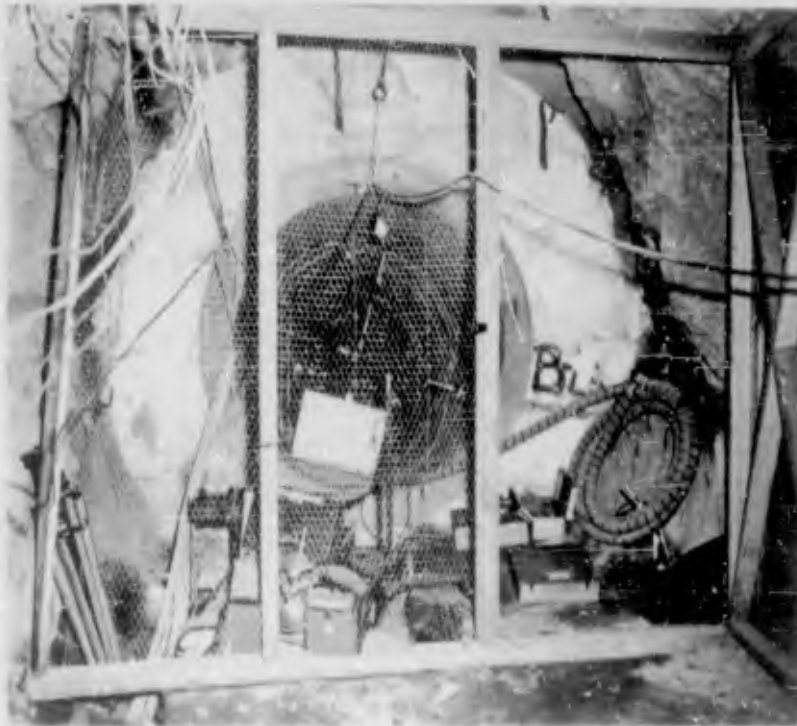
Figure 3.54 Re-entry bypass drift (B Drift right).

Because of the extensive damage to B5a and B6a, the first two test sections in B Drift, right, it was necessary to bypass these two liners by means of a new drift. The bypass drift was ultimately extended to intersect the gap between B3a and B5c, as shown in Figure 3.54.

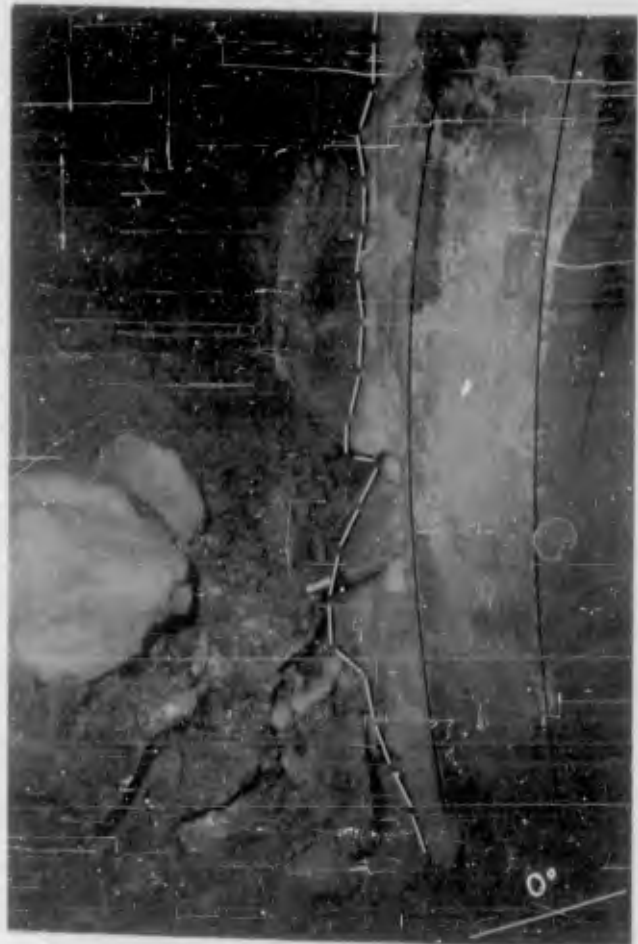
Figure 3.57, a view looking into the test section, shows the postshot interior condition. Both diameter-change scratch gages were broken. The debris covering the floor consisted of broken rock from both ends of B3c, as well as broken concrete and pieces of foam from the next test section, B3b.

Figure 3.57 Interior B3c (postshot). (DASA - NOU 237-09 NTS-62)

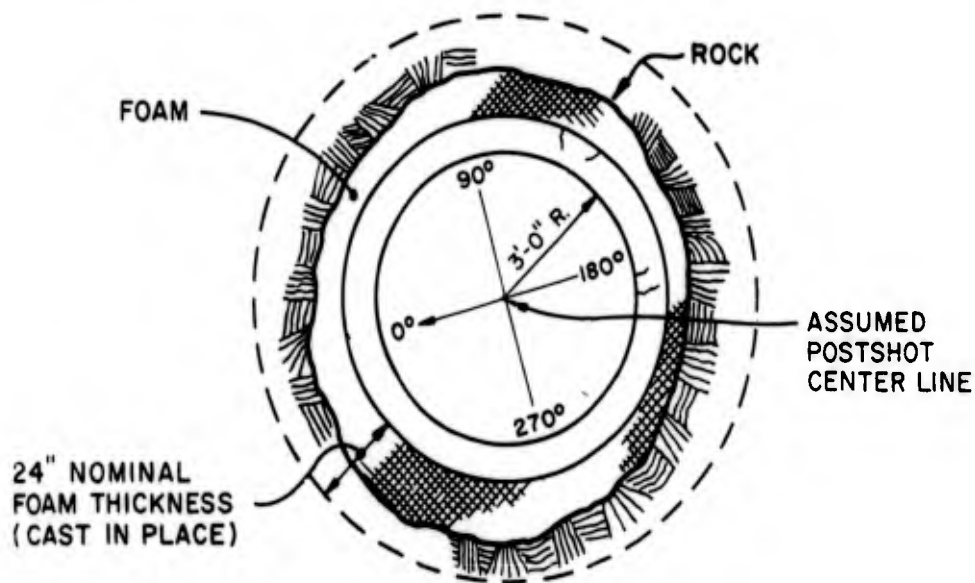
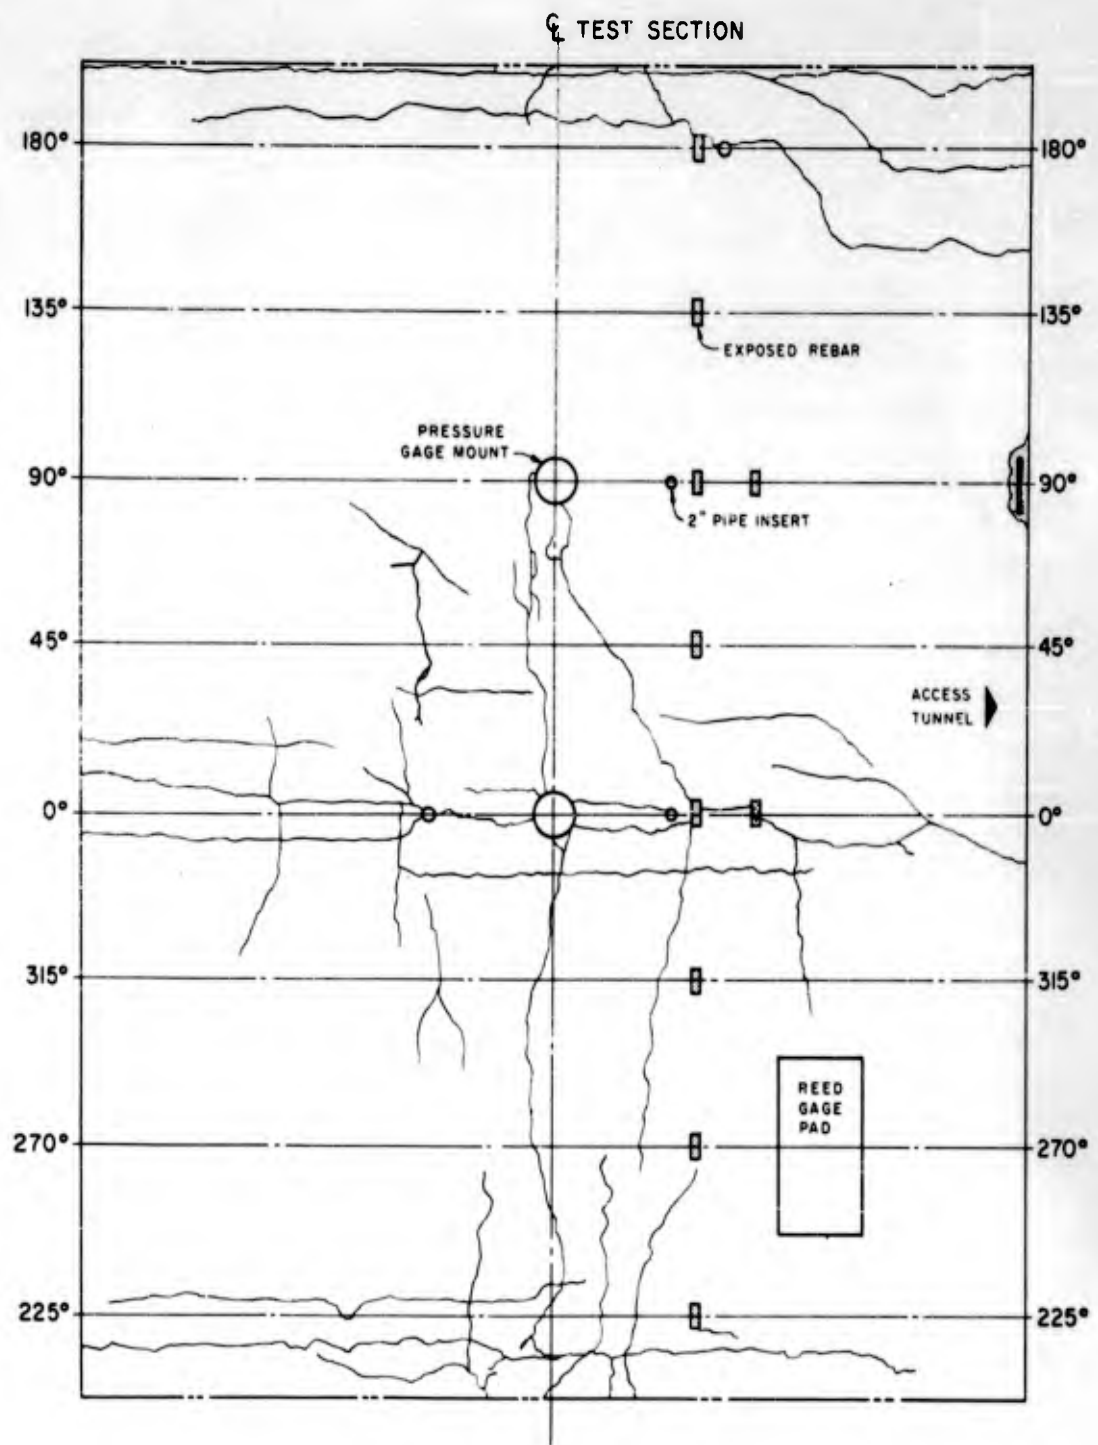
Figure 3.59 B3c, foam outline at ends of test section.

Figure 3.59 illustrates the cracks found at the ends of the concrete liner and the compression of the foam. The crack pattern on the inside concrete surface is illustrated by Figure 3.60. The majority of the longitudinal cracks were near the 0° or 180° points.

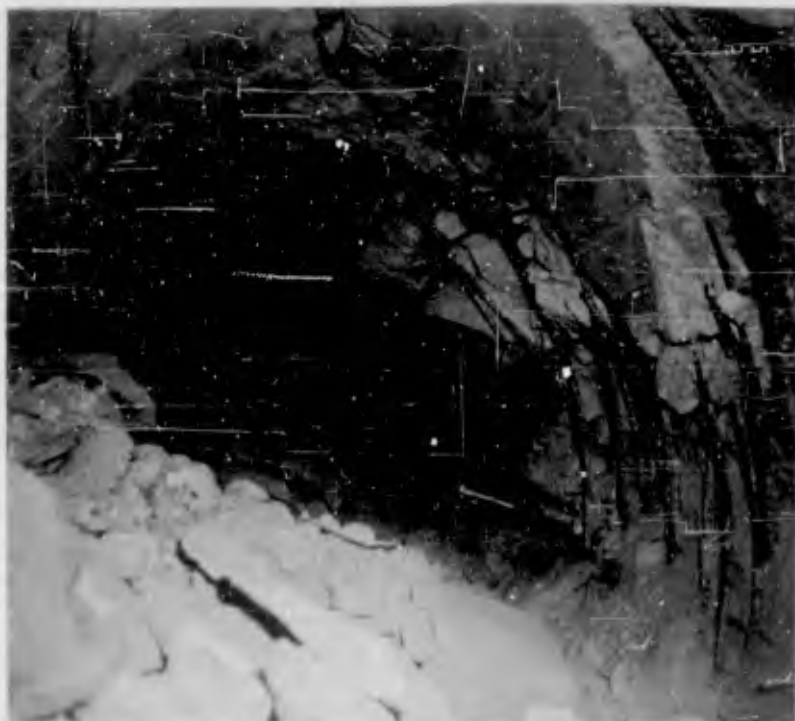
Figure 3.60 B3c, inside surface crack patterns.

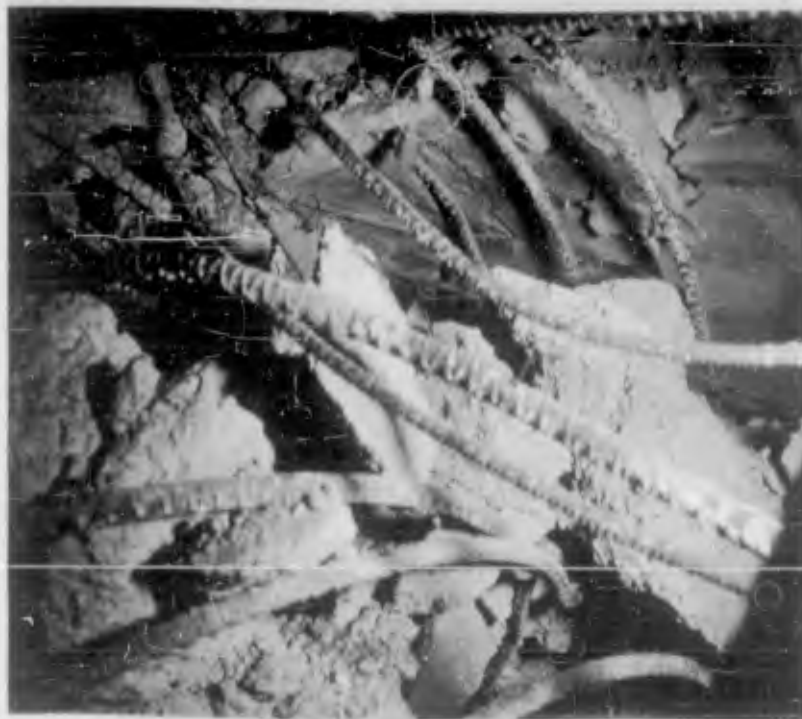
Backpacking. A pre-shot view of this test section was previously shown in Figure 2.52. The postshot condition is shown in Figure 3.61. The concrete liner suffered heavy damage and was completely closed at the far (west) end. The reinforcing bars were exposed in many areas by crushing of the concrete. The heaviest damage occurred between 0° and 90° , exposing both layers of reinforcing steel. In some places, the reinforcing bars at 0° had broken loose and had been propelled across the liner. Severe buckling of reinforcing bars can be seen at 90° and at 225° . The foam backpacking was exposed over a large area of the far end of the liner, as shown in Figure 3.62. Note that the foam was essentially in place with only a few pieces broken away.

Both diameter-change scratch gages were heavily damaged. The STL reed gage canister at the far end of the liner was broken free from the concrete. The one at the near (east) end is shown in Figure 3.61.

Figure 3.61 Test Section B3b (postshot) (DASA - NOU 237-11 NTS-62).

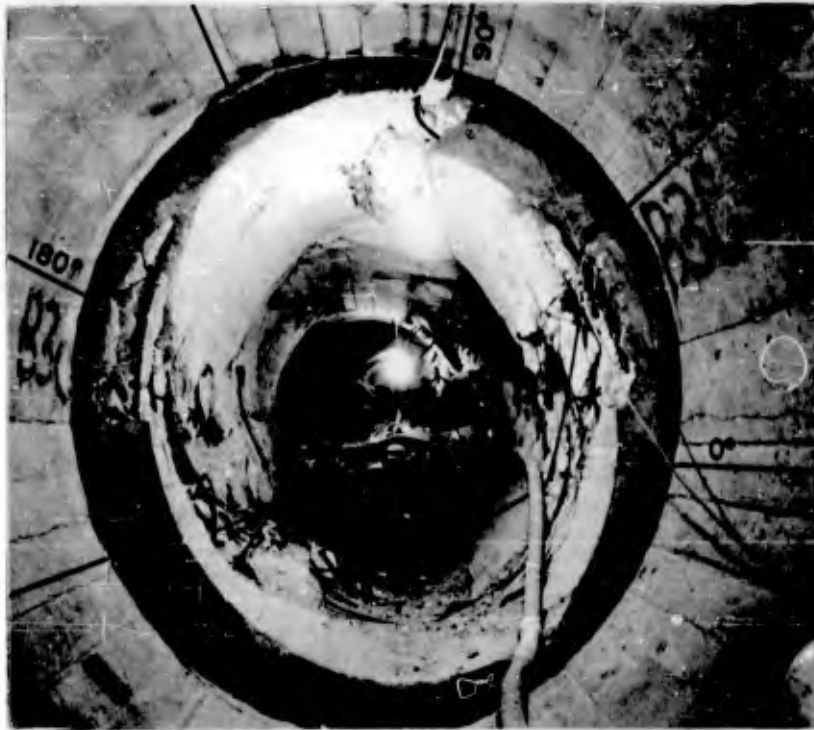
Figure 3.62 Close-up, west half B3b at 45° (post-shot). Note exposed polyurethane foam behind reinforcing bars (DASA - NOU 237-12 NTS-62)

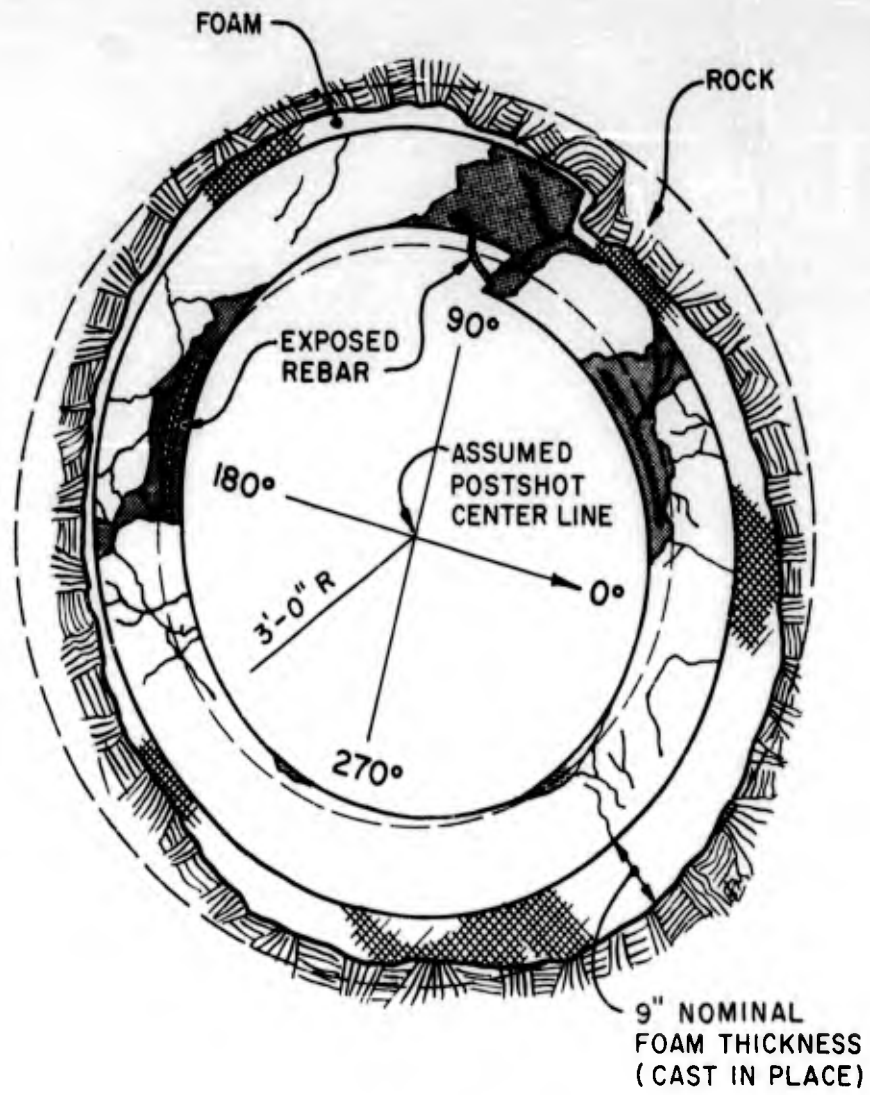
Figure 3.64 B3b, foam outline at east end of test section.

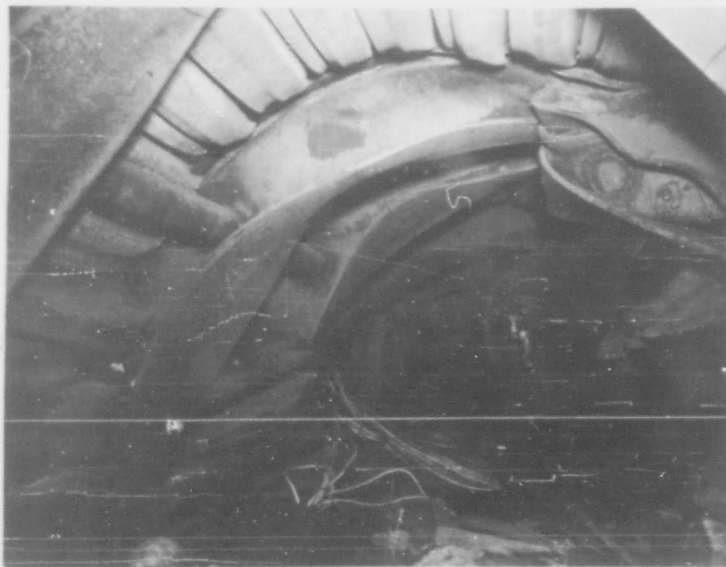
Figure 3.66 Test Section B4a (postshot) (DASA - NOU 323-07 NTS-62).

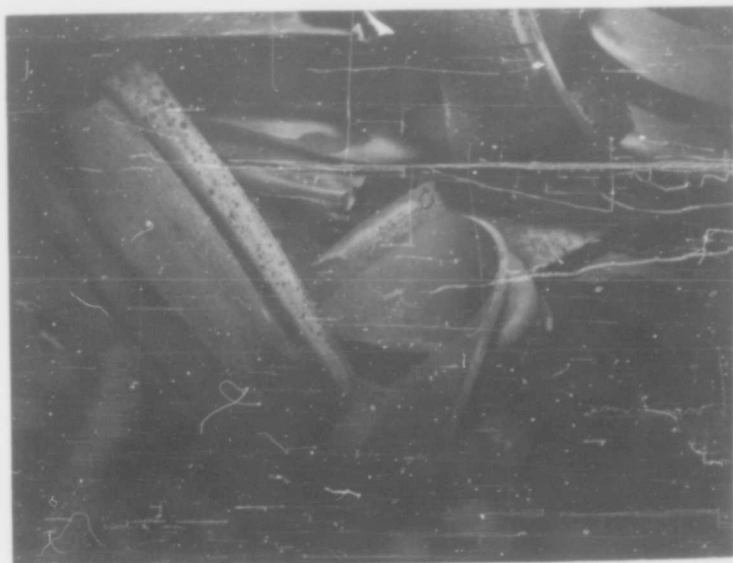
Figure 3.67 Close-up view B4a at 0° (postshot).
Note buckling of wide flange ring (DASA - NOU 323-06 NTS-62).

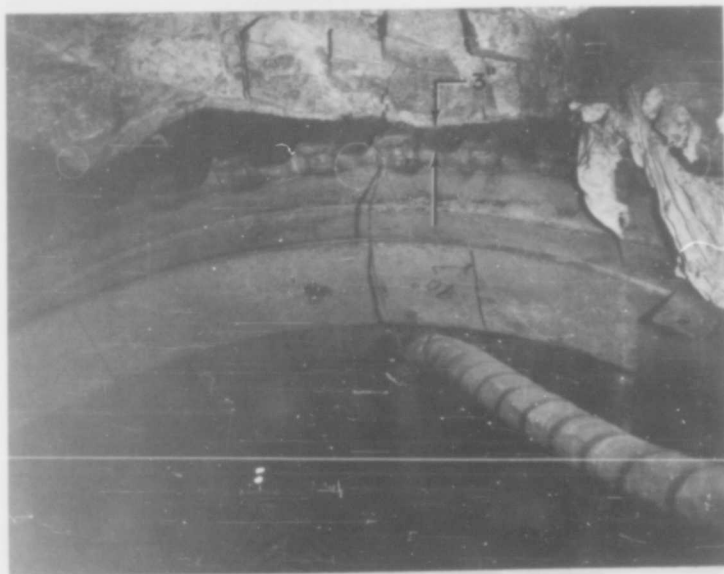
Figure 3.68 East end B4a at 90° (postshot). Note
compressed cinders and crushed steel decking
(DASA - NOU 316-10 NTS-62).
