The objectives were to obtain information on the mechanics of tunnel damage and on the loading and response of various tunnel liners. The ultimate use of such information will be the development of improved design procedures for underground protective construction in rock.

Generally, the results indicated that the measured values of the various shock parameters were within the preshot estimates. The damage at the closest and farthest test drifts was about as expected; however, the damage at the intermediate-range drift was somewhat greater than expected. Data recovery and the results of the electronic and mechanical measurements

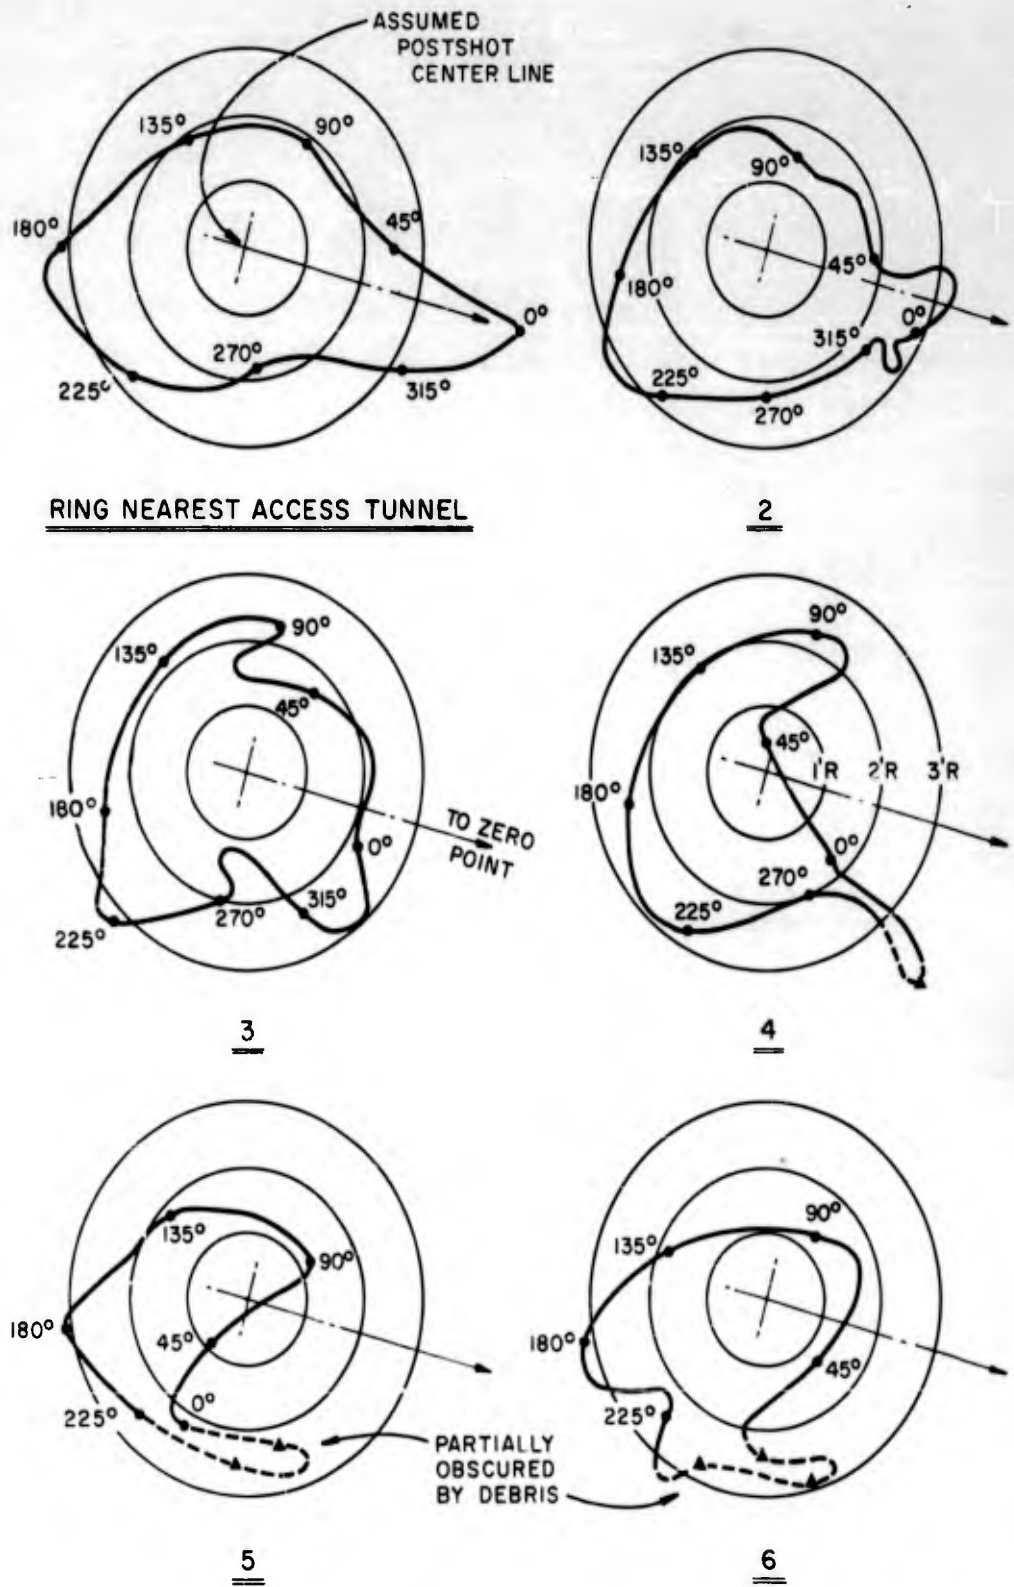
Figure 3.69 B4a, distorted shape of wide-flange rings (inside flanges only).

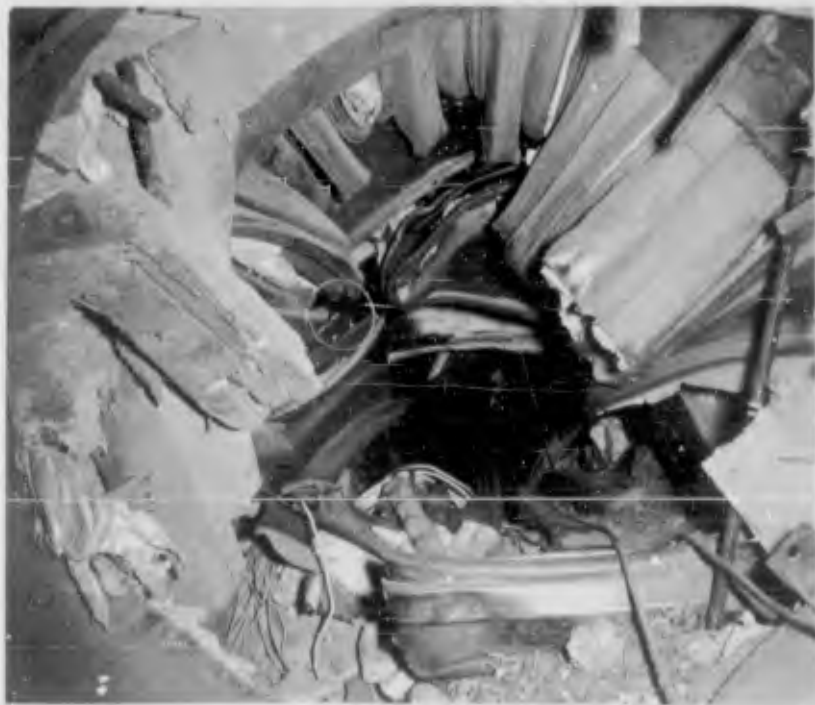
Figure 3.71 Test Section B4b (postshot) (DASA - NOU 390-06 NTS-62).

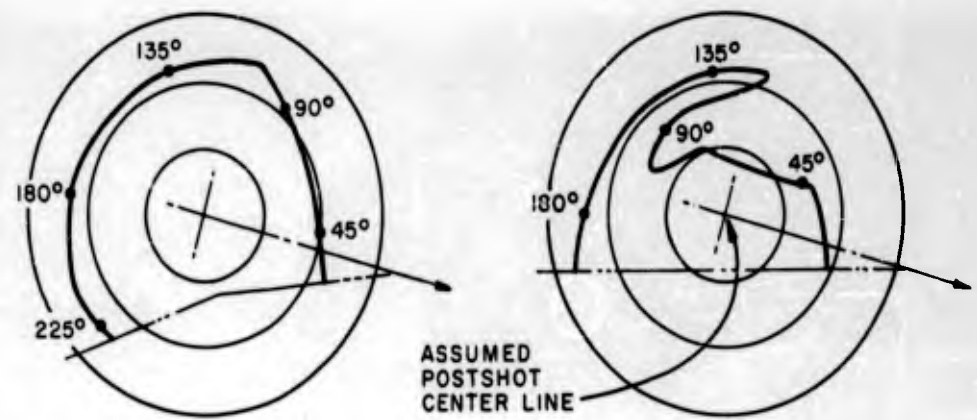
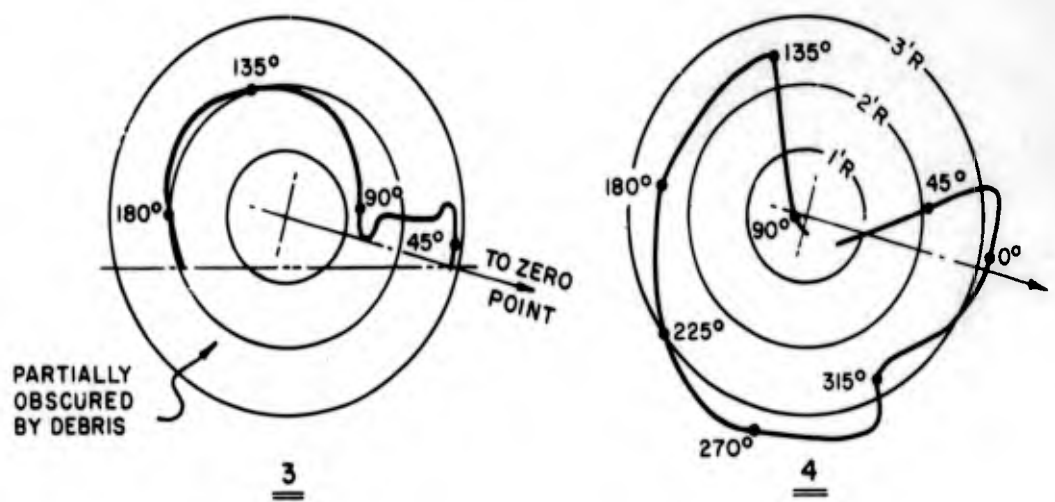
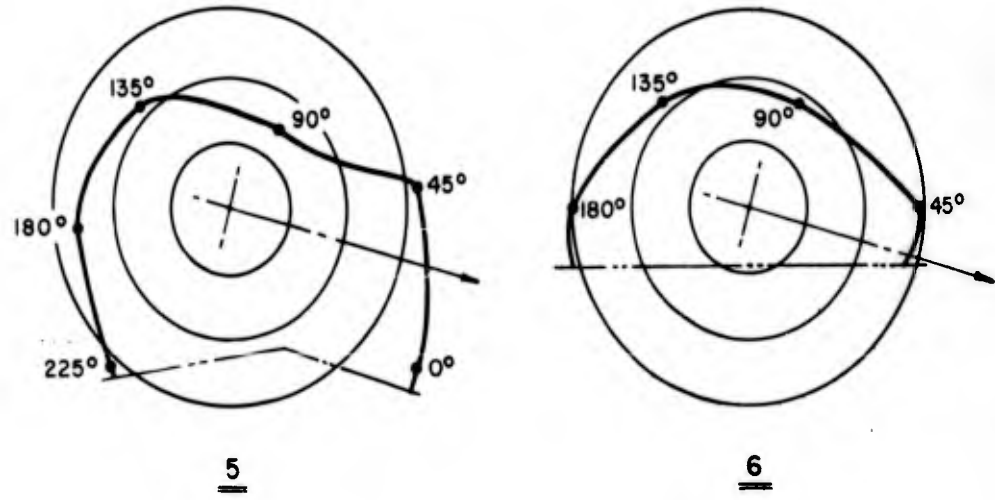
Figure 3.72 B4b, distorted shape of wide-flange rings (inside flanges only).

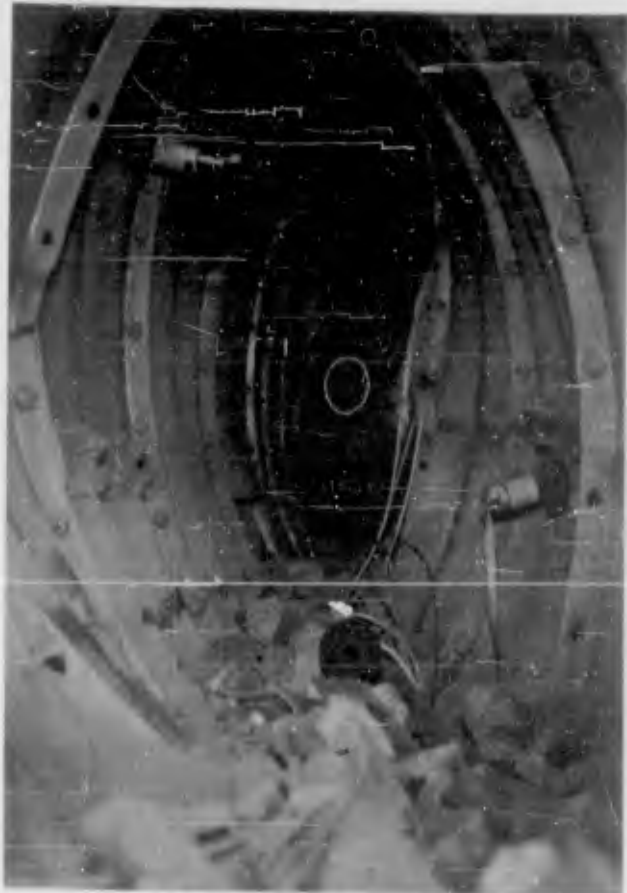
Figure 3.74 Test Section B5b (postshot) (DASA - NOU 332-06 NTS-62).

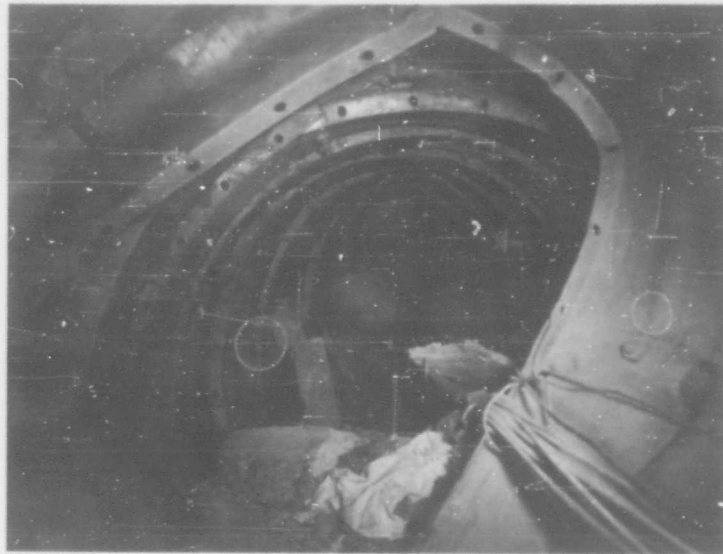
Figure 3.75 B5b from B6b (postshot). Note overlapped tunnel liner plates at the left (DASA - NOU 332-05 NTS-62).

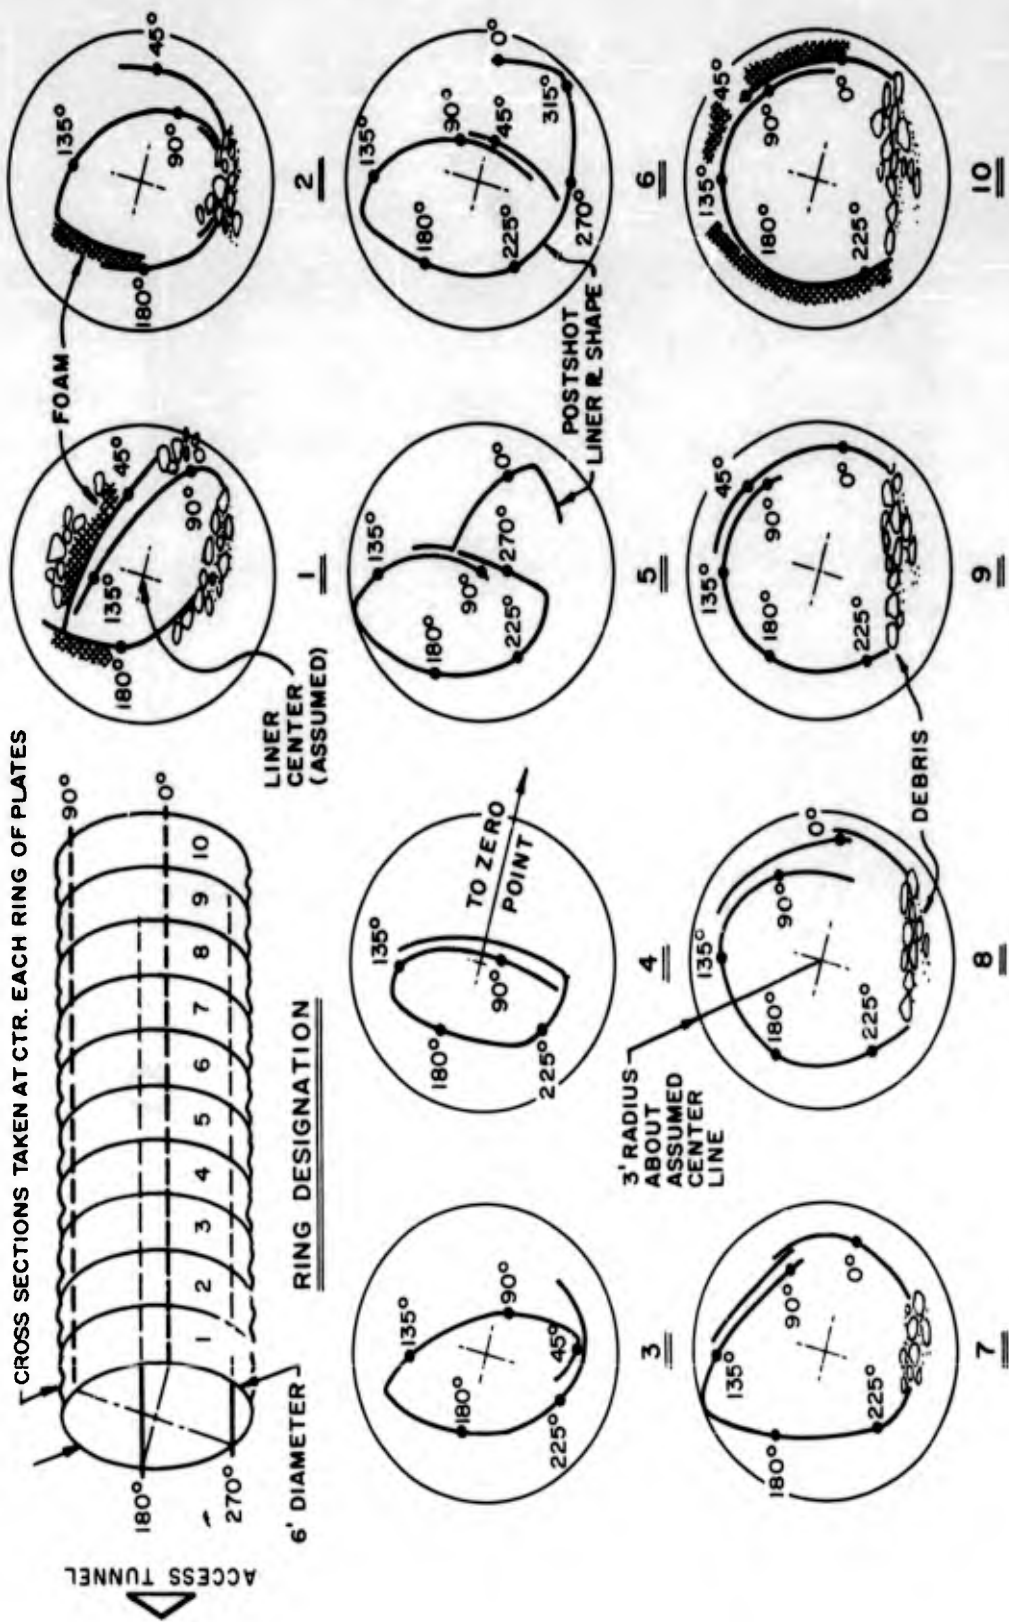
Figure 3.76 B5b, postshot condition of tunnel liner plates.

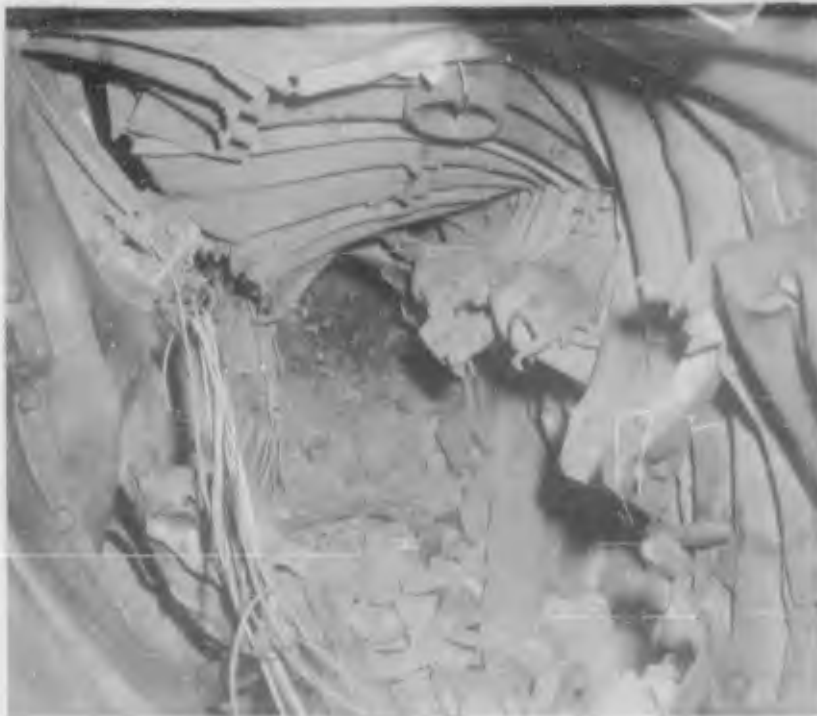
Figure 3.78 Close-up of interior of B6b during clean-up (postshot). Note failure of bolt holes in tunnel liner plates (DASA - NOU 482-02 NTS-62).

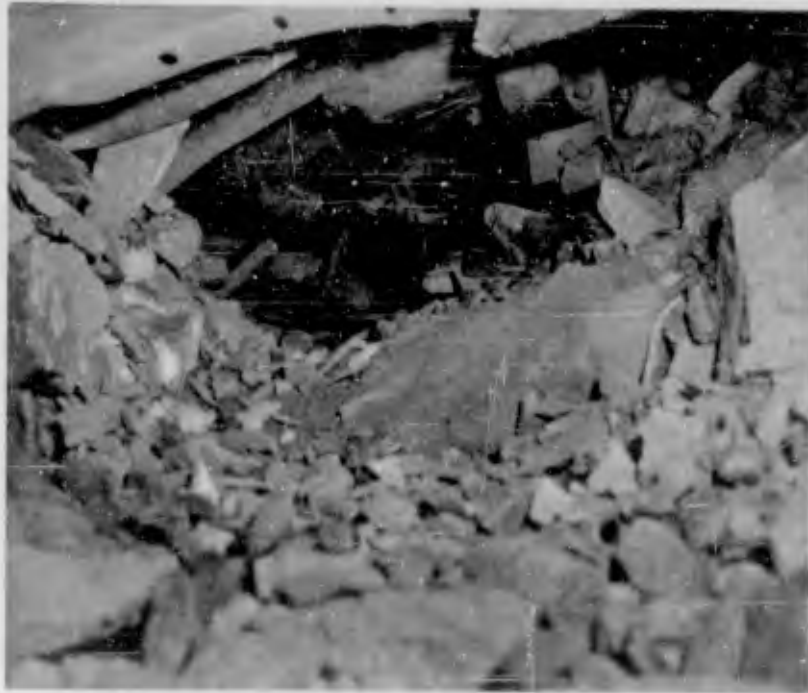
Figure 3.80 B7a as viewed from B6b (postshot)
(DASA - NOU 482-01 NTS-62).

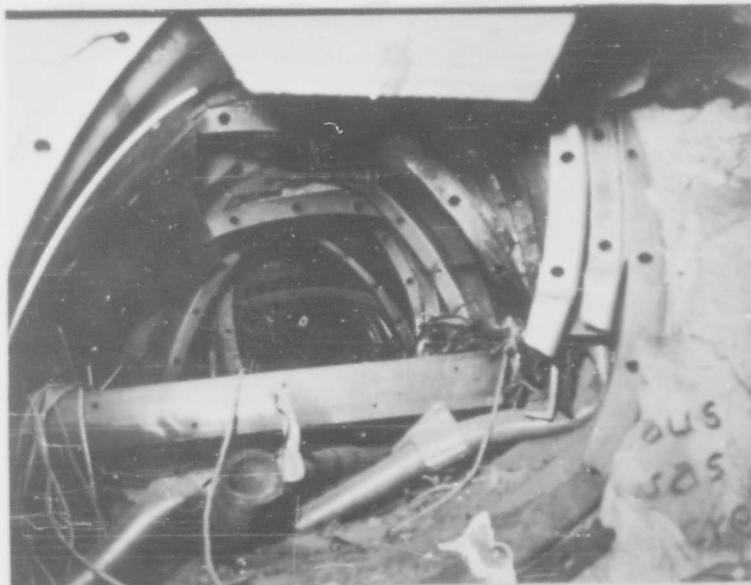
Figure 3.83 Test Section B5a (postshot). Damaged
stereo camera station has been removed (DASA -
NOU 316-07 NTS-62).

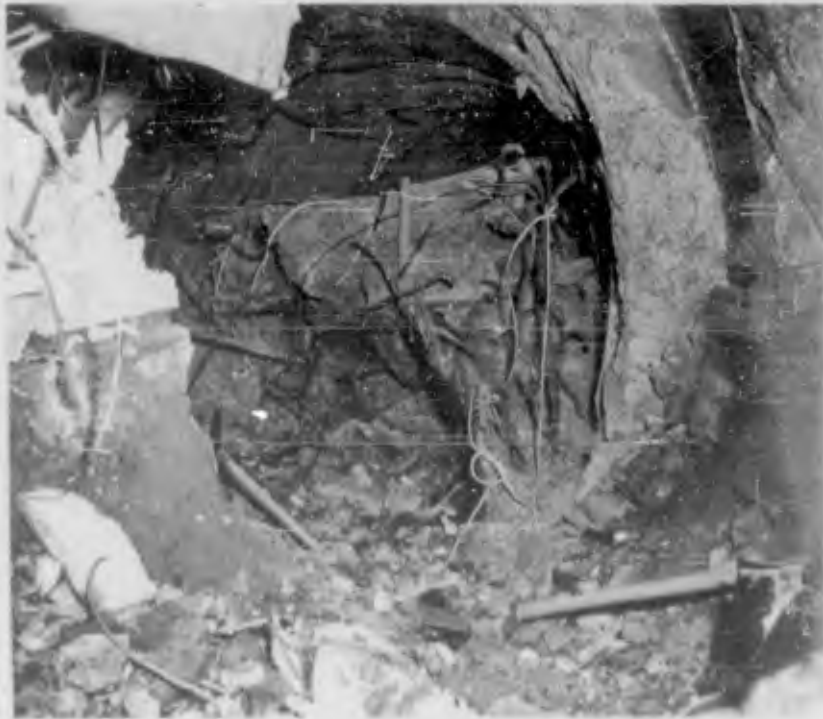
crete With Nine-Inch Cinder Backpacking. Figure 3.85 is a pre-shot photograph of this test section. The postshot view is shown in Figure 3.86. This picture was taken from the bypass drift excavated for re-entry purposes. The floor heaved and almost closed the liner opening. Less than two feet remained

Figure 3.86 West end B3d as viewed from bypass drift (postshot). Note floor heave (DASA - NOU 339-08 NTS-62).

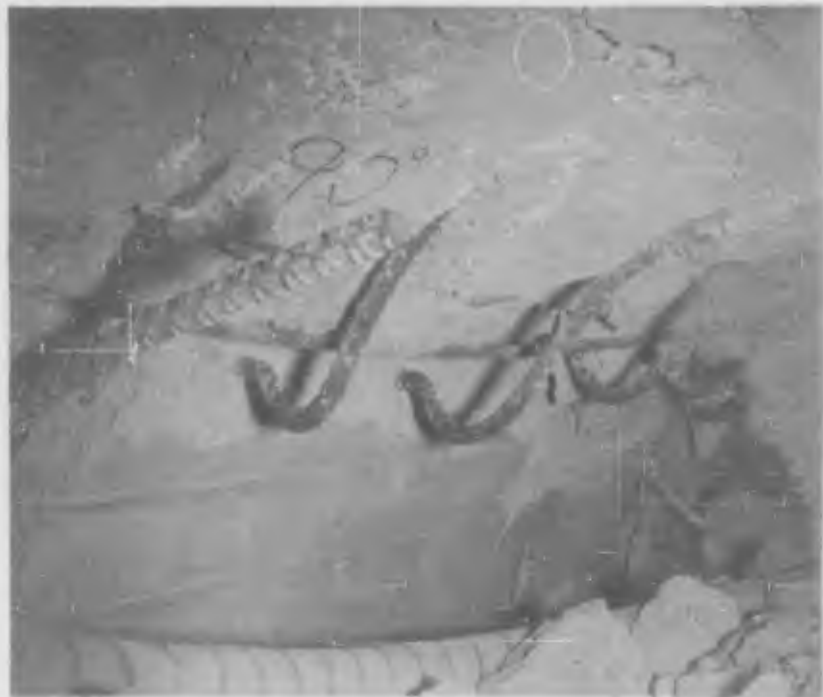
Figure 3.87 Close-up view B3d (postshot). Note buckled reinforcing bars at 90° (DASA - NOU 324-03 NTS-62).

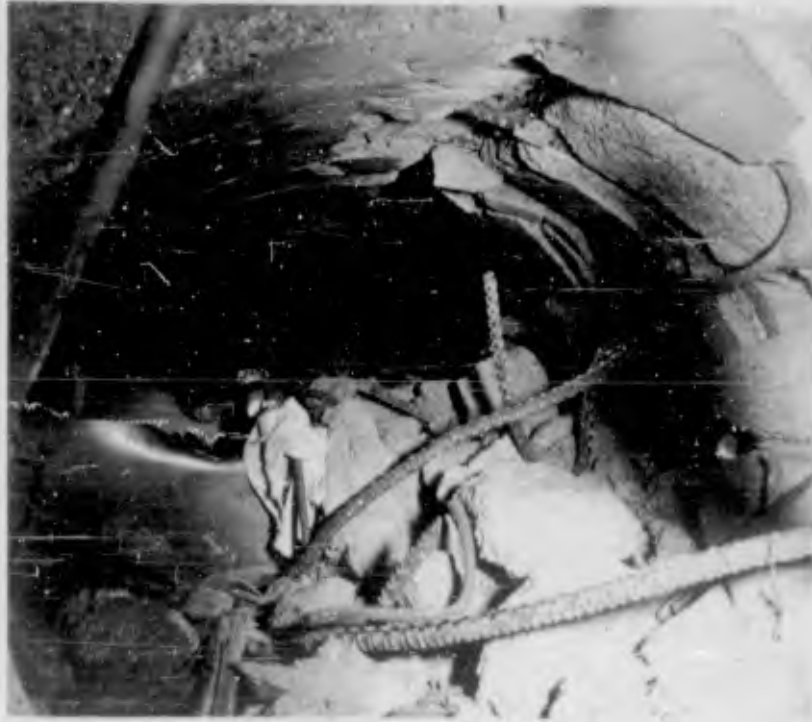
Figure 3.88 B3d as viewed from B4c (postshot)
(DASA - NOU 365-01 NTS-62)

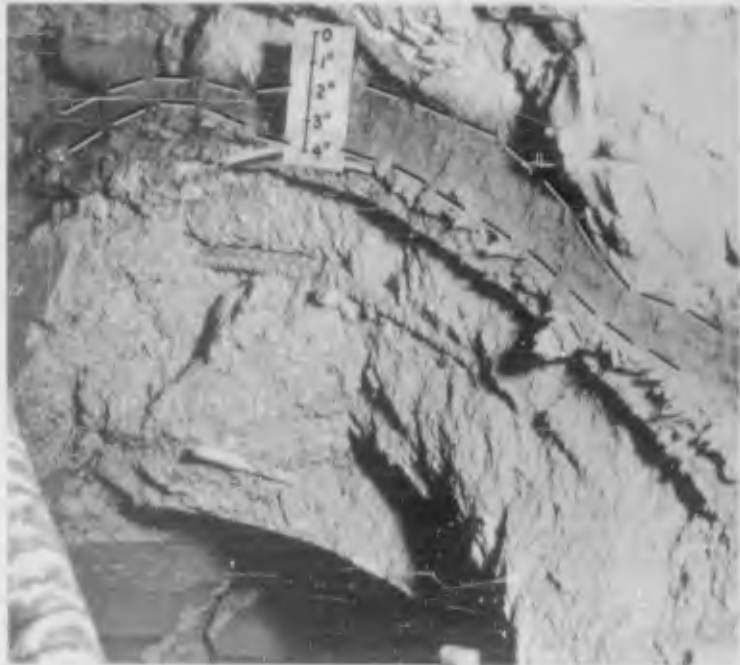
As can be seen in Figure 3.89, the cinder back-packing was compressed from an original nominal nine-inch thickness to approximately two to four inches. This crushing occurred over all the visible portions of the concrete liner.

Figure 3.89 West end B3d at 90° (postshot). Note
compression of cinders (DASA - NOU 324-04 NTS-
62).

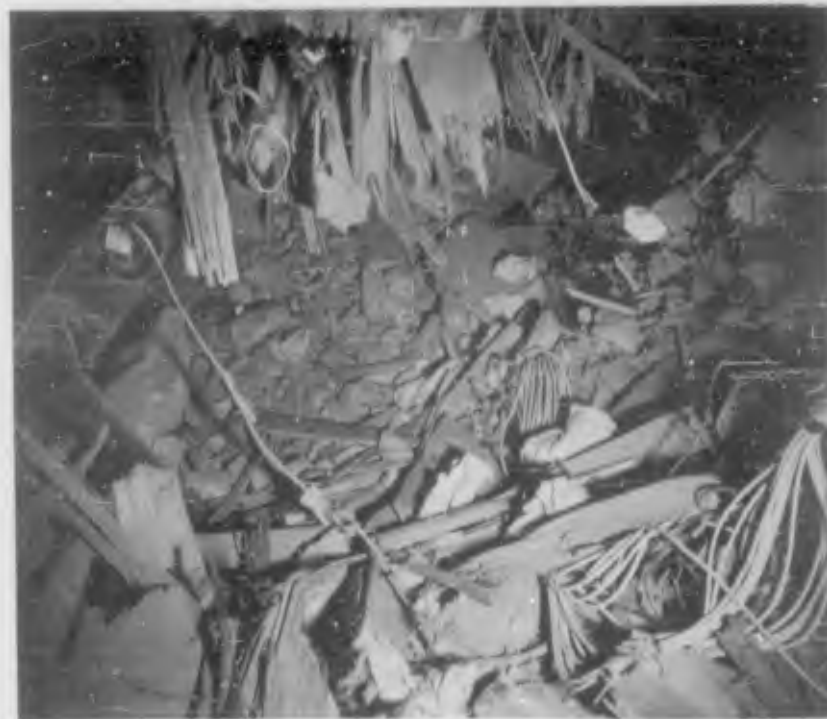
The timber lagging generally failed by flexure at mid-span between wide flange rings. The foam back-packing was not highly compressed. Most of the debris seen within the liner in Figure 3.91 was broken foam and wood. Most of the fly-rock was contained behind the lagging. Figure 3.93 is a view of the only significant rock breakthrough observed.

Figure 3.91 Test Section B4c (postshot) (DASA - NOU 365-03 NTS-62).

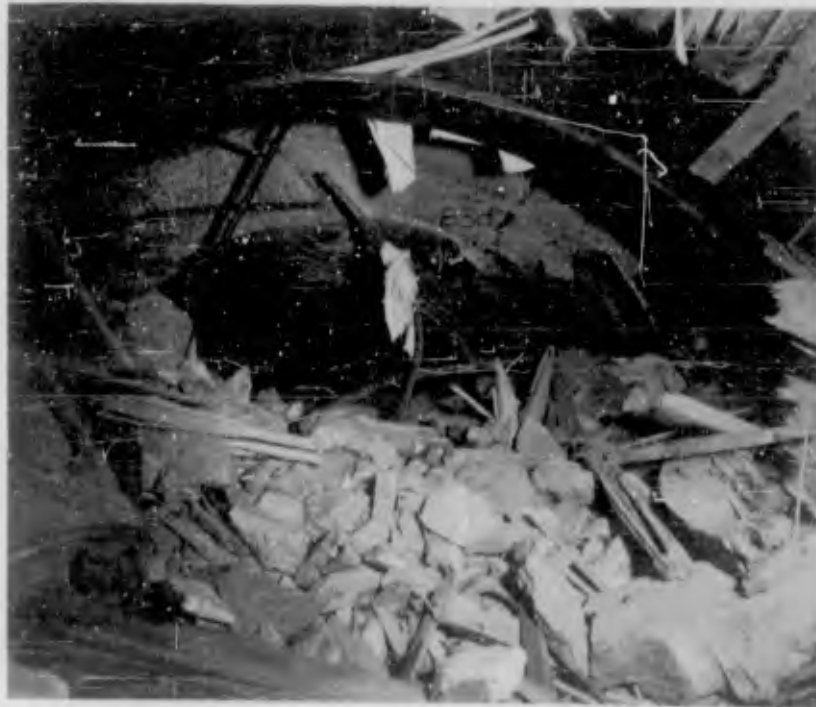
Figure 3.92 Interior B4c, view to west (postshot)
(DASA - NOU 365-02 NTS-62).

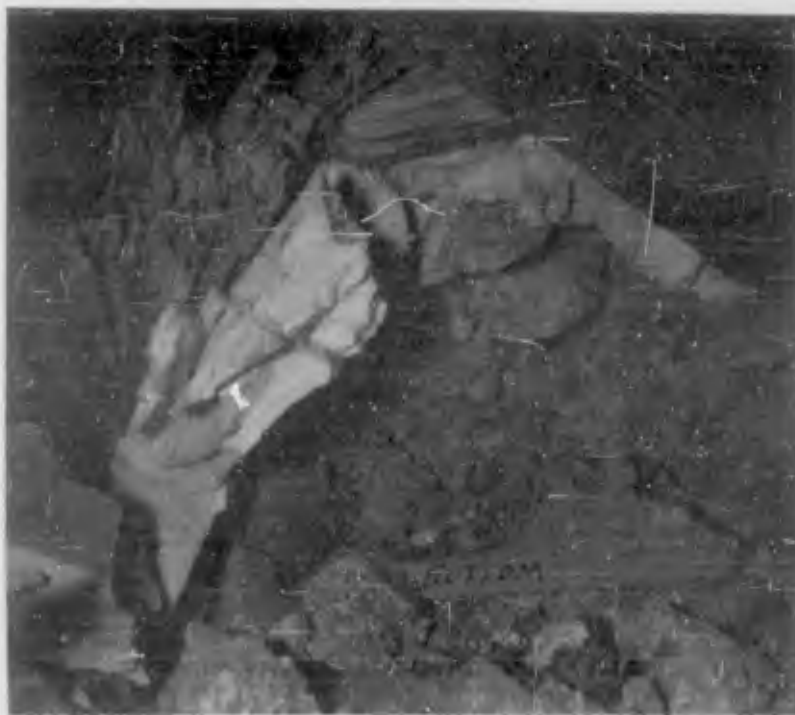
Figure 3.93 Close-up rock break through B4c (post-shot). Note broken wood lagging and compressed polyurethane foam (DASA - NOU 365-06 NTS-62).

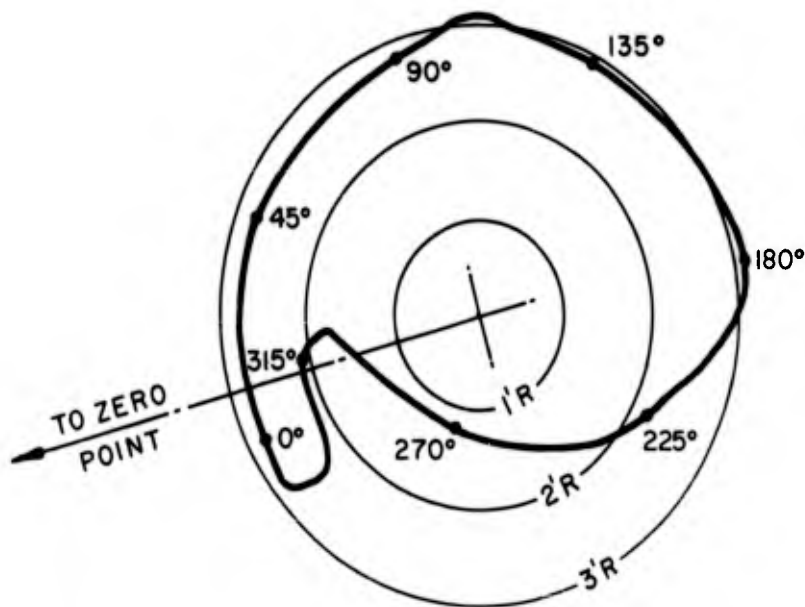
Sufficient debris was removed from around the second and third wide flange rings to permit sketches to be made. The approximate shape of these two rings is shown in Figure 3.94.

Figure 3.94 B4c, distorted shape of wide-flange rings (inside flanges only).

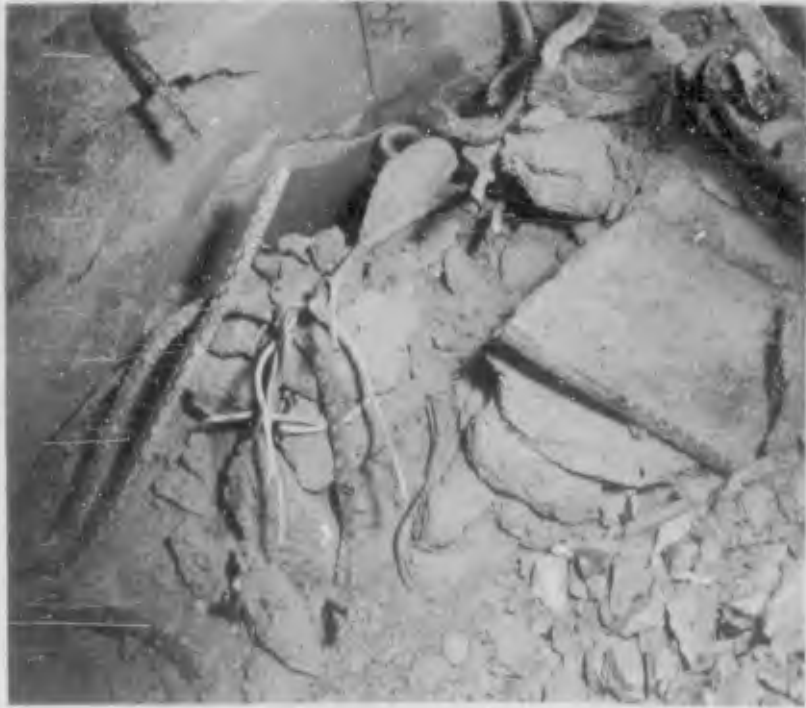
A view of the upper half of this test section as seen from B5c is shown in Figure 3.97. The zero point is to the right in this view.

Figure 3.97 East end B3a as viewed from B5c (post-shot) (DASA - NOU 390-08 NTS-62)

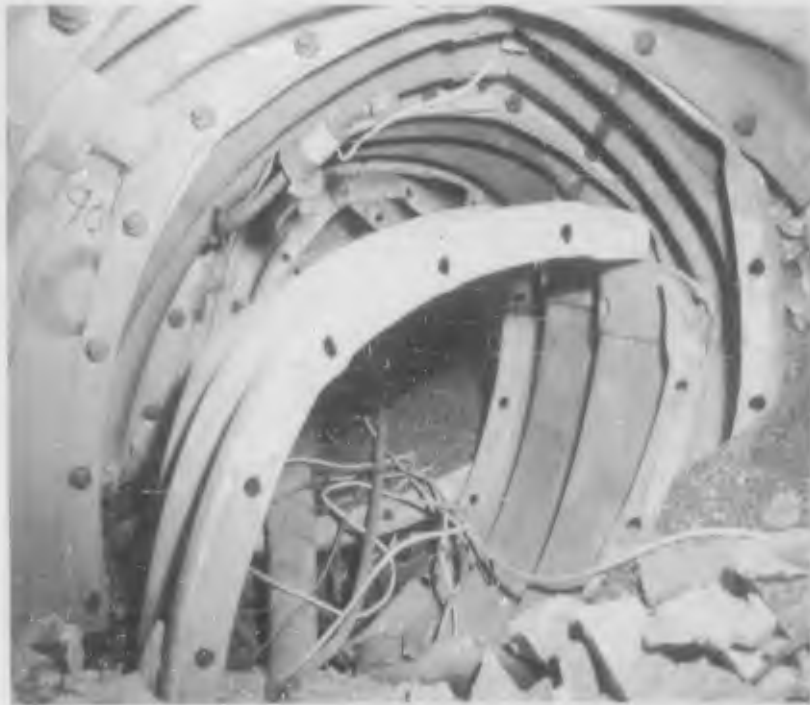
Figure 3.98 shows the interior of B5c as first viewed upon re-entry. The two liner plates in the foreground were completely free and were removed by hand after the photograph was taken.

Figure 3.98 Interior view B5c (postshot) (DASA - NOU 390-03 NTS-62)

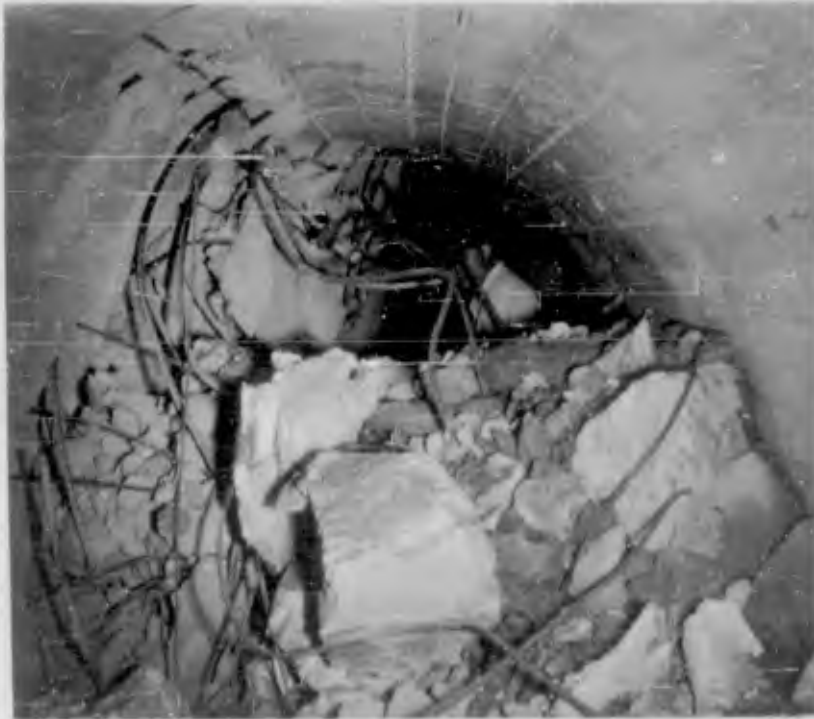
(1) A3c, Eight-Inch Reinforced Concrete With 24-Inch Cast-in-Place Foam Backpacking. Figure 3.99 is a pre-shot view of A3c. A postshot view is shown in Figure 3.100. The liner was more heavily damaged on the side toward zero point. At 0⁰, the rock had broken through the liner and intruded the reinforcing bars and foam into the liner. Many large pieces of foam were found intermixed with the broken rock and concrete within the liner, as can be seen in Figure 3.101, which is a

Figure 3.101 Interior view A3c (postshot), view from west. Note large pieces of polyurethane foam (white) (DASA - NOU 480-02 NTS-62).

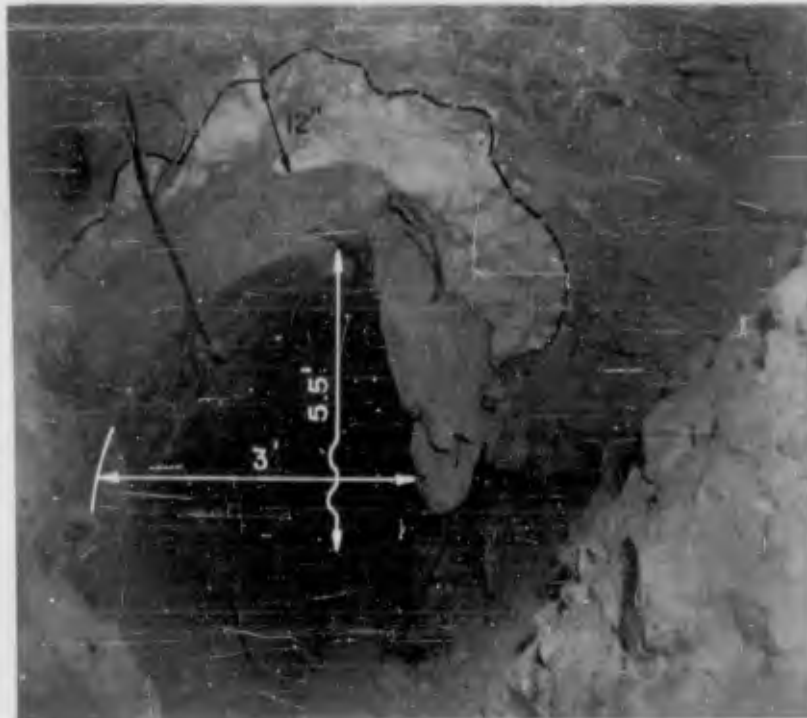
The half of the liner away from zero point was severely fractured, although there was no breakthrough of the concrete. Many severe cracks and much broken concrete were evident on this side. Figure 3.102 illustrates the deformation of the liner and the foam back-packing.

Figure 3.102 East end A3c (postshot). Note polyurethane foam outline and deformation of the concrete liner (DASA - NOU 467-03 NTS-62)

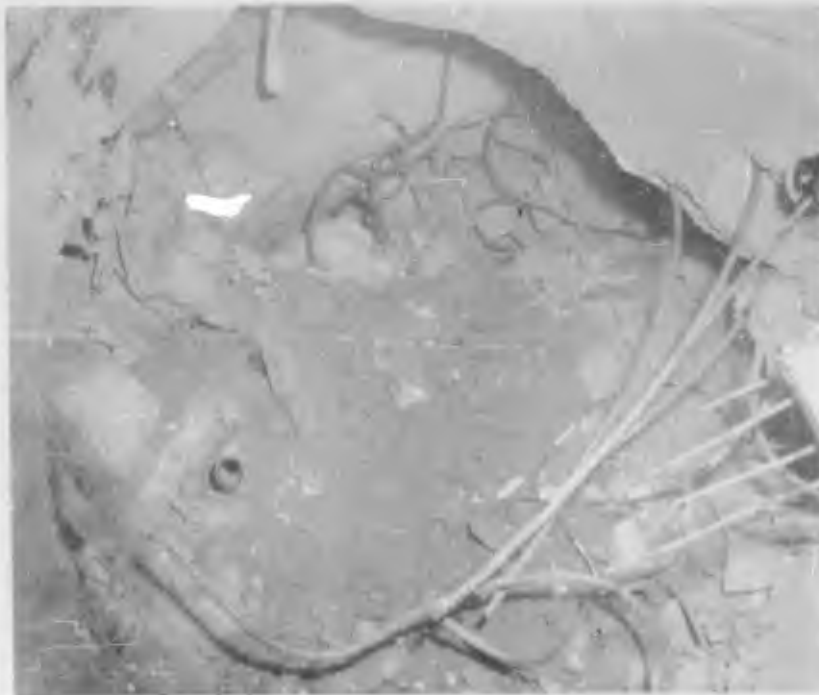
(2) A3b, Twelve-Inch Reinforced Concrete With 9-Inch Cast-in-Place Foam Backpacking. A3b appeared to have failed in the same manner as A3c. The foam was highly compressed, and the liner was completely filled with broken rock and concrete, as can be seen in Figure 3.103. Re-entry to the left side of A Drift was terminated at the east end of A3b.

Figure 3.103 East end A3b as viewed from A3c (postshot) (DASA - NOU 482-03 NTS-62).

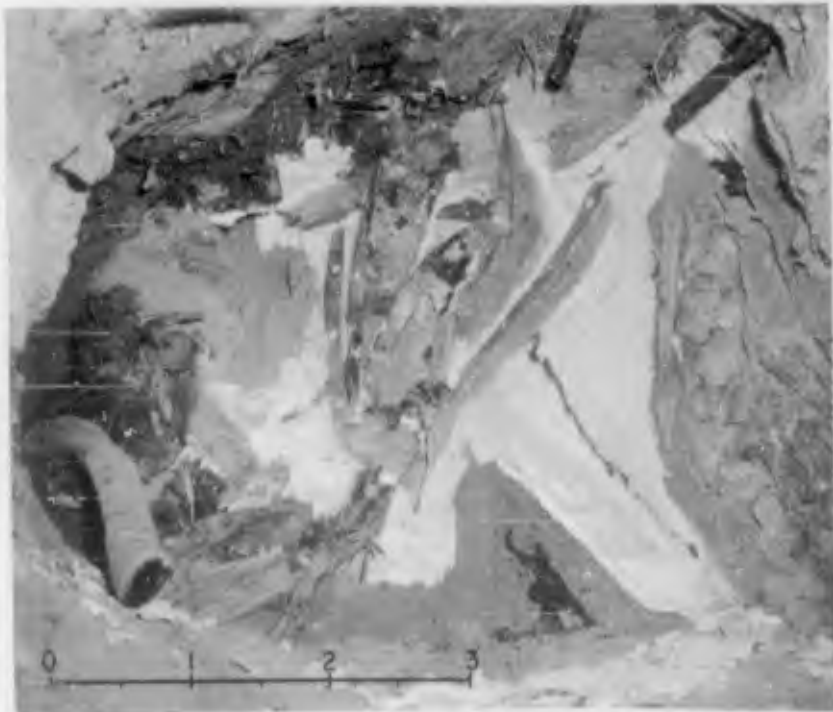
A5a, Three-Gage Steel Liner Plate With Twenty-Inch Precast Foam Backpacking. Figure 3.104 is a post-shot view of A5a taken from the access tunnel. The liner was completely closed, and the foam backpacking was highly distorted. The foam appeared to have deformed plastically around the collapsed tunnel liner plates. The rock outline, originally a nominal ten feet in diameter, was reduced to approximately four feet. Recovery work in the right side of A Drift was suspended at this point. All other test sections in the right side of A Drift are assumed to be closed.

Figure 3.104 West end A5a (postshot). Note collapsed tunnel liner plates and distortion of polyurethane foam backpacking (DASA - NOU 494-02 NTS-62).

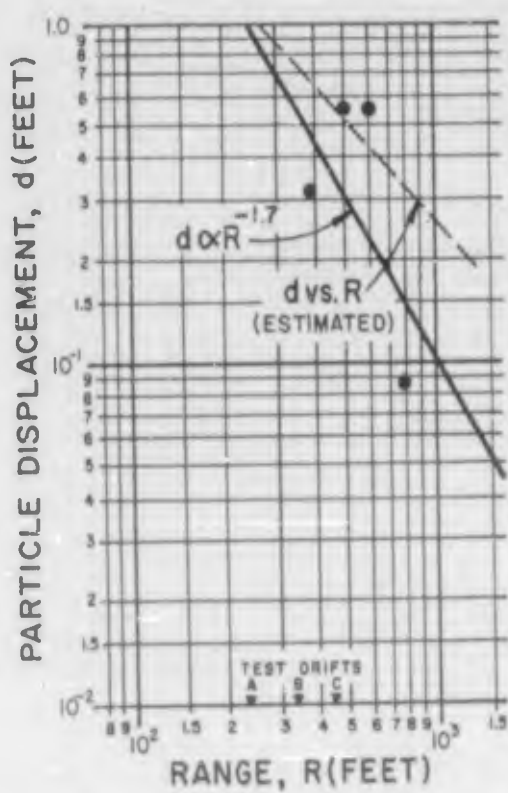
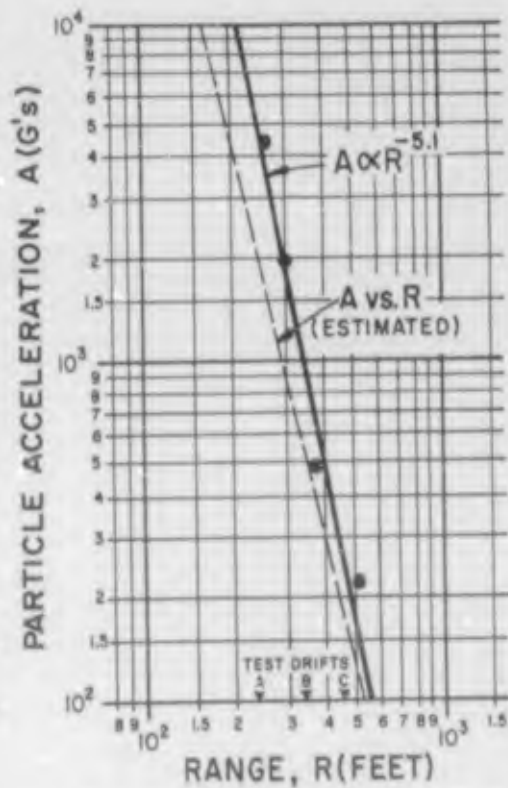
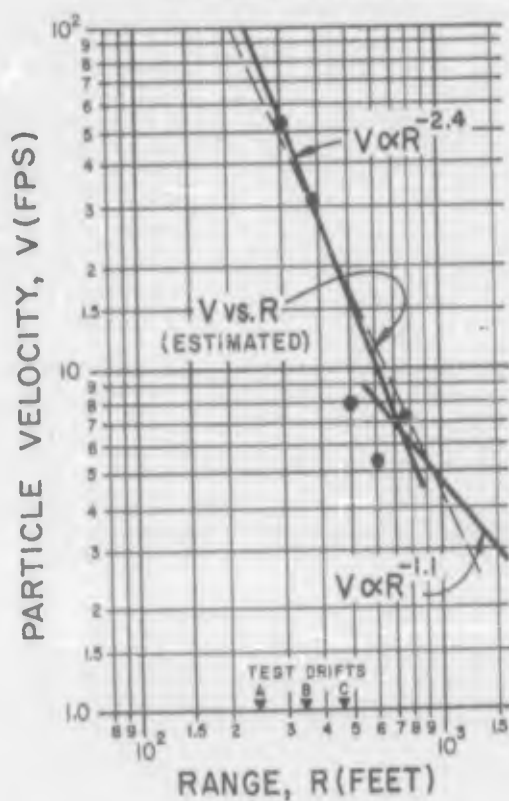
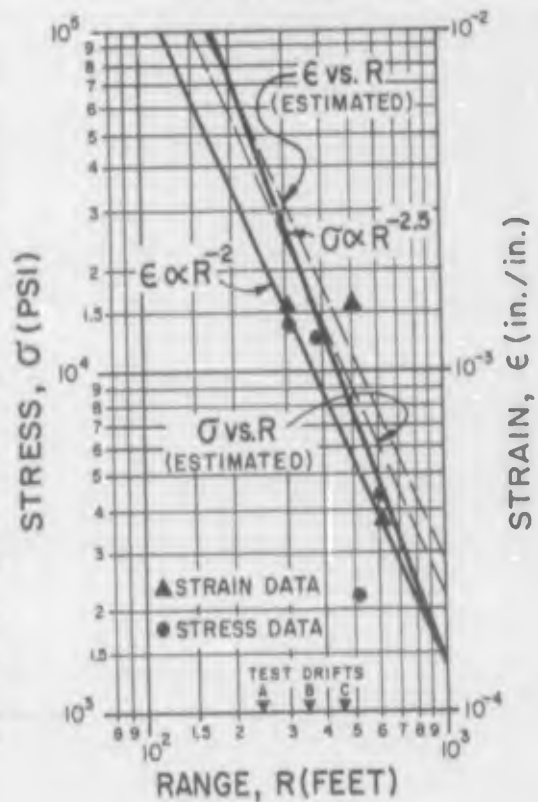
Figure 3.115 Free-field effects. Measured peak values versus preshot estimates.

Generally speaking, the breakage appears to vary as the inverse cube of the slant range at close-in ranges but drops off rapidly beyond Zone 3. This attenuation rate of three for breakage is somewhat larger than the attenuation rates for free-field particle velocity (2.4) and stress (2.5) but smaller than the rate of attenuation for acceleration (5.1), shown in Figure 3.115.

Shock Parameters. A comparison of the free-field measurements with the preshot estimates was shown in Figure 3.115. It can be seen that the measurements were approximately equal to the postshot estimates. Since it appears that the increase in detonation yield and the lower granite competency did not have any great influence on the recorded shock parameters, it would seem that these factors were compensating. However, this cannot be considered conclusive because of the uncertainties in estimating shock parameters. The recorded

Particle Motion Measurements, Project 3.3 (SC). The peak values of the free-field measurements made by Project 3.3 were presented in Table 3.2. A comparison of this data with the preshot estimates (Figures 1.6 and 1.7) was shown in Figure 3.115. In general the free-field data and the preshot estimates made for this project agree. It is considered that these data are reliable.

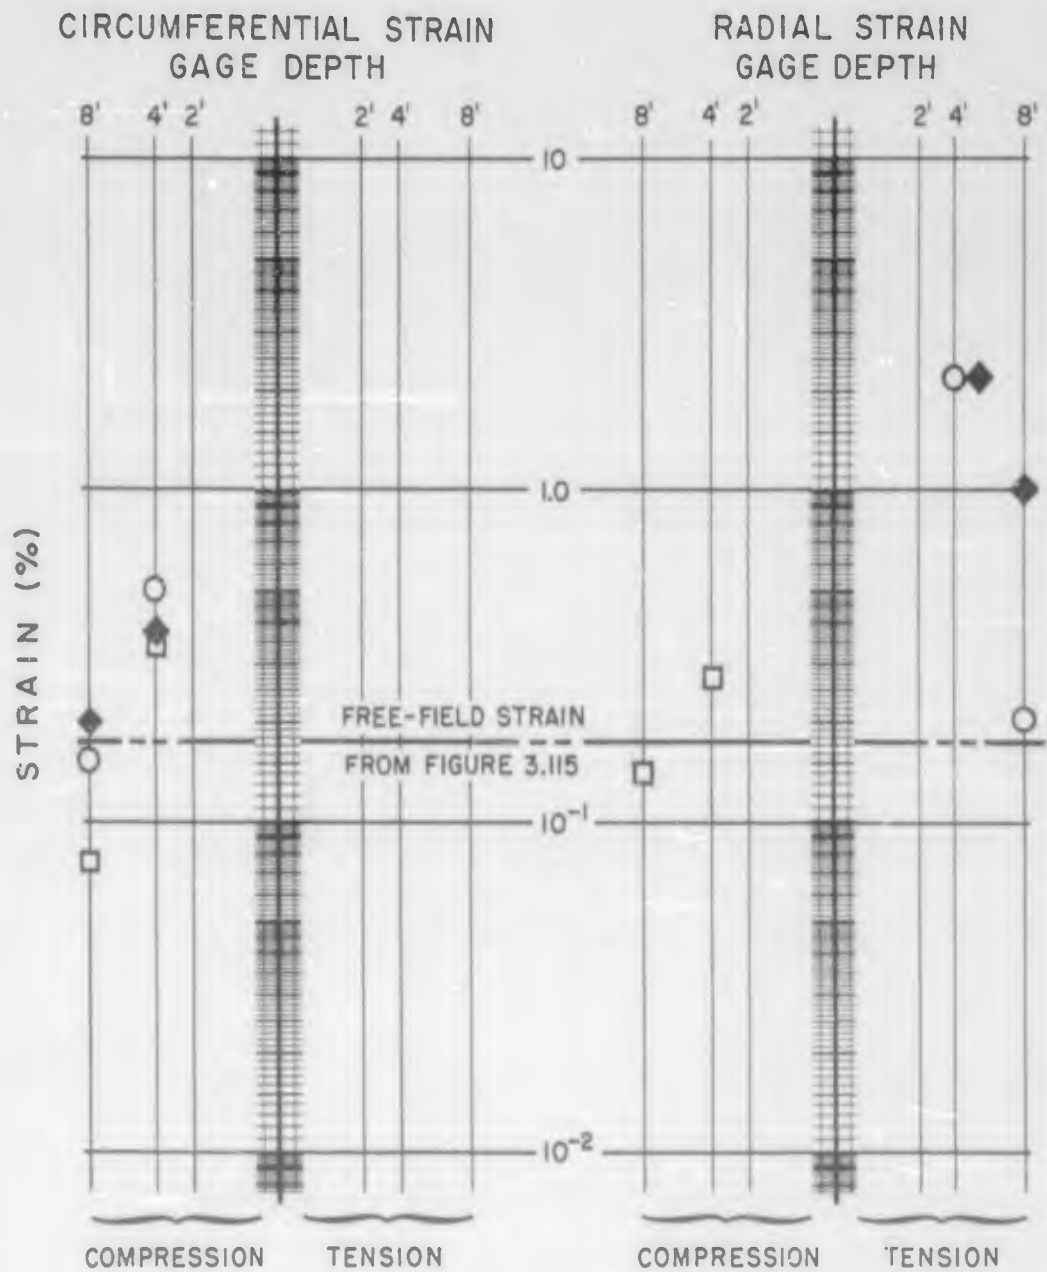
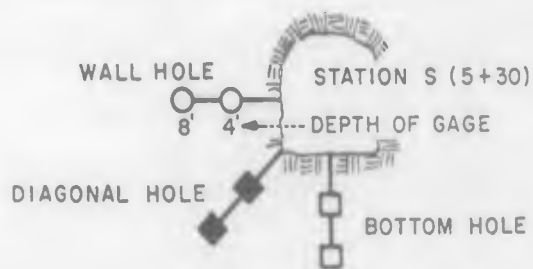
Figure 3.116 Measured peak strain values, access tunnel at Station S.

The peak values of strain measured around the access tunnel at Stations S and T were tabulated in Table 3.3 and shown in Figures 3.116 and 3.117. The stations were located within the two sand plugs. The amounts of tunnel breakage at these two stations are given in Figure 4.1. It can be seen that breakage at the closer-in Station S was approximately 5

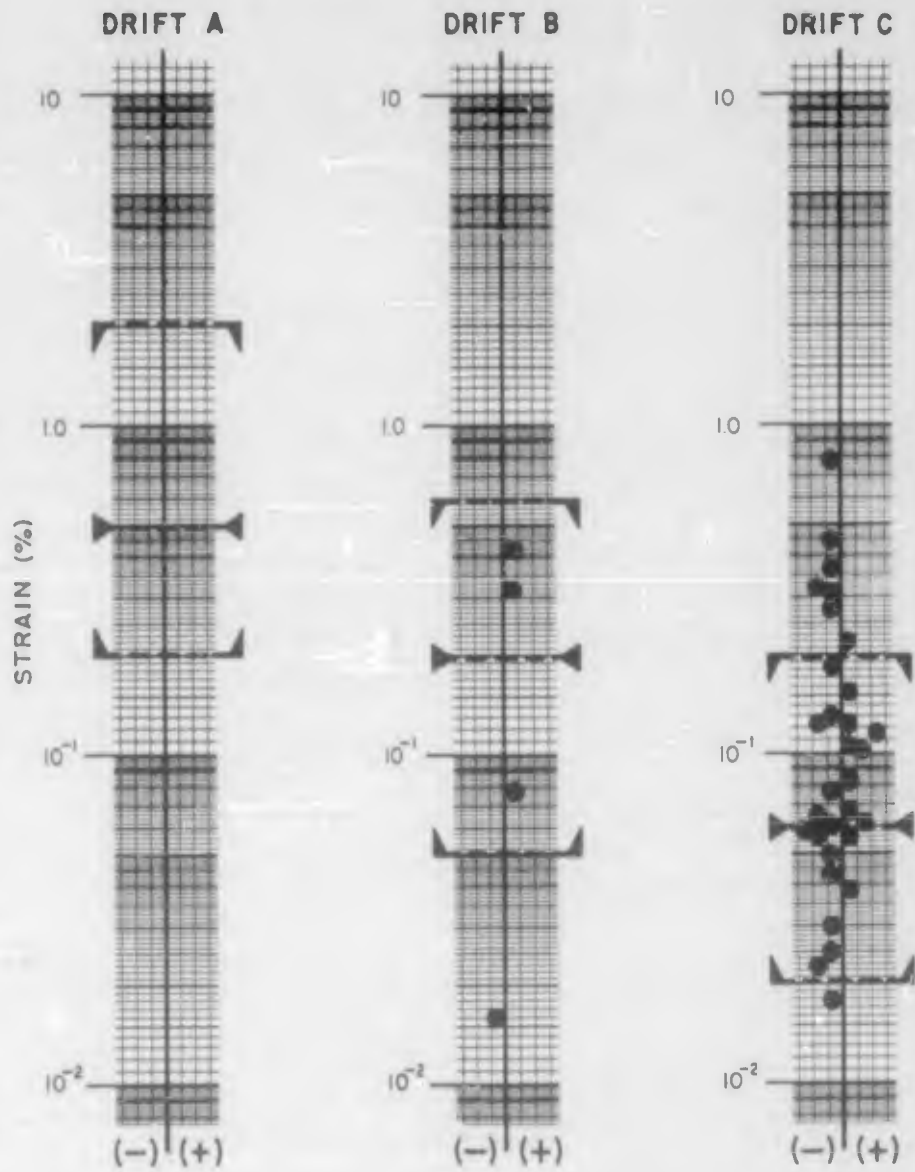
Figure 3.118 Circumferential strain in lining (mechanical).

The peak values of strain from these records were plotted in Figure 3.118. It can be seen that most of the peak values of strain for liners in C Drift were within the upper values of the pre-shot estimates. The residual circumferential strains in C Drift as determined by Whittemore gage measurements, Figure 3.145, were concentrated within the lower values of the preshot estimates. Because the Whittemore gage measurements are residual strains, while the deForest gage data represents peak strains, the data from these two types of measurements appear to be consistent and the deForest gage records recovered are considered reliable.
