The objectives were to obtain information on the mechanics of tunnel damage and on the loading and response of various tunnel liners. The ultimate use of such information will be the development of improved design procedures for underground protective construction in rock.

Generally, the results indicated that the measured values of the various shock parameters were within the preshot estimates. The damage at the closest and farthest test drifts was about as expected; however, the damage at the intermediate-range drift was somewhat greater than expected. Data recovery and the results of the electronic and mechanical measurements

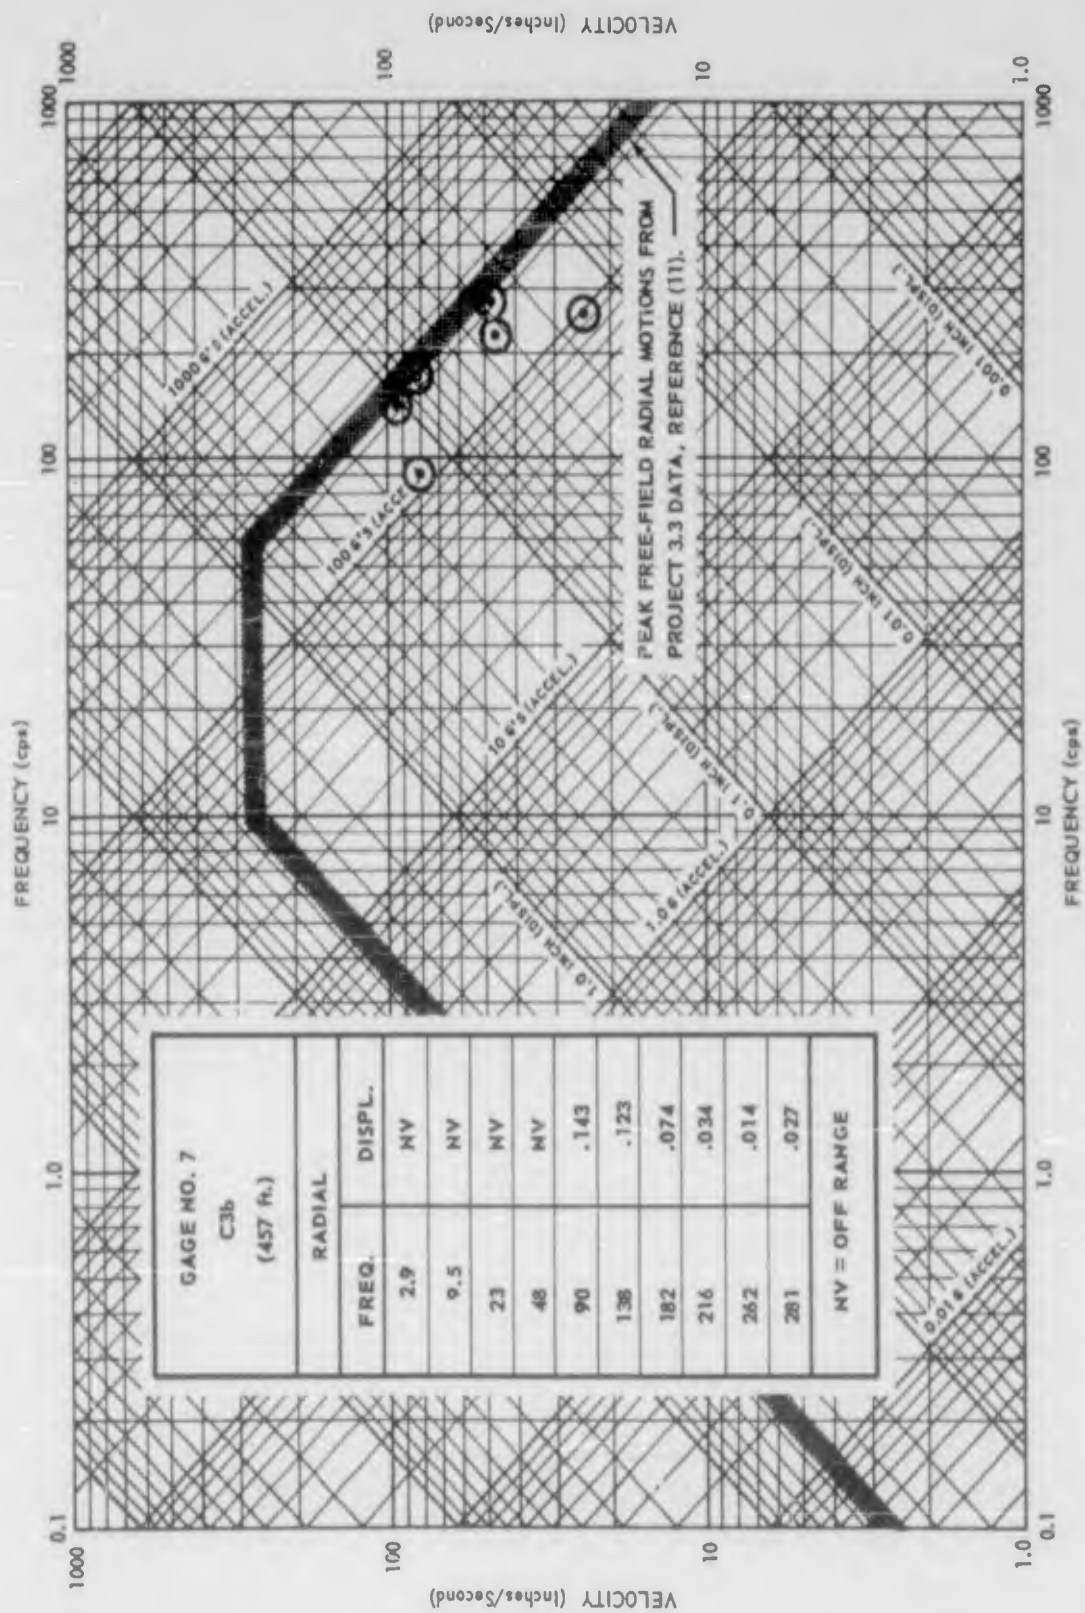
Figure 3.129 C3b, shock spectra (STL).

The shock spectra data points from liners with backpacking in C Drift (Figures 3.129, 3.130, and 3.132) fell only slightly below the trapezoid, whereas the data points obtained in B Drift (Figures 3.133, 3.134, and 3.135) fell significantly below

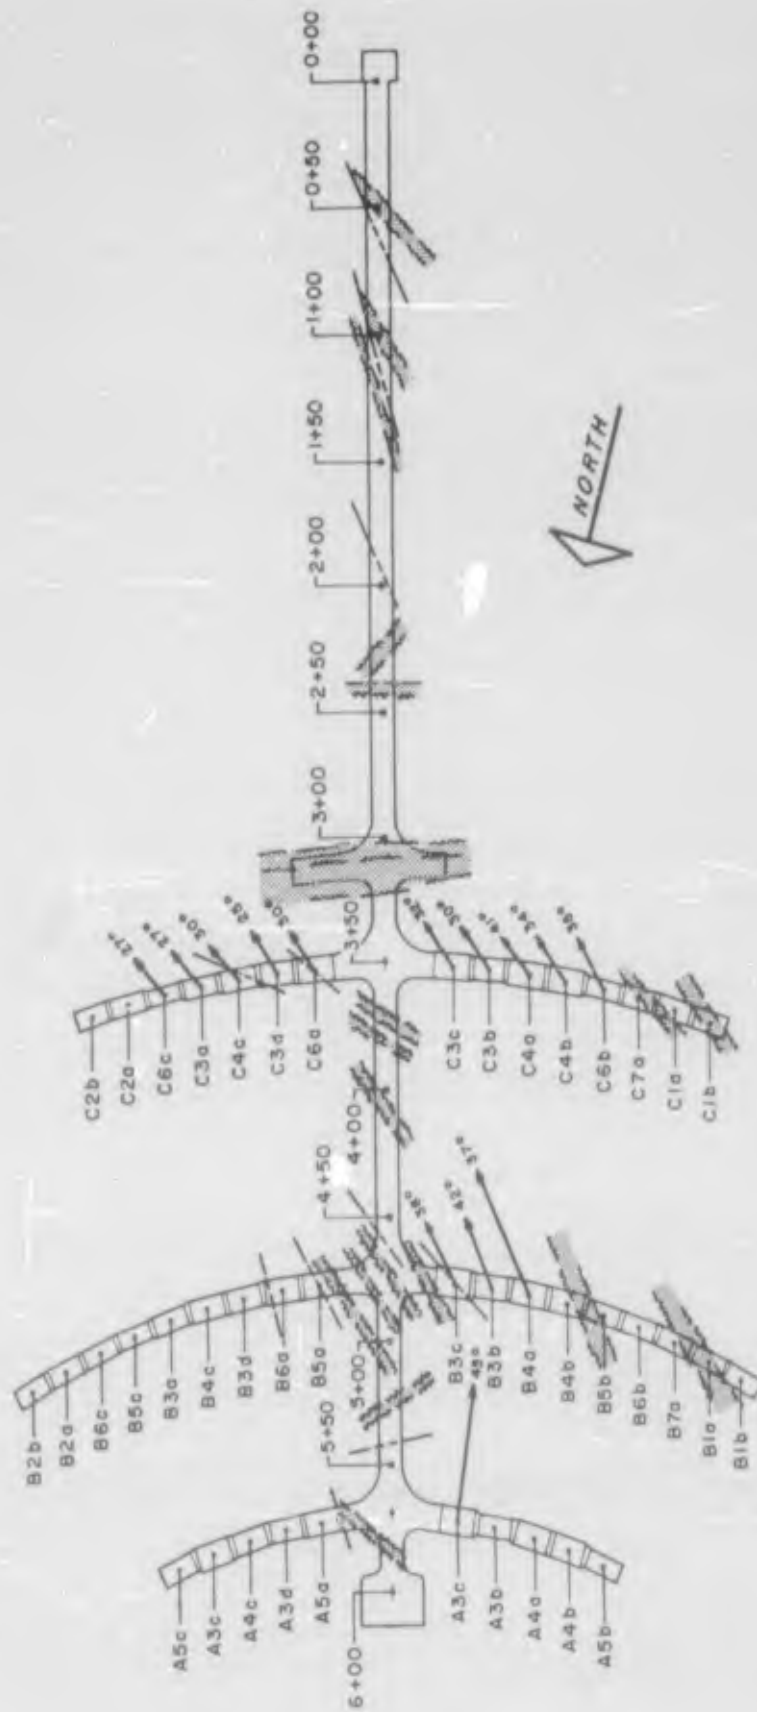
Figure 3.138 Translation of liners (plan view).

Another indication of the influence of geology on response is the parallelism of the horizontal components of liner translation with the northwesterly trending fault system as shown in Figure 3.138. The contribution of the geologic environment to the vertical components of liner translation was not as obvious. Other factors, such as stress relief in an upward direction (to the surface), might also have influenced the vertical angle of translation.

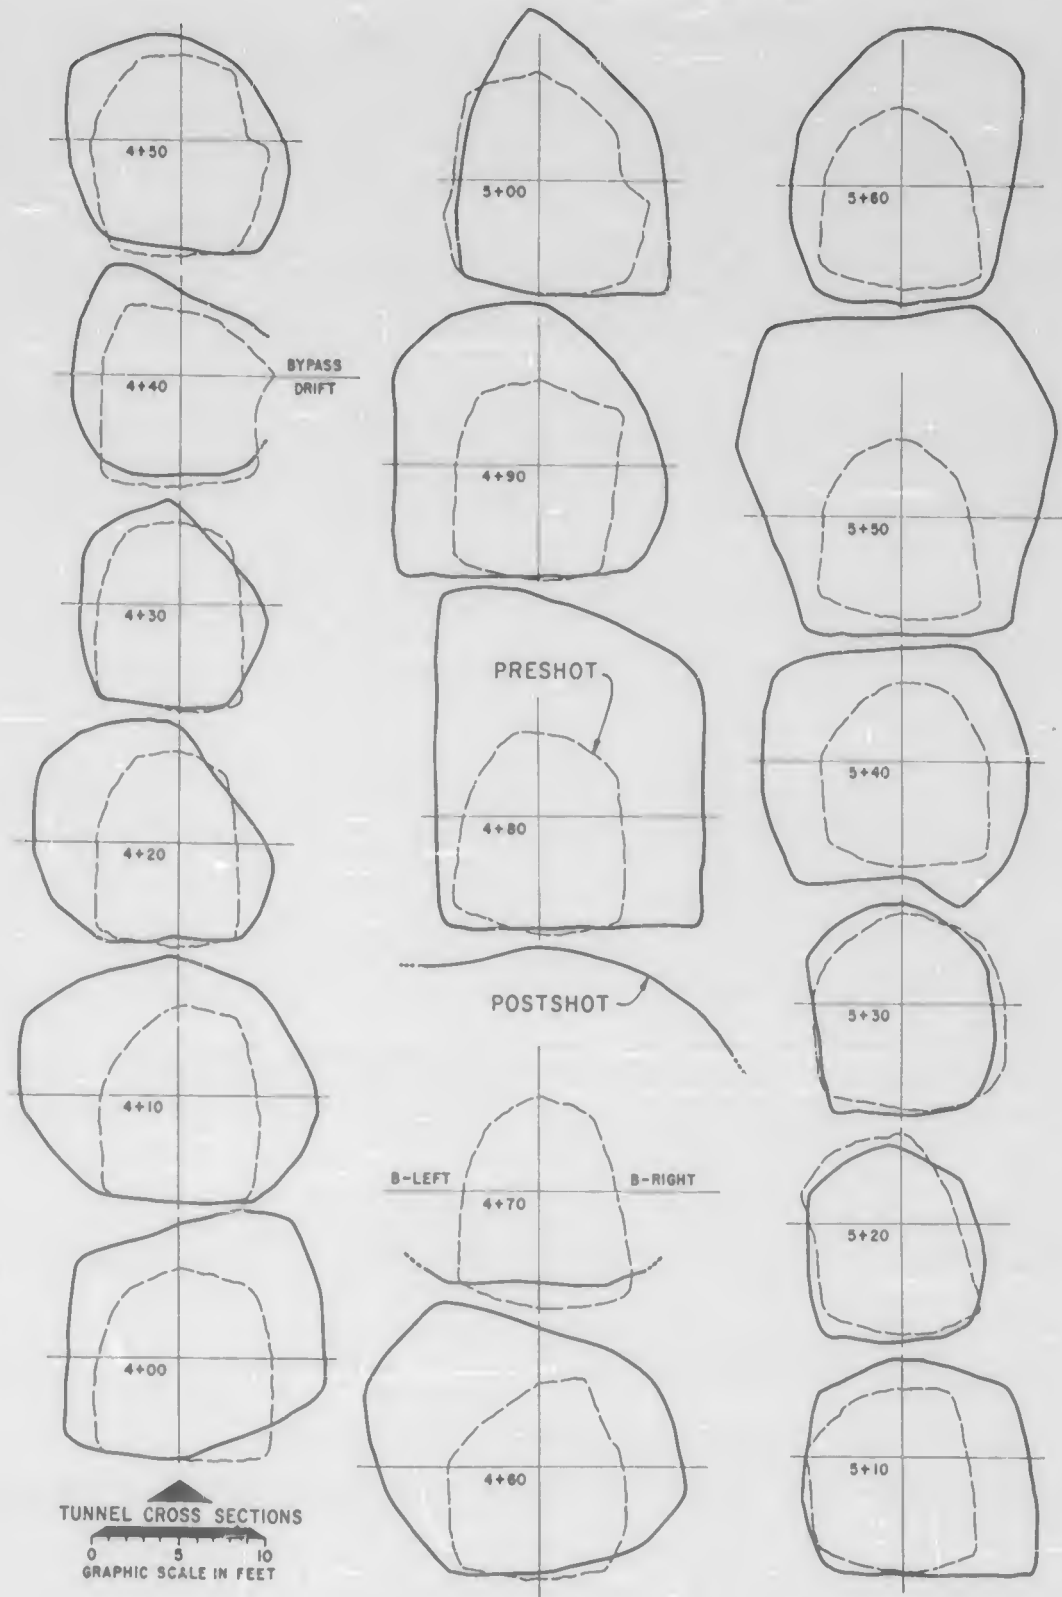
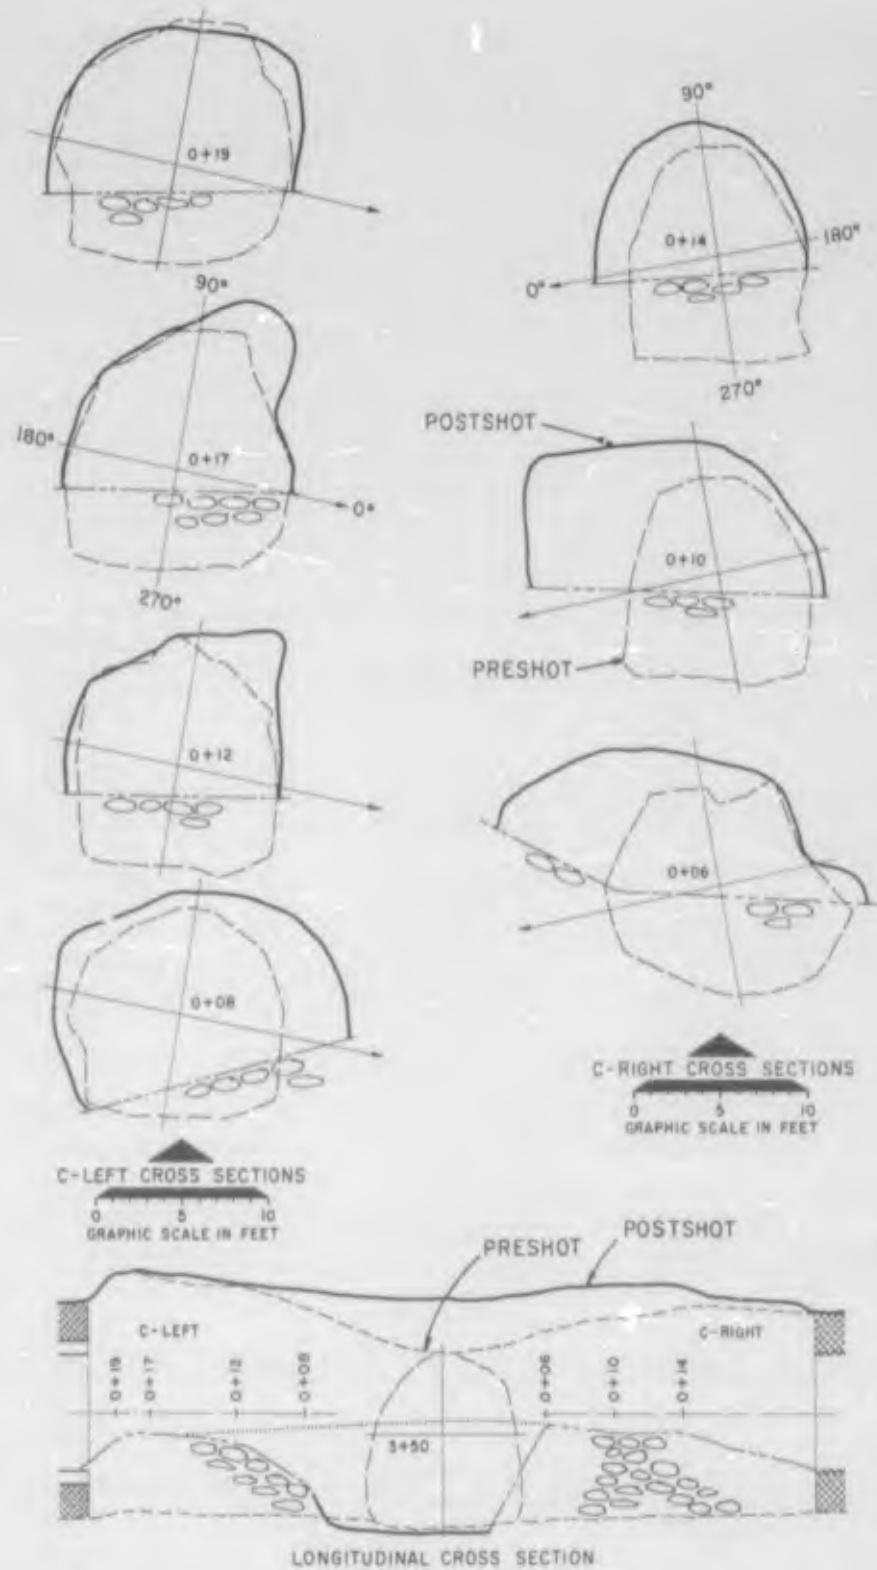
Figure 3.139 Access tunnel cross sections.

Access tunnel rock breakage data derived from comparisons of the pre- and postshot cross sections are presented in Figure 3.142 wherein the cumulative volumes and ratios of cross sectional areas are given.

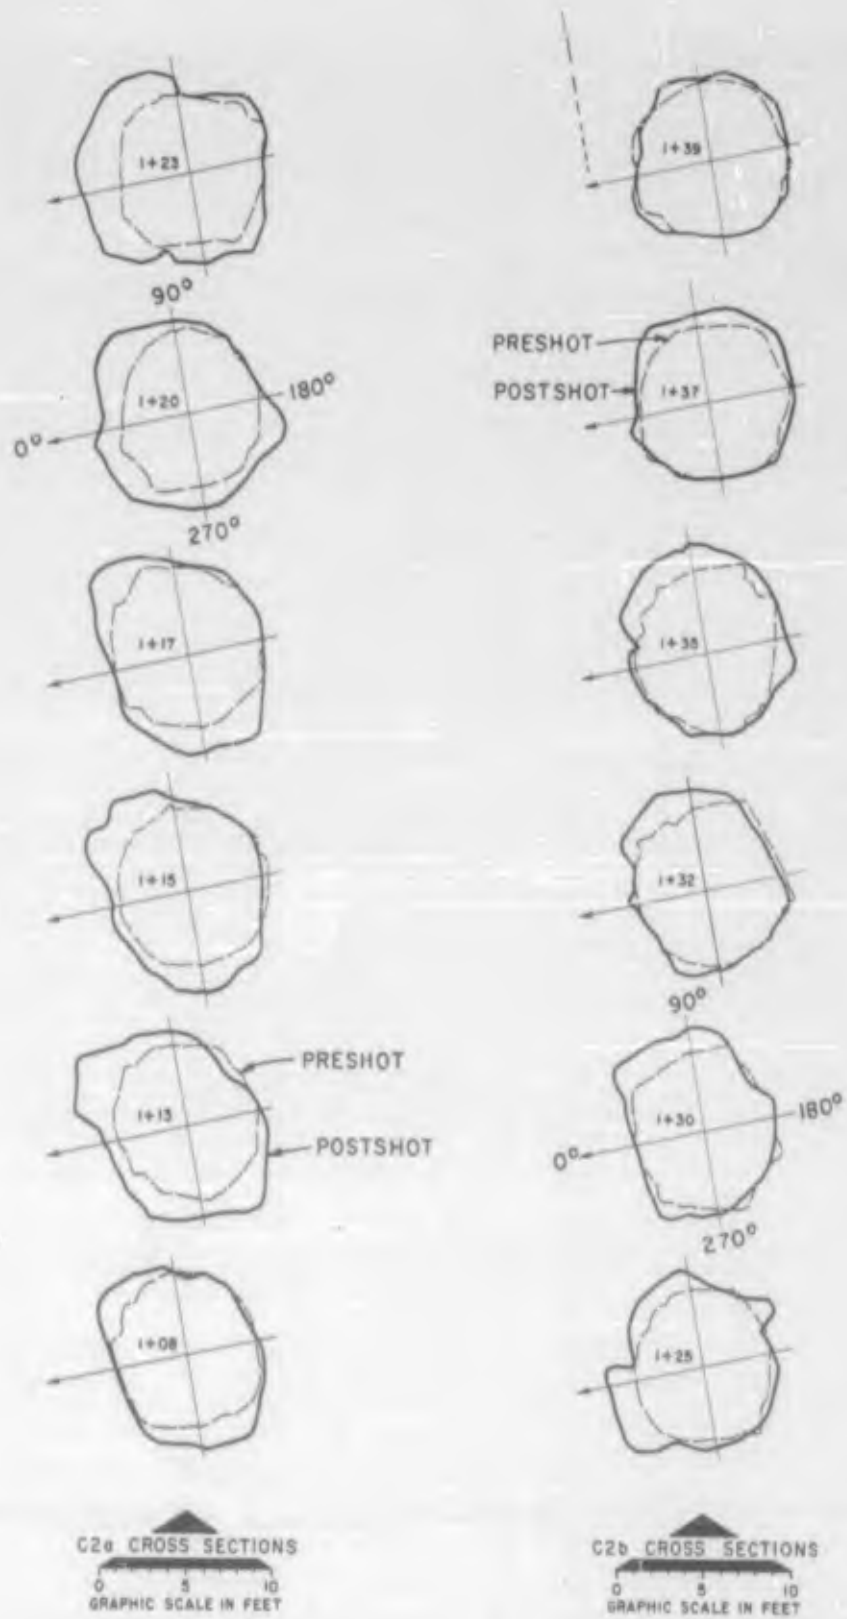
Figure 3.140 Cross sections, C Drift transition zones.

Also, the percentage of area increase due to rock breakage was about the same as can be seen by comparing Figures 3.140 and 3.141. It is therefore apparent that within the range of tunnel sizes compared, there were no appreciable differences in response.

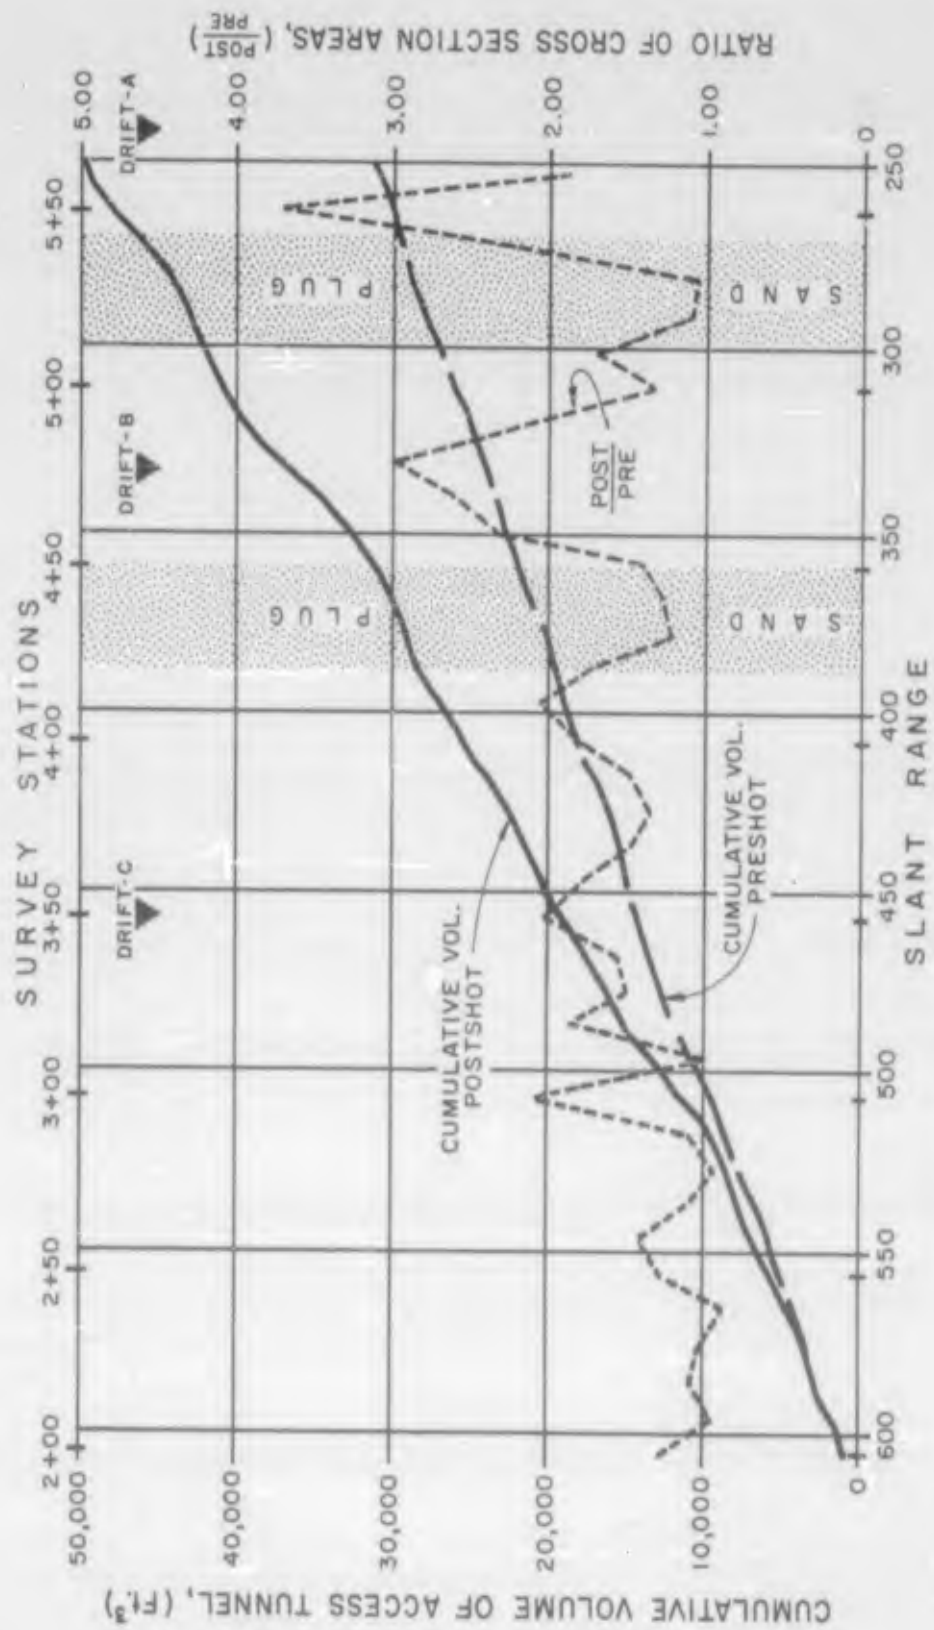
Figure 3.141 Cross sections, C2a and C2b.

The amount of rock breakage in Section C2a (unlined) was shown in Figure 4. 1. These data points are based on pre- and postshot cross sections shown in Figure 3. 141. No data were available from the unlined test sections in B Drift because of inaccessibility due to damage. However, the unlined test sections can reasonably be assumed to be closed, i. e., the breakage is in excess of 100 percent. Based on the data points from C Drift and the inferred breakage in B Drift, it can be seen that the breakage percentages of the unlined sections are approximately the same as those observed in the main access tunnel. Accordingly, it can be assumed that the degree of damage is not markedly a function of orientation of the drift or tunnel with respect to the point of detonation. Therefore, as a first order approximation, the relationships for breakage versus range shown in Figure 4. 1 are considered applicable to both the access tunnel and the test drifts.

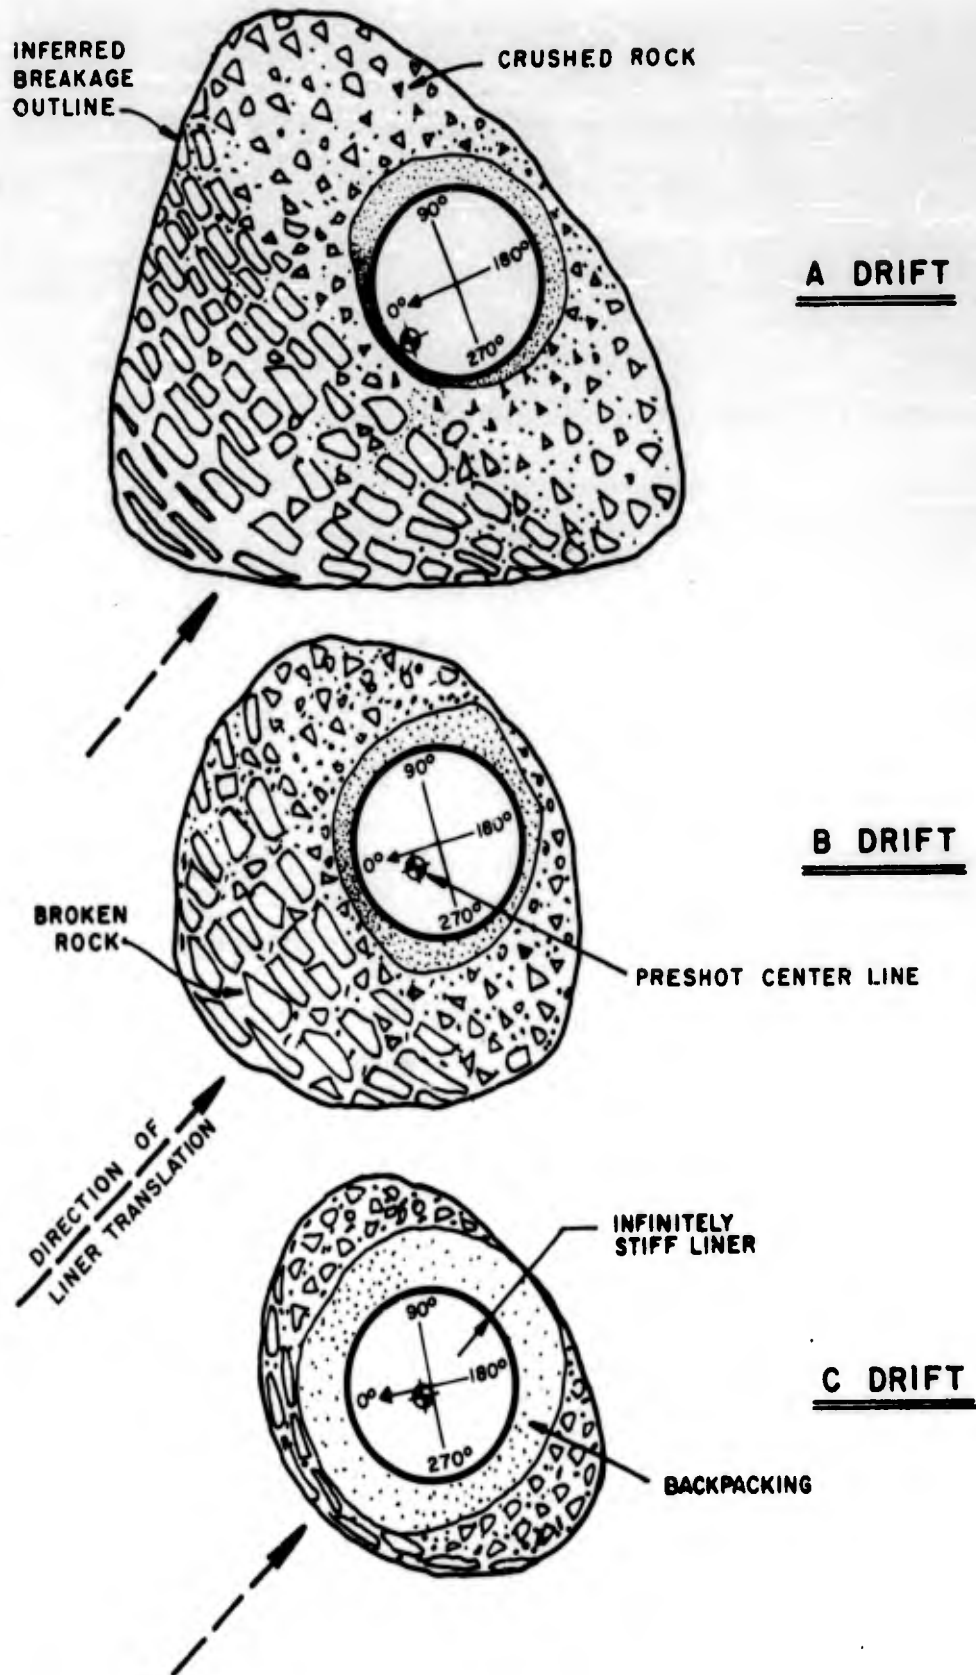
Figure 4.1 Rock breakage versus range, access tunnel and test drifts.

breakage quantities although the modes of failure may have differed for the two orientations. Therefore, it is believed that the data in Figure 4.1 can be used for purposes of estimating rock breakage quantities for circular tunnels oriented either parallel or perpendicular to the direction of stress wave travel.

The peak values of strain measured around the access tunnel at Stations S and T were tabulated in Table 3.3 and shown in Figures 3.116 and 3.117. The stations were located within the two sand plugs. The amounts of tunnel breakage at these two stations are given in Figure 4.1. It can be seen that breakage at the closer-in Station S was approximately 5

(1) Damage-distance relationships (access tunnel). The amount of access tunnel damage as a function of range was shown graphically in Figure 3.7 and numerically in Figure 4.1. The measured free-field shock parameters were given in Figure 3.115. It can be seen that the attenuation rate for rock breakage is approximately the same as for free-field stress and particle velocity. This is approximately valid at ranges from heavy breakage (about 100 to 300 percent of the original cross section) to light breakage (about 20 to 30 percent of the original cross section). The breakage falls off rapidly beyond the vicinity of the elastic range (reported in Reference 11 to be at 735 feet). The correlation of the observed breakage percentage with the measured shock parameters provides the necessary test data for improving design and analysis procedure for re-entry facilities involving underground nuclear tests.
