OPERATION

# PLUMBBOB

Project 1.8b

EFFECTS of ROUGH TERRAIN on DRAG-SENSITIVE  
TARGETS (U)

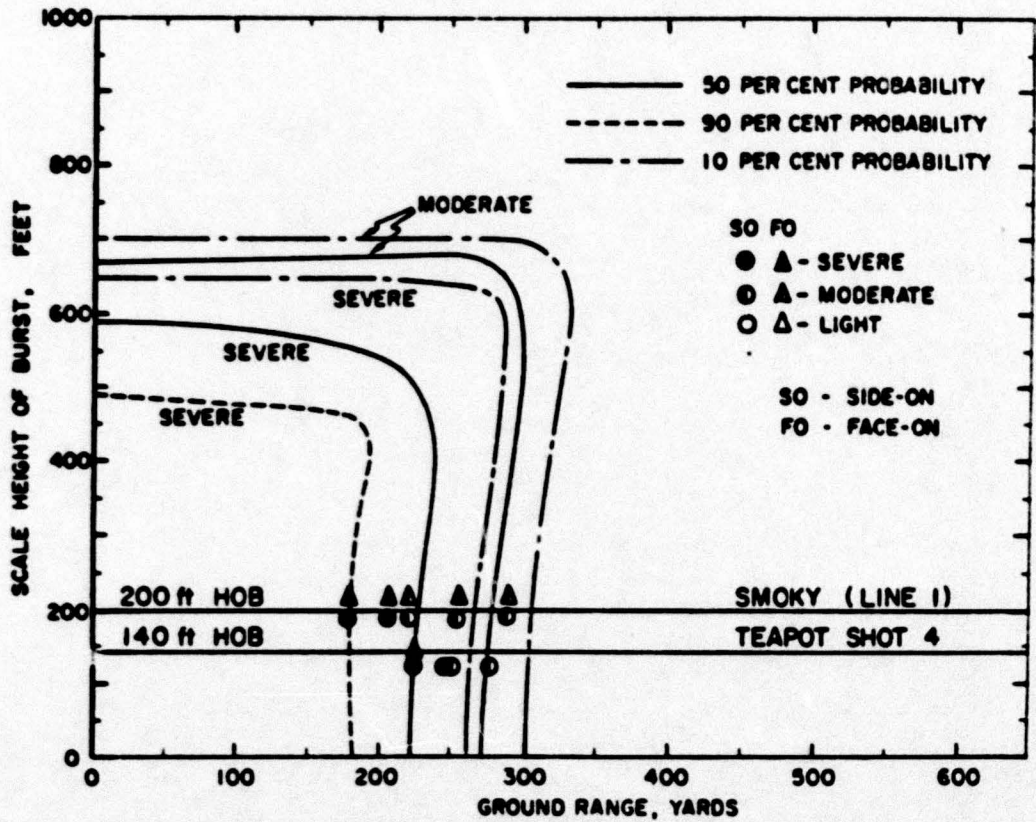
Figure 12 Comparison of Smoky Line 1 with Teapot Shot 4 and the Damage Chart of TM 23-200 scaled to 1 kt.

Figure 12 compares the damage sustained by the vehicle stations along the control line with that predicted by the TM 23-200 vehicle-damage chart. Data from another NTS shot of the same yield (Teapot, Shot 4, 43 kt at a height of burst of 500 feet is also plotted on this chart. The comparisons show that the control line results were typical for an NTS shot over level terrain both with respect to the TM 23-200 damage chart and the NTS shot of similar yield. (Note: The TM 23-200 chart was revised since this data was compiled; however, the revised material, at the height of interest, was only slightly altered.)

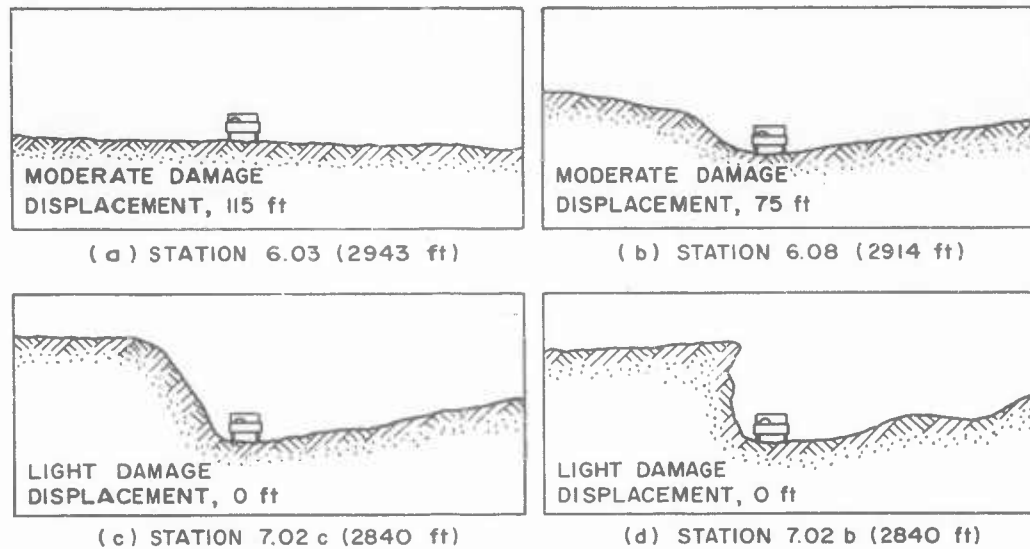
Figure 14 Terrain profiles for vehicle stations.

The comparison of Stations 6.03, 6.08, and 7.02 in Figure 14 shows that, at about the same ground range, significant reduction in damage was obtained when proper advantage was taken of existing terrain accidents. The vehicle at Station 6.03 (2,943 feet) on the control line was displaced 115 feet, sustained moderate damage, and would have required about 12 hours of maintenance work to restore to combat usability. The corresponding vehicle at Station 6.08 (2,914 feet) on Line 2 was displaced 75 feet and sustained moderate damage requiring 4 hours maintenance time. Those vehicles at Stations 7.02a and 7.02b were not displaced and only lightly damaged, requiring no repair time.
