WT-1132

The primary purpose of Project 5.1 of Operation TEAPOT was to determine the structural responses and progression of failure in the post-buckling range of aircraft structures when subjected to destructive gust loads produced by a nuclear explosion. Three QF-80 drones, chosen as the test vehicles, participated in full-scale field tests conducted at the Nevada Test Site during Shot 12.

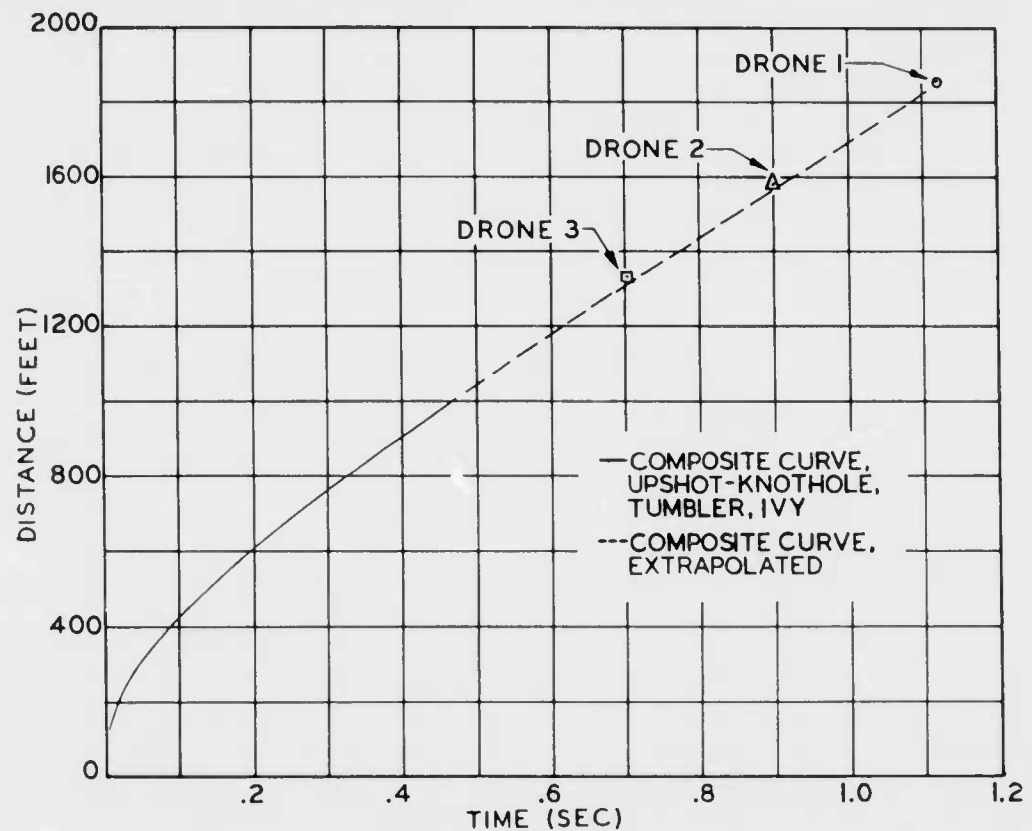
Figure 6.1 Shock Wave Time of Arrival versus Slant Range  
(Data Reduced to 1 KT at Sea Level, Shot 12)

Time of Arrival. In Figure 6.1 shock-wave time of arrival is plotted against slant range as measured at the three drones. The data have been reduced to 1 KT at sea level standard conditions for comparison with other tests. This method of treatment is referred to as A-scaling. The actual figures for shock-wave time of arrival are given in Table 5.2. These figures represent the initial deflection of the normal acceleration trace as measured on both local recording and telemetering records for Drones 1 and 2 and from telemetering records alone for Drone 3. A curve of time

of arrival versus slant range as obtained from the data presented in Projects 1.1a and 1.2, Operation Upshot-Knothole WT-710, "Air Blast Measurements," is plotted in Figure 6.1 and is used for comparative purposes. The data for this curve have also been A-scaled and represent a composite of the results obtained during Operations Upshot-Knothole, Tumbler, and Ivy. The composite curve does not overlap the drone measurements in range, so they cannot be compared absolutely. However, extrapolation of the curve as shown by the dashed line indicates close agreement. The composite curve is based on a single incident shock wave and the measured values are for

the incident wave reinforced with a reflected wave. Therefore, the measured values would normally be expected to be slightly lower than the composite.

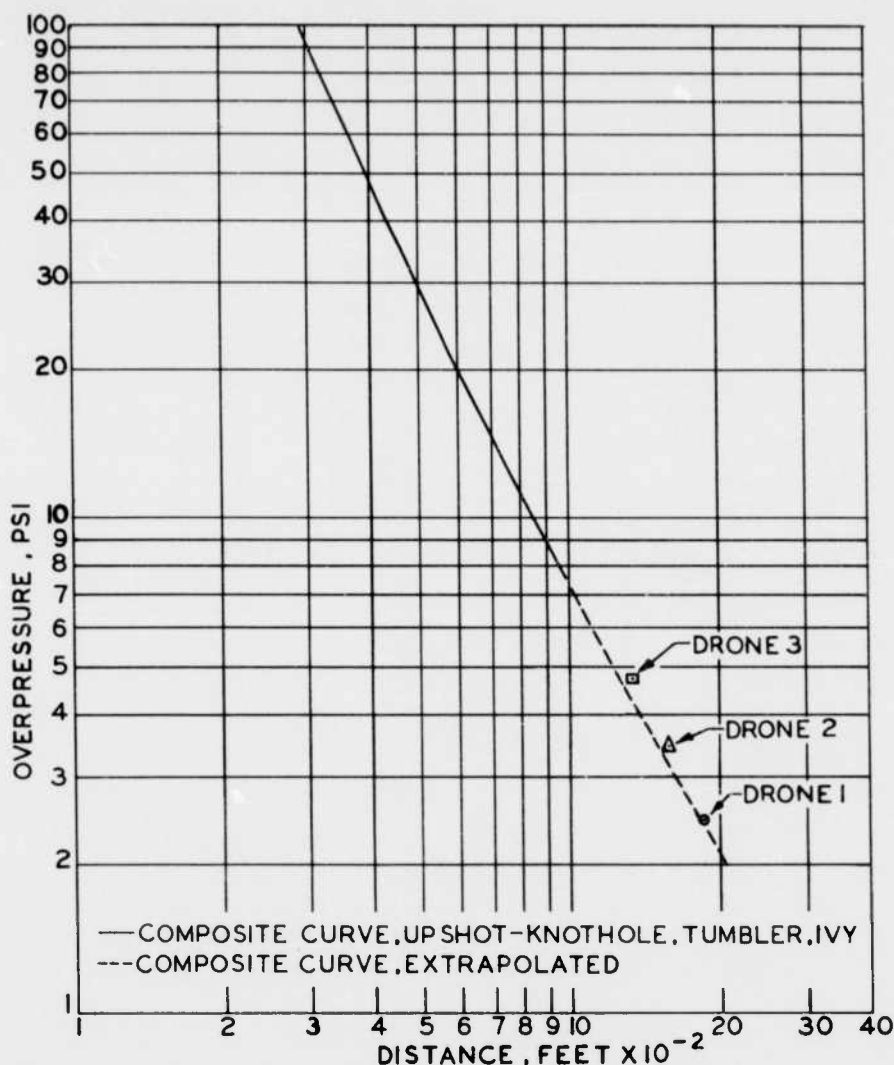
Figure 6.2 Peak Overpressure versus Slant Range  
(Data Reduced to 1 KT at Sea Level, Shot 12)

Overpressure. In Figure 6.2 is an A-scaled graph of overpressure versus slant range. This figure shows the comparison of overpressure measurements at the drones with the free air composite curve from Operations Upshot-Knothole, Tumbler, and Ivy as obtained from WT 1102. These overpressure measurements were obtained from the telemeter records, which

lost synchronization just after the peak acceleration was reached. Therefore the peak values were not clearly recorded, and it was necessary to extrapolate the curves obtained and to estimate the peak values reached. The figures used are the best obtainable and are believed to be reasonably

accurate. In view of the method used to arrive at these figures, however, no definite accuracy limits should be assigned.

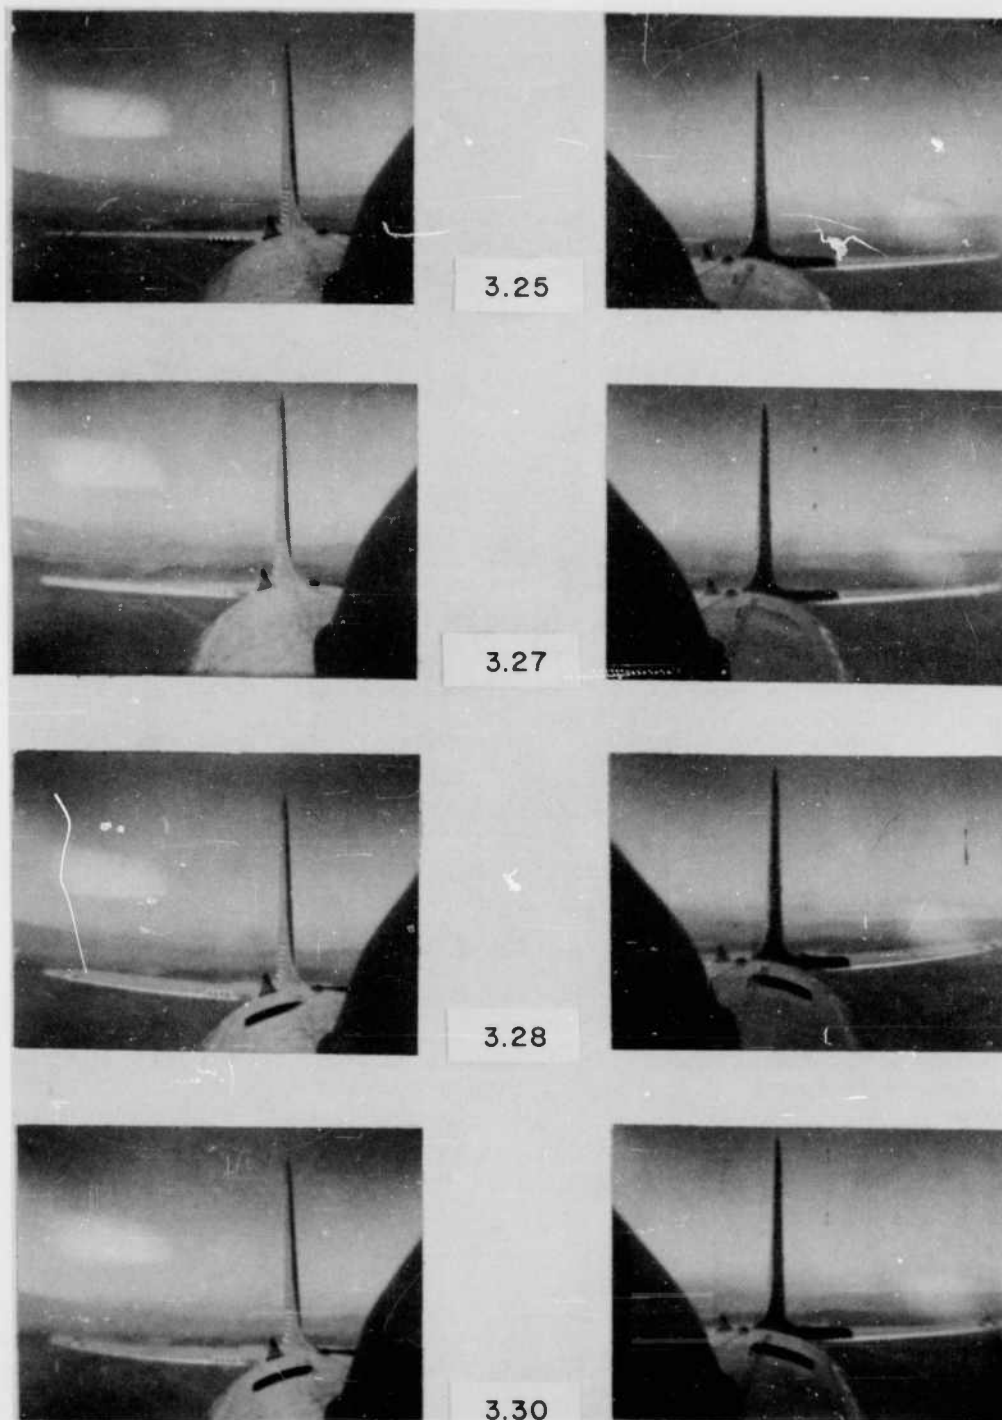
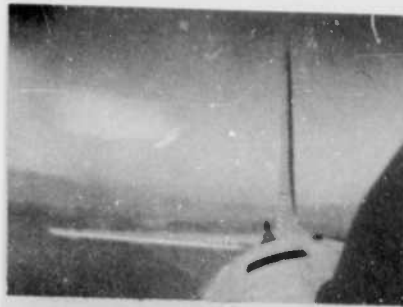
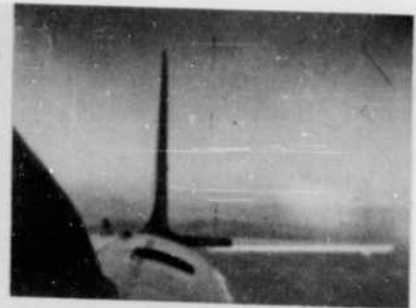
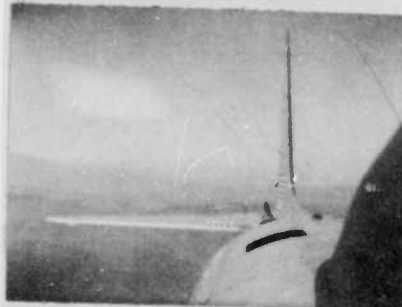
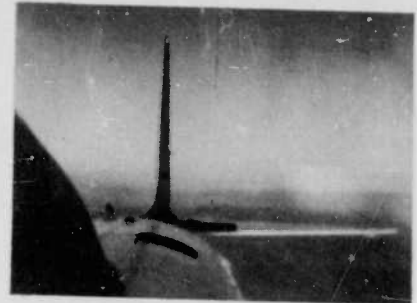
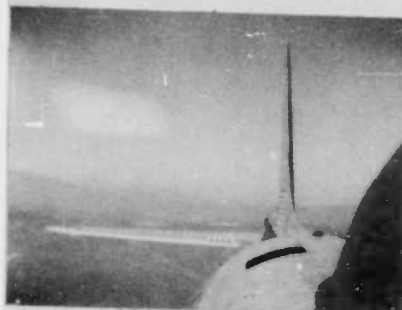
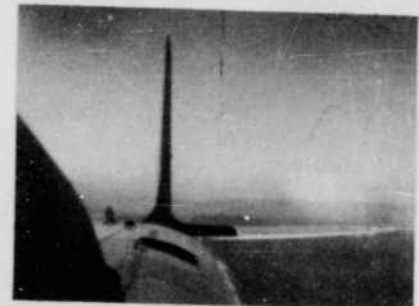
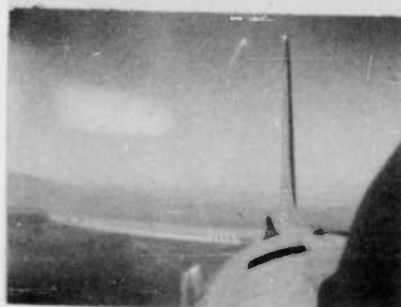
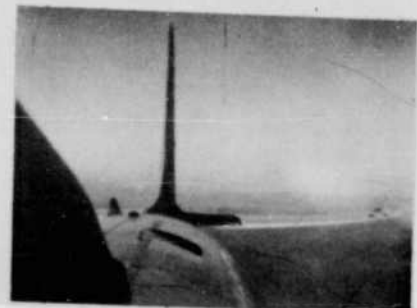
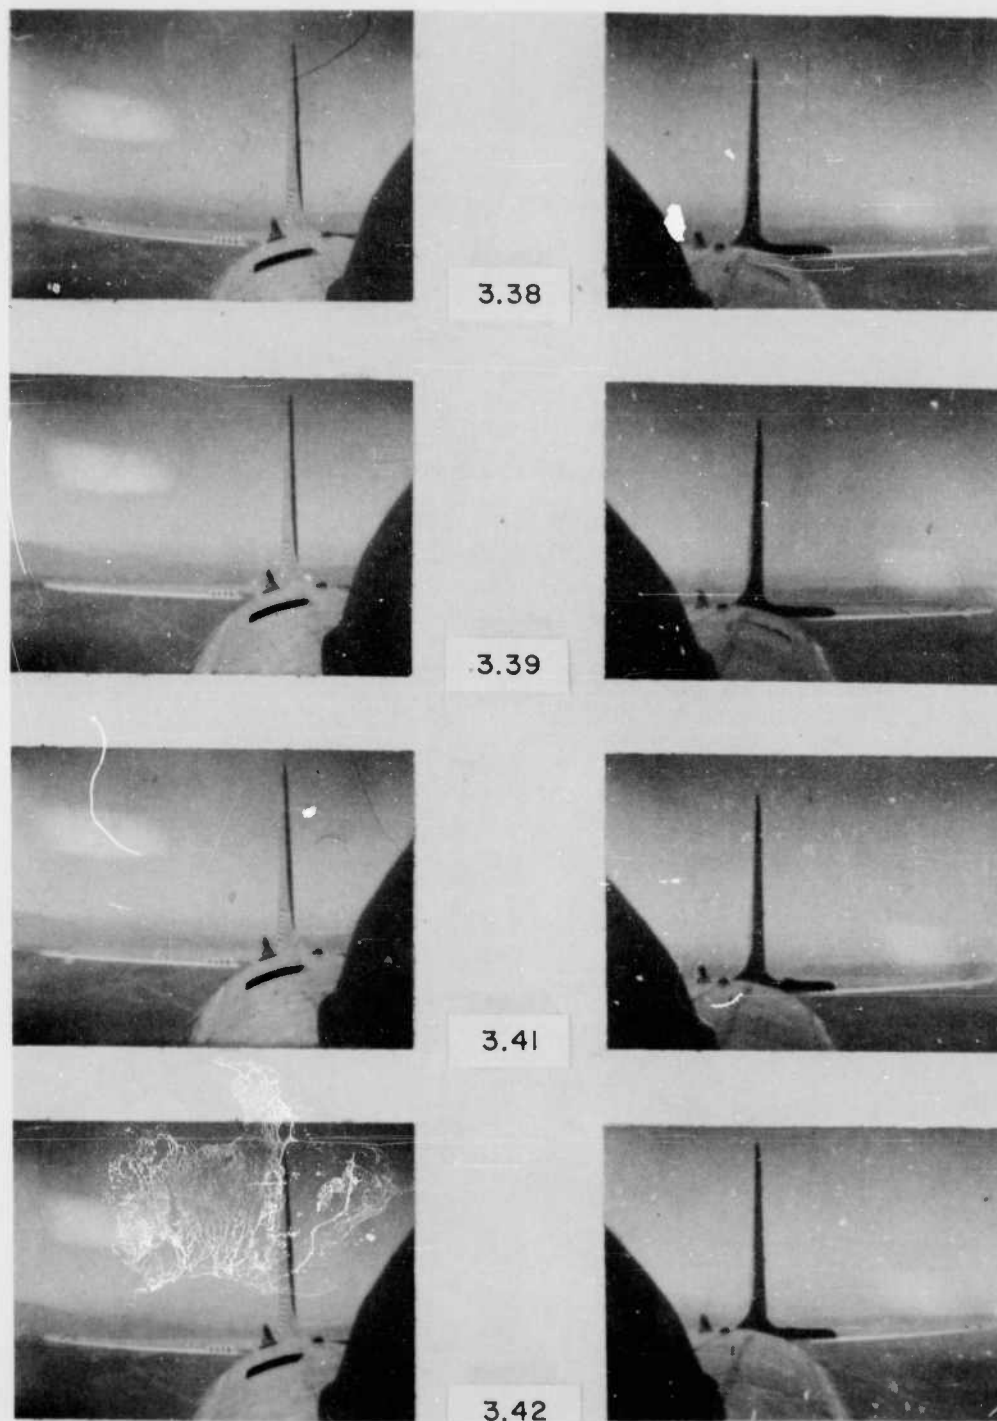
Figure 6.3 Horizontal Stabilizer Deflection at Shock Arrival,  
Drone 1. Numbers represent seconds after time zero.

In Figure 6.3 is presented a portion of the sequence of photographs for Drone 1 which were used to measure the horizontal-stabilizer deflections presented in this report. These photographs cover the shock arrival and about the first 0.18 second after shock arrival, or past the two major peaks. Comparable illustrations are shown in Figures 6.4 and 6.5 for Drones 2 and 3.

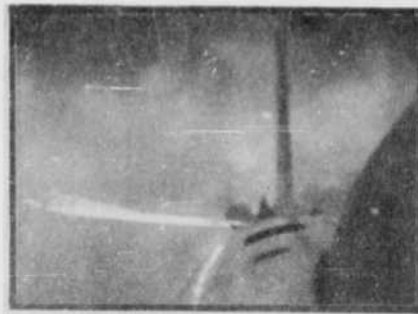
Figure 6.5 Horizontal Stabilizer Deflection at Shock Arrival, Drone 3. Numbers represent seconds after time zero.

An interesting photograph is shown in Figure 6.5, Sheet 1, at 2.07 seconds on the right side of the page. In this picture the camera caught two images of the left side of the horizontal stabilizer, one just before failure was reached and the other just after. Since the exposure time of

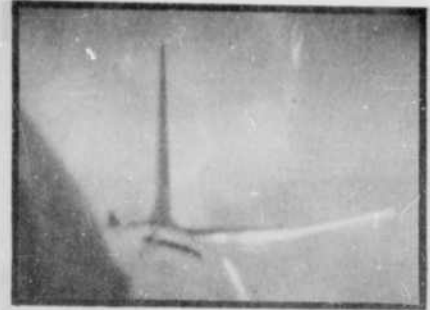
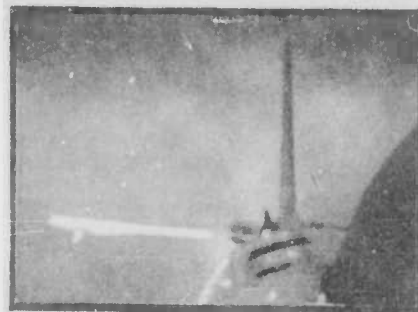
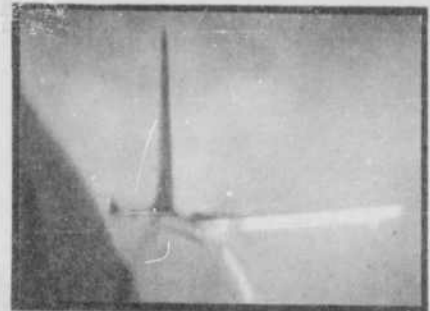
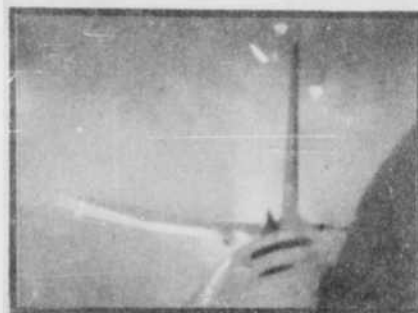
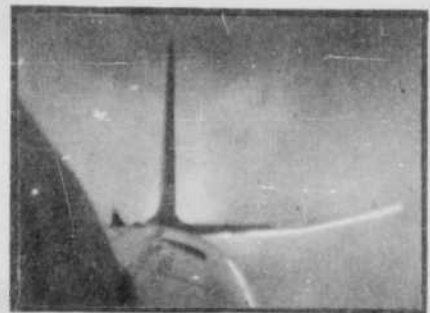
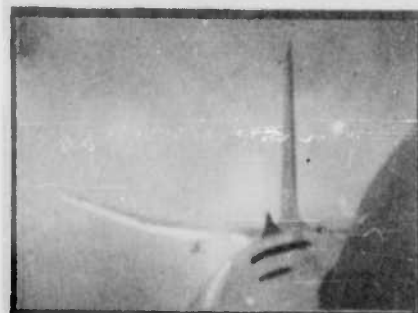
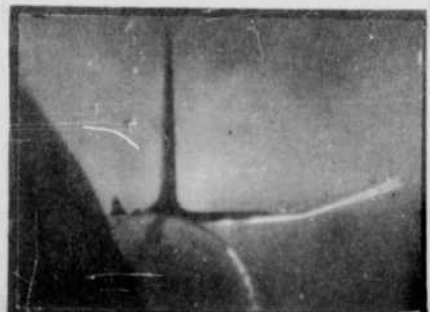
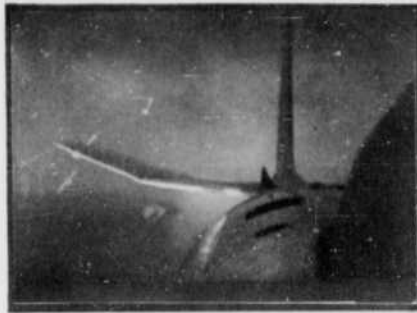
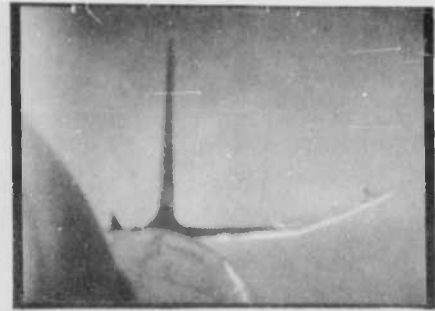
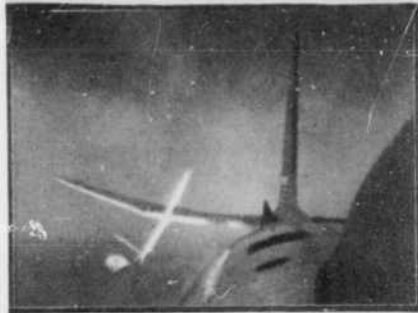
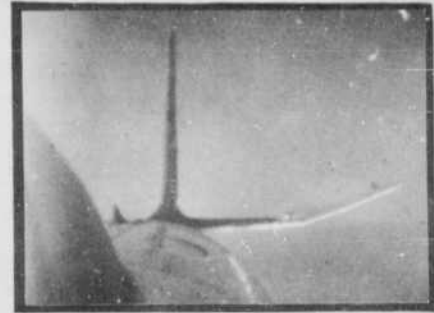
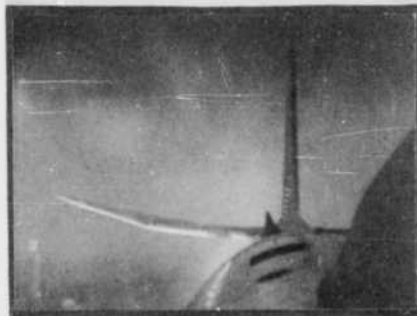
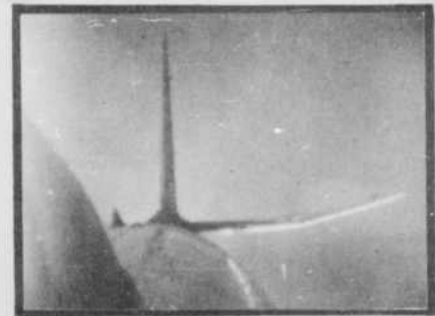
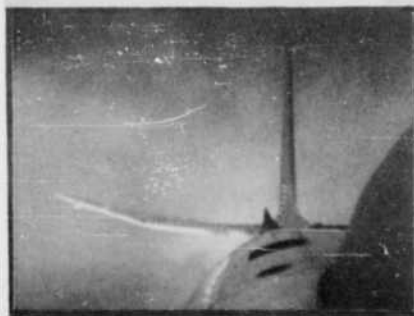
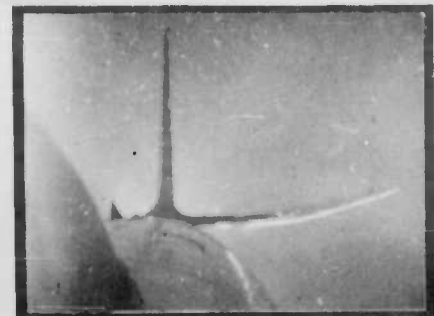
Figure 6.5 Continued.

this frame is less than 0.008 second, the picture clearly shows the rapidity of stabilizer movement and the wide range of position covered by a single frame.

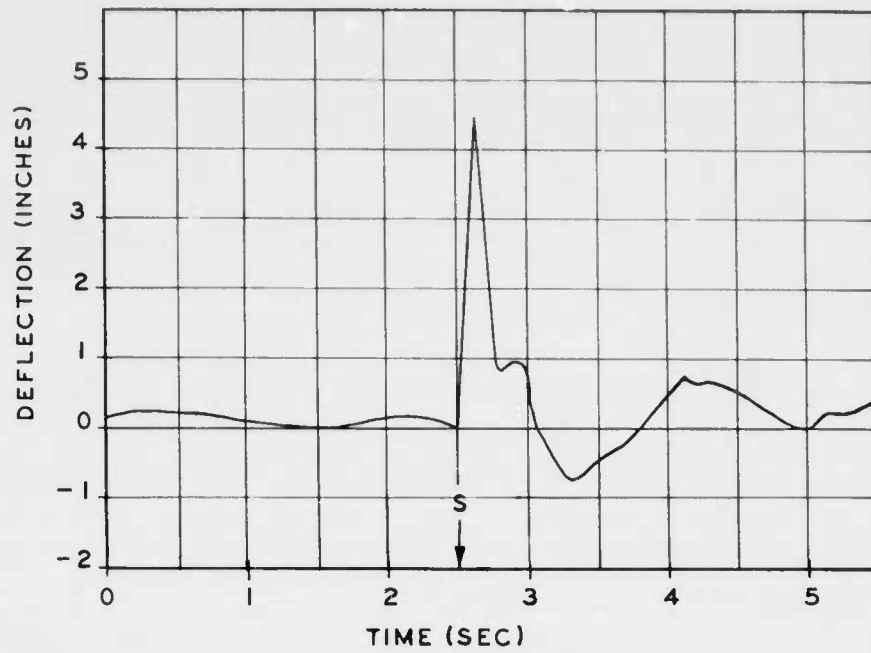
Fuselage. Fuselage deflection was obtained from airborne Cameras 2 and 5 and was measured at Station 373. Reference marks were painted on the vertical stabilizer a little aft of the leading edge. The change in position of these marks was measured and multiplied by the calibration factor to obtain deflection in inches. The accuracy of the individual data points is  $\pm 0.54$  inches. A typical fuselage deflection-versus-time history is presented in Figure 6.6.

Figure 6.6 Fuselage Deflection versus Time After  $T_0$ ,  
Station 373, Drone 2

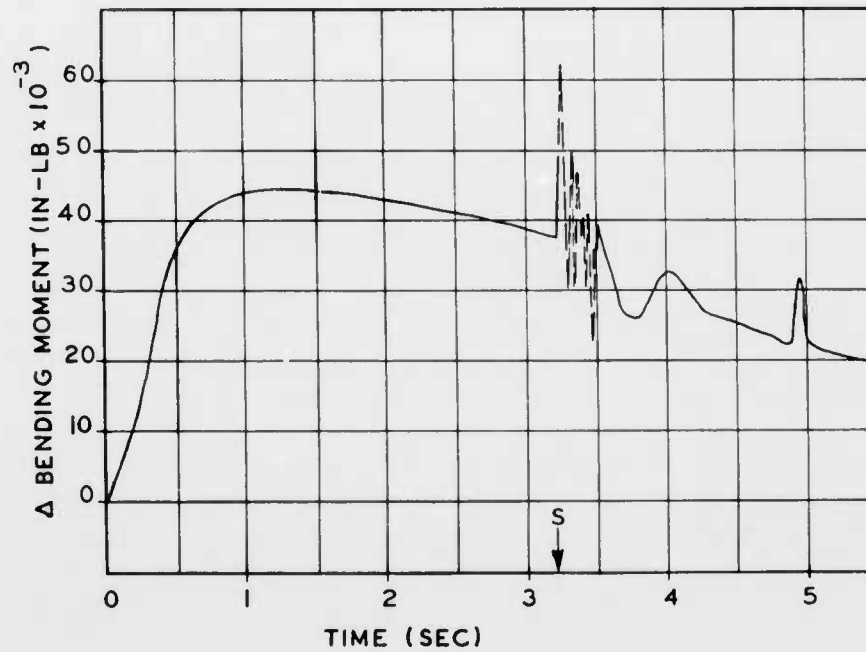
A typical bending-moment curve is presented in Figure 6.7, with the dashed line representing that portion of the curve which was not clearly legible on the record. In this figure the strain-gage response is termed "apparent" bending moment, because it includes the thermal effects at time zero which are not actually bending moment.

Figure 6.7 Horizontal Stabilizer Apparent Bending Moment,  
Station 43 Left, Drone 1

cameras between time zero and shock arrival and shown in the deflection figures of Chapter 5. This was also shown by the large deflections of the bending moment curves between time zero and shock arrival (see Figure 6.7).

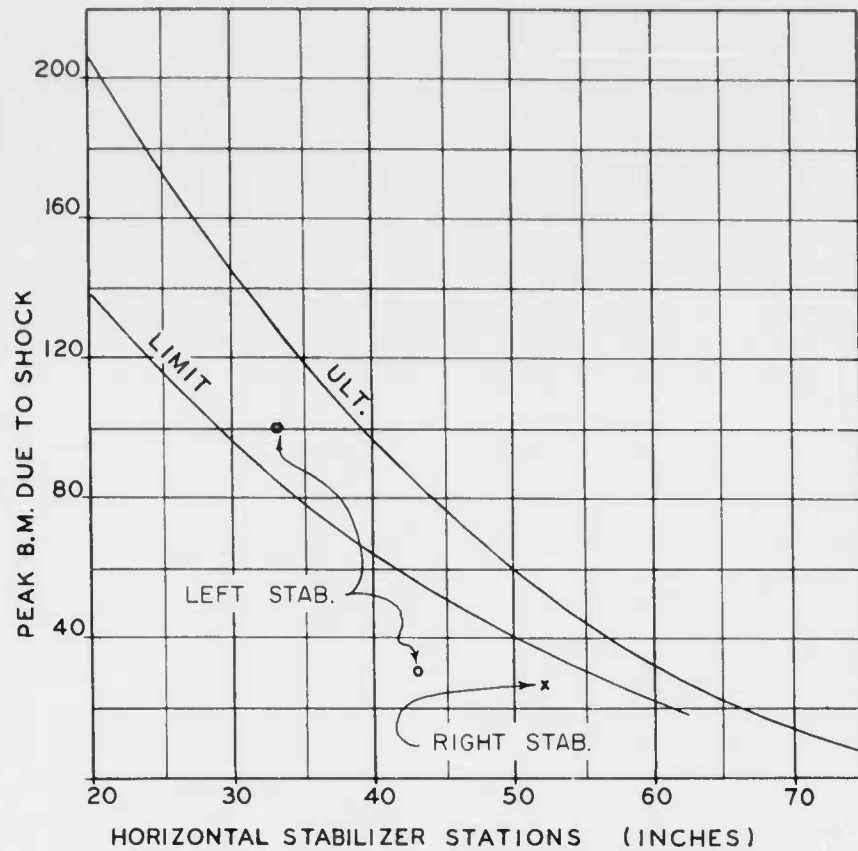
Figure 6.8 Comparison Between Peak Bending Moments and Limit Loads, Drone 1

are plotted against horizontal-stabilizer station and compared with limit load. This graph shows that the measurement at Station 43 does not form a smooth curve with Stations 33 and 52 and is far below limit load. It is therefore assumed to be in error. This is possibly due in part to the proximity of the bending moment measuring station to the actual break station.

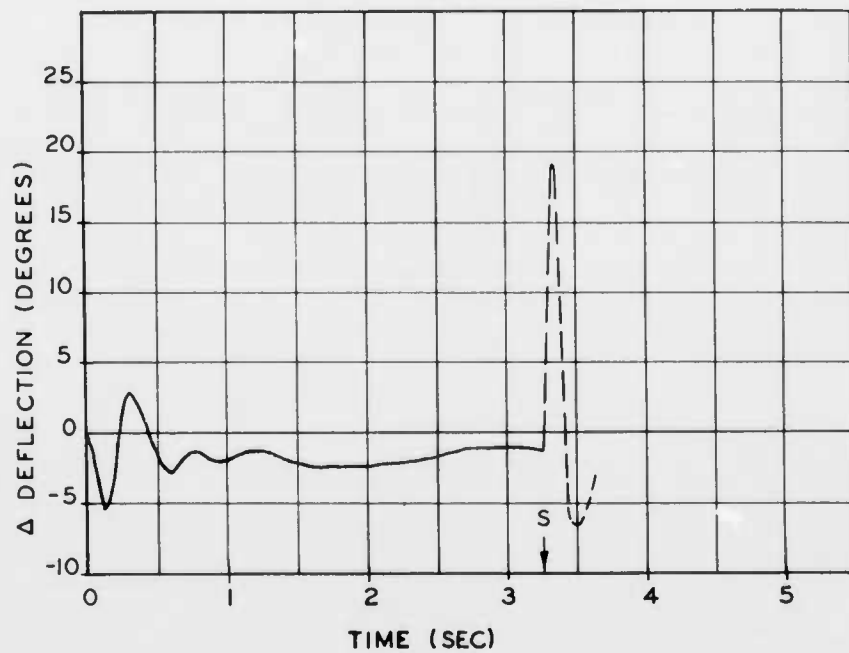
Figure 6.9 Elevator Deflection. Station Zero, Drone 1

6.2.5 Elevator Deflection. In Figure 6.9 is presented the elevator deflections at Station 0 on Drone 1. The elevator deflection for Drone 1 was obtained from the local recorder records and for Drones 2 and 3 from the telemeter records. The values of elevator deflection at shock arrival are obtained in the same manner as the bending moments discussed in the previous section and should be treated accordingly.

Except for the deflection at shock arrival, the curve of Figure 6.9 is typical of all three drones. For Drones 2 and 3 no deflections were measured after shock arrival. Although the amount of deflection varied from  $-5^{\circ}$  on Drone 1 to  $-9^{\circ}$  on Drone 3, it was generally the same for all stations on a given drone. The oscillation immediately following time zero was observed to have the same approximate period for all drones. The amplitude, however, varied inversely with the distance from the blast. This oscillation was also observed on all drone instrument-panel cameras as control-stick motion. No explanation of this phenomenon can be advanced at this time, however.

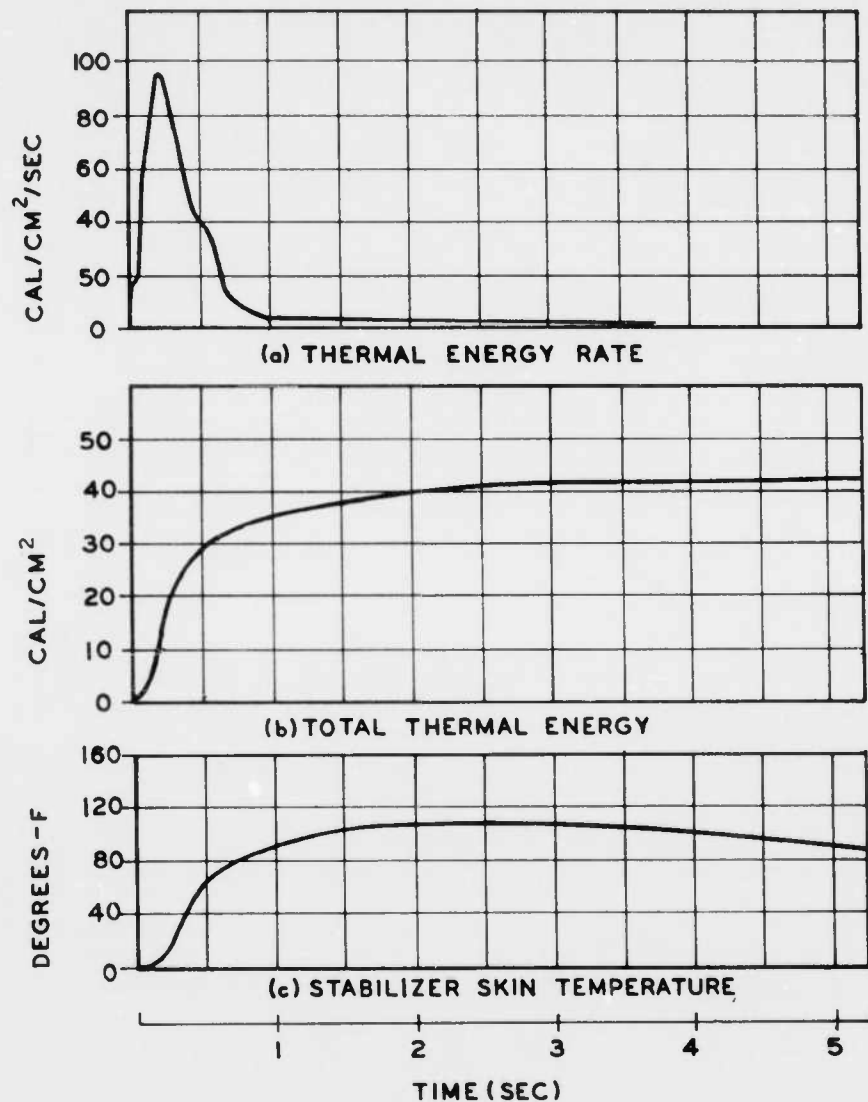
Time-history curves of thermal-energy rate, total thermal energy and horizontal-stabilizer skin temperature are given in Figure 6.10. These curves are typical of all drones, except for peak values obtained. As expected, the decline of thermal energy rate between 0.2 and 0.7 second was slower for Drone 3 and faster for Drone 1 than that shown for Drone 2. The total thermal energy leveled off at 5 to 6 seconds, and skin temperature reached a maximum at 2 to 3 seconds. The maximum values measured for all drones are given in Table 5.3.

Figure 6.10 Thermal Curves, Drone 1

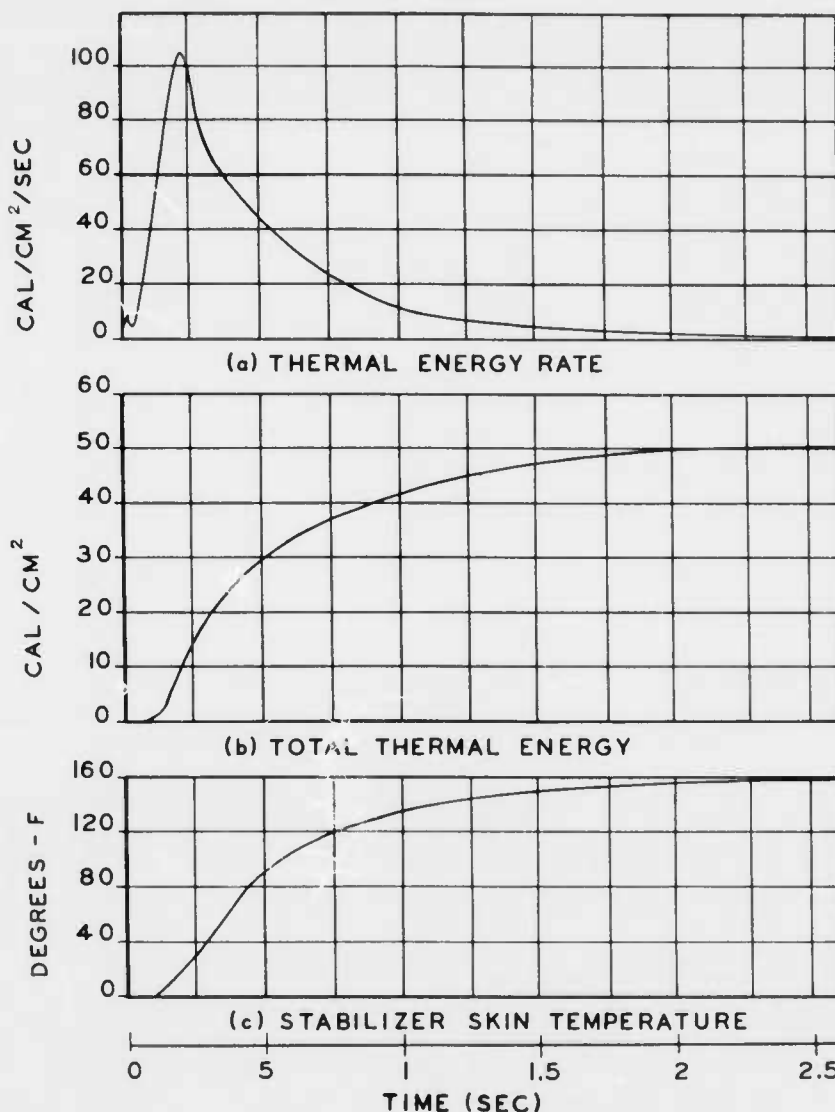
\* This is not maximum value for Drones 2 and 3, since thermal energy was still increasing when the record was lost at shock arrival. See Figures 6.11 and 6.12.

Figure 6.11 Thermal Curves, Drone 2

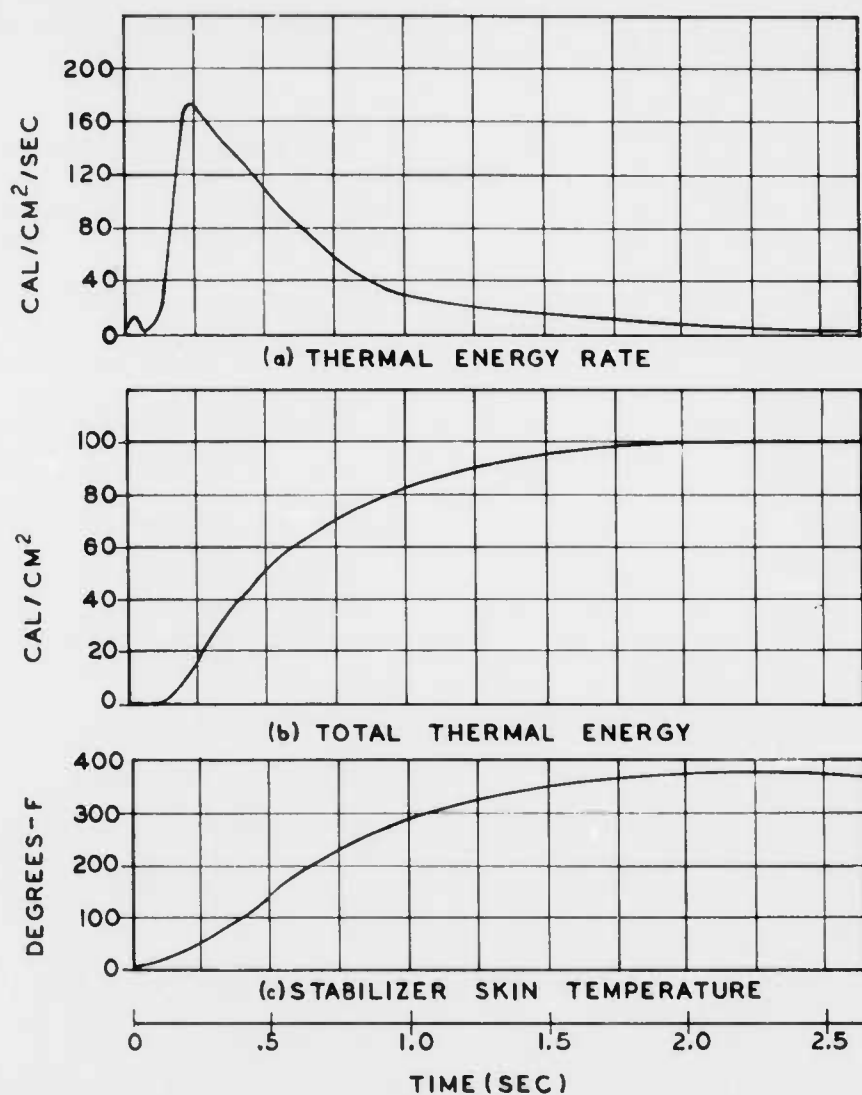
Figure 6.12 Thermal Curves, Drone 3
