# BUREAU OF SHIPS GROUP TECHNICAL INSPECTION REPORT

**OPERATION CROSSROADS.**  
U.S.S. LCT's 705, 816, 818, 874, 1013,  
1078, 1112, 1113

TEST ABLE

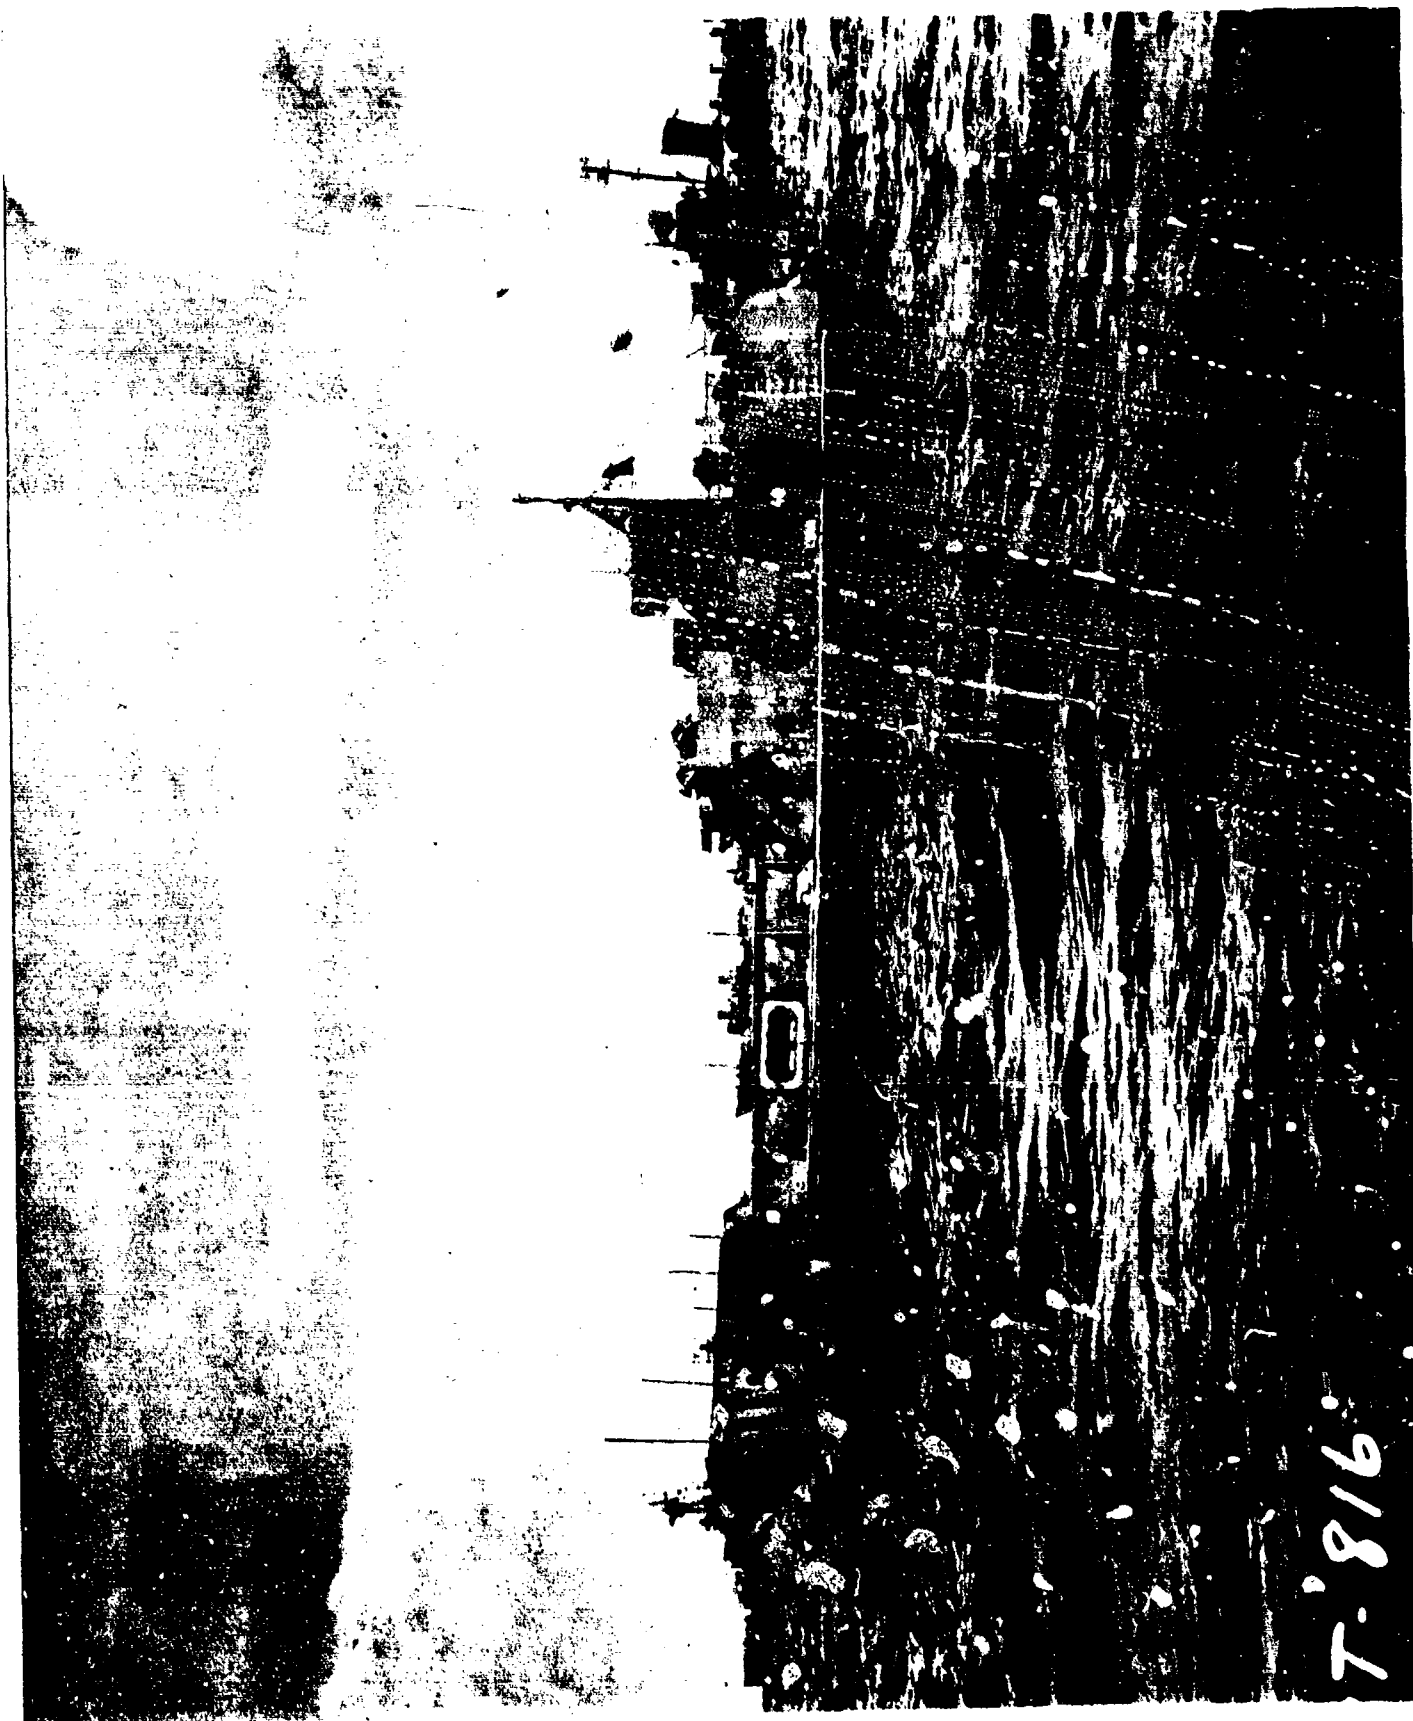
AA-CR-218-2889-9. View from off port beam after Test A.

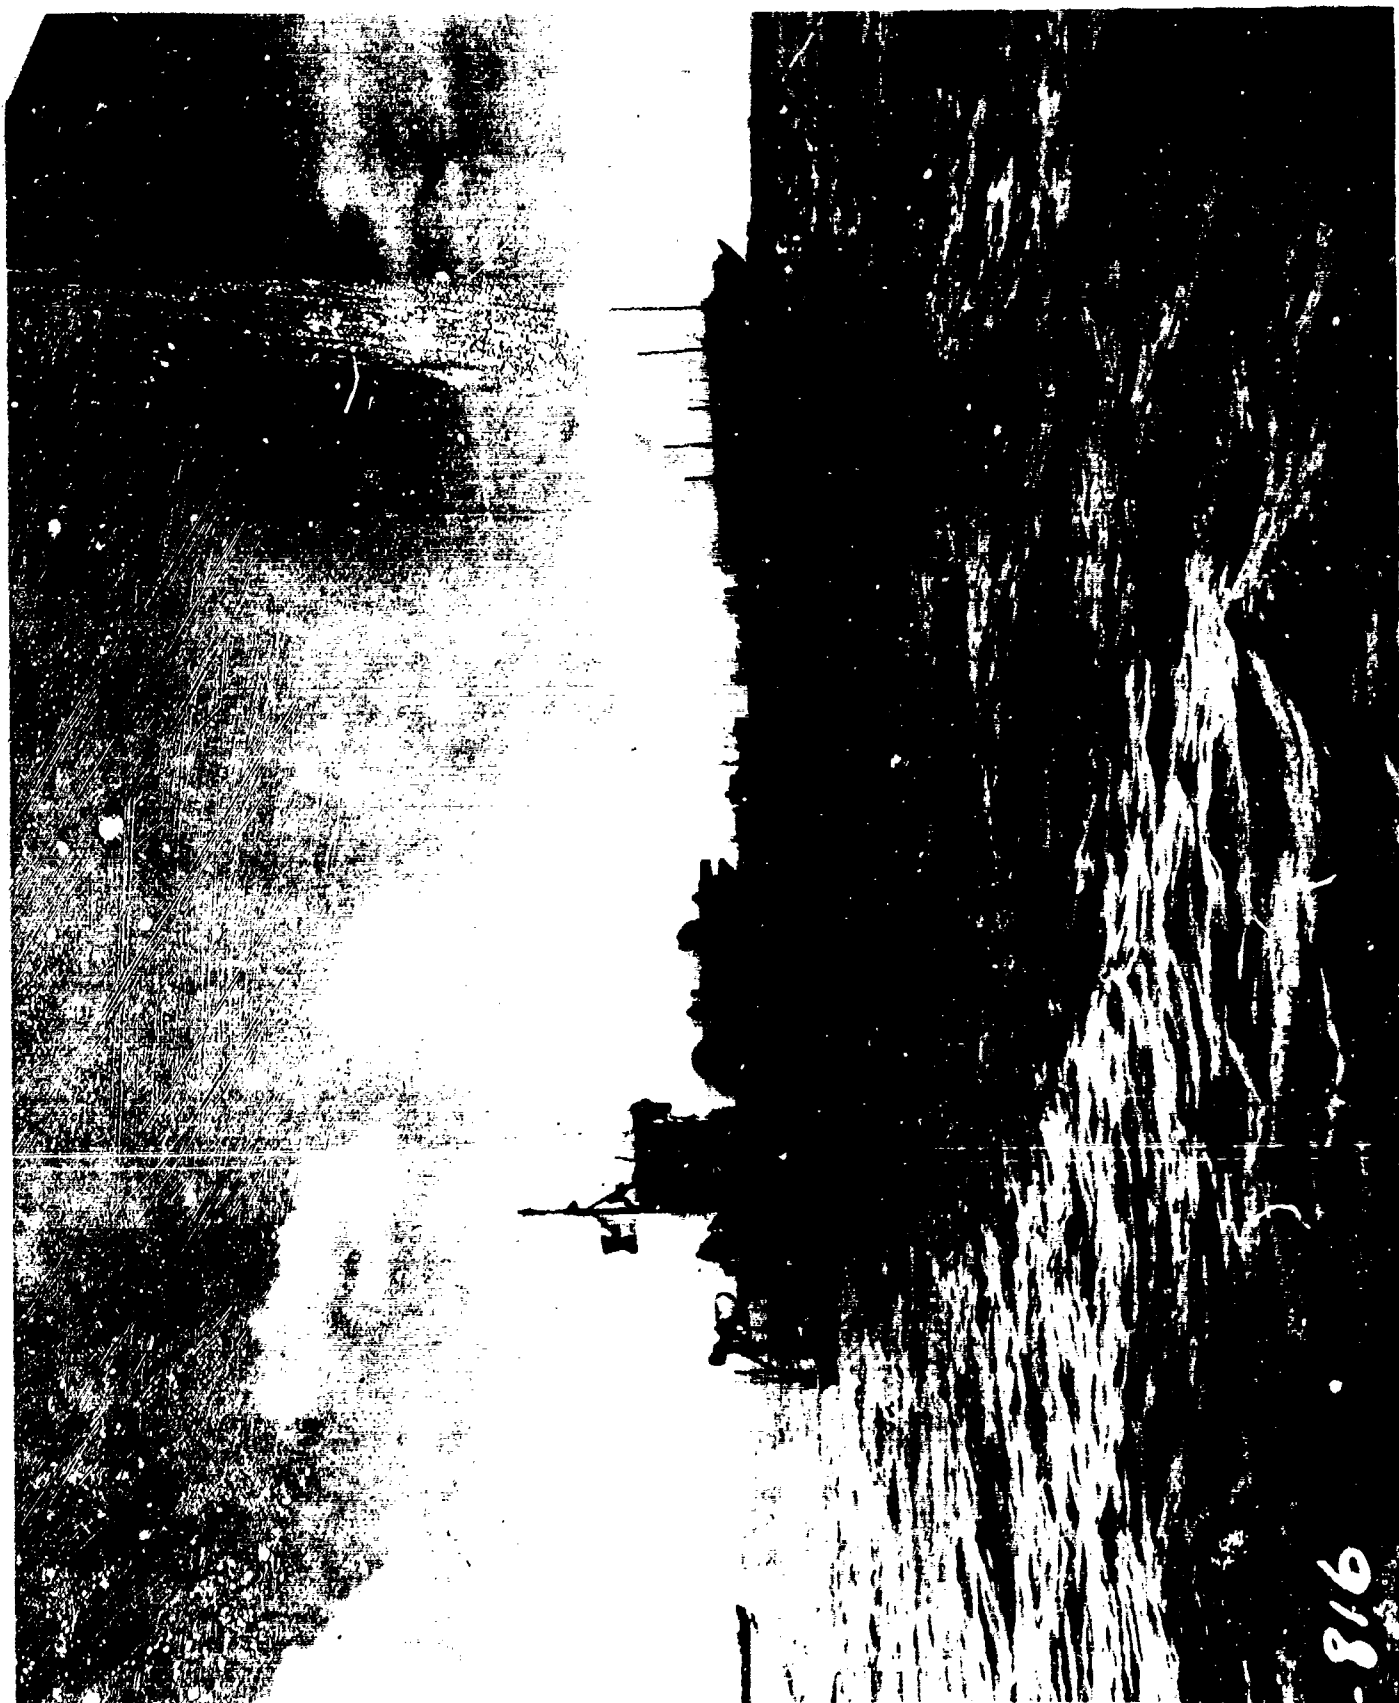
AA-CR-218-2889-5. View from off starboard beam after Test A.

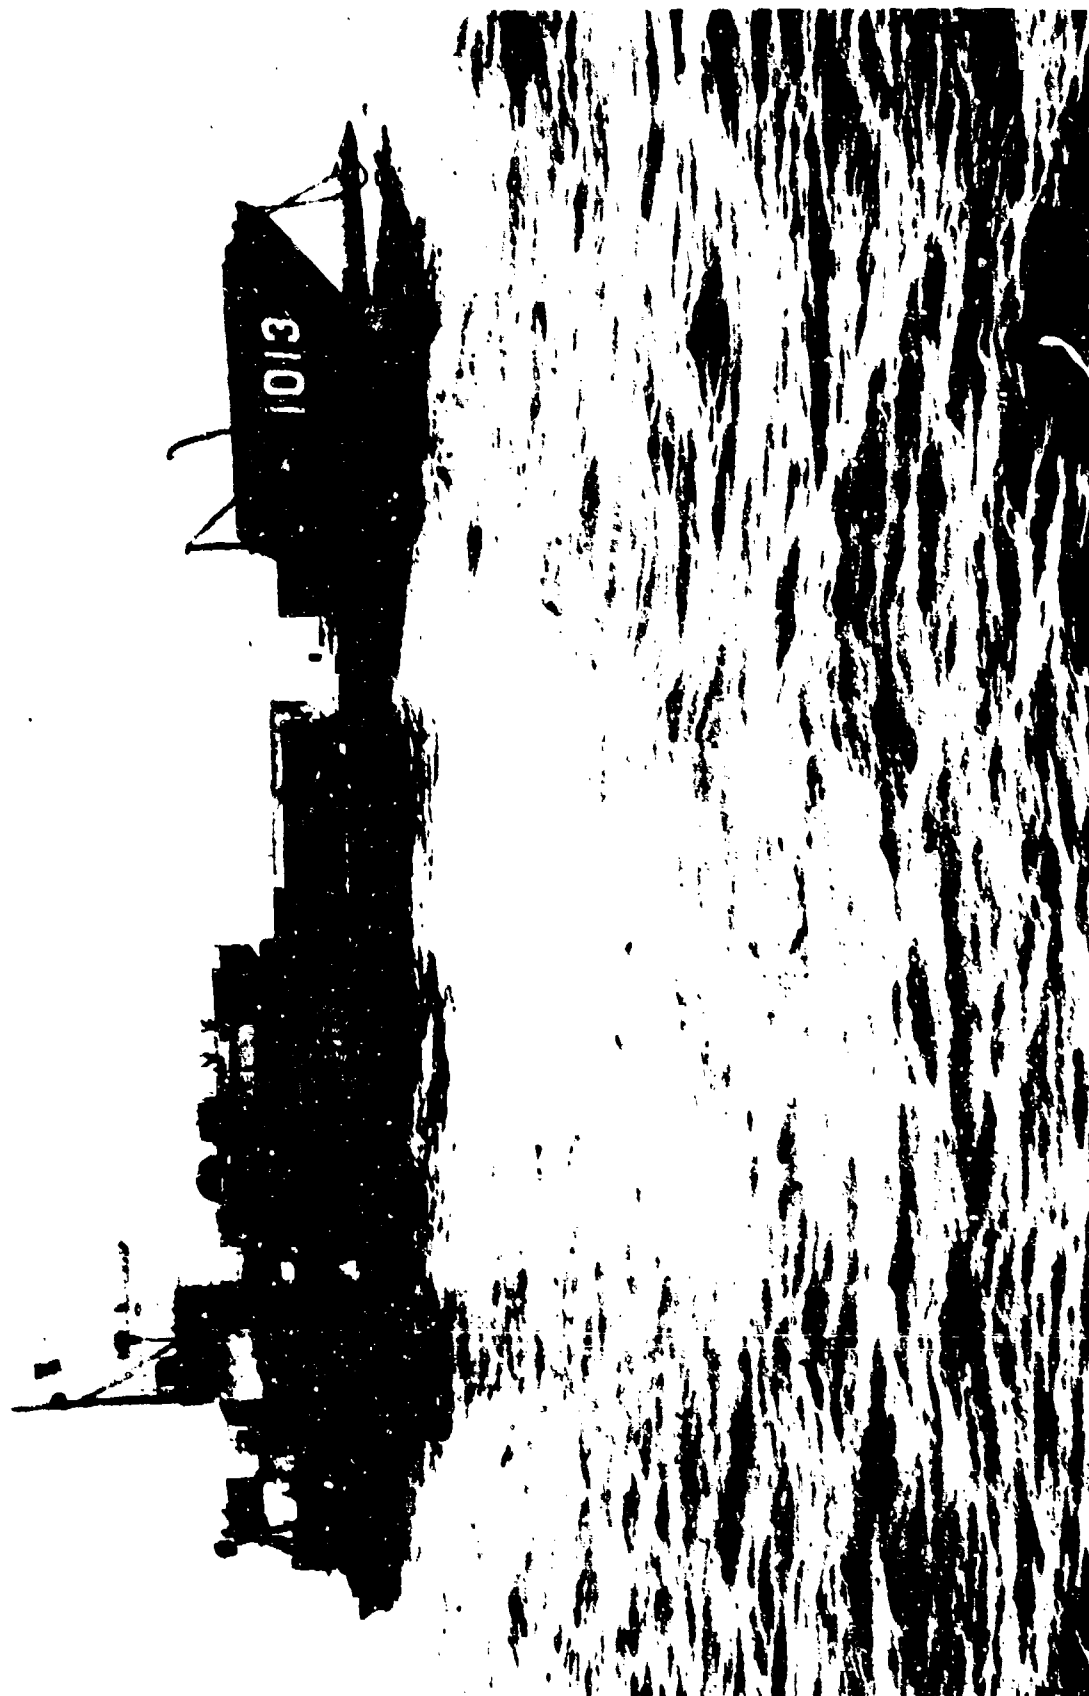
AA-CR-227-87-49. View from starboard beam after Test A.

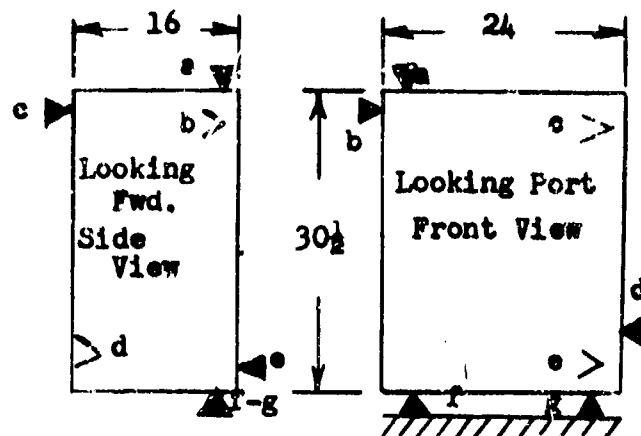
### DD410 #1 Cases:

Location: On Model TDQ Radio Transmitter, in Radio Transmitter Room (forward port corner near exterior bulkhead), First Superstructure Deck.

Type of Mounting: C type mounts on four bottom corners.  
Clearance about 1/4 inch.

Able: There was negligible shock or damage caused by test Able.

Baker: The shock caused by Baker test was of great severity. The transmitter room and its contents were in such disorder that no quantitative measurements were possible.

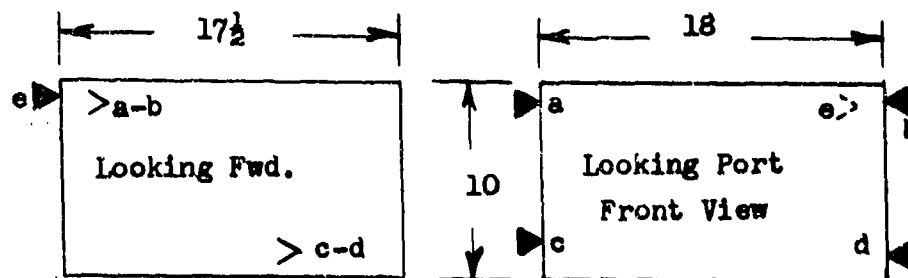
DD410 #2 Gages:

Location: On Model RCK Radio Receiver, in Radio Transmitter Room, First Superstructure Deck. (In Forward Port Corner above TDQ.)

Type of Mounting: L type mounts on four bottom corners.  
Clearance to shoulders of mounts is 1/8 inch.

Able: There was negligible shock or damage caused by test Able.

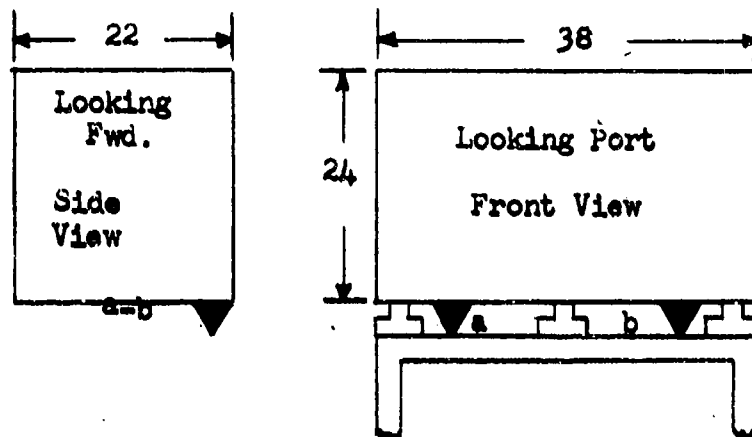
DD410 #3 Gages:

Location: On Range and Train Indicator type CRP-55ABC-3  
Room, Second Superstructure Deck (port side).

Type of Mounting: Three C type mounts, as shown, run the full depth of the equipment. Clearance is about 1/2 inch.

Able: There was negligible shock or shock damage caused by test Able.

Baker: The shock caused by Baker test was very severe. The mounts did not fail although they were not stiff enough to be effective.

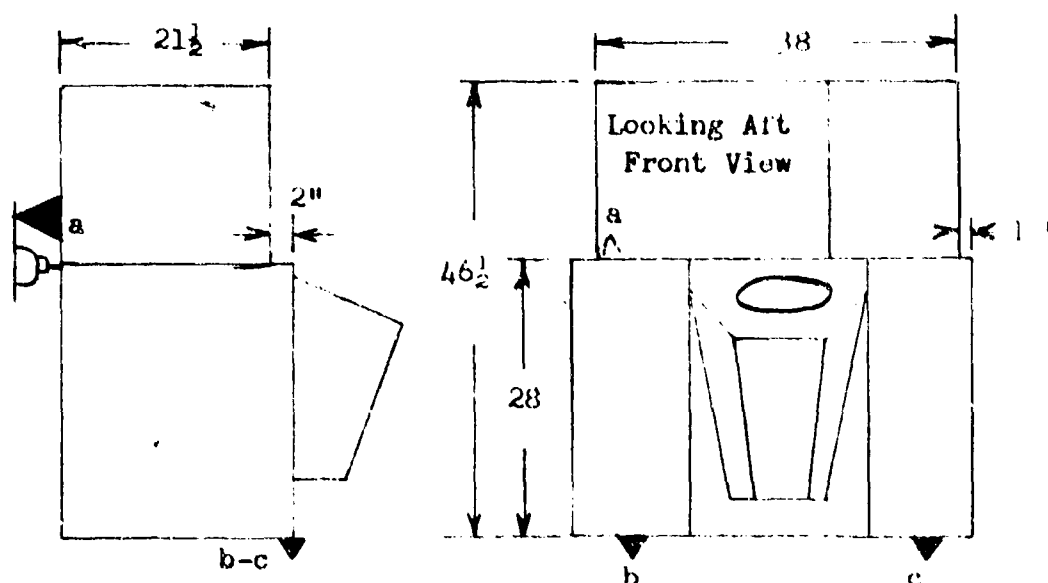
DD410 #4 Gages:

Location: On Plan Position Indicator type CG, in C.I.C. Room (after starboard corner), Second Superstructure Deck.

Type of Mounting: Short C type mounts on each of four bottom corners. L type mounts on the back upper corners of the lower unit. Clearance from 1/4 to 3/8 inch before mounts bottom.

Able: The deflections caused by test Able were small.

Baker: The unit was knocked entirely free of its supports during test Baker. All mounts on the base of the equipment failed. The upper rear mounts pulled a bulkhead "T" section loose.

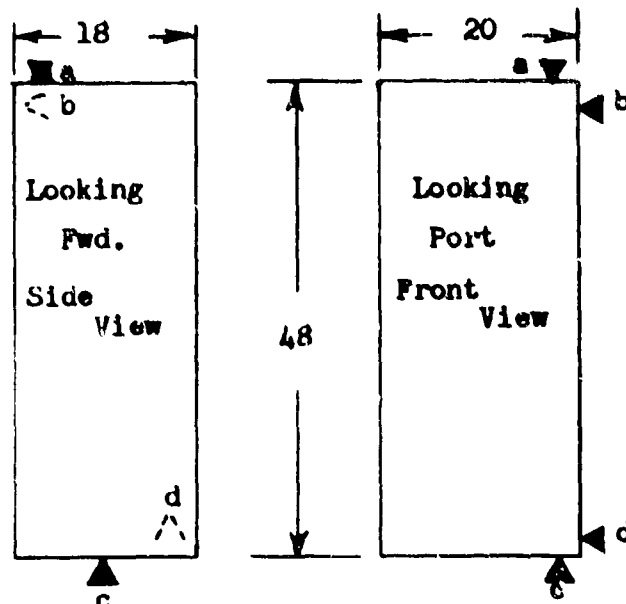
DD410 #5 Gages:

Location: On Radar Transmitter Model SC-2, type CG, in Radar Transmitter Room, Second Superstructure Deck.

Type of Mounting: Short C type mounts on four bottom corners and in middle of front and back bottom edges. C type mounts on upper back corners. Vertical clearance less than 1/8 inch (rubber had crept).

Able: Only small deflections and no damage were caused by test Able.

Baker: All of the mounts failed for test Baker, allowing the gear to become loose. The compartment was wrecked.

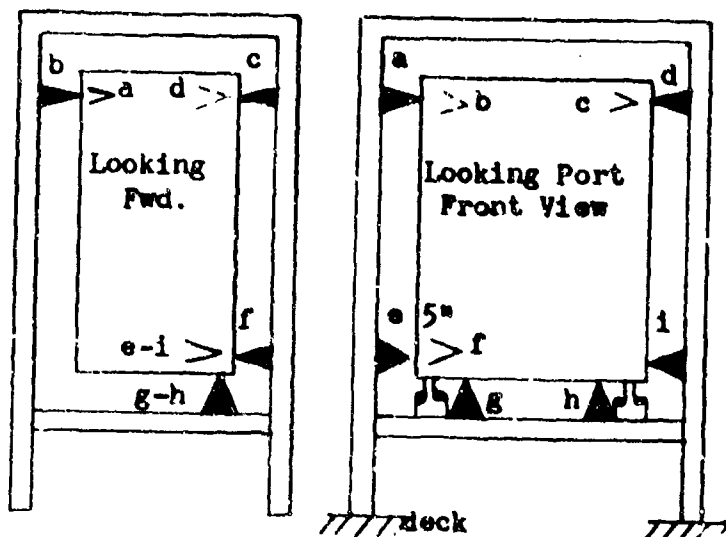
## DD419 #1 Gages:

Location: On Radio Transmitter Model YDQ, in Forward Port Corner of Radio Transmitter Room, First Superstructure Deck.

Type of Mounting: Short C type mounts on each of four bottom corners. Clearance of mount is about 1/4 inch vertically.

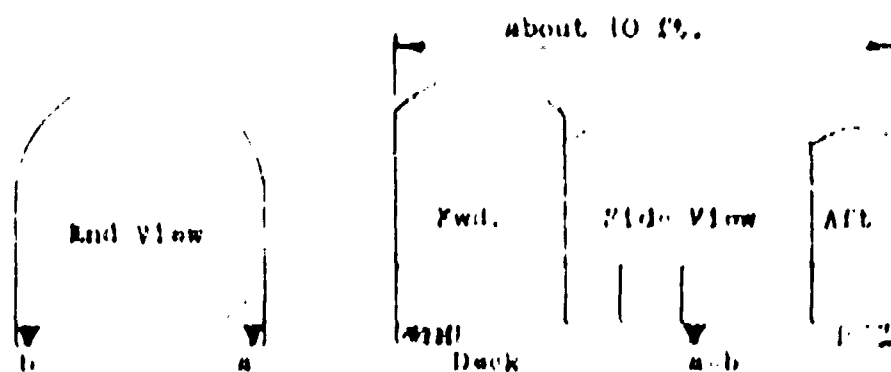
### APA64 #1 Gages:

Location: On Turbo-Generator (BuShip's Section 6 2 Special Item #11 #15), in Forward Cargo Hold Lowest Level.

Type of Mounting: The unit is solidly mounted at the four bottom corners, but it has a long unsupported span between the ends. The unit weighs about 15 tons.

Abse: There was no measurable deflection of the long unsupported span of the Turbo-generator, caused by the Abse test.

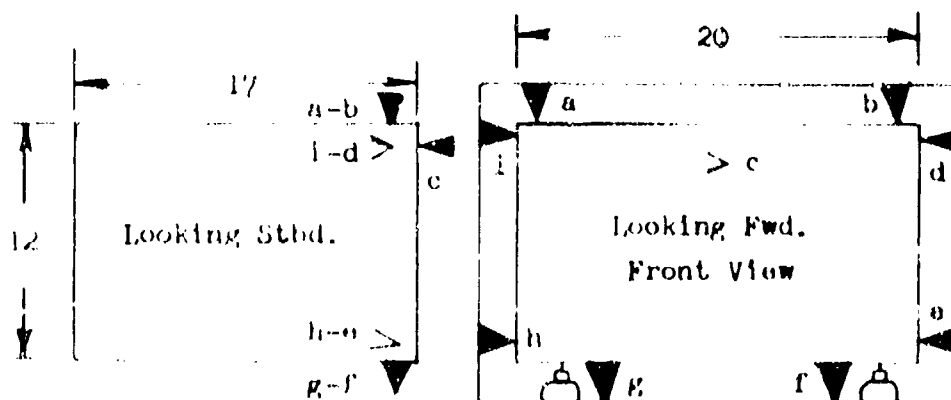
#### BB34 #1 Gages:

Location: On Model RMO Radio Receiver, in Forward Starboard Corner of Main Radio (Receiving) Room, Third Deck Interior Room between Frames 50-55.

Type of Mounting: L type mounts on the four bottom corners. Clearance is not apparent but is on the order of 3/8 to 1/2 inch. The unit is mounted in an angle iron frame that is attached to a forward interior bulkhead.

Able: The shock at this interior part of the ship was negligible. The deflections are generally less than would be caused by a sustained acceleration of  $1g$ .

Baker: The vertical component of the shock was severe causing  $3/4$  inch upward motion and solid bottoming. However, there was no apparent damage to the receiver. The shock in the horizontal direction was negligible.

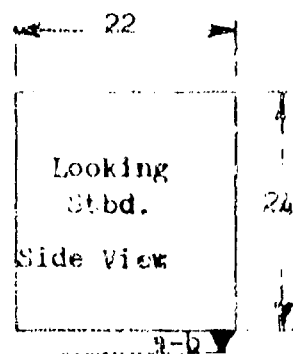
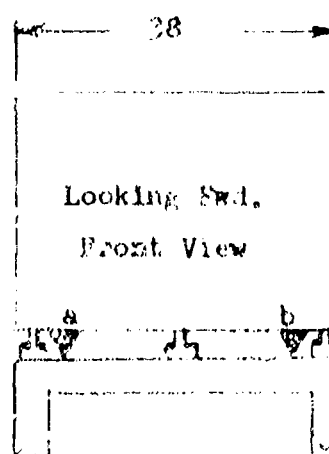
BH 34 #1 Gages:

Location: On Range and Train Indicator, type GMP-55 AFH, in Forward Port Corner of C.I.C. Room on Signal Bridge.

Type of Mounting: Three C type mounts run the full depth of the equipment as shown above. Vertical clearance of mounts is about 1/2 inch.

Baker: It is probable that the apparatus bottomed, but with little excess energy. If it is assumed, as a reasonable approximation, that the frequency of vertical vibration is 10 cps, then at least 1/2 inch clearance is required. This is about 5 times the static deflection. The equipment was not obviously damaged.

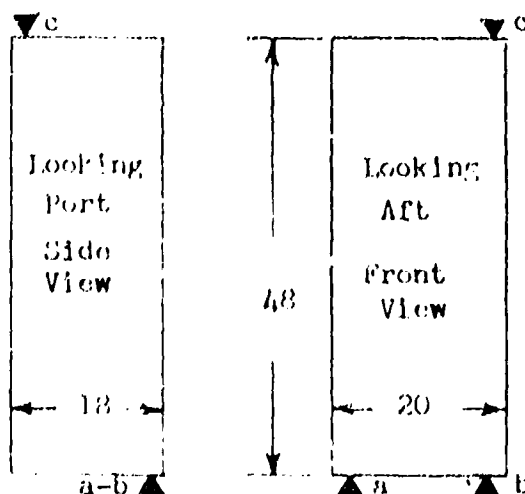
BB34 #4 Gages:

Location: On Radar Transmitter Model SK type CG-52ABH, in #2 Combat (frame 64) on the Flag Bridge.

Type of Mounting: Eight C mounts used on the bottom corners and on edges midway between corners, two C type mounts on upper back corners.

Able: There was no damage and negligible shock intensity registered by this equipment.

Baker: The mounting system is adequate to protect this radar from noticeable damage. However, the deflections were very large which indicated severe shock conditions.

Type of damage caused by Baker test to Combat #2 compartment is indicated by the failure of the bonding of the sheer mounts (holding the gyro repeater) the train indicator was thrown out of place; and the optical range finder was broken out of the saddle.

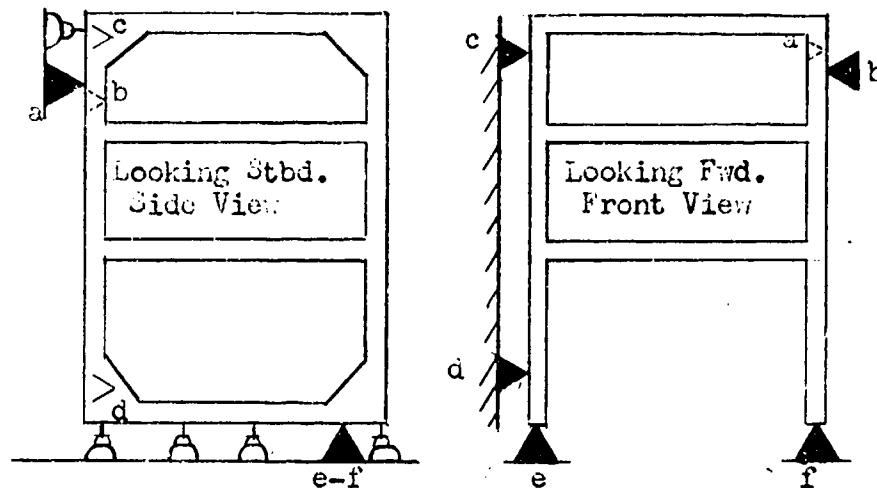
### CA24 #3 Gages

Location: On Shock Mount Rack Containing Fire Control Radar Gear, located on Port Side of Radar Transmitter Room.

Type of Mountings: Four L type mounts under each side bottom edge. The L type mounts on upper back corners. Clearance 1/8 inch to shoulders of mounts.

\*Rubber of upper back shock mount failed.

Able: This apparatus was attached to the deck and to bulkheads. The mounts attached to the bulkhead were strained and one failed. The vertical shock was minor compared with those transmitted by the bulkhead.

**Baker:** The compartment was in such chaotic condition that no measurements could be made. The Rack was still held in place by the mounts.

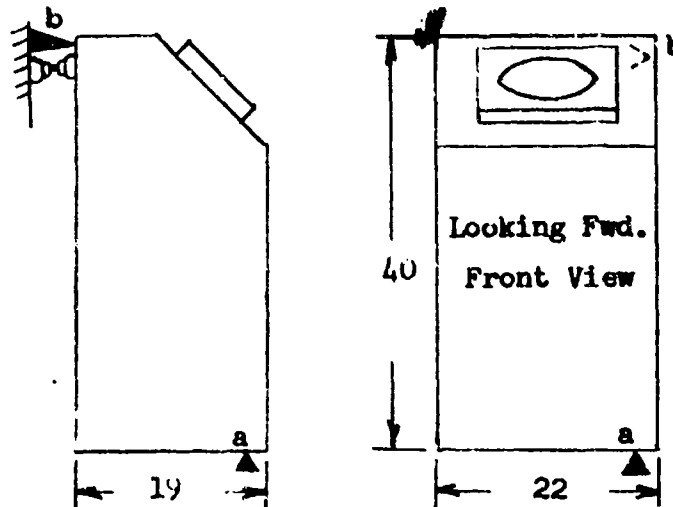
GA24 #5 Gauge:

Location: CB Plan Position Indicator type CB-51000, Near Center of Forward Bulkhead of C.I.S. Room.

Type of Mounting: Combination mounts on each of four bottom corners. These consist of C type mounts plus a rubber sandwich in parallel. Stabilizing L type mounts are located at upper back corners. Clearances were not determinable.

Able: There was no apparent damage to the P.P.I. or to its mounting supports. The displacements indicate a minor shock.

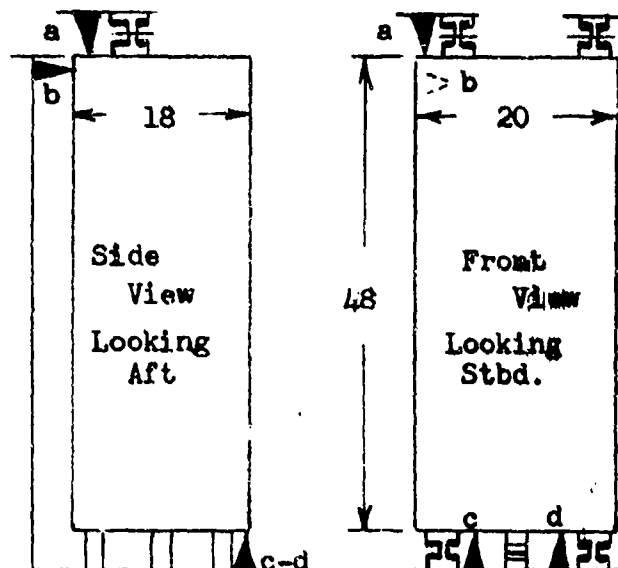
CA25 #2 Gages:

Location: On Radar Transmitter type OG-52ABH, in Radar Transmitter Room (frame 45-47).

Type of Mounting: C type mounts used on four bottom corners and at center of four bottom edges. Two C type mounts are used on the upper back edge. Clearance to bottom 1/4 inch.

Able: The top mounts were destroyed. The lower mounts probably bottomed. The general damage within the transmitter room is minor, but the damage outside of the room is very extensive.

Baker: Because of the damage caused by Able test no observations were made for Baker test.

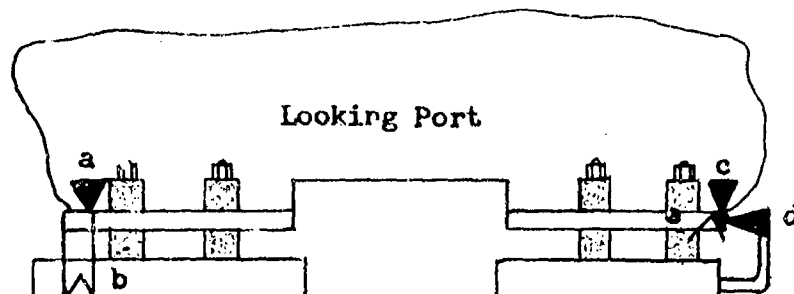
SS184 #1 Gages:

Location: On Shock Mounted Motor Generator Set, in Port Forward Corner of compartment below the control cubicle.

Type of Mounting: Mounts are as shown on each of the four bottom corners of the M-G set. The rubber is about 1 1/4 inches thick.

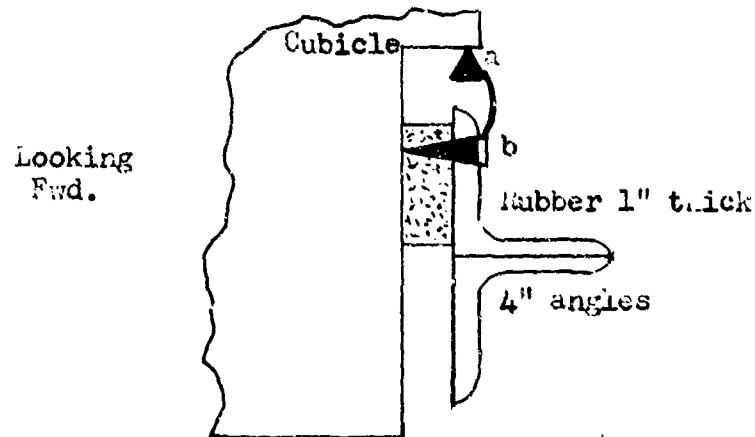
SS196 #1 Gages

Location: On Control Cubicle, Lower Starboard Edge about four feet from After Edge, in After Maneuvering Room. The gages are shown in the accompanying figure.

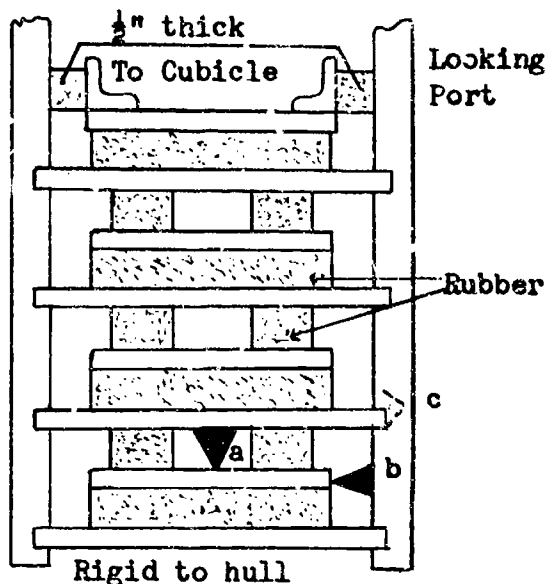
**SS196 #3 Gages:**

**Location:** On Control Cubicle, Upper Forward Starboard Corner, in After Maneuvering Room. Gage positions are shown in the figure below.

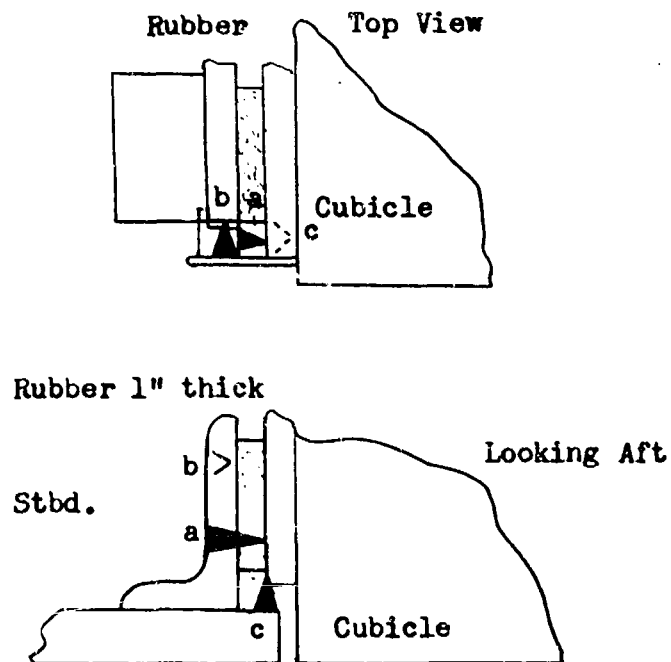
SS308 #1 Gages:

Location: On Control Cubicle, Lower Forward Starboard Mount in After Maneuvering Room. Gage positions are illustrated on the accompanying figure.

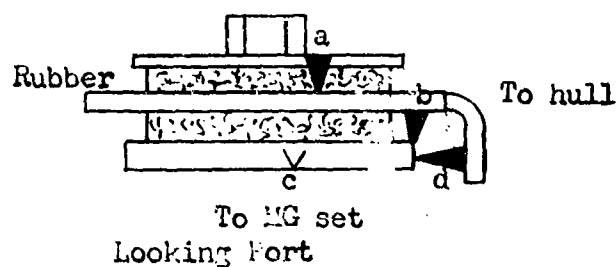
SS308 #2 Gages:

Location: On #2 Lighting Motor Generator, Forward Upper Mount, on port Side of After Maneuvering Room.

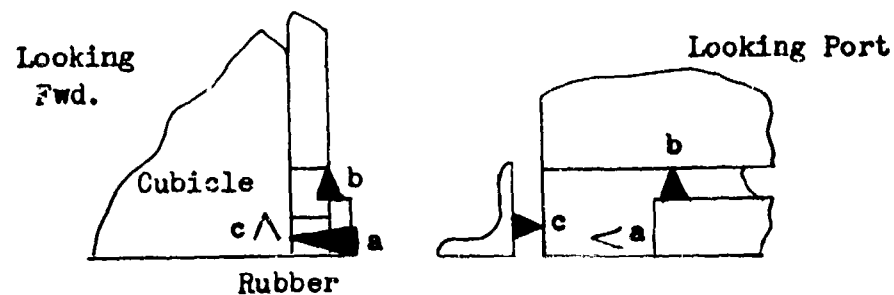
SS308 #4 Gages:

Location: On Lower After Starboard Corner of Control Cubicle, in After Maneuvering Room.

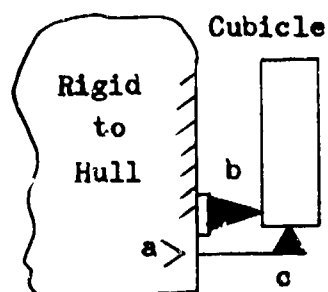
SS308 #5 Gages:

Location: On Upper Forward Port Corner of the Cubicle, in After Maneuvering Room.

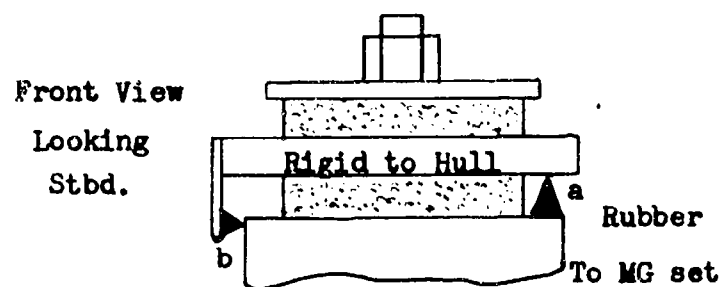
SS308 #6 Gages:

Location: On #1 Lighting Motor Generator Set. Upper Forward Mount, on Starboard Side of After Maneuvering Room.

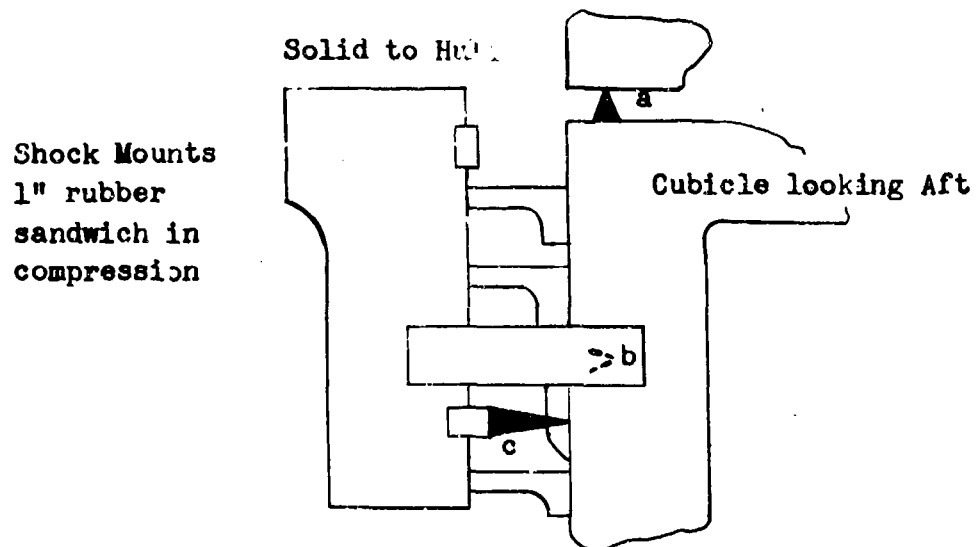
SS335 #1 Gages:

Location: On Upper Forward Starboard Corner of Control Cubicle in After Maneuvering Room.

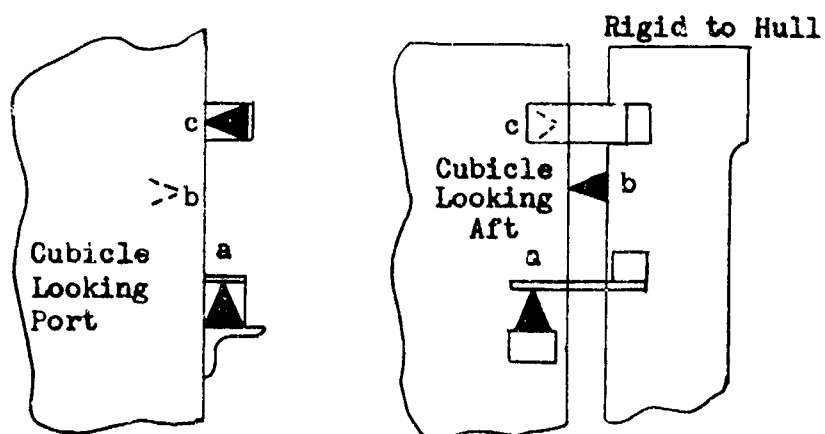
### SS335 #3 Gages:

Location: On Upper Forward Port Corner of Control Cubicle  
in After Maneuvering Room.

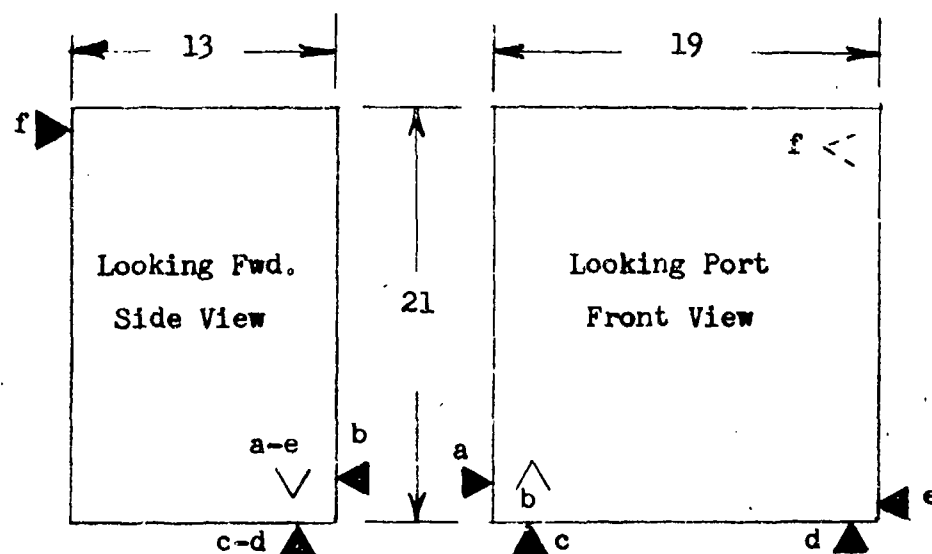
SS335 #4 Gages:

Location: On Model SJ-1 Radar Transmitter-Receiver type CW-43AAF-1, at Center of Port Side of Conning Tower.

Type of Mounting: L type mounts on four bottom corners and on two upper back corners. Clearance of mounts is about 1/4 inch to their shoulders which are about 1 inch thick.

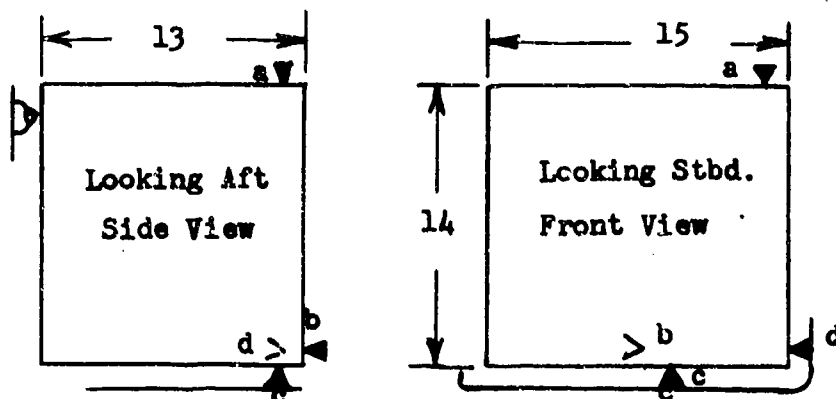
## SS335 #5 Gages:

Location: On Model SJ-1 Radar Main Control Unit type  
CBB-23ADH, at Center of Starboard Side of Conning Tower.

Type of Mounting: L type mounts on each of four bottom corners and on the two top back corners. Clearance 1/16 to 1/8 inch to shoulders of mounts.

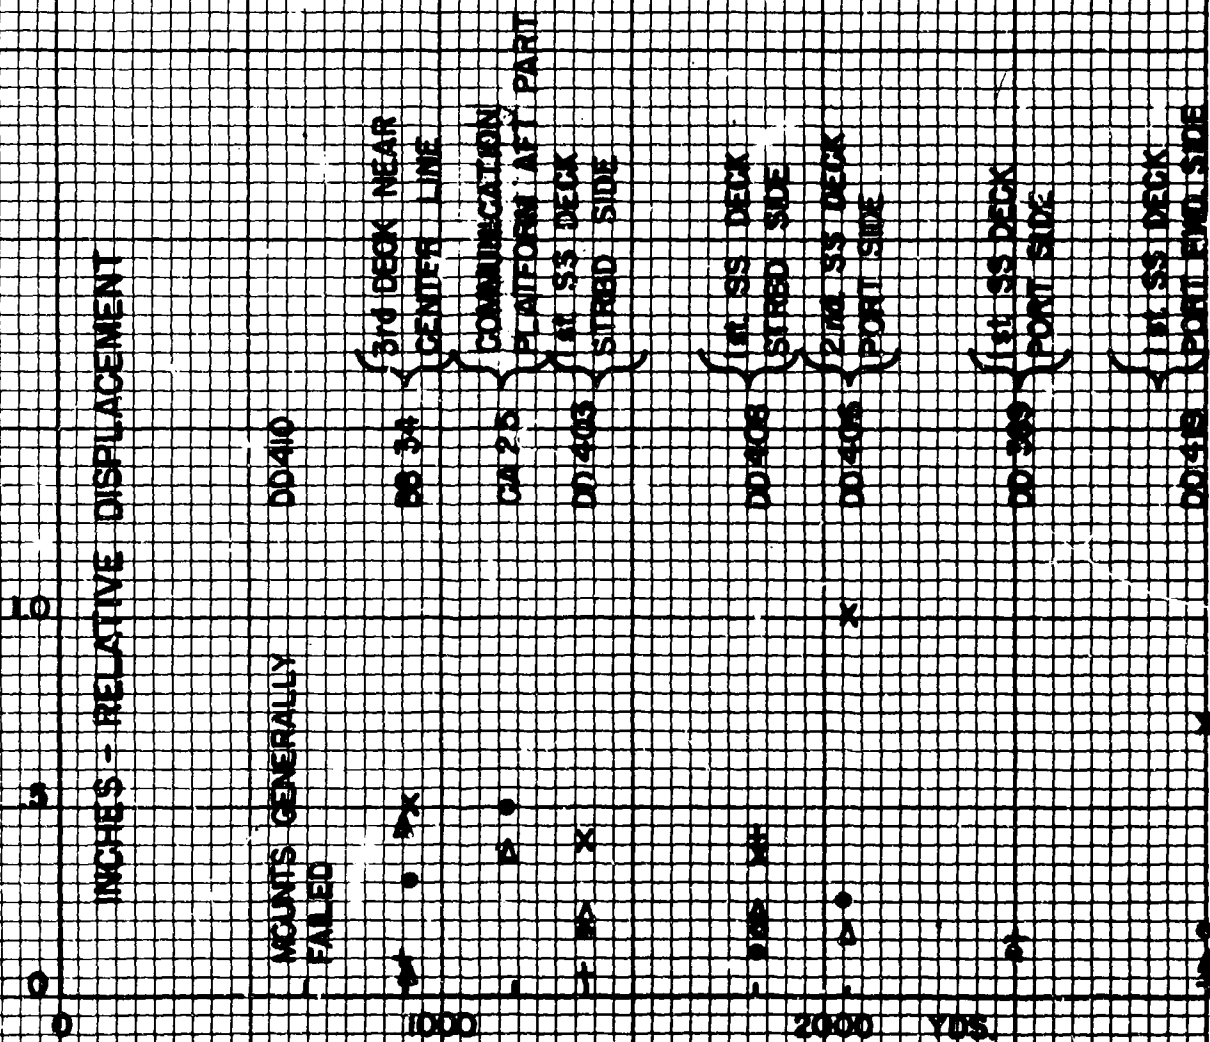
# MAXIMUM RELATIVE DISPLACEMENT OF RADIO TRANSMITTER, MODEL TDQ, WITH RESPECT TO ITS SUPPORTS

NATURAL FREQ: VERTICAL - 12 CPS.  
 ROCKING - 4-7 CPS.  
 (BOTH LOWER MODES)
