BUREAU OF SHIPS GROUP
TECHNICAL INSPECTION REPORT

OPERATION CROSSROADS.
U.S.S. CATRON (APA 71).

TEST BAKER [U]. (8)

OPERATION CROSSROADS

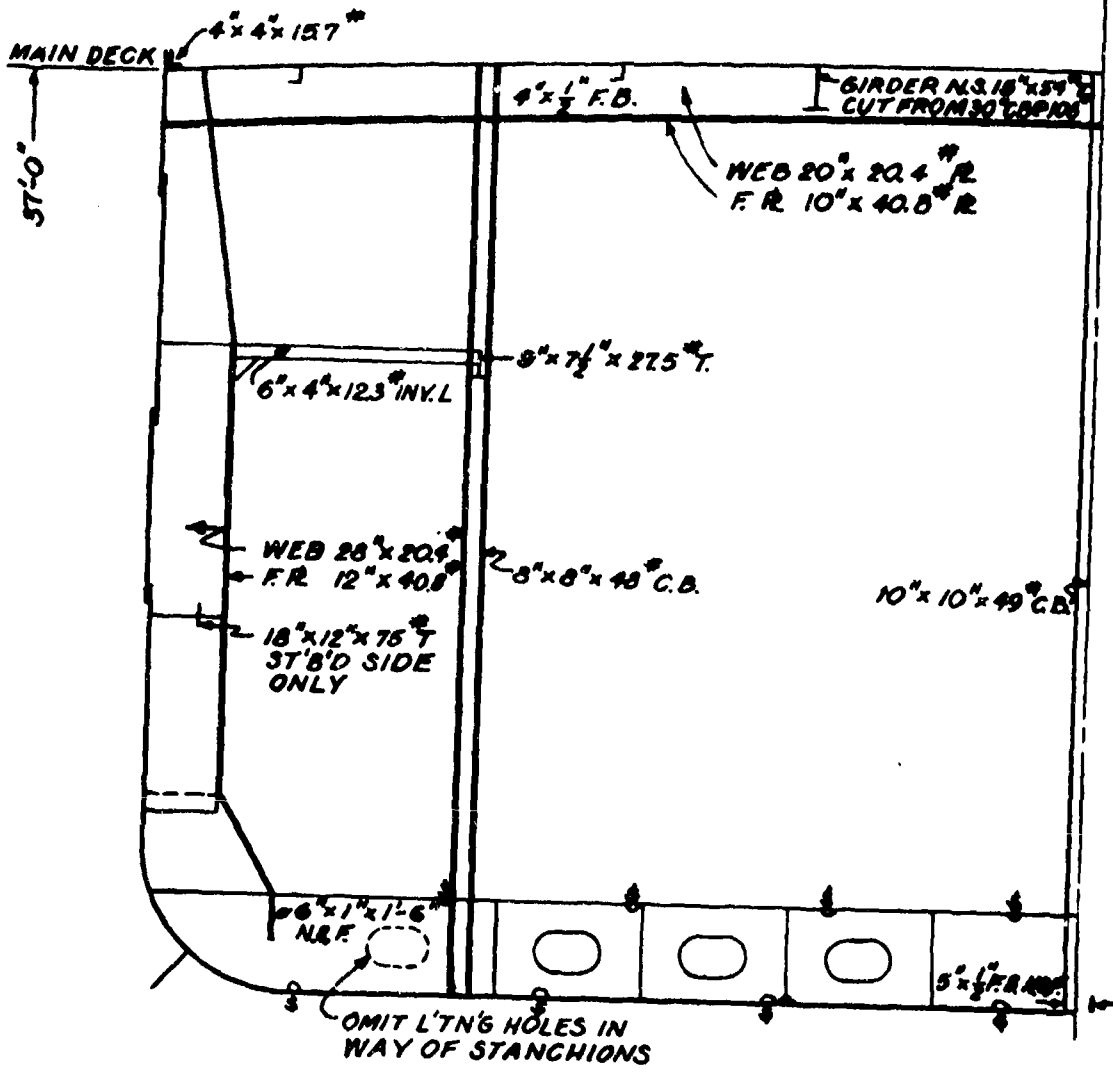
FRAME 76 LOOKING AFT
 MIDSHIP SECTION

The shaft alley bilges and starboard shaft alley were flooded through the stern tubes. The after machinery space flooded from the starboard shaft alley through the bulkhead gland. The forward machinery space flooded through a broken 1/2" salt water cooling line to the main circulator lube oil cooler. The auxiliary machinery space flooded to a depth of about six feet through the starboard shaft gland from the forward machinery space.
