JOINT TASK FORCE ONE

ARMY GROUND GROUP  
(TASK GROUP 1.4)

FINAL REPORT  
OF  
ATOMIC BOMB TESTS

27 January 1946 to 30 September 1946

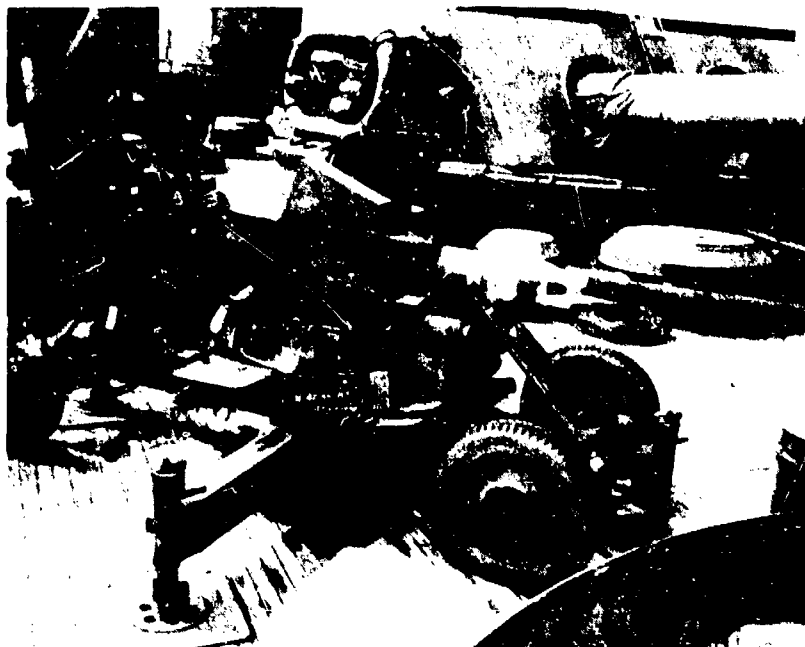
(1) Fig. 5 shows the method of securing the Gun, 40mm, AA, M1, w/mount, Gun, 40mm, AA, M2A1, (Item 22), to the deck. Three perpendicular plates were welded between the outrigger jack stews and floats, which in turn were welded to plates for more area, which were secured to the deck by four through bolts.

**Fig. 5 - USS Arkansas - Carriage, 40mm, AA, M2A1 -  
Showing method of securing to deck.**

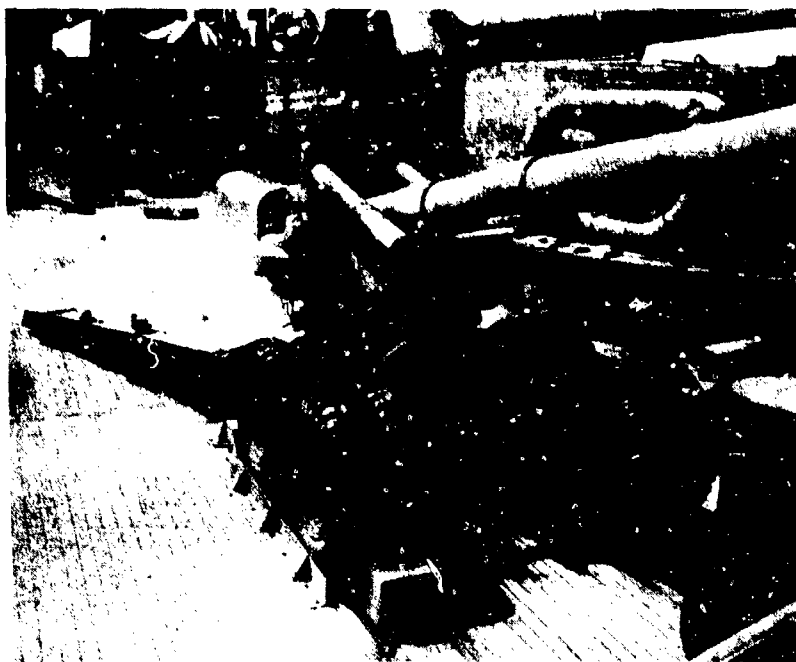
(3) Fig. 7 and Fig. 8 are views of securing the Gun, 155mm, M2, w/carriage, Gun, 155mm, M1A1 and Recoil Mechanism, M3, (Item 24), to the deck of the USS Arkansas and the USS Pennsylvania respectively. The latter photograph shows the strongback over the bottom carriage horn secured by bolts through the deck, a wooden saddle cut to the contour of the horn was placed under the strongback. The former photograph shows the wheel blocking and also the angle iron which prevented side shifting of the carriage. Over the trail can be seen the through U-bolts which hold the trails to the deck. Only one limber, M5, was displayed, and that on the USS Pennsylvania.

**Fig. 7 - USS Arkansas - Carriage Gun, 155mm, M1A1 -  
Right front view.**

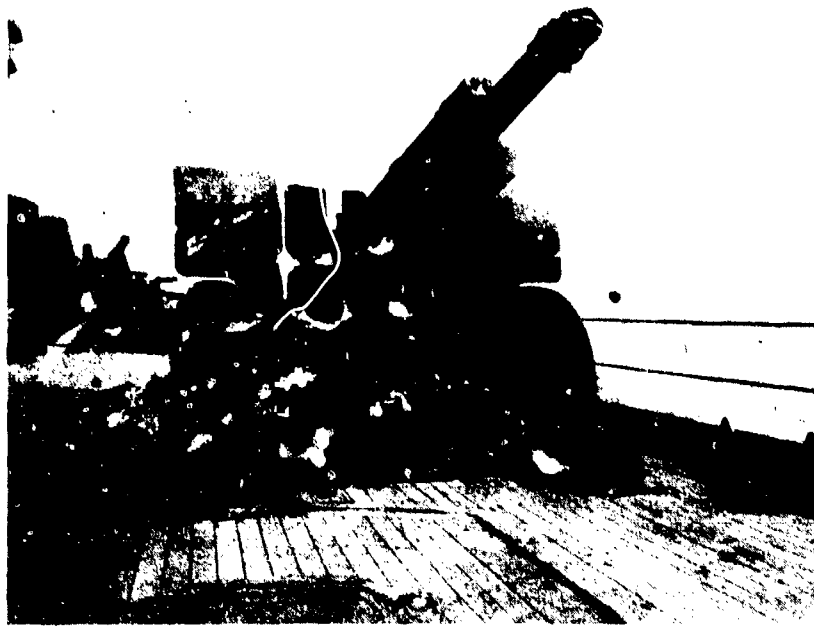
(4) Fig. 9 and Fig. 10 are typical photographs of the Howitzer, 105mm, M2A1, w/carriage, Howitzer, 105mm, M2A2, and Recoil Mechanism, M2A1, (Item 25), secured to the deck. Blocking

Fig. 9 - USS Arkansas - Howitzer, 105mm M2A1 -  
Right front view showing deck fastenings.

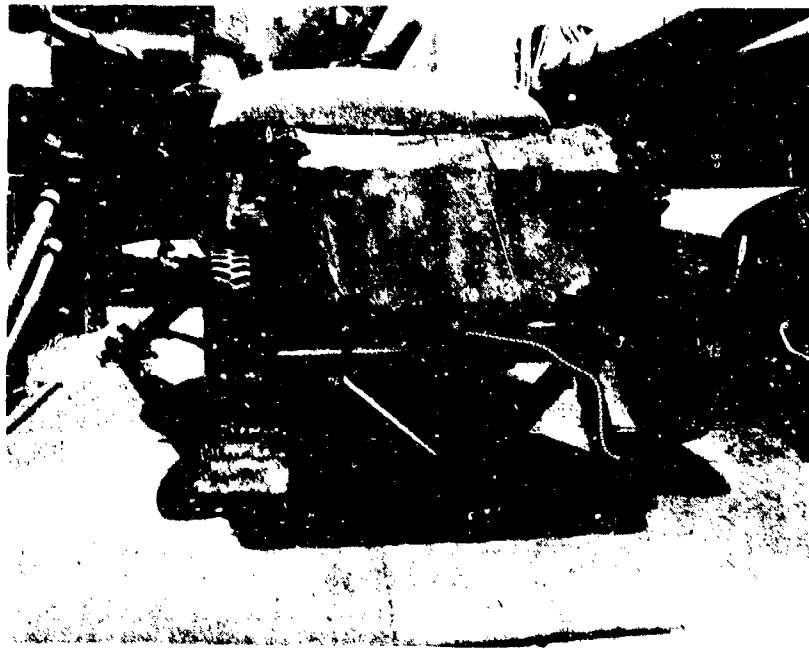
(5) Fig. 11 and Fig. 12 show the Launcher, Rock-4, 4.5", T66E2, Complete, (Item 26). In the latter it will be noticed that the vertical spade had been burned off the trails and the float area welded to a plate of larger area which is in turn bolted to the deck. The former photograph shows the bolts through the firing pedestal. All bolts were through the deck.

Fig. 11 - USS Nevada - Launcher, Rocket, 4.5", T66E2 -  
Front view showing method of securing to deck.

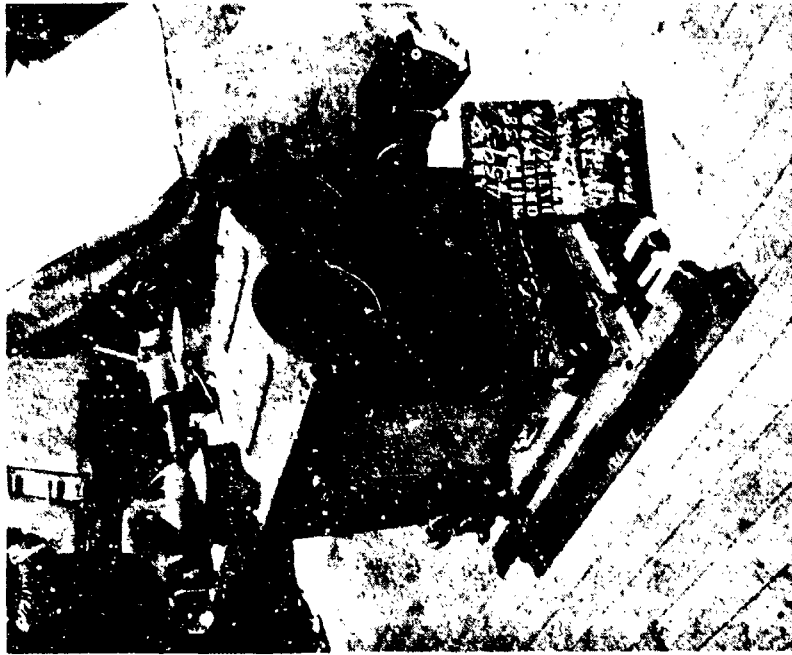
d. The Director, M7A1B1, (Item 31), was displayed without its tripod, resting on the traveling base. Two methods of securing were used. On all ships except USS Pennsylvania special fixtures were constructed to hold the director down by means of the porter bar holes as shown in Fig. 37. On the USS Pennsylvania the traveling base was bolted to channel iron as shown in Fig. 38.

Fig. 38 - USS Pennsylvania - Director,  
W7A1B1 - Method of securing by  
means of the traveling base.

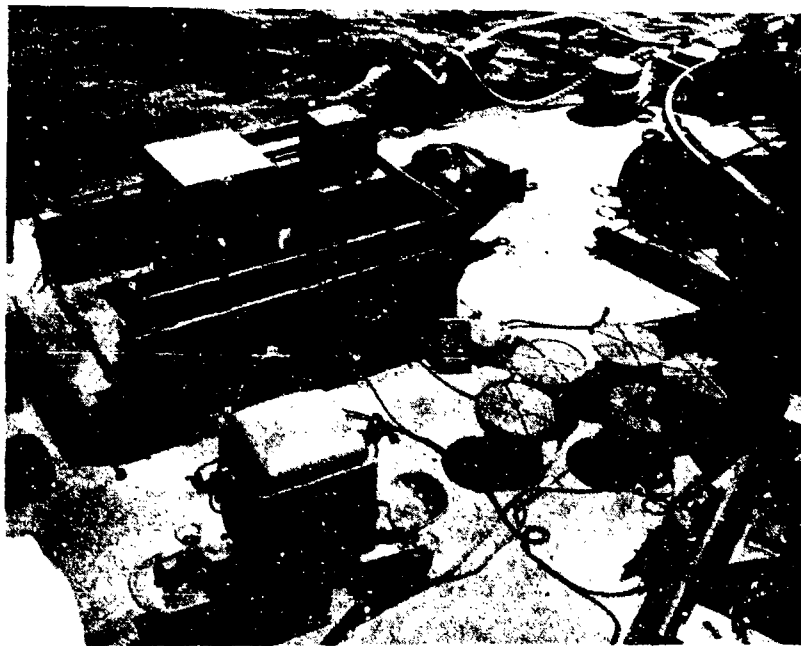
f. The Cable System, M1 (Item 45), was displayed on the deck connecting the generator, height finder, director, and 90mm AA Gun, in the normal manner as shown in Fig. 40.

Fig. 40 - USS Nevada -- Cable System, W1 in use.

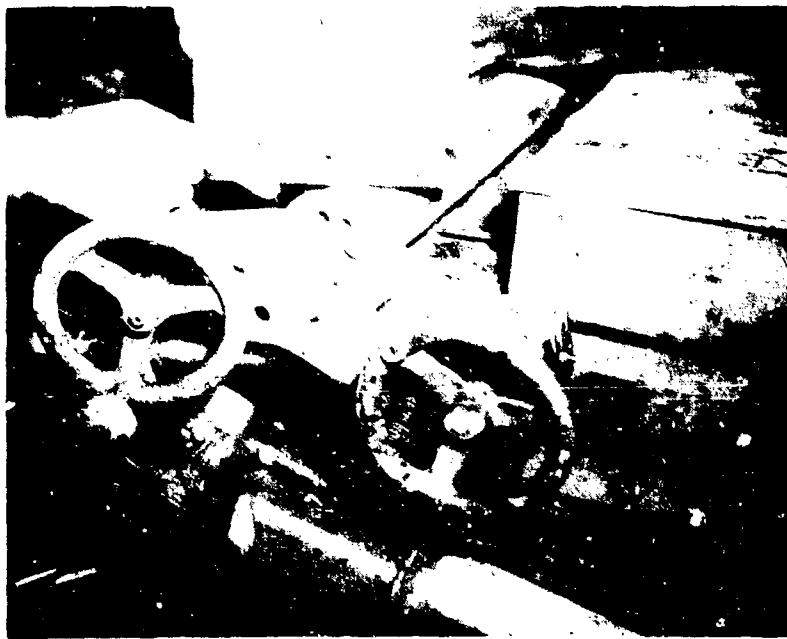
b. Damage to the Launcher, approximately 60% masked, on the USS Nevada was practically identical with that experienced on the USS Arkansas. The elevating mechanism was damaged beyond efficient operation when three 1/2" bolts anchoring the elevating mechanism to the bottom carriage were sheared, see Fig. 104. The accessories box installed on top of the tube nest was deformed by pressure, as shown in Fig. 105. The left trail tie rod was broken immediately forward of the turnbuckle, exactly where the tie rod on the USS Arkansas broke, and appeared to be a tension break at the weld, caused by deformation of the deck. The tires were inflated. The paint was slightly scorched. The damage to Fire Control Components was limited to a broken wire on the extension light of the sight mount.

Fig. 104 - USS Nevada - Launcher, Rocket, 4.5", T66E2 -  
Detail of failure to elevating and traversing  
mechanism bracket.

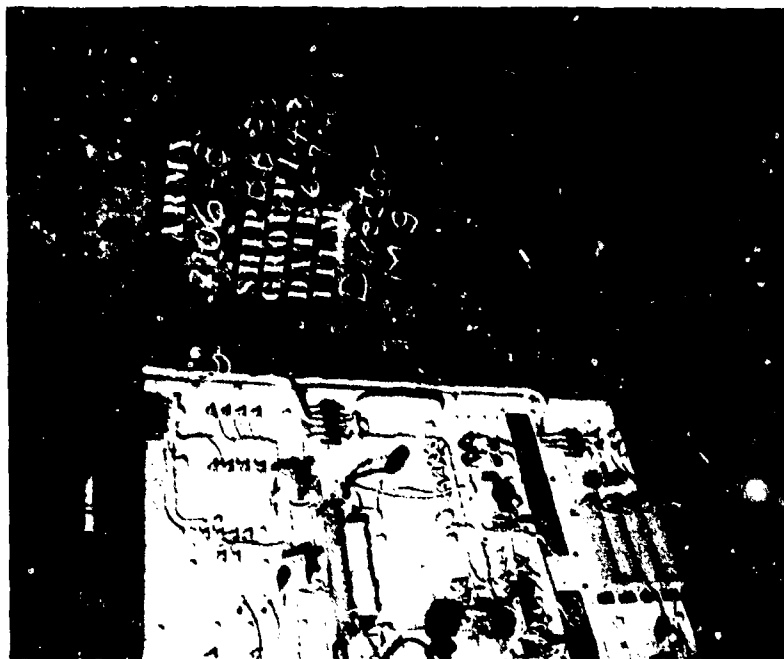
(3) Power Unit M3 - The cover and the top were blown off. The left side was crushed inward smashing the 2740 and 393A tubes and three tube sockets, see Fig. 163. The unit was torn from its shock mounting, but the shock mounting remained clamped to the trailer floor. The transformer unit on the right was torn from the frame

Fig. 163 - USS Arkansas - Power Unit, M32 -  
Left side after Test Able.

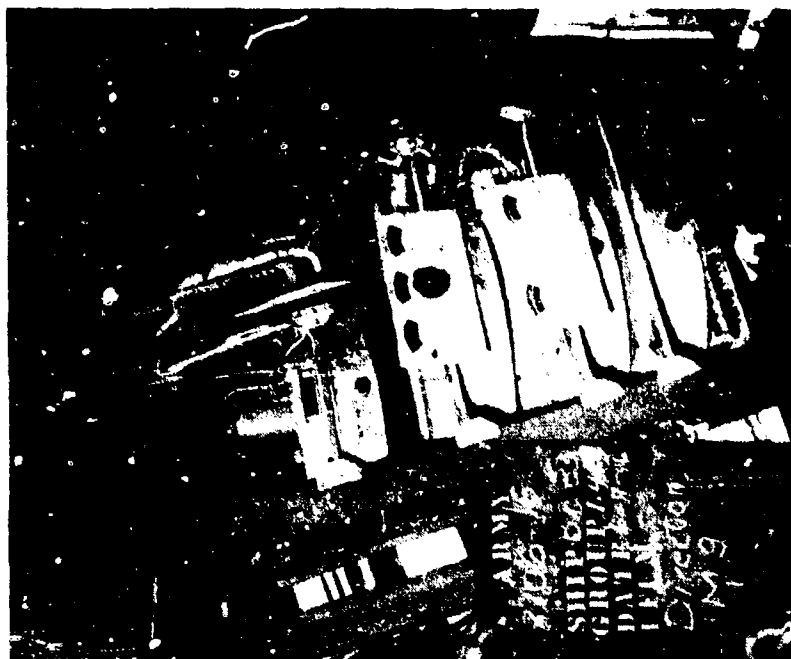
beyond repair, see Fig. 156, Fig. 157 and Fig. 158. In this report the correction panel which faces the rear of the trailer, will be considered as the front of the computer. The blast struck the top, rear, and right sides. All four covers were torn from their fastenings, one being carried 30 feet from the trailer. The top was partially torn free and crushed inward, see Fig. 158. The complete unit was twisted, bent, and torn from the shock mounting, and the shock mounting torn from its clamps. The clamps were bent and broken. The computer frame was bent at the front left corner as though it had struck the side of the lower trailer body, see Fig. 158 and Fig. 159. The adjustment panel was blasted inward, the meters blown from it and smashed and the switches rendered inoperable, see Fig. 160. A large number of amplifier units were twisted and torn from the frame. A few vacuum tube receptacles were cracked and twisted. Those few vacuum tubes that were broken were crushed by the twisting of the computer frame and the resultant shifting of component units. Vacuum tubes withstood the blast and subsequent testing revealed no internal damage. Some wiring was broken due to units shifting. The servo oil levels were slightly low but no leaks were evident. Although the computer was unserviceable as such, the majority of its component units were individually undamaged. See Fig. 159, Fig. 160, Fig. 161 and Fig. 162.

Fig. 162 - USS Arkansas - Computer, M3A2 -  
Rear view after Test Able.

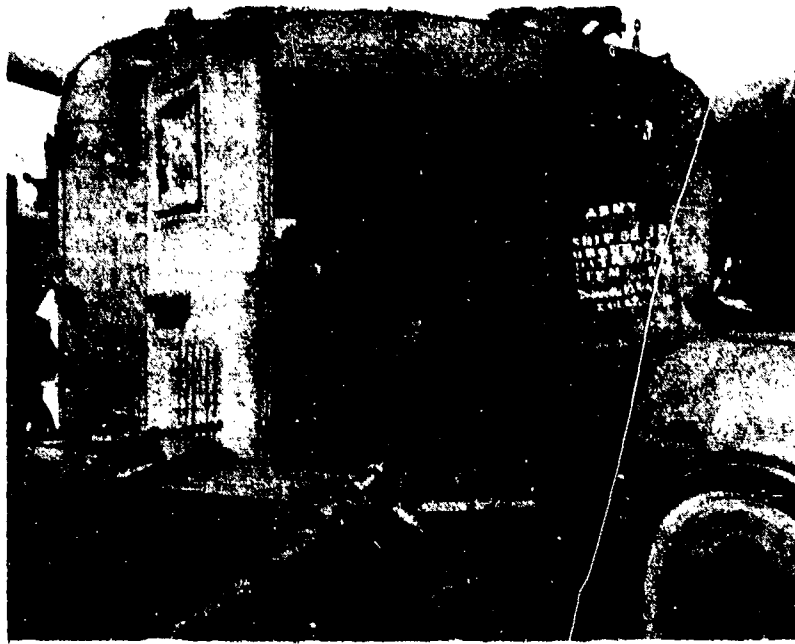
g. The director was only slightly damaged on the USS Pennsylvania. It was repaired and returned to serviceable condition. It had been struck by the blast on its rear left but was partially shielded by the generating unit. Fig. 172.

Fig. 172 - USS Pennsylvania - Director, M9A2 - Rear view of trailer, M14 after Test Able.

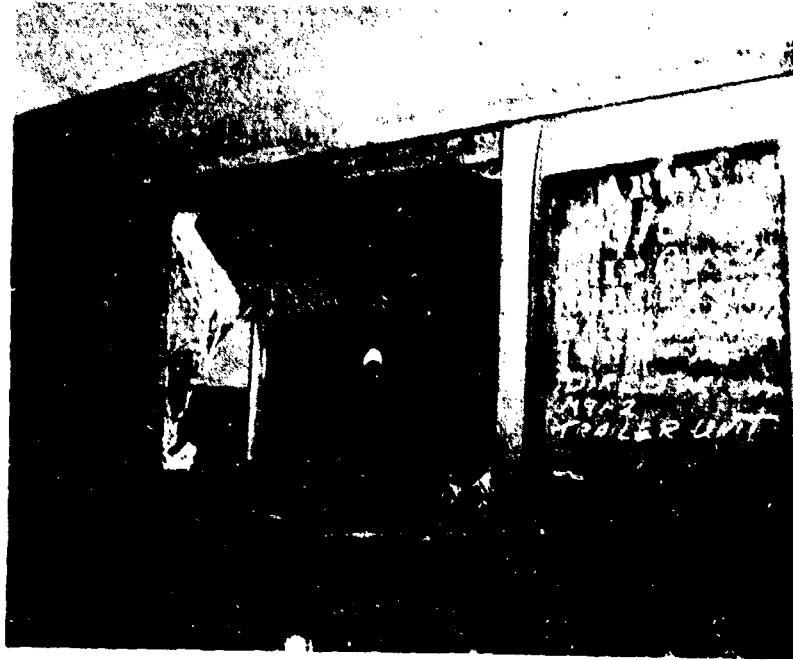
d. M9A2 on the USS Saratoga. The damage on the USS Saratoga was limited to the trailer. The blast struck the left side, bowing it in slightly and breaking out the window on that side. The left door window and the right side window were cracked. See Fig. 176, Fig. 177 and Fig. 178.

Fig. 176 - USS Saratoga - Director, M9A2 - Left window of trailer, M14 broken in Test Able.

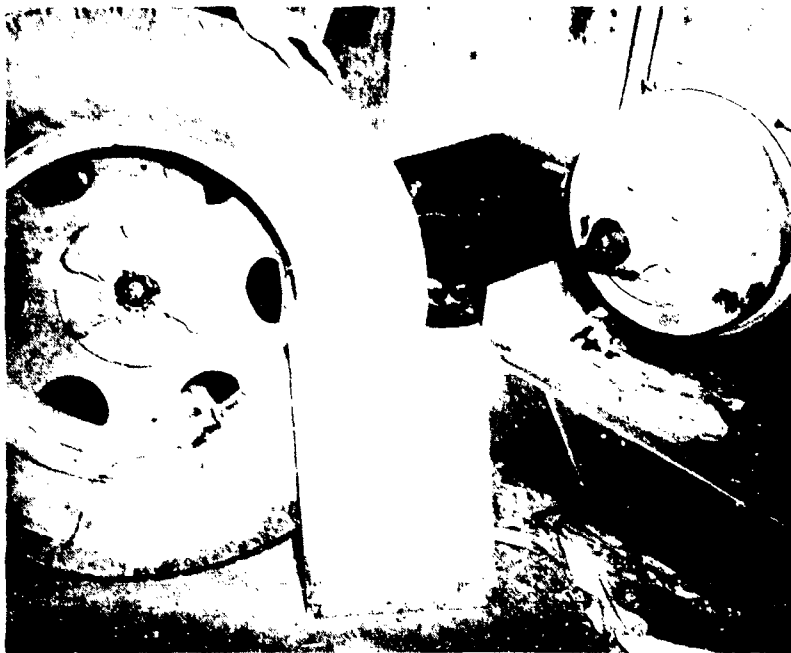
movement. In striking the pan side, the right rear wheel hub was broken, see Fig. 183 and Fig. 188. The cable used to secure the left rear corner of the trailer was pulled loose. The leveling jacks had been lowered and were supporting the weight of the trailer. In skidding, all the jack legs were bent to the left making them unusable for this reason. The mechanism for raising and lowering the jacks was unaffected. The body was bowed slightly on the left side from the blast and on the inner right side partly by the blast and partly from being struck by some object that pierced the sheet metal, see Fig. 77. The same photograph shows the damage to the tail gate after it was blown upward from the lowered position, bowing it and breaking one spoke. This in no way affected the braking mechanism. The plastic reflectors and plastic cover lenses for the trailer lights, exposed to the heat of the blast, were discolored and the surface shriveled. The left rear daylight stop and tail-light lens frame was bent and the plastic lens missing.

Fig. 188 - USS Arkansas - Unit, Generating, M7A1  
Damage to right rear wheel.

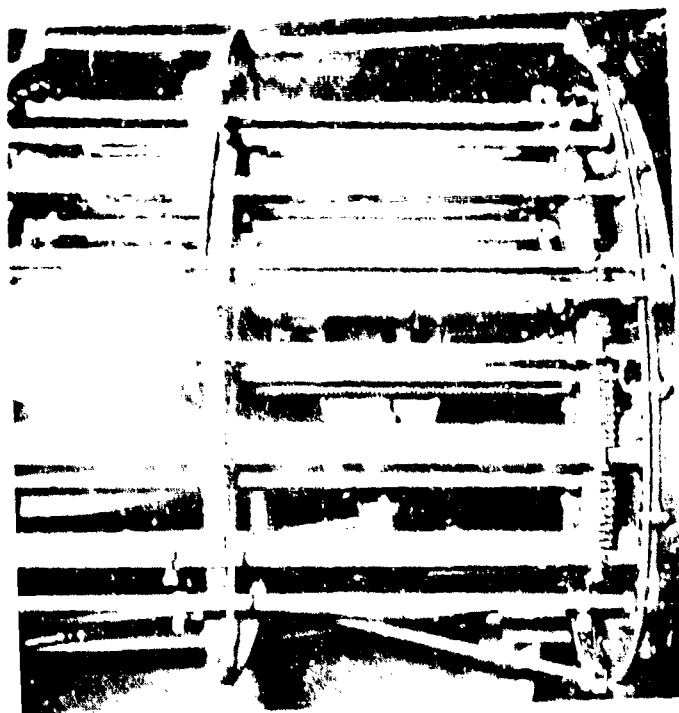
a. On the USS Arkansas, the preservative was dried from all exposed outside surfaces but because of the paint on the parts of the feed mechanism very little rust was apparent. The grease coating was still in the bore and around the breech. Some flying object had struck the left Shell Retaining Ring (C-153596) bending it as seen in Fig. 196. The feed mechanism was functioned manually through a complete cycle and the firing pin operated.

Fig. 196 - USS Arkansas - Gun, 75mm, AC, M10 -  
Test Able damage.

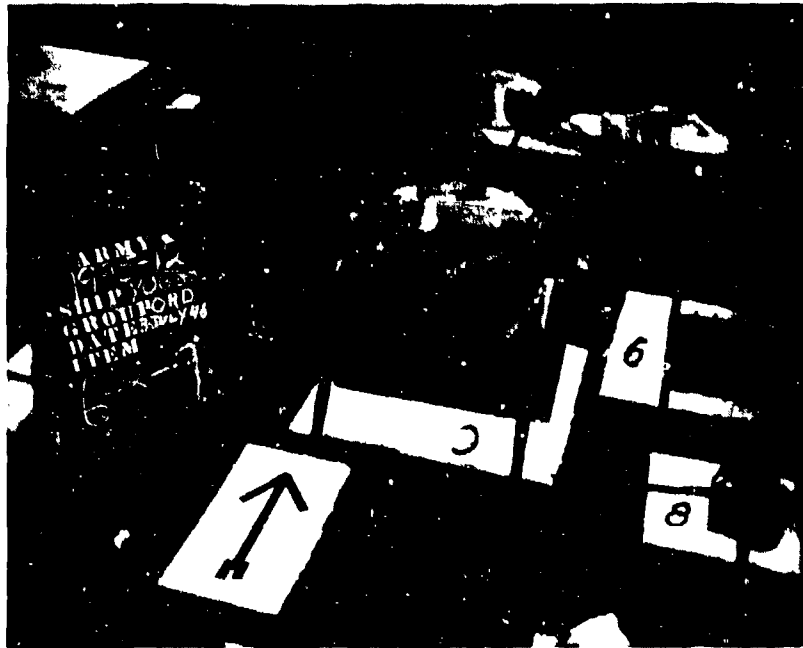
f. Cartridge, AP, Cal..50, M2 (Item #6). Ten rounds of this item were displayed on a metal plate, see Fig. 210. On the YOG 83, Fig. 211, the cartridges were not damaged by the blast but were badly corroded. On all other ships no damage to the display items was apparent.

h. Cartridge, AP, Cal..50, M2 (Item #8). Ten rounds were displayed in a cardboard carton, Fig. 210, Fig. 212, and Fig. 211. On the YOG 83, prior to Test Able, the carton had fallen open due to rain. After the test, the tape used to hold the carton together was torn and scorched and the markings on the carton were burned off by the heat of the blast. The carton had been badly

Fig. 211 - YOG 83 - Damage to Items 6, 7, 8, and 9 after Test Able.

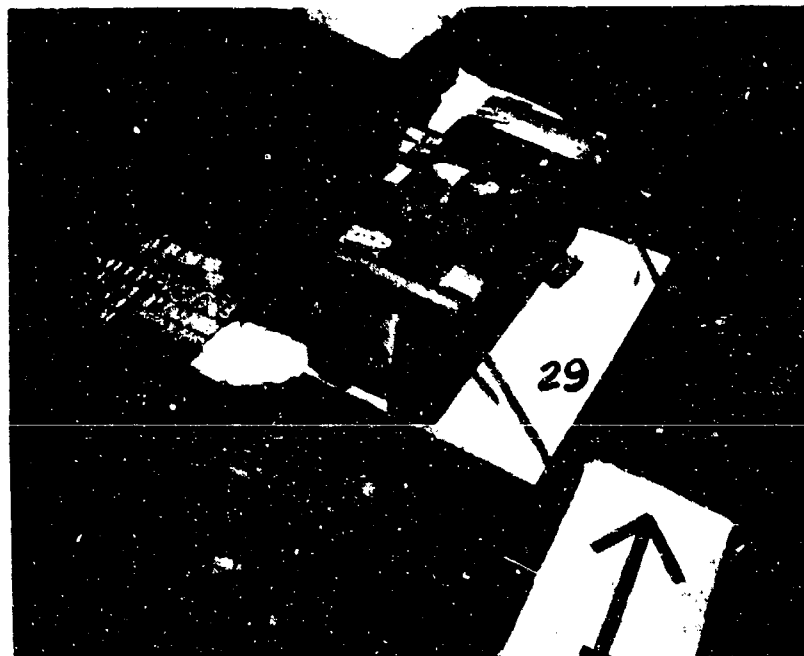
2. Cartridge, TP, M306 (T22) w/Fuse, Dummy, T126 for 57mm Rifle (Item #29). Two rounds were displayed in their wooden box, Fig. 241. On the YOG 83, Fig. 242, the box was displaced 1/2" by the blast. The wood was scorched and slightly charred on the exposed sides and the top. The rope handle was also scorched. The nomenclature was too badly scorched to be legible on the end of the box. This box had been restencilled before display and the old nomenclature was showing through the new on the side away from the blast. The hardware was corroded and scorched on the right side. The ammunition was apparently in good condition inside the box. On the LST 52, the box was scorched on the blast side. On the LST 661, the box was slightly scorched but the markings remained legible. This item was partially masked toward the bow on the LST 661. On the remaining two vessels, there was no apparent damage.

Fig. 242 - YOG 83 - View of scorched and charred surfaces of Item 29 after Test Able.

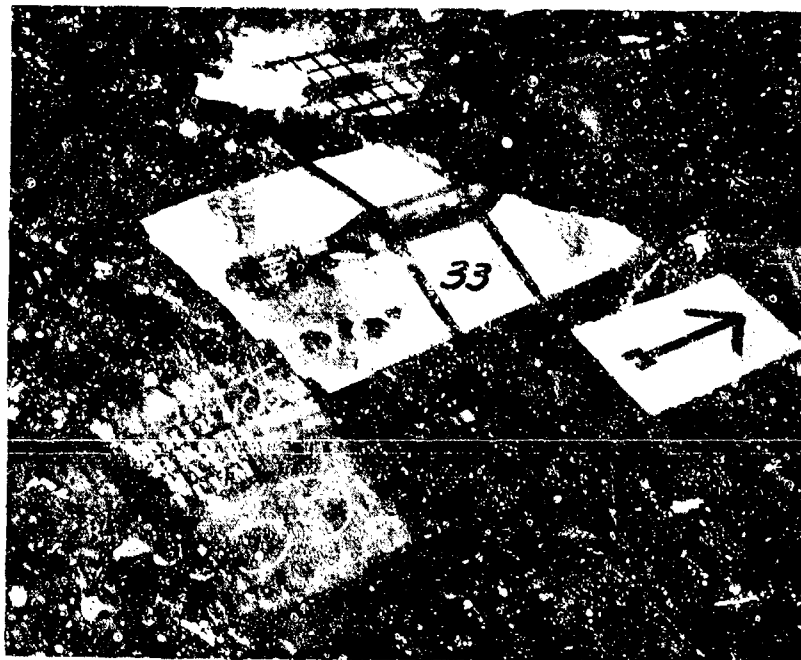
i. Shell, HE (hv) M56, w/o Fuze, 81mm Mortar (Item #33). One round was displayed bare, see Fig. 249. On the YOG 83, Fig. 244 and Fig. 250, both before and after Test Able, there was loose TNT in the booster cavity. The propellant increments had broken down before the test and were destroyed by the bombing. The holding clips were in position but rusted. The fins were rusted by the atmosphere. On the LST 52, Fig. 251, the propellant was destroyed and although the primer and ignition cartridge were intact and did not function, their cardboard container was slightly scorched. The propellant clip was rusty. On the LST 661, the increments were burned off by the heat from the bomb blast, but the ignition cartridge was undamaged. On the remaining ships, no damage was apparent.

Fig. 250 - YOG 83 - Damage to Item 33 after Test Able.

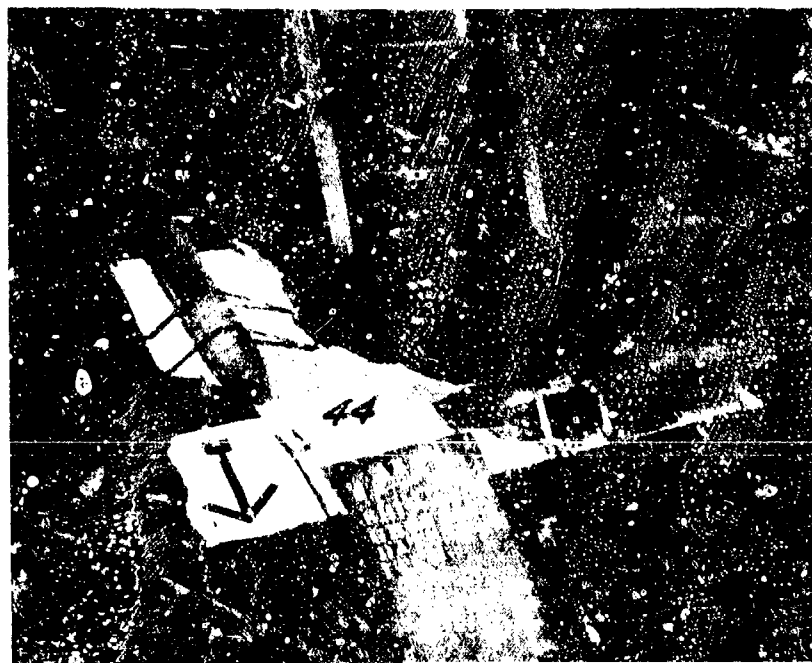
Fig. 268 - YOG 83 - Damage to Item 44 after Test Able.

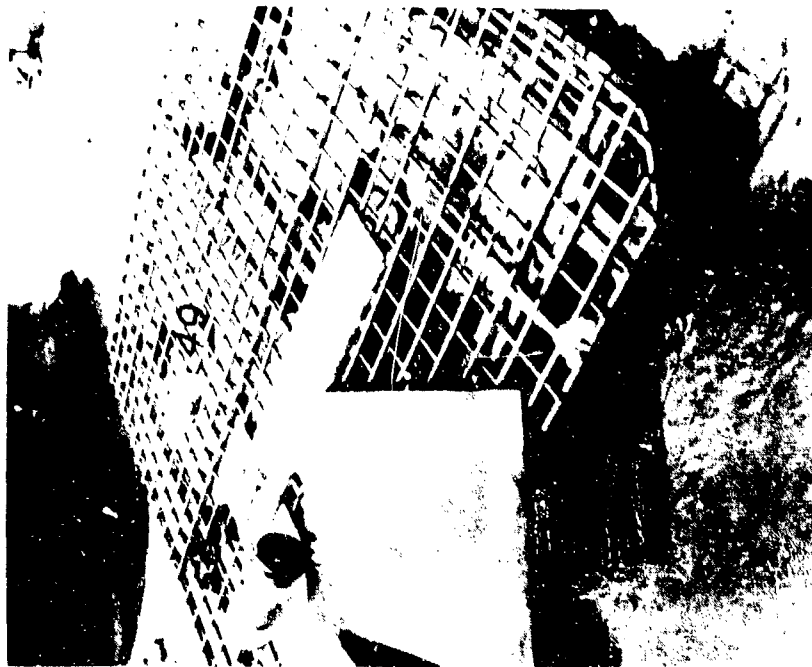
a. Fuse, T.M., M43A3, w/Booster, M20A1 (Item #49). One fuze was displayed bare on a sheet metal plate. Fig. 280. On the YOG 83, the fuze was slightly corroded. No visible damage was done by the bomb. On the LST 52, the item was displaced 29" forward but suffered no damage, Fig. 281 and 282. No damage was apparent on any other target ship.

Fig. 282 - LST 52 - Items 49 and 50  
after Test Able.

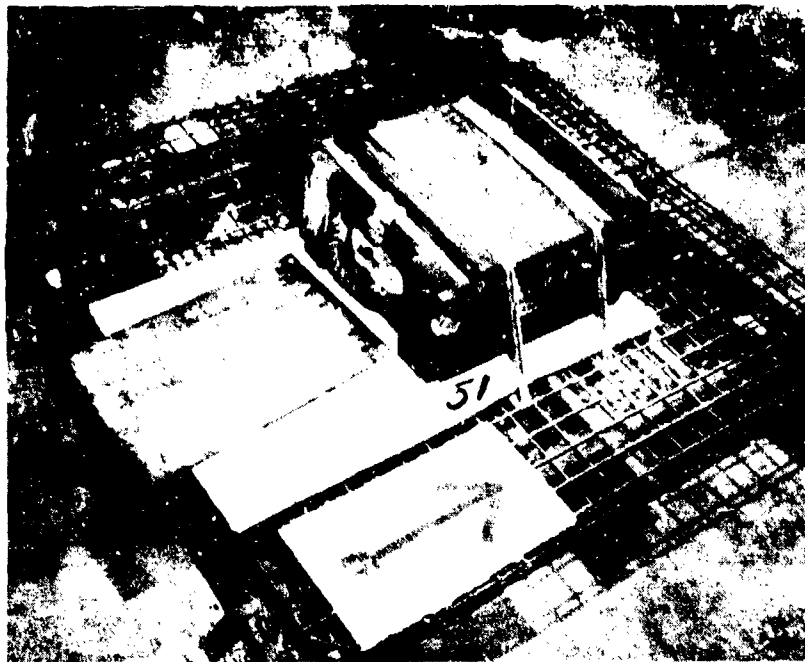
c. Fuse, T.M., M43A3, w/Booster, M20A1 (Item #51). Twenty-three fuzes were displayed in a wooden box, Fig. 285. On the YOG 83, Fig. 286 and Fig. 287, the side and end toward the blast were scorched and charred about equally. The nomenclature facing the bomb was obliterated by scorching. The box was scorched on the blast side, on the LST 52, but was serviceable. On the LST 661, the box was slightly scorched on the side directly exposed to the blast but the markings were still legible. On the LST's 220 and 545, there was no apparent damage.

Fig. 287 - YOG 83 - Damage to Item 51 after Test Able.

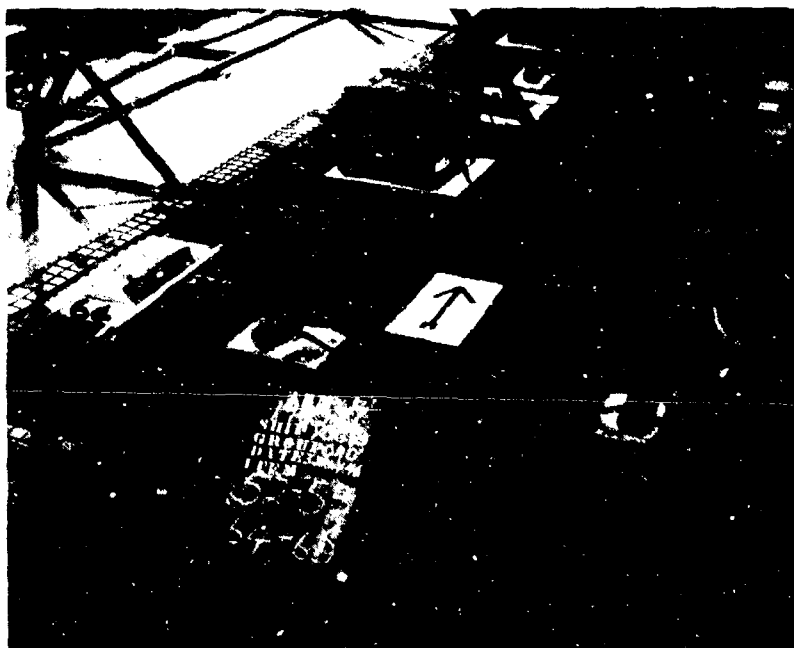
e. Fuse, T.M., M43A1, w/o Booster (Item #53). One fuze was displayed in a fiber container, Fig. 288. On the YOG 83, Fig. 289 and Fig. 292, the container was slightly scorched on the blast side and end. The paper was peeled and tattered. The markings protected by the steel strappings were legible, but all other markings were obliterated. On the LST 52, the fiber container was slightly scorched on the blast side and was dented by the straps. No damage was apparent on the remaining

Fig. 292 - YOG 83 - Damage to Items 52, 53, 64, and 65  
after Test Able.

On the YOG 83, Fig. 289 and Fig. 292, the only damage was a slight scorching on the rear of the booster cup. The plate on which the item was displayed was bent upward, by the blast. The fuze remained in position. On the LST 661, the item was masked by a beam. No damage was apparent on the remaining ships.

g. Fuze, P.D., M52A1, w/o Booster (Item #65). One fuze was displayed in a fiber container, Fig. 306. On the YOG 83, Fig. 289 and Fig. 292, the container paper and tape were scorched and peeled. The paint was scorched from the bottom of the container. All markings were obliterated. On the LST 52, Fig. 307, the container was crushed by a falling hatch cover. The container had been dented by the straps when securing it to the pallet. On the LST 661, the container had been struck by a wooden hatch cover but was undamaged. No damage was apparent on the other ships.

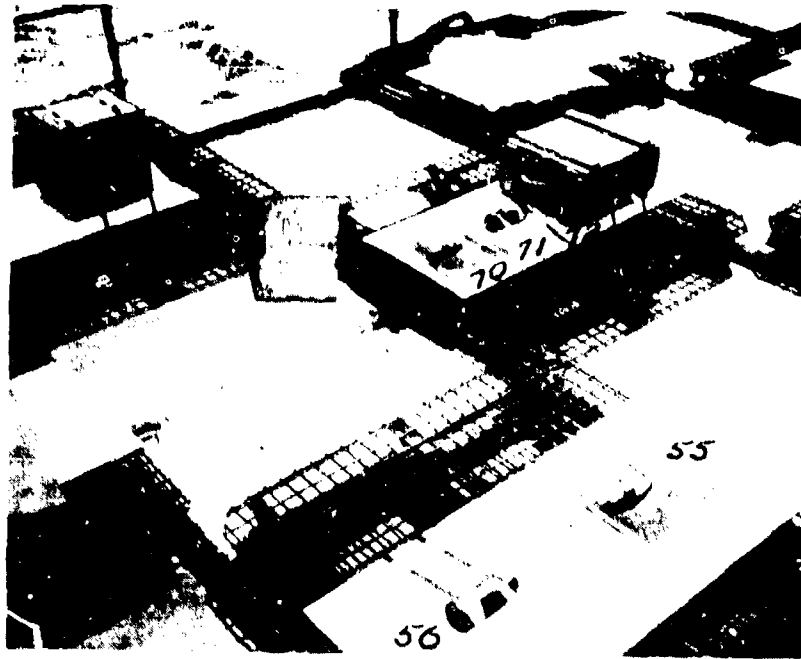
Fig. 295 - YOG 83 - Method of displaying Items 55, 56, 70, 71, and 72.

y. Fuze, T and SQ, M55A3, w/Booster, M21A4 (Item #70). One fuze was displayed bare on a sheet metal plate, Fig. 310. On the YOG 83, Fig. 295, the black powder time train rings functioned but the booster did not. There was a slight corrosion on the fuze and booster due to rain. No damage was visible on the remaining LSTs.

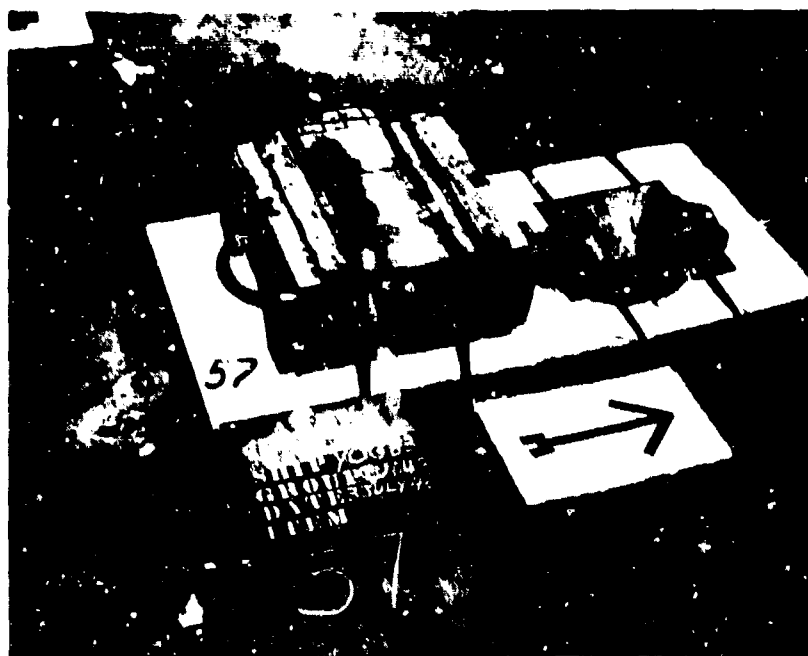
Fig. 297 - YOG 83 - View after Test Able of the scorched box of Item 57.

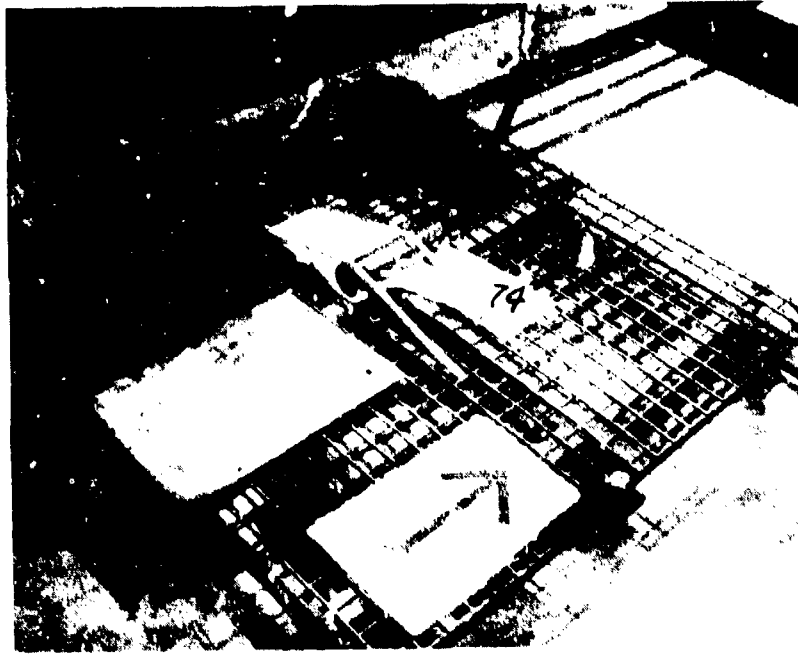
Fig. 315 - YOG 83 - Damage to Item 74 after Test Able.

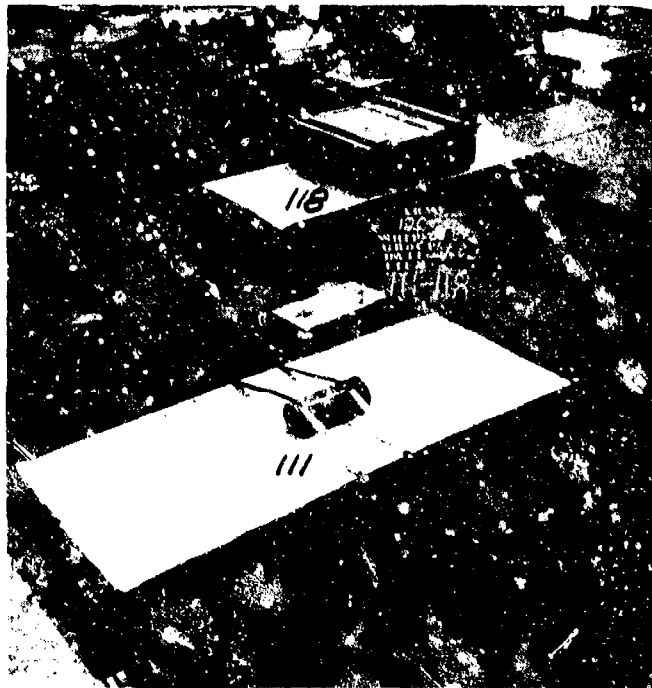
b. Fuse, Bomb, Nose, AN-M103A1, w/Booster (Item #111). This fuse was displayed in a metal can, Fig. 322. On the YOG 83, Fig. 323 and Fig. 324, the side and end of the can was scorched. The scorched area was approximately 3" x 6". The scorched area was also slightly rusted. On the LST 52,

Fig. 323 - YOG 83 - Method of securing Items 111 and 116.

i. Fuse, Flare, M.T., M111A2, w/Booster (Item #118). Twenty-three of these fuzes were displayed in a wooden box, Fig. 337. On the YOG 83, Fig. 323 and Fig. 338, the blast side and end were scorched. The markings on the side were illegible, but those on the end were legible because the rope masked them. The box was shifted approximately 1/4" by the blast. On the LST 52, the box was scorched on the blast side but was still serviceable. On the LST 661, the box was also slightly scorched. The markings were legible. No damage was apparent on the remaining ships.

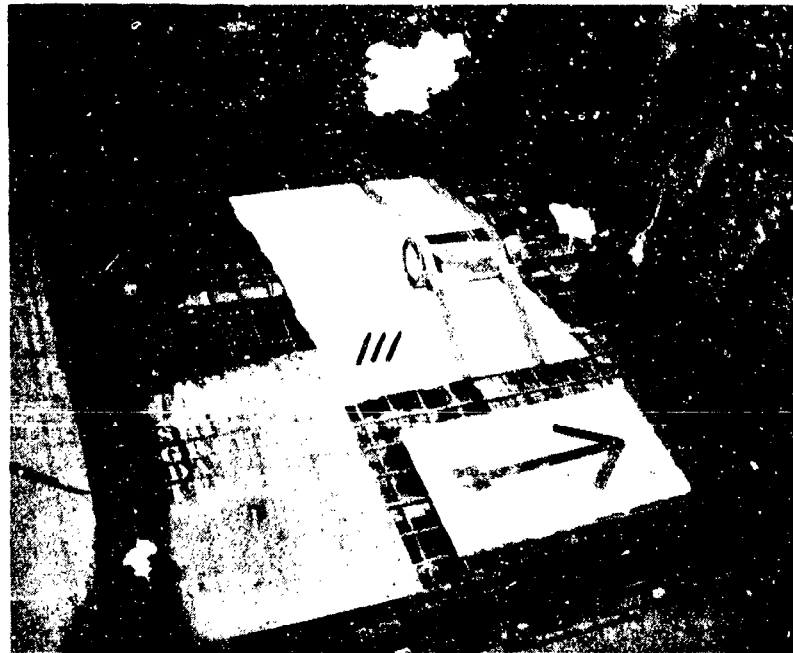
Fig. 324 - YOG 83 - Damage to Item 111 after Test Able.

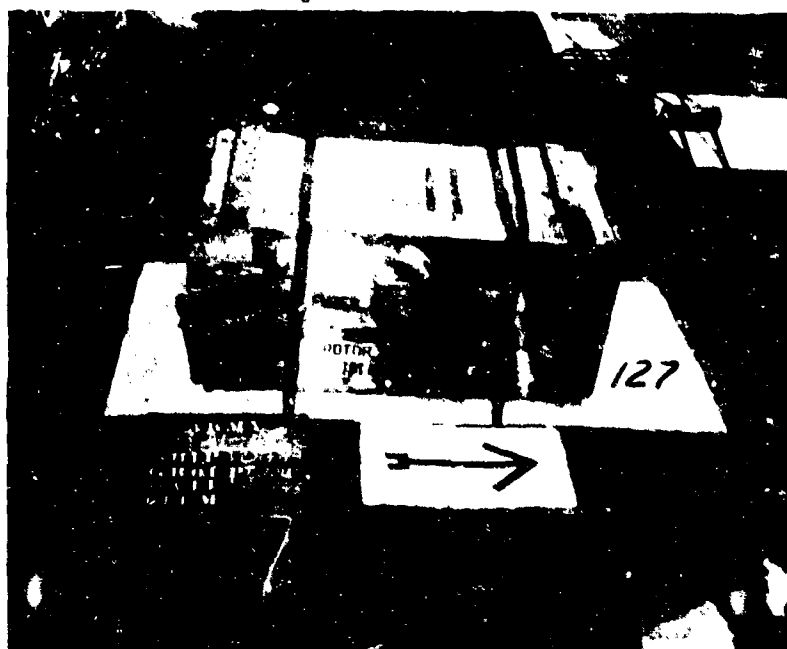
Fig. 346. On the YOG 83, Fig. 325 and Fig. 347, the exposed side was scorched and half of the markings were illegible. A small stone was driven approximately 3/16" into the box. The hardware on the same side of the box was scorched. On the LST 52, the box was scorched but remained serviceable. On the LST 661, the box was slightly scorched. No damage was apparent on the remaining ships.

Fig. 347 - YOG 83 - Damage to Item 127 after Test Able.

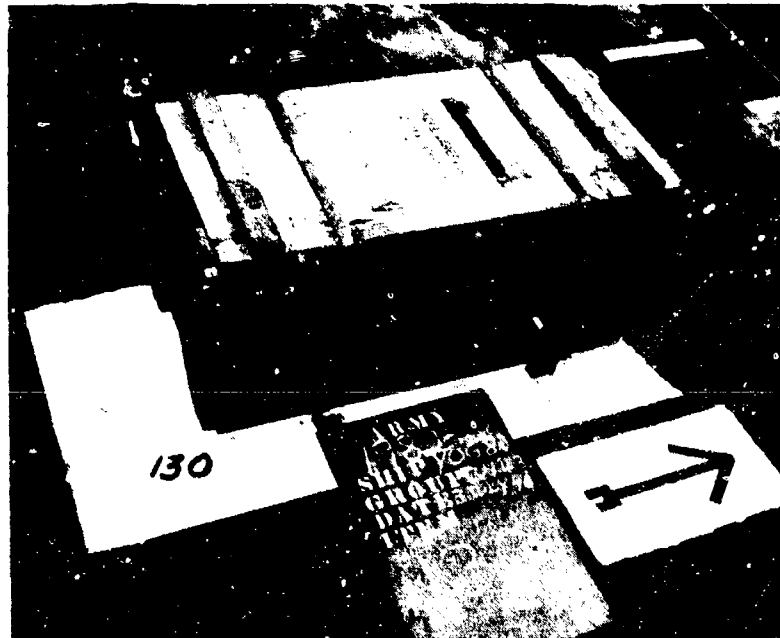
Fig. 350 - YOG 83 - Test Able damage to Item 130.

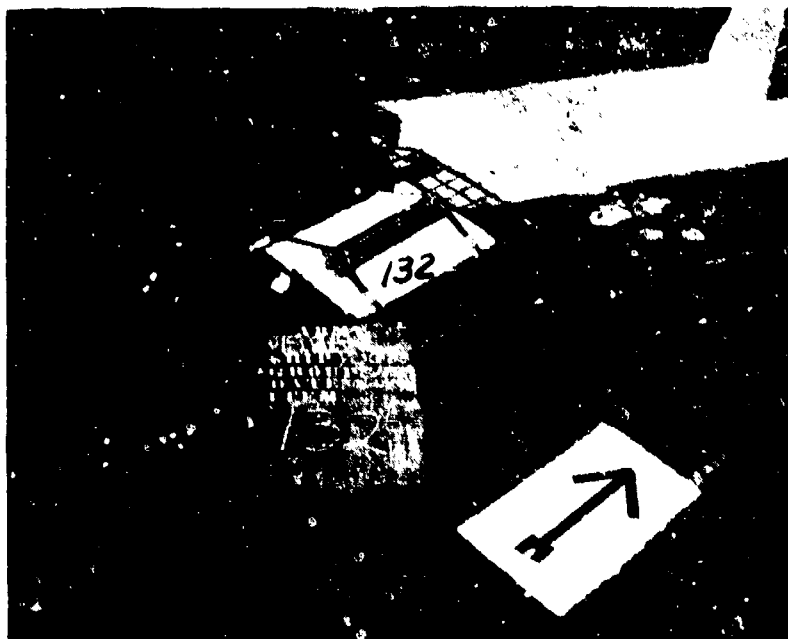
Fig. 353 - YOG 83 - Damage to Item 132 after Test Able.

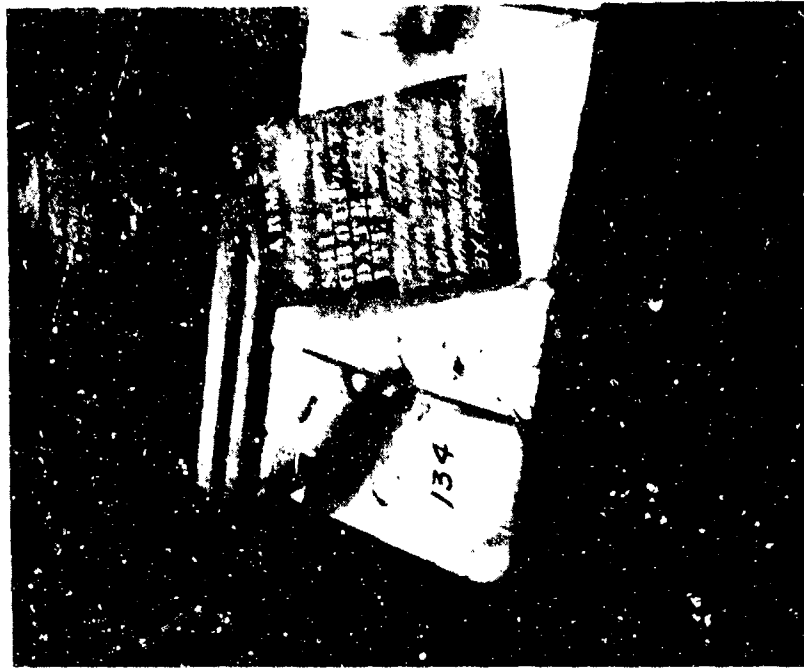
Fig. 358 - LST 52 - Damage to Item 134 after Test Able.

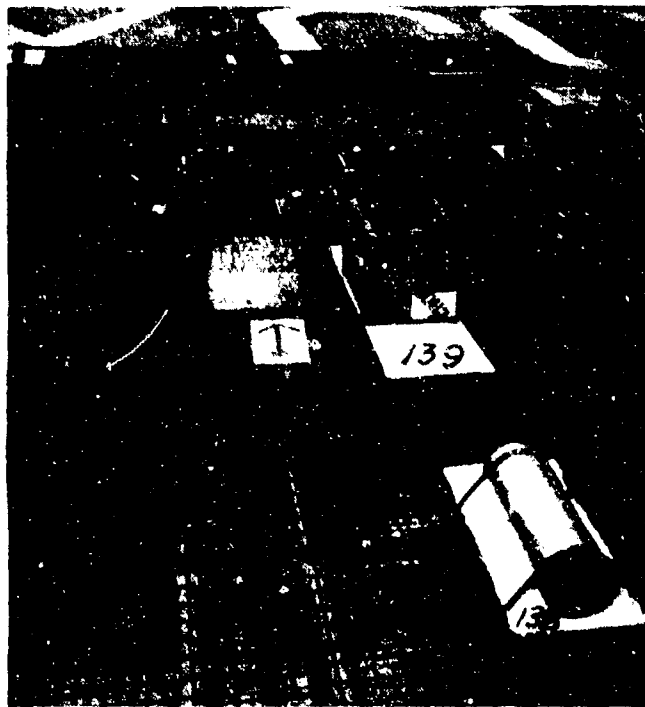
Fig. 361 - YOG 83 - Method of securing  
Item 138 and 139.

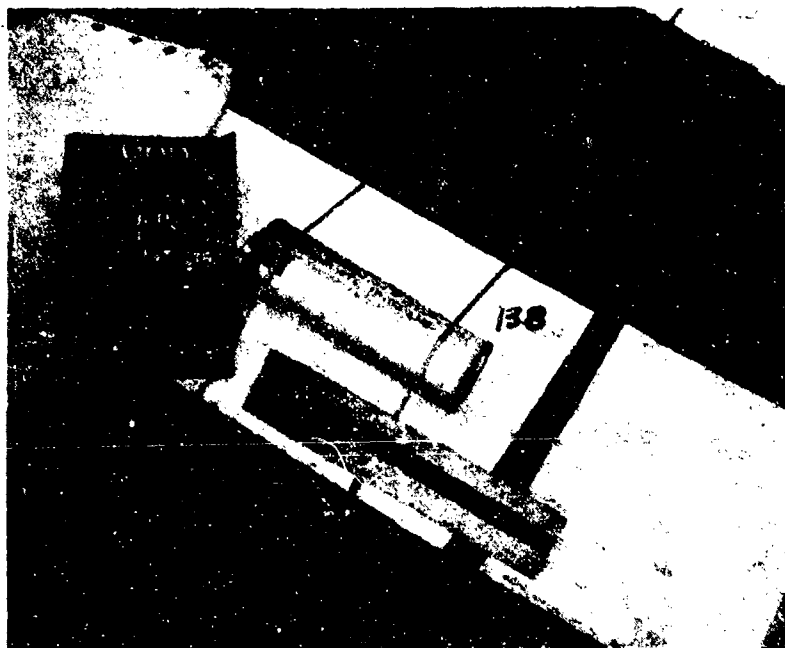
Fig. 362 - LST 52 - Damage to Item 138 after Test Able.

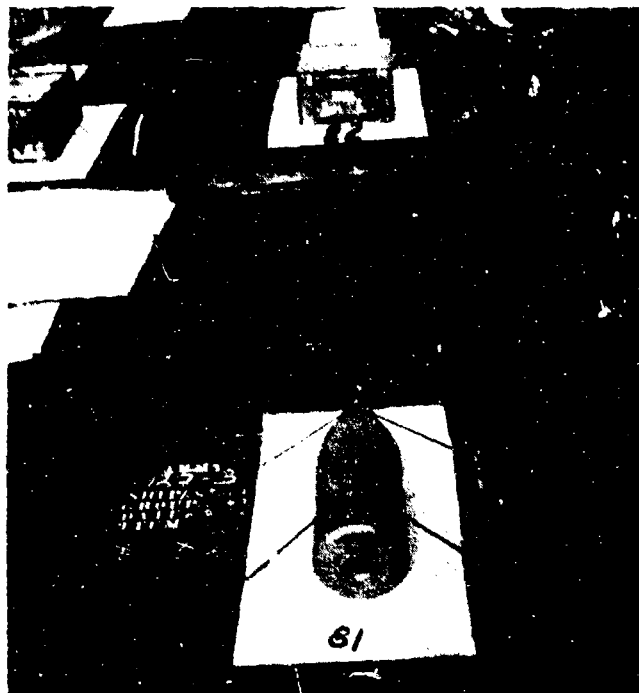
a. Head, Rocket, HE, 7.2", T37, w/o Fuze (Item #81). One was displayed bare, Fig. 363. On the YOG 83, Fig. 364, rubber gasket between the motor adapter and the closure plug appeared to have been scorched and in so doing had discolored the adapter. There was rust on the front edge of the head. The head, on the LST 661, was masked. On all other ships no damage was apparent.

b. Head, Rocket, HE, 7.2", T37, w/o Fuze (Item #82). One was displayed in a wood box, Fig. 363. On the YOG 83, Fig. 364 and Fig. 365, one side was charred extensively, while the end was charred only slightly. Asbestos matting was spattered on the sides away from the blast. The box had shifted 1" with the blast. The lid had been displaced 3/8". A cleat on the severely scorched side was partially broken off. On the LST 52, the box was scorched on the blast side. Before Test Able, the lid was badly split. Some of the small pieces were missing. On the LST 661, the box was scorched on the side directly exposed to the blast. The markings on that side were obliterated. No damage was apparent on the LSTs 220 and 545.

Fig. 363 - LST 661 - Method of securing Items 81 and 82.

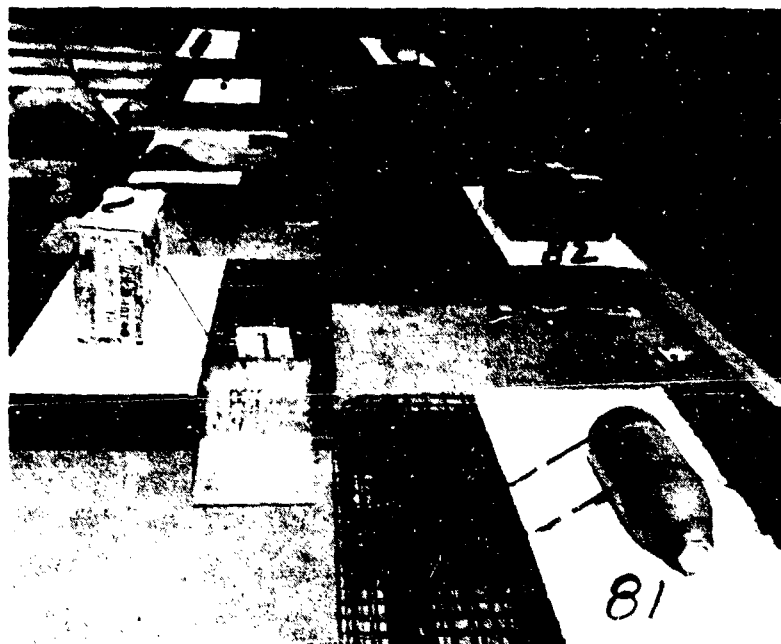
Fig. 364 - YOG 83 - Method of securing Items 81 and 82.

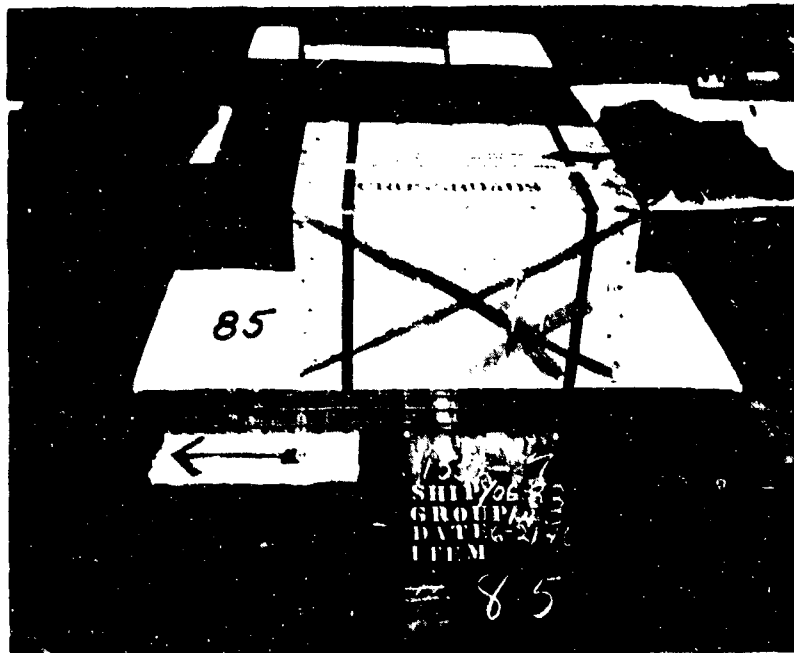
d. Motor, Rocket, 2.25", MK3 (Navy) (Item #85). Seven motors were displayed in a wood box, Fig. 367. On the YOG 83, the rear end, right side, and top were scorched and the markings were obliterated. The box was moved 1" by the blast. On the LST 52, Fig. 368, the box was scorched on the blast side and the box was moved 20" with the blast. The tie-down straps had been broken. On the LST 661, the box was scorched on the side directly exposed to the blast. The markings on that side were obliterated. No damage was apparent on the LSTs 220 and 545.

Fig. 367 - YOG 83 - Method of securing Item 85.

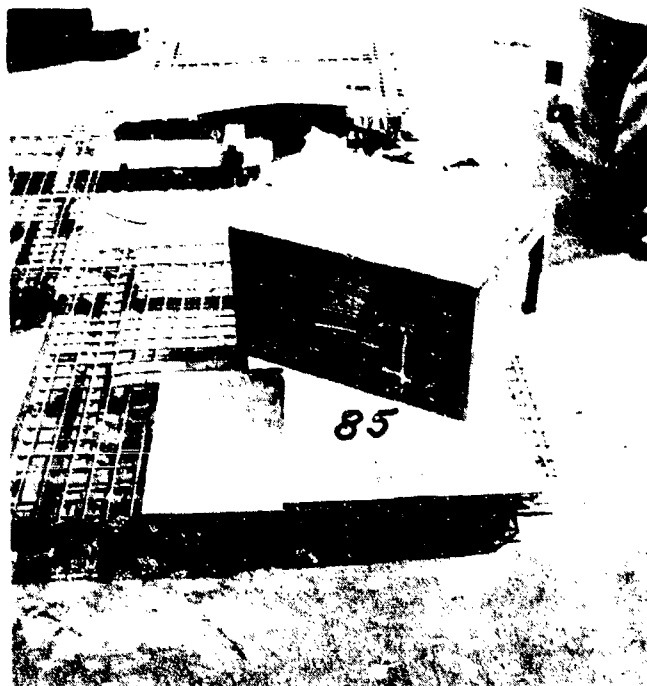
Fig. 368 - LST C2 - Damage to Item 85 after Test Able.
