JOINT TASK FORCE ONE

ARMY GROUND GROUP  
(TASK GROUP 1.4)

FINAL REPORT  
OF  
ATOMIC BOMB TESTS

27 January 1946 to 30 September 1946

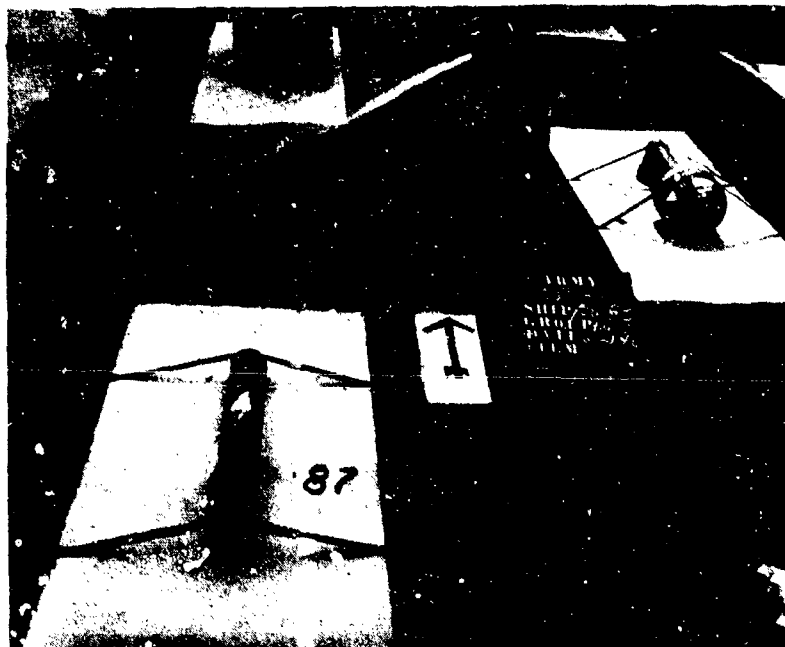
f. Rocket, Practice, AT, 2.36", M7A3 (Item #87). One rocket was displayed in a fiber container, Fig. 371. On the YOG 83, Fig. 372 and Fig. 373, the container was moved to the left 3-1/2" by the blast. Two layers of fiber paper were torn and scorched on the side facing the blast. The exposed end of the container was devoid of paint. A section of the tape containing part of the nomenclature was torn from the side facing the blast. On the side away from the blast the tape was intact and the marking was legible. On the LST 52, Fig. 374, the fiber container was scorched on the blast side and dented by the straps. The item is serviceable but the markings were obliterated. No damage was apparent on the other ships.

Fig. 372 - YOG 83 - Method of securing Item 87.

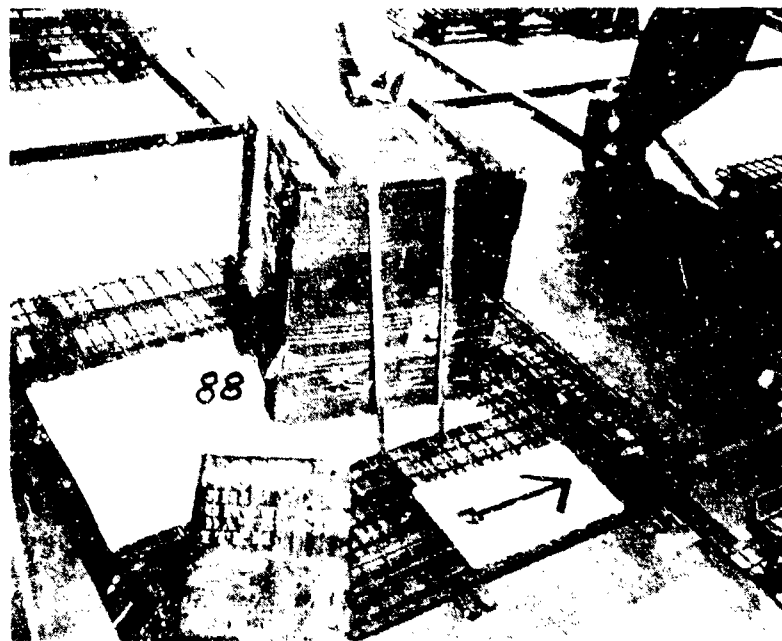
g. Rocket, Practice, AT, 2.36", M7A3 (Item #88). Eighteen were displayed in a wood box, Fig. 334. On the YOG 83, Fig. 321 and Fig. 375, the box was moved 4" by the blast. The top was pushed forward 1" more than the bottom so that the box resembled a parallelogram. The nails holding the box together were bent. The nomenclature on the side and end was obliterated by scorching but that on the top was only partially obliterated. On the LSTs 52 and 661, the box was scorched on the blast side but was serviceable. No damage was apparent on the remaining LSTs.

Fig. 375 - YOG 83 - Damage to Item 88 after Test Able.

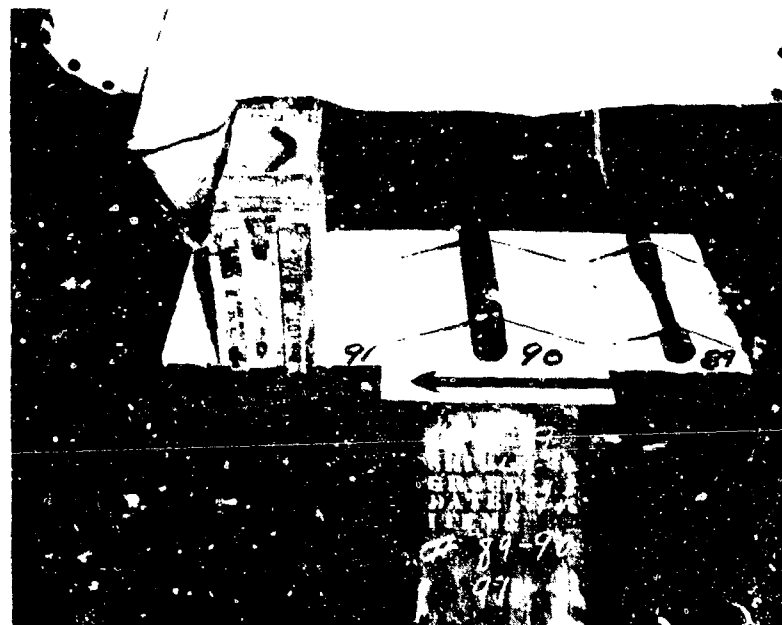
h. Rocket, HE, AT, 2.36", M6A3F (Item #89). One Rocket was displayed here, Fig. 376. On the YOG 83, before the test, the stabilizer tube threads were rusty. After the test, the fins were rusted both inside and out. The stencilling was slightly scorched. On the LST 52, the item was unserviceable, because of shroud denting caused in strapping the rocket to the pallet. The rocket was partially masked from the blast by a ladder. No further damage resulted. No damage was apparent on any of the other ships.

i. Rocket, HE, AT, 3.36", M6A3F (Item #90). One round was displayed in a fiber container, Fig. 376. On the YOG 83, Fig. 377 and Fig. 378, the fiber container was scorched and peeled. The sealing tape had a slight tear but the nomenclature was legible. On the LST 52, the container was dented by the strapping. It was partially masked by a ladder. The item was scorched on the LST 661. No damage was apparent on the remaining ships.

Fig. 376 - LST 52 - Method of securing Items 89, 90, and 91.

j. Rocket, HE, AT, 2.36", M6A3F (Item #91). Six of these rockets were displayed in a wood box, Fig. 376. On the YOG 83, there was a slight scorching on one side, the end cleats, and top cleats of the box. The end cleats were also split. The unexposed sides had been splattered with asbestos matting. The box was moved 1" by the blast. On the LST 52, the item was masked partially by a Jacob's ladder and no damage resulted. On the LST 661, the box was slightly scorched but the markings were still legible. No damage was apparent on the remaining ships.

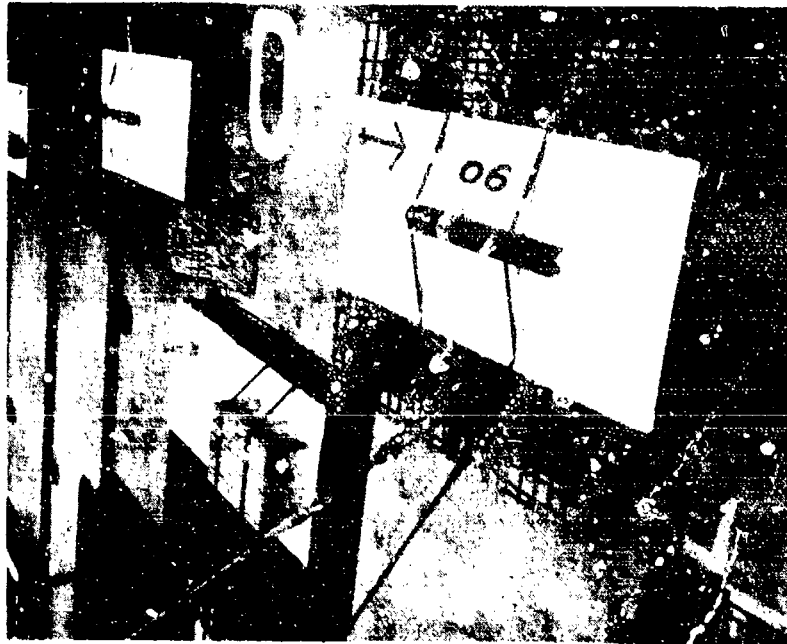
Fig. 377 - YOG 83 - Method of securing  
Item 90.

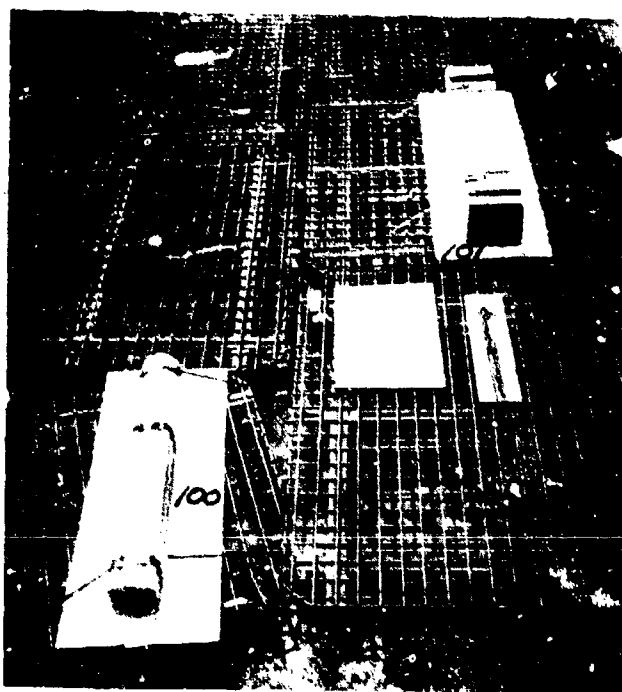
h. Flare, Airport, F15 (Item #100). One flare was displayed bare, see Fig. 390. On the LST 52, the flare

Fig. 390 - LST 661 - Method of securing Items 100 and 101.

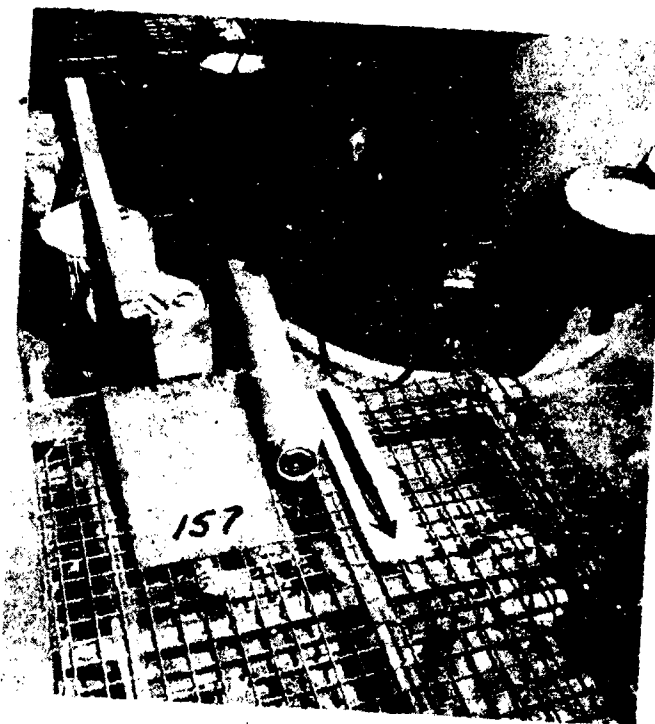
d. Cartridge, Snake, Demolition, M3 (Item #157). One was displayed bare, see Fig. 426. On the LST 52, see Fig. 427 and Fig. 428, the cartridge was blown from the pallet onto the port side of the deck. There was no damage incurred other than superficial dents in the casing. No damage was apparent on the other ships.

Fig. 428 - LST 52 - Damage to Item 157  
after Test Able.

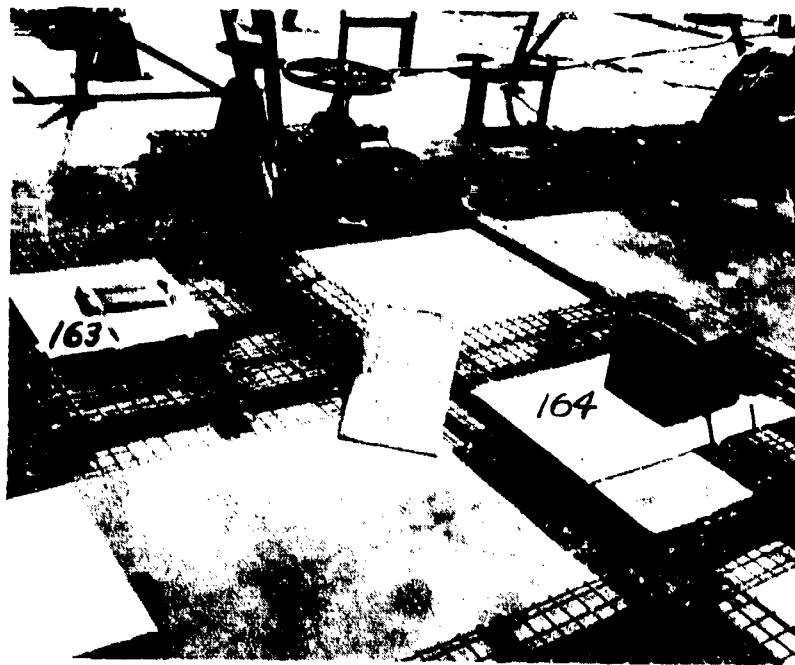
Fig. 441 - YOG 83 - Damage to Items 163 and 164 after Test Able.

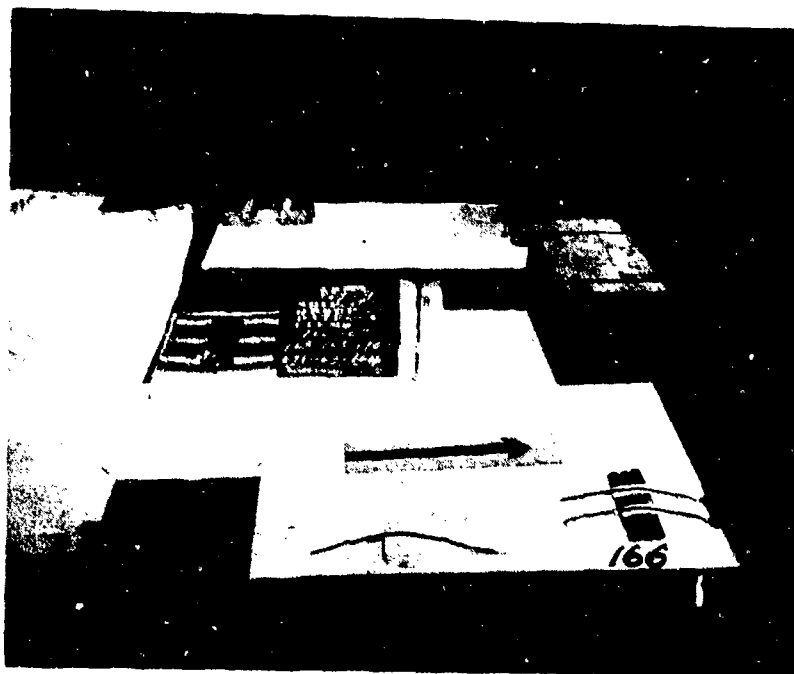
Fig. 445 - LST 52 - Method of securing Item 166.

m. Dynamite, 40% (Item #166). Three sticks were displayed bare, see Fig. 445. On the YOG 83, before the test, see Fig. 446, the paper wrapping on one stick started to open. After Test Able, see Fig. 447, this stick had melted and there was a pool of explosive on the metal plate. The paper wrapping on the other two sticks had been slightly opened. On the LST 52, see Fig. 448: the three sticks were broken in half by the blast and were held together only by the paper wrapping. The dynamite showed signs of decomposition and was therefore disposed of. There was no damage apparent on the remaining ships.

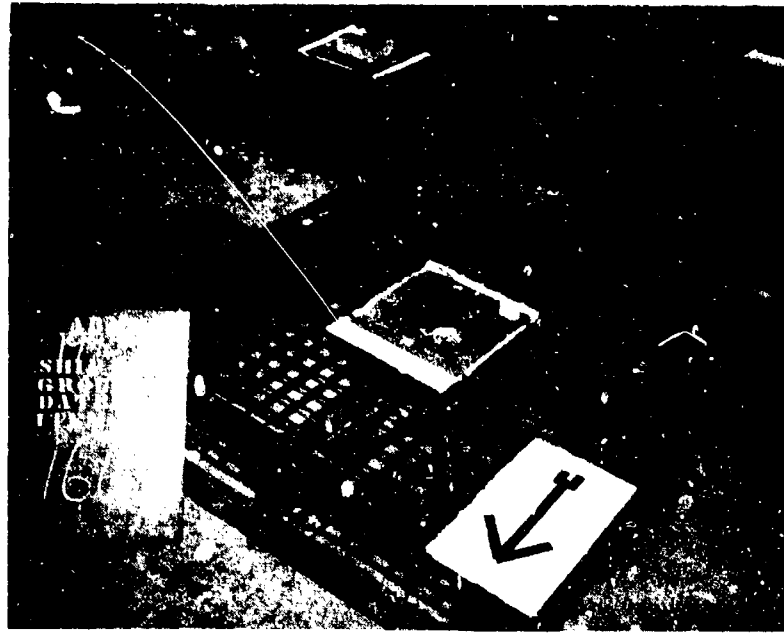
Fig. 447 - YOG 83 - Damage to Item 166 after Test Able.

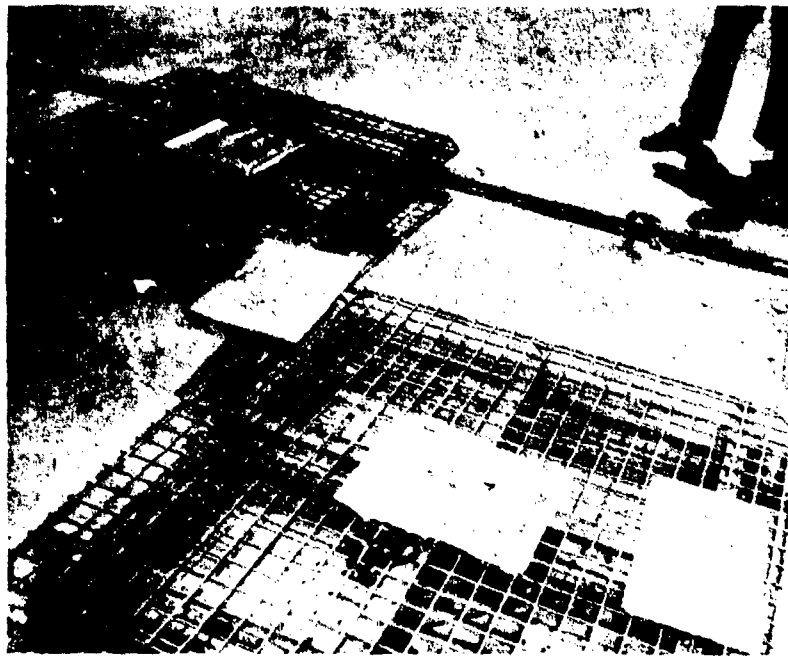
o. Cap, Blasting, Electric, #8 (Item #168). Six caps were displayed bare, see Fig. 451. On the YOG 83, see Fig. 452 and Fig. 453, one cap had detonated. Three caps showed evidence of heat and two were in good condition. The wires showed evidence of scorching and all of the shunts were blown off. The two caps which were in good condition were well covered by their lead wires so that the wires protected the caps from the heat. On the LST 52, the paper tubes covering the wires and caps were scorched on the ends. There was no damage to the wires or caps. No damage to this item was evident on any of the other ships.

**Fig. 453 - YOG 83 - View after Test Able showing the damage to Item 168 and the destruction of Item 170.**

g. Cap, Blasting, Non-Electric, #8 (Item #170). Six caps were displayed bare, see Fig. 455. On the YOG 83, see Fig. 456 and Fig. 453, all were destroyed. On the LST 52, one cap was rotated 50°, but did not detonate. No damage was reported on the other ships.

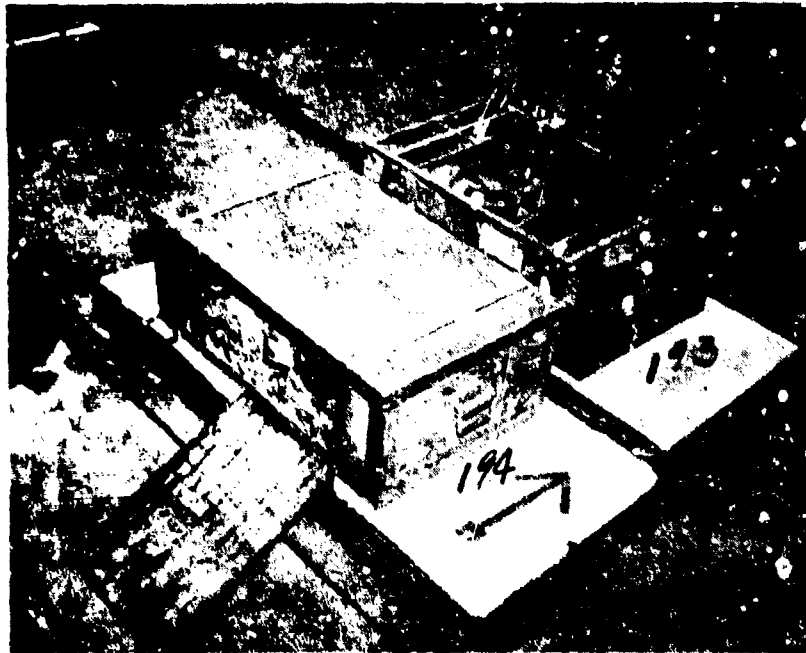
m. Set, Demolition, No. 2, Engr. Platoon, Complete, w/o explosives (Item #193). One set was displayed with the lid of the chest open, see Fig. 461. On the YOG 83, see Fig. 462, Fig. 463, and Fig. 464, the top was blown 19 feet forward from the chest and landed upside down. The exposed end of the chest was scorched slightly. No damage occurred to the items in the chest. On the LST 52, see Fig. 465, the chest was scorched on the end and the lid was closed violently by the blast, fracturing the plastic case containing the galvanometer. On the

Fig. 463 - YOG 83 - Damage to Items 193 and 194 after Test Able.

X. Set, Demolition, No. 2., Engr. Platoon, Complete, w/o explosives (Item #149). One set was displayed in the closed chest, see Fig. 461. On the YOG 83, see Fig. 462 and Fig. 463, the items were not visibly damaged by the blast. The box was scorched on the end and rear but the markings were still legible. The marks made by the strap-ping were clearly visible. On the LST 52, the chest was scorched and the straps were broken. No damage was reported on the other ships.

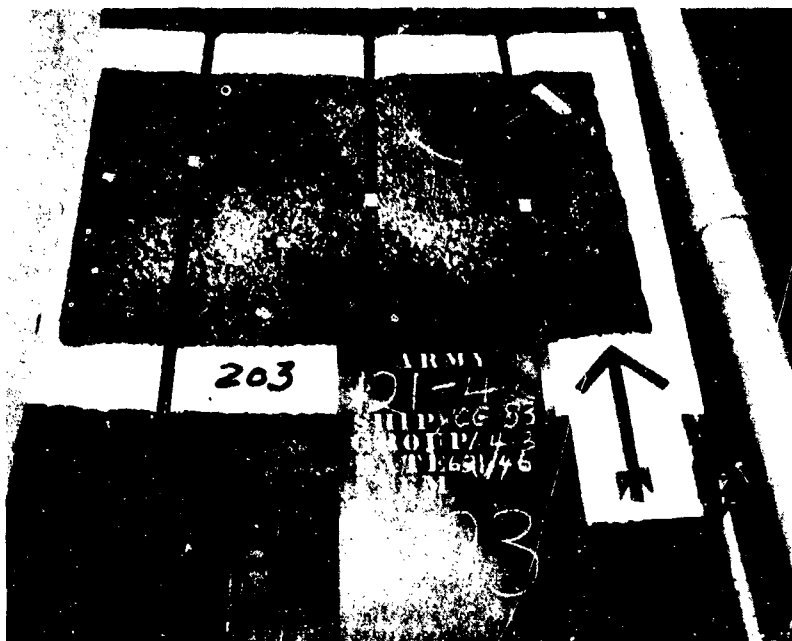
Fig. 471 - YOG 83 - Method of displaying Item 203.

d. Buna E (Butaprene NEM) (Item #203). On the YOG 83, Fig. 471, the sample was blown over the side. On the LST 52, Fig. 472 and Fig. 435, the item was displaced but suffered no damage. There was no apparent change on the remaining three ships.

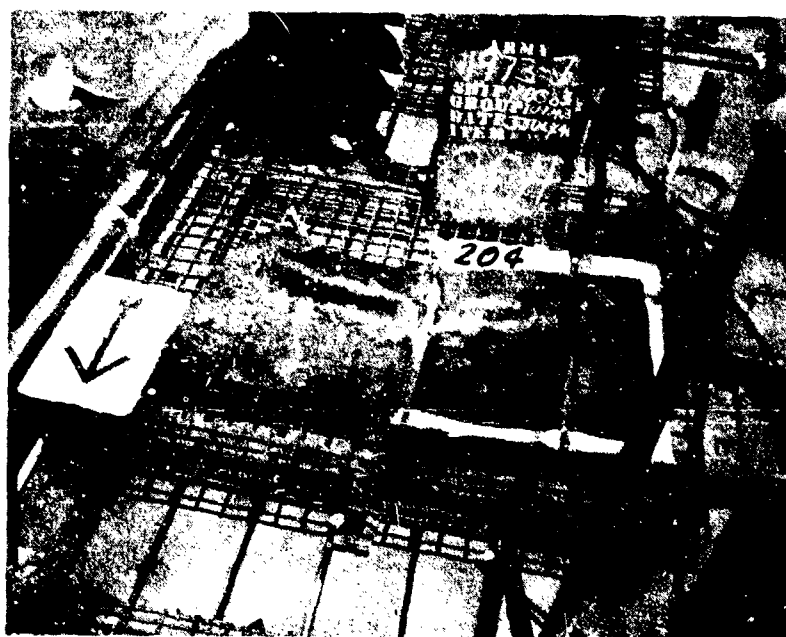
Fig. 473 - YOG 83 - Method of securing Item 204.

e. Natural Grade Rubber (Item #204). On the YOG 83, Fig. 473 and Fig. 474, the rubber sample was scorched and its painted identification marking was burned off. The sample was curled under the middle strap. One strap

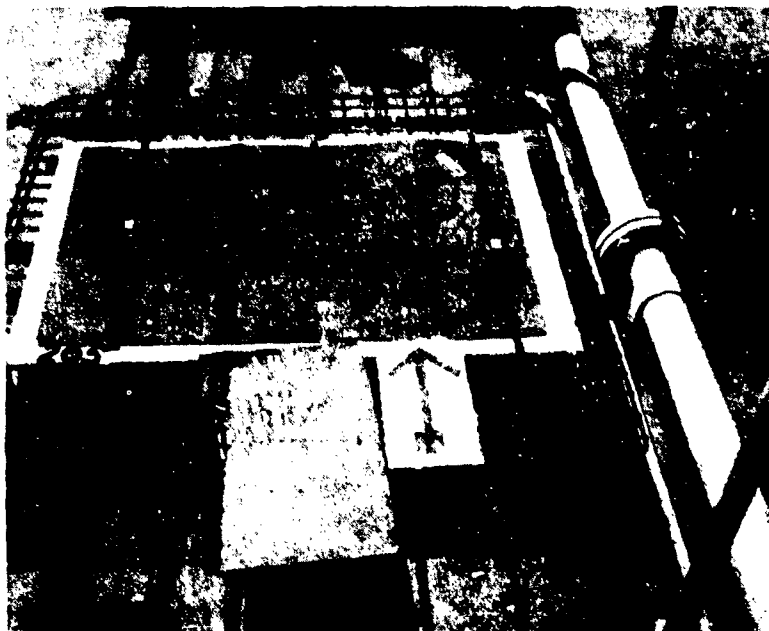
Fig. 475 - YOG 83 - Method of securing Item 205.

f. Black Butyl (Item #205). On the YOG 83, Fig. 475, the item was apparently blown over the side. There was no damage on the other ships.

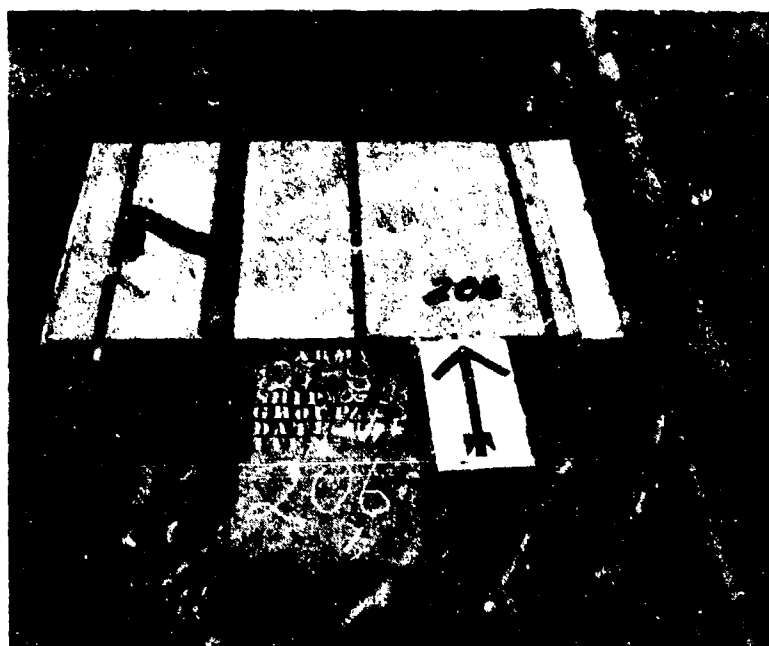
Fig. 476 - YOG 83 - Method of displaying Item 206.

g. White Butyl (Item #206). On the YOG 83, Fig. 476, the sample was blown off the pallet and was slightly scorched. On the LST 52, Fig. 477, the item was not recovered. It is believed to have been blown overboard by the blast. No damage was apparent on the other ships.

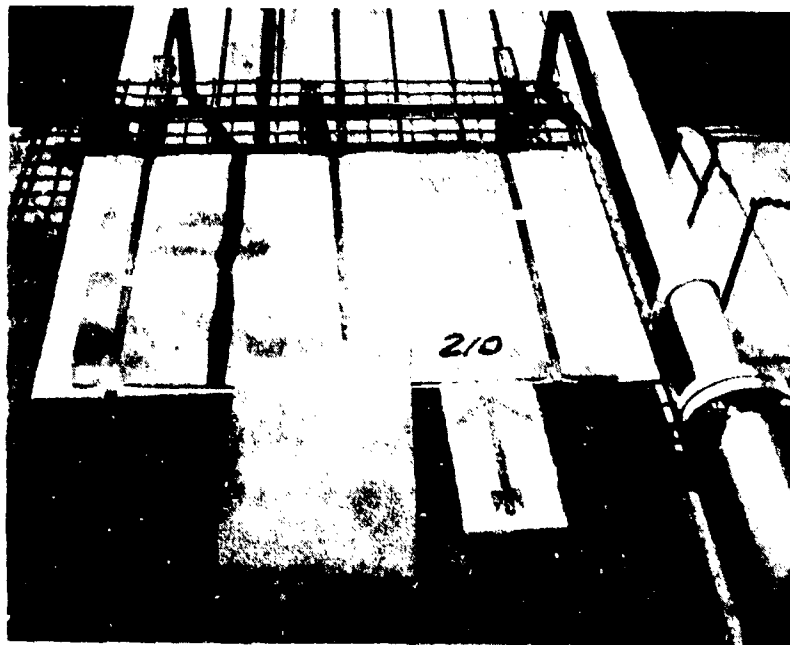
Fig. 481 - YOG 83 - Method of securing Item 210.

k. Gum Perbunan (Item #210). On the YOG 83, Fig. 481, the item was apparently blown over the side. There was no damage on the other ships.

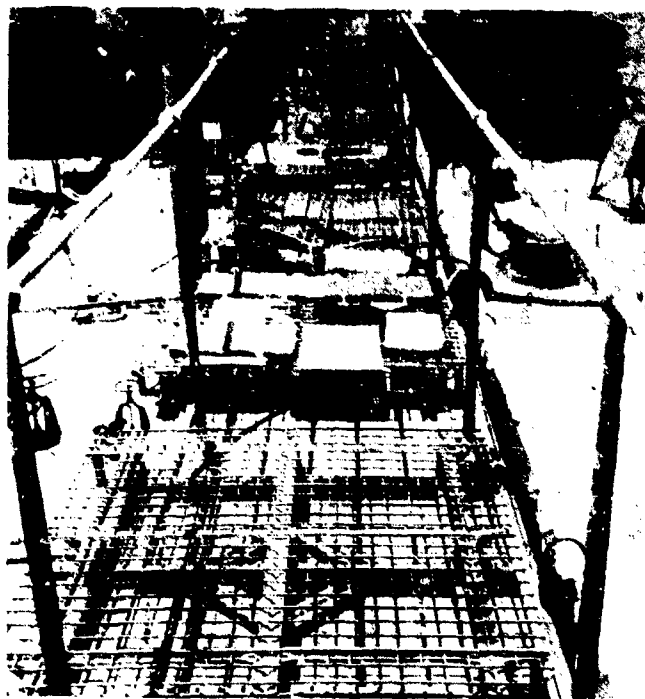
l. See Fig. 482 for overall view of the condition of the rubber samples on the YOG 83.

Fig. 482 - YOG 83 - View after Test Able,  
showing the damage to the rubber  
samples displayed on the catwalk.
