WTC-RESEARCH AND DEVELOPMENT REPORT

# A Facsimile Report

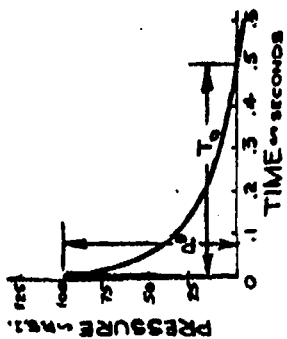
FIGURE 2

Figure 2 indicates the shape of the air blast wave on a pressure-time basis.  $P_0$  is the maximum or peak pressure.  $T_0$  is the duration of the positive pressure phase. The figure illustrates the values for the pressure wave at a point 360 yards out from the center of detonation. It will be noted that the peak pressure is reached almost instantaneously. The length of application of the load,  $T_0$ , varies from about 0.5 second to one second, according to Table I.

This time interval is generally in excess of the natural period of vibration of all ship structures except, possibly, the ship as a whole. Hence, the dynamic load factor by which the peak pressures given in Table 2 must be multiplied to obtain the equivalent static pressure head is approximately 2. In other words, the scantlings of a structure 750 yards from the burst must be designed to resist a static load of 42 pounds per square inch to resist the dynamic impact of the peak pressure of the atomic air burst.

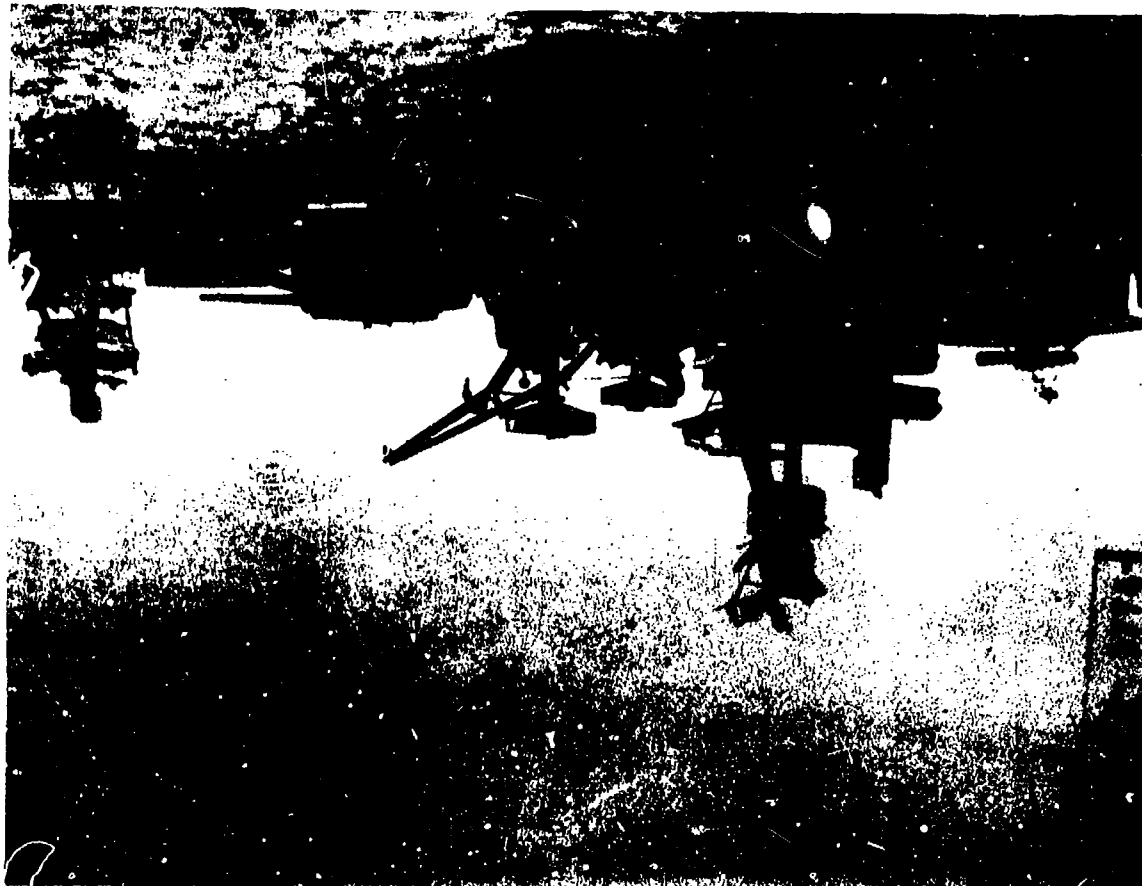
AA-CR-82-1774-11. U.S.S. ARKANSAS (BB33). General view of superstructure from port. Mainmast radar pole mast is hanging over forward side of mainmast. Pole mast on foremast is bent double.

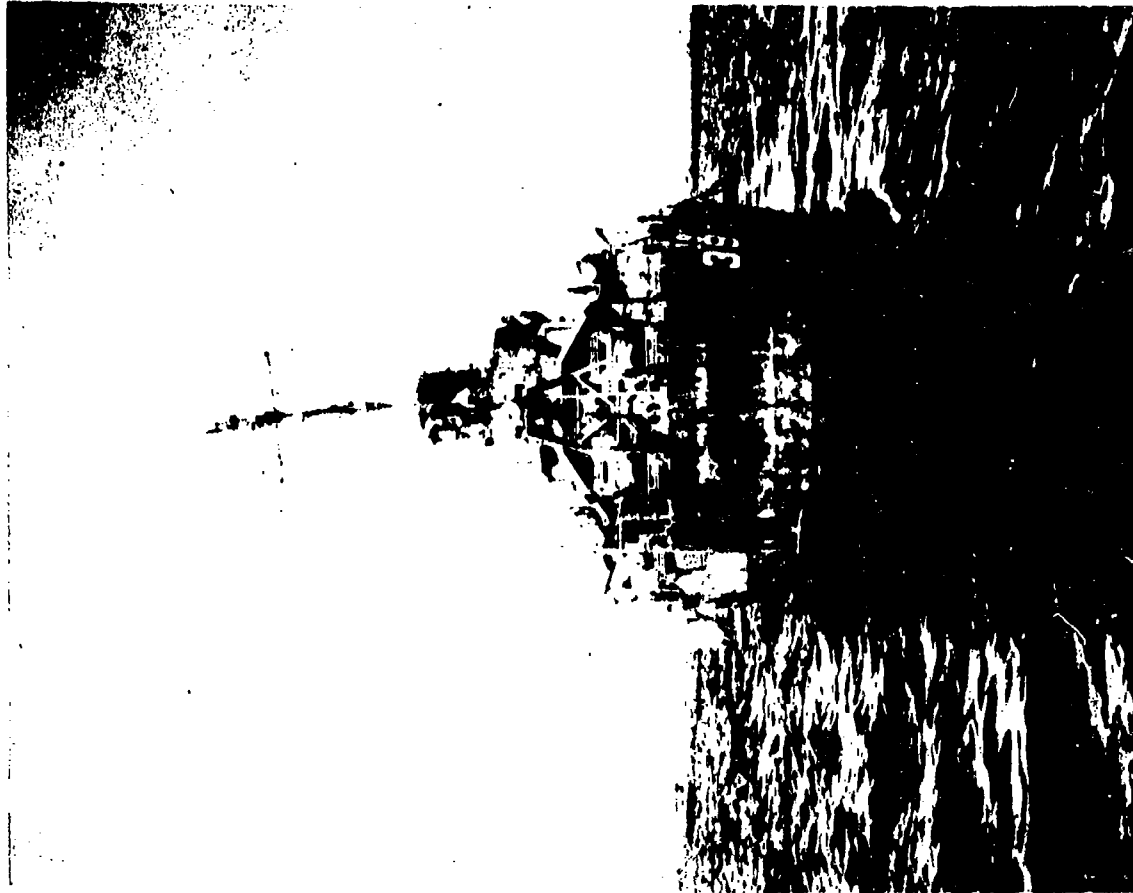
3. Beyond the 900 yard range from the blast center damage to pole masts and spars is not serious. There is no apparent damage to the masts on BRULE (APA66), at 950 yards. RHIND (DD404), located about 1000 yards from the burst suffered a failure of the radar on the foremast (Photo 1771-10, page 45) but the masts themselves are essentially undamaged (Photo 2003-4, page 46). At 1100 yards, the foremast on RALPH TALBOT (DD390) is bent to port (Photo 227-50-41, page 47) but damage to masts beyond 1000 yards

AA-CR-227-50-41. U.S.S. RALPH TALBOT (DD390). General view from directly astern, showing bend in foremast.
