# CATEGORY II TEST REPORT FOR WIND MEASURING SET AN/TMQ-15

CATEGORY II TEST REPORT FOR  
WIND MEASURING SET AN/TMQ-15

Weather Observing and  
Forecasting System 433L  
(Contract No. AF 19(626)-16)

Report No. WSC E-29

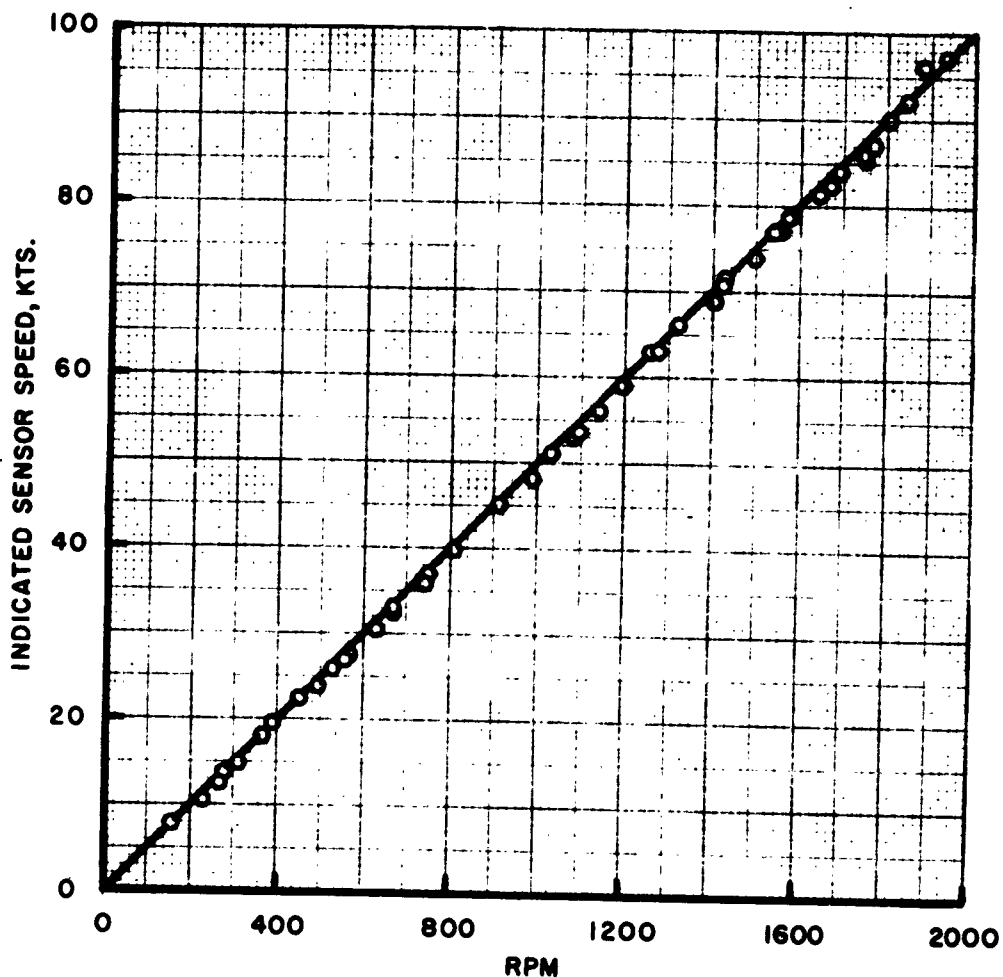
FIG. 7

b. AN/TMQ-15 Speed Sensor RPM versus AN/TMQ-15 Indicated Speed  
(see Figure 7)

PLOT OF TRUE TUNNEL SPEED VS AN/TMQ-15 SPEED

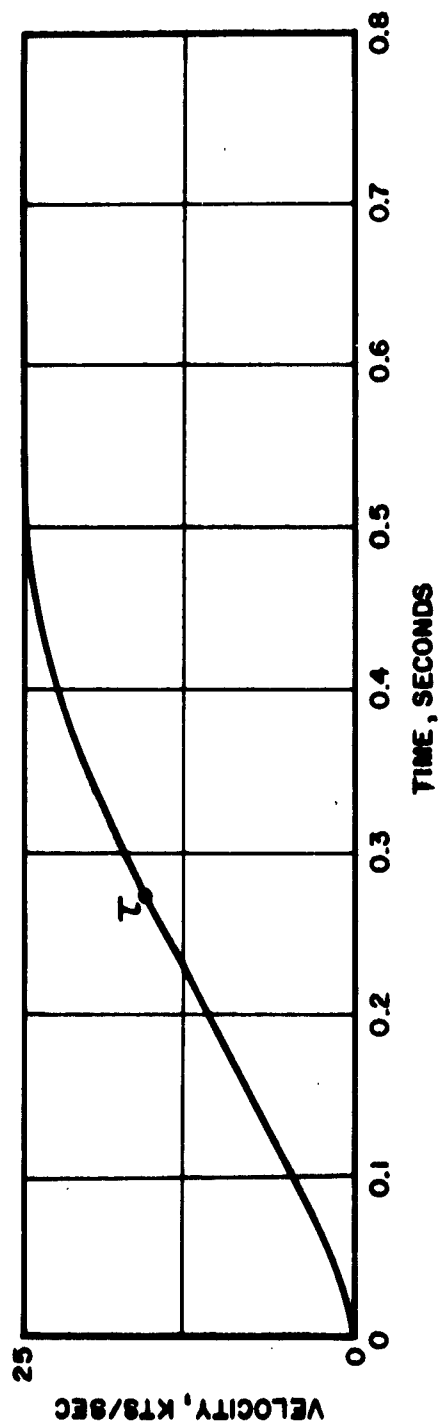
FIG. 9

c. Response Time of AN/TMQ-15 Anemometer Cup Assembly (see Figure 9)

NOTE:  $\tau = \frac{1}{T} = 62.5\%$ , ONE TIME CONSTANT = 0.27 SEC.
