### DYNAMIC TEST OF AN AIRCRAFT LITTER INSTALLATION

One of a Series of Reports Pertaining to the  
Dynamic Crash Test of a U.S. Army H-21 Helicopter

March 1963

TRECOM Technical Report 63-3

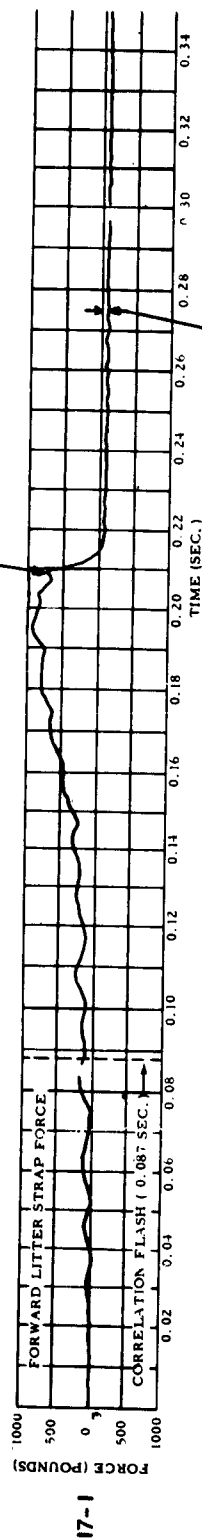
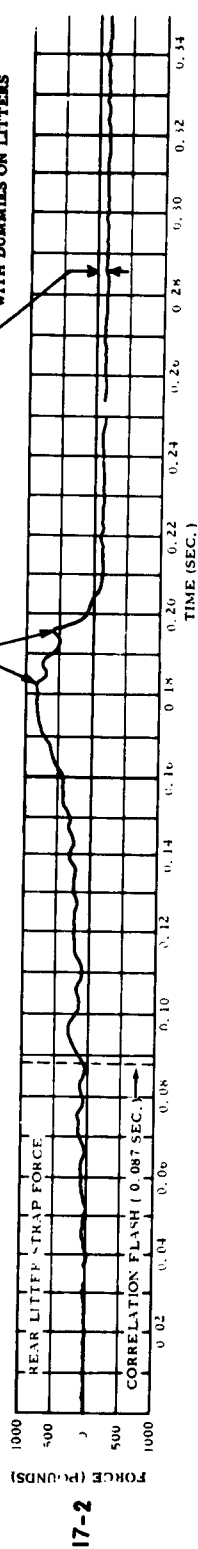
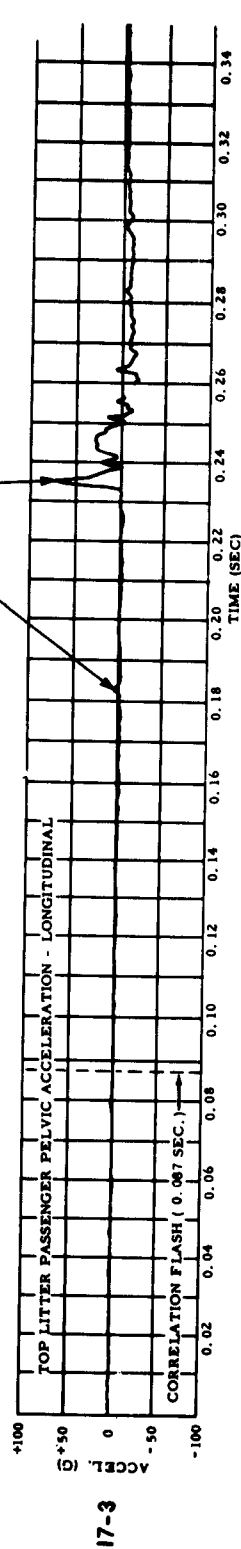
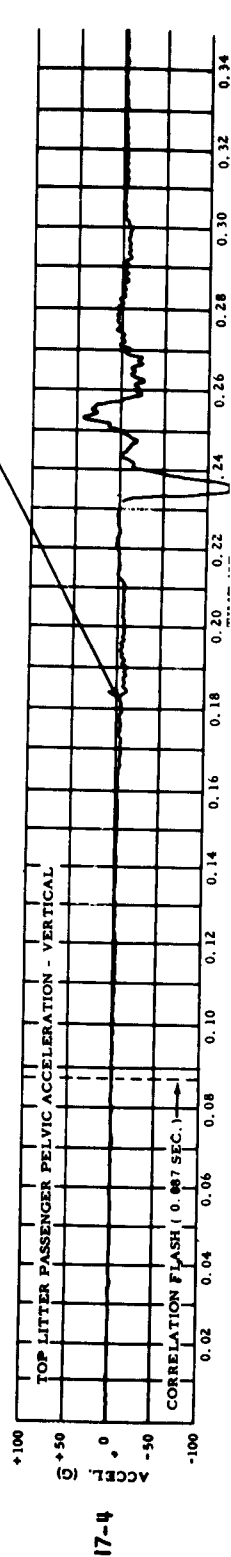
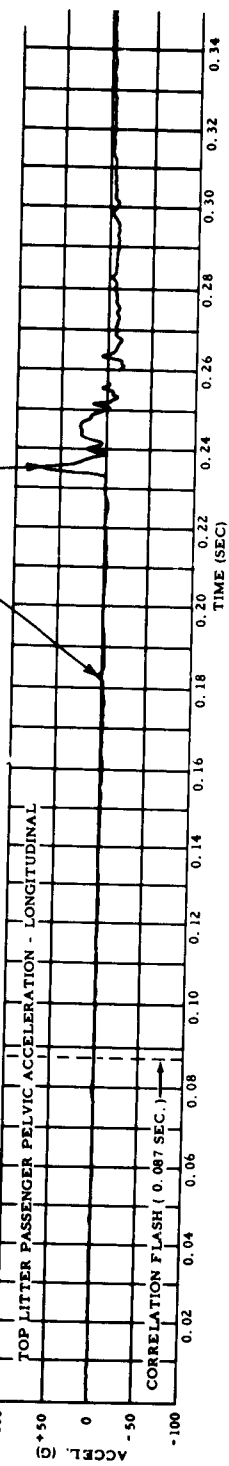
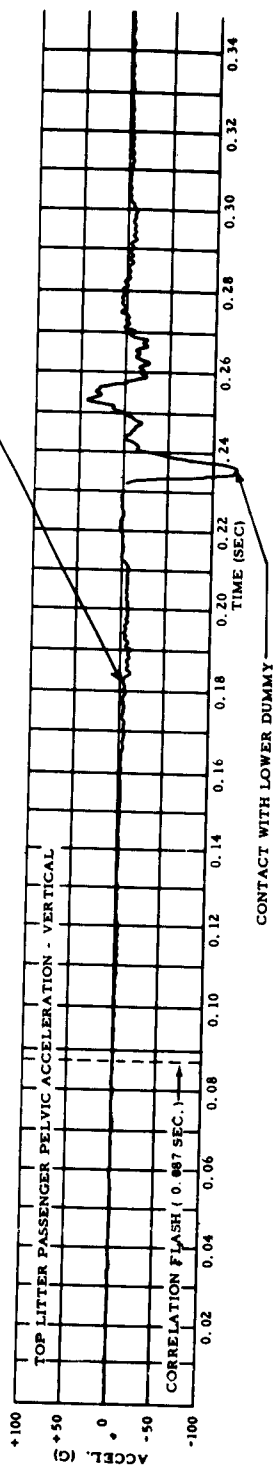
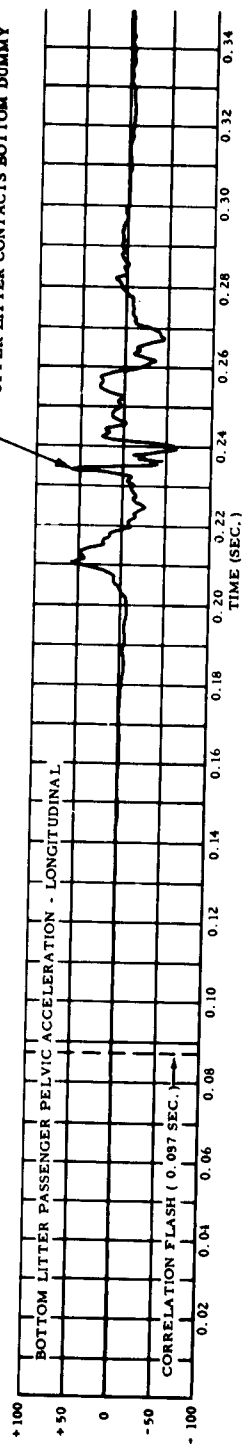
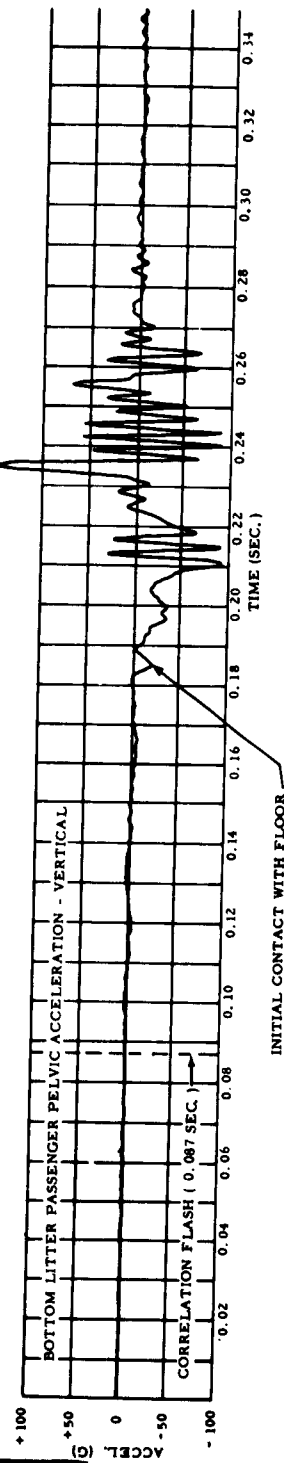
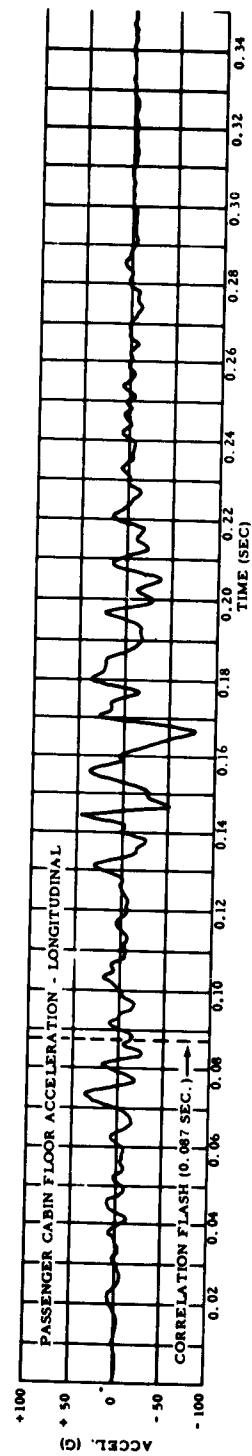
6. The top litter patient impacted the lower dummy at 0.23 second, as shown in Figure 18. A "vertical" acceleration of 125G (see Figure 17-4) and a simultaneous longitudinal acceleration of 70G (Figure 17-3) were recorded. A positive vertical acceleration of 150G (Figure 17-6) was also recorded in the lower dummy. A positive acceleration in this instance implies that downward load has been applied as was obviously the case here.

SEPARATION FROM REAR LITTER STRAP

CONTACT WITH LOWER DUMMY

UPPER LITTER CONTACTS BOTTOM DUMMY

INITIAL CONTACT WITH FLOOR
