# DESIGN DIVISION TECHNICAL REPORT

**PHILADELPHIA NAVAL SHIPYARD**  
**PHILADELPHIA, PENNSYLVANIA**

COLLECTION OF LETTER REPORTS  
OF VIBRATION SURVEYS  
ISSUED DURING 1962

F. A. HEINZE  
AND  
D. S. BROGDEN

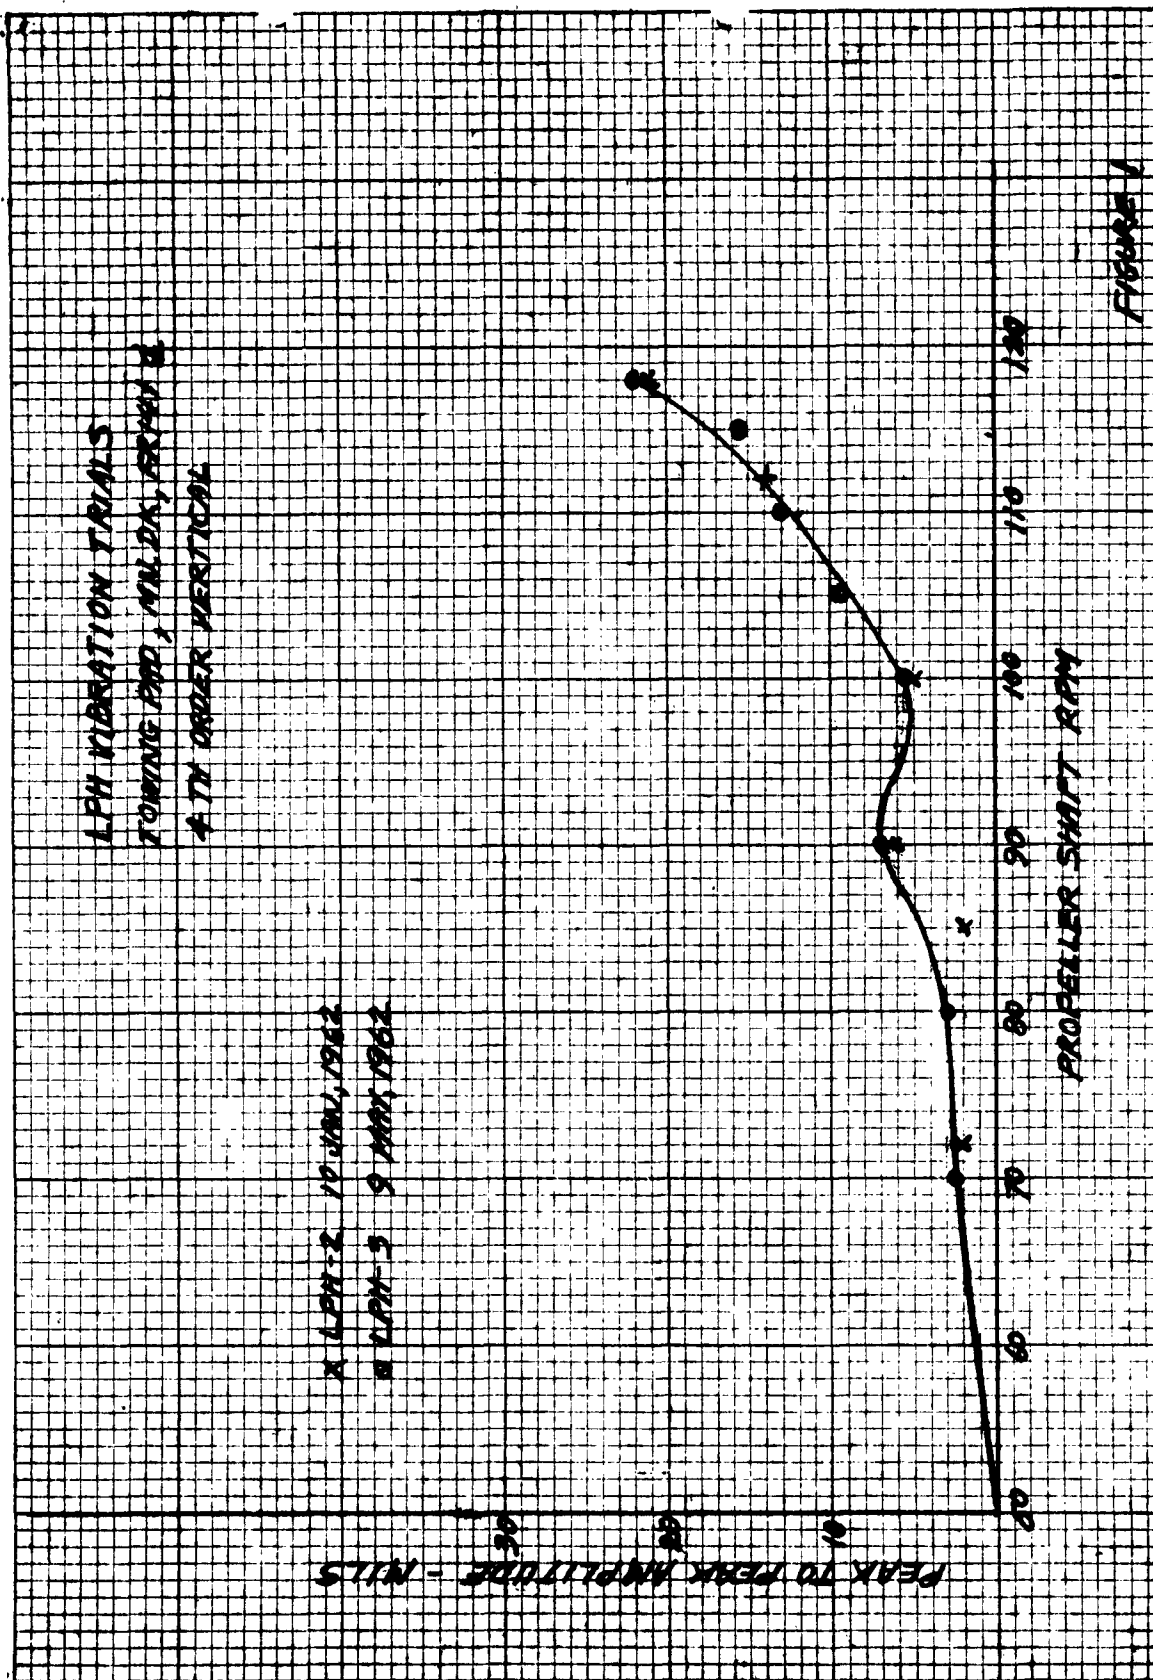
LPH VIBRATION TRIALS  
TOWING PAD, HANDED, FROM 1/2  
4TH ORDER TRANSVERSE

4. Results of the measurements at the towing pad, Frame 141, are plotted in figures 1 and 2 of enclosure (1). Data obtained on USS IWO JIMA (LPH-2) at 15,900 tons displacement on 10 January 1962 are plotted for comparison. It should be pointed out that vibration levels during hard turns are far from steady and the maximum amplitudes were found to vary considerably between various turns at the same rudder angle and speed. Therefore, the comparison between LPH-2 and LPH-3 in hard turns should not be given too much weight.
