NUMBER D2-80092

UNCLASSIFIED TITLE Cryogenic Tanks Development -

(Dyna Soar)

MODEL NO. X-20A CONTRACT NO. AF33(657)-7132

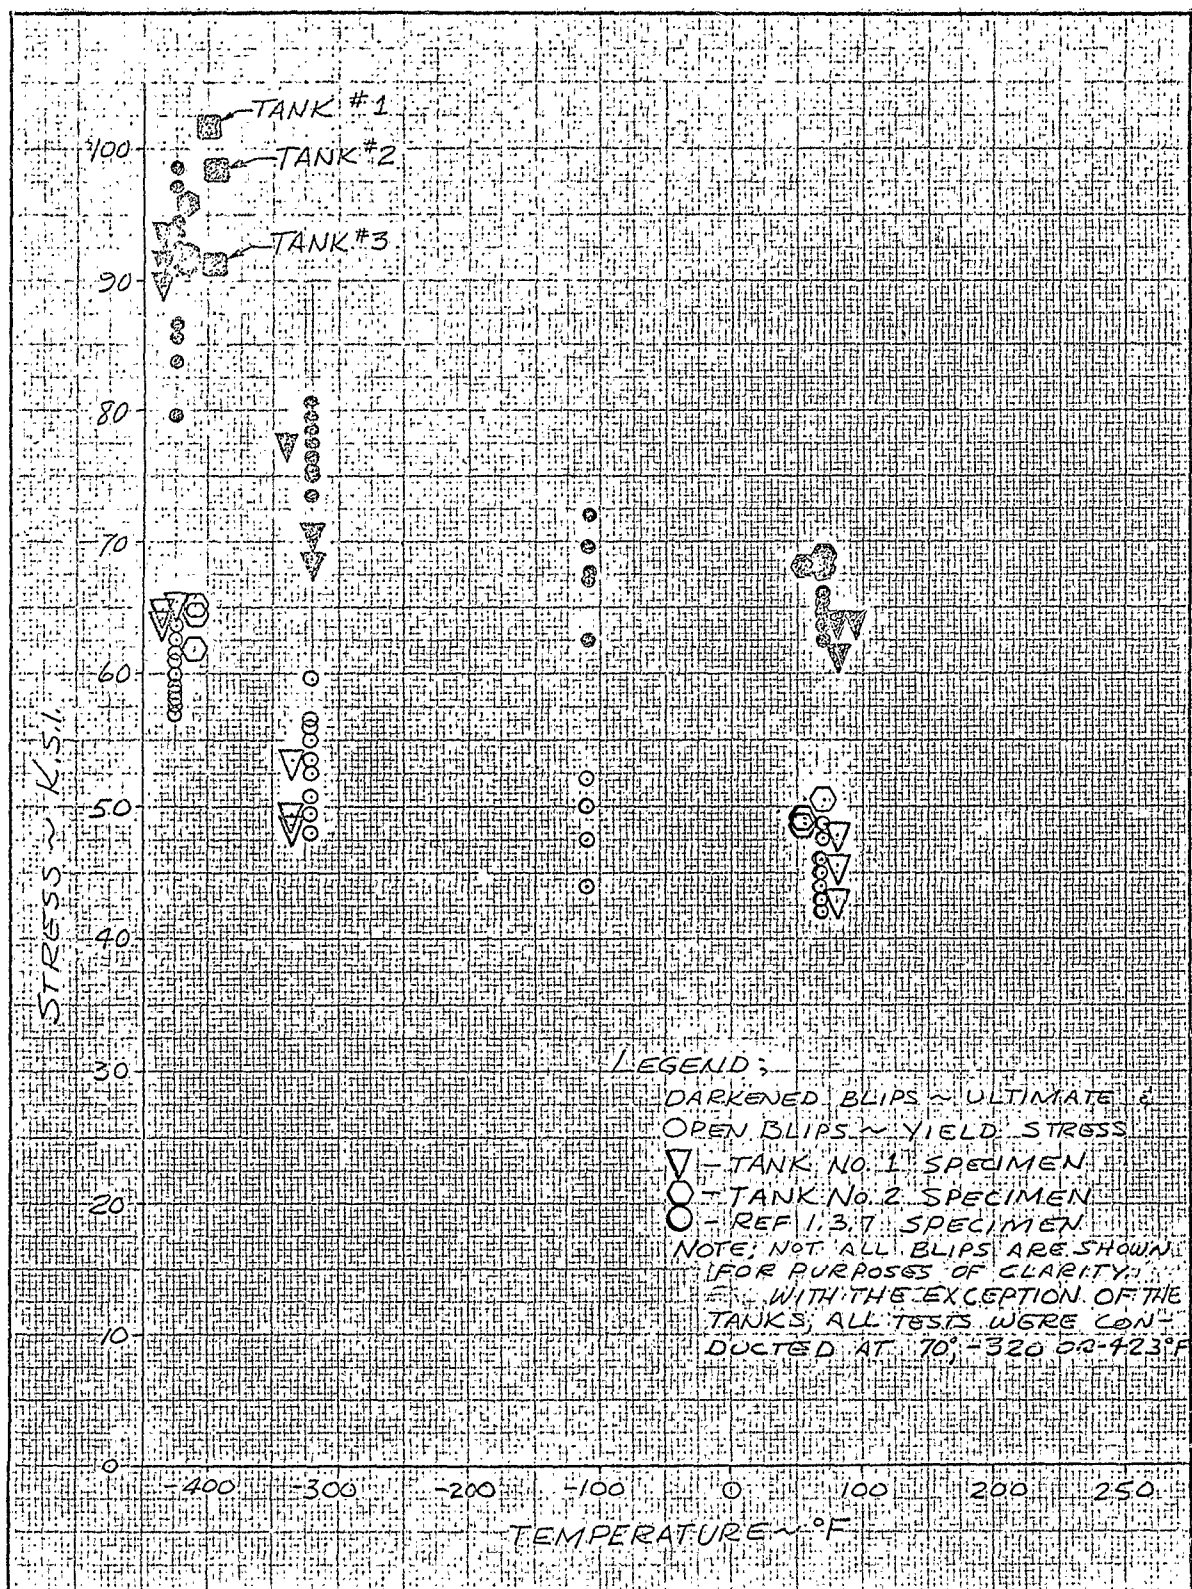
| CALC | D. MATTERAND 4/10/5 | REVISED | DATE | FIGURE 1.21 | D2-80092 |

Figure 1.21 is plot of the base metal tests obtained in Reference 1.3.7 and the data obtained in this test program as summarized in Reference 1.3.6. In addition, the calculated burst stresses from Table 1.7.1 are also indicated. The plot of data indicates that the tanks burst at stresses equal to or higher than the uniaxial test specimen.

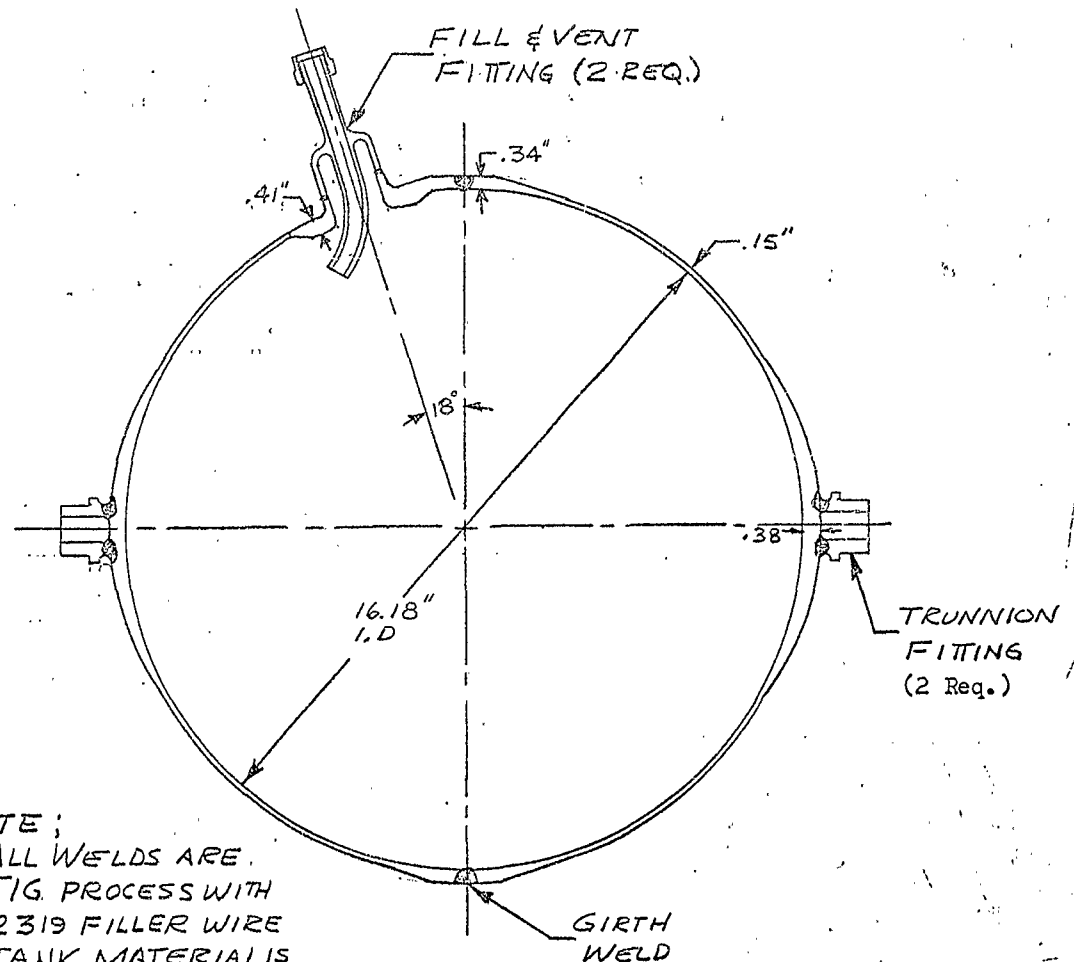
FIGURE 2.1  
INNER LN<sub>2</sub> TANK SHELL

Production tanks will not have "as welded" joints in the shells, nor will such obvious stress raiser be tolerated.
