**CH-21A HELICOPTER AIRFRAME DEFORMATION
UNDER A DYNAMIC CRASH CONDITION**

One of a Series of Reports
Pertaining to the Dynamic Crash Test of a U. S. Army CH-21A Helicopter

January 1964

TRECOM Technical Report 63-77

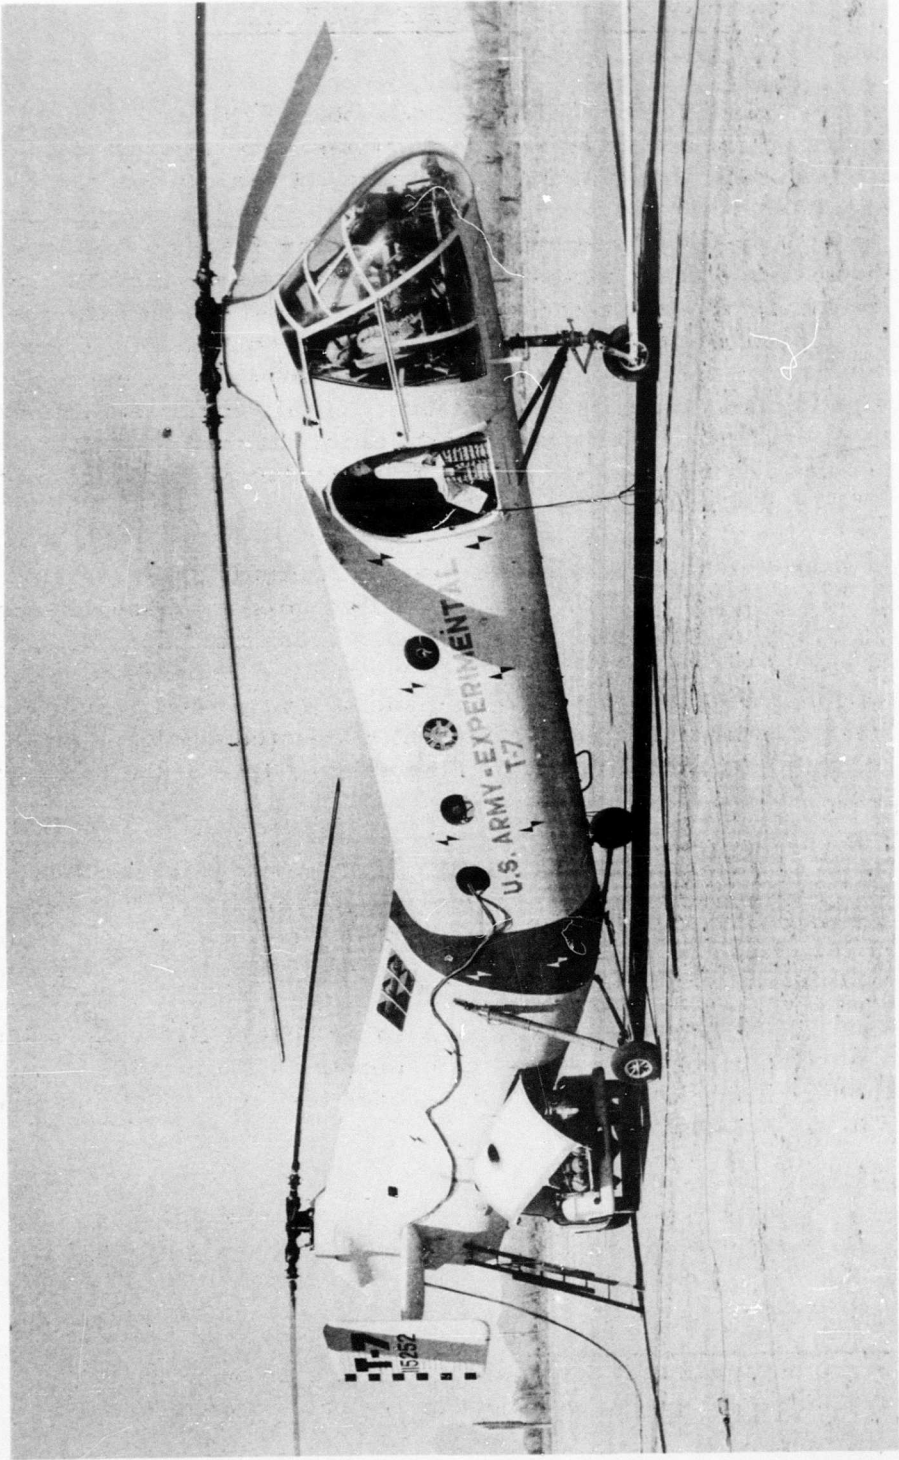
Figure 1. Test Vehicle Prior to Crash.

Note the various markings on the fuselage which aid in the study of structural deformation during crash.

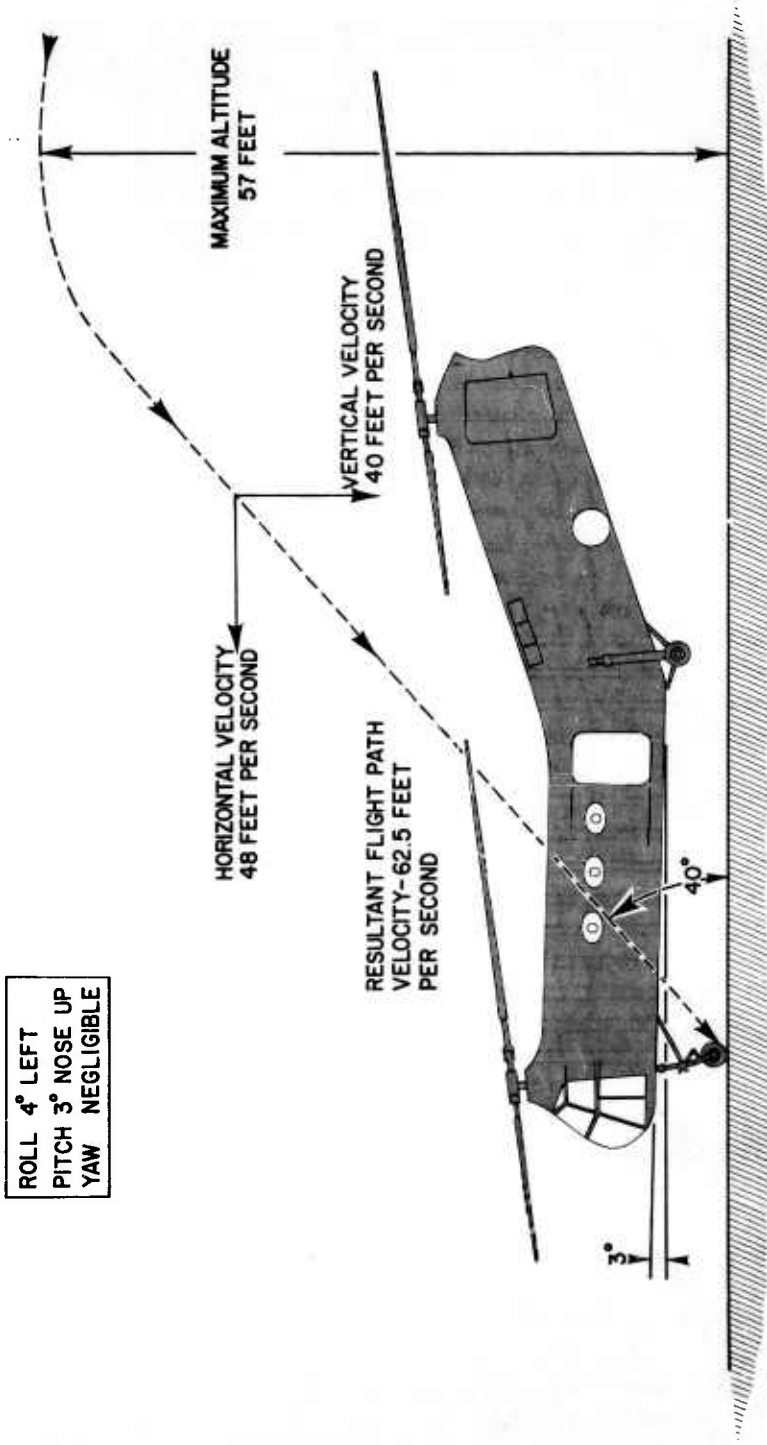
Figure 4. Crash Conditions of Altitude and Velocity.

AIRCRAFT VELOCITY AND ATTITUDE AT INITIAL IMPACT

ROLL 4° LEFT
PITCH 3° NOSE UP
YAW NEGLIGIBLE

The entire cargo compartment lower body, including fuselage skin, floor support structure, and lower sections of body frames, was crushed by impact. Because the aircraft impacted with a slight left roll (Figure 4), the lower fuselage sustained more damage on the left side than on the right side.

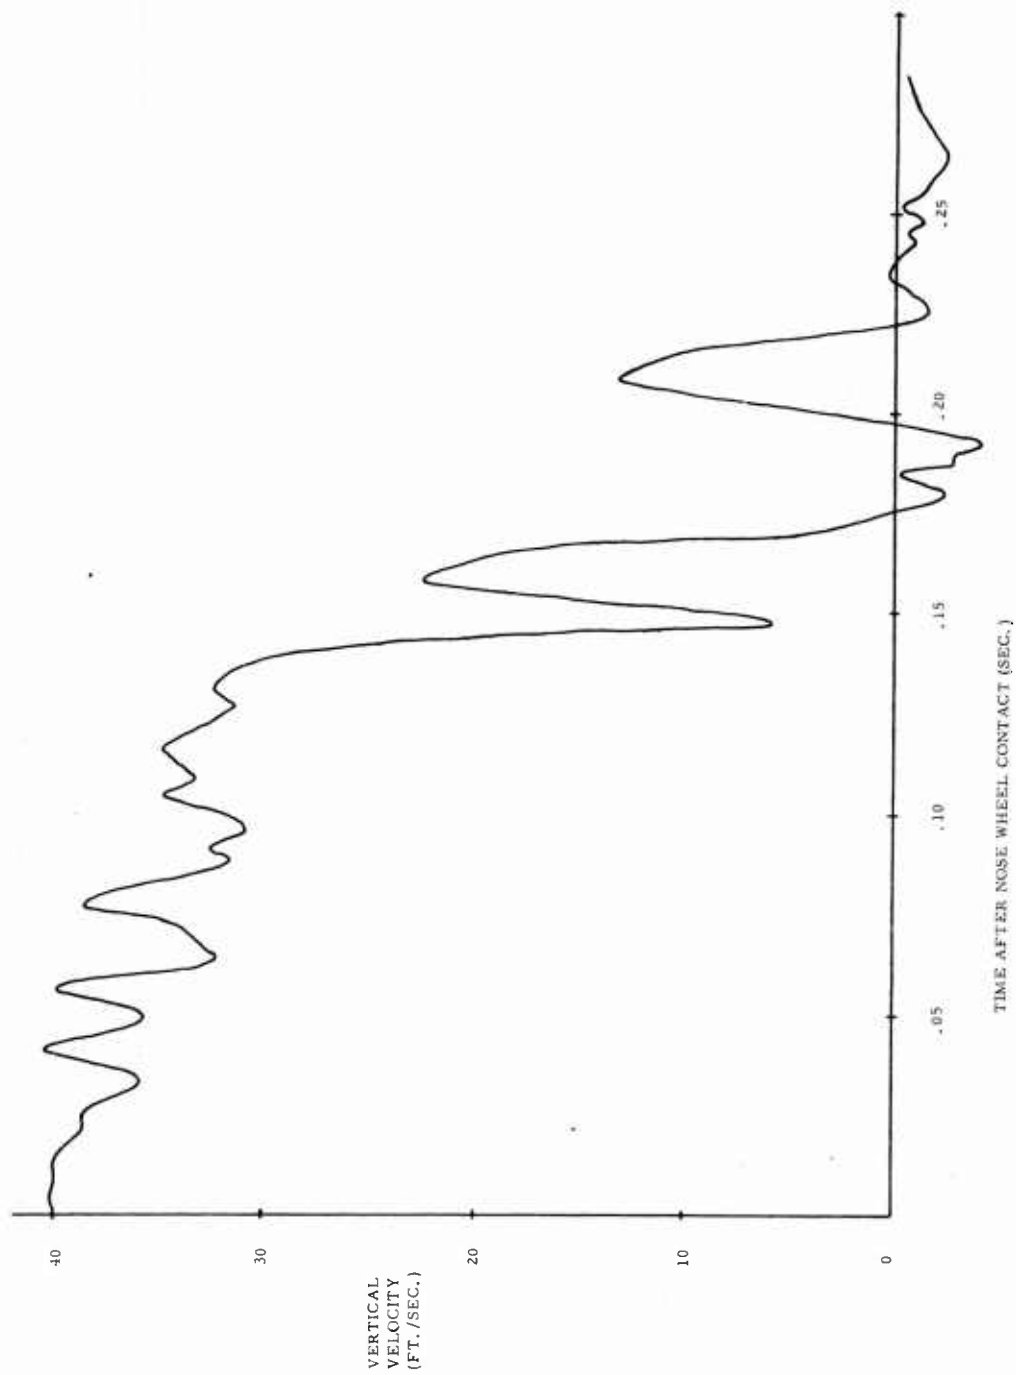
Figure 26. Vertical Velocity vs. Time, Cargo Compartment Floor.

The cargo compartment floor vertical accelerometer data were integrated to obtain the vertical velocity versus time curve of Figure 26. This curve shows a vertical velocity change at the end of 0.250 second of approximately 40.75 feet per second, which correlates closely with the vertical velocity of 40 feet per second which was obtained from the Fairchild Flight Analyzer data.

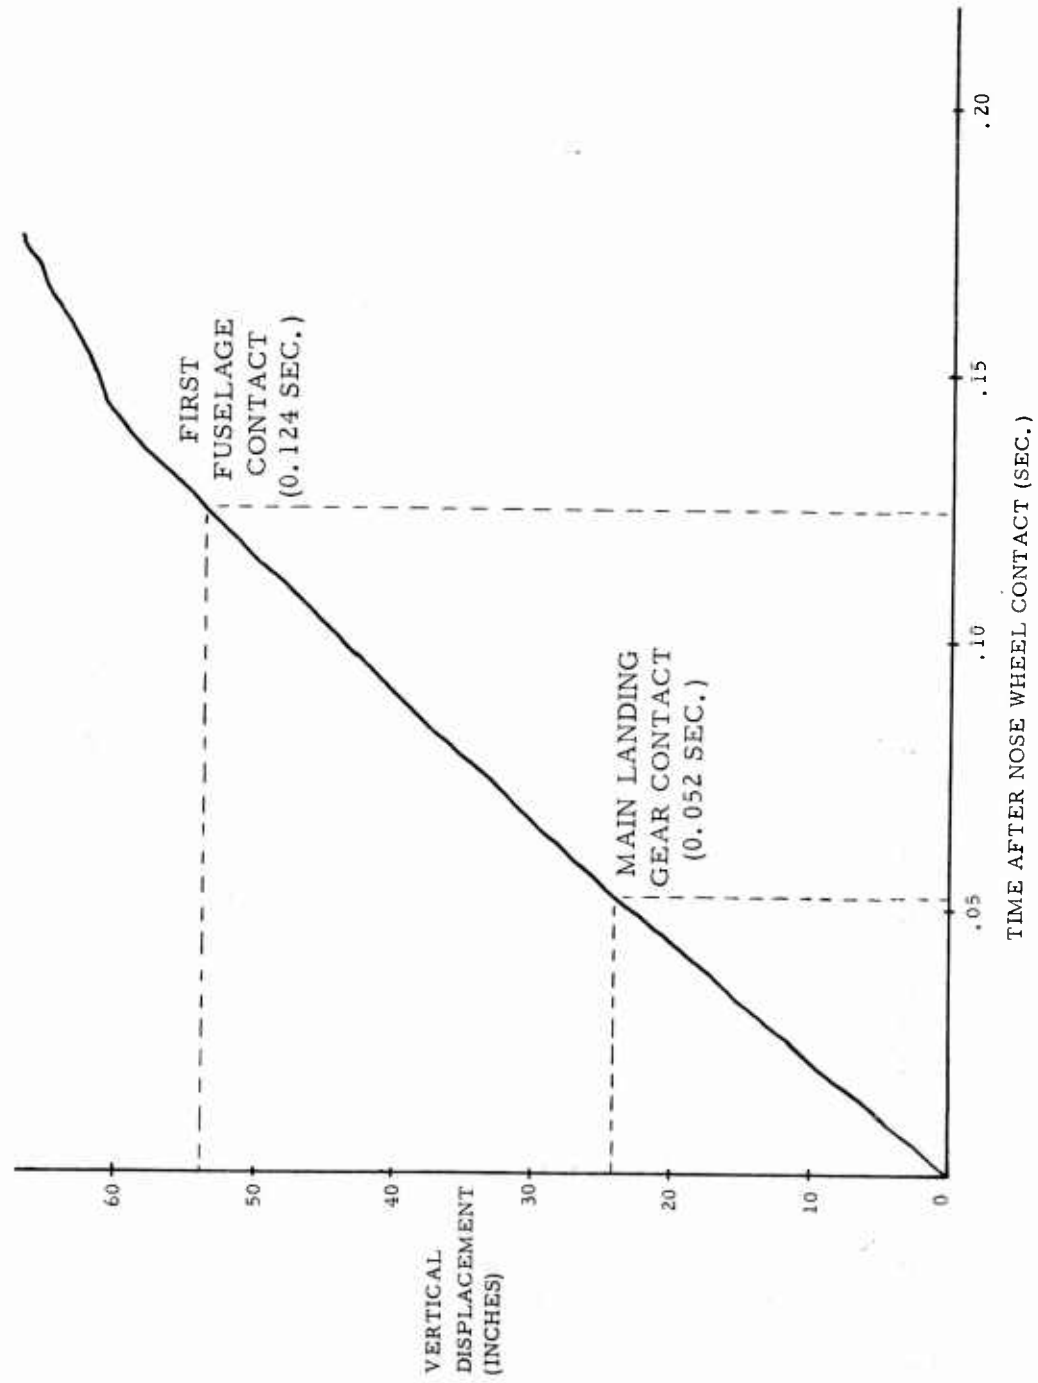
Figure 27. Vertical Displacement vs. Time, Cargo Compartment Floor.

With a CH-21A in the same attitude as the crash attitude, the vertical distance between the bottom of the nose gear and the bottom of the main gear is approximately 24.5 inches. The distance between the bottom of the main gear and the bottom of the fuselage at the point where the fuselage contacted the ground is approximately 29.0 inches, and the vertical distance between the bottom of the fuselage and the cargo compartment floor at the location of the accelerometer, fuselage station 270, is approximately 18 inches. Thus, the total possible vertical displacement of this accelerometer was approximately 70.5 inches. The difference between the computed vertical displacement and this maximum measured value is 4.65 inches. Postcrash observation placed the floor of the fuselage approximately 5 inches above the runway at the location of the accelerometer mount. The close correlation of both velocity change information and vertical displacement data as obtained from two separate sources is added proof of the validity of this accelerometer data.
