Technical Note N-622

TSUNAMI DAMAGE AT KODIAK, ALASKA, AND CRESCENT CITY,  
CALIFORNIA, FROM ALASKAN EARTHQUAKE OF 27 MARCH 1964

U. S. NAVAL CIVIL ENGINEERING LABORATORY  
Port Hueneme, California

ABSTRACT

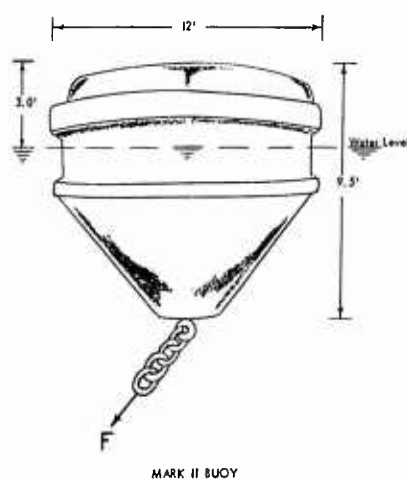
Near the Crash Boat Harbor, sea shells brought in from the harbor by the tsunami were found deposited on land 10 to 15 feet above MLLW. Adjacent to the supply building a 16-foot-diameter mooring buoy (Figure 17A) was washed ashore after being torn from its offshore anchorage. The magnitude of the force on the buoy when submerged is estimated in Figure 17B. This estimate indicates that where the buoy is fully submerged, as it was by the tsunami, the added load is approximately 36 times the load from an assumed mooring chain while neutrally floating. This would seem enough to tear the mooring from its anchorage.

Problem: Force to tear out ring from bottom of mooring buoy.

Assume: Total buoy vol. = 789.7 cf  
Vol. below water = 450.6 cf  
Reserve displacement = 789.7 - 450.6 = 339.1 cf  
Wt. of mooring chain = 20 lbs/ft  
Neglect current and wind.

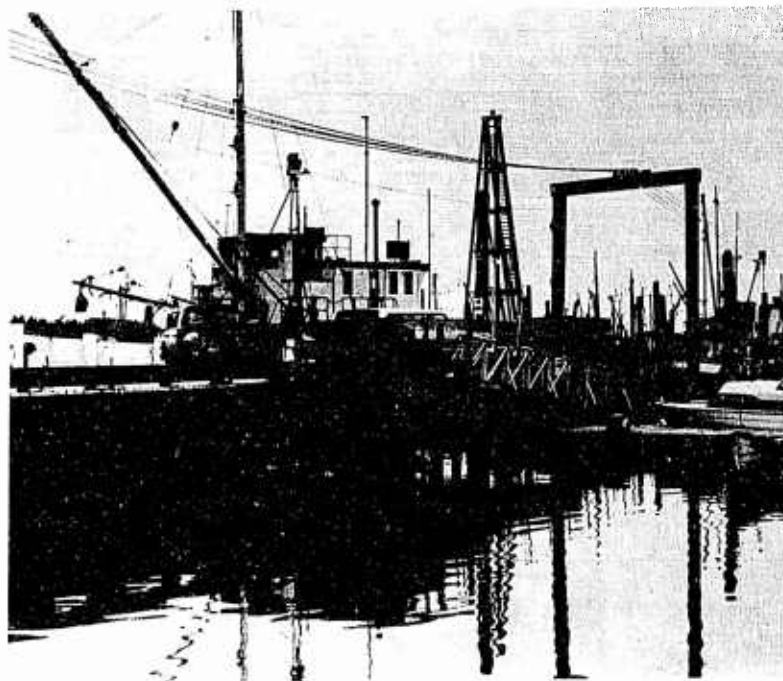
Figure 24. Fishing fleet two hours before the quake. Some boats were maneuvered to safer coves by their owners, while those unmanned rammed into the business section of the city. (PIO, Kodiak NAVSTA)

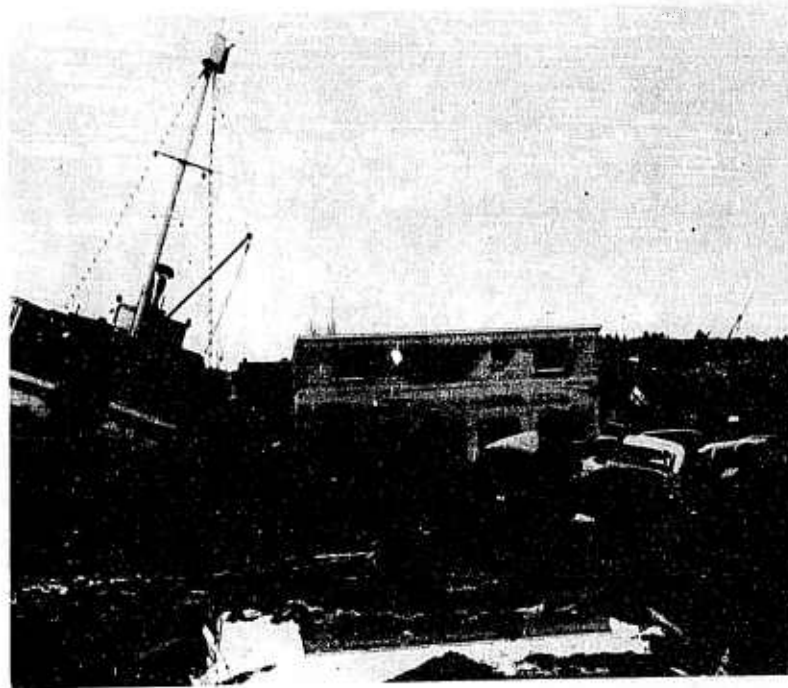
Vehicles in the flooded area were ruined. Furnishings and equipment of homes and offices were damaged when water poured in through broken windows and doors (Figure 28 and 29). Most boat owners and vehicle owners with comprehensive insurance can collect on damages. Interviews with townspeople revealed that the home and business owners did not carry seismic sea wave insurance because of its nonavailability or prohibitive cost.

Figure 28. Vehicle and boat owners with insurance can collect on damages. Business and home owners did not carry "tidal-wave insurance".

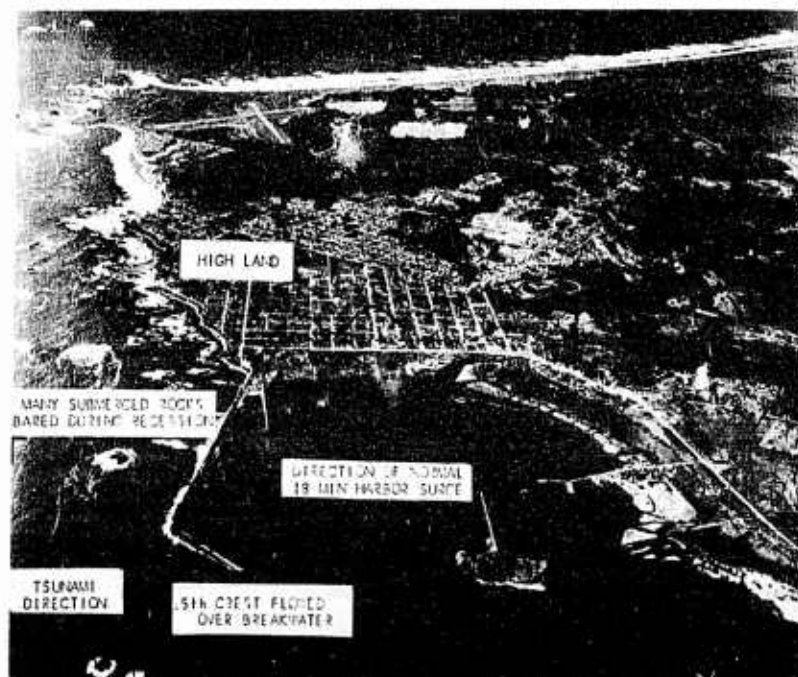
The central business section (of 35 blocks) was swept by the largest of the seismic waves; it crested at 0115 PST on 28 March. The lower dashed high water mark in Figure 36 was that reached by the first wave which crested at 2352 PST 27 March; the higher mark is that reached by the largest wave (Figure 40) which crested on the top of a high tide and also at the end of an eighteen minute harbor surge.

Figure 36. Crescent City's harbor has breakwater protection from storm waves but not from tsunami waves. Dashed lines show high water marks.

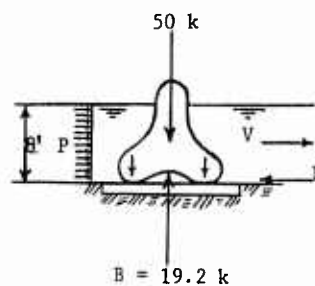
Standing sentinel-like at the city limits and greeting visitors to Crescent City from the South is a giant concrete tetrapod weighing 25 tons. This was erected as a monument in 1958 to mark the first place in the Western Hemisphere where the tetrapod was used in the construction of a breakwater. During the tsunami flooding (Figure 37A) this tetrapod was displaced from its pedestal. It is calculated that a water speed of 14 miles per hour would be necessary to slide this tetrapod from its base (Figure 37B). However, one witness claims he saw a large log bump and shove the tetrapod.

Calculation to find water velocity to slide large tetrapod off base:

Wt. = 25 T; Coef. of Frict. = 0.65    Total vol. = 325  
 Vol. = 325 cf; Drag coef. = 1.2    Vol. in air = 25  
 B = 300 cf x 64 pcf = 19.2 K    Subm. vol. = 300

V =  $\frac{500 \times 32.2 \times 2}{1.2 \times 64}$  = 20 fps = 14 MPH

Figure 37B. Unit pressure and approximate velocity required to slide 25 ton tetrapod.

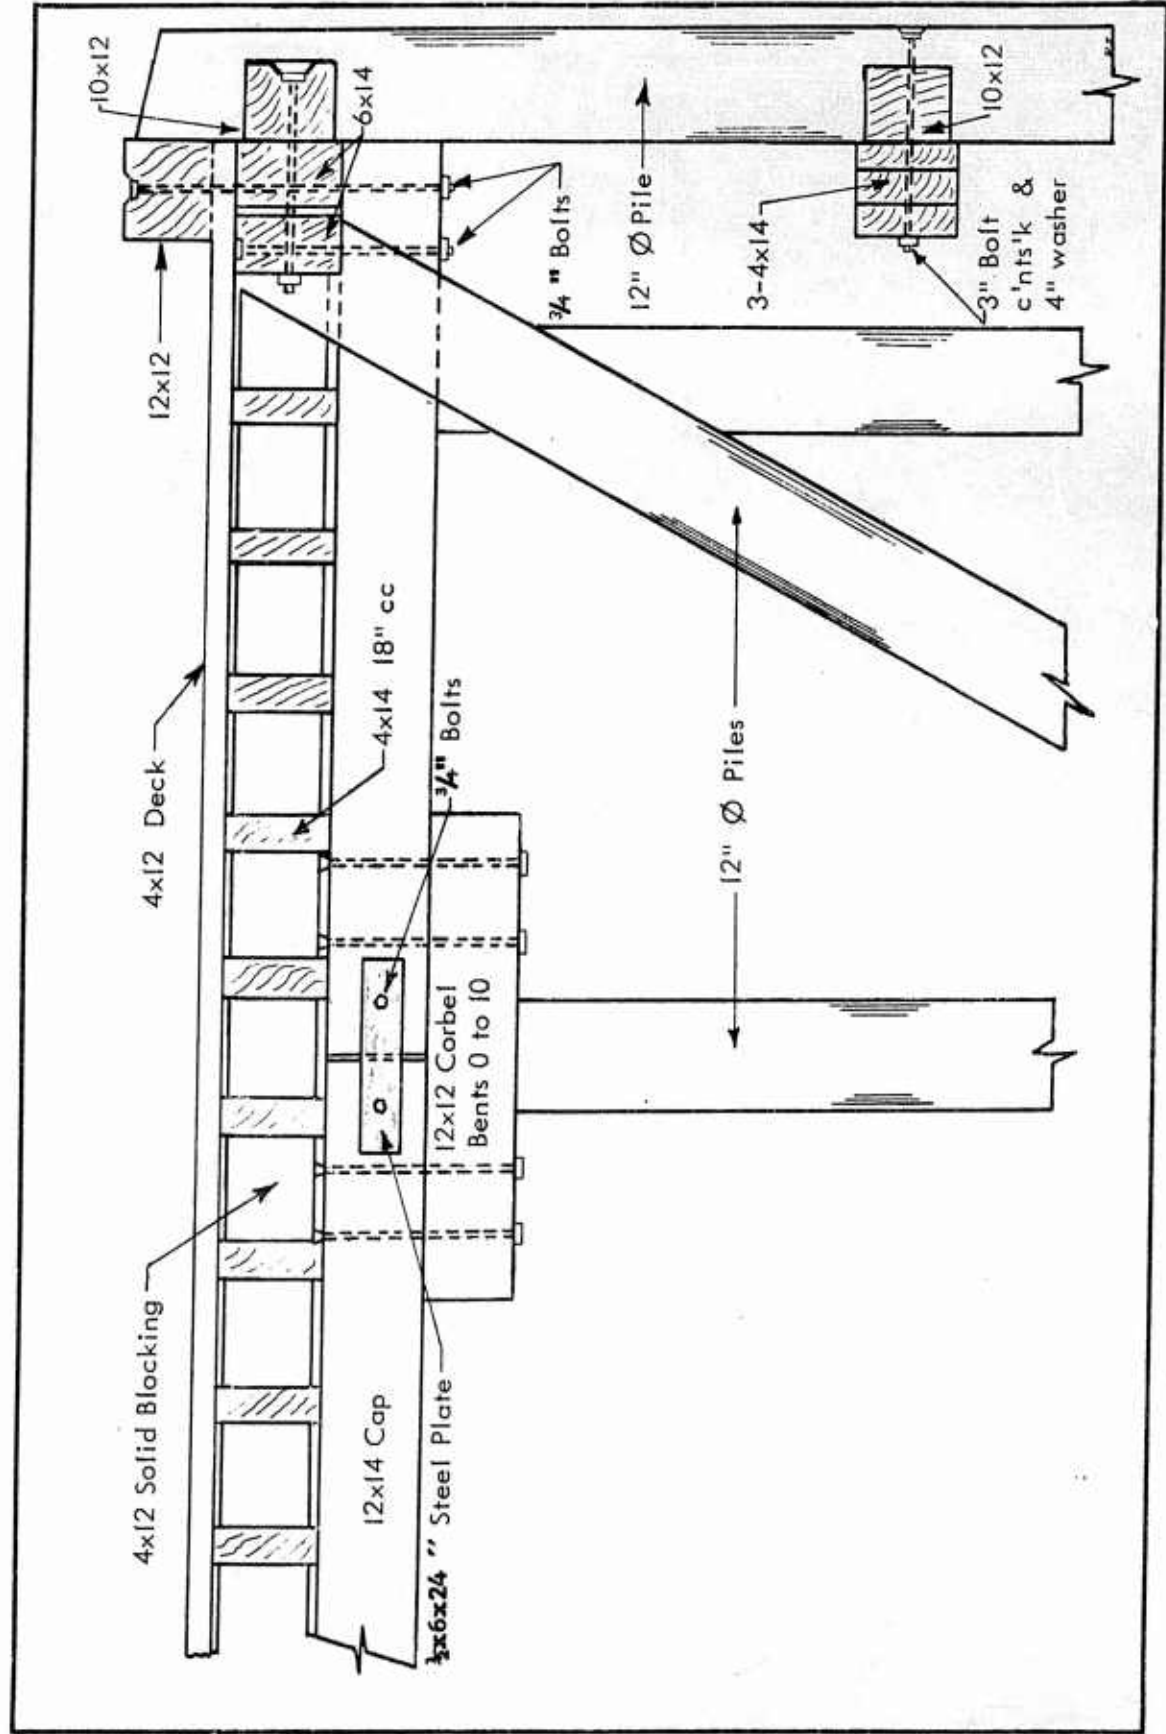
FIGURE 44. TYPICAL SECTION OF CITIZENS DOCK AT CRESCENT CITY, CALIFORNIA  
 (From City Engineer, Crescent City) SCALE:  $\frac{1}{2}"=1'$

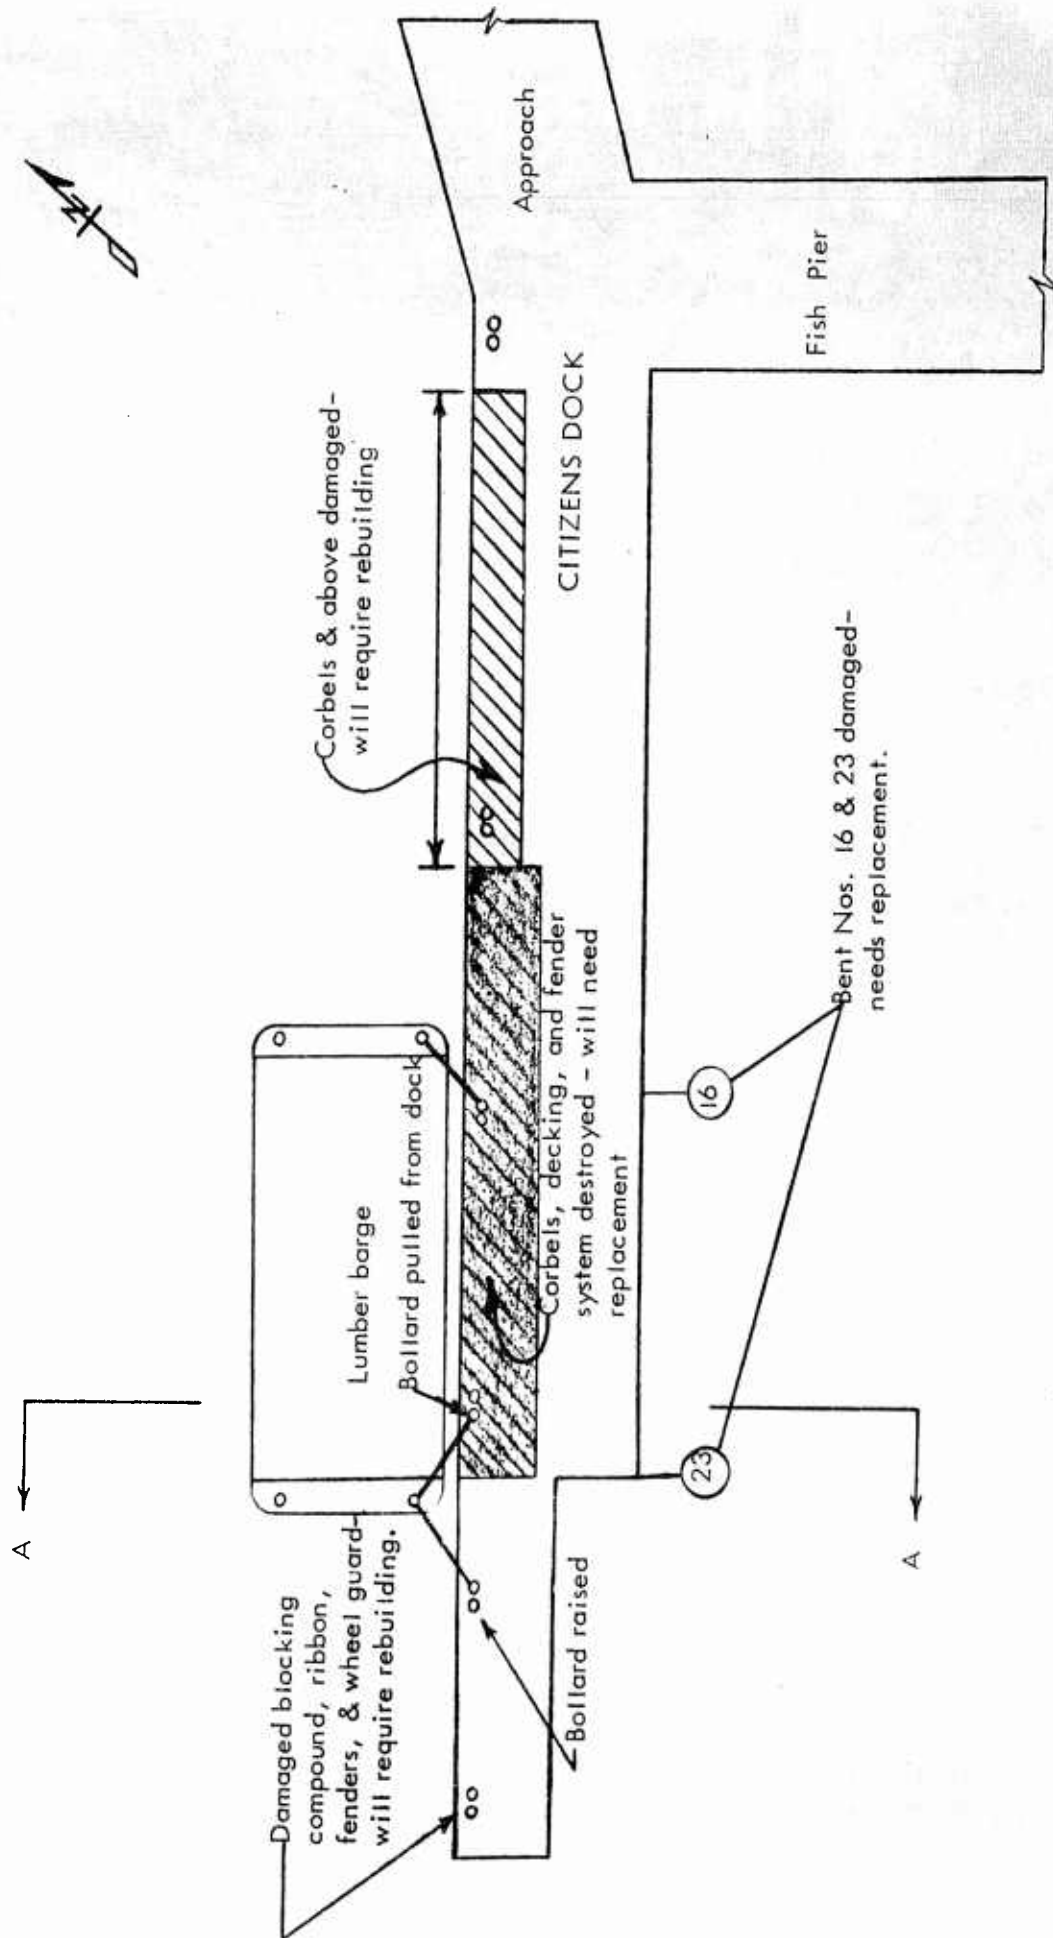
The only damage to the fish pier on Citizen's Dock was along the centerline where the deck raised about six inches. This was due to lack of steel straps between pile caps and stringers. The commercial fish shacks on the pier were displaced (Figure 45).

Figure 45. Plan of Citizens Dock showing moored lumber barge and pier.

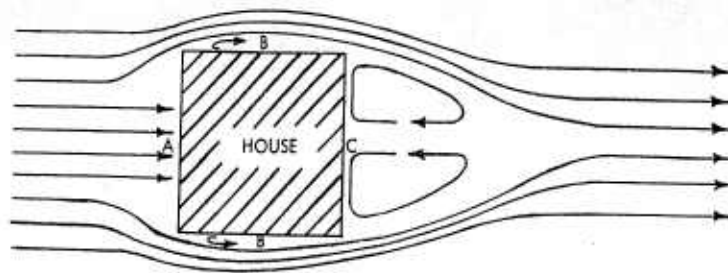
Figure 61A. Flow around typical house.

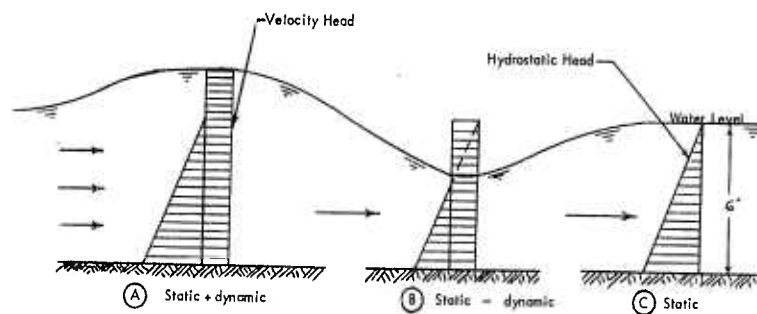
| $V = 5 \text{ fps} \rightarrow$ | $384 + 24 = 408 \text{ lbs/sf}$ | $384 - 24 = 360 \text{ lbs/sf}$ | $384 \text{ lbs/sf}$ |
| $V = 10 \text{ fps} \rightarrow$ | $384 + 100 = 484 \text{ lbs/sf}$ | $384 - 100 = 284 \text{ lbs/sf}$ | $384 \text{ lbs/sf}$ |

Figure 61B. Fluid pressure diagram around typical house.

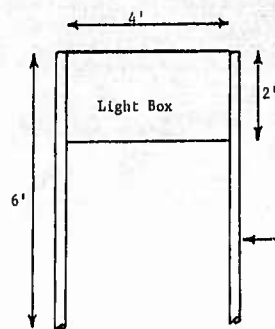
Prob: Find load per  $\text{in}^2$  which will produce yielding of post at base.

Assume:  $S = 30 \text{ KSI}$   
 $I_{\text{post}} = 1.18 \text{ in}^4$   
 $ID = 2.468$   
 $OD = 2.375$   
 $C = 1.437$   
 $C_D = 0.35$   
 $\bar{y} = \frac{\sum \Delta y}{\sum A} = \frac{82,080}{1,512} = 54.2"$
