CRASH INJURY INVESTIGATION

U. S. ARMY HU-1A

BELL IROQUOIS HELICOPTER ACCIDENT

Fort Carson, Colorado

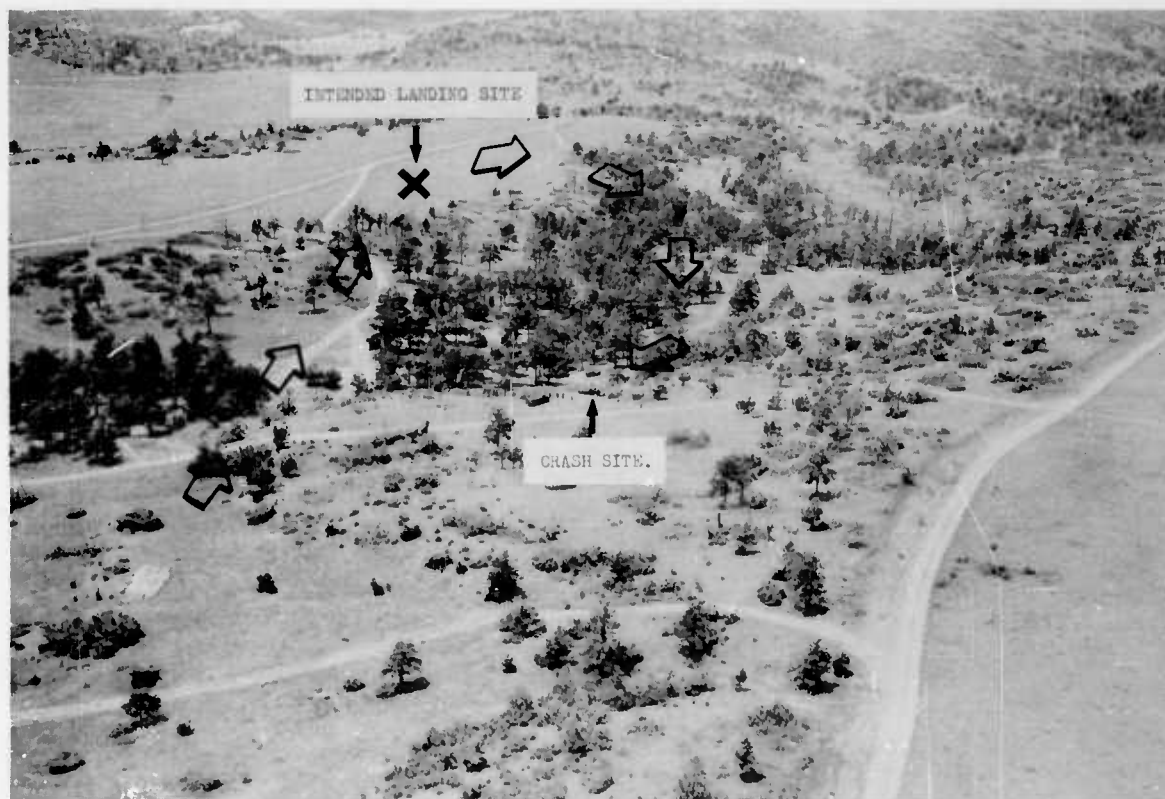
Figure 2. Aerial view showing the flight path, intended landing site and crash site.

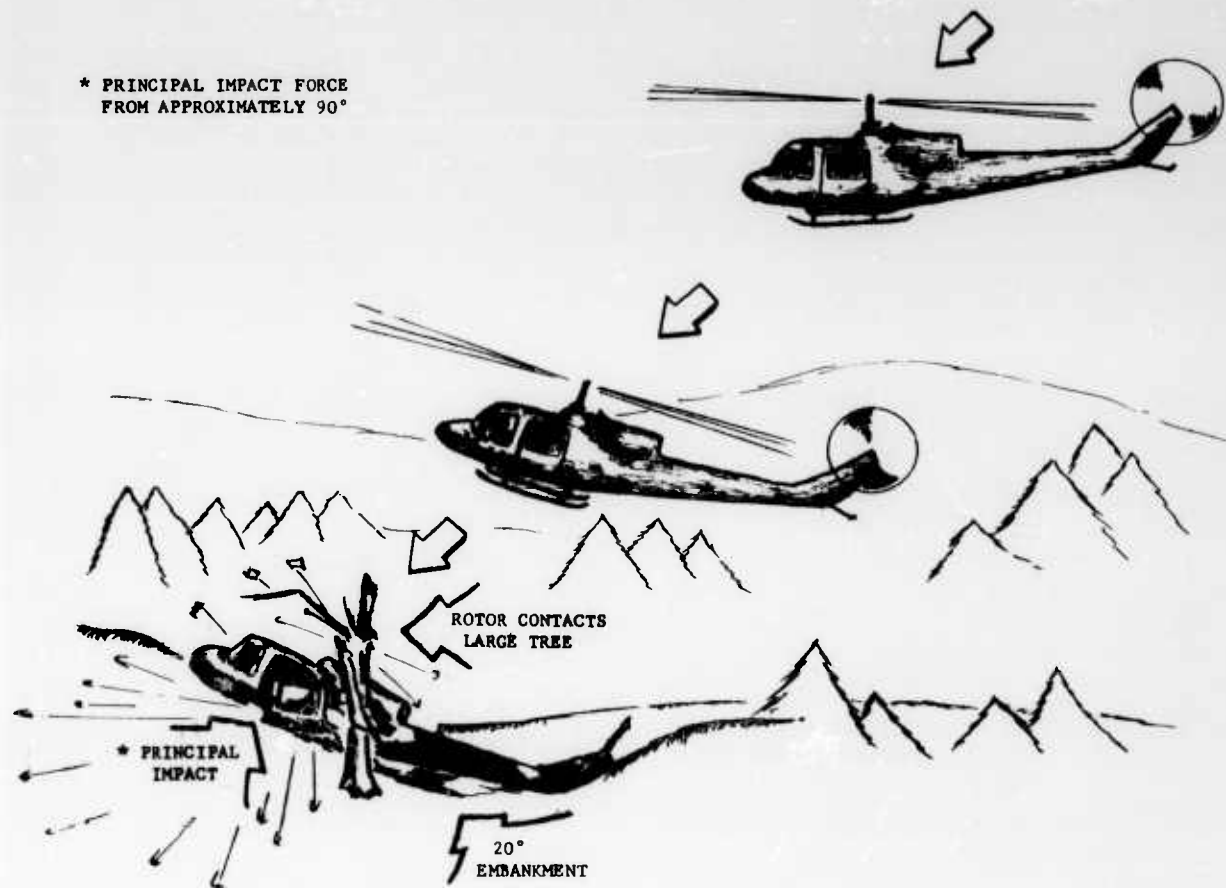
The kinematic behavior of the aircraft during the crash is shown in Figure 3.

Figure 3. Kinematic drawing of the crash sequence

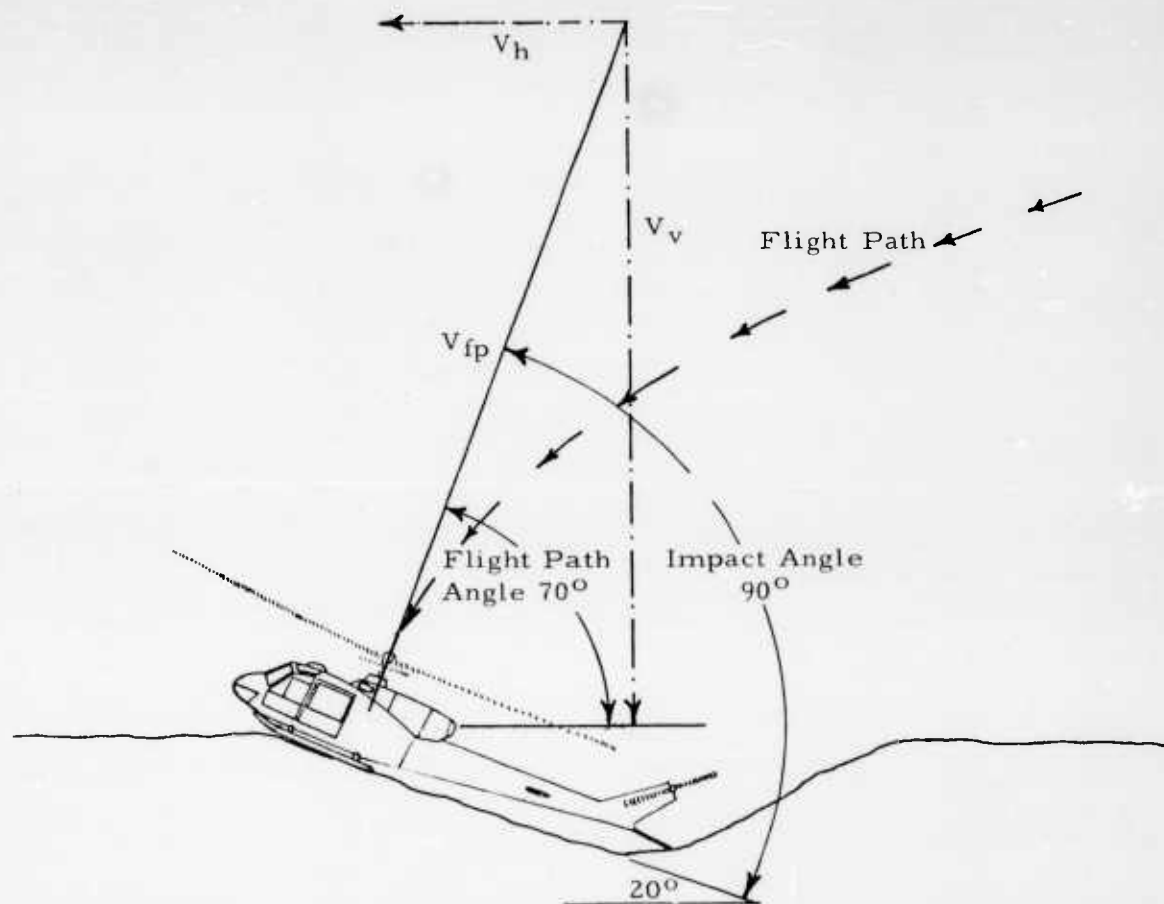
The following illustration presents a graphic description of flight path, terrain, impact angle, stopping distances, velocities, etc.

The most reliable estimate of velocity at the instant of impact was the rate of descent. The investigation determined this to be in the order of 2000 feet per minute (V_v - vertical velocity = 2000 ft./min).
